Your Ref: TP/IP/52477/2018
Our Ref : CI/TPD18018433/Z

MECHANICAL INSPECTION REPORT OF MOTORCYCLE JQE 1418

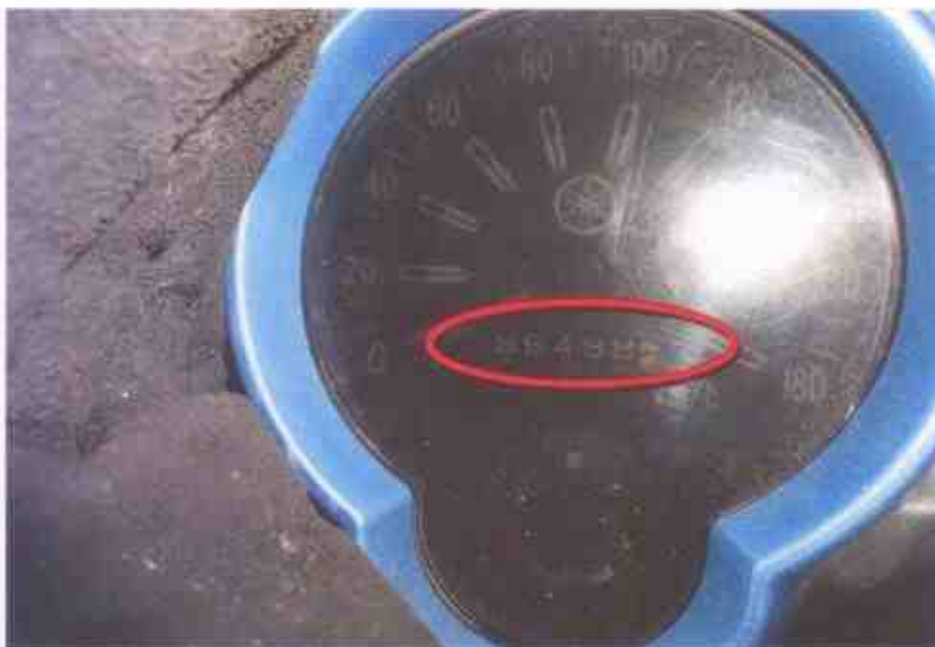
Photo 1 shows the mileage at the time of inspection was recorded to be 964987km.

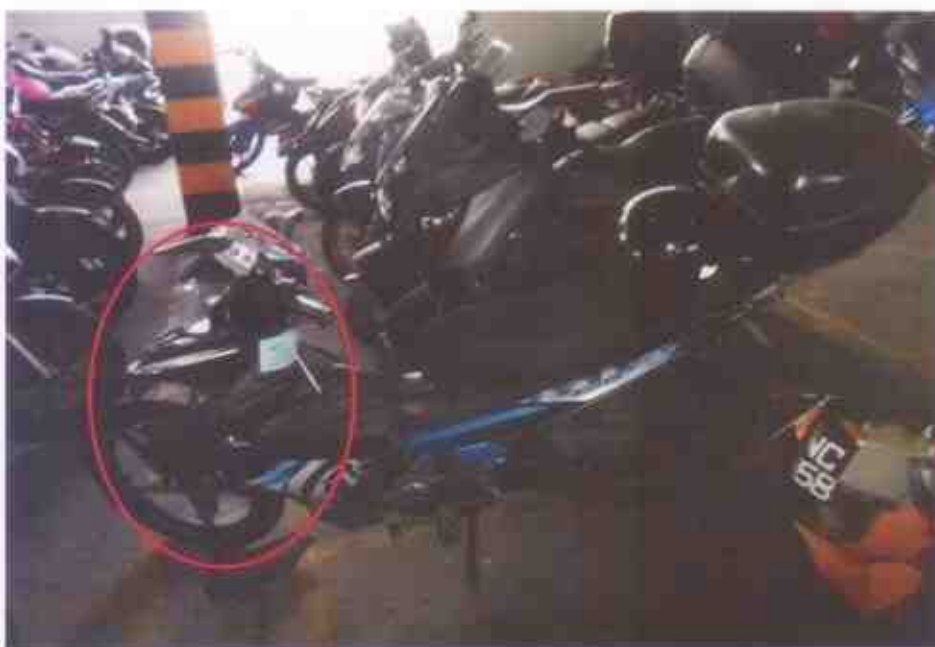
Photo 2 shows a general view of the front left body of the Motorcycle at the time of our inspection. The Motorcycle was observed to be sustained with relatively extensive impact due to the accident collision. Amongst the body parts damaged was its front fork, which was observed to be dislodged from the front wheel.

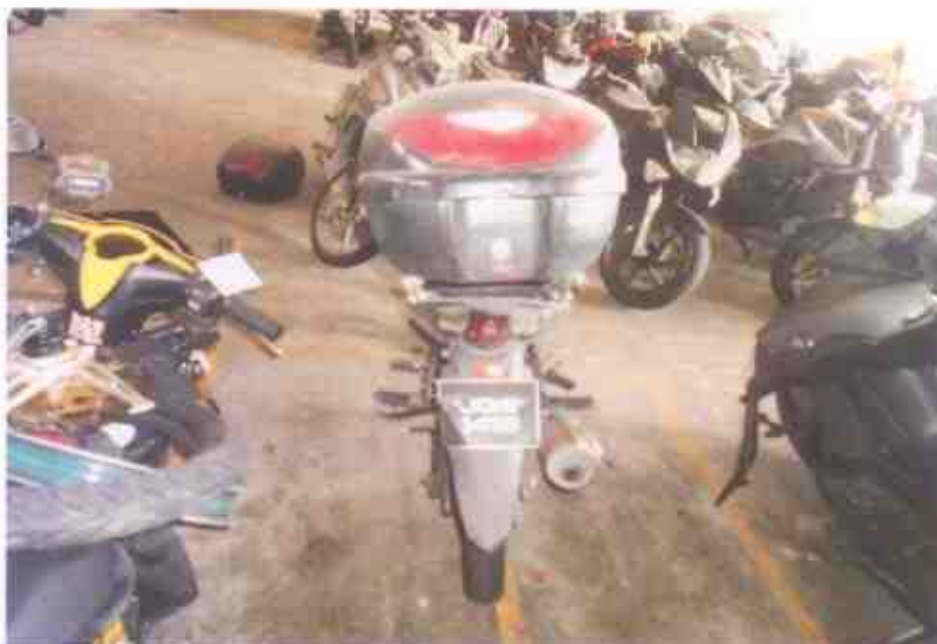
Photo 3 shows a general view of the rear body of the Motorcycle at the time of our inspection. The Motorcycle was observed to be in generally good condition unaffected by the accident.

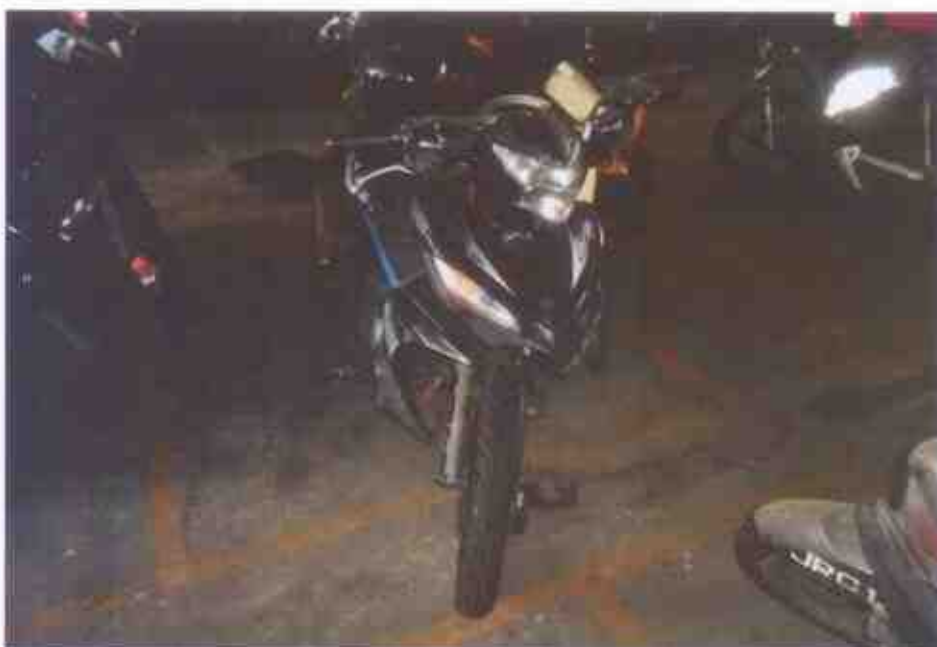
Photo 4 shows a general view of the frontal portion of the Motorcycle at the time of our inspection. The Motorcycle was observed to be sustained with relatively extensive impact due to the accident collision.

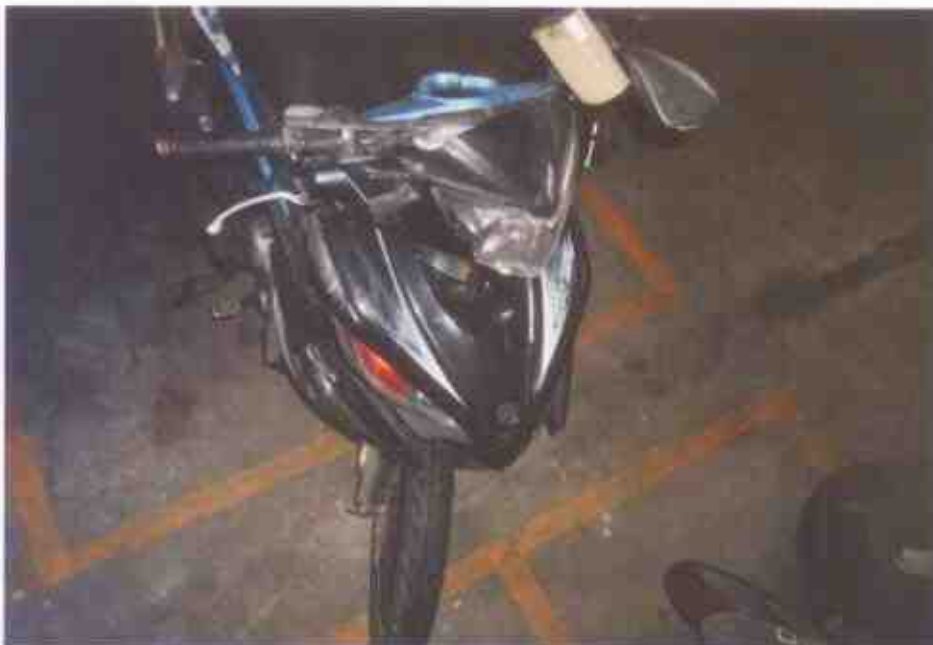
Photo 5 shows a semi close-up view of the frontal portion of the Motorcycle at the time of our inspection. The Motorcycle was observed to be sustained with relatively extensive impact due to the accident collision.

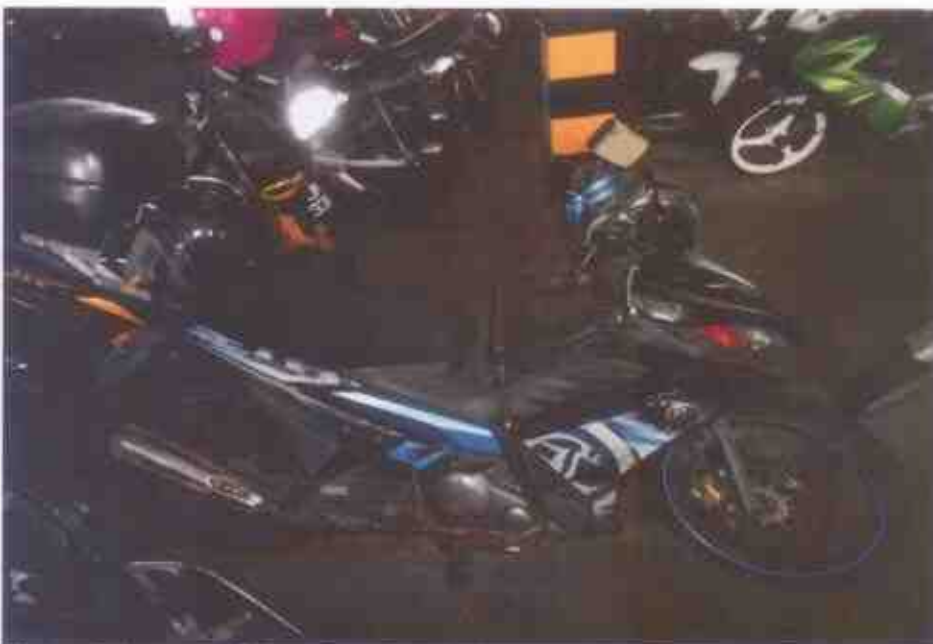
Photo 6 shows a general view of the front right portion of the Motorcycle at the time of our inspection. The Motorcycle was observed to be sustained with relatively extensive impact due to the accident collision.

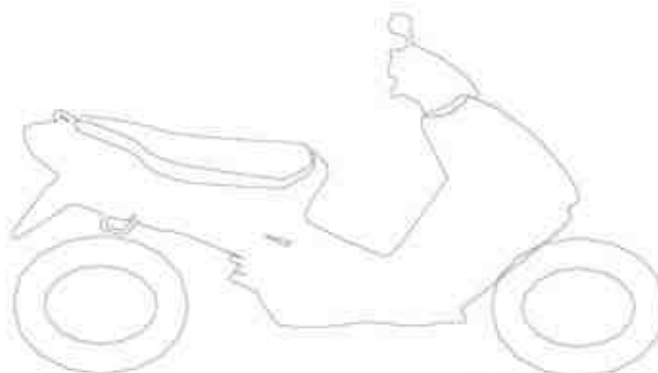
Metzeler Sportee Street
80/90 - 17 (5mm)

Maxxis Diamond MA-3D
70/90 - 17 (3mm)-(Deflated –
torn mark on the left side near to
the wheel rim area)

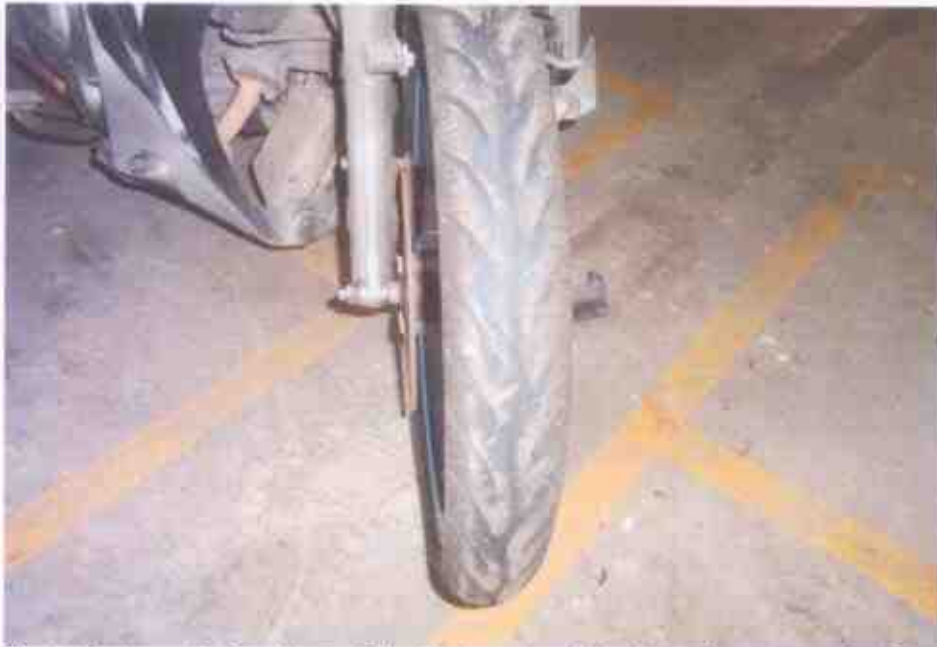
Photo 7 shows the front tyre of the Motorcycle at the time of our inspection. The front tyre was observed to be deflated with remaining tread depth of approximately 3mm as a result of the accident.

20. Whereas the front tyre was found to be deflated & have sustained with torn mark on the left side of the front tyre near to the wheel rim due to the accident impact. However, the tread pattern of the front tyre was clearly visible with remaining tread depth of approximately 3mm.

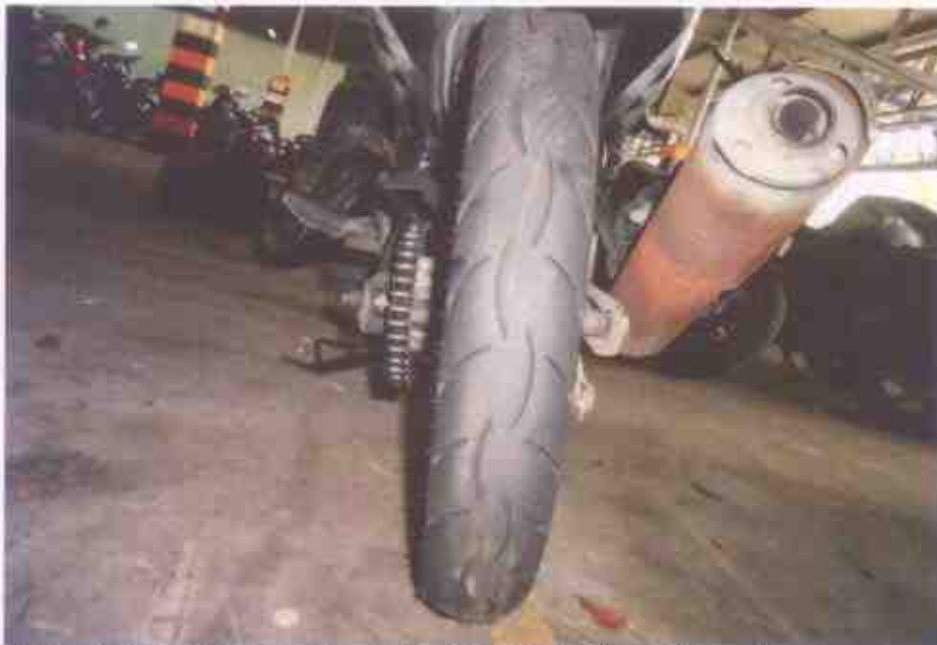
Photo 8 shows the rear tyre of the Motorcycle. The pattern of the tread was clearly visible with remaining tread depth of about 5mm. There was no tear, burst mark(s) and/or punctured hole(s) on the sidewalls as well as across the tread of the rear tyre unaffected by the accident's impact collision.

19. The rear tyre of the Motorcycle was found to be in a serviceable condition. There was no tear, cut or burst mark(s) on the outer and the inner sidewalls as well as across the tread of the tyre. It was sufficiently inflated for vehicular operation with remaining tread depth of approximately 4mm.

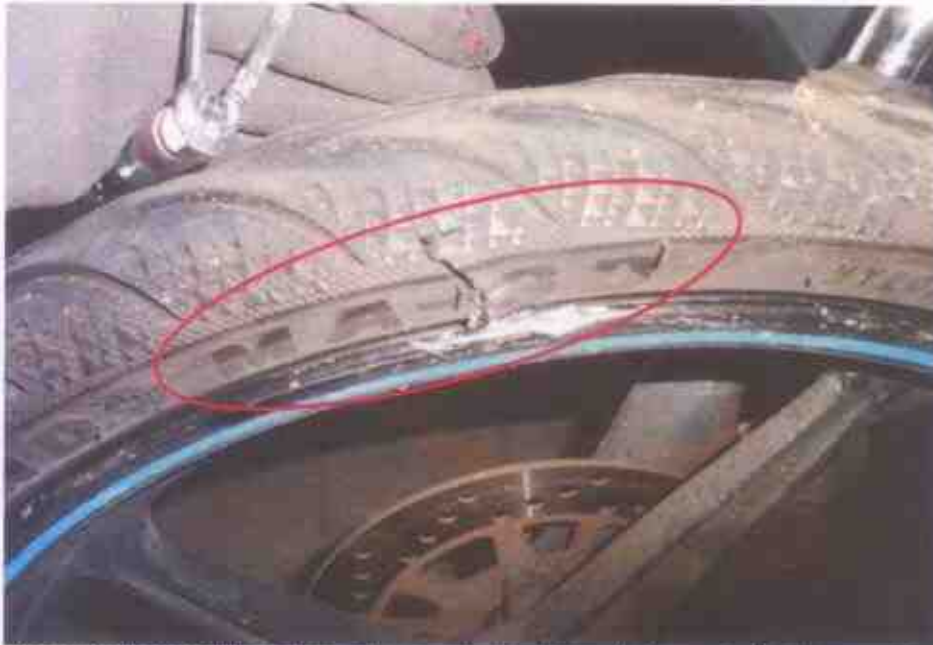
Photo 9 shows further observation on the front tyre that was deflated caused by torn mark at time of our inspection due to the accident's collision impact.

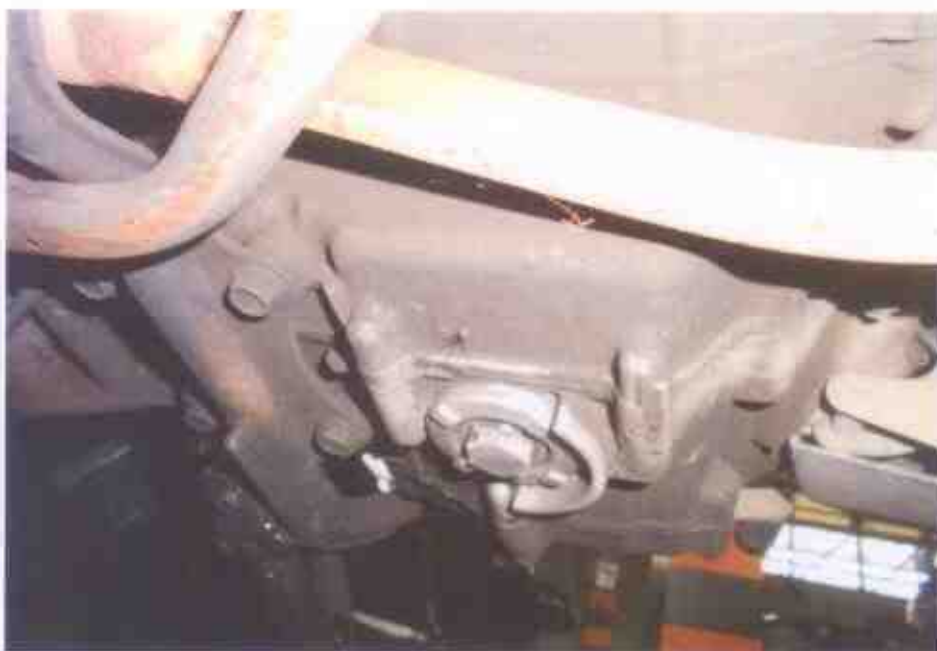
Photo 10 shows the undercarriage of the Motorcycle's engine. No signs or indication of any engine leakage at time of our inspection.

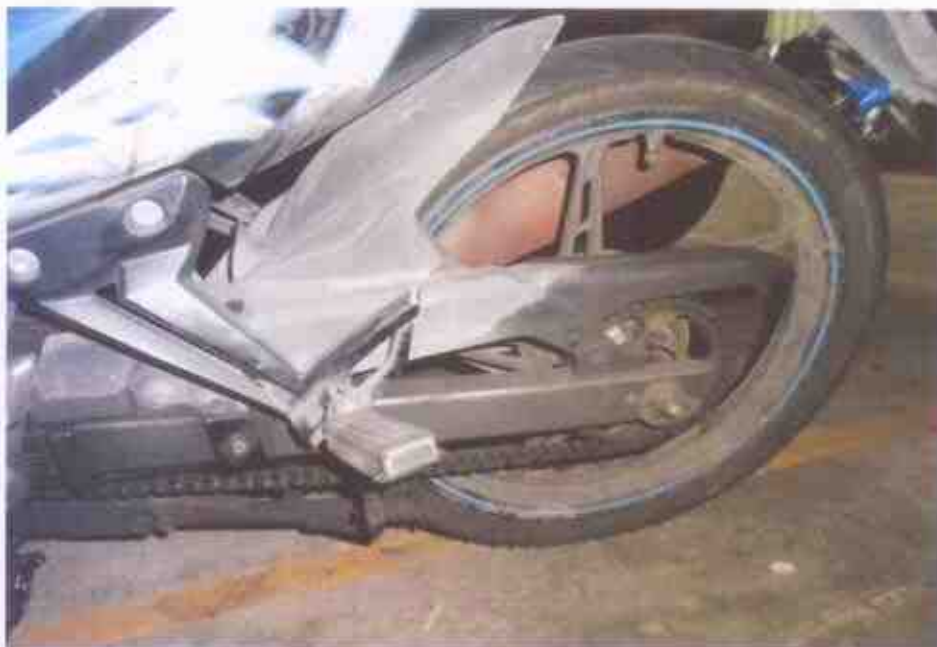
Photo 11 shows the general view of the gear train (arrowed) of the Motorcycle, which was observed to be intact with no misalignment. It was also adequately lubricated for operating purposes.

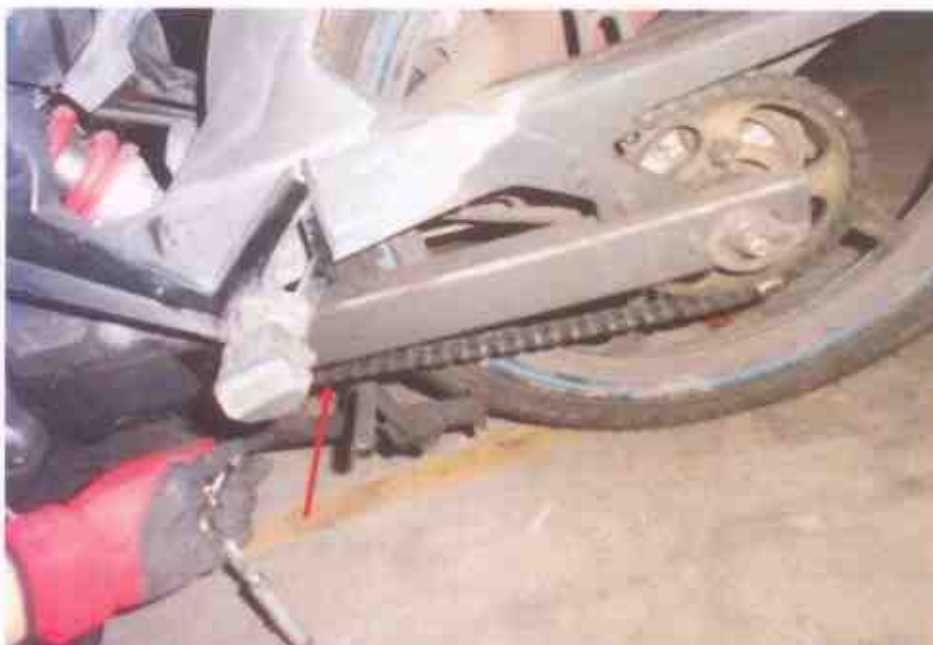
Photo 12 shows the general view of the gear train (arrowed) of the Motorcycle, which was observed to be intact with no misalignment. It was also adequately lubricated for operating purposes. Free play tension was also observed & found adequately acceptable.

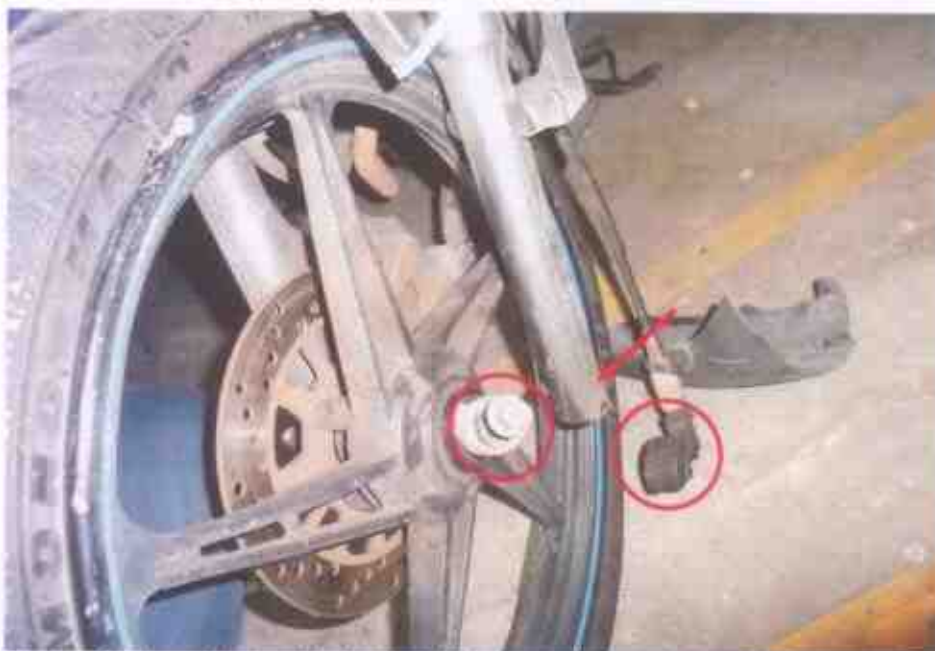
13. For this case, we were not able to conduct any test(s) on the steering system of the Motorcycle due to the damage on its front fork. The front fork was found to be dislodged from the front wheel as a result of the accident, hence causing the whole steering system to be in a state of immobility.
14. The brake system of the Motorcycle was of a semi-hydraulic type, where hydraulic (brake fluid) pressure controls the brake for the front wheel while the brake for the rear wheel is controlled by mechanical means (cables and springs). The brake for the front wheel is engaged by pulling the brake lever at the right side of the Motorcycle's handle bar while the brake for the rear wheel is engaged by stepping on the brake pedal at the right side foot rest of the Motorcycle.

Photo 13 shows the front fork (circled & arrowed) was observed to be dislodged as a result of the accident. Hence, we are not able to conduct any tests on the steering system of the Motorcycle.

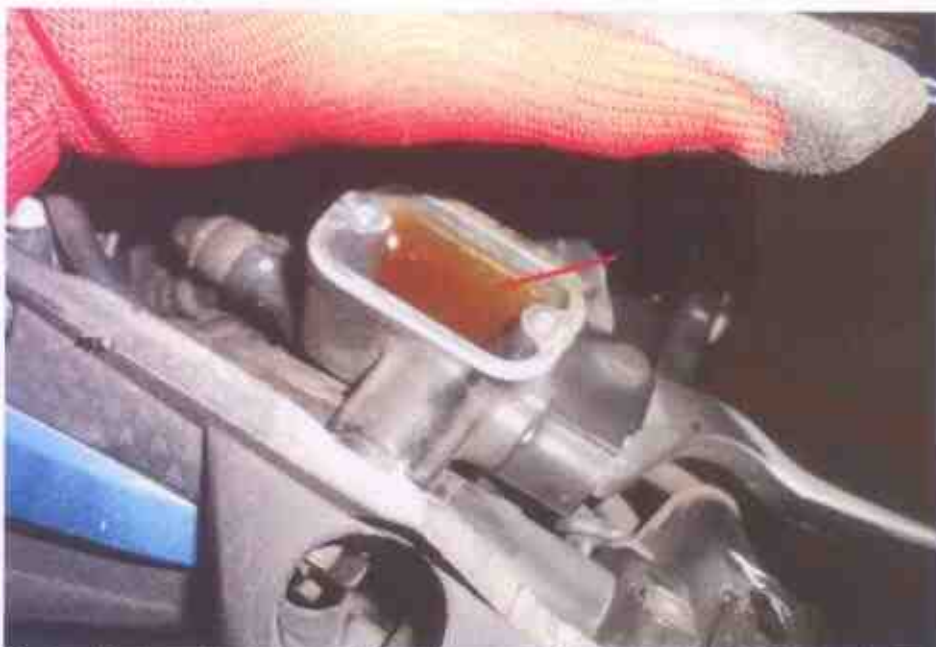
Photo 14 shows the front brake fluid reservoir had indicated that the brake fluid was of sufficient level for operational purposes, and without contamination.

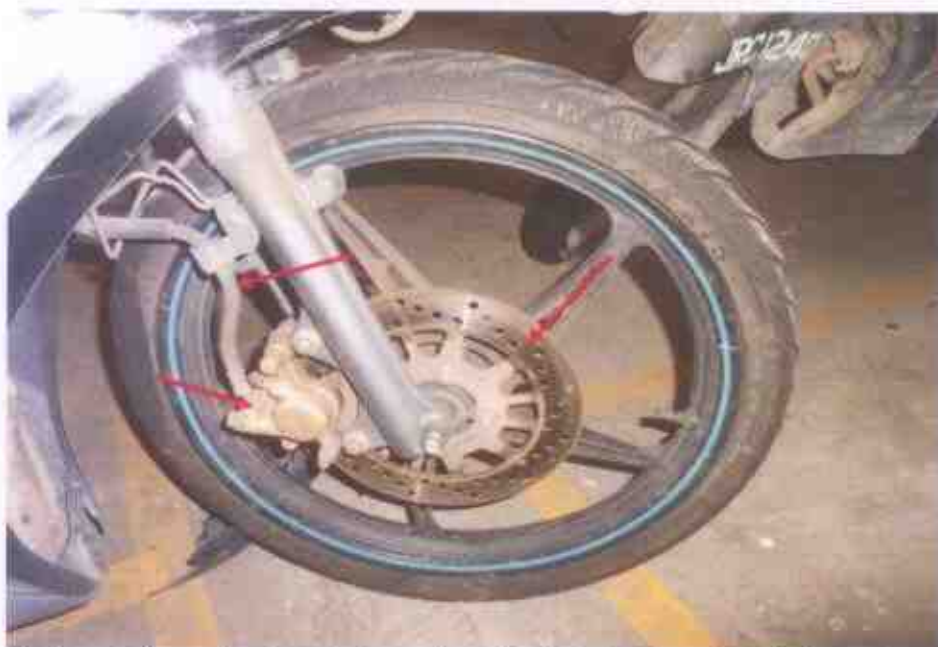
Photo 15 shows the front brake calliper, front brake disc, front brake pad and front brake hose of the Motorcycle, which are all part of the components in the front brake system of the Motorcycle. Our observation found that the front braking components were unaffected by the accident.

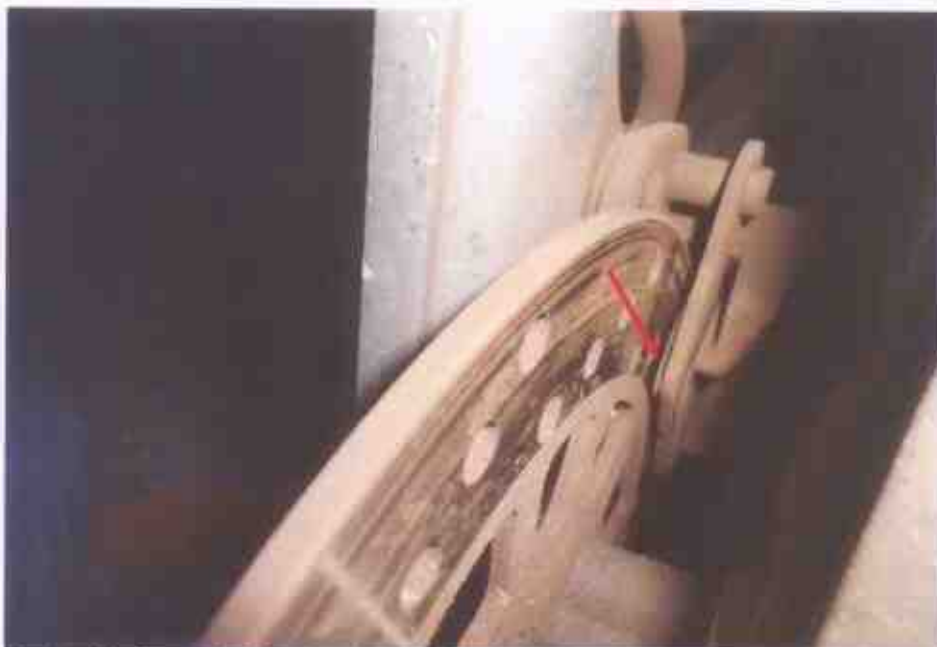
Photo 16 shows the front brake pad of the Motorcycle (arrowed), which are part of the components in the front brake system of the Motorcycle reveal to be adequately sufficient for operational purposes.

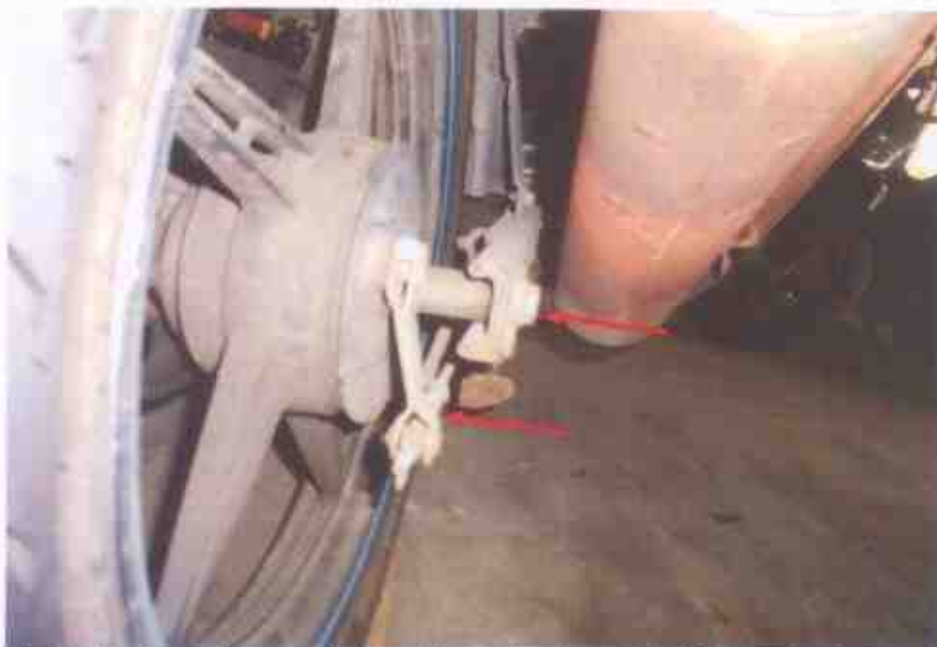
Photo 17 shows the rear brake cable and spring of the Motorcycle (arrowed), which are all part of the components in the rear brake system of the Motorcycle reveal all to be intact and without damage.
