Your Ref: TP/IP/51657/2018  
Our Ref :CI/TPD18018436/Z

14<sup>th</sup> November 2018

### **MECHANICAL INSPECTION REPORT OF MOTORCYCLE FBM 8439Z**

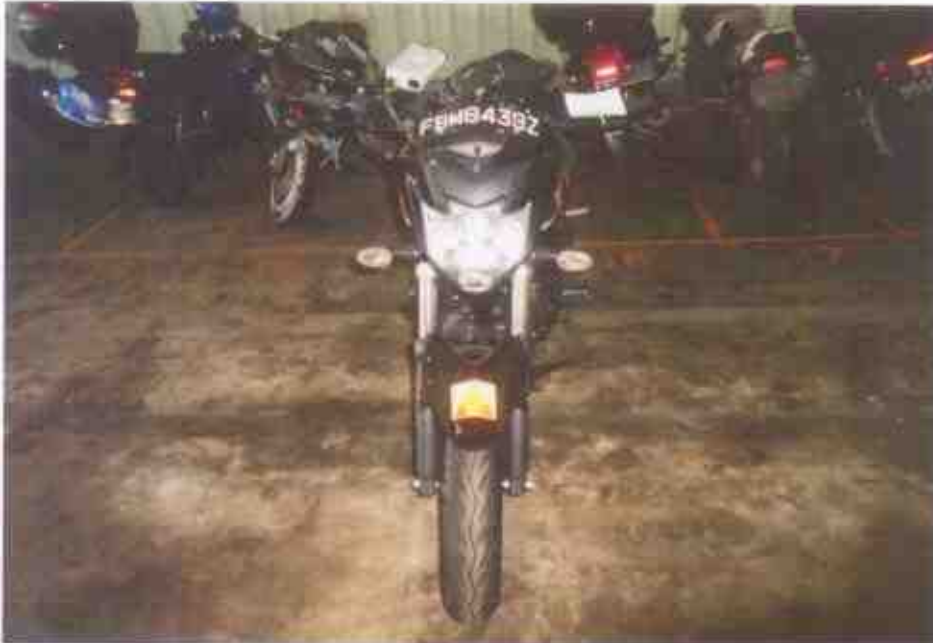
4. The mileage of the Motorcycle was not recorded due to the malfunction of the electronic ignition system likely due to the accident's impact.
5. The Motorcycle was observed to have sustained minor damages at the frontal portion. The body part that was found to have been damaged was the front fairing amongst others as a result of the accident.
6. This was likely due to the consistency of the accident's case facts that the Motor Cycle was travelling along Yishun Avenue 9 towards Avenue 8 when a pedestrian crossed from the right to left of Motor Cycle thus both collided. See photo 1 to 5 below.

**Photo 1** shows a general view of the front body of the Motorcycle at the time of our inspection. The Motorcycle was observed to have sustained relatively minor damages at time of inspection. The damages were observed to be confined to its front fairing.

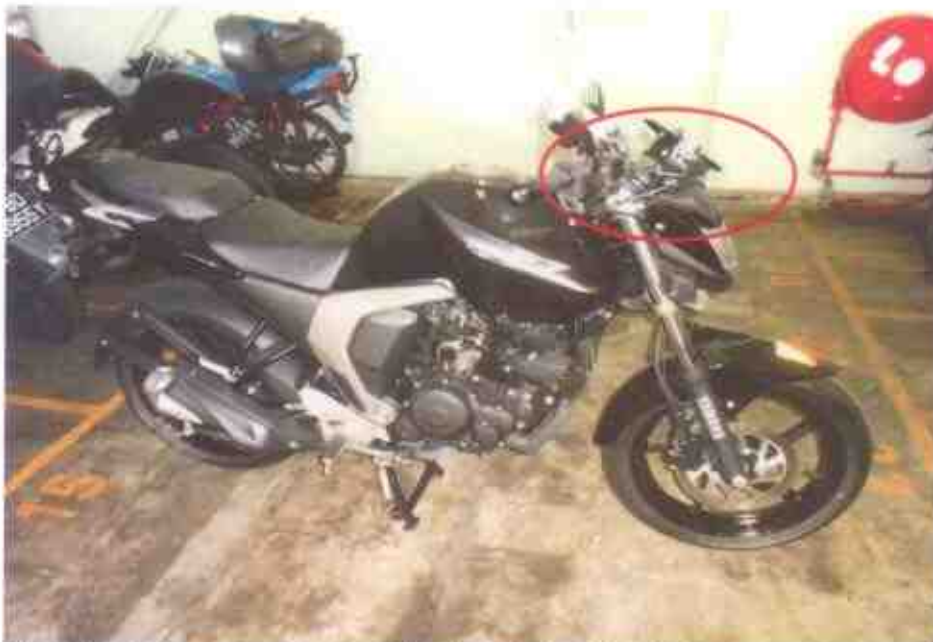
**Photo 2** shows a general view of the right body of the Motorcycle at the time of our inspection. The Motorcycle was observed to be in good condition unaffected by the accident.

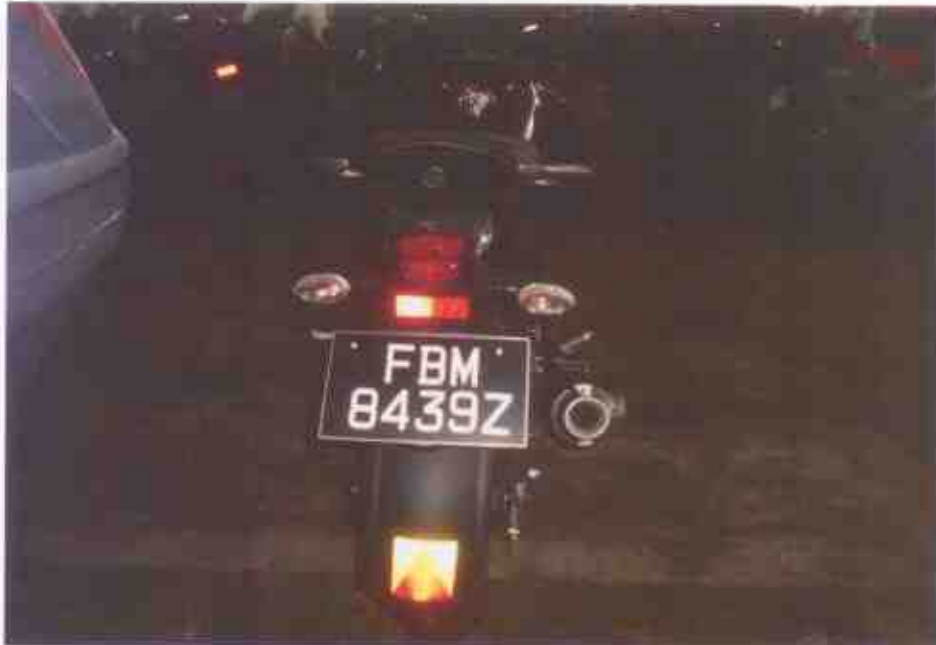
**Photo 3** shows a general view of the rear body of the Motorcycle at the time of our inspection. The Motorcycle was observed to be in good condition unaffected by the accident.

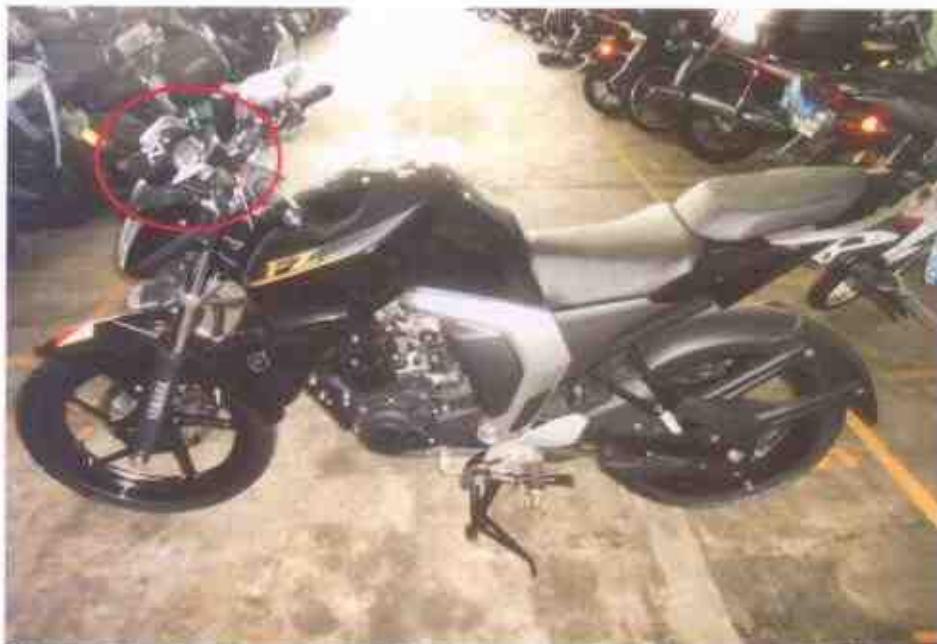
**Photo 4** shows a general view of the left body of the Motorcycle at the time of our inspection. The Motorcycle was observed to be in good condition unaffected by the accident.

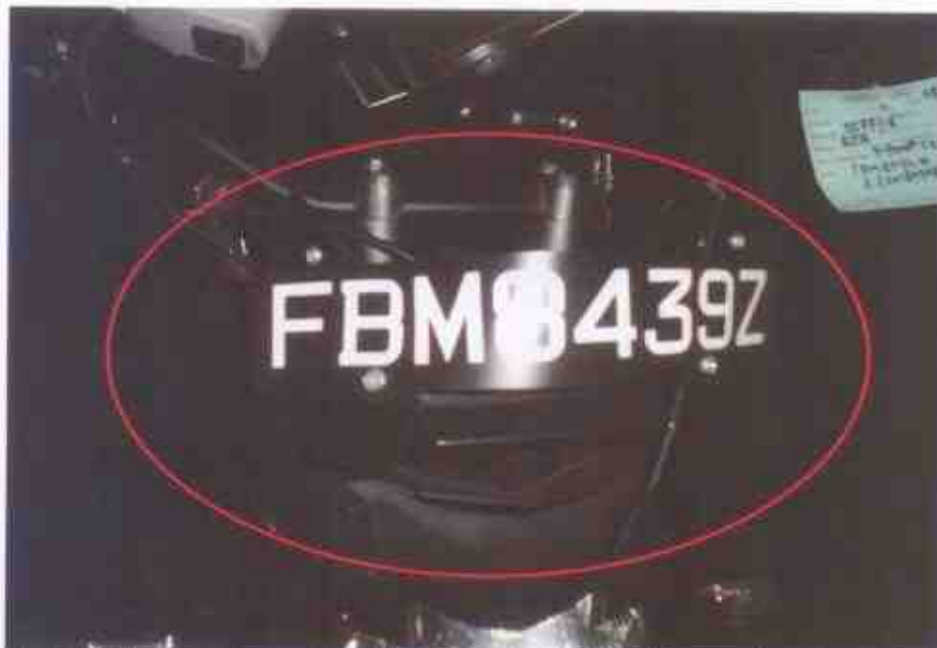
Photo 5 shows a closer view of the front fairing of the Motorcycle at the time of our inspection. The Motorcycle was observed to have sustained with relatively minor damages due to the accident collision. (Circled)

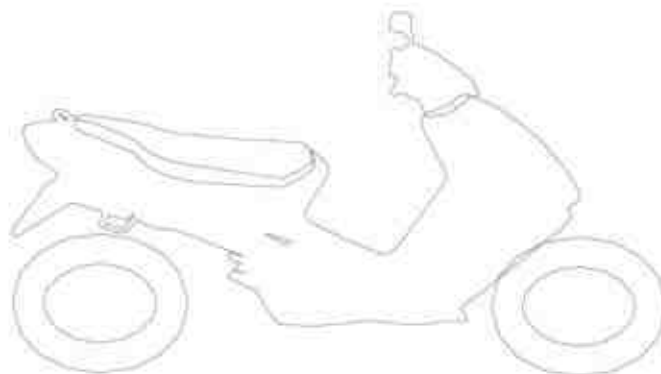
7. The condition of the Motorcycle's 2 tyres was observed to be in serviceable condition. The tread pattern of the 2 tyres was clearly visible. We did not observe any tear, burst mark(s) and/or punctured hole(s) on the sidewalls as well as across the tread of the 2 tyres. The 2 tyres were both observed to be sufficiently inflated for vehicular operation. The tyre brand, tyre size and remaining tread depth of the 2 tyres were recorded as follows:-

MRF Revz-y  
140/60 - R17 (4mm)

MRF Nylon Grip Zap  
100/80 - R17 (5mm)

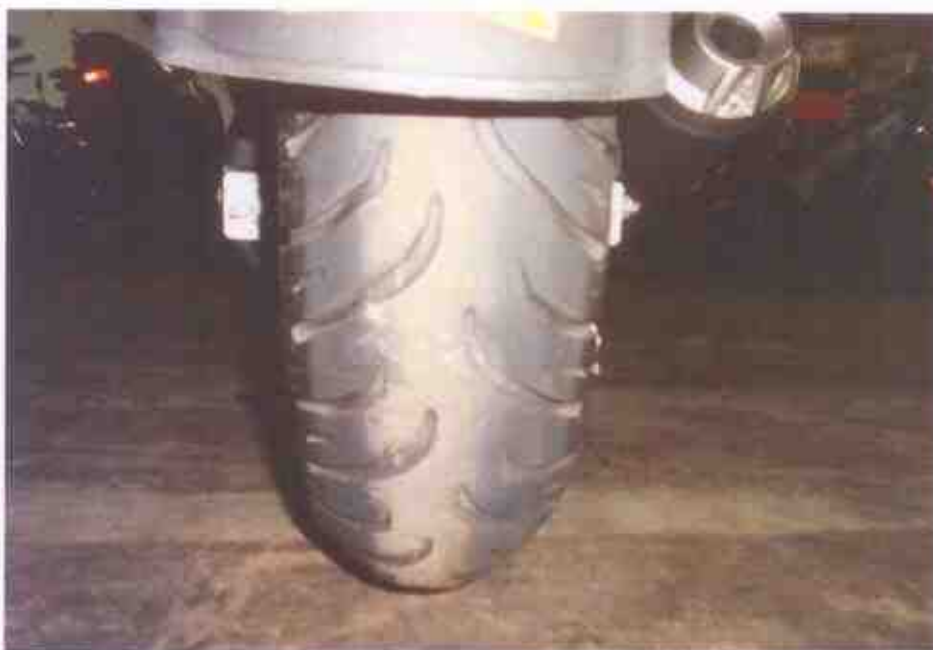
**Photo 6** shows the rear tyre of the Motorcycle. The rear tyre was observed to be in serviceable condition with remaining tread depth of approximately 4mm. The tyre was also observed to be sufficiently inflated for vehicular operation.

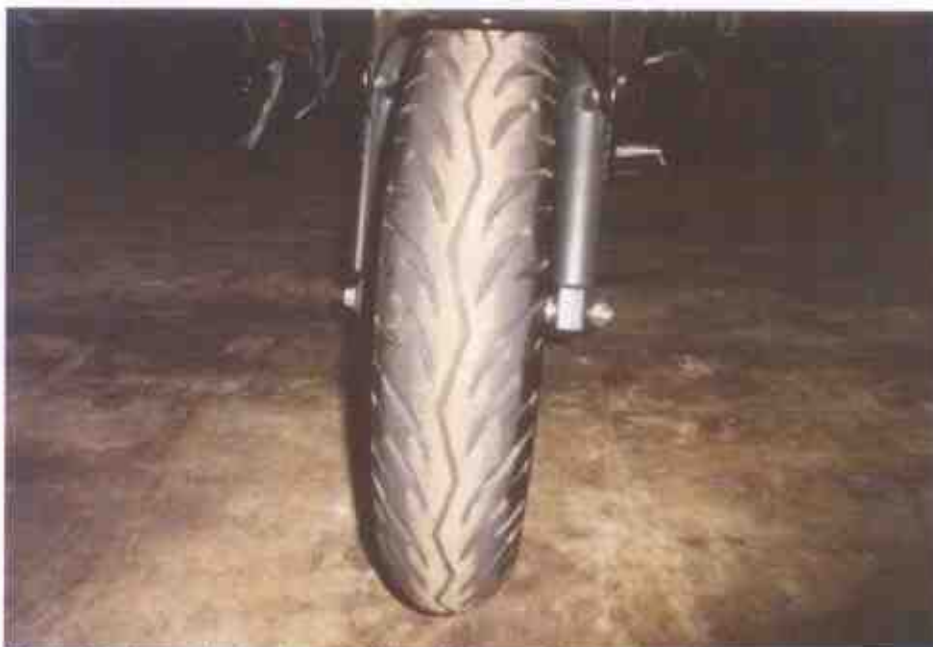
**Photo 7** shows the front tyre of the Motorcycle. The front tyre was observed to be in serviceable condition with remaining tread depth of approximately 5mm. The tyre was also observed to be sufficiently inflated for vehicular operation.

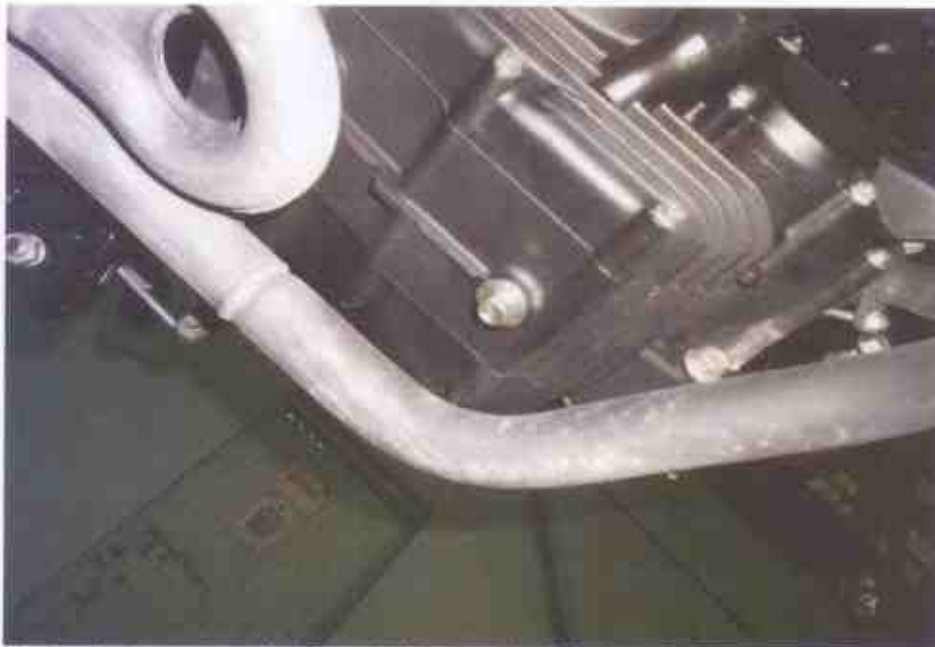
Photo 8 shows no sign(s) or indication(s) of fluid leak observed around the underside of the engine area of the Motorcycle.

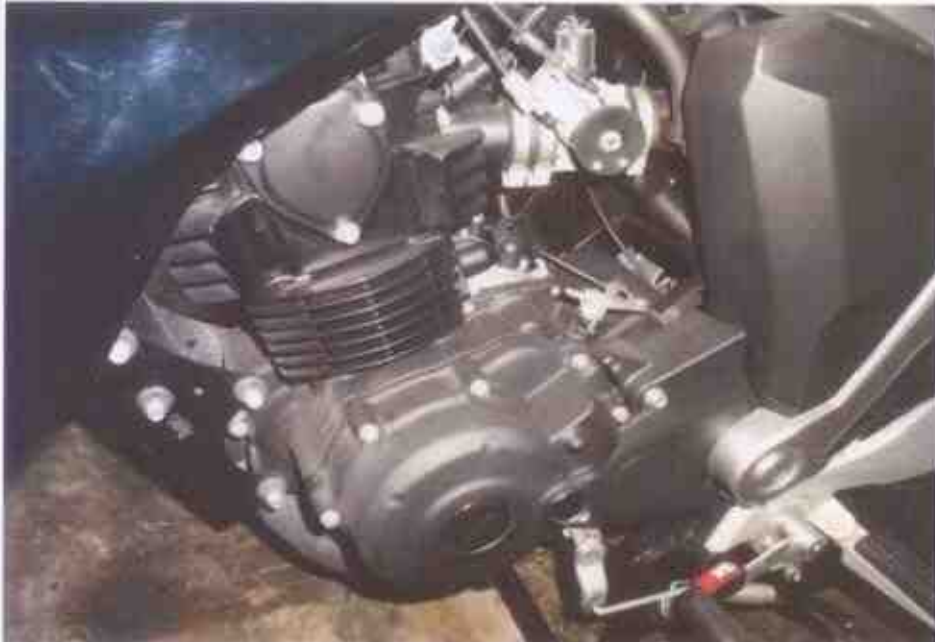
**Photo 9** shows no sign(s) or indication(s) of fluid leakage stain observed around the engine area of the Motorcycle.

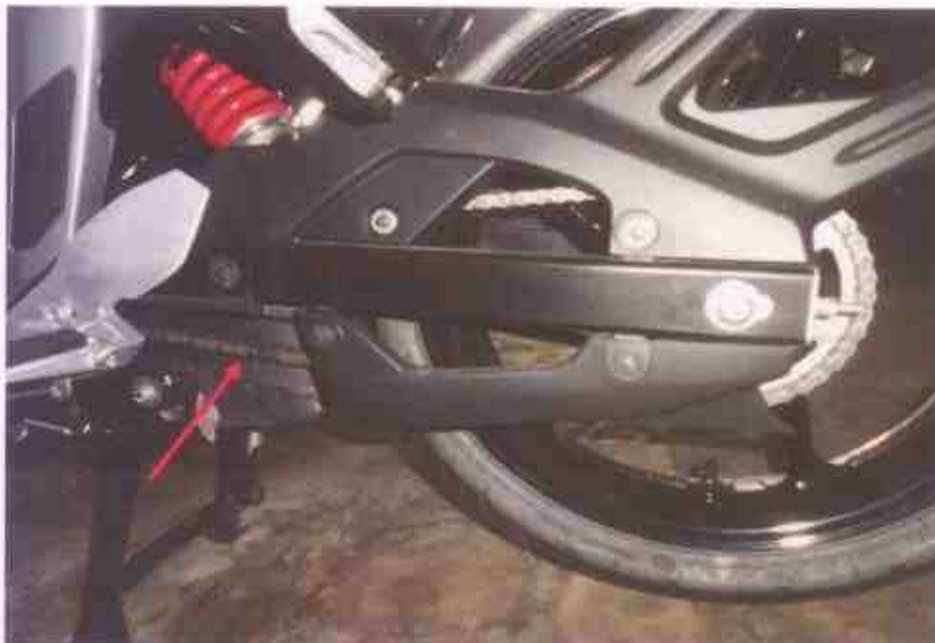
**Photo 10** shows the general view of the gear train (arrowed) of the Motorcycle, which was observed to be intact with no misalignment. It was also adequately lubricated for operating purposes.

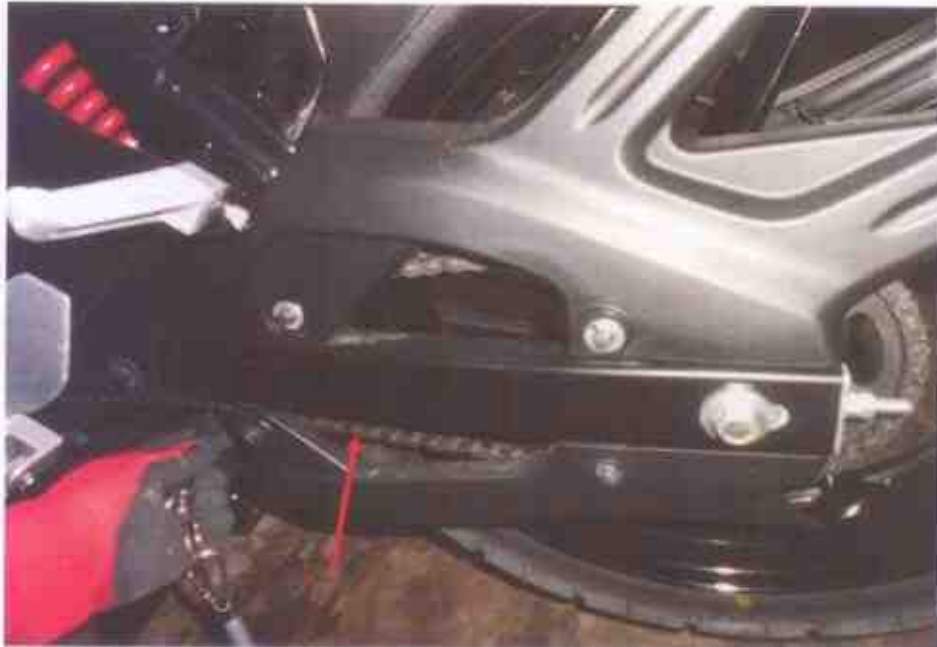
Photo 11 shows the general view of the gear train (arrowed) of the Motorcycle, which was observed to be intact with no misalignment. It was also adequately lubricated for operating purposes. Free play tension was also observed & found adequately acceptable.

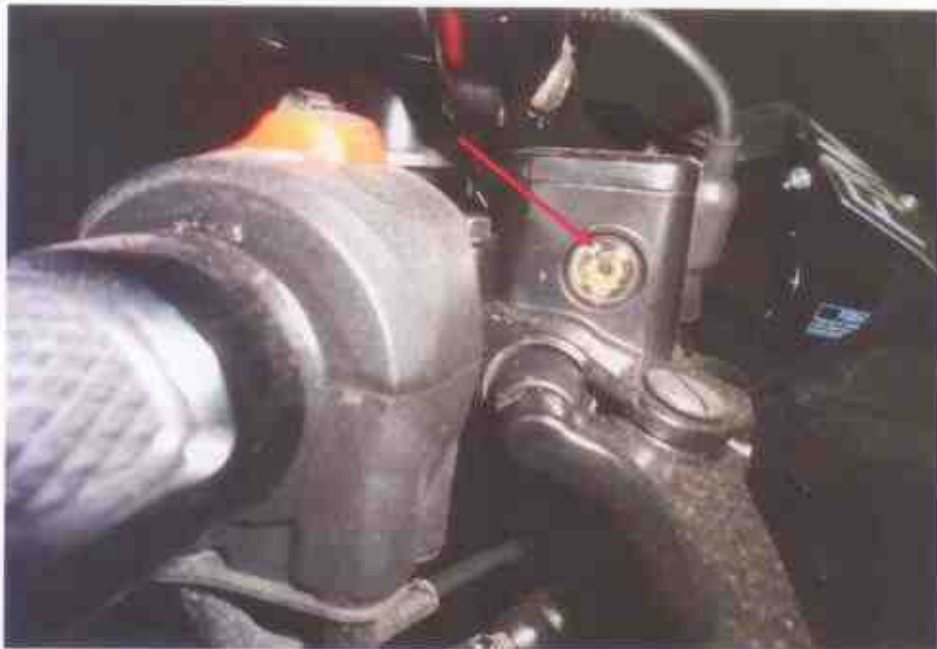
Photo 12 shows our checks on the brake fluid (front) reservoir had also indicated that the brake fluid was of sufficient level for operational purposes, and without contamination.

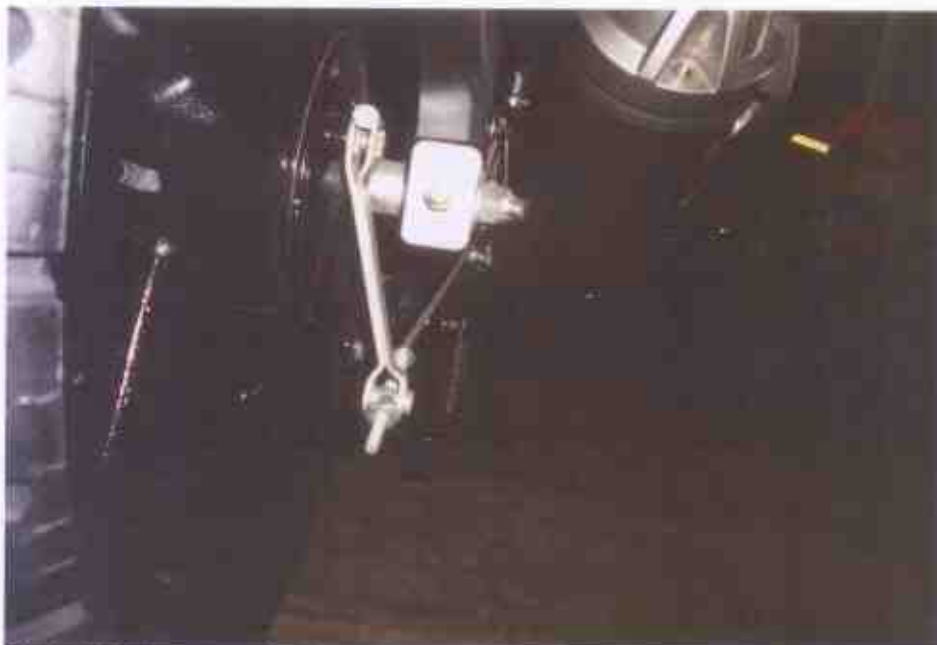
Photo 13 shows our checks on the rear brake components. It had also indicated that the rear brake was serviceable for operational purposes.

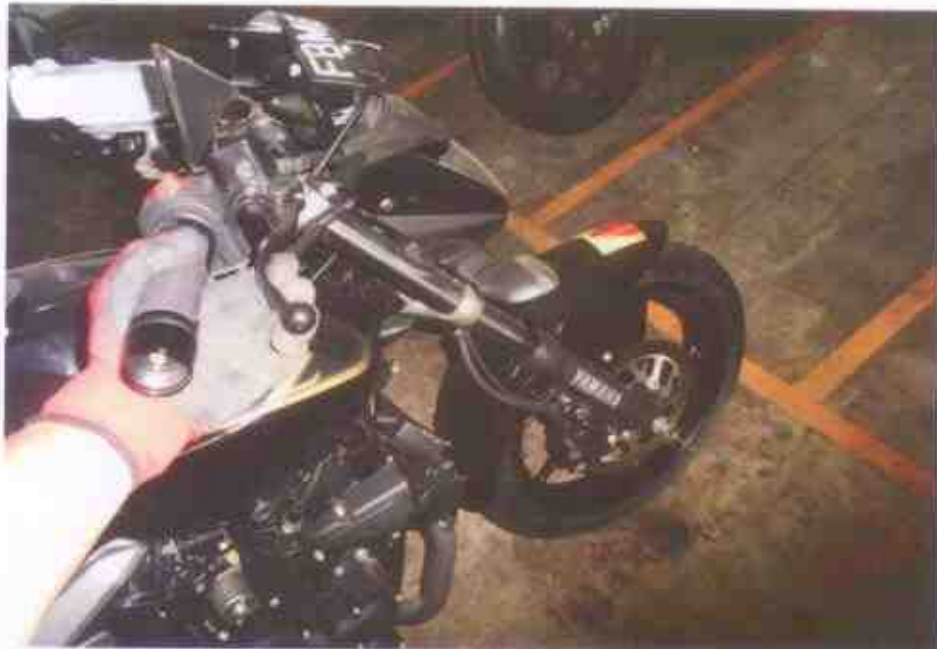
**Photo 14** shows testing of the braking of the front brake in progress. There was some resistance felt (spongy like feel) upon pressing the brake lever.

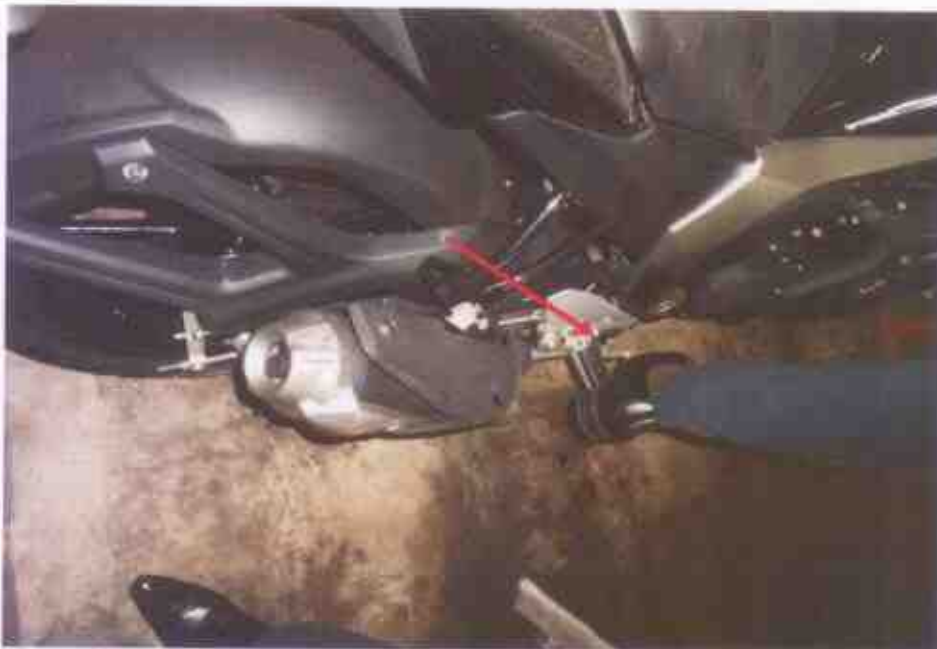
**Photo 15** shows testing of the braking of the rear brake in progress. There was some resistance felt (spongy like feel) upon stepping on the brake pedal.

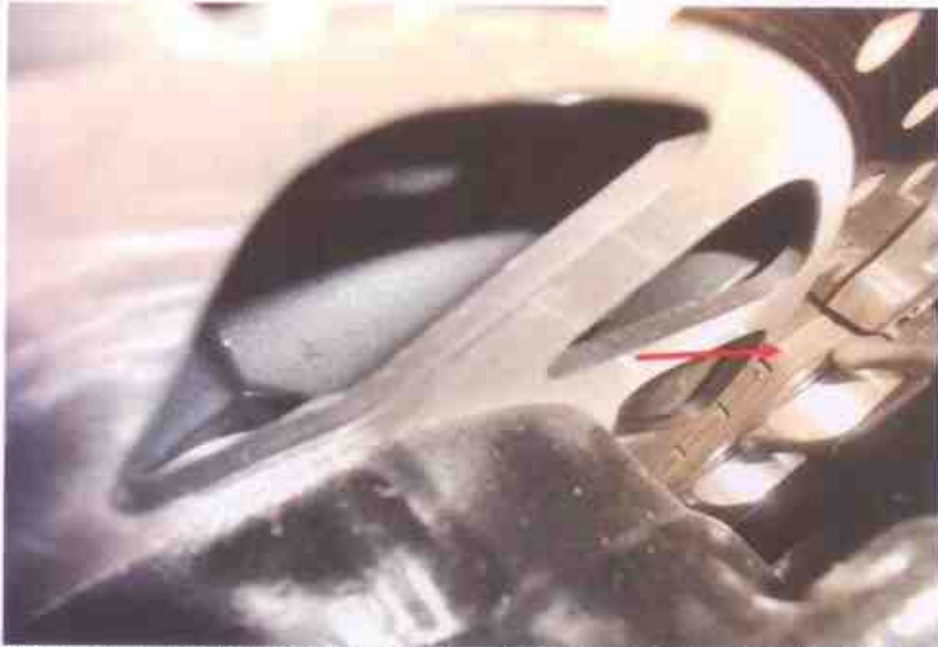
Photo 16 shows the front brake pad at time of our inspection. The frictional material was observed to be sufficient for operational purposes.
