Your Ref: TP/IP/53769/2018
Our Ref :CI/TPD18018437/Z

19th November 2018

MECHANICAL INSPECTION REPORT OF MOTORCYCLE JSH 9356

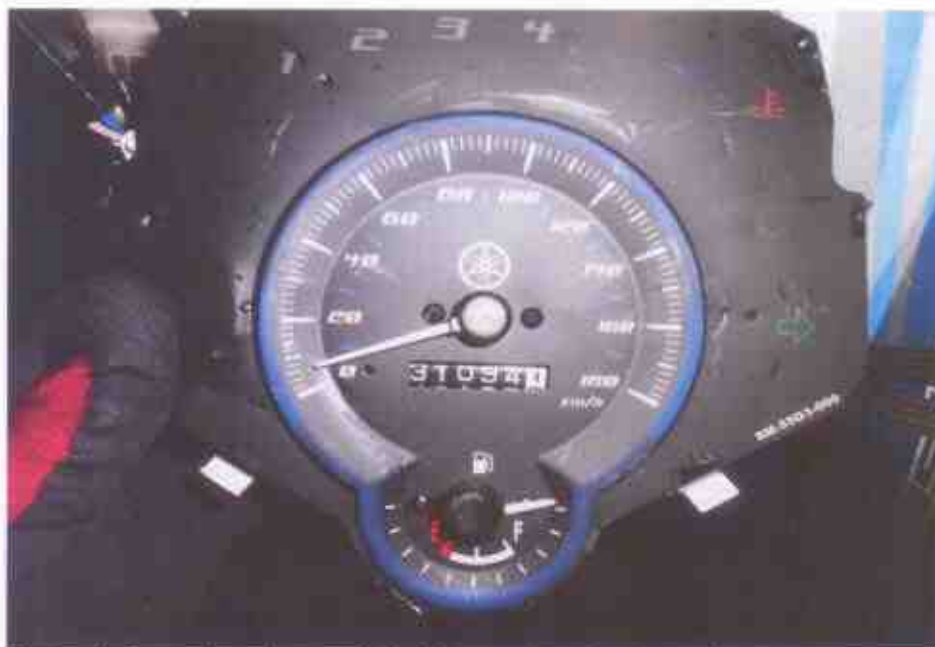
Photo 1 shows the mileage of the Motorcycle at the time of our inspection was recorded at 310941km.

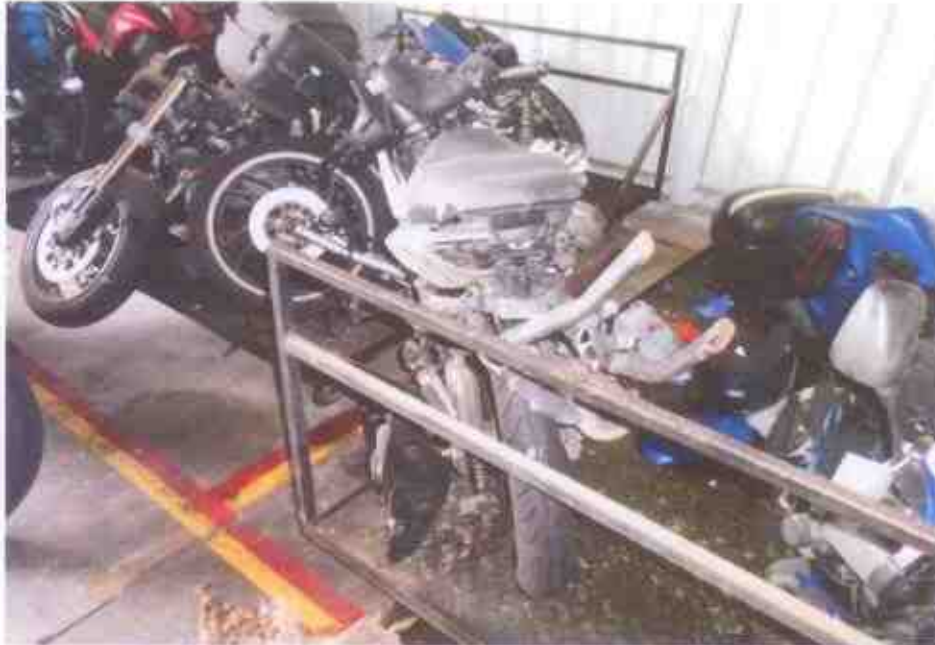
Photo 2 shows the Motorcycle rear portion that was observed to be severely damaged by the accident's impact collision. The rear parts that were observed to be damaged include its rear tail lamp, compartment rack, seat assembly and missing licence plate amongst others.

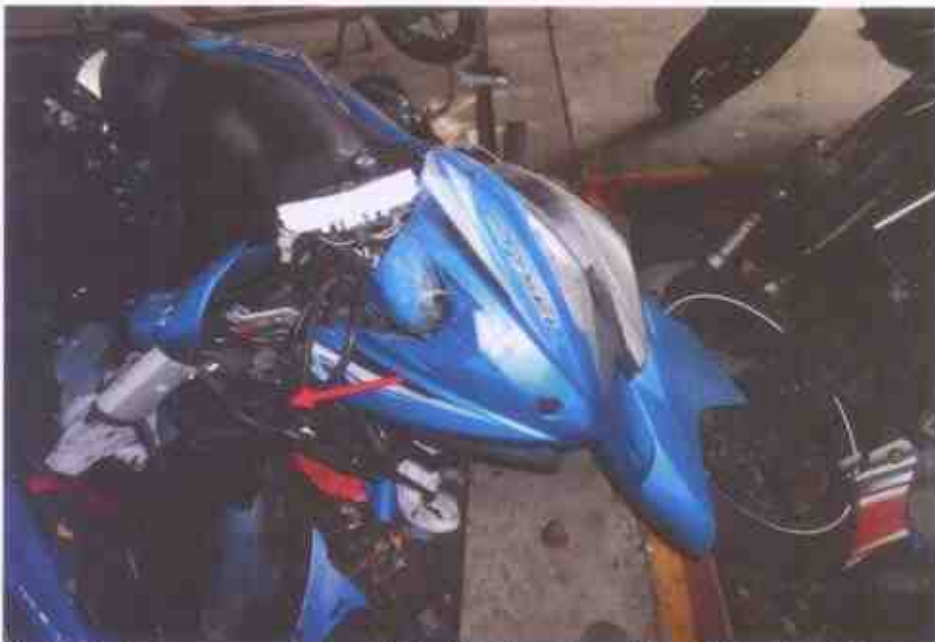
Photo 3 shows a close-up view of the frontal portion of the Motorcycle at the time of our inspection. The Motorcycle was observed to have sustained relatively extensive impact including damages to the steering system due to the accident collision.

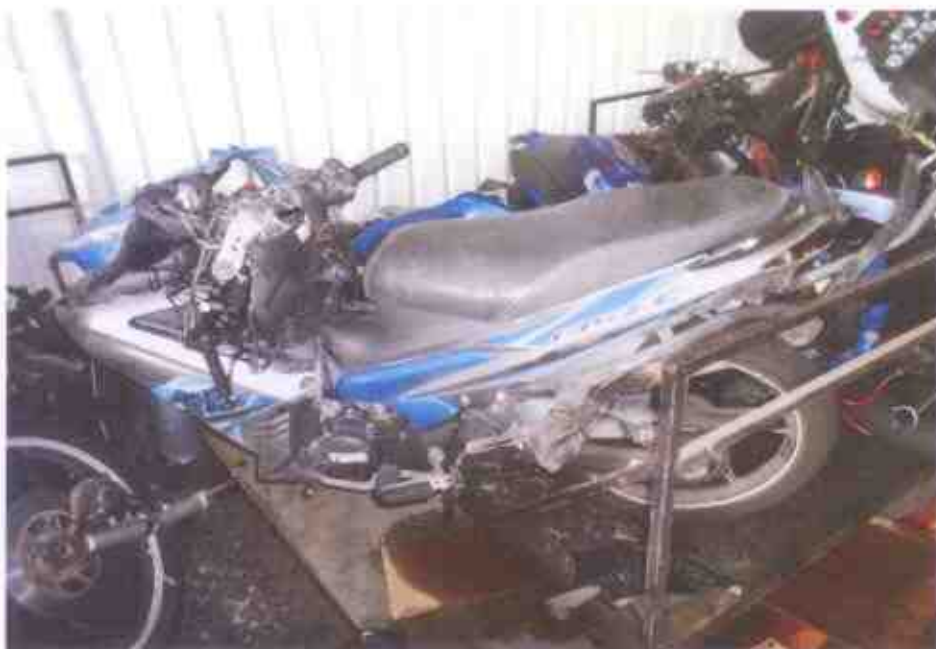
Photo 4 shows a general view of the left body of the Motorcycle at the time of our inspection. The Motorcycle was observed to have sustained damages at the frontal portion, rear portion, along both its left side and right side.

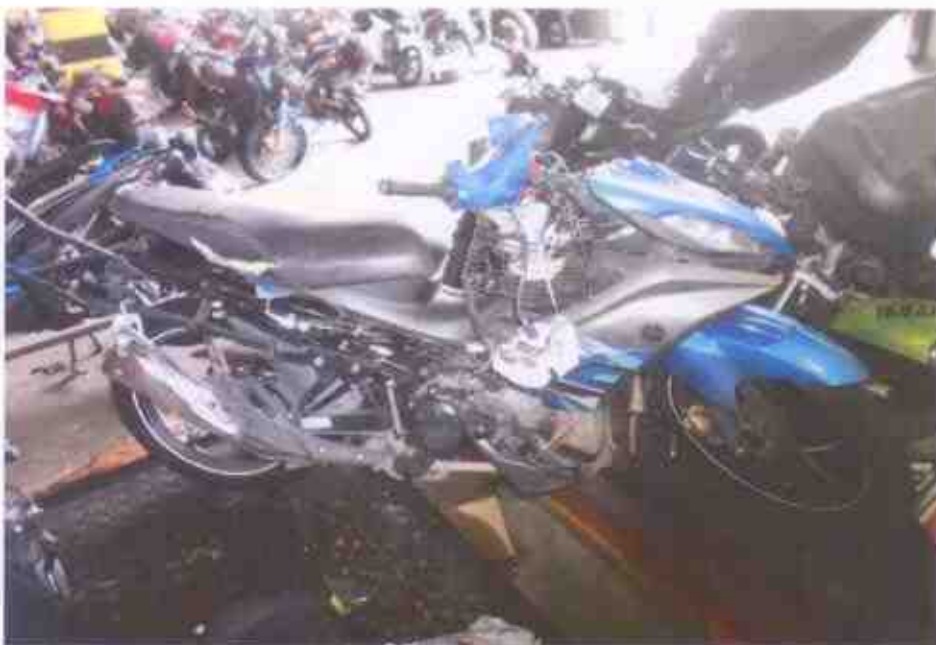
Photo 5 shows a general view of the right portion of the Motorcycle at the time of our inspection. The Motorcycle was observed to have sustained relatively extensive impact due to the accident collision.

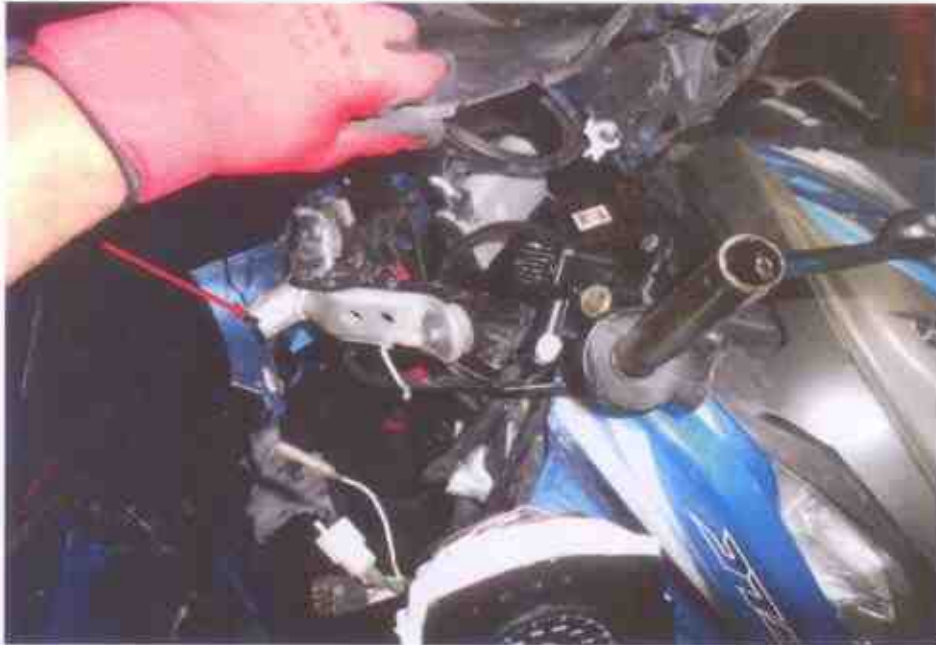
Photo 6 shows a close-up view of the dislodged handle bar. The Motorcycle was observed to have sustained relatively extensive impact including damages to the steering system to the accident collision.

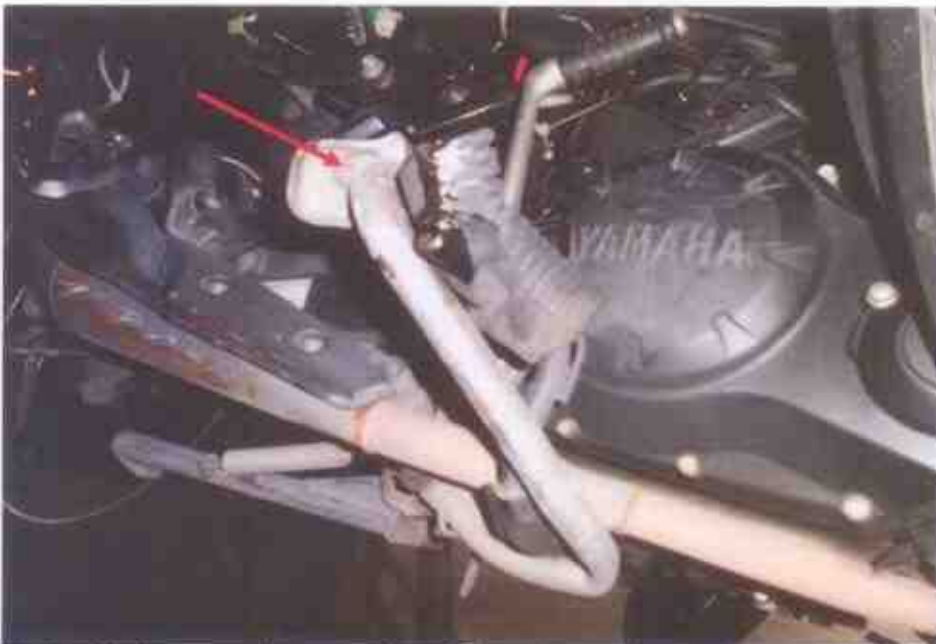
Photo 7 shows a close-up view of the damaged rear brake pedal. The Motorcycle was observed to have sustained relatively extensive impact including damages to the braking system to the accident collision.

13. Braking components such as brake foot pedal for the rear brake was noted to be damaged (buckled inwards) by the accident at the material time of our inspection.

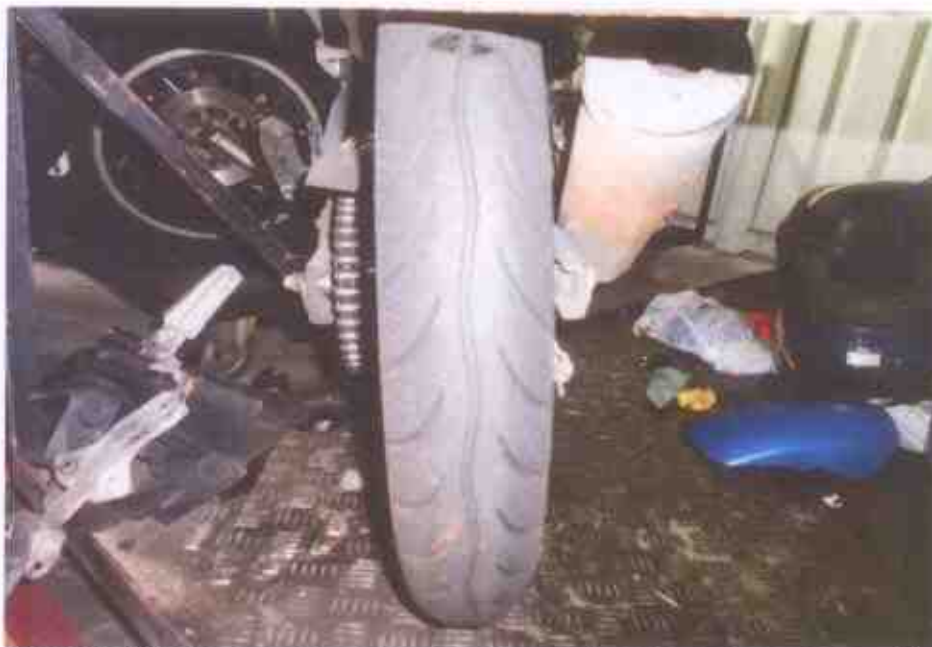
Photo 8 shows the rear tyre of the Motorcycle at the time of our inspection. The rear tyre was observed to be in serviceable condition with remaining tread depth of approximately 5mm. The tyre was also observed to be sufficiently inflated for vehicular operation. There was no significant damage observed on the rear wheel rim & tyre.

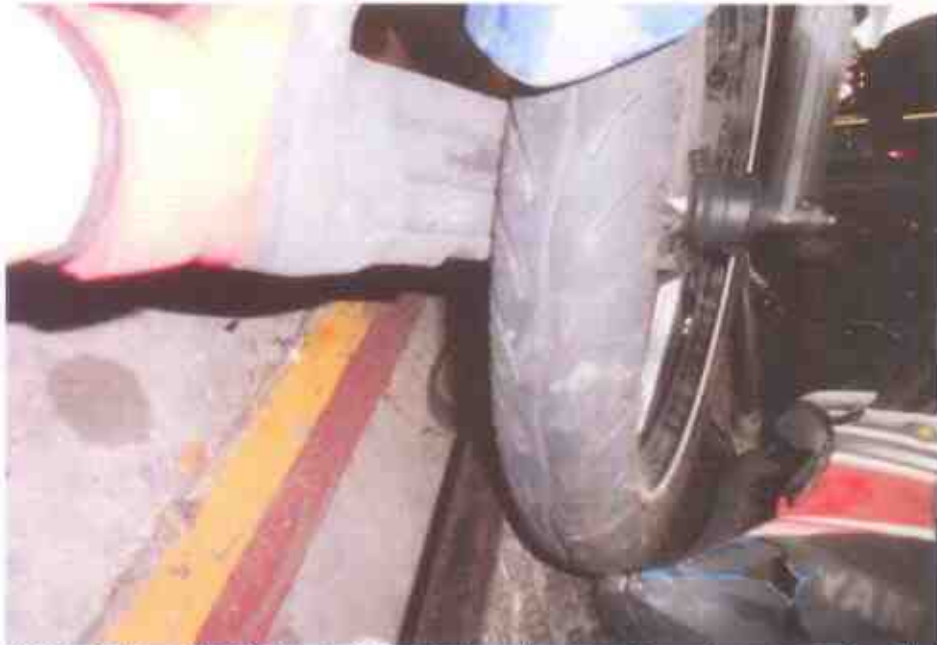
Photo 9 shows the front tyre of the Motorcycle at the time of our inspection. The pattern of the tread was clearly visible with remaining tread depth of approximately 4mm. There was no tear, burst mark(s) and/or punctured hole(s) on the sidewalls as well as across the tread of the front tyre. However, the wheel rim was observed to be broken as a result of the accident.

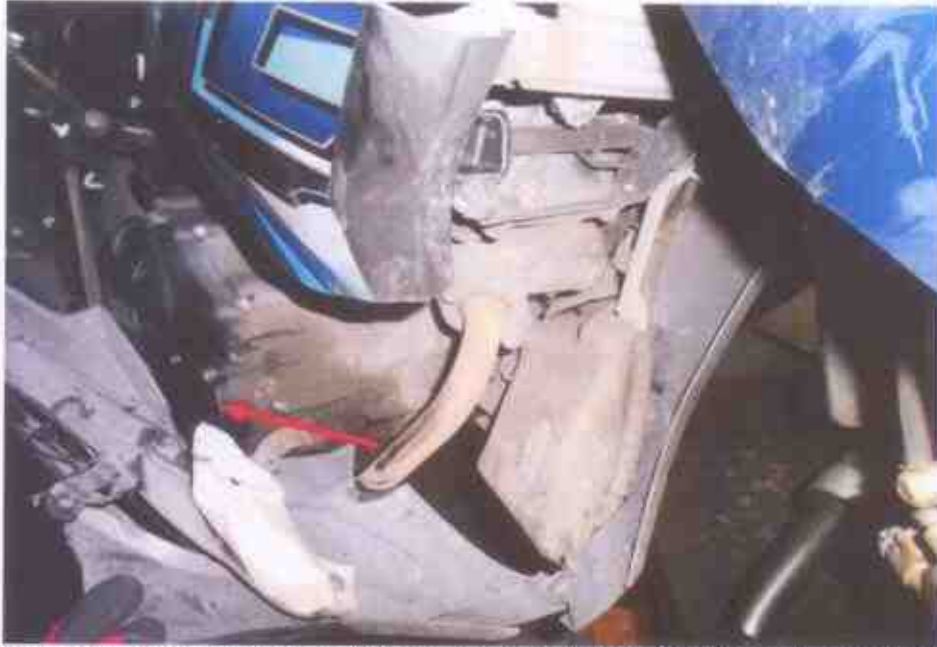
9. Upon examination of the engine area of the Motorcycle, we had observed that the various engine related parts and components were intact with no visible damage. The engine underside was however observed to be covered with brownish fluid, suggesting leakage of fluid as a result of the accident.
10. The gear chain of the Motorcycle was found to be intact without any misalignment. It was also adequately lubricated for operating purposes. See photo 10 – 13 below.

Photo 10 shows sign(s) or indication(s) of fluid leakage observed around the engine's underside area of the Motorcycle.

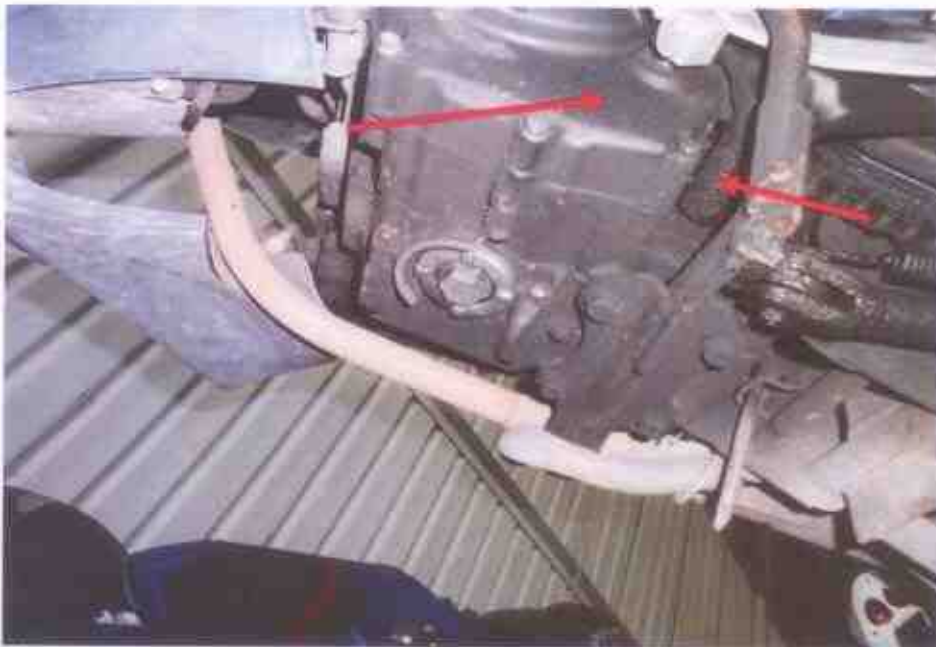
Photo 11 shows sign(s) or indication(s) of fluid leakage observed at the engine's undercarriage of the Motorcycle.

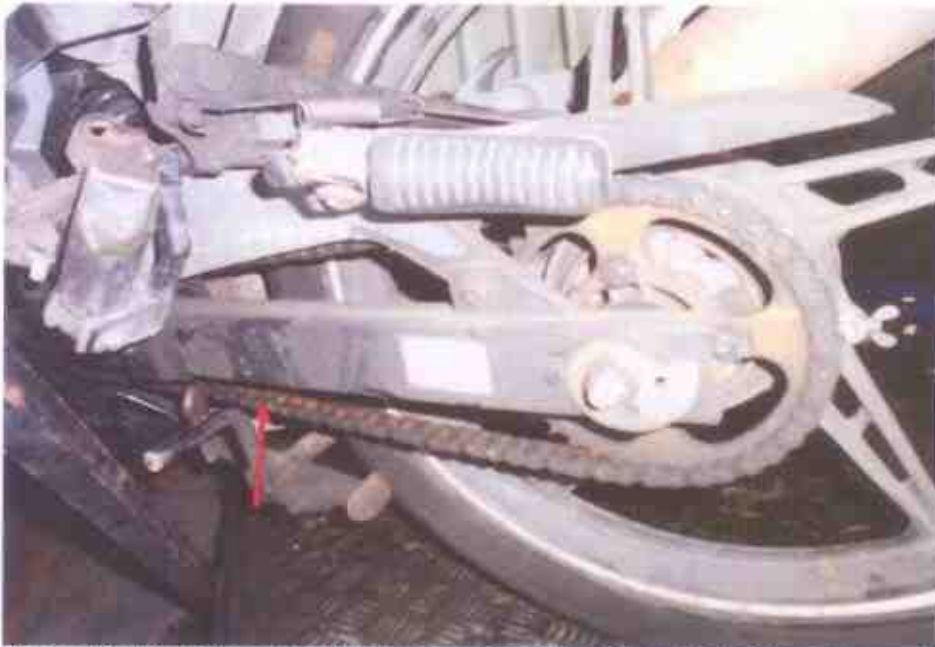
Photo 12 shows the general view of the gear train (arrowed) of the Motorcycle, which was observed to be intact with no misalignment. It was also adequately lubricated for operating purposes.

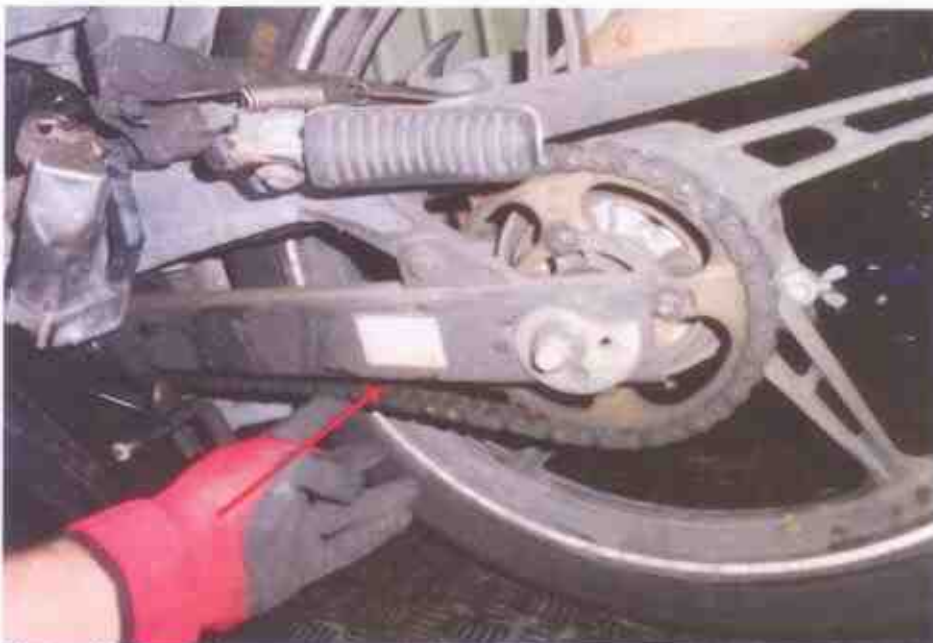
Photo 13 shows the general view of the gear train (arrowed) of the Motorcycle, which was observed to be intact with no misalignment. It was also adequately lubricated for operating purposes.

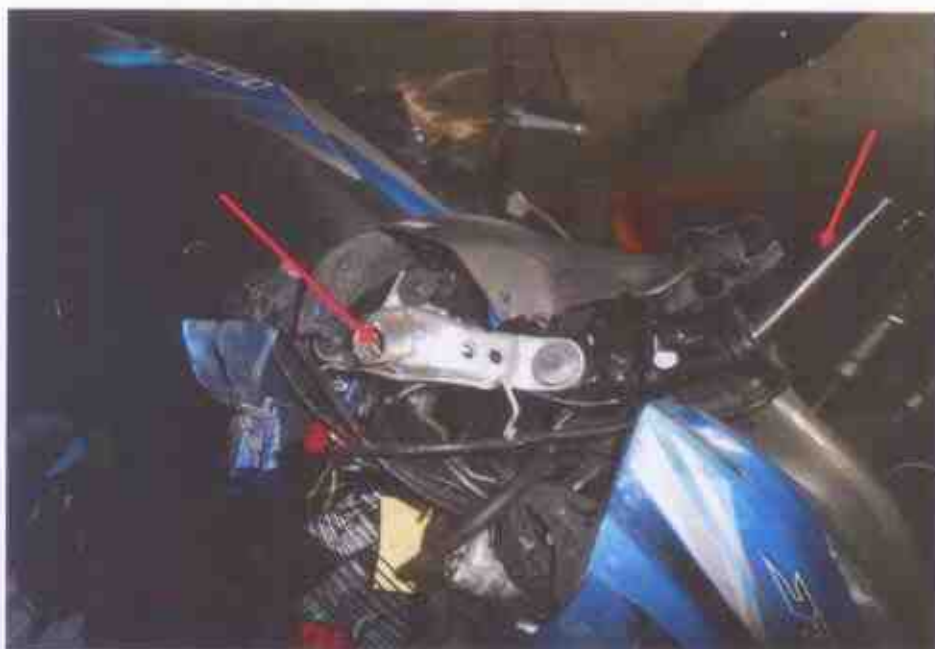
11. For this case, we were not able to conduct any test(s) on the steering system of the Motorcycle due to the damages on its handle bar and front fork. It was found to be damaged as a result of the accident, hence causing the whole steering system to be in a state of immobility.

Photo 14 shows the handle bar (arrowed) was observed to be damaged as a result of the accident.

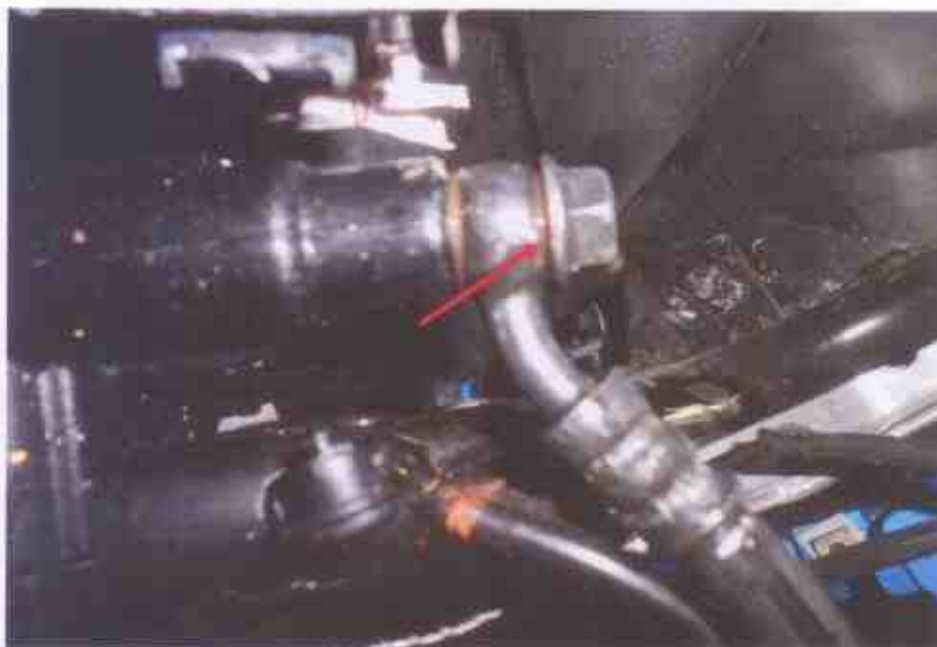
12. The brake system of the Motorcycle was of a semi-hydraulic type, where hydraulic (brake fluid) pressure controls the brake for the front wheel while the brake for the rear wheel is controlled by mechanical means (cables and springs). Our visual examination of the various components in the front brake system, like the brake disc, brake pad & brake calliper, revealed to be unaffected by the accident. However, brake fluid leakage was observed upon gripping the front hand brake lever. Brake fluid leakage was observed to be coming from the connection hose after the brake reservoir on the right hand side of the handle bar. This was likely due to the accident's impact collision.

Photo 15 shows the front brake fluid leakage was observed to be caused by the accident. The brake fluid leakage was observed to be coming from the connecting hose when we grip the hand brake lever at the time of our inspection.

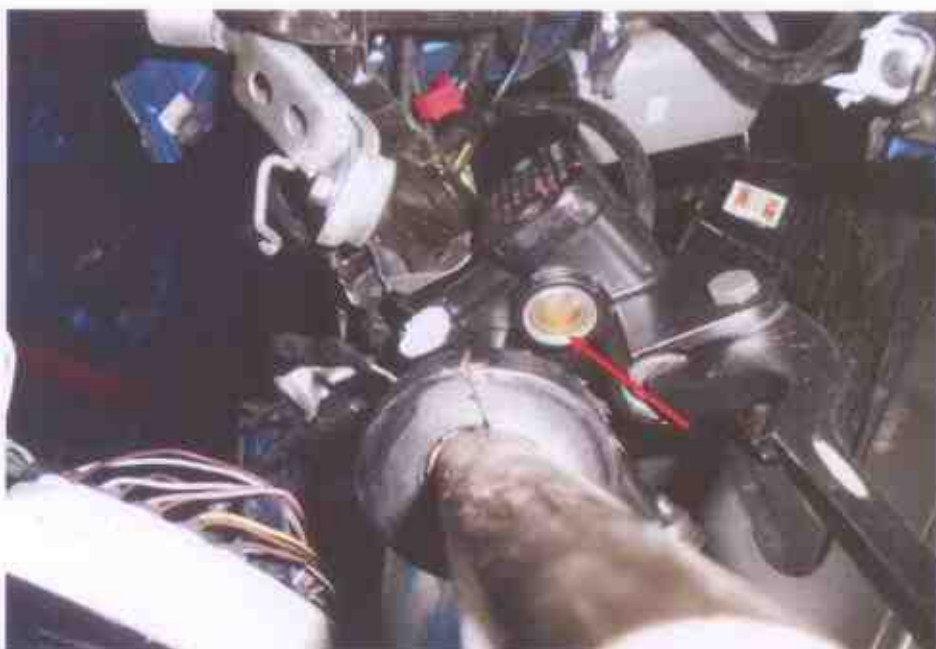
Photo 16 shows the front brake fluid was still at a sufficient level despite leakage observed at the connecting hose.

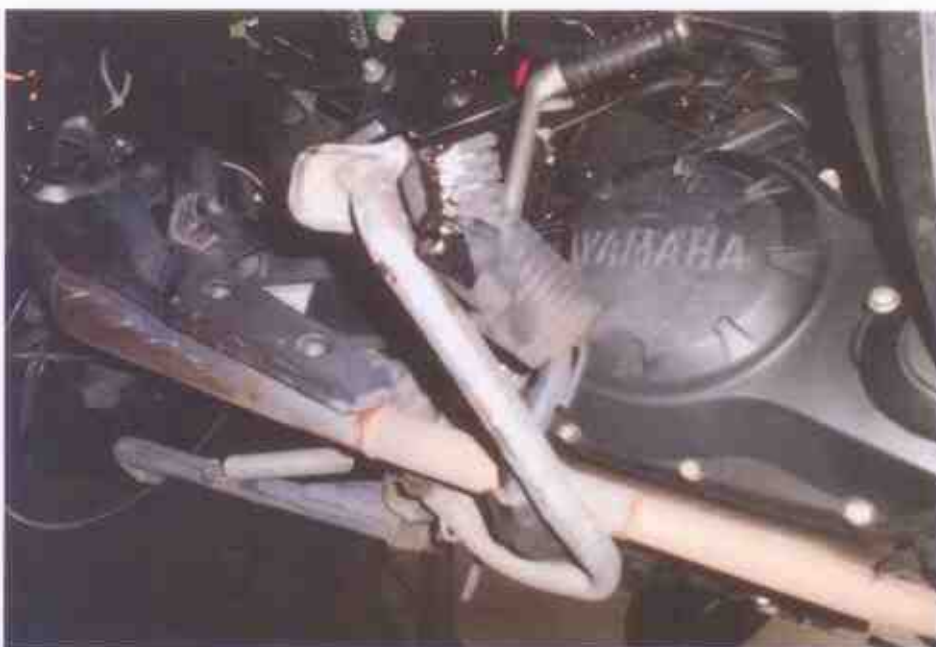
Photo 17 shows the rear brake pedal (arrowed) was observed to be in damaged due to the accident's impact collision.

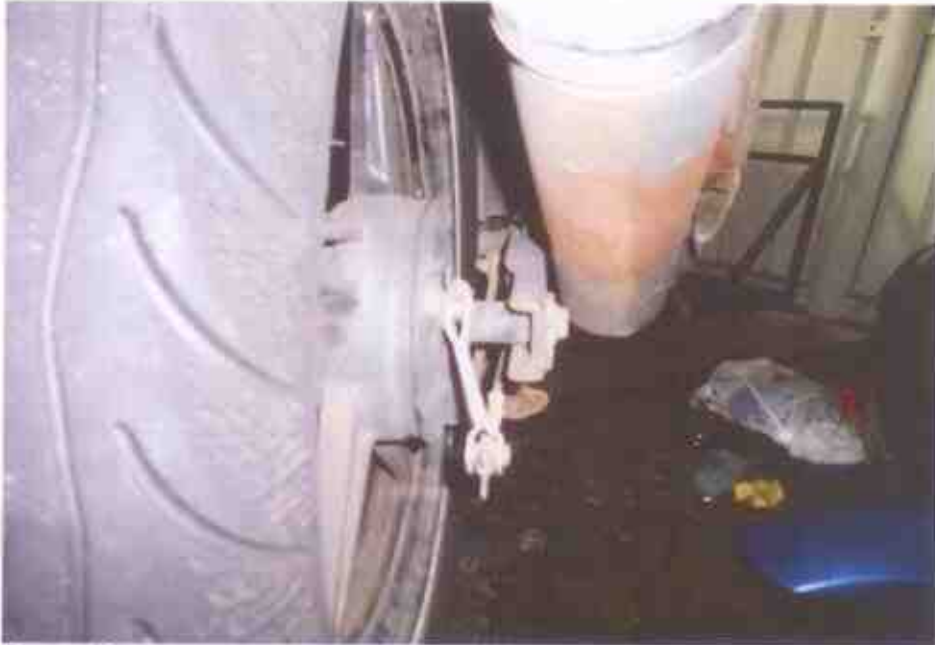
Photo 18 shows the rear brake drum spring & cable was observed to be in serviceable condition unaffected by the accident despite the damage sustained on the foot brake pedal.

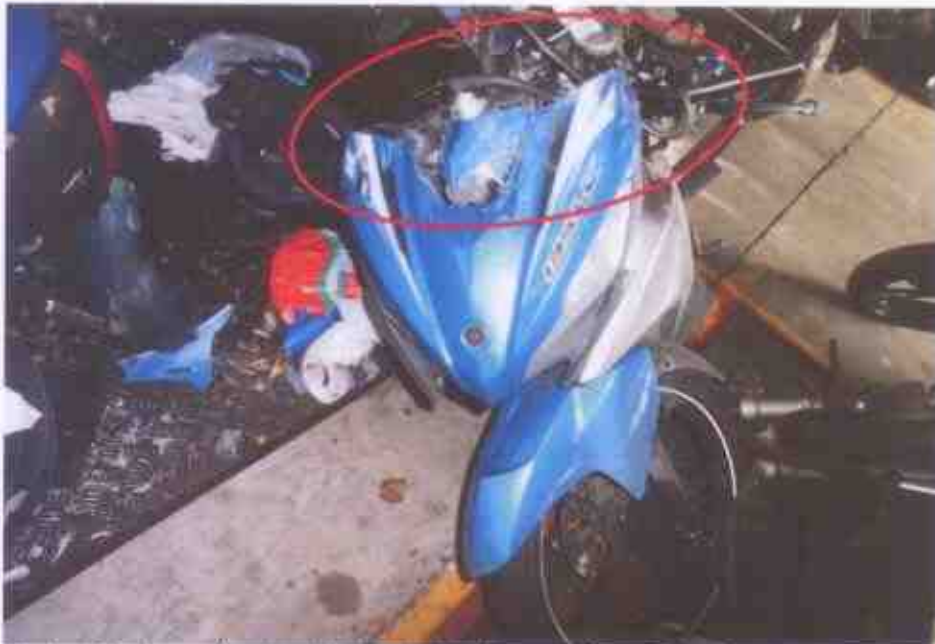
Photo 19 shows the handle bar (circled) was observed to be damaged as a result of the accident. Hence, we are unable to conduct any tests on the steering system of the Motorcycle.
