Your Ref: TP/IP/53769/2018
Our Ref : CI/TPD18018438/Z

19th December 2018

MECHANICAL INSPECTION REPORT OF MOTOR TAXI SHC 7938M

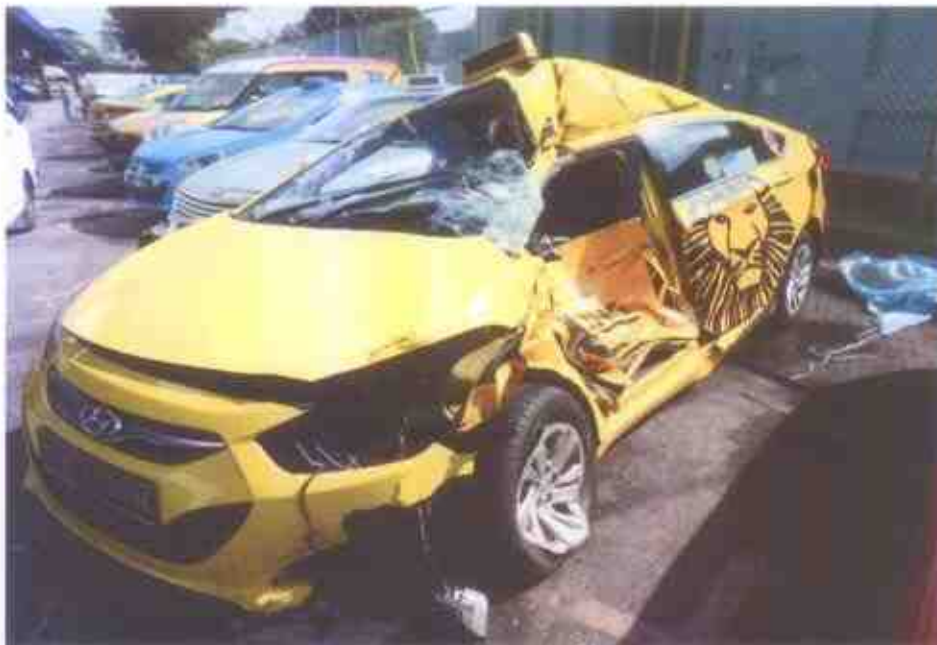
Photo 1 shows a general view of the frontal left portion of the Motor Taxi at the time of our inspection. The Motor Taxi was observed to have sustained extensive impact damage at its frontal, left & rear portion. The impact force was significant, causing the various parts and components to be damaged as a result of the accident.

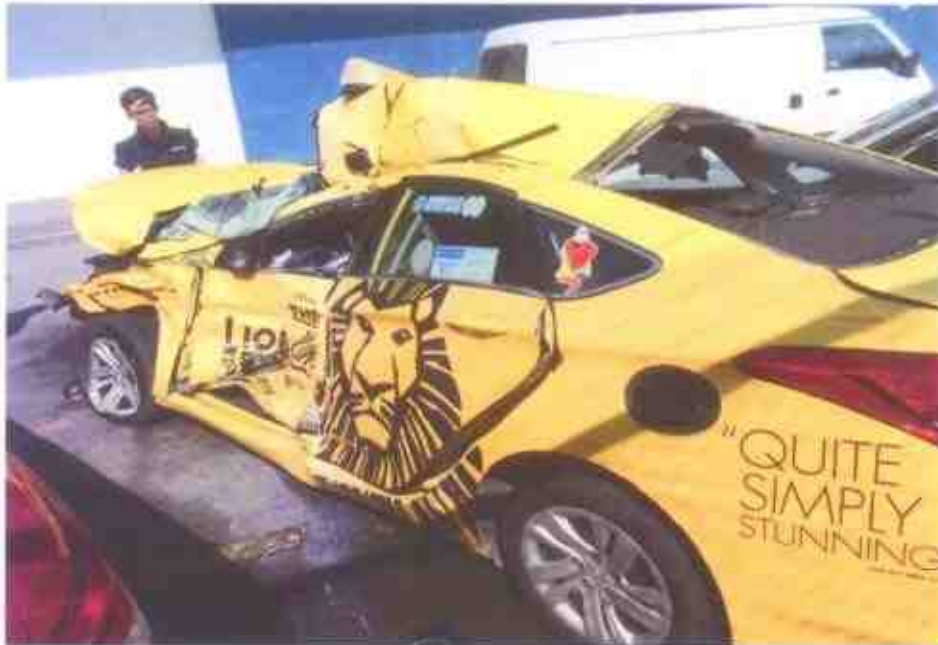
Photo 2 shows a general view of the rear left portion of the Motor Taxi at the time of our inspection. The Motor Taxi was observed to have sustained extensive impact damage at its front right portion.

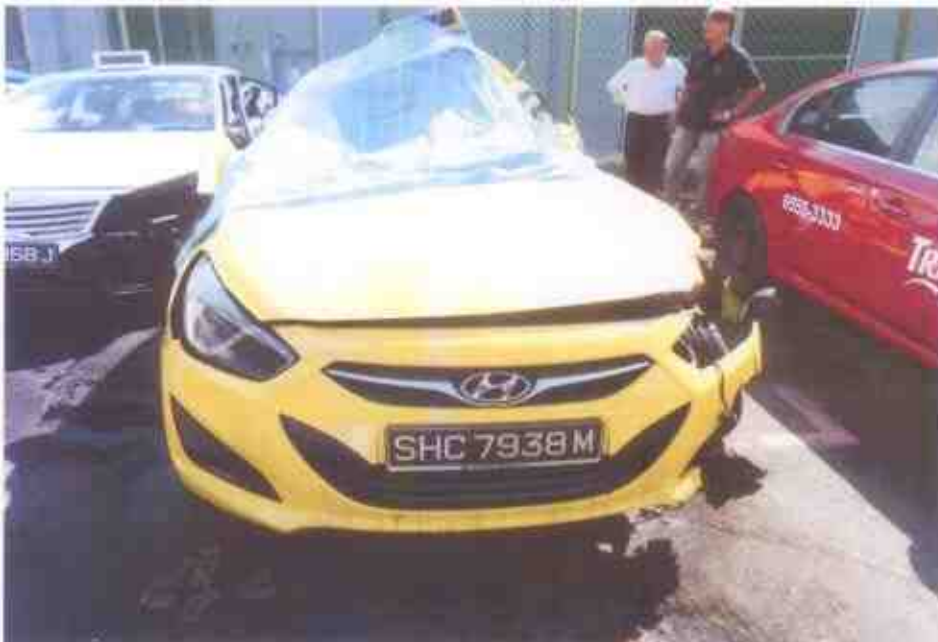
Photo 3 shows a general view of the front portion of the Motor Taxi at the time of our inspection. The Motor Taxi was observed to have sustained extensive impact damage at its front left & right portion.

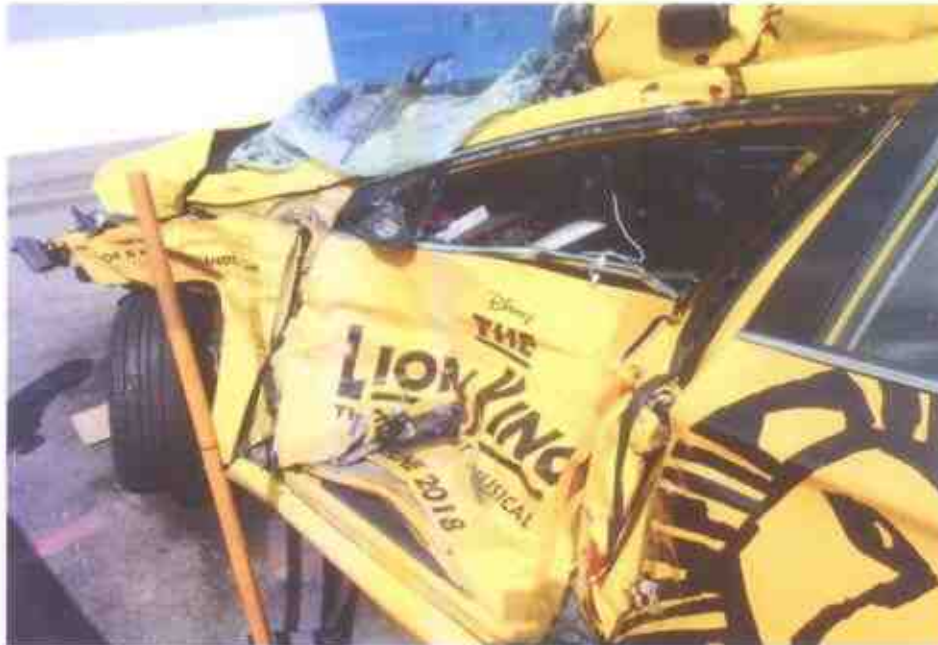
Photo 4 shows a closer view of the damage sustained on the left portion of the Motor Taxi. The impact force was significant, causing the left portion of the Motor Taxi to be pushed inwards, towards the right of the Motor Taxi.

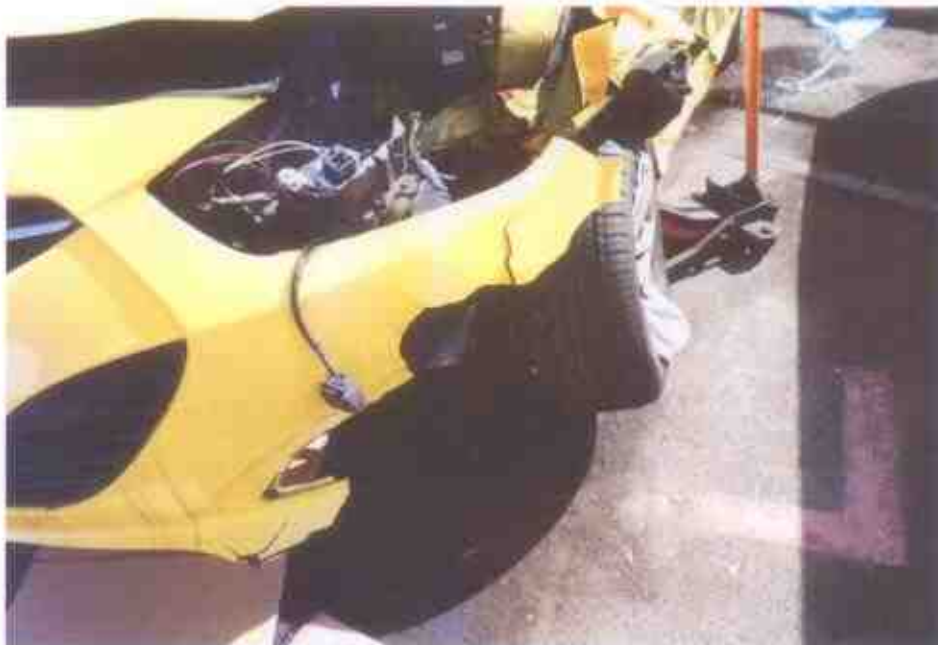
Photo 5 shows a closer view of the damage sustained on the front left of the Motor Taxi. The impact force was significant, causing the various parts and components inside the engine compartment to be damaged.

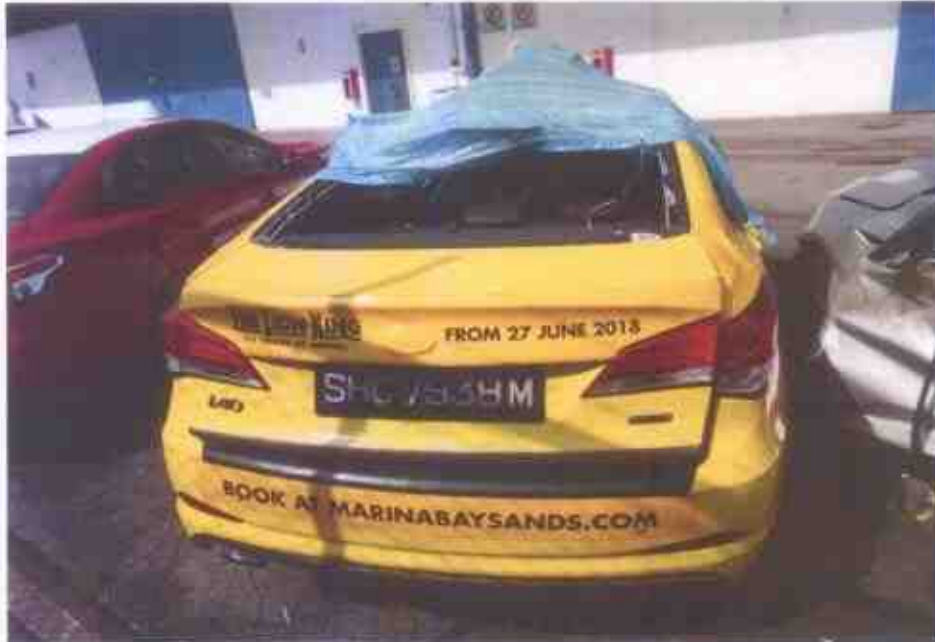
Photo 6 shows a closer view of the damaged rear boot lid. The impact force was significant, causing it to be misaligned due to the accident's impact.

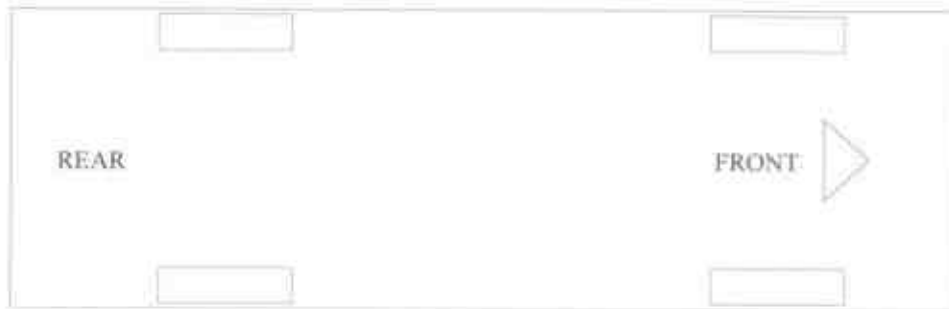
Triangle 205/60R16 (4mm)

Triangle 205/60R16 (5mm)(Deflated)

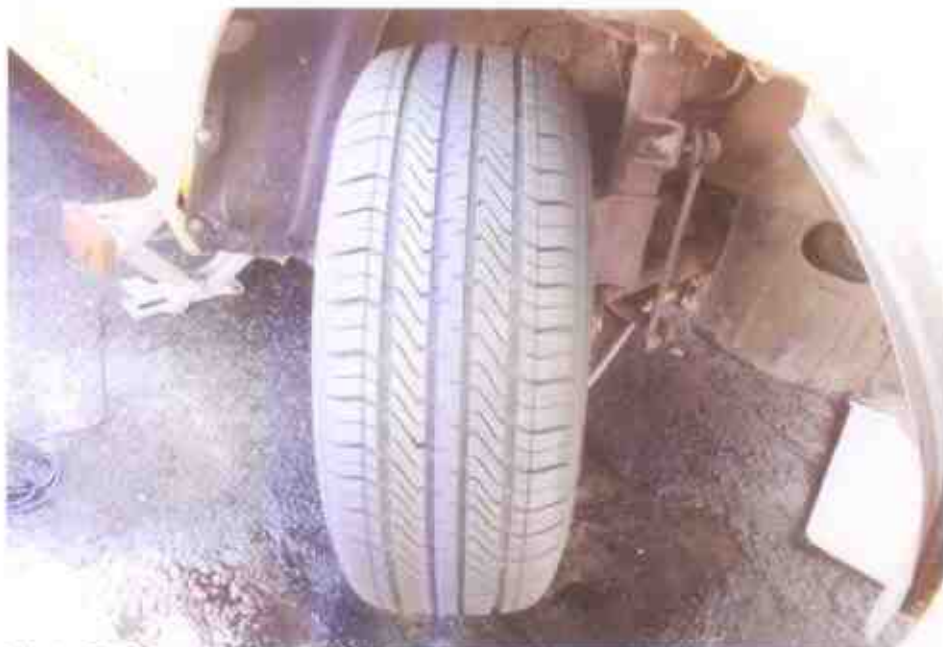
Photo 7 shows the condition of the front right tyre of the Motor Taxi, which was observed to be deflated with remaining tread depth of approximately 5mm. However, there was no tear, cut or burst mark(s) on the outer and the inner sidewalls as well as across the tread of this tyre.

22. As for the 2 front tyres, they were observed to be deflated at the time of our inspection. The 2 front tyres were found to be slipped off out from the steel wheel rims original position likely due to the accident's impact collision. However, we did not find any tear, cut or burst mark(s) on the outer and the inner sidewalls as well as across the tread of the 2 front tyres with remaining tread depth of approximately 5mm each.

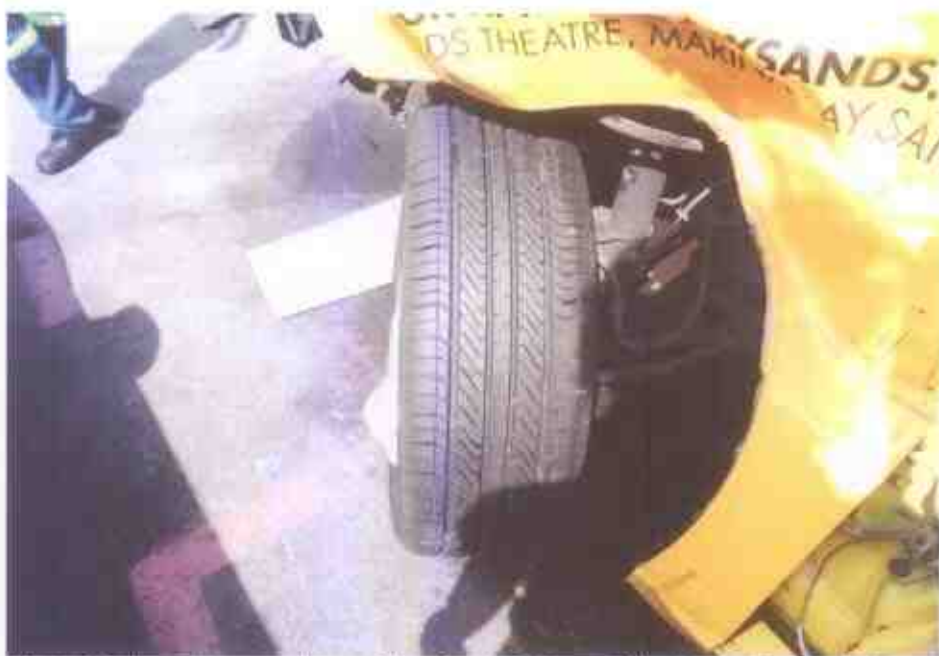
Photo 8 shows the condition of the front left tyre of the Motor Taxi, which was observed to be deflated with remaining tread depth of approximately 5mm. However, there was no tear, cut or burst mark(s) on the outer and the inner sidewalls as well as across the tread of this tyre.

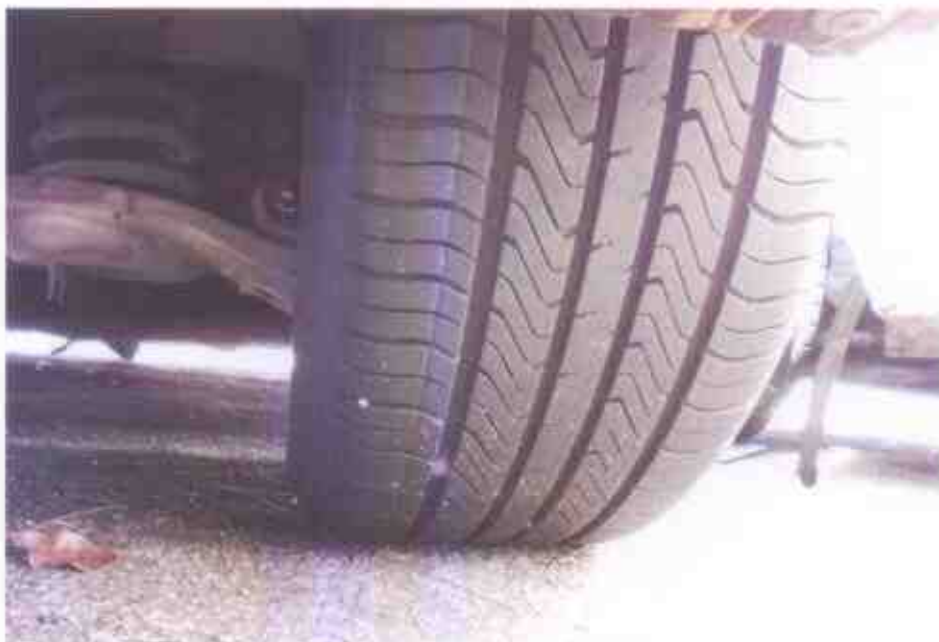
Photo 9 shows the condition of the rear right tyre of the Motor Taxi, which was observed to be in serviceable condition with remaining tread depth of approximately 4mm. There was also no tear, cut or burst mark(s) on the outer and the inner sidewalls as well as across the tread of this tyre.

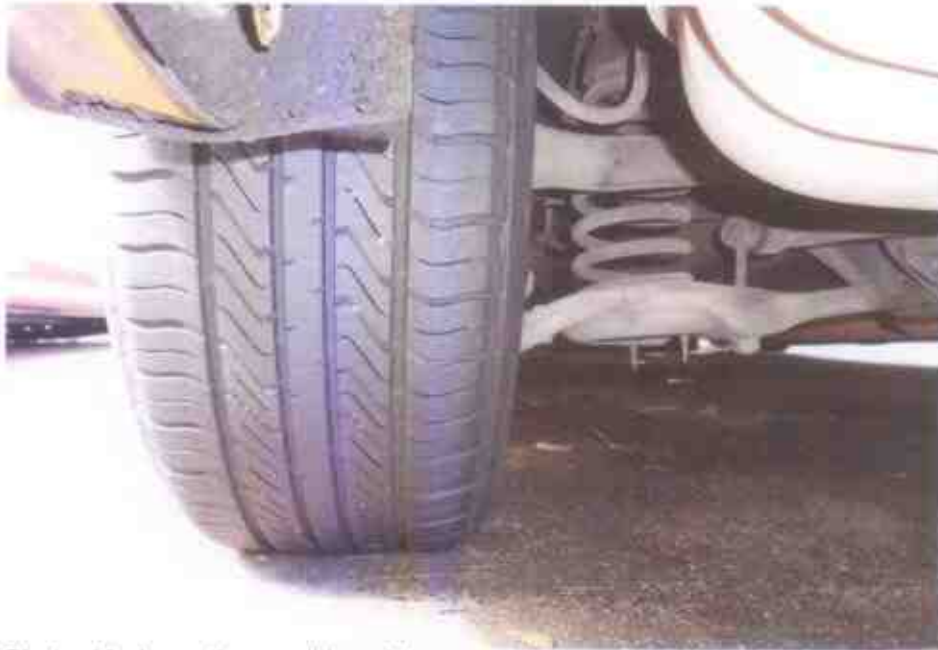
Photo 10 shows the condition of the rear left tyre of the Motor Taxi, which was observed to be in serviceable condition with remaining tread depth of approximately 4mm. There was also no tear, cut or burst mark(s) on the outer and the inner sidewalls as well as across the tread of this tyre.

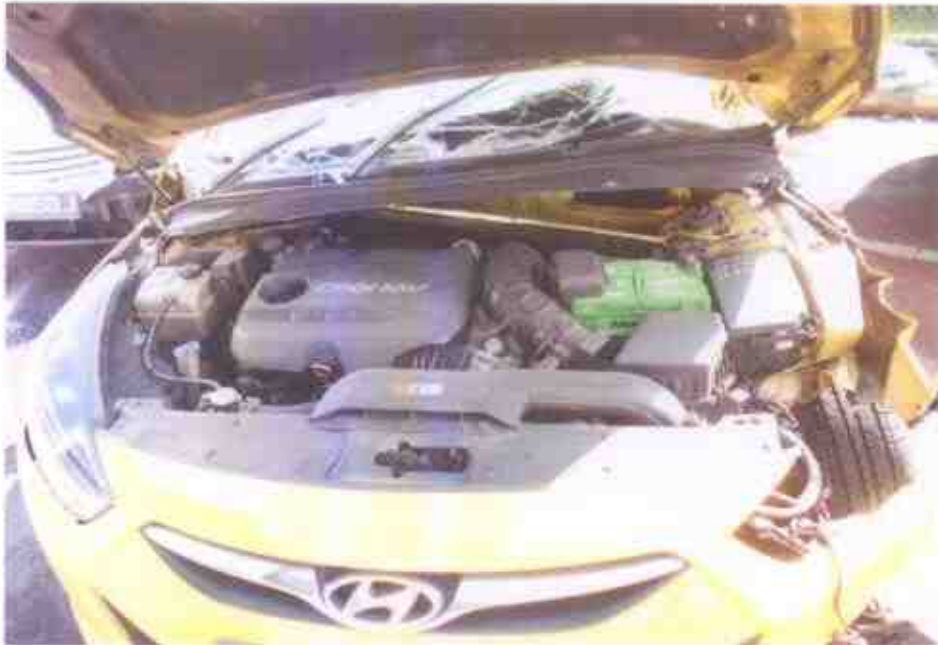
Photo 11 shows a general view of the Motor Car's engine compartment. Some of the various parts and components inside the engine compartment were observed to be affected by the accident. There were also sign(s) or indication(s) of fluid leakage and/or fluid stain within the engine compartment.

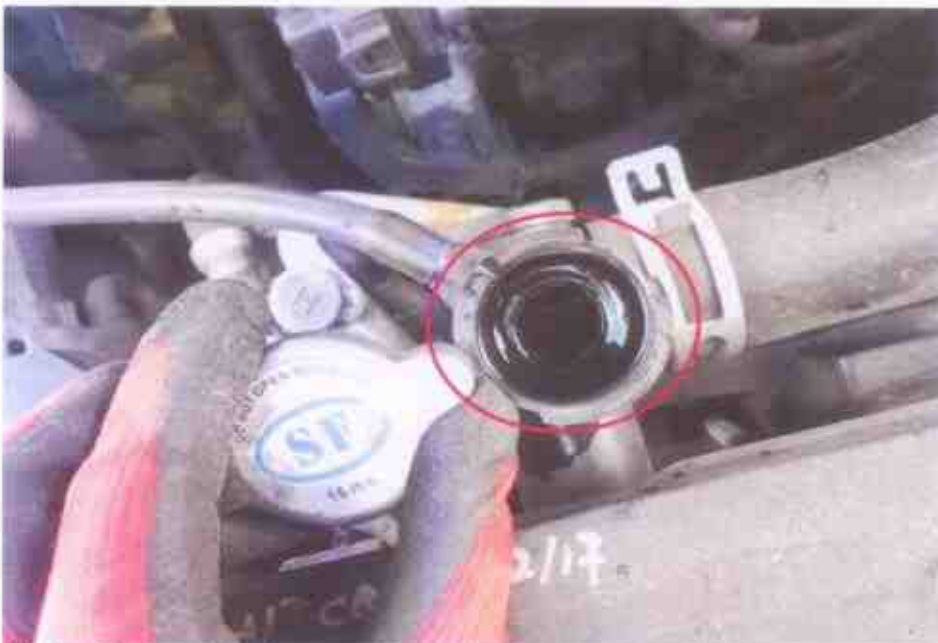
Photo 12 shows the close up view of the engine coolant that was seen empty affected by the accident's impact.

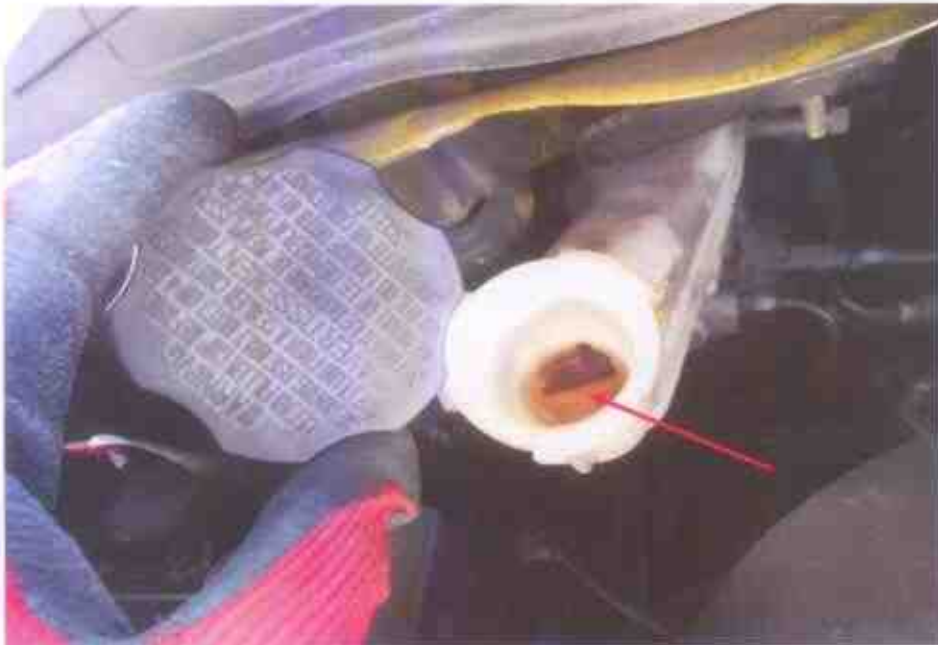
Photo 13 shows the close up view of the brake fluid that was seen with sufficient level not affected by the accident's impact.

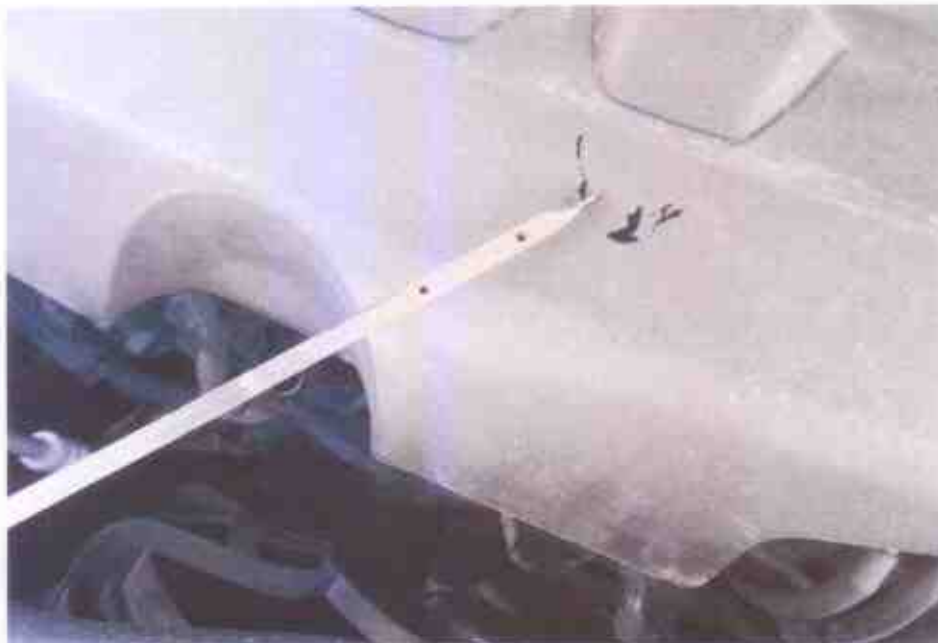
Photo 14 shows the engine oil dip stick of the Motor Taxi at the time of our inspection. The engine oil was observed to be insufficient level as a result of the accident.

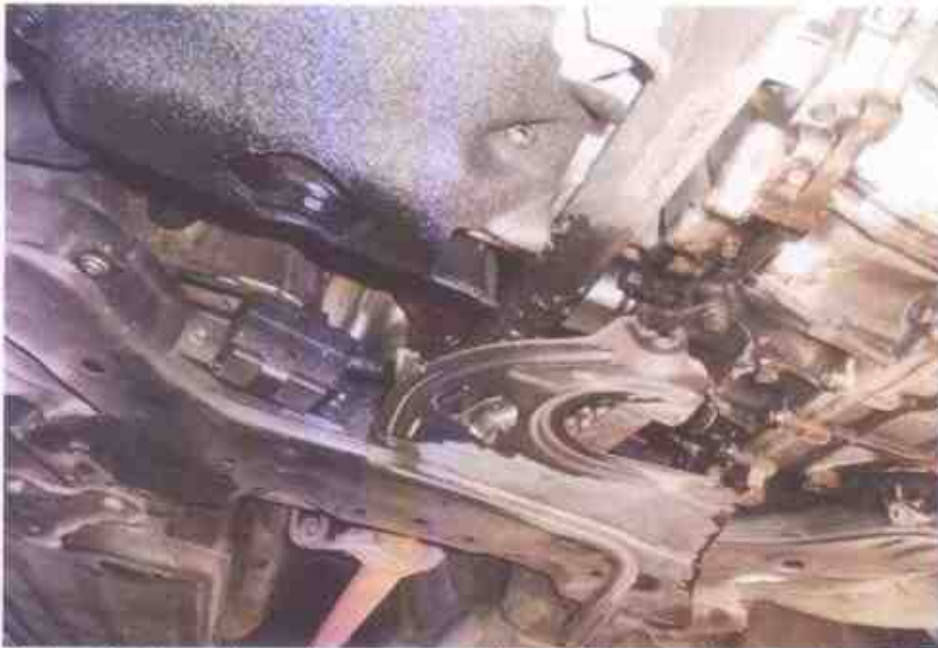
Photo 15 shows the undercarriage of the engine area. It was observed to sustained fluid leakage as a result of the accident.

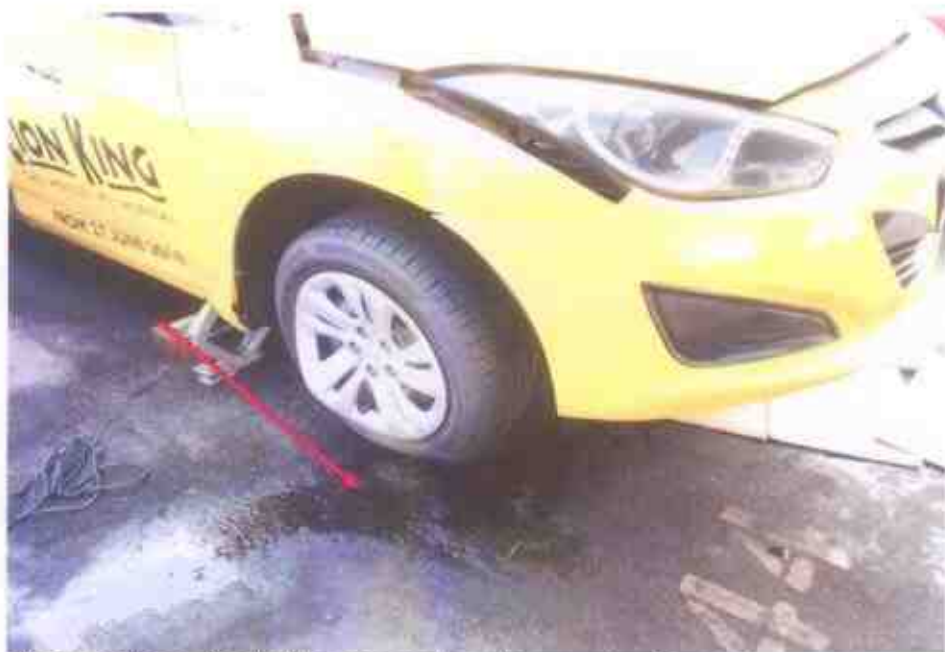
Photo 16 shows the fluid leakage spill on the ground surface.

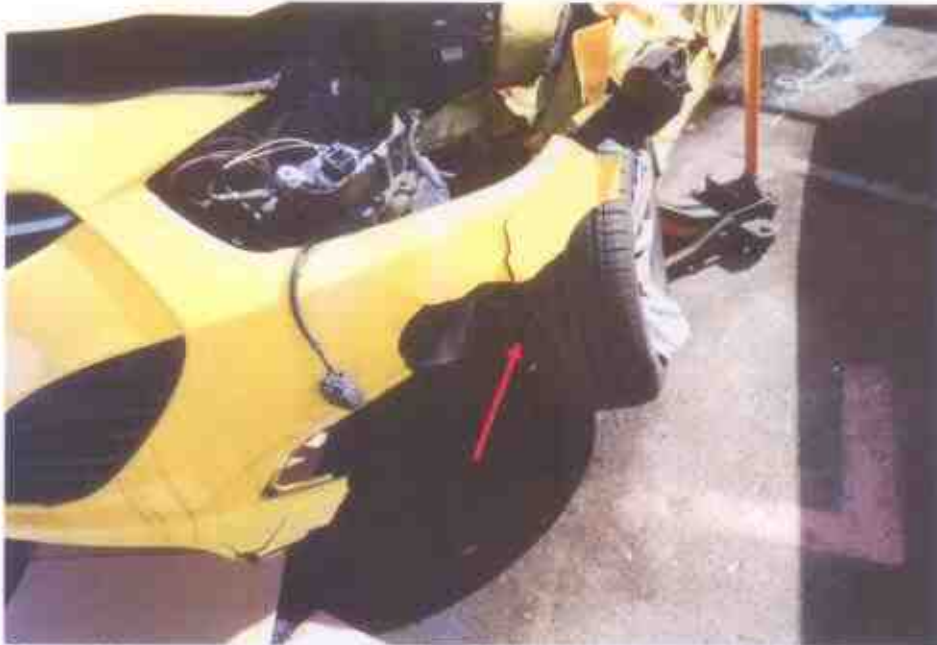
Photo 17 shows the misalignment of the front left wheel of the Motor Taxi.

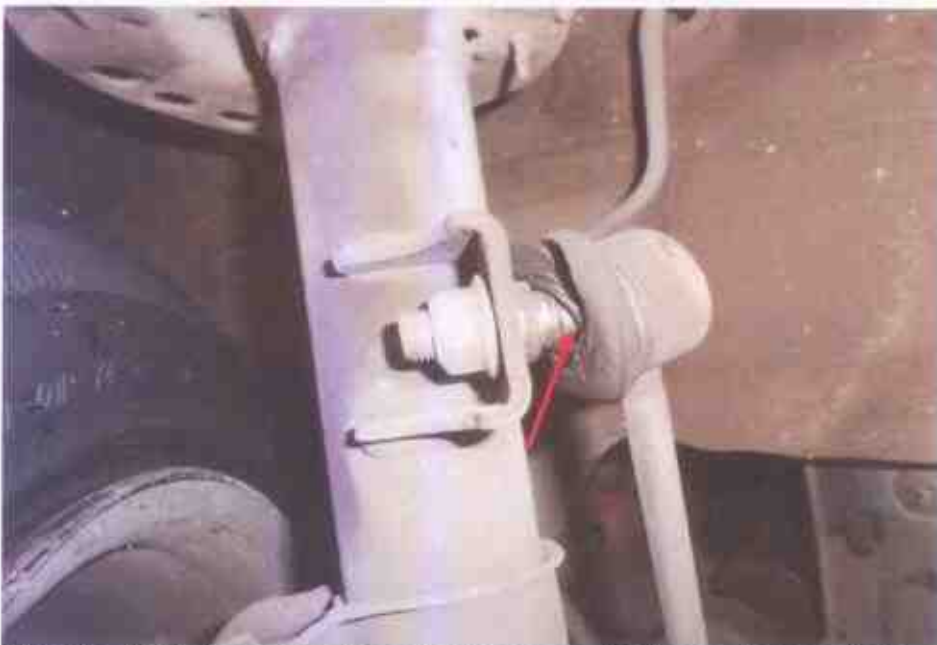
Photo 18 shows the damaged tie rod of the front right wheel of the Motor Taxi.

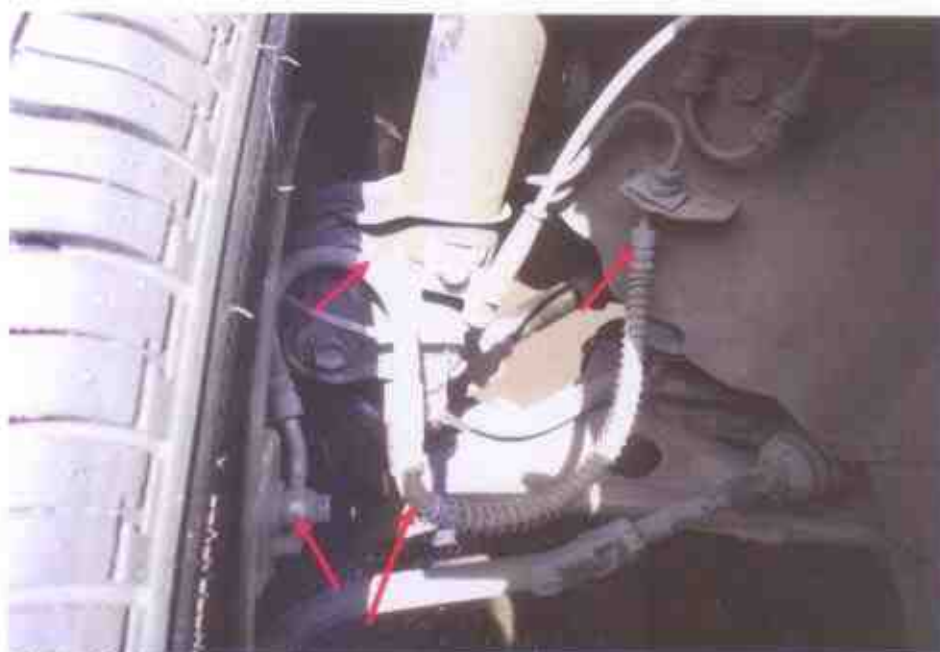
Photo 19 shows the braking components at the front left wheel of the Motor Taxi. We did not observe any leakage of brake fluid at the time of our inspection of the Motor Car.

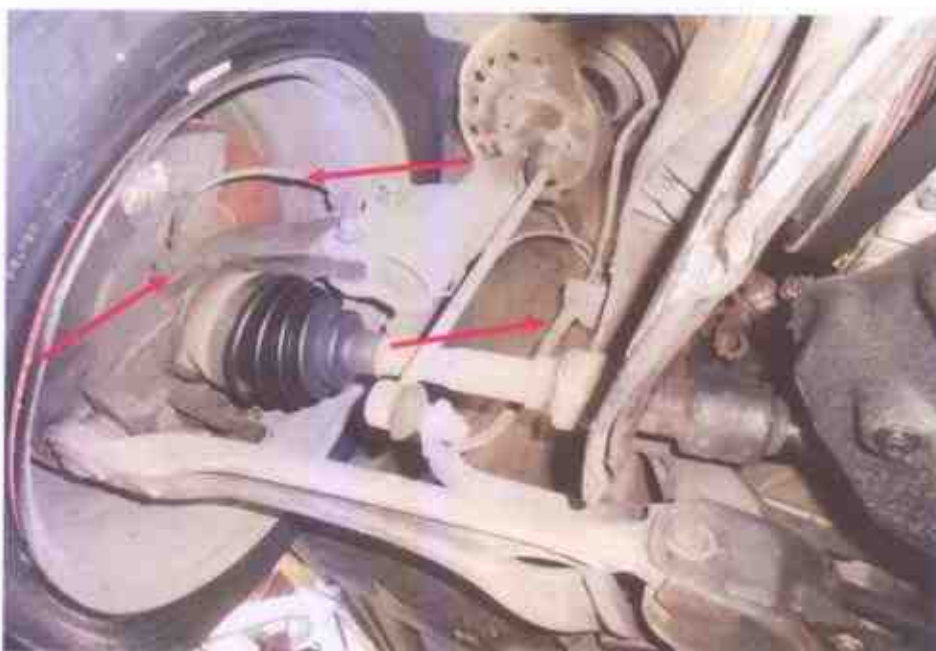
Photo 20 shows the braking components at the front right wheel of the Motor Taxi. We did not observe any leakage of brake fluid at the time of our inspection of the Motor Taxi.

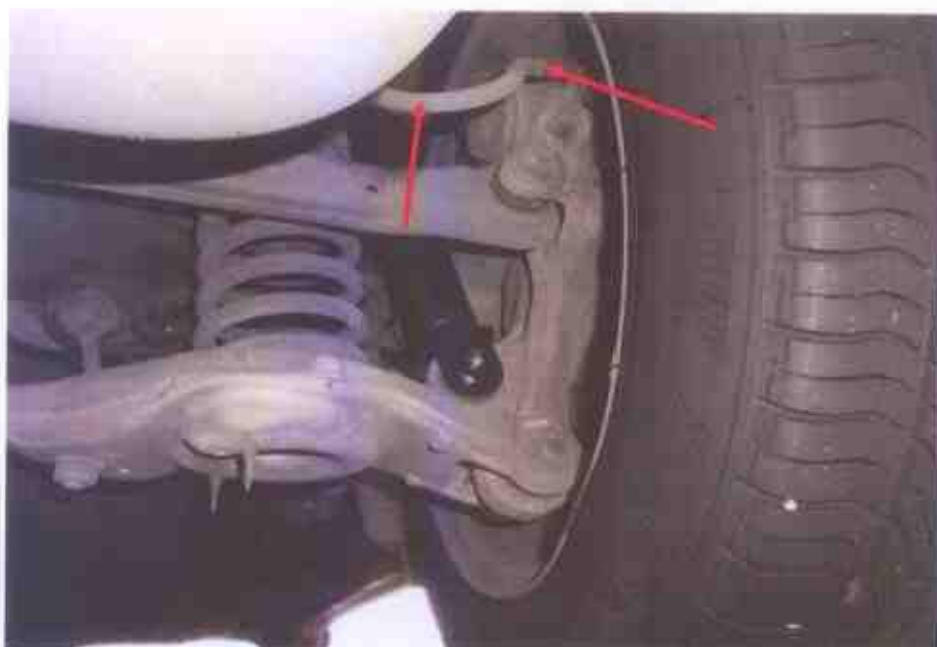
Photo 21 shows the braking components at the rear right wheel of the Motor Taxi. We did not observe any leakage of brake fluid at the time of our inspection of the Motor Taxi.

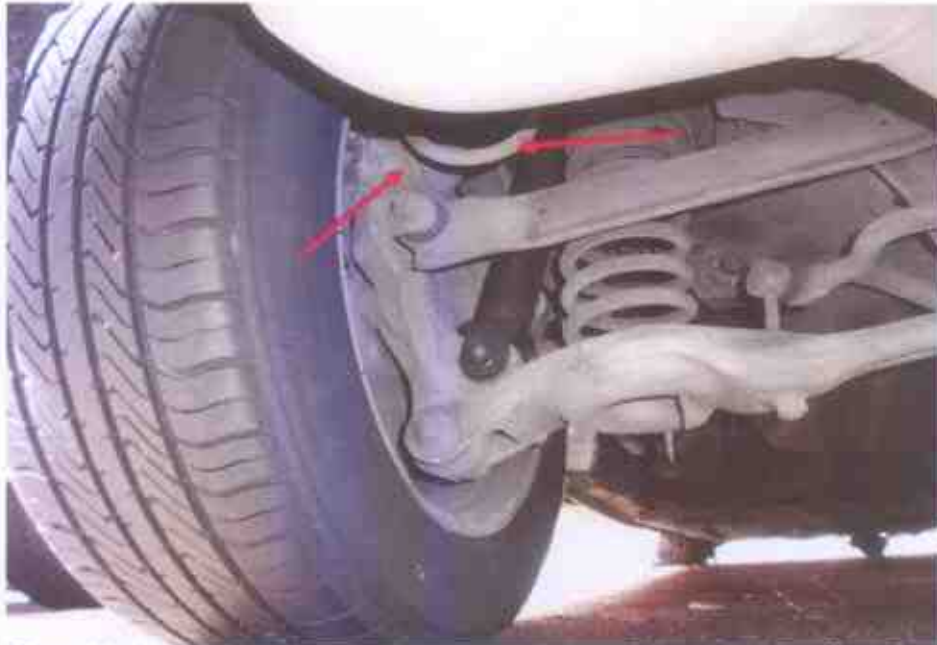
Photo 22 shows the braking components at the rear left wheel of the Motor Taxi. We did not observe any leakage of brake fluid at the time of our inspection of the Motor Taxi.
