Your Ref: TP/IP/46761/2018
Our Ref : CI/TPD18018440/Z

09th January 2019

MECHANICAL INSPECTION REPORT OF MOTOR CAR SKC 3331D

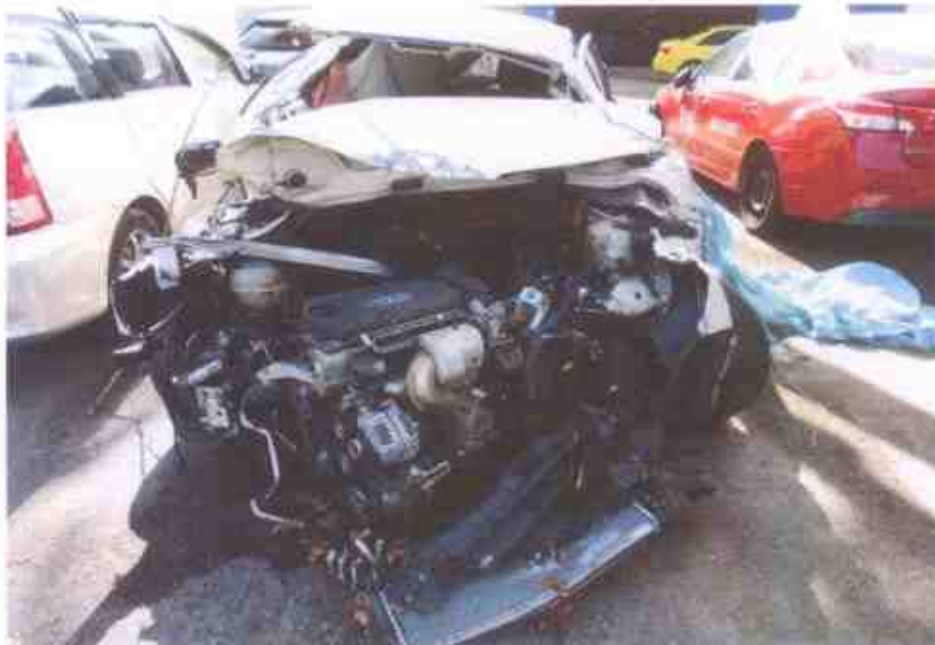
4. The mileage of the Motor Car at the time of our inspection was not recorded as its ignition system was severely damaged by the collision.
5. The Motor Car had sustained extensive impact damage at its frontal portion, left, right & rear portion. The impact force was significant, causing the various parts and components inside the engine compartment to be damaged. This had included its engine assembly and transmission assembly, which were both amongst the multiple parts and components inside the engine compartment that were pushed inwards, towards the rear of the Motor Car.

Photo 1 shows a general view of the frontal portion of the Motor Car at the time of our inspection. The Motor Car was observed to have sustained extensive impact damage at its frontal portion. The impact force was significant, causing the various parts and components inside the engine compartment to be damaged.

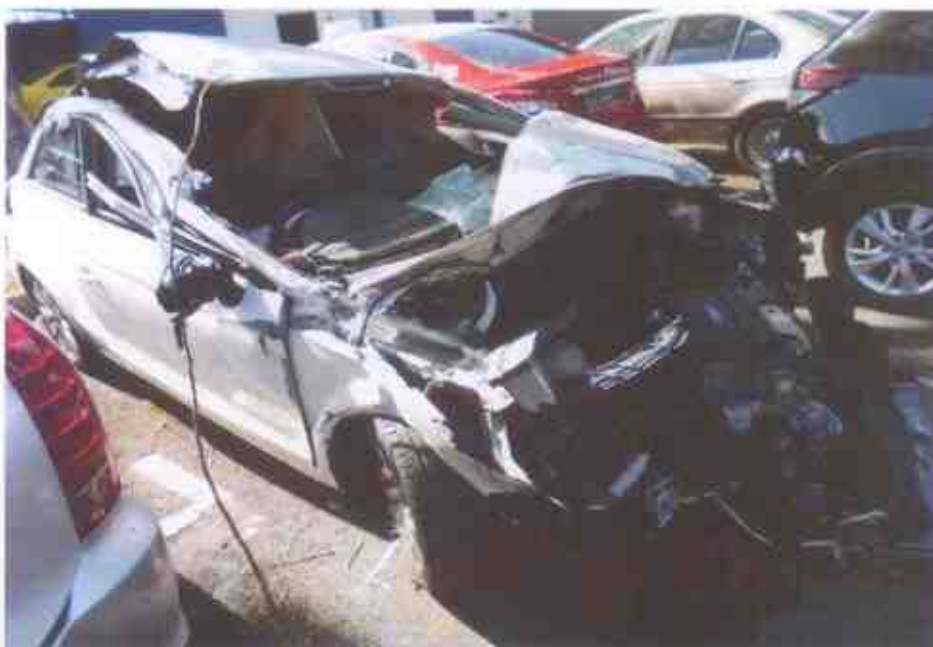
Photo 2 shows a general view of the front right portion of the Motor Car at the time of our inspection. The Motor Car was observed to have sustained extensive impact damage at its frontal portion.

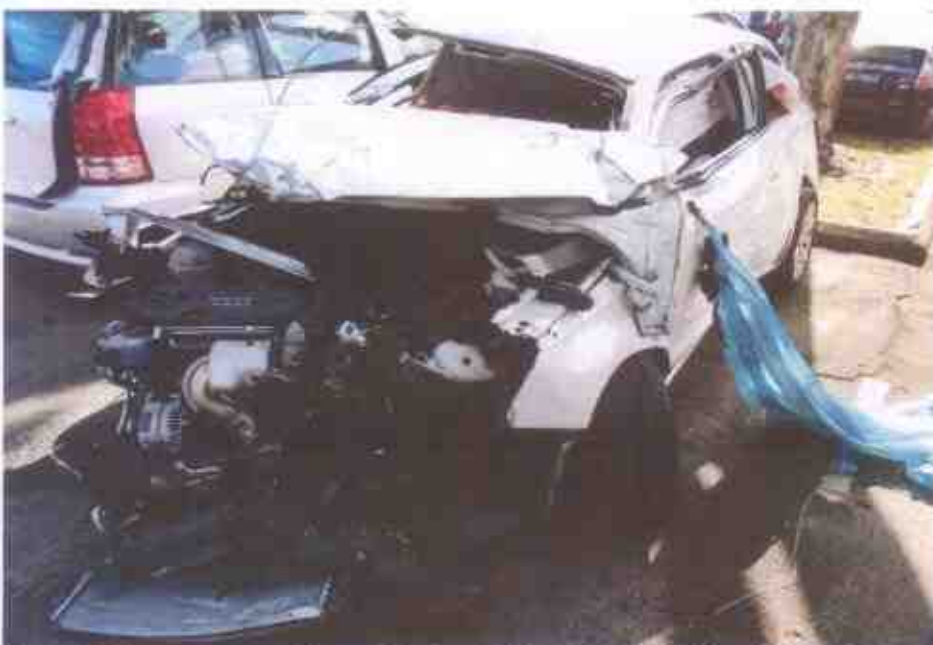
Photo 3 shows a general view of the front left portion of the Motor Car at the time of our inspection. The Motor Car was observed to have sustained with extensive impact damage at its frontal portion.

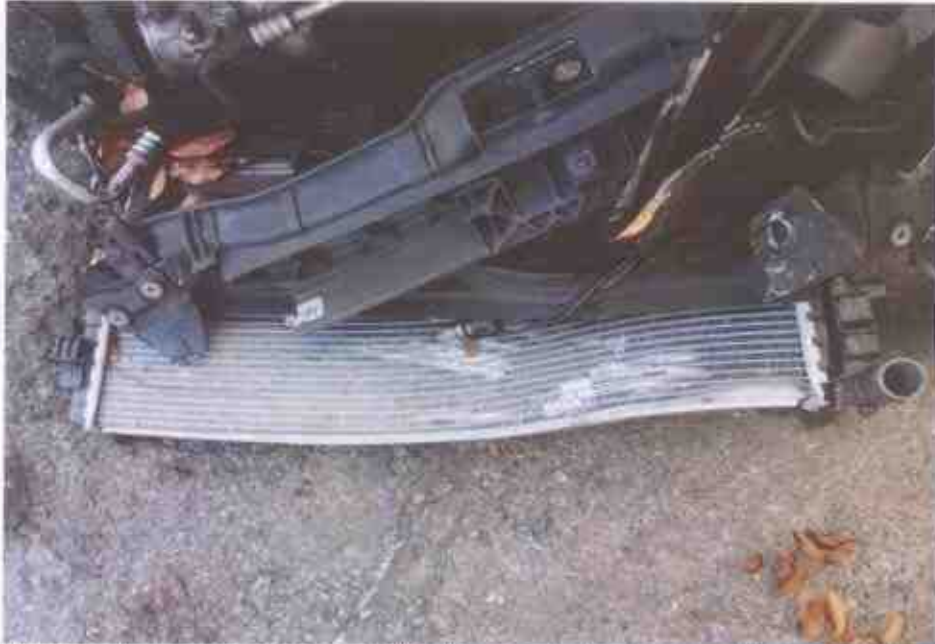
Photo 4 shows a closer view of the damage at the frontal portion of the Motor Car's engine. The impact force was significant, causing the various parts and components inside the engine compartment to be dislodged from its original installation.

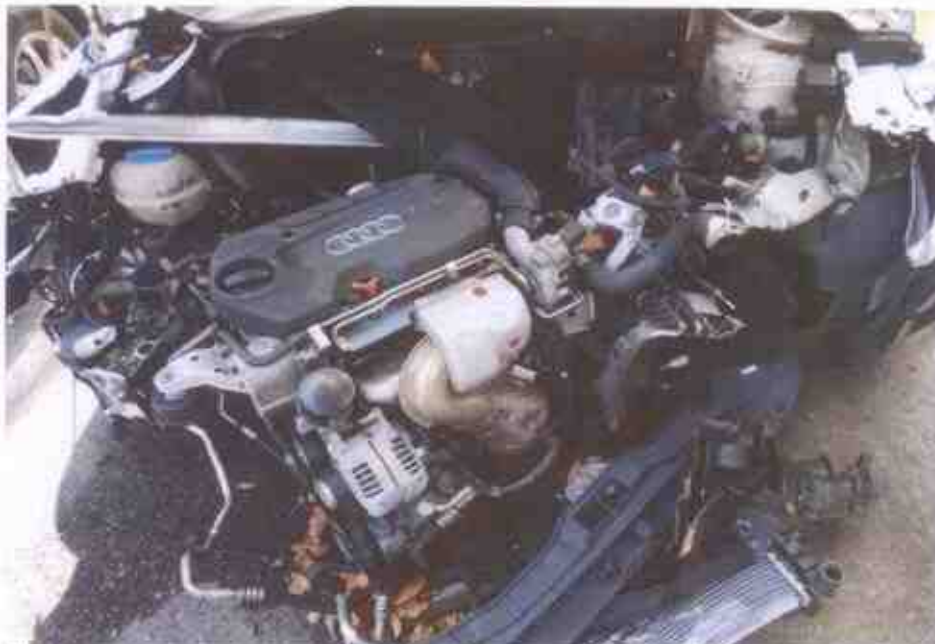
Photo 5 shows a closer view of the damage at the frontal right portion of the Motor Car. The impact force was significant, causing the various parts and components inside the engine compartment to be dislodged from its original installation.

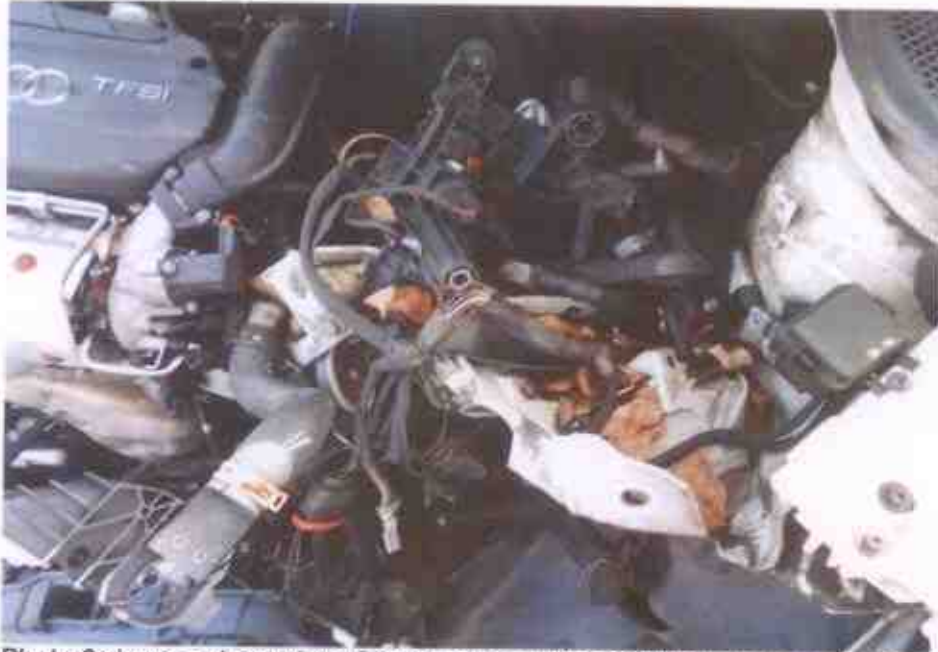
Photo 6 shows a closer view of the damage at the frontal left portion of the Motor Car. The impact force was significant, causing the various parts and components inside the engine compartment to be dislodged from its original installation.

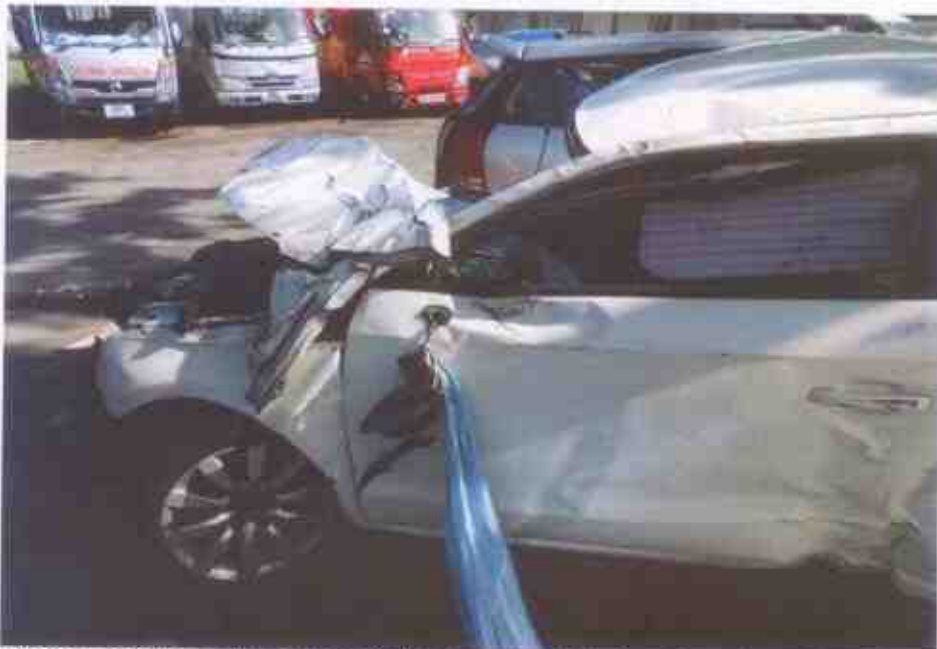
Photo 7 shows a closer view of the damage at the frontal portion of the Motor Car. The impact force was significant, causing the various parts and components inside the engine compartment to be pushed inwards, towards the rear of the Motor Car.

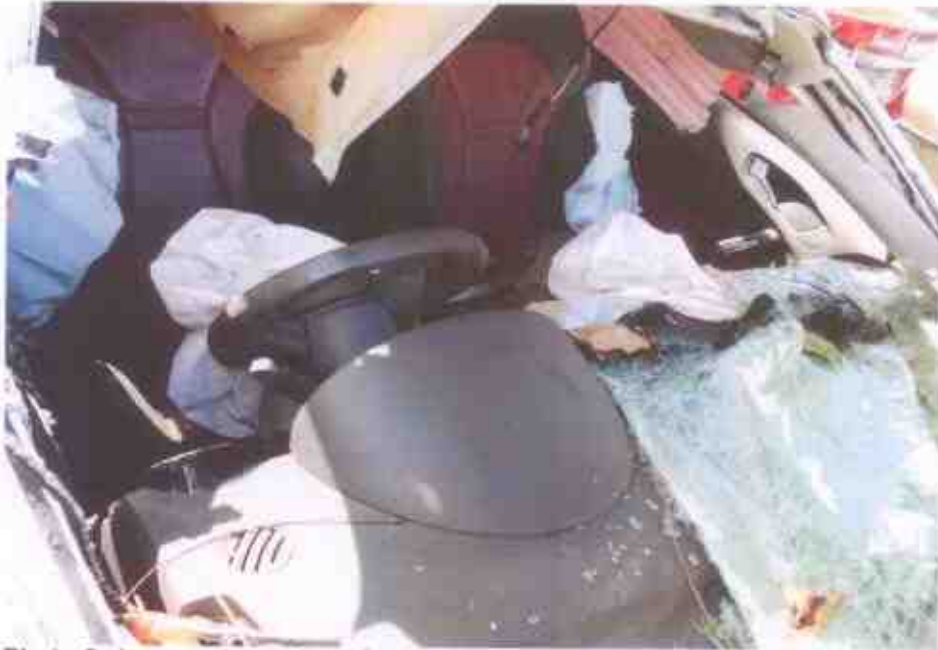
Photo 8 shows a closer view of the damage at the driver's seat of the Motor Car. The impact force was significant, causing the various parts and components inside the interior compartment to be pushed inwards, including its ignition system.

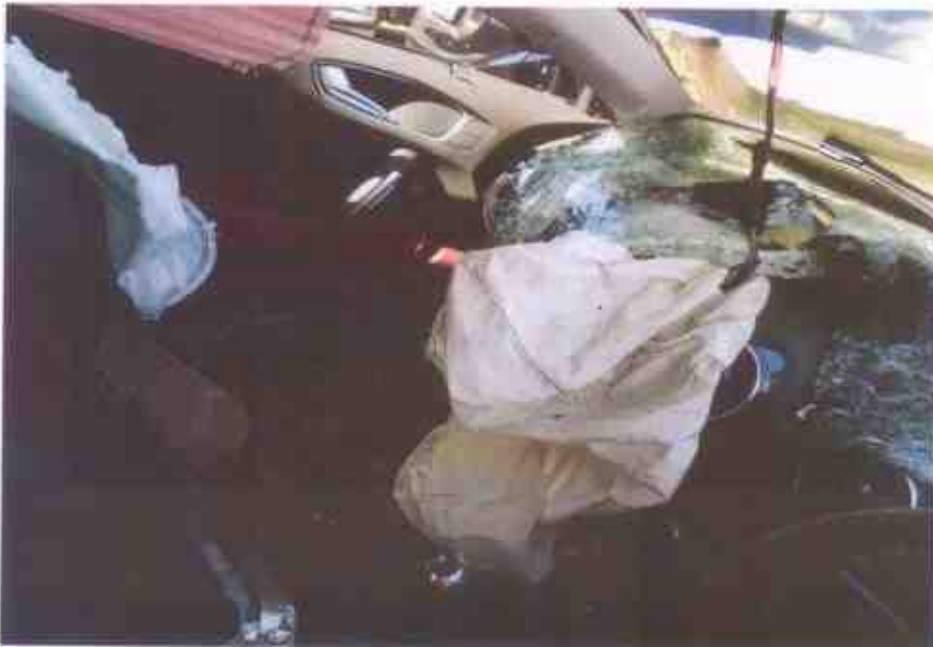
Photo 9 shows a closer view of the left front passenger seat of the Motor Car. The impact force was significant, causing the various parts and components inside the engine compartment to be pushed inwards, towards the rear of the Motor Car.

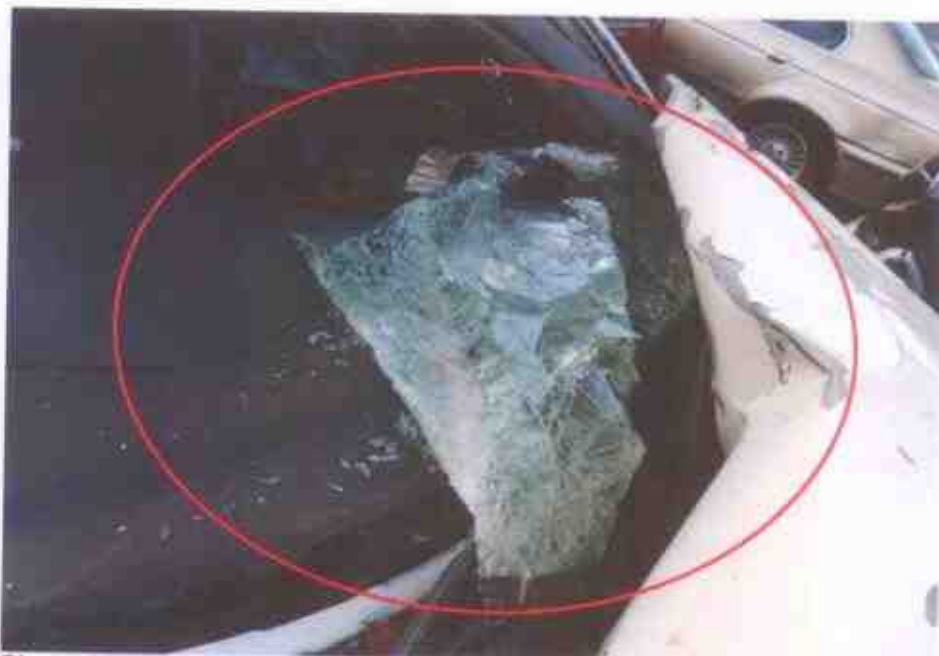
Photo 10 shows a closer view of the damage at the windscreen area of the Motor Car. The impact force was significant, causing the windscreen to sustain a shattering cracked.

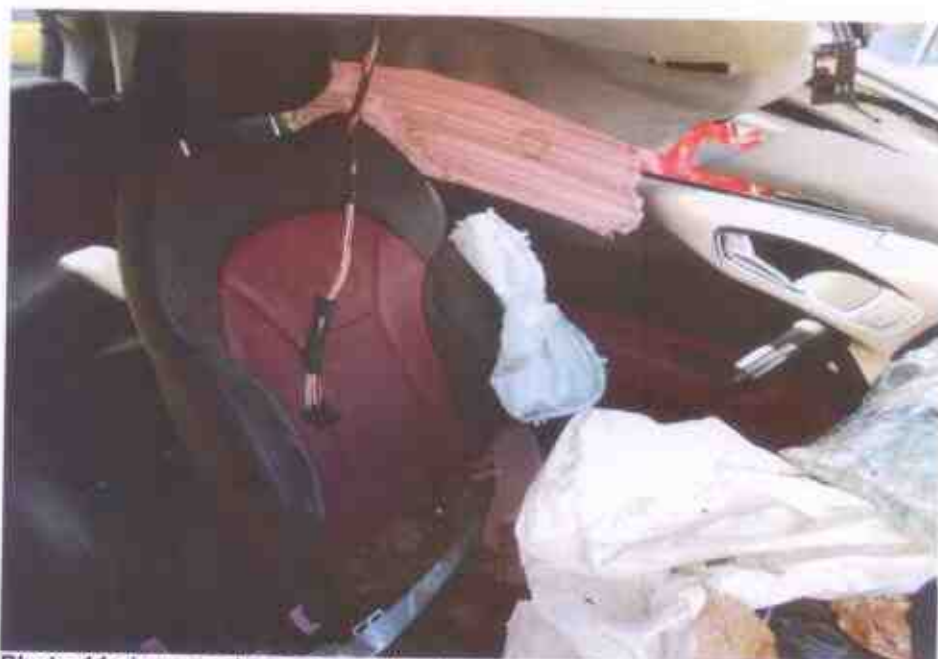
Photo 11 shows a closer view of the damages at the interior portion of the Motor Car due to the extensive impact collision at time of the accident.

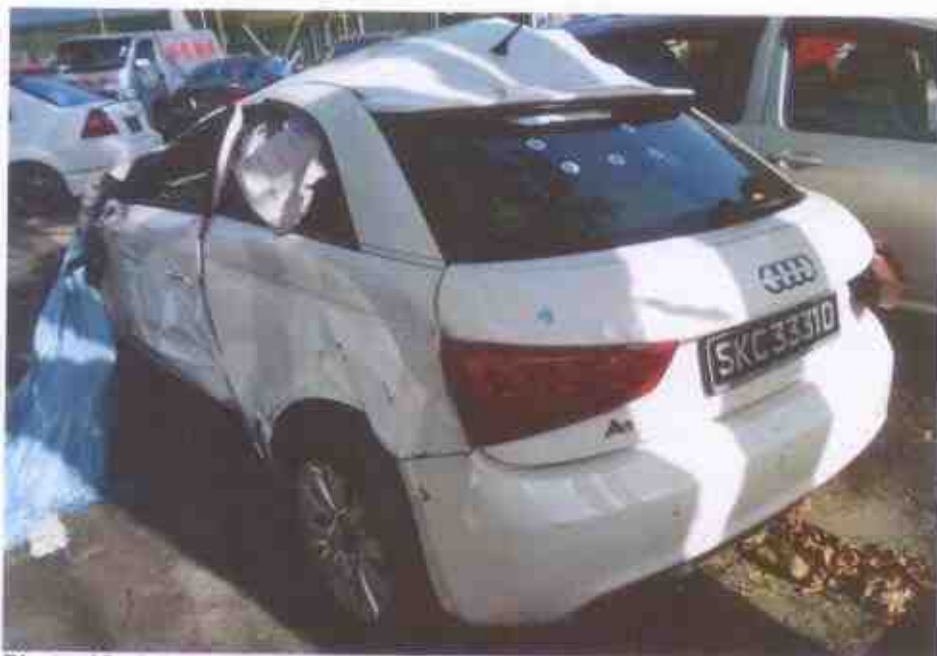
Photo 12 shows a general view of the rear left portion of the Motor Car at the time of our inspection. The rear portion was observed to be relatively sustained with minor impact by the accident that caused the rear bumper to be dislodged.

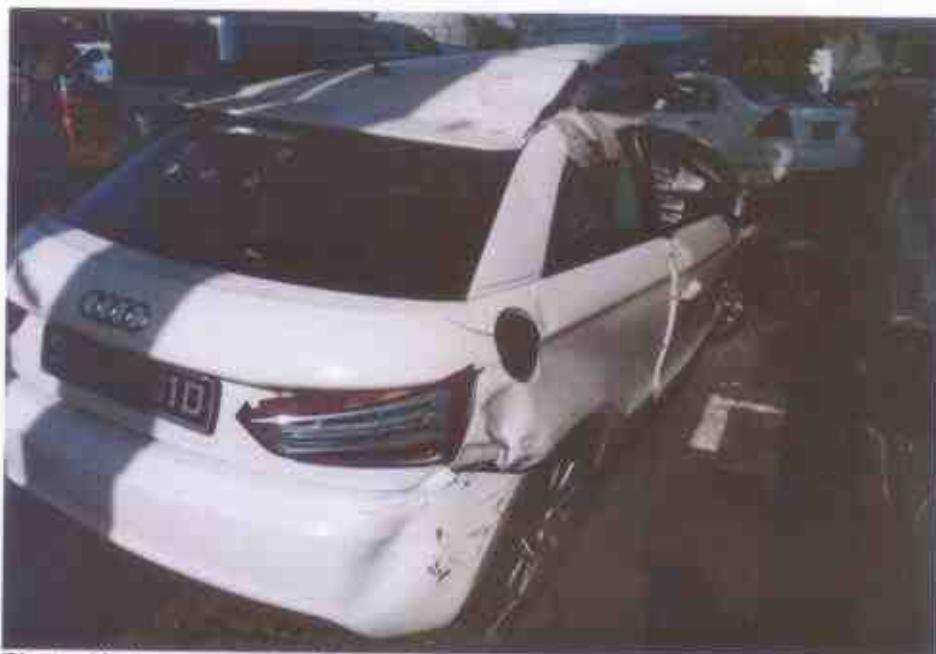
Photo 13 shows a general view of the rear right portion of the Motor Car at the time of our inspection. The rear portion was observed to be relatively sustained with minor damages.

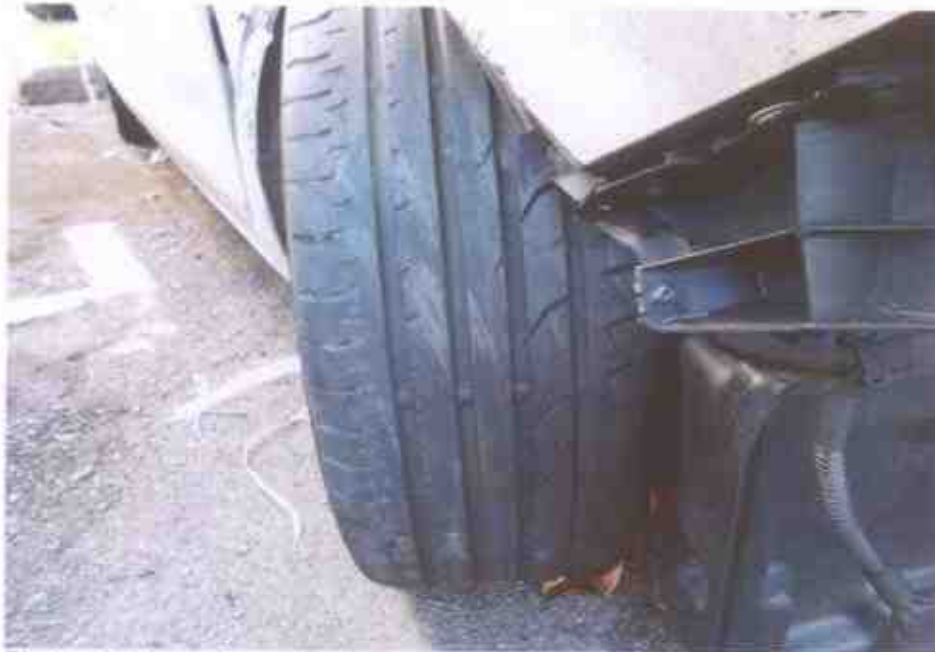
8. The 4 tyres were observed to be wrapped around alloy wheel rims that were found to be without any significant damage except for some marks of grazing nature on the outer spokes of the wheel rims, which are commonly associated to grazing against a road kerb. See photo 14 – 17 below.

Photo 14 shows the condition of the front right portion of the Motor Car, which was observed to be in serviceable condition. We did not find any tear, cut or burst mark(s) on the outer and the inner sidewalls as well as across the tread of the 4 tyres. The 4 tyres were also observed to be sufficiently inflated for vehicular operation with remaining tread depth of approximately at 4mm.

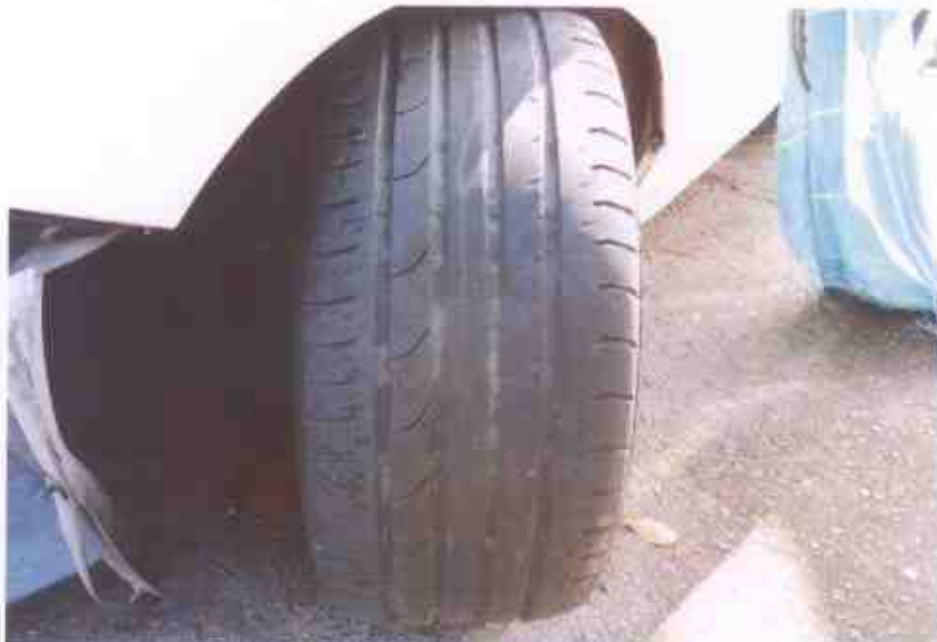
Photo 15 shows the condition of the front left tyre of the Motor Car, which was observed to be in serviceable condition. The 4 tyres were also observed to be sufficiently inflated for vehicular operation with remaining tread depth of approximately at 4mm.

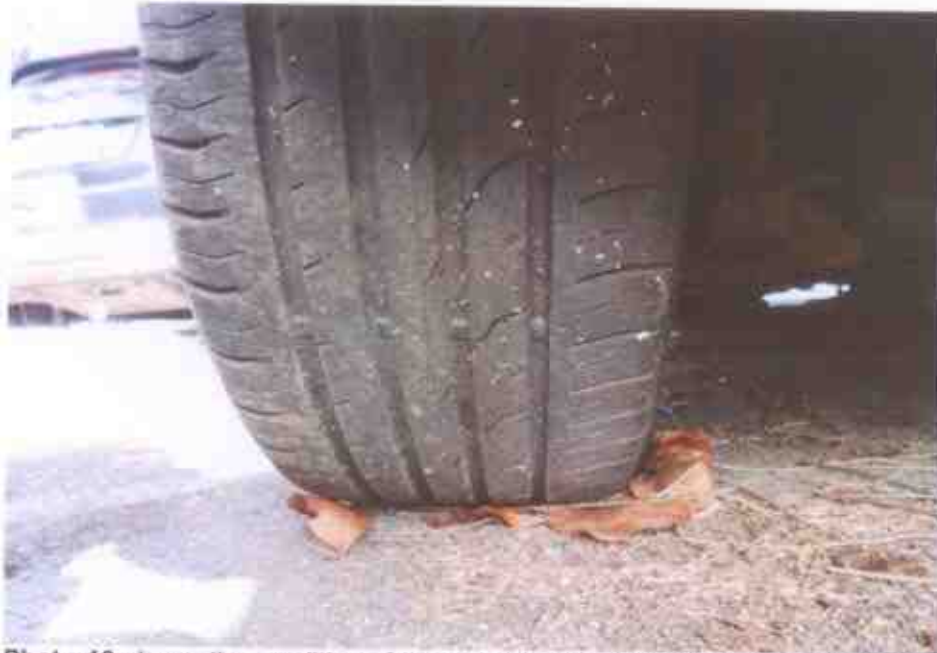
Photo 16 shows the condition of the rear left tyre of the Motor Car, which was observed to be in serviceable condition. The 4 tyres were also observed to be sufficiently inflated for vehicular operation with remaining tread depth of approximately at 4mm.

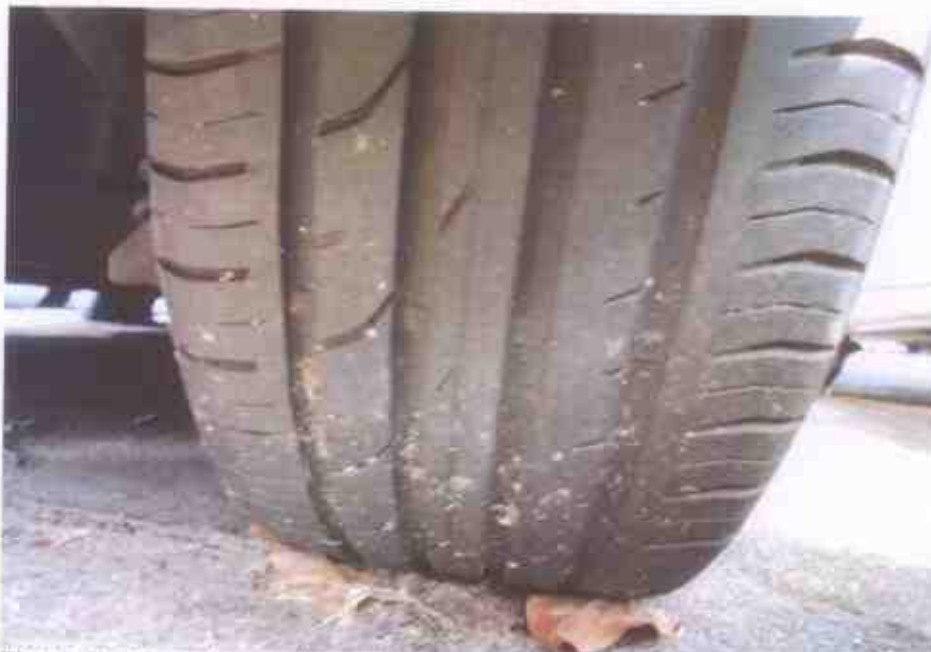
Photo 17 shows the condition of the rear right tyre of the Motor Car, which was observed to be in serviceable condition. The 4 tyres were also observed to be sufficiently inflated for vehicular operation with remaining tread depth of approximately at 4mm.

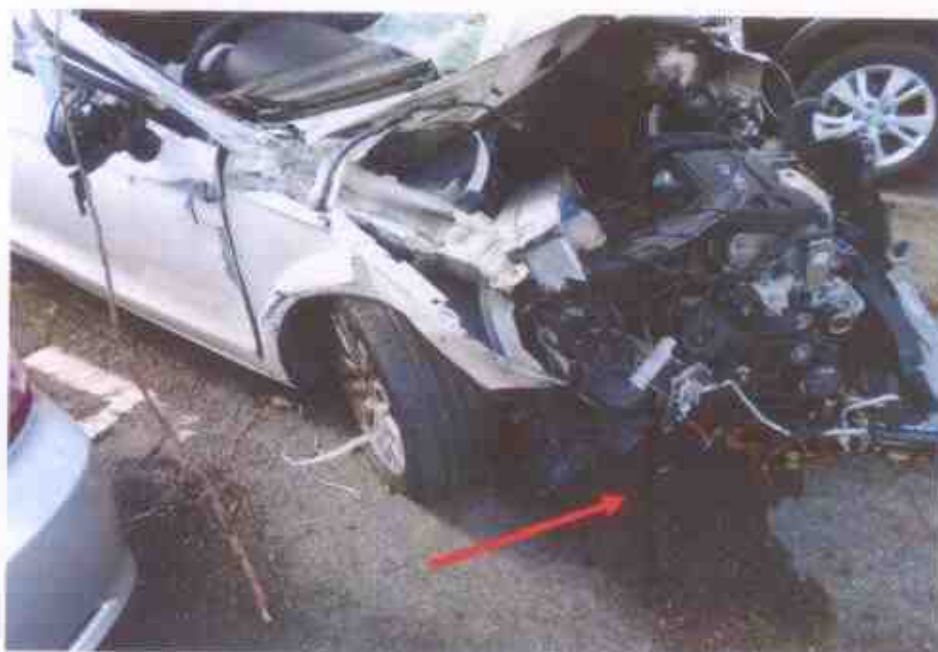
10. Leakage of the various operating fluids like the engine oil, engine coolant, power steering fluid and brake fluid was also noted. Given the extent of damages to the engine compartment, the leakages were likely due to the accident. The engine undercarriage was however observed to be covered with fluid, suggesting leakage of fluid. There was no accumulation of dust and/or dirt particles on the engine housing where the fluid stains had formed. This would indicate that the fluid leakage was a fresh leak and likely to be a result of the accident. We were therefore unable to comment whether these operating fluids were of sufficient level and without contamination for vehicular operation prior to the accident. See photo 18 to 21 below.

Photo 18 shows the semi-close up view of the dislodged engine of the Motor Car. Signs of fluid leakage stains were observed on the ground due to the accident's impact. Fluids such as brake fluid, steering fluid, engine fluid & coolant fluid were found to be leaking as a result of the accident.

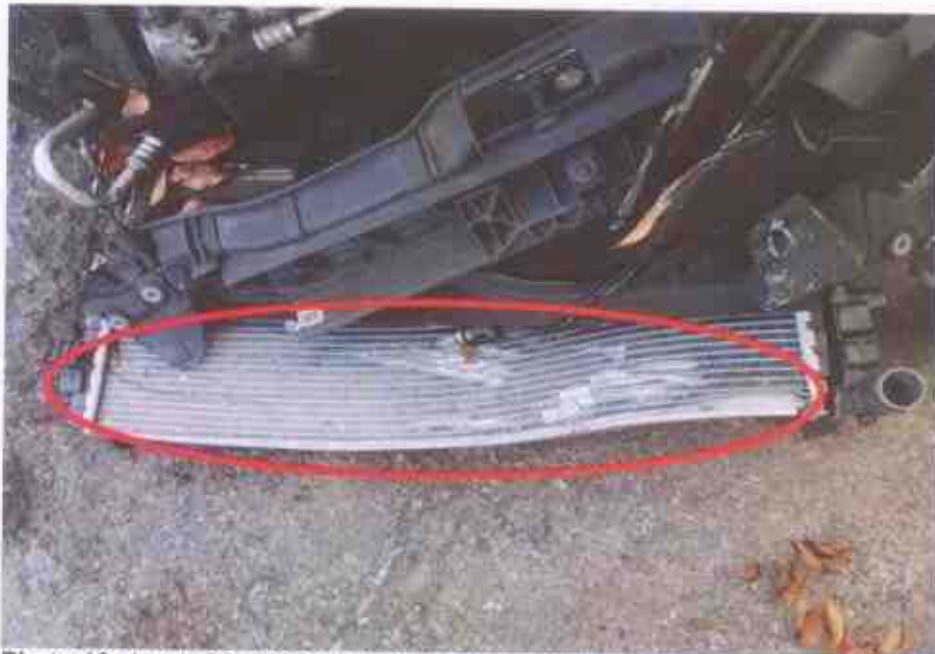
Photo 19 shows the close up view of the radiator's tank that was observed to be damaged likely due to the accident impact. Hence cause leakage to the coolant fluid.

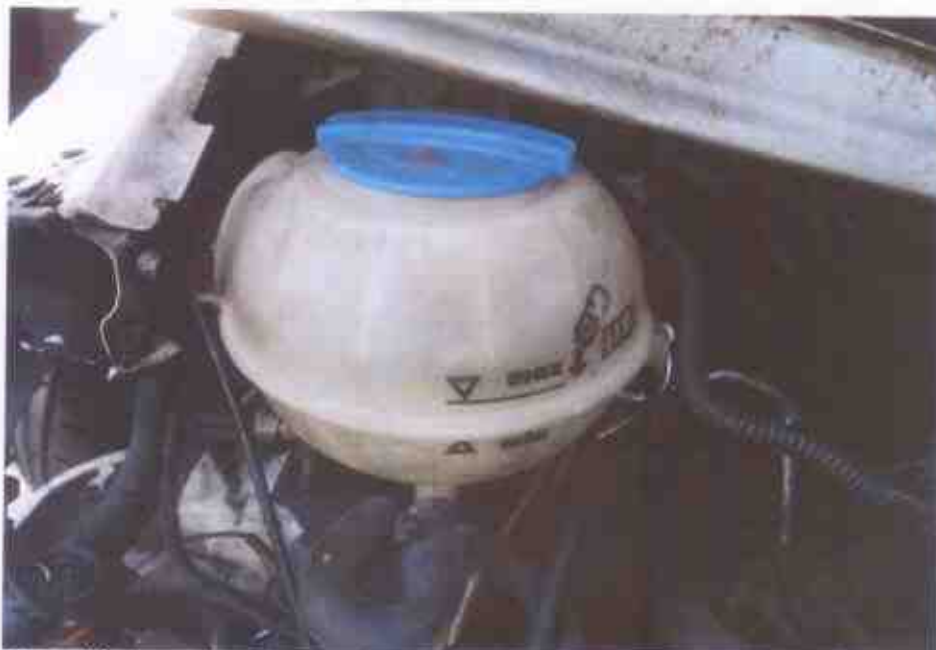
Photo 20 shows the close up view of the empty coolant fluid reservoir due to the accident impact.

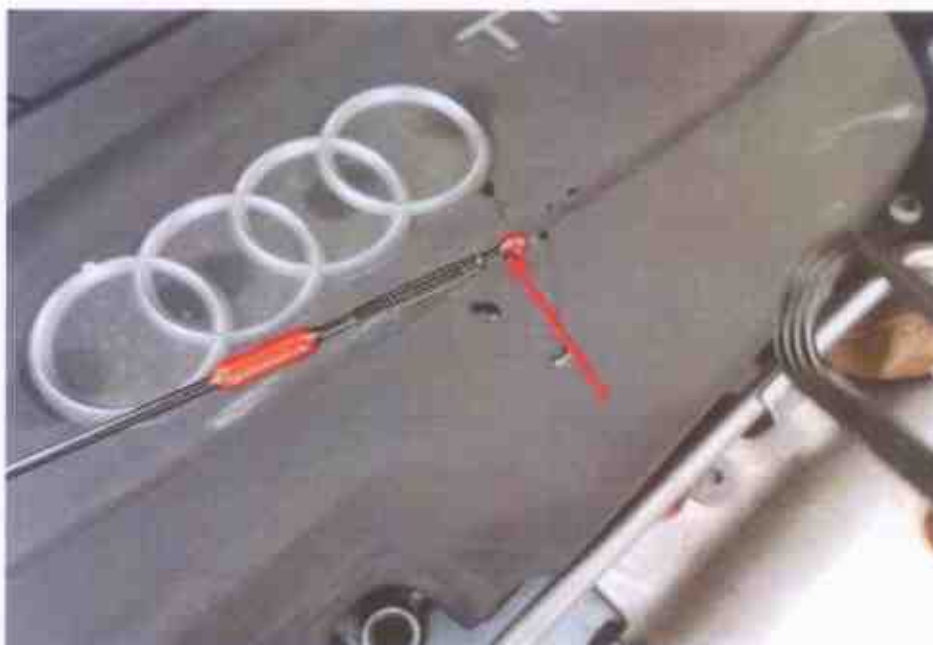
Photo 21 shows the close up view of the insufficient engine fluid due to the leakage as a result of the accident.

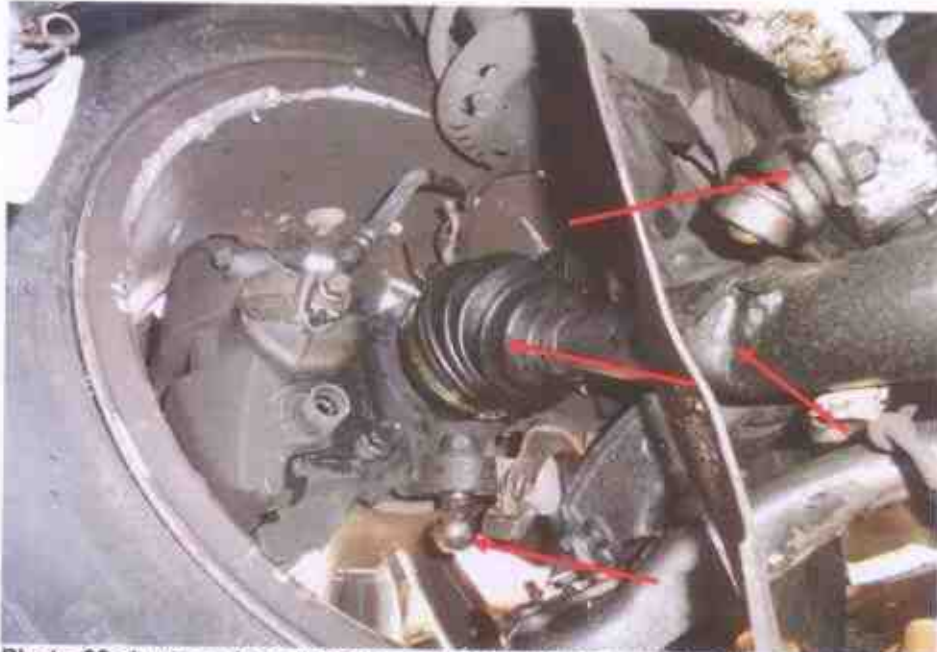
Photo 22 shows a close up view on the front left drive shaft of the Motor Car. We were not able to conduct any tests on the steering system of the Motor Car due to the damage to these components.

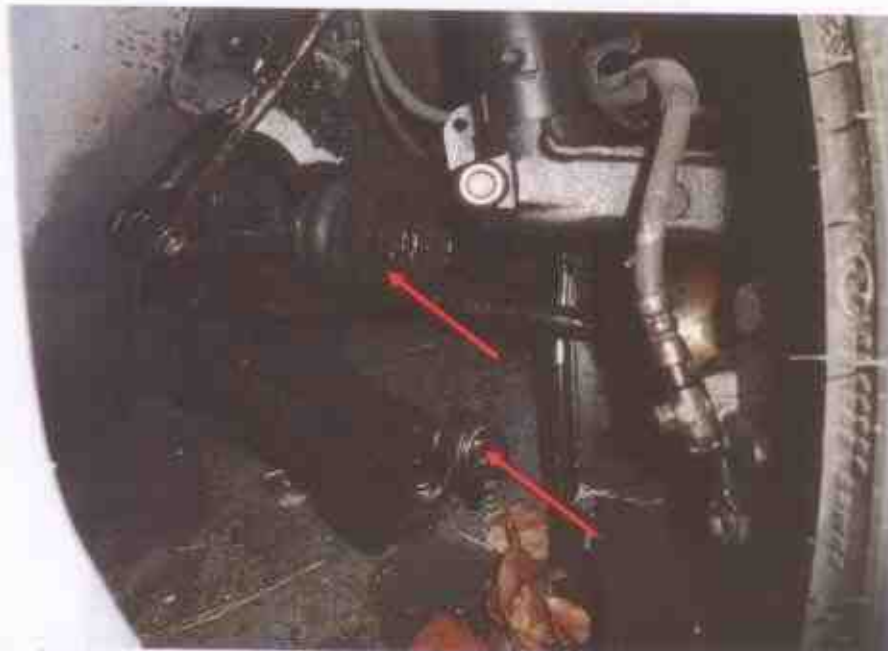
Photo 23 shows the damaged on the front right drive shaft of the Motor Car. We were not able to conduct any tests on the steering system of the Motor Car due to the damage to this components, as well as leakage of fluids.

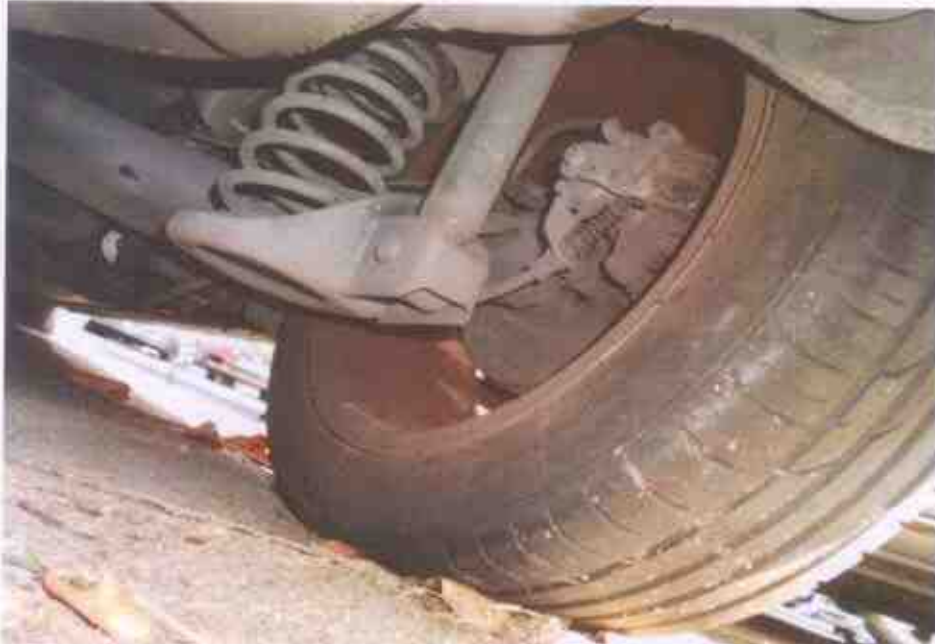
Photo 24 shows the braking & steering components at the rear right wheel of the Motor Car. We did not observe any leakage of brake fluid at the time of our inspection of the Motor Car.

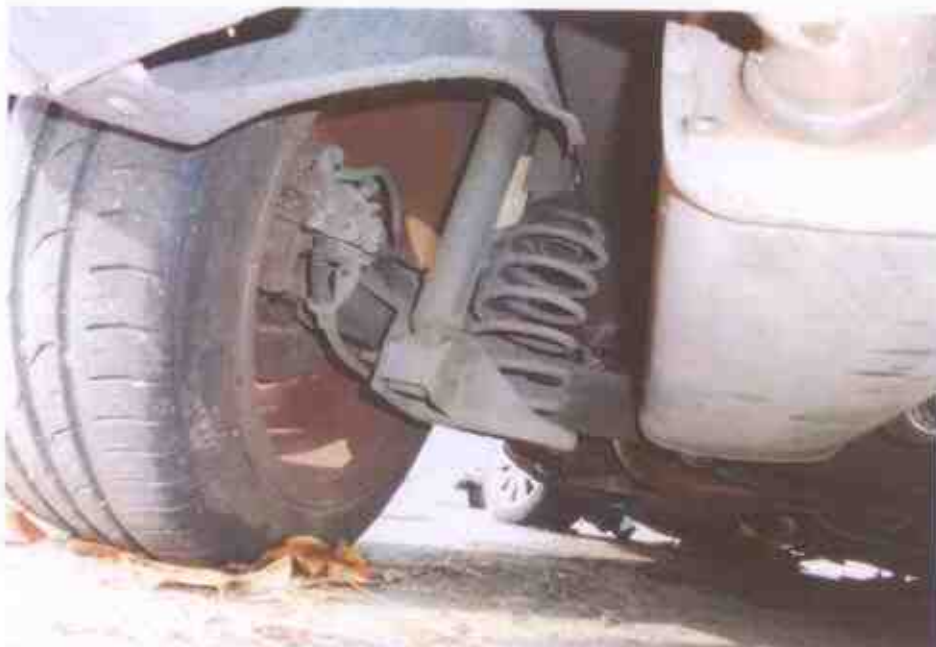
Photo 25 shows the braking & steering components at the rear left wheel of the Motor Car. We did not observe any leakage of brake fluid at the time of our inspection of the Motor Car.

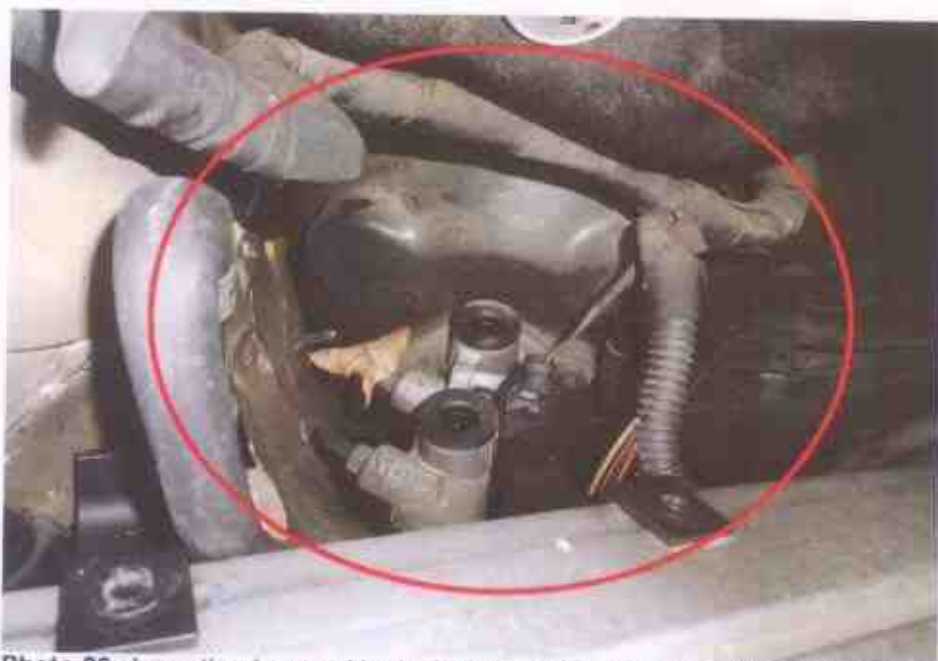
Photo 26 shows the damaged brake booster of the Motor Car. We observe signs of brake fluid leakage at the time of our inspection of the Motor Car.

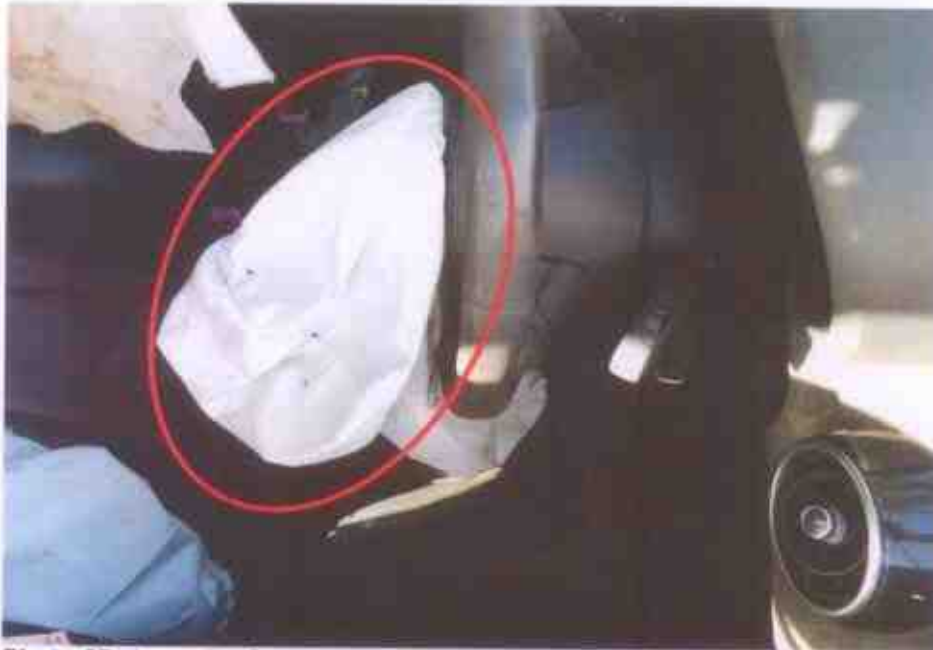
Photo 27 shows the Supplemental Restraint System (SRS) of the Motor Car was however likely to be in normal operating condition at the material time of the accident. The evidence of the deployed front driver's airbag indicates that the impact sensors and control module of the Motor Car's SRS were all in serviceable condition at the material time of accident.

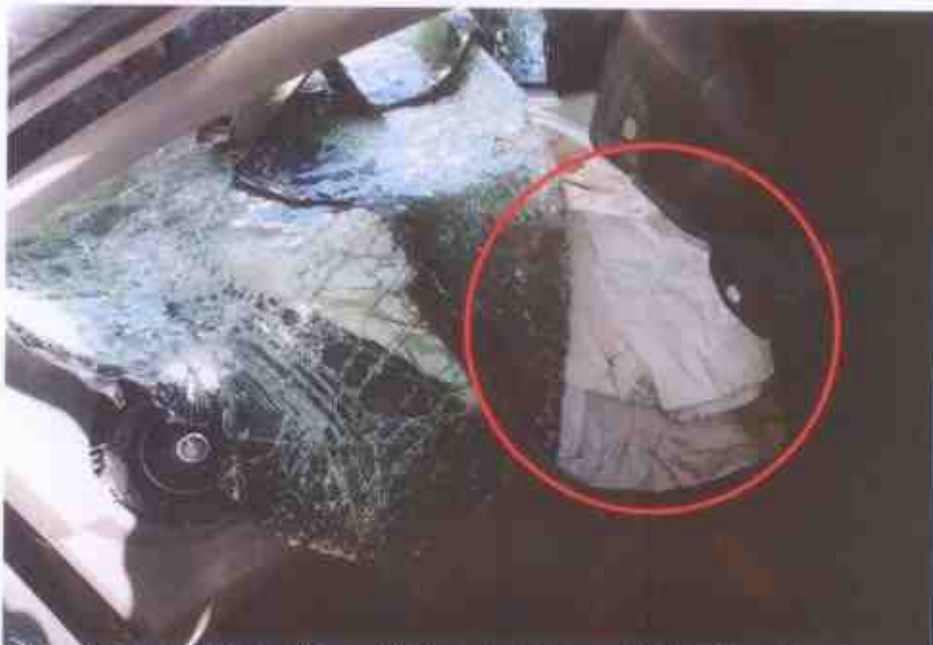
Photo 28 shows the Supplemental Restraint System (SRS) of the Motor Car was however likely to be in normal operating condition at the material time of the accident. The evidence of the deployed front passenger's airbag indicates that the impact sensors and control module of the Motor Car's SRS were all in serviceable condition at the material time of accident.
