Your Ref: TP/IP/52969/2018
Our Ref :CI/TPD18018441/Z

26th November 2018

MECHANICAL INSPECTION REPORT OF MOTORCYCLE AKD 1832

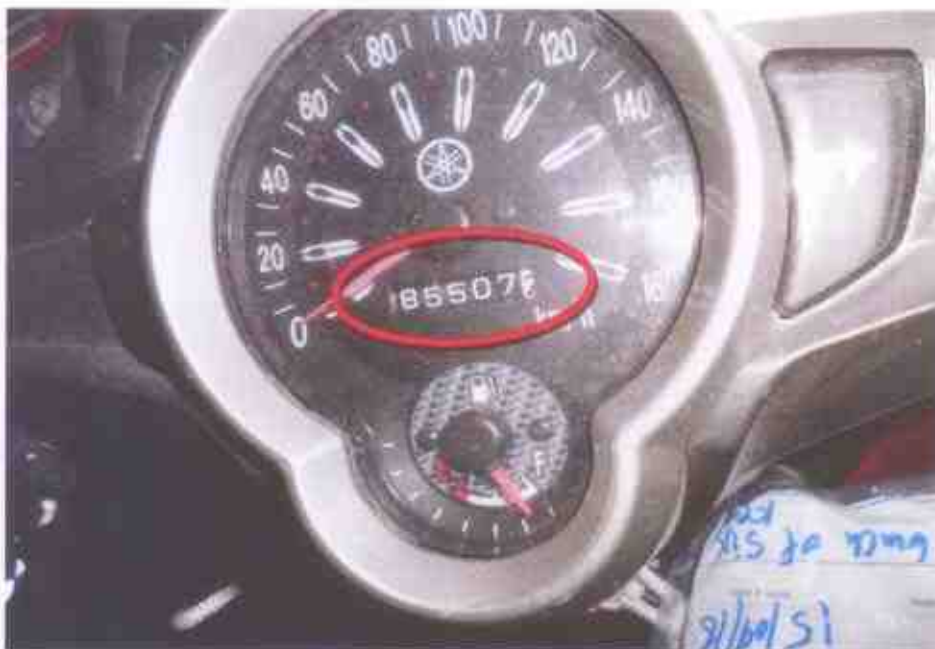
Photo 1 shows the mileage of the Motorcycle recorded at time of our inspection was 855072km.

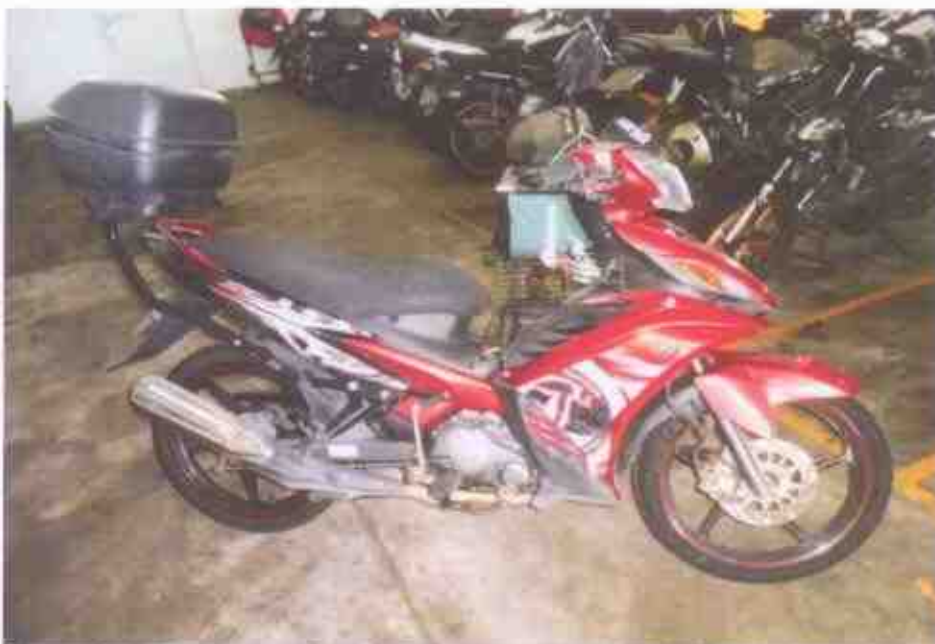
Photo 2 shows a general view of the right body of the Motorcycle at the time of our inspection. The Motorcycle was observed to have sustained minor damages as a result of the accident.

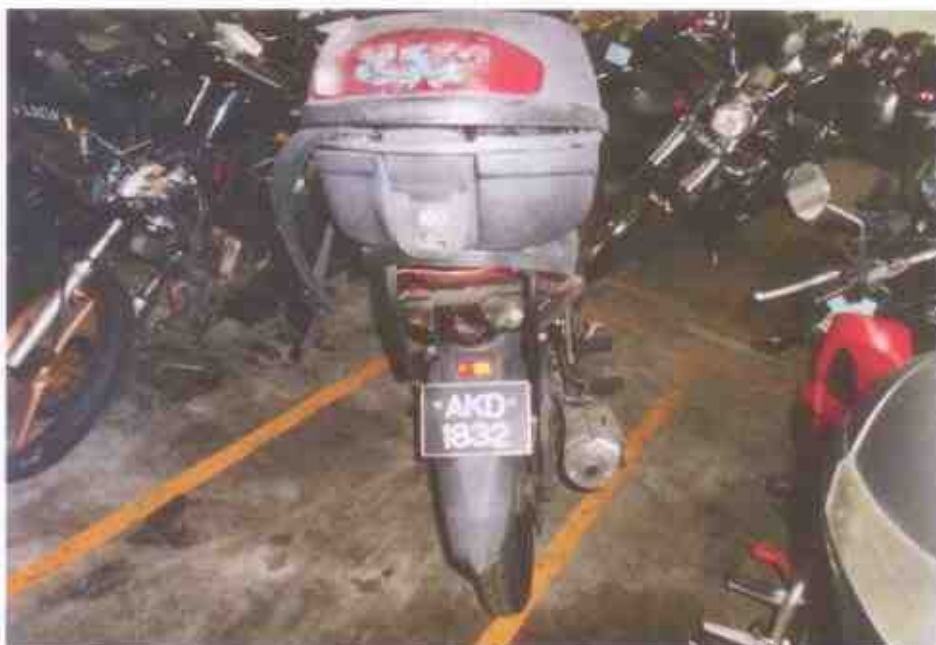
Photo 3 shows a general view of the rear body of the Motorcycle at the time of our inspection. The Motorcycle was observed to sustained minor damage at the rear portion at time of inspection.

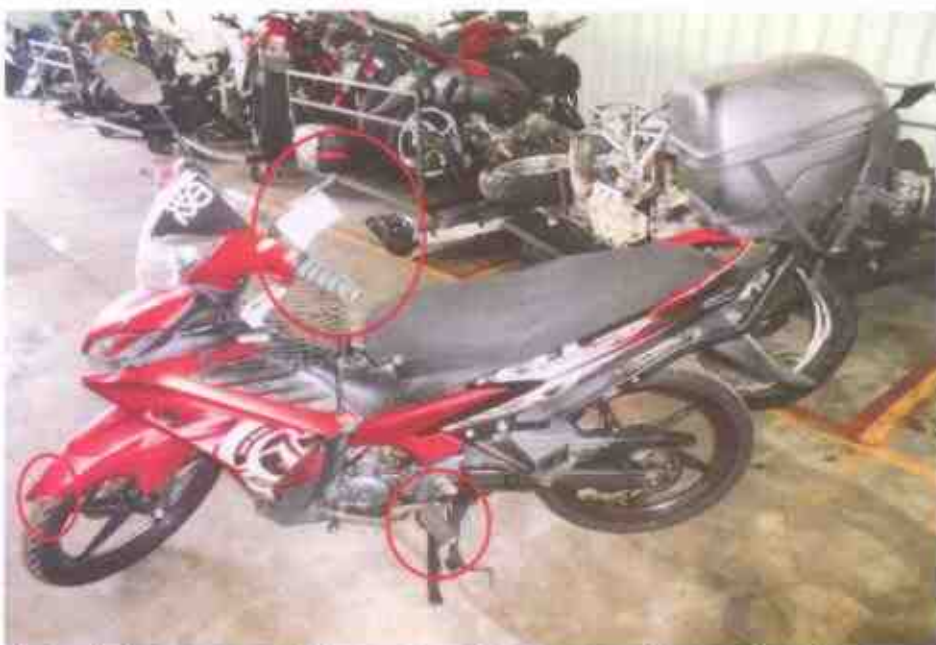
Photo 4 shows a general view of the left body of the Motorcycle at the time of our inspection. The Motorcycle was observed to have sustained minor damages which includes missing left wing mirror, slight bend handle bar, bent foot rest amongst others as a result of the accident.

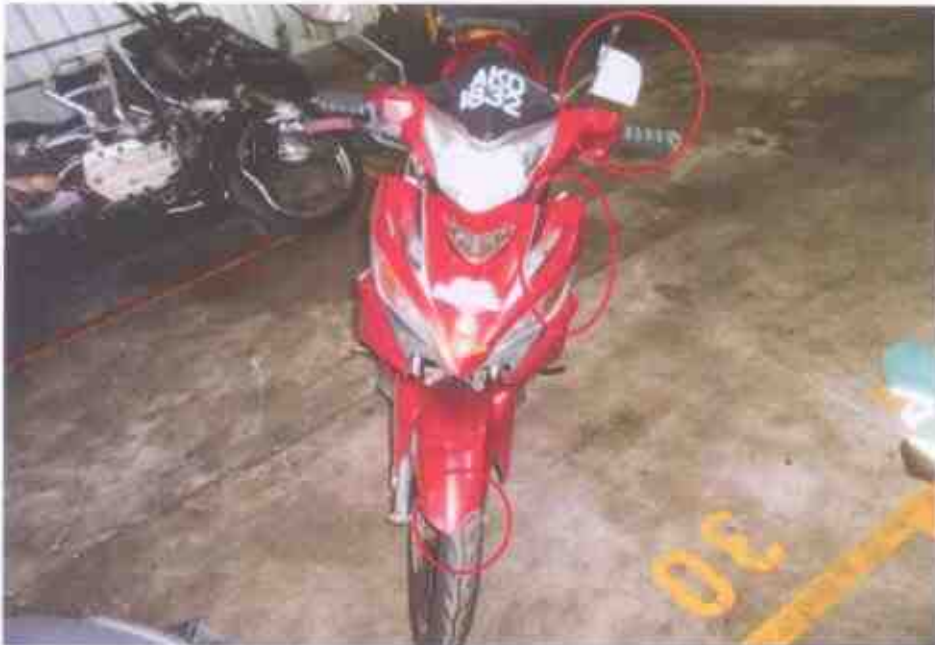
Photo 5 shows a general view of the front portion of the Motorcycle at the time of our inspection. The Motorcycle was observed to have sustained minor damages which include missing left wing mirror, slight bend handle bar, and bent foot rest amongst others as a result of the accident.

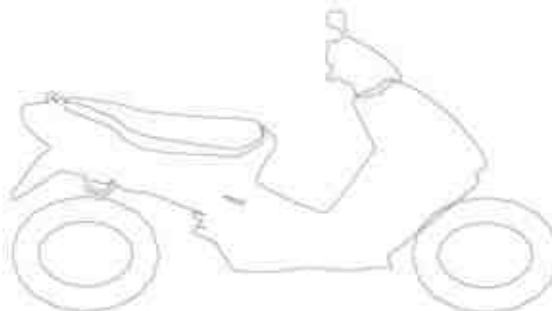
7. The condition of the Motorcycle's 2 tyres was observed to be in serviceable condition. The tread pattern of the 2 tyres was clearly visible. We did not observe any tear, burst mark(s) and/or punctured hole(s) on the sidewalls as well as across the tread of the 2 tyres. The 2 tyres were both observed to be sufficiently inflated for vehicular operation. The tyre brand, tyre size and remaining tread depth of the 2 tyres were recorded as follows:-

Maxxis Diamond MA-3D 80/90 - R17 (2mm)

Maxxis Diamond MA-3D 70/90 - R17 (3mm)

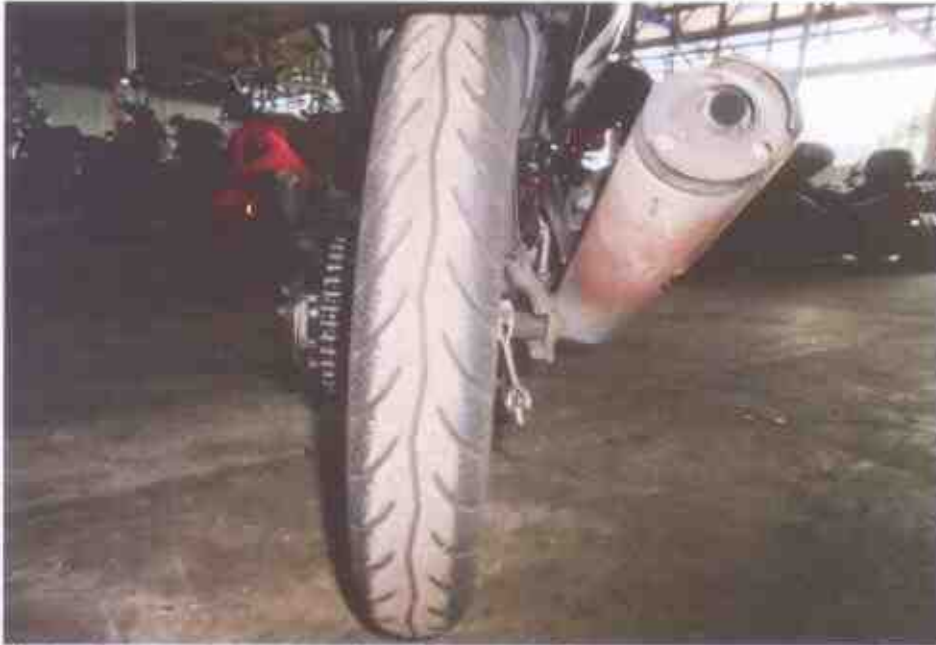
Photo 6 shows the rear tyre of the Motorcycle. The rear tyre was observed to be in serviceable condition with remaining tread depth of approximately 3mm. The tyre was also observed to be sufficiently inflated for vehicular operation.

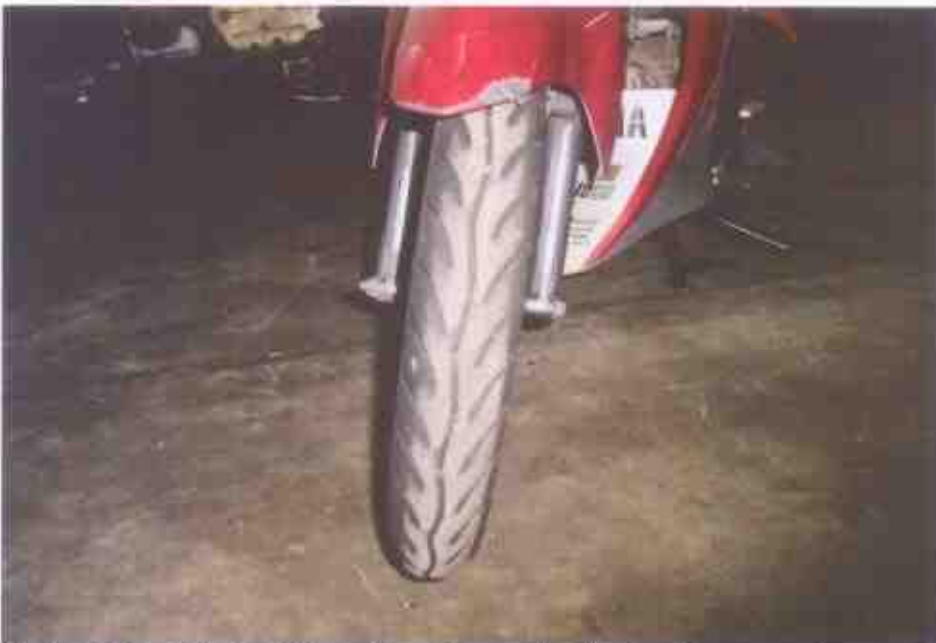
Photo 7 shows the front tyre of the Motorcycle. The front tyre was observed to be in serviceable condition with remaining tread depth of approximately 2mm. The tyre was also observed to be sufficiently inflated for vehicular operation.

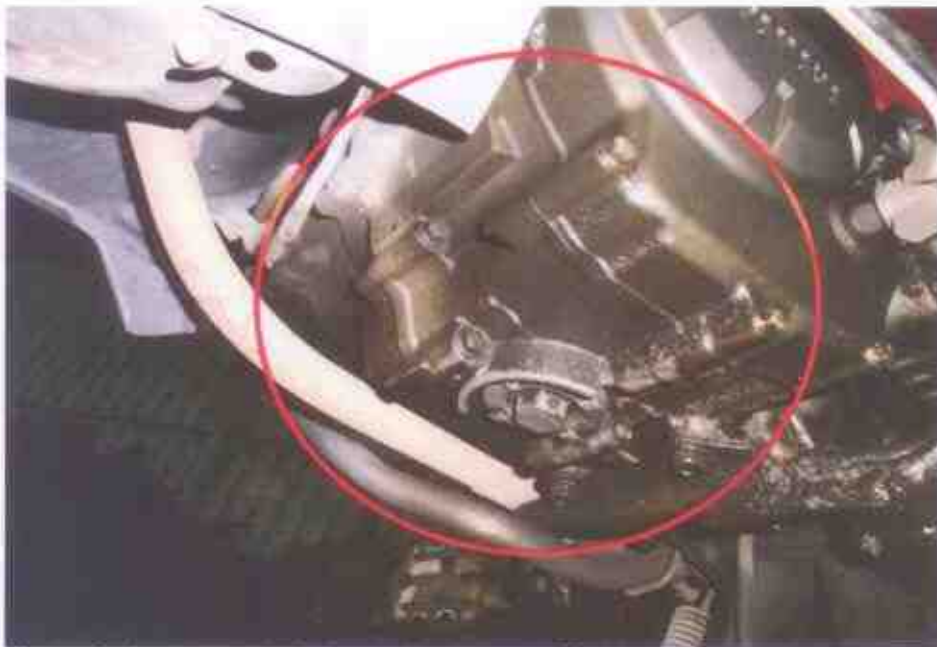
9. Upon examination of the Motorcycle's engine area, we had observed that the various engine related parts and components were intact with no visible damage. The engine underside was however observed to be covered with brownish fluid, suggesting leakage of fluid as a result of the accident.
10. The gear chain of the motorcycle was found to be intact without any misalignment. It was also adequately lubricated for operating purposes. Free play tension test was also conducted & found adequately acceptable. See photo 8 – 11 below.

Photo 8 shows no sign(s) or indication(s) of fluid leak observed around the underside of the engine area of the Motorcycle.

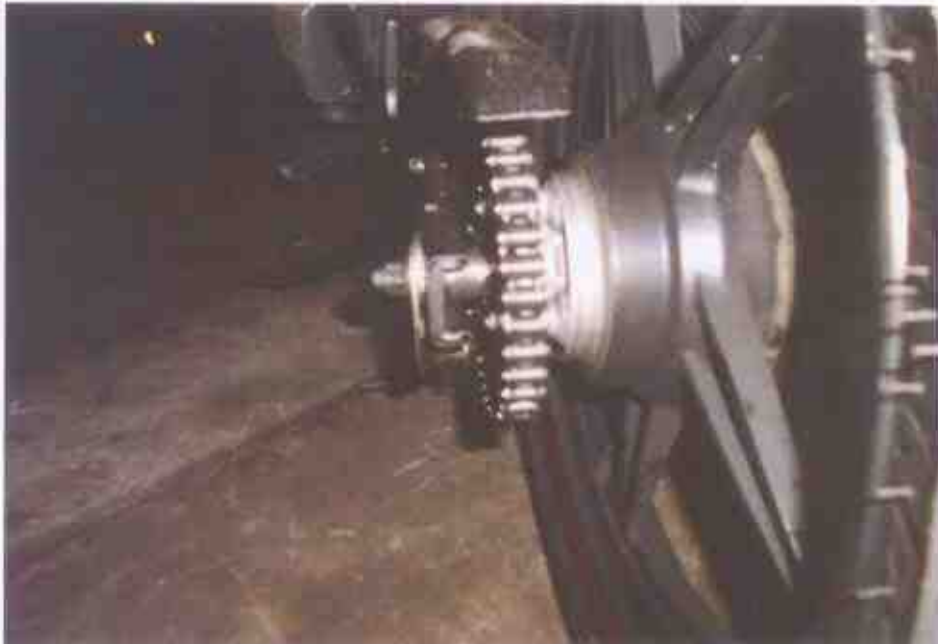
Photo 9 shows the general view of the gear train of the Motorcycle, which was observed to be intact with no misalignment. It was also adequately lubricated for operating purposes.

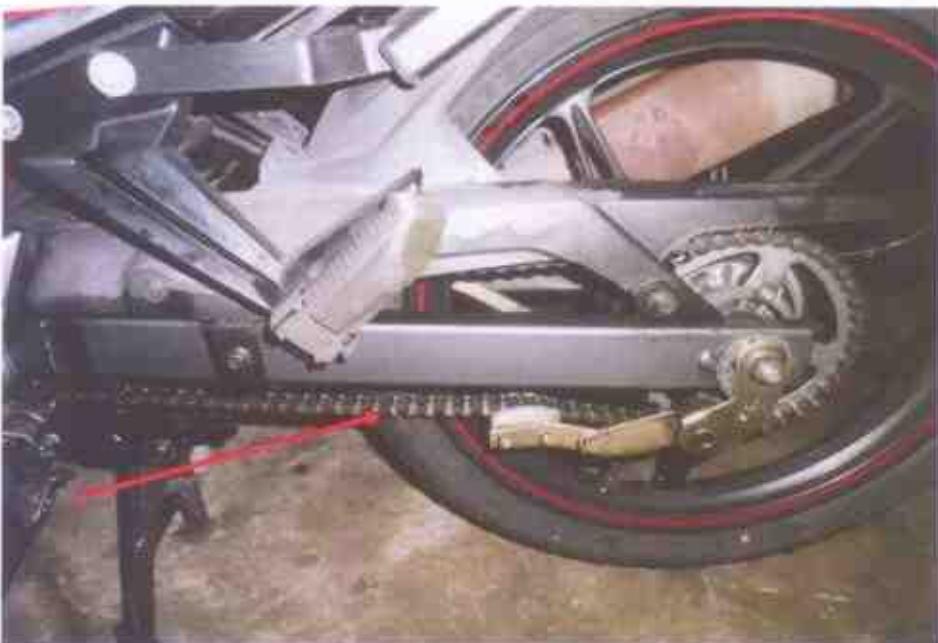
Photo 10 shows the general view of the gear train (arrowed) of the Motorcycle, which was observed to be intact with no misalignment. It was also adequately lubricated for operating purposes.

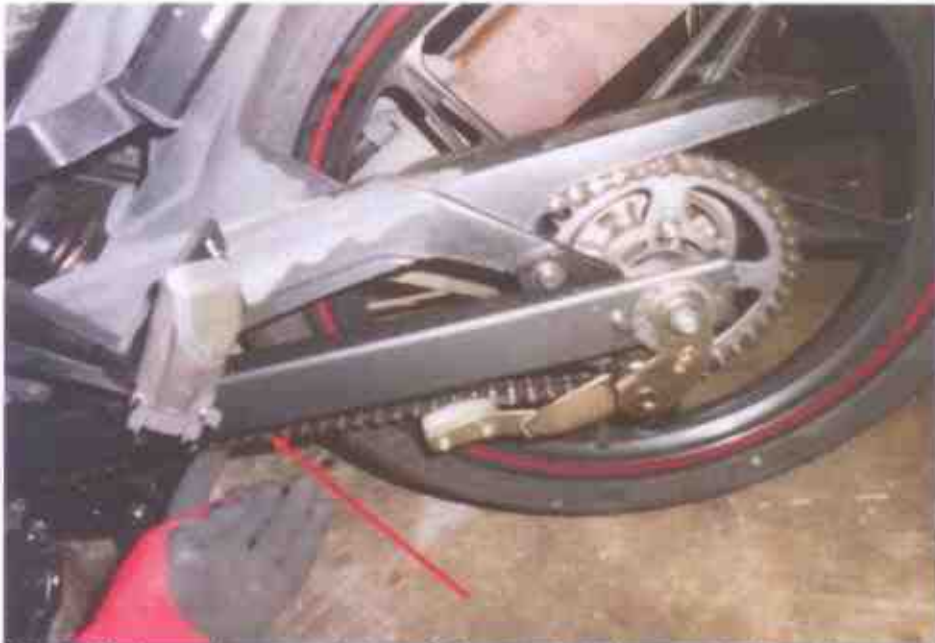
Photo 11 shows the general view of the gear train (arrowed) of the Motorcycle, which was observed to be intact with no misalignment. It was also adequately lubricated for operating purposes. Free play tension was also observed & found adequately acceptable.

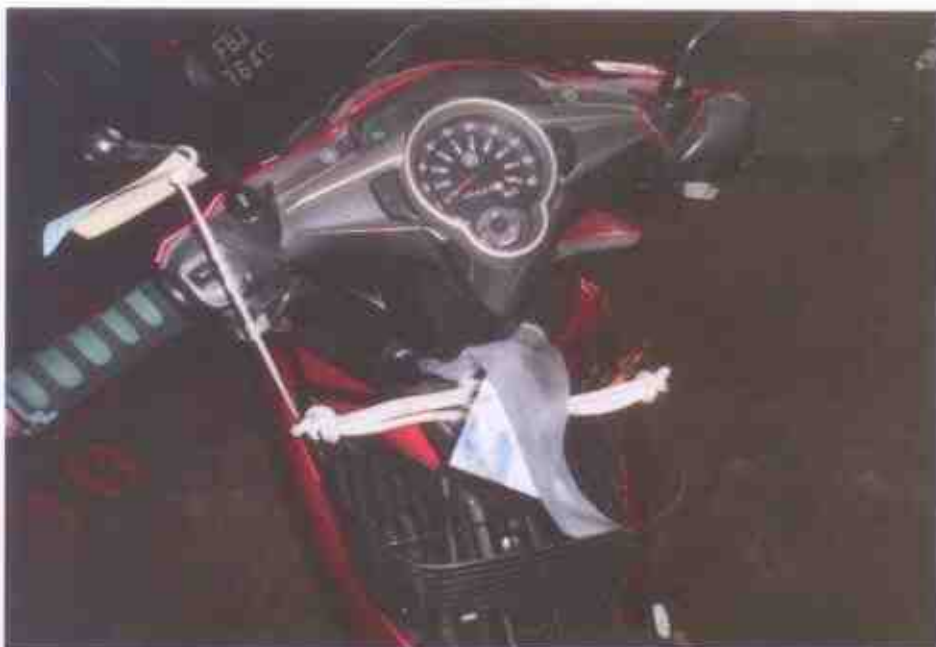
11. Our checks on the various steering components of the Motorcycle had revealed that its steering system was in serviceable condition. Its front fork was found to be intact and undamaged. Despite a slight bend to the left side handle bar (due to the accident) an operational test towards the left and right also did not produce any abnormal free play and/or resistance.
12. The brake system of the Motorcycle was of a semi-hydraulic type, where hydraulic (brake fluid) pressure controls the brake for the front wheel while the brake for the rear wheel is controlled by mechanical means (cables and springs). The brake for the front wheel is engaged by pulling the brake lever at the right side of the Motorcycle's handle bar while the brake for the rear wheel is engaged by stepping on the brake pedal at the right side foot rest of the Motorcycle.

Photo 12 shows the steering system was observed to be in a serviceable condition. It was able to be steered to the full left & right at time of our inspection.

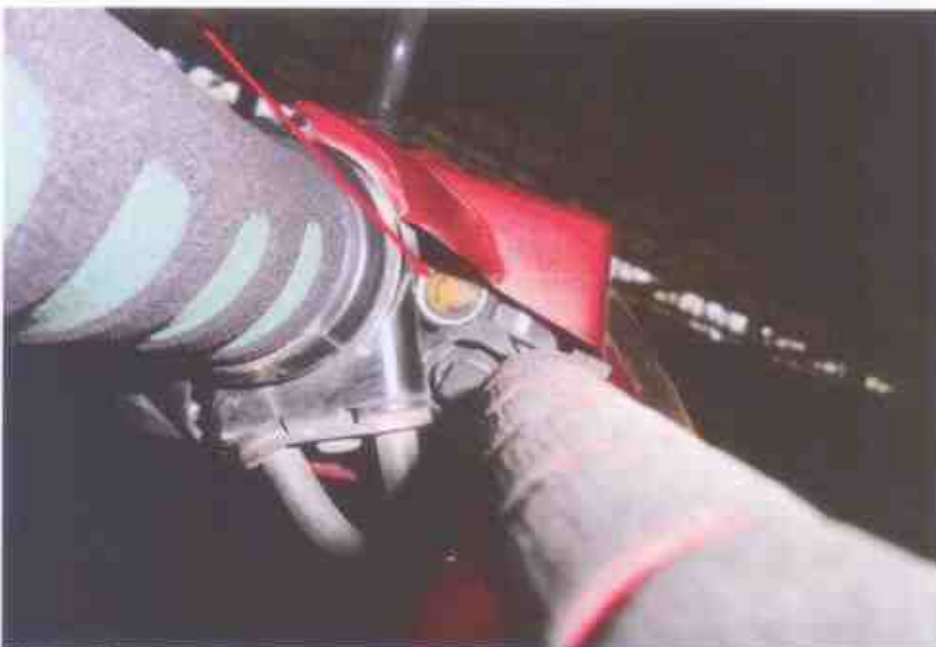
13. Static brake tests conducted on the Motorcycle front & rear brakes had appeared to indicate that the braking system of the Motorcycle was in serviceable condition. The Motorcycle's braking system like the brake discs, brake callipers, brake lever, brake foot pedal, rear brake cable & spring and brake hoses revealed all to be intact and without damage. There was some resistance felt (spongy like feel) upon pressing the brake lever & stepping on the rear brake foot pedal. This would indicate that there was no leakage of pressure/vacuum in the brake system. Our checks on the front brake fluid reservoir had also indicated that the brake fluid was of sufficient level for operational purposes, and without contamination.

Photo 13 shows our checks on the brake fluid reservoir had also indicated that the brake fluid was of sufficient level for operational purposes, and without contamination.

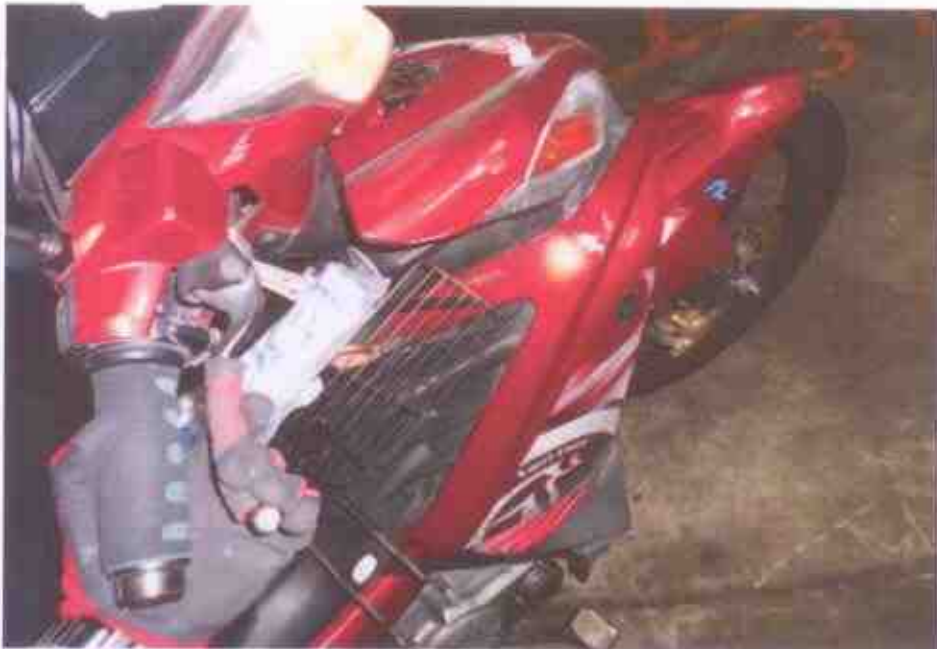
14. We subsequently carried out an operational test of the Motorcycle's braking system. This was done by riding on the Motorcycle moving forward and backward, getting the Motorcycle in motion via 1st & 2nd gear, and thereafter engaging the front brake and rear brake of the Motorcycle. At the end of the short operational test, we did not observe any abnormal behaviour of the Motorcycle's braking system. The front wheel and rear wheel of the Motorcycle were able to stop rotating immediately upon depressing the brake lever and stepping on the brake pedal.

Photo 14 shows testing of the braking of the front brake in progress. There was some resistance felt (spongy like feel) upon pressing the brake lever.

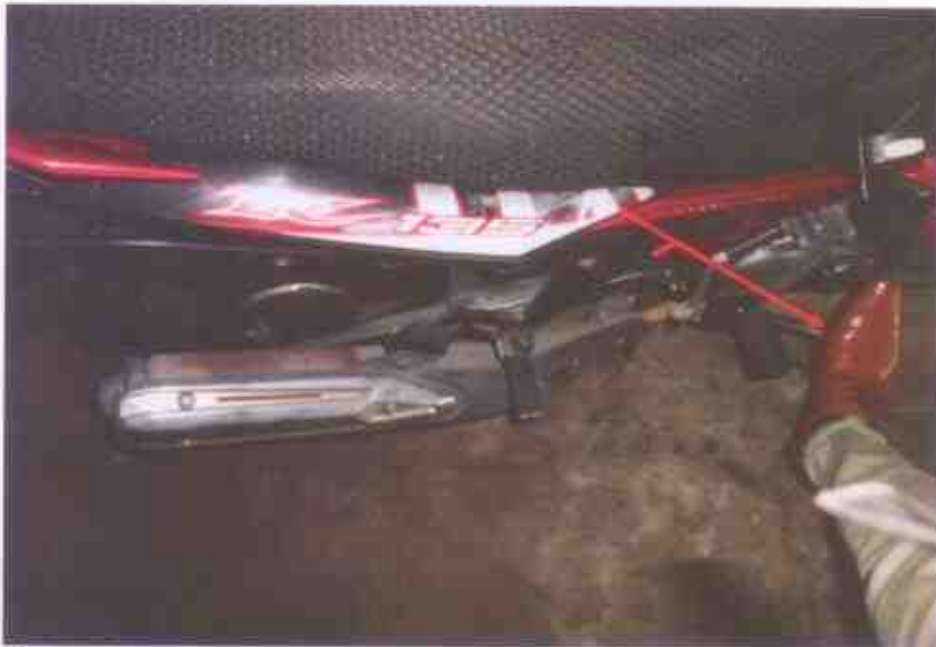
Photo 15 shows testing of the braking of the rear brake in progress. There was some resistance felt (spongy like feel) upon stepping on the brake pedal.
