MECHANICAL INSPECTION REPORT OF MOTOR TAXI SHC 8268G

1. We refer to your request on 27th September 2018 to conduct a physical inspection of a motor taxi bearing registration number SHC 8268G (herein referred to as "**Motor Taxi**"), which was involved in a fatal road traffic accident on 15th September 2018.
2. The objective of the inspection is to determine if there was any possible mechanical failure to the Motor Taxi that may have contributed to the accident.
3. Following the request, we had carried out a physical inspection of the Motor Taxi on 26th October 2018 at the premises of Traffic Police vehicle pound, 517 Airport Road Singapore 539942. We now set out below our observations and comments with respect to this inspection.

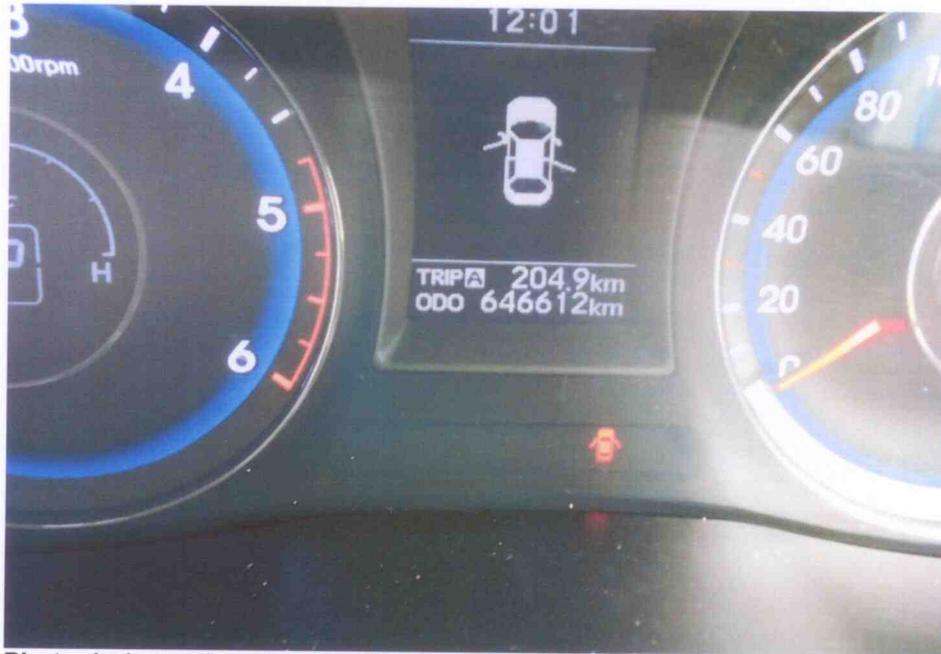
Photo 1 shows the mileage of the Motor taxi at the time of our inspection was recorded at 332164km.

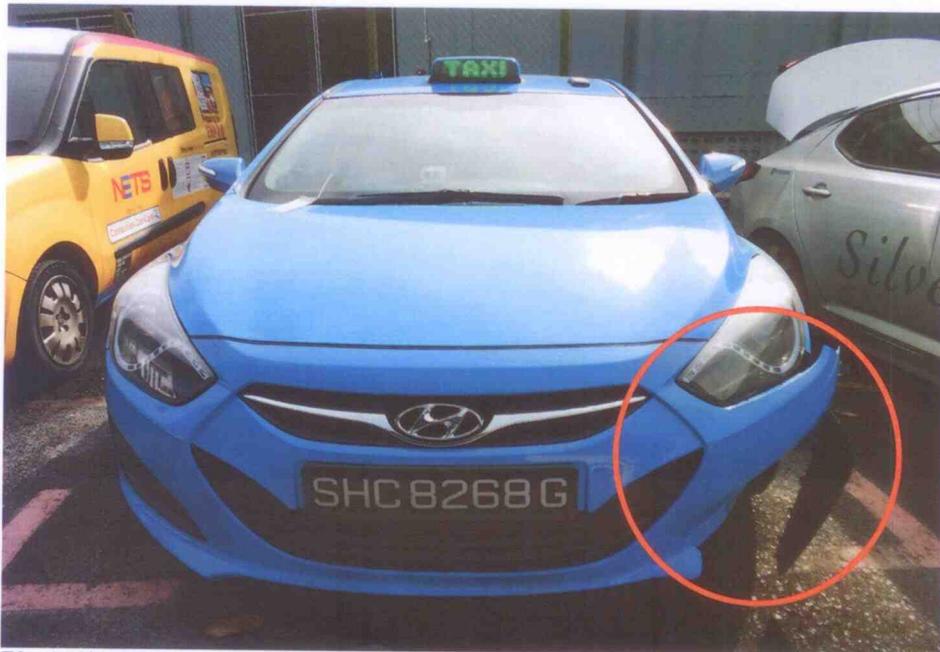
Photo 2 shows a general view of the front body of the Motor Taxi at the time of our inspection. The Motor Taxi was observed to have sustained a relatively minor impact damages that was confined to its frontal left portion. Its front lower bumper was observed to be pushed inwards likely due to the accident's collision impact.

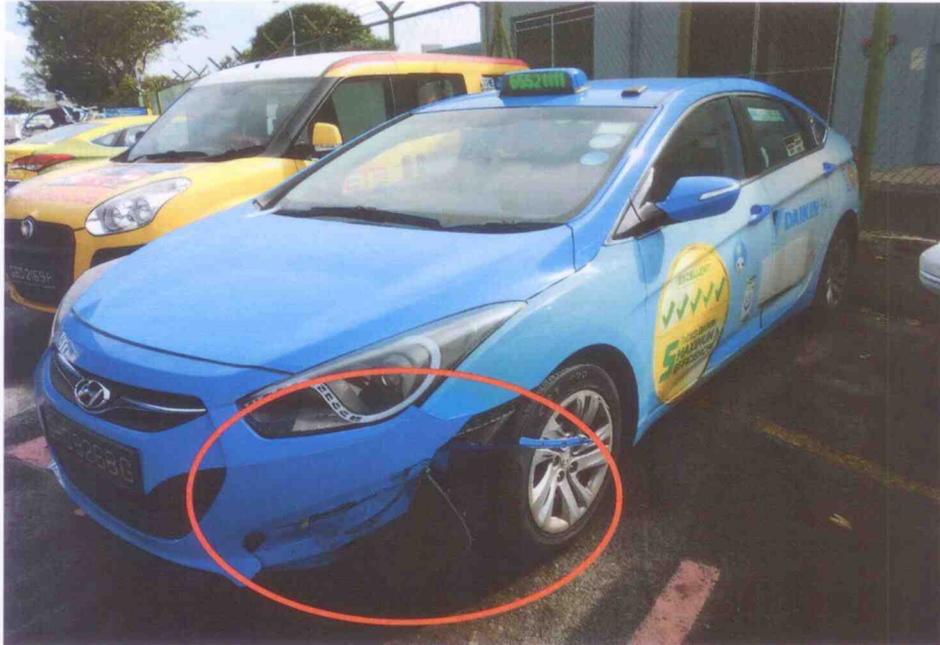
Photo 3 shows a general view of the front left body of the Motor Taxi at the time of our inspection. The Motor Taxi was observed to have sustained a relatively minor impact damages that was confined to its frontal left portion.

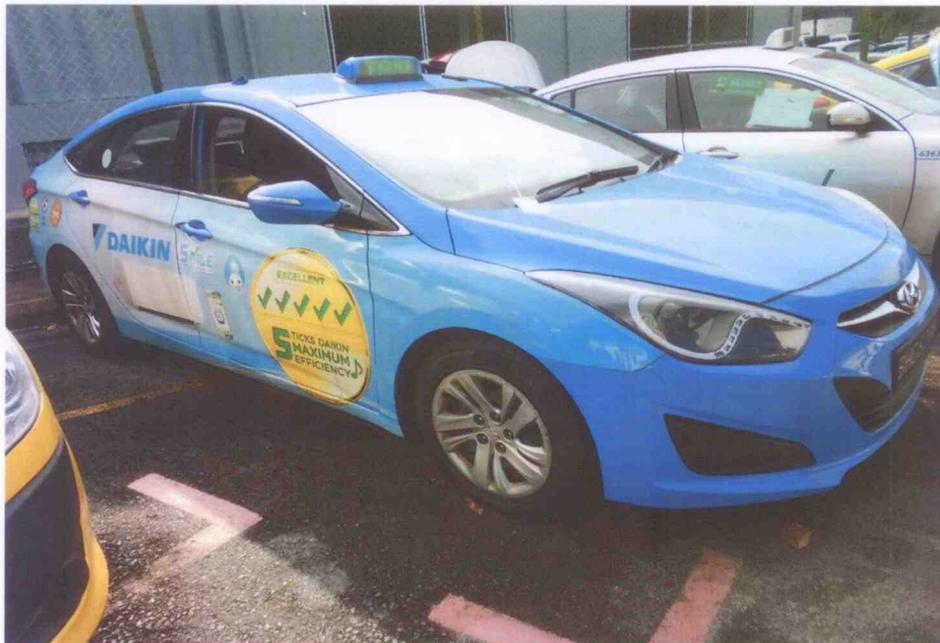
Photo 4 shows a general view of the front right body of the Motor Taxi at the time of our inspection. The Motor Taxi was observed to have sustained a relatively minor impact damages that was confined to its frontal left portion.

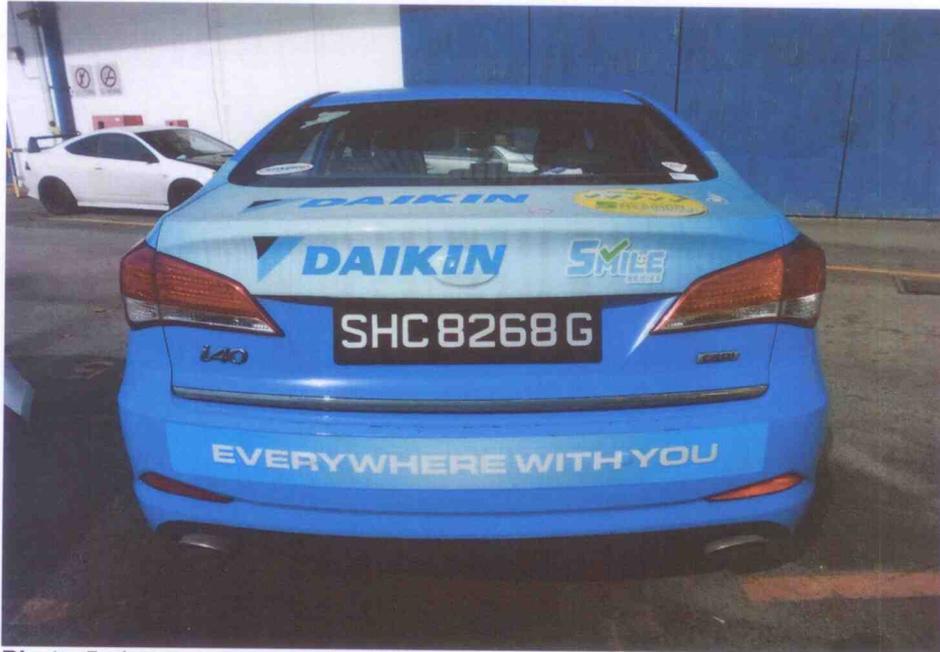
Photo 5 shows a general view of the rear body of the Motor Taxi at the time of our inspection. The Motor Taxi was observed to be in good general condition.

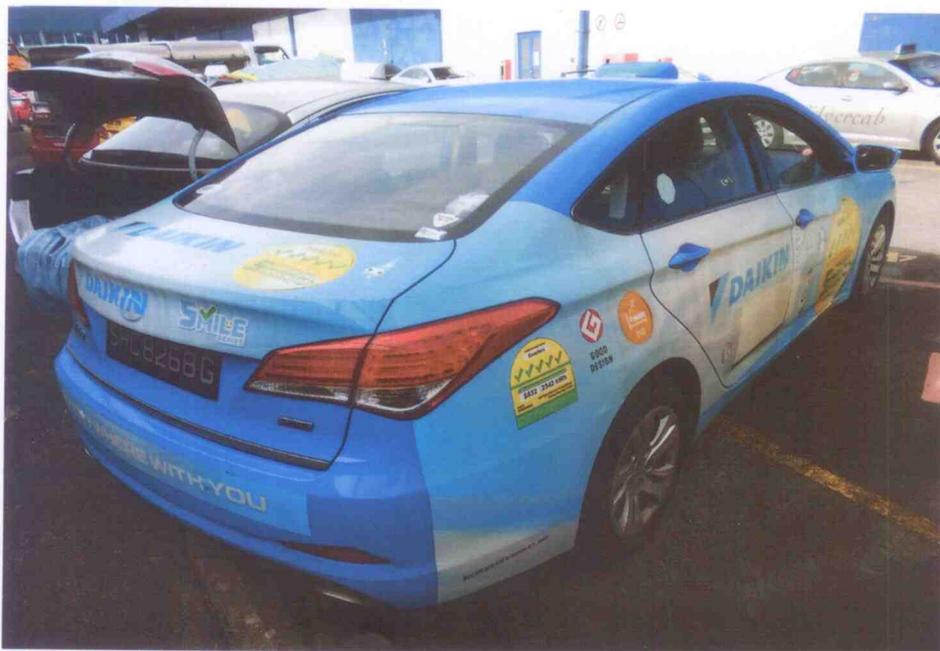
Photo 6 shows a general view of the rear right body of the Motor Taxi at the time of our inspection. The Motor Taxi was observed to be in good general condition.

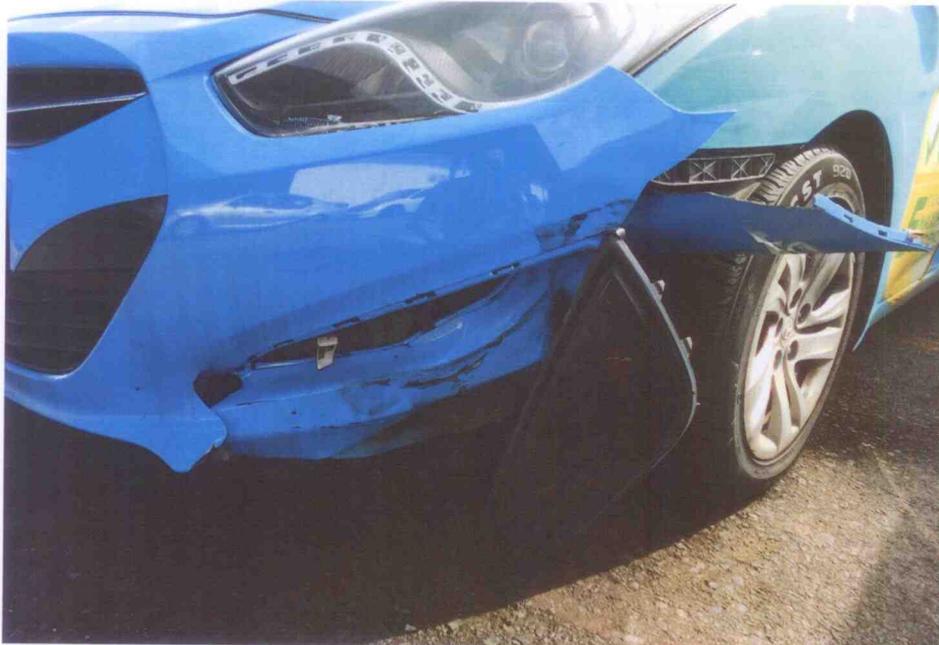
Photo 7 shows a semi close up view of the front left portion of the Motor Taxi at the time of our inspection. The Motor Taxi had sustained relatively minor damages at the front left lower bumper portion likely due to the accident.

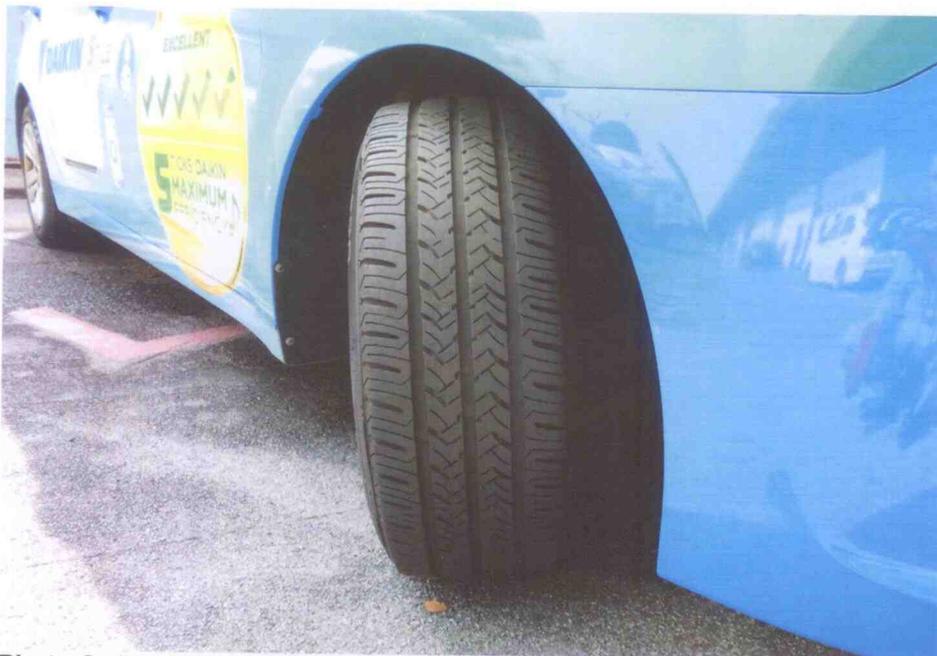
Photo 8 shows the condition of the front right tyre of the Motor Taxi, which was observed to be in serviceable condition with remaining tread depth of approximately 6mm. There was no tear, cut or burst mark(s) on the outer and the inner sidewalls.

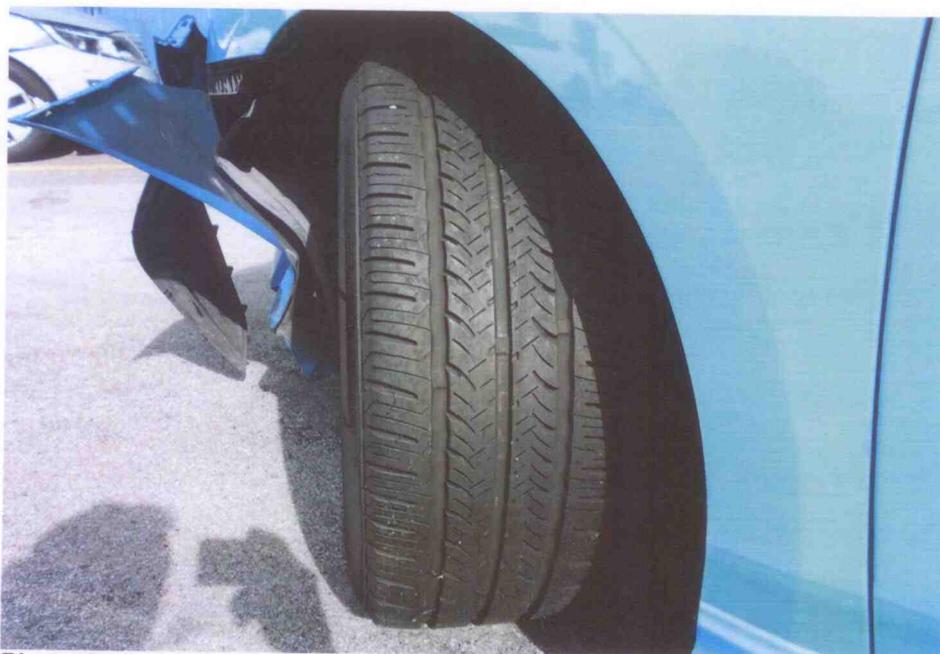
Photo 9 shows the condition of the front left tyre of the Motor Taxi, which was observed to be in serviceable condition with remaining tread depth of approximately 6mm. The tyre, which was wrapped around alloy wheel rim, was also observed to be sufficiently inflated for vehicular operation.

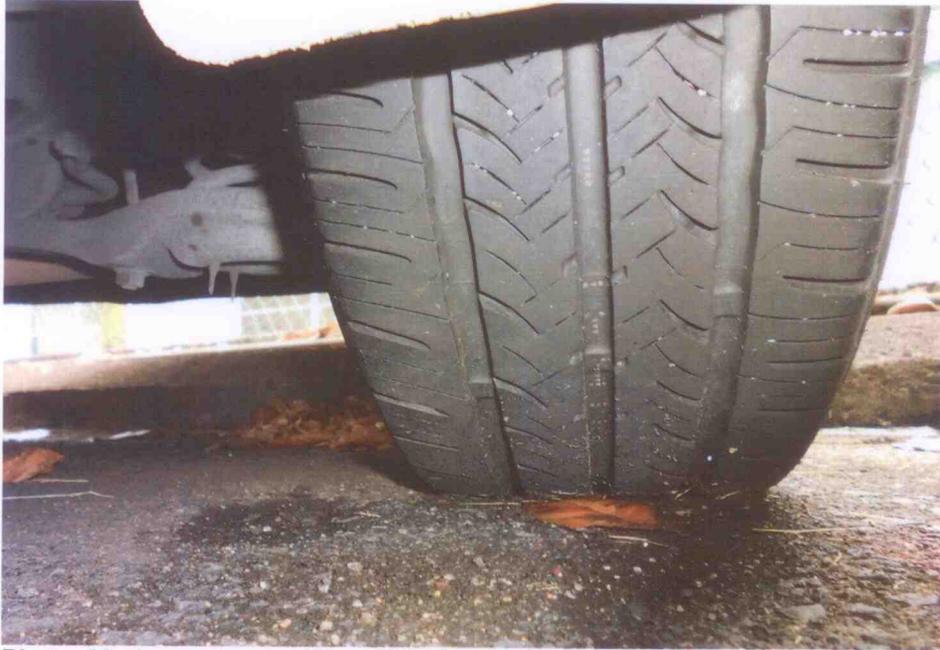
Photo 10 shows the condition of the rear left tyre of the Motor Taxi, which was observed to be in serviceable condition with remaining tread depth of approximately 7mm.

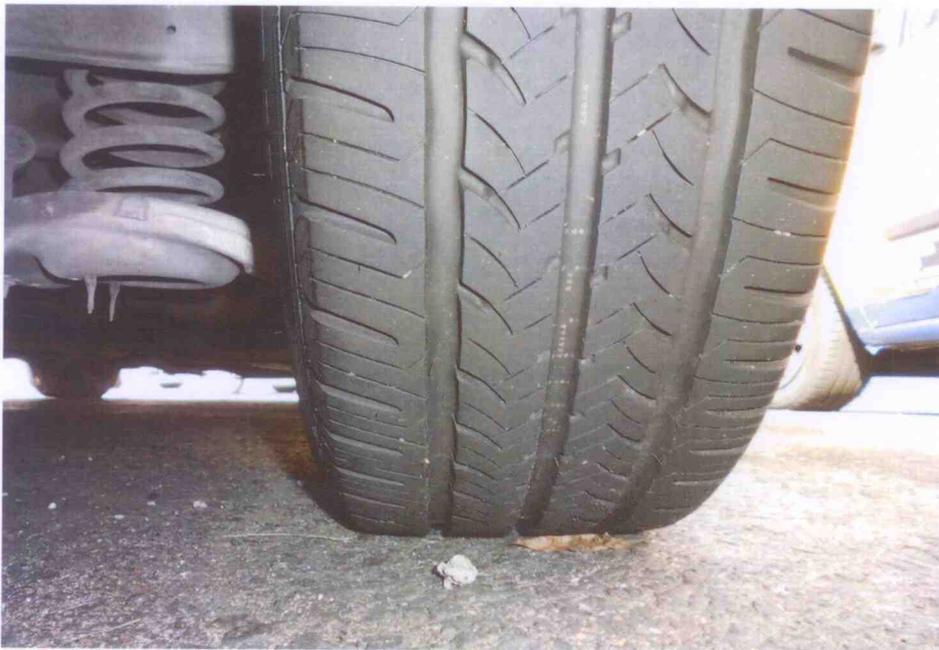
Photo 11 shows the condition of the rear right tyre of the Motor Taxi, which was observed to be in serviceable condition with remaining tread depth of approximately 7mm.

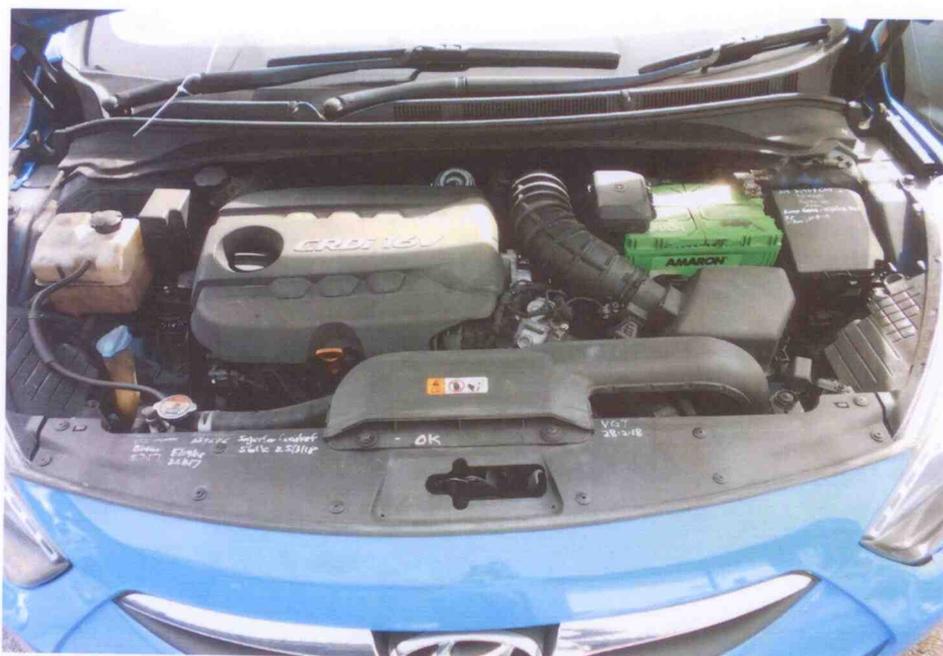
Photo 12 shows a general view of the Motor Car's engine compartment. The various parts and components inside the engine compartment were unaffected by the accident. There was also no sign(s) or indication(s) of fluid leakage and/or fluid stain within the engine compartment.

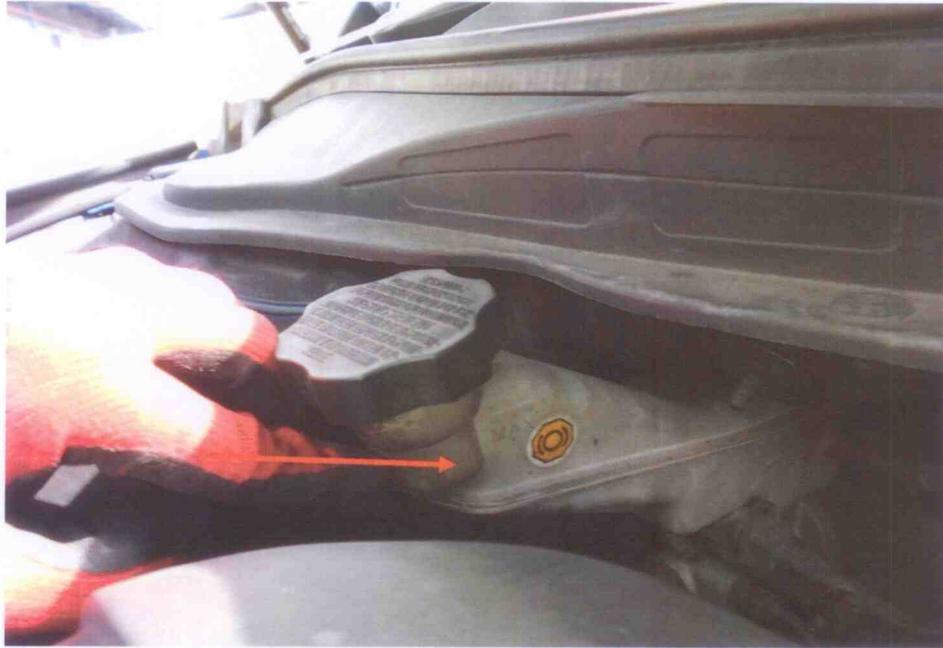
Photo 13 shows the brake fluid reservoir of the Motor Taxi at the time of our inspection. The brake fluid was observed to be of sufficient level (arrowed) and without any visible contamination.

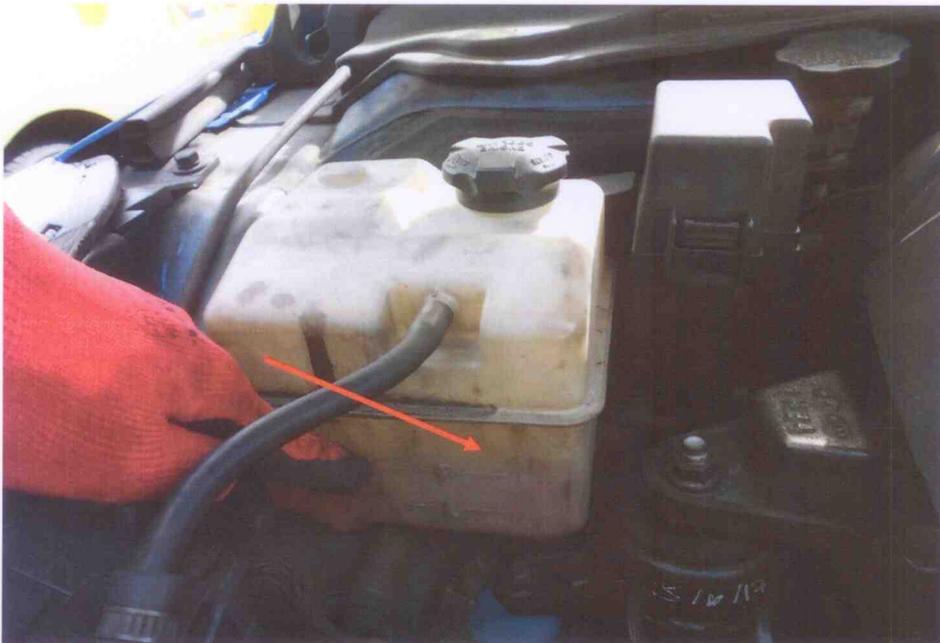
Photo 14 shows the engine coolant fluid reservoir of the Motor Taxi at the time of our inspection. The engine coolant fluid was observed to be of sufficient level and without any visible contamination.

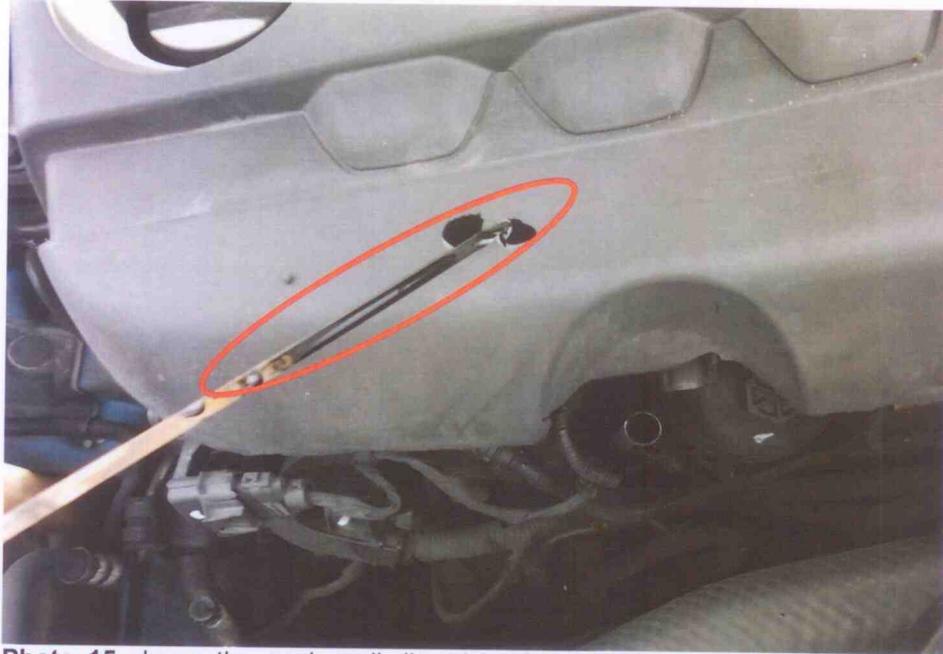
Photo 15 shows the engine oil dip stick of the Motor Taxi at the time of our inspection. The engine oil was observed to be of sufficient level and without any visible contamination.

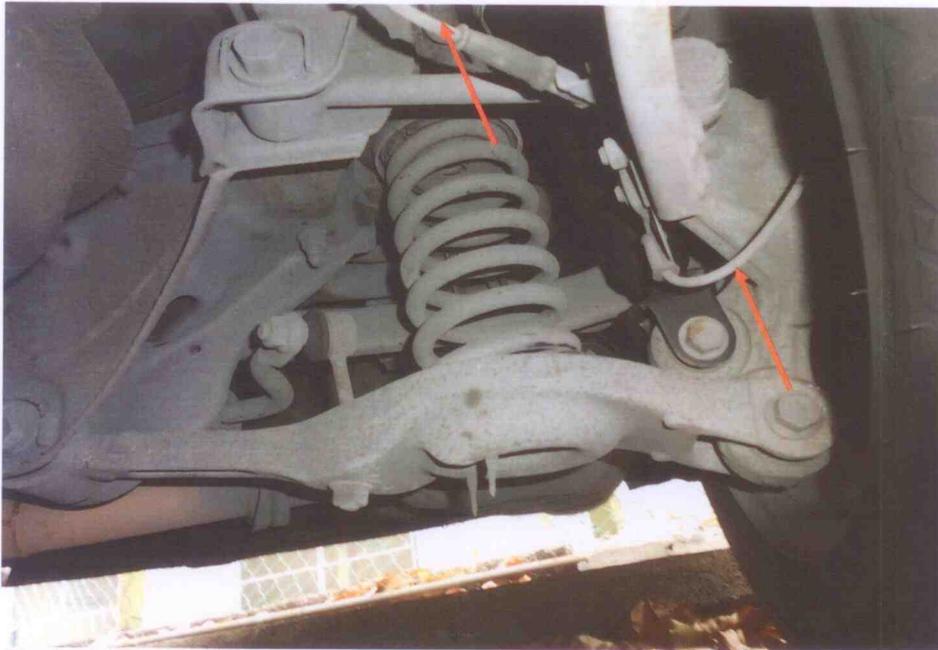
Photo 16 shows the brake hose (arrowed) at the rear left wheel of the Motor Taxi. We did not observe any leakage of brake fluid at the time of our inspection of the Motor Taxi. Our visual inspection of the various mechanical components of the Motor Taxi's braking system revealed all to be intact without visible damage.

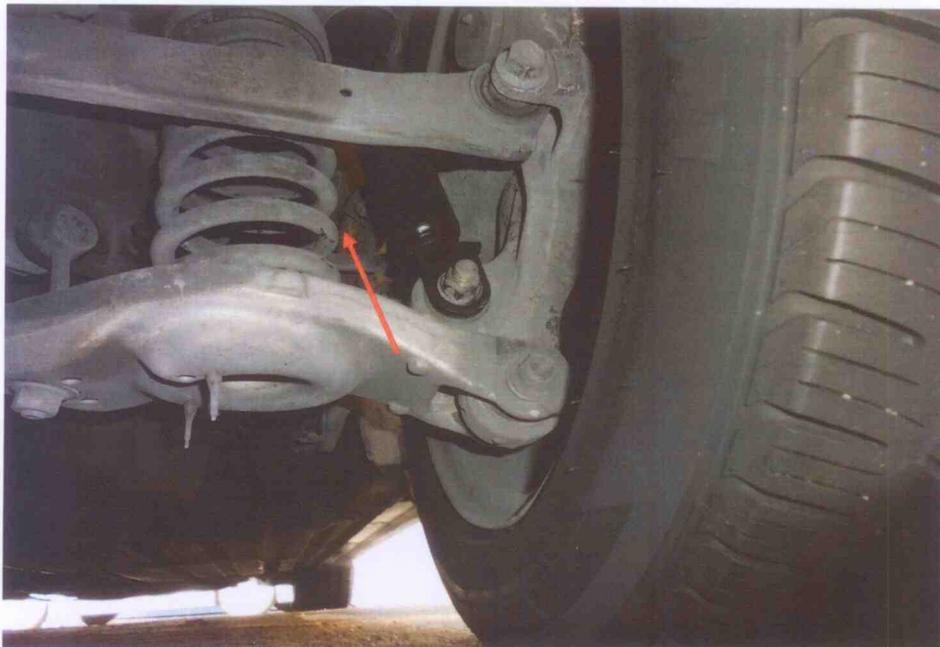
Photo 17 shows the brake hose (arrowed) at the rear right wheel of the Motor Taxi. We did not observe any leakage of brake fluid at the time of our inspection of the Motor Taxi. Our visual inspection of the various mechanical components of the Motor Taxi's braking system revealed all to be intact without visible damage.

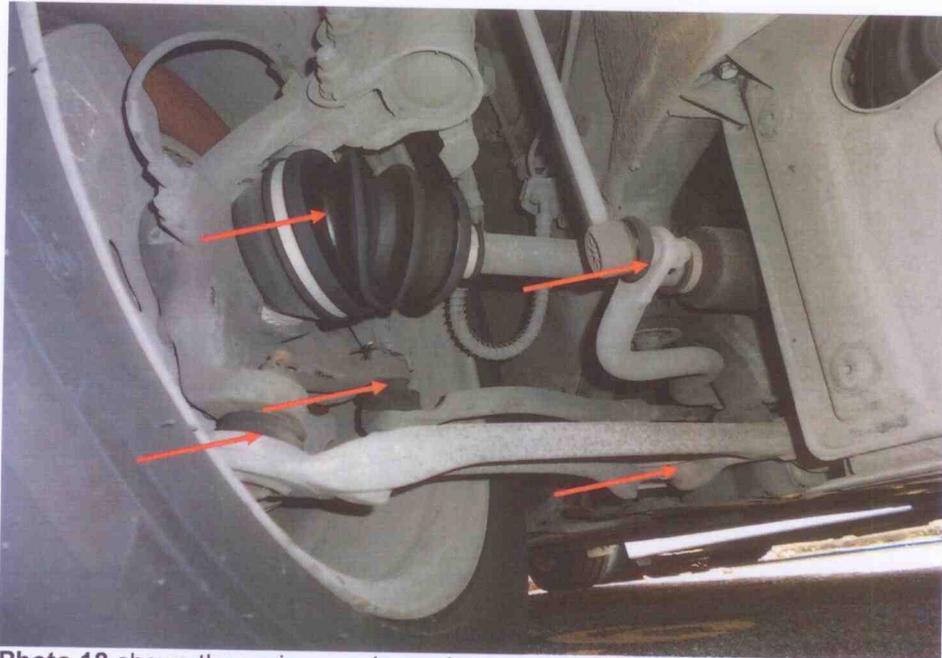
Photo 18 shows the various undercarriage components at the front right wheel of the Motor Taxi, in particular the steering tie rod (arrowed). The various steering components were all found to be intact, suggesting that the steering system of the Motor Taxi was likely to be in serviceable condition.

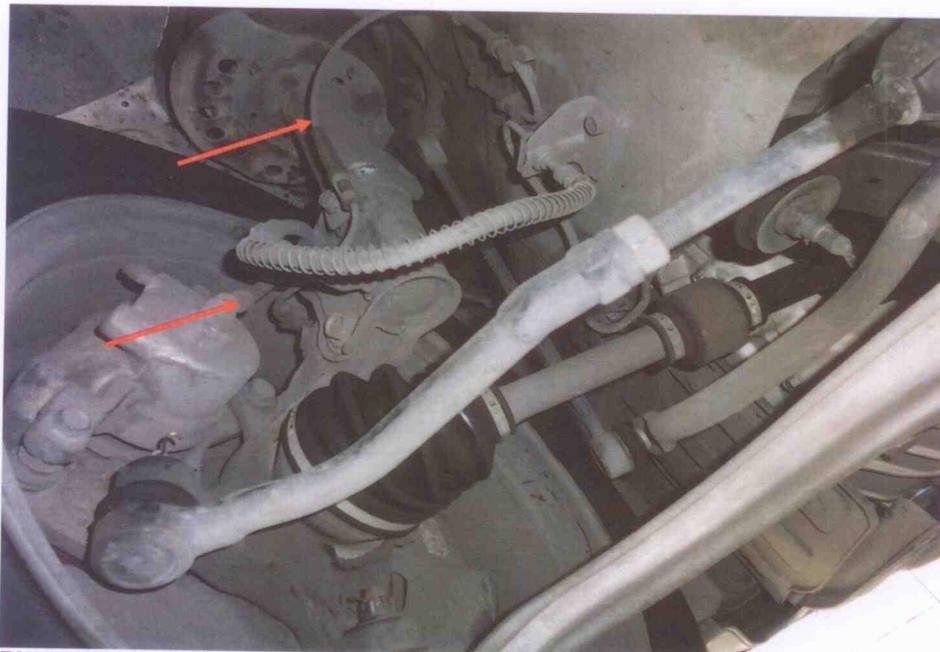
Photo 19 shows the various undercarriage components at the front left wheel of the Motor Taxi. We did not observe any leakage of brake fluid (arrowed) at the time of our inspection of the Motor Taxi. Our visual inspection of the various mechanical components of the Motor Taxi's braking system revealed all to be intact and without visible damage, indicating that the braking system was likely to be in serviceable condition at the material time of accident.

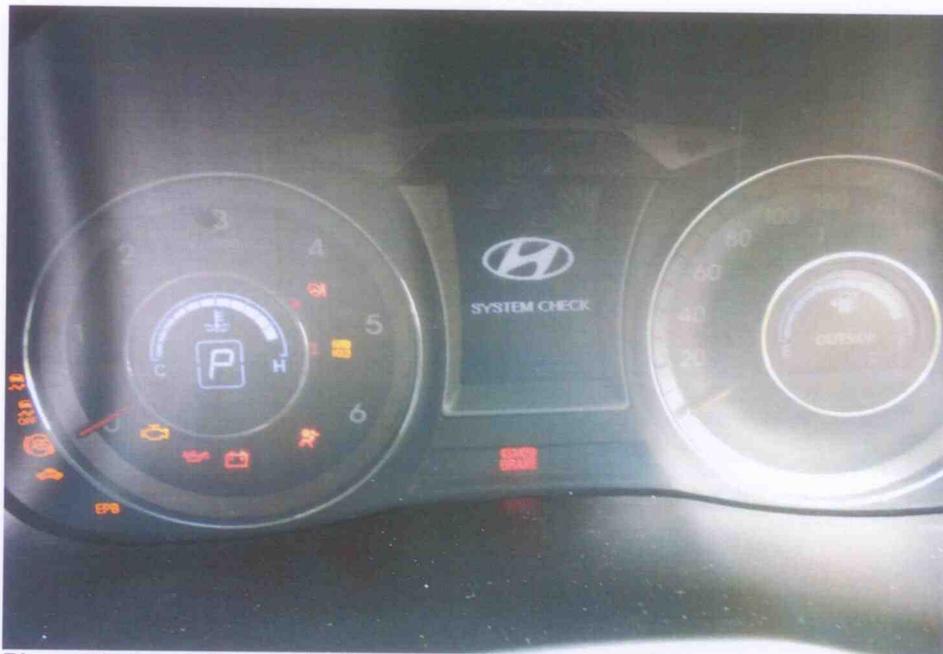
Photo 20 shows the warning lights for the various electronic operating systems of the Motor Taxi appearing on its instrument panel during the self-test when the engine is cranked, in particular the ABS light, SRS light, engine check light, battery light and brake light amongst others.

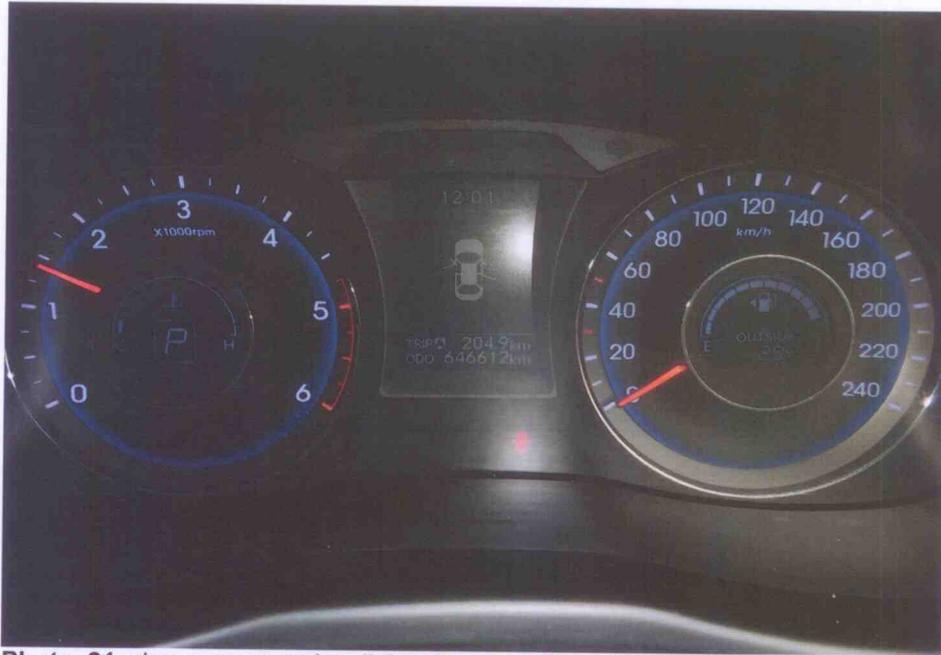
Photo 21 shows no warning lights illuminated on the instrument panel of the Motor Taxi after the engine was cranked. This would suggest that there was no abnormality to the various electronic operating systems of the Motor Taxi, like the ABS light engine check light, battery light and brake light.

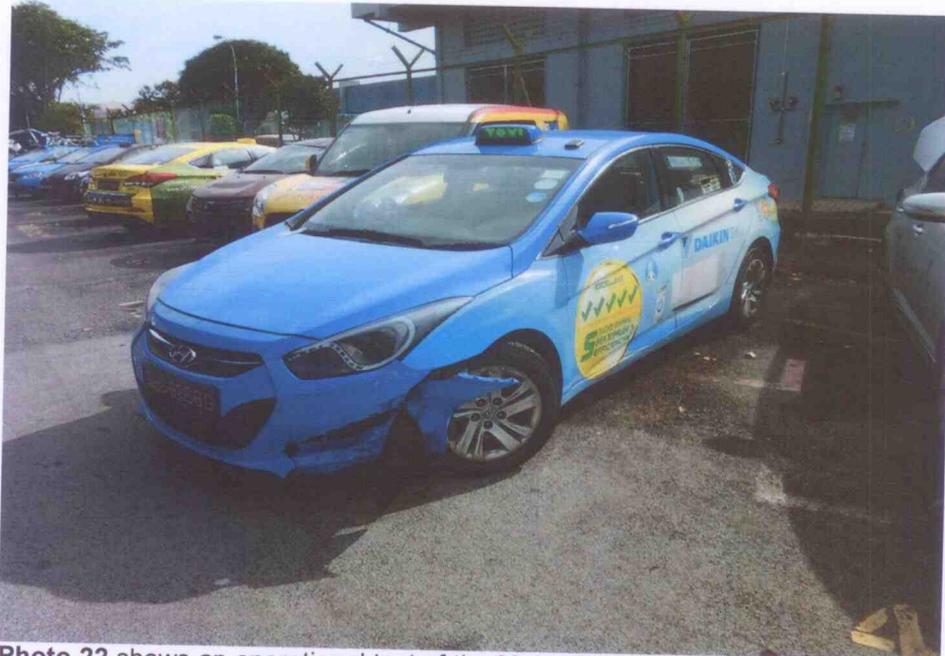
Photo 22 shows an operational test of the Motor Taxi. We were able to move the vehicle reverse, forward and backward normally.

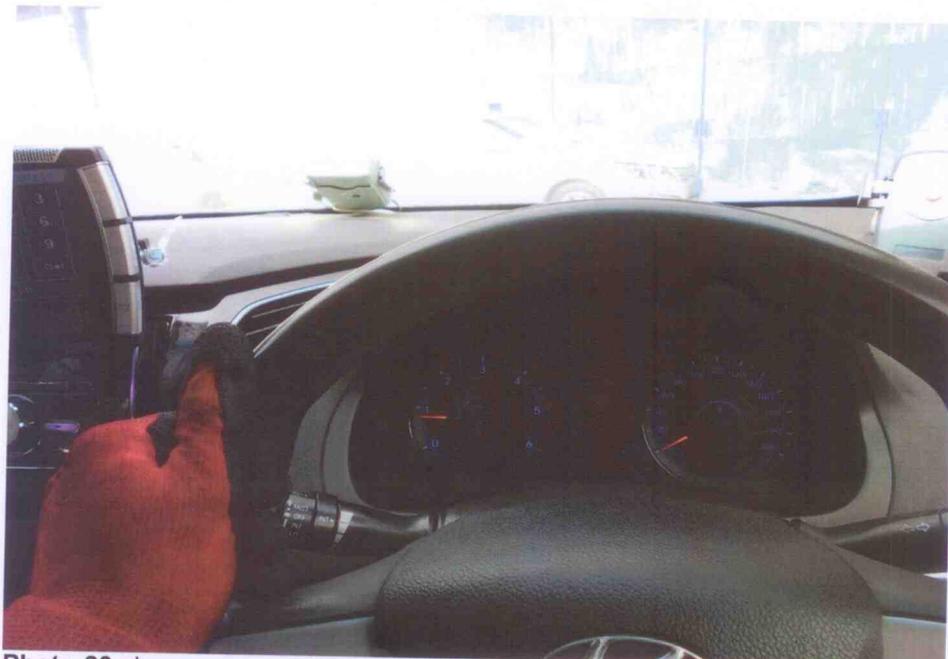
Photo 23 shows an operational test of the Motor Taxi. We were able to move the vehicle reverse, forward and backward normally.
