Your Ref: S8M00XC2
Our Ref : CS/ASM18018451/N

**TECHNICAL INVESTIGATION REPORT OF FIRE INCIDENT INVOLVING THE
INSURED VEHICLE PZ 8118R ON 27 SEPTEMBER 2018**

Vehicle Registration No.	: PZ 8118R
Make / Model	: ISUZU LT 134P
Chassis No	: JALLT134P77000316
Year of Registration	: May 2008
Mileage	: 380,293km

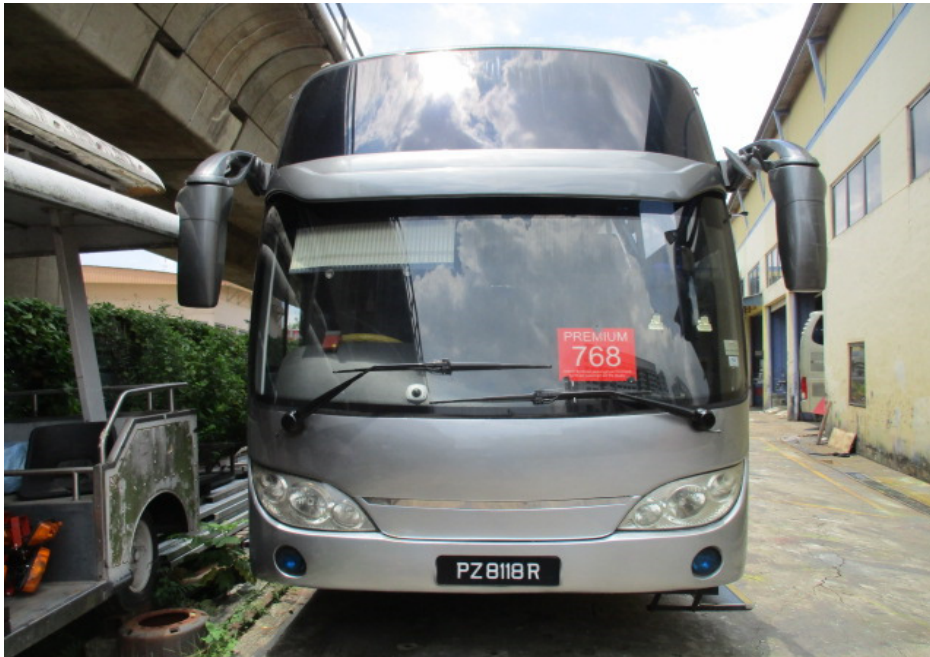
Photo 1 shows the general view of the front portion of the Insured Vehicle at the time of our inspection. The front portion of the Insured Vehicle was relatively unaffected by the fire.

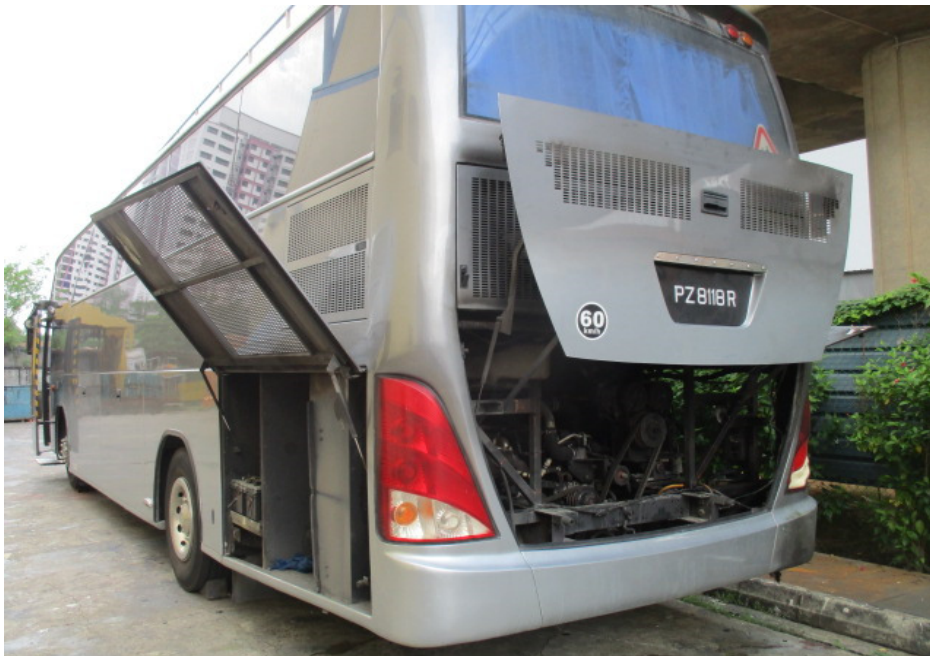
Photo 2 shows the general view of the rear left portion of the Insured Vehicle at the time of our inspection. The rear left portion of the Insured Vehicle was relatively unaffected by the fire.

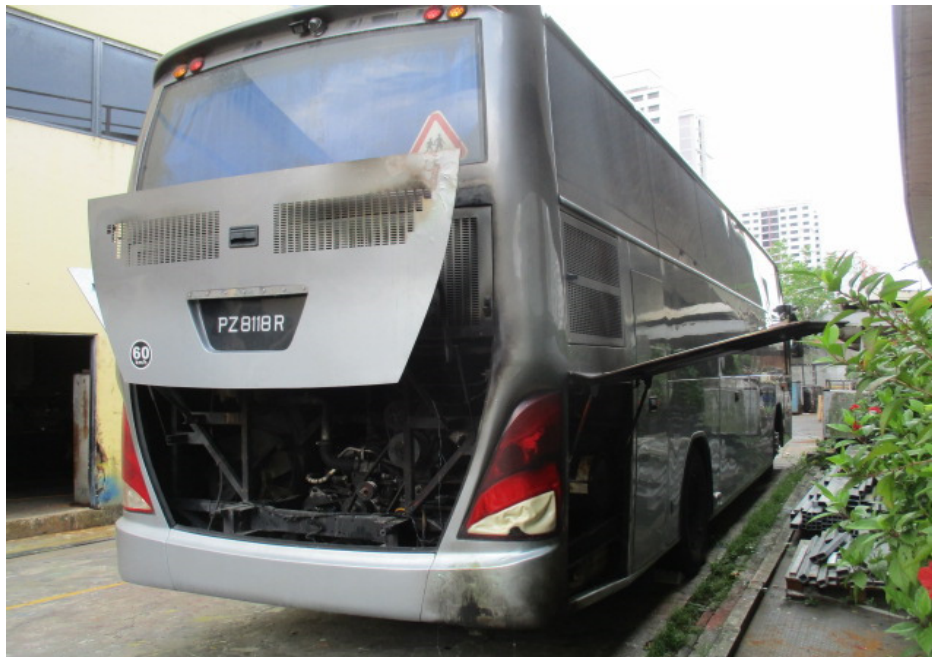
Photo 3 shows the general view of the right rear portion of the Insured Vehicle at the time of our inspection. The exterior body of the Insured Vehicle had sustained significant fire damage at the rear right portion.

6. For this particular case, the fire appears to have originated within the engine compartment of the Insured Vehicle, somewhere around the rear right portion of the engine compartment. This can be determined from the nature of the fire damage which was more extensive at the rear right portion. The rear left portion had sustained minimal fire damage. Basing on the circumstances of the fires' origin at the material time of incident as well as examining the area where the extent of fire damage was most severe, we can determine that the fire had likely started from the rear right portion of the engine compartment of the Insured Vehicle.

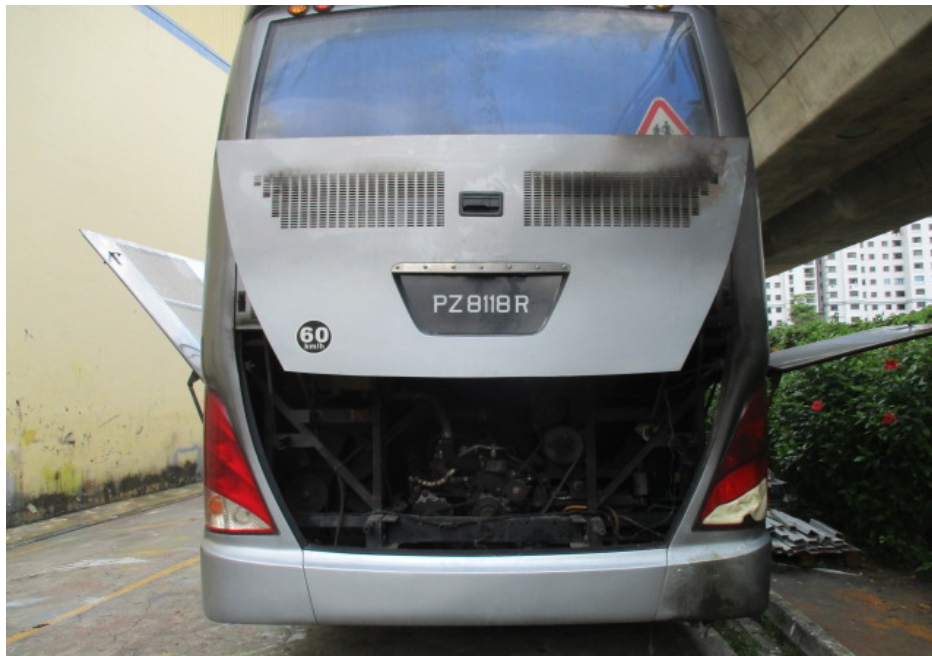
5. The exterior body of the Insured Vehicle had sustained fire damage at the rear portion. Affected parts had included the rear windscreen, engine panel, side panels, tail lights and rear bumper, amongst others. The engine compartment of the Insured Vehicle had sustained significant fire damage. The interior compartment of the Insured Vehicle was observed to be unaffected by the fire. See photos 1 – 6 below.

Photo 4 shows the general view of the rear portion of the Insured Vehicle at the time of our inspection. The Insured Vehicle had sustained fire damage at the rear portion. Affected parts had included the rear windscreen, engine panel, side panels, tail lights and rear bumper, amongst others.

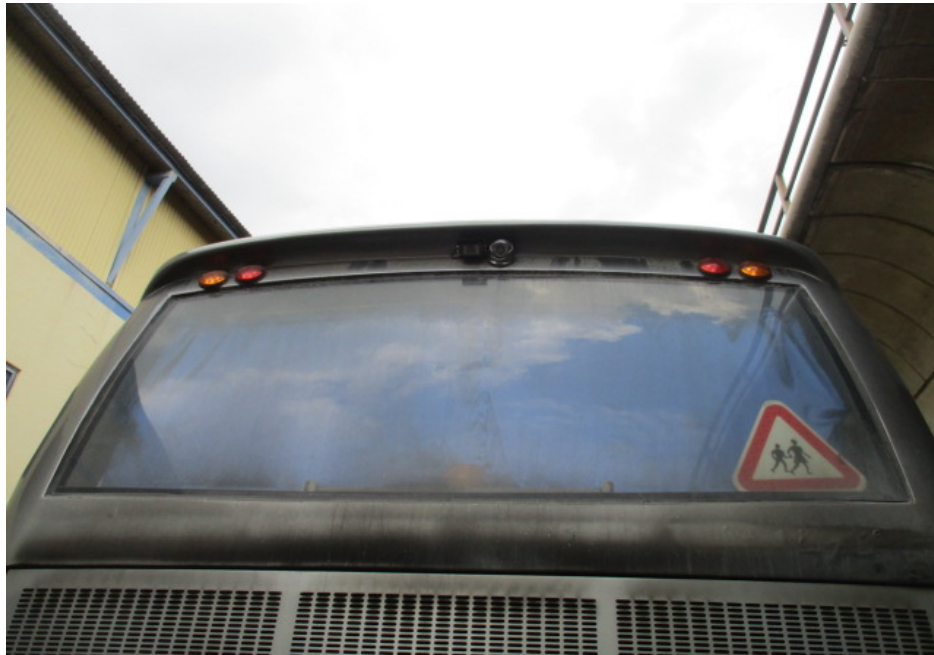
Photo 5 shows the general view of the damaged rear windscreen of the Insured Vehicle at the time of our inspection.

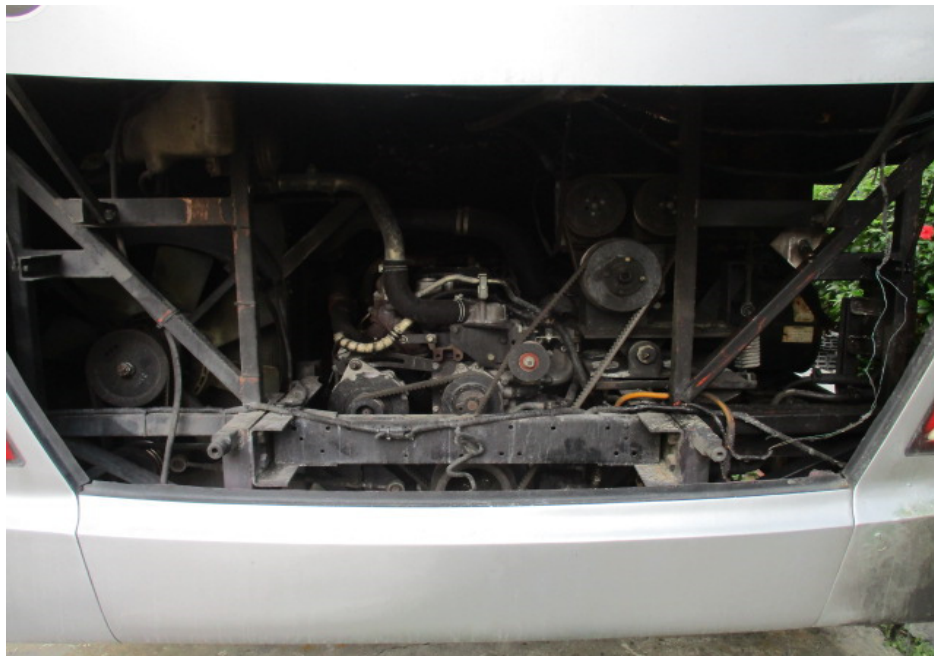
Photo 6 shows a general view of the engine compartment of the Insured Vehicle at the time of our inspection. The engine compartment of the Insured Vehicle was significantly affected by the fire. Most of the parts inside the engine compartment were found to be partially burnt and/or melted as a result of the fire.

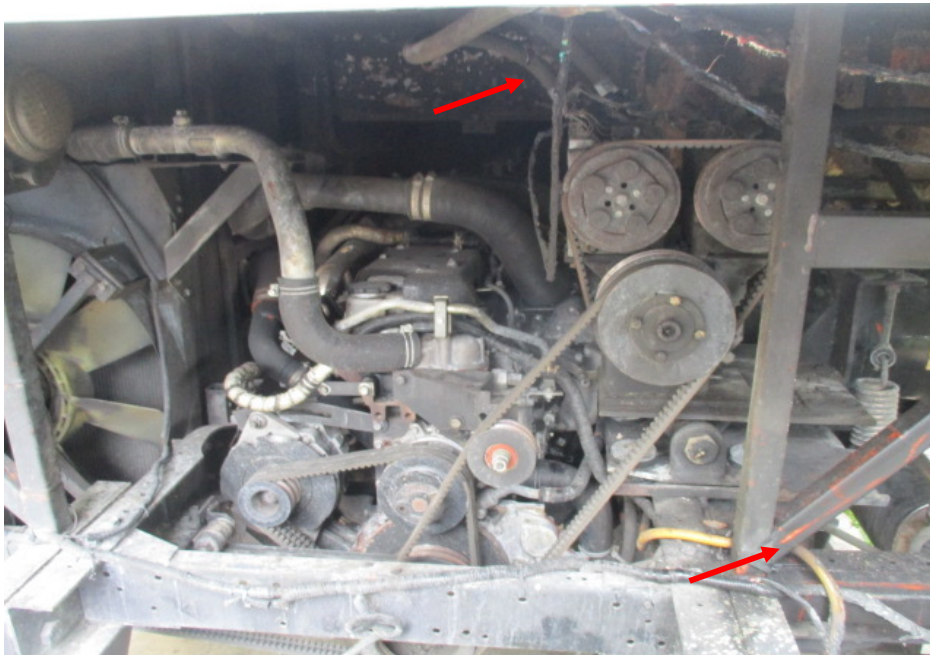
Photo 7 shows a closer view of the burnt engine compartment of the Insured Vehicle. The fire damage was more extensive at the rear right portion (arrowed). The rear left portion had sustained minimal fire damage.

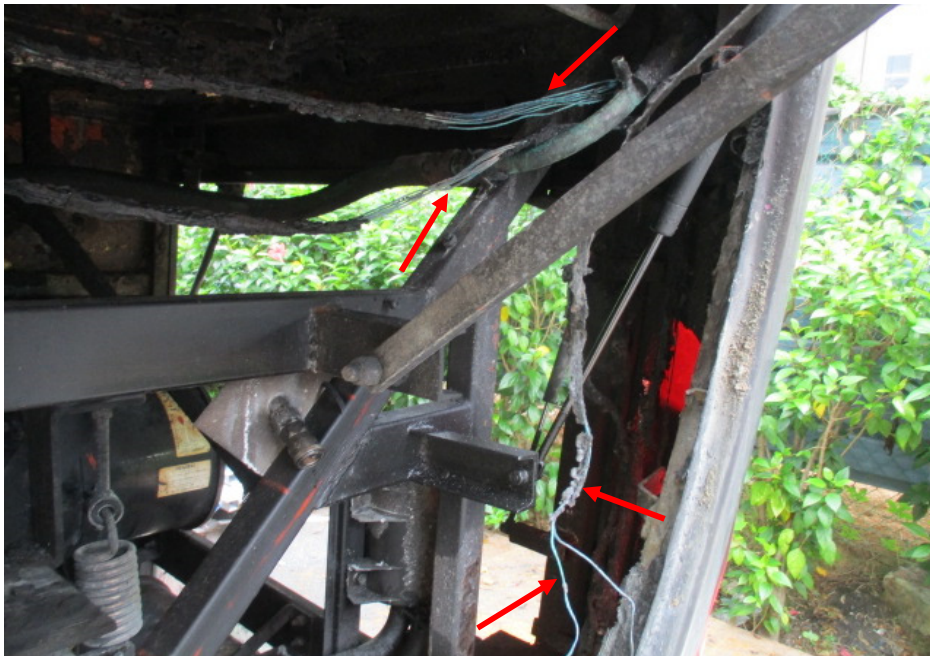
7. Upon closer examination of the rear right portion of the engine compartment of the Insured Vehicle as well as around the immediate vicinity to where the fire had likely started, we had found greenish residue on several burnt stretches of original factory fitted wirings around the rear right portion of the engine compartment. The presence of such greenish residue indicates internal heating of copper wires, a sign of an electrical short circuit occurring. The greenish residue is normally left behind from oxidation as a result of chemical reaction involving the copper wires. This physical evidence would then appear to suggest that the cause of fire to the Insured Vehicle could have possibly been due to electrical in nature. See photos 7 - 10 below.

Photo 8 shows a view of the greenish residue found on several burnt stretches of original factory fitted wirings around the rear right portion of the engine compartment (arrowed) of the Insured Vehicle.

18. The possibility of the fire being due to electrical in nature would then seem more likely given that engine overheating and external factors would seem unlikely. The fire being due to electrical nature is also supported by greenish residue found on several burnt stretches of original factory fitted wirings around the rear right portion of the engine compartment of the Insured Vehicle, which was earlier discussed in paragraph 7 above.

20. Having investigated and technically analysed the damages of burnt nature to the Insured Vehicle, we are of the view that the cause of fire to the Insured Vehicle was of electrical in nature. For this particular case, the fire had originated along the original factory fitted wirings around the rear right portion of the engine compartment of the Insured Vehicle.
21. We did not find any evidence which had suggested that the cause of fire to the Insured Vehicle was due to poor maintenance and/or recurring electrical problem.
22. Our investigations had also revealed that at the time of writing this report, there is no manufacturer recall of electrical nature to similar make and model vehicle as the Insured Vehicle that may pose a fire risk.

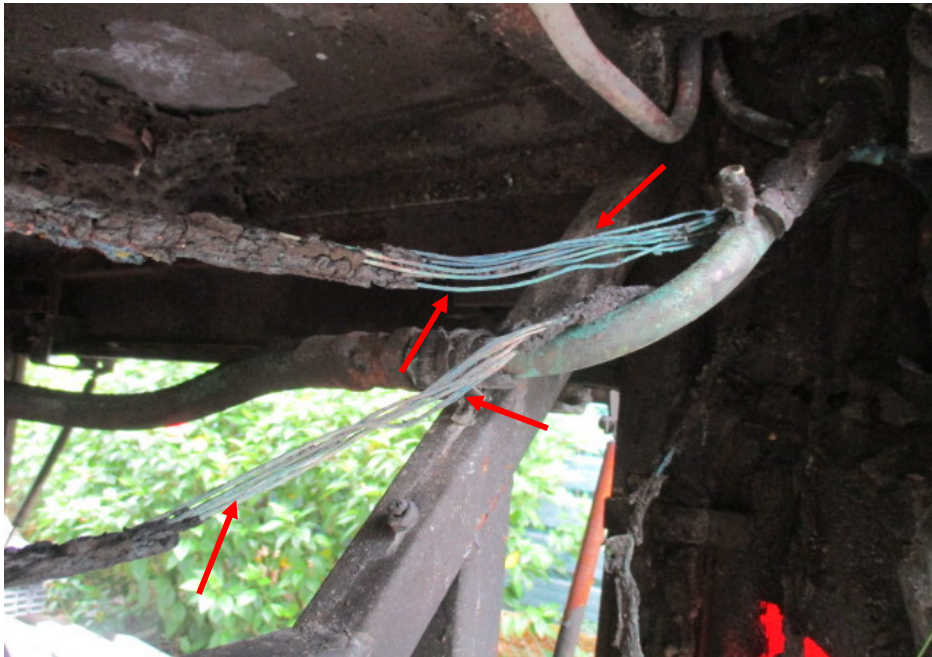
Photo 9 shows a closer view of the greenish residue that was found on several burnt stretches of original factory fitted wirings around the rear right portion of the engine compartment (arrowed) of the Insured Vehicle.

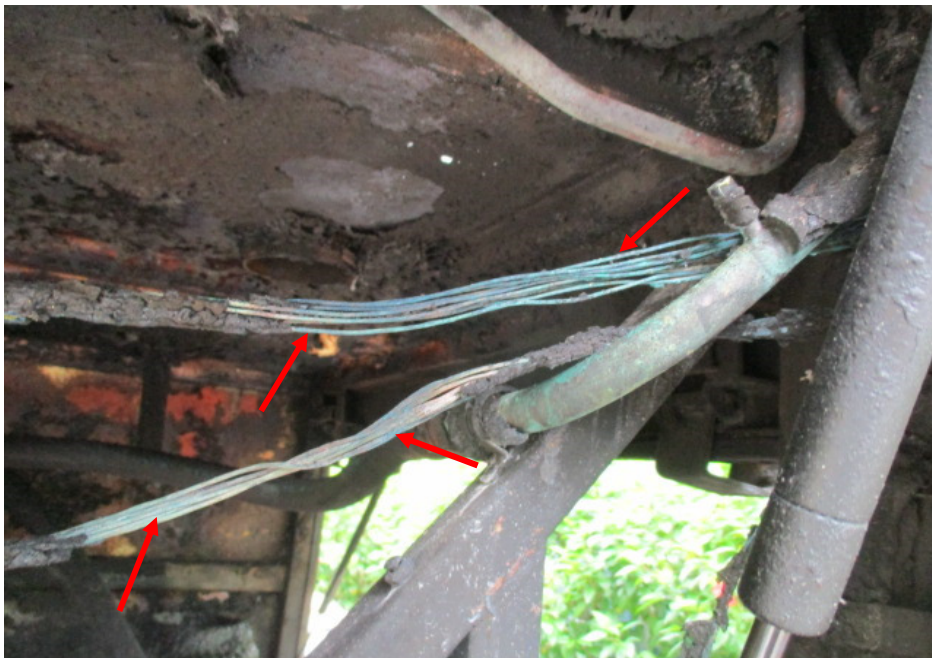
Photo 10 shows a close up view of the greenish residue that was found on several burnt stretches of original factory fitted wirings around the rear right portion of the engine compartment (arrowed) of the Insured Vehicle.
