## VEHICLE DAMAGE INSPECTION REPORT

Our Ref: 507/TP/2018

Reg No:	SLR5283E	Make &	Hyundai
Reg date:	18/8/2017	Model	Tucson 2.0 GLS
Colour:	Brown	Engine No:	G4NAHU466891
Type:	Motor Car	Chassis No:	KMHJ3813MJU560708
Type of Claims:	Third Party	Odometer No:	20396km
		Engine Cap:	1999cc

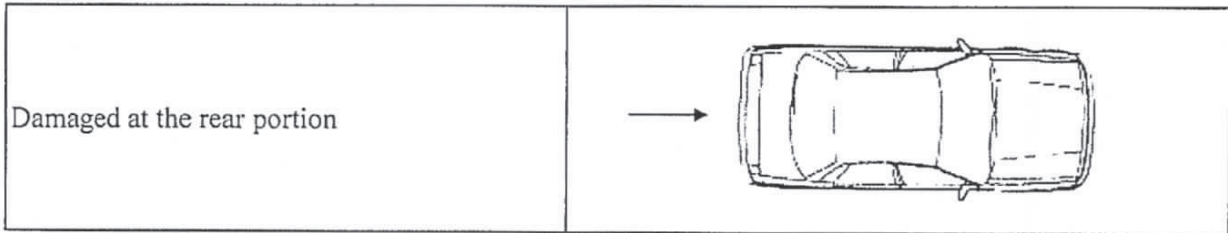
### POINT OF IMPACT

Our visual inspection of the vehicle revealed that the damages noted are at the rear portion.

We have inspected the actual damages found on the vehicle and recommend the replacement of parts and repairs accordingly. The estimated repair cost is \$11,707.20. The repairer has agreed to undertake the repairs at our adjusted lump sum amount of \$8,100.00.
