Vehicle No. SHF 526Z
Insured Veh. YP 1239S
Claim No. SNM18D04898/C02/9
Policy No. DMCVSN3006991800
Accident Date 11/10/2018
Inspection Date 12/10/2018

Ref : CC3/CTI18018655/Kka3n2

ADJUSTMENT ON REPAIR COST FOR VEHICLE NO. SHF 526Z

PHOTOGRAPHS FOR VEHICLE NO. SHF 526Z

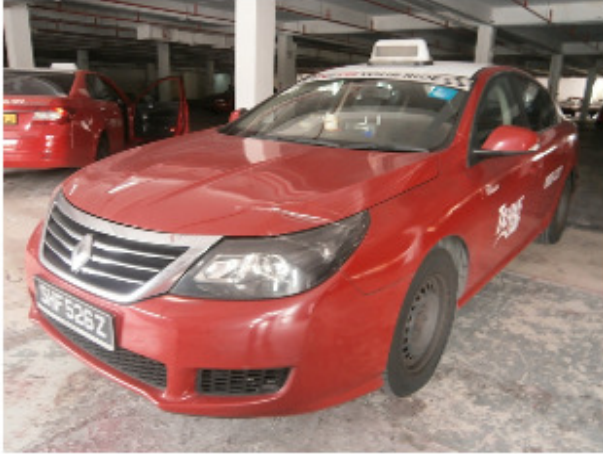
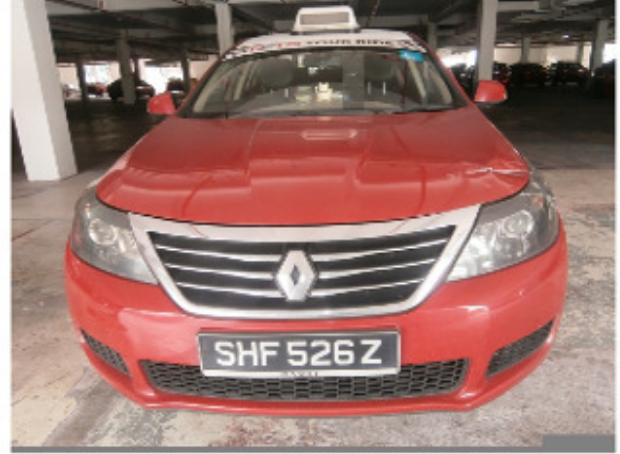
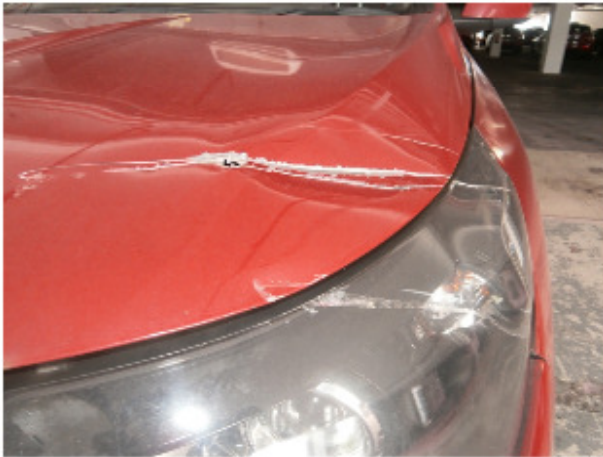
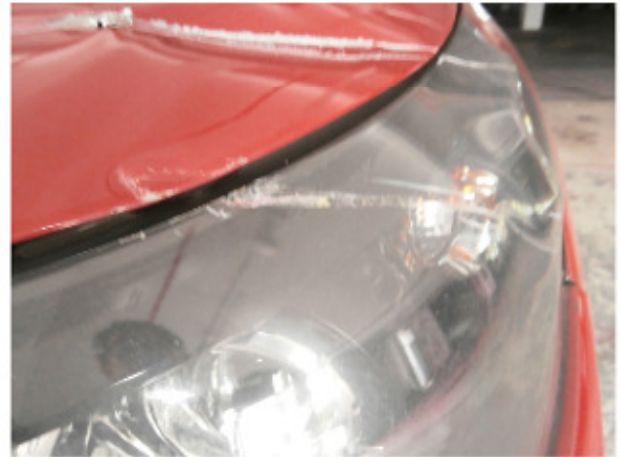
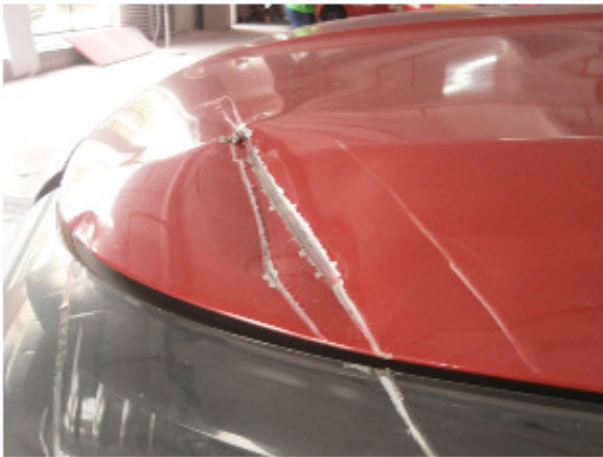
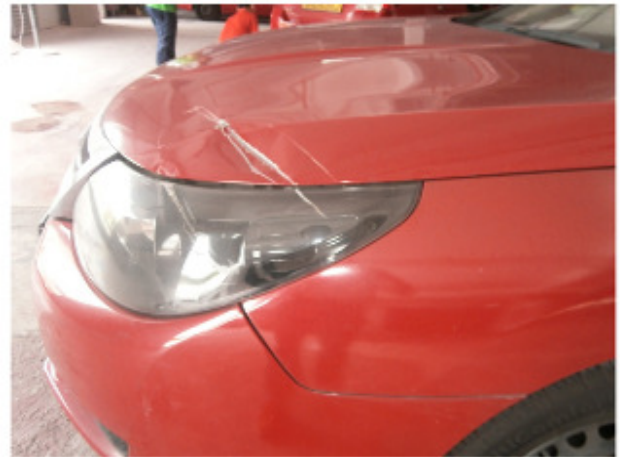
INSPECTION

THE VEHICLE SUSTAINED DAMAGES AT THE N/S FRONT PORTION.
