Your Ref: PR1808036389
Our Ref : CI/BSH18018749/D

16 October 2018

INVESTIGATION REPORT OF UNREGISTERED VOLKSWAGEN MOTOR CARS DAMAGED BY GLASS SHARDS ON 08 AUGUST 2018

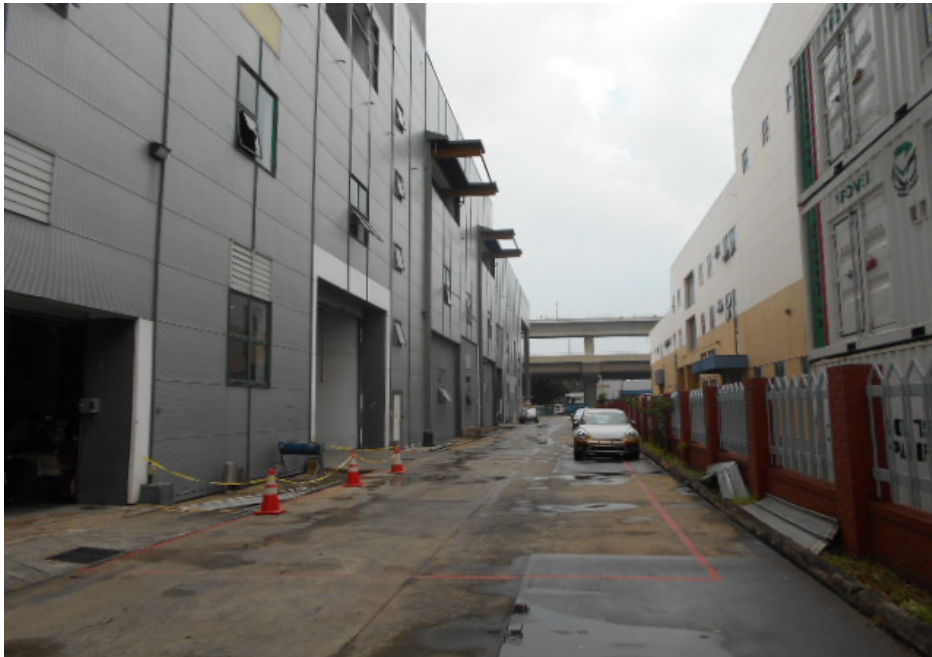
3. I visited the Incident Location on 15 August 2018 where I was first shown 3 pieces of bent metal sheets lying along the side of the driveway. One of the metal sheets was lying on the ground beside the building while the other 2 metal sheets were lying on the ground adjacent to the perimeter. I was informed that the 2 metal sheets were initially lying on the driveway and were subsequently removed to the perimeter in order not to cause obstruction to the driveway.

Photo 1 shows a general view of the driveway where the 3 pieces of bent metal sheets were first discovered on the morning of 08 August 2018.

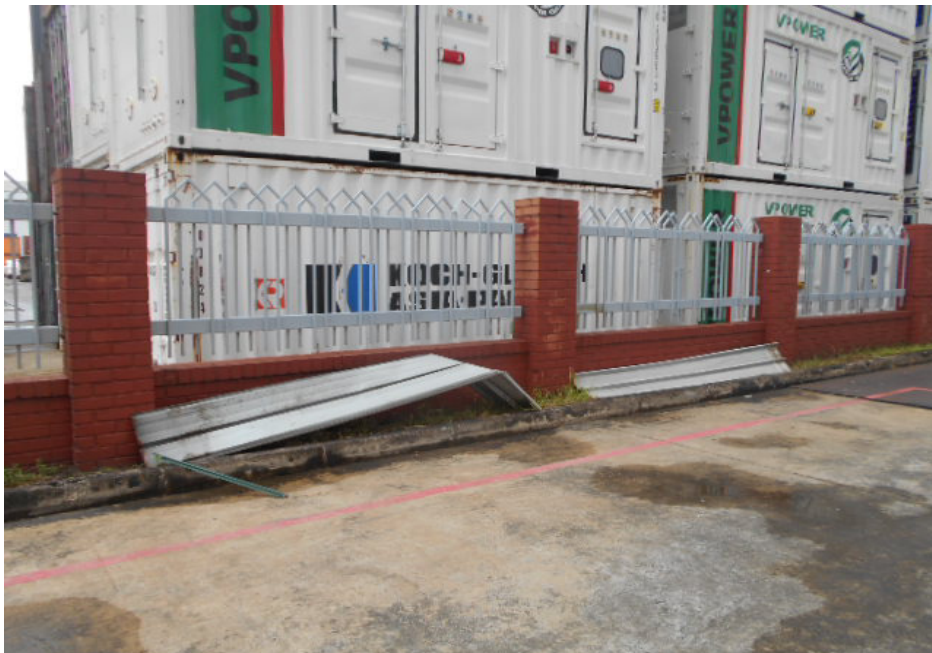
Photo 2 shows the 2 pieces of bent metal sheets that were initially lying on the driveway before being removed to the side to prevent obstruction to the driveway. These metal sheets were detached from the roof of a neighbouring warehouse by strong winds and blown to Toll Logistics premises at 17 Tuas Avenue 9.

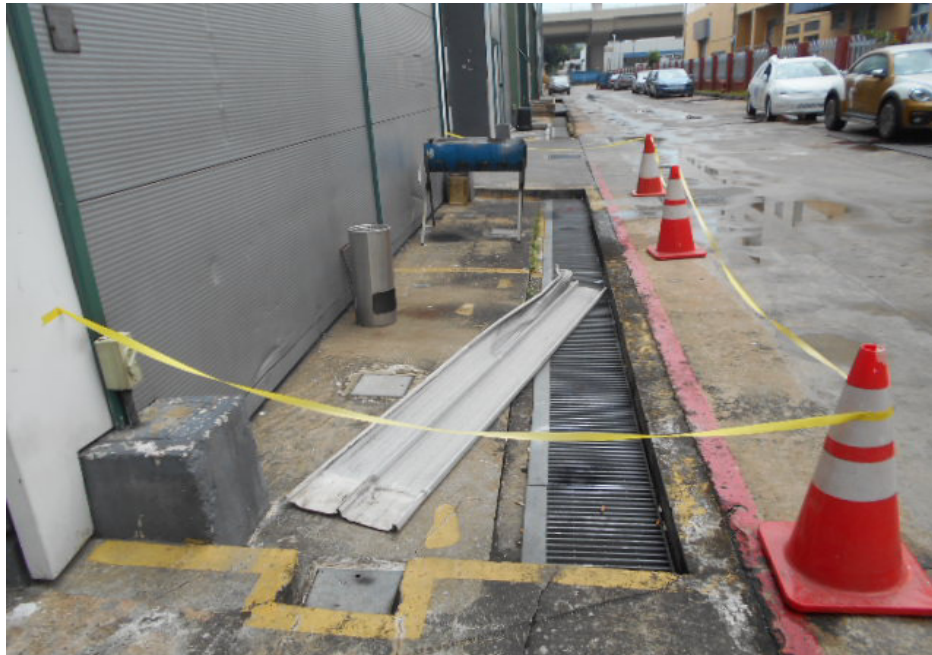
4. One of the building windows, above the single metal sheet, was observed to be broken. Glass shards were also found on the ground in the immediate vicinity of where this metal sheet was lying.

Photo 3 shows the bent metal sheet that was lying on the ground beside the building of Toll Logistics. This metal sheet was detached from the roof of a neighbouring warehouse by strong winds and blown to Toll Logistics premises at 17 Tuas Avenue 9. Glass shards were also found on the ground in the immediate vicinity of where this metal sheet was lying.

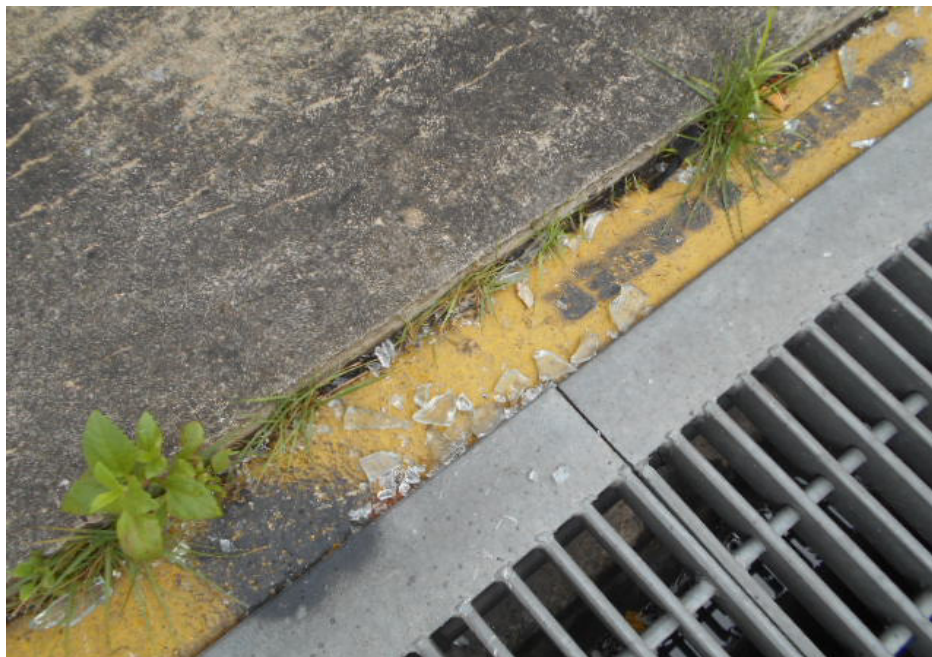
Photo 4 shows the glass shards that were found on the ground beside the building of Toll Logistics.

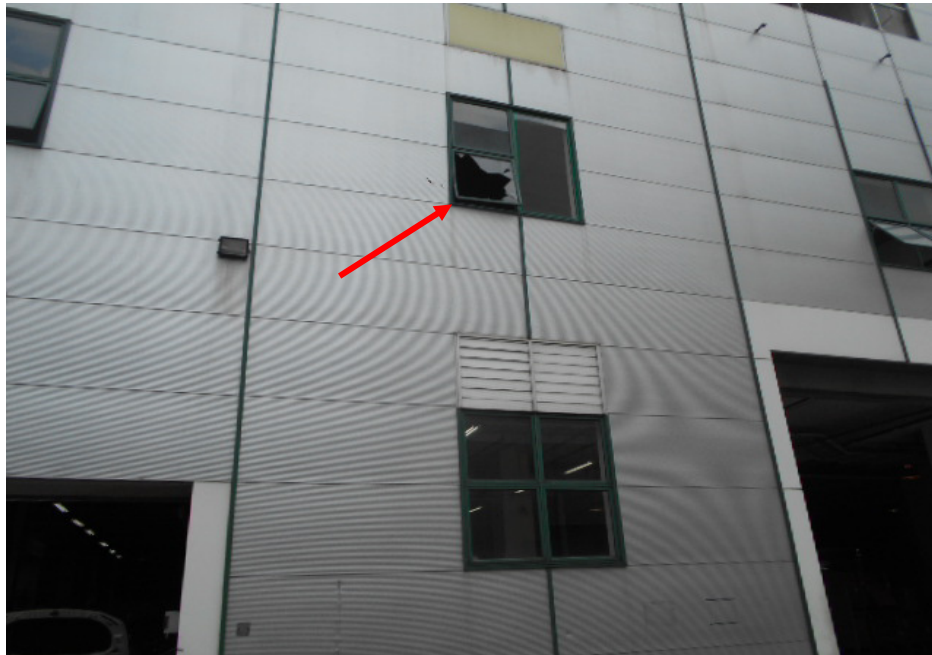
Photo 5 shows one of the building windows (arrowed) that was broken. This broken window was above the location where the single metal sheet and glass shards were found.

20. Investigations revealed that the glass of the window was shattered when a piece of metal sheet hit onto the window. This metal sheet was one of 3 pieces of metal sheets that became detached from the roof structure of a neighbouring warehouse and blown over to the premise of Toll Logistics.

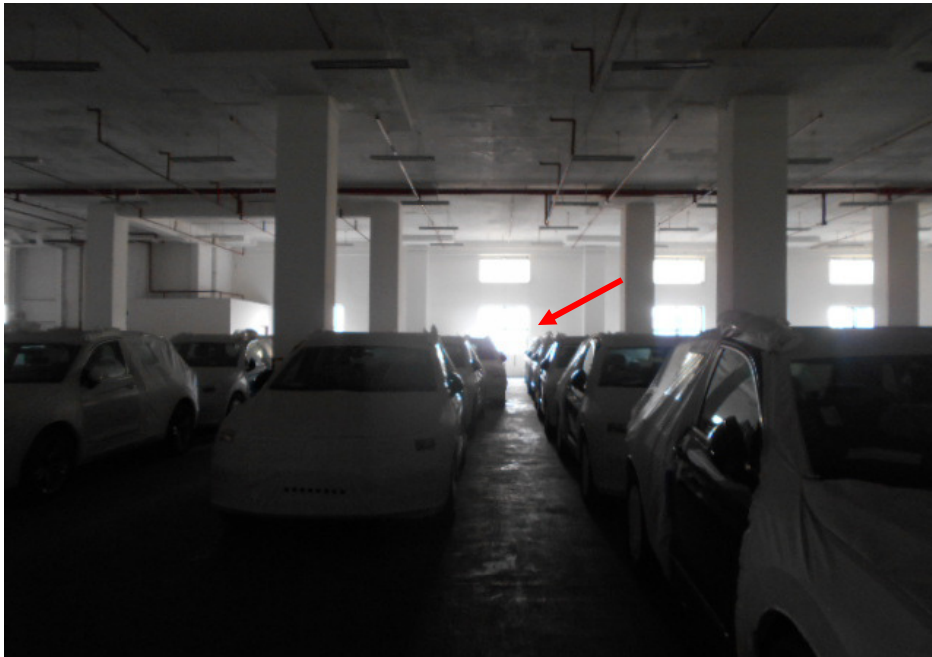
6. I was then led to the second level of the building where the broken window was located. I note that the entire second level of the building is a storage facility where unregistered Volkswagen motor cars are stored. The broken window was located at the end of row D. Unregistered Volkswagen motor cars were parked up to the area directly in front of the broken window.

Photo 6 shows the second level of the building, which is a storage facility for unregistered Volkswagen motor cars. The broken window (arrowed) was located at the end of row D.

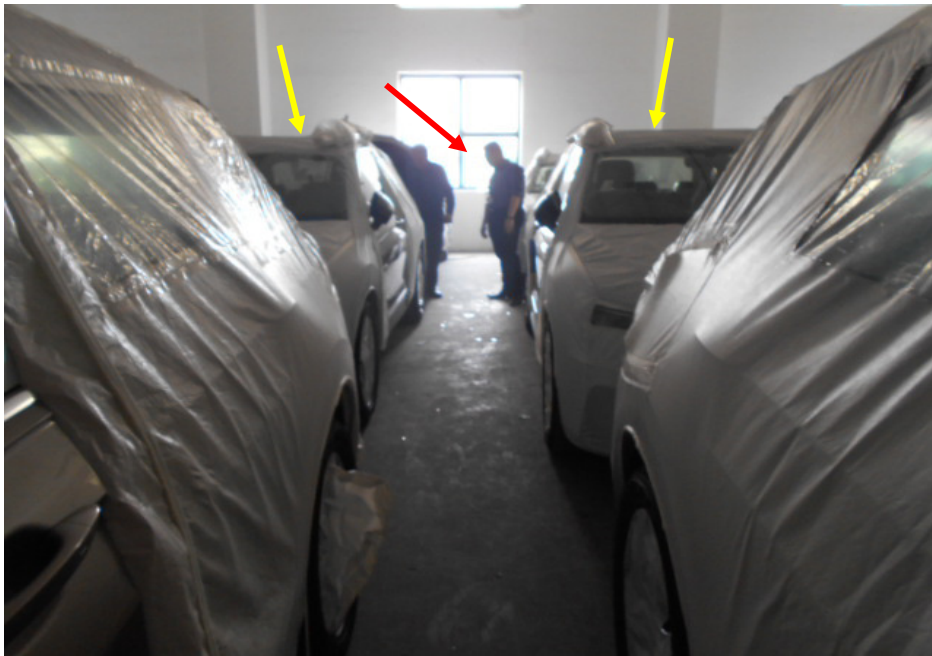
7. I also observed multiple glass shards scattered on the ground, directly below the broken window, to the ground where the second row of unregistered Volkswagen motor cars were parked (from the perspective of the broken window).

Photo 7 shows a general view of the area near the broken window (red arrow) at the second level of the building. Multiple glass shards were scattered on the ground, directly below the broken window, to the ground where the second row (yellow arrow) of unregistered Volkswagen motor cars were parked (from the perspective of the broken window).

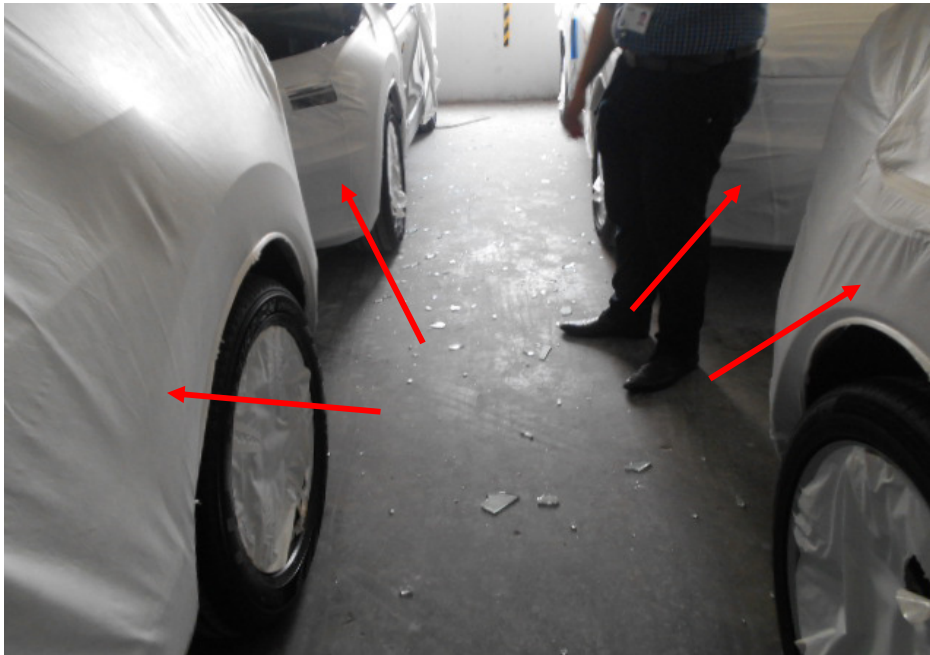
9. Following the location where the scattered glass shards were found, there could be 4 unregistered Volkswagen motor cars potentially damaged by glass shards from the broken window. These were the 2 parked nearest to the broken window and the 2 parked in front of these 2. See photo 6 – 10 below.

Photo 8 shows some of the glass shards that were found on the ground at the second level. Following the location where the scattered glass shards were found, there could be 4 unregistered Volkswagen motor cars (arrowed) potentially damaged as a result of the glass shards from the broken window.

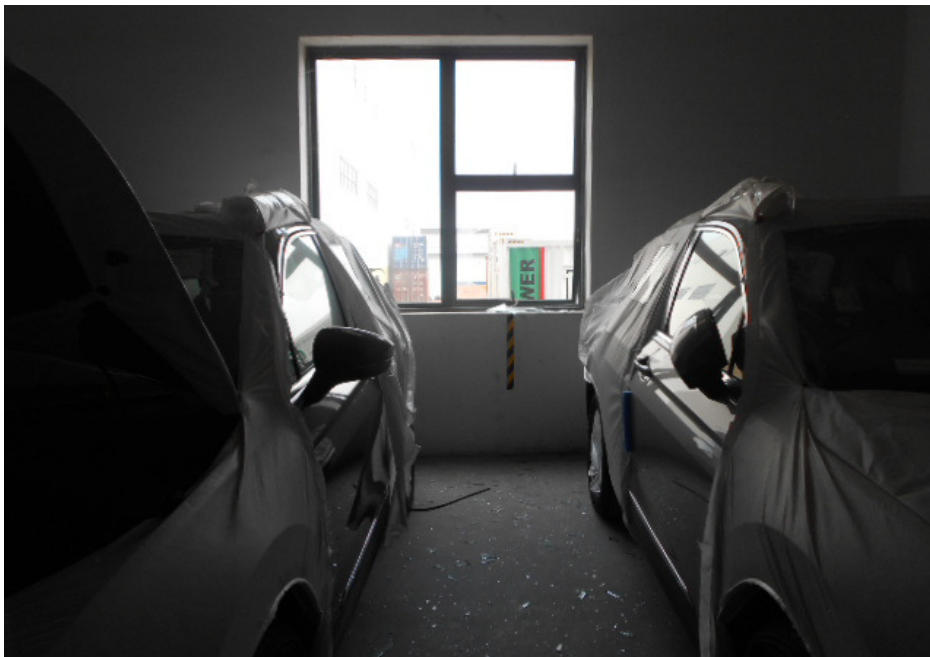
8. Upon my examination of the 2 unregistered Volkswagen motor cars nearest to the broken window, I note that they were still covered with protection cover. Relatively small cut marks were found on some areas of the protection cover and upon partial removal of the protection cover, I had observed minor scratch/cut marks on the body of these 2 unregistered Volkswagen motor cars.

Photo 9 shows a closer view of the broken window and the 2 unregistered Volkswagen motor cars that were parked nearest to the broken window.

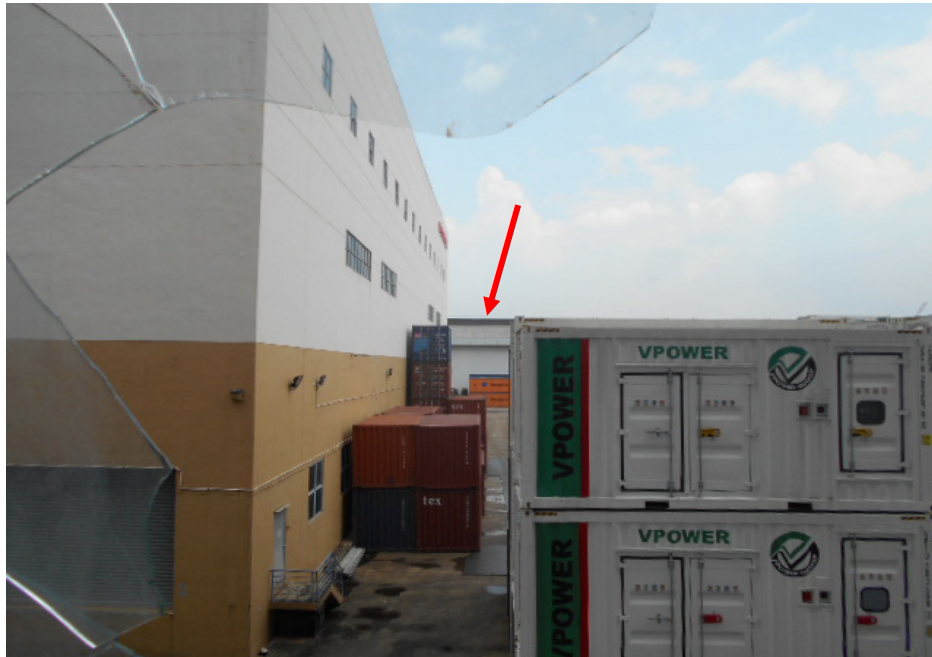
5. I was pointed to the roof of a warehouse building that was approximately 300m to 400m away, where similar type of metal sheets was affixed as its roof structure. I was informed that when the Incident was first discovered on the morning of 08 August 2018, checks by the staff of Toll Logistics revealed that the metal sheets were detached from the roof of this warehouse by strong winds and blown over during the night. See photo 1 – 5 below.

Photo 10 shows the roof of a warehouse building (arrowed) that was approximately 300m to 400m away, where similar type of metal sheets was affixed as its roof structure. I was informed that when the Incident was first discovered on the morning of 08 August 2018, checks by the staff of Toll Logistics revealed that the metal sheets were detached from the roof of this warehouse by strong winds and blown over during the night.

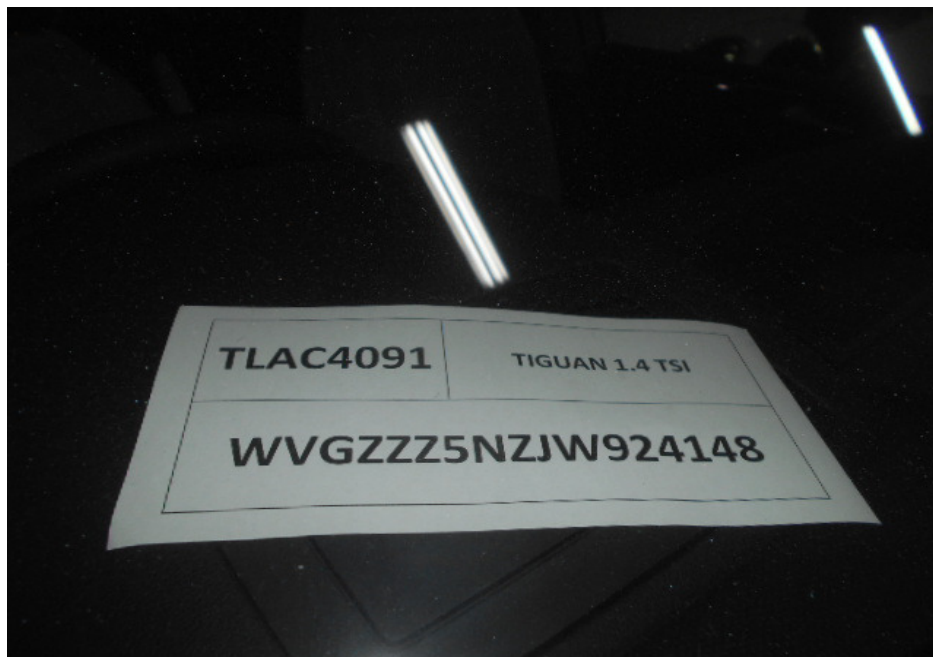
Photo 11 shows the chassis number of the first unregistered Tiguan model Volkswagen motor car that was affected by the Incident.

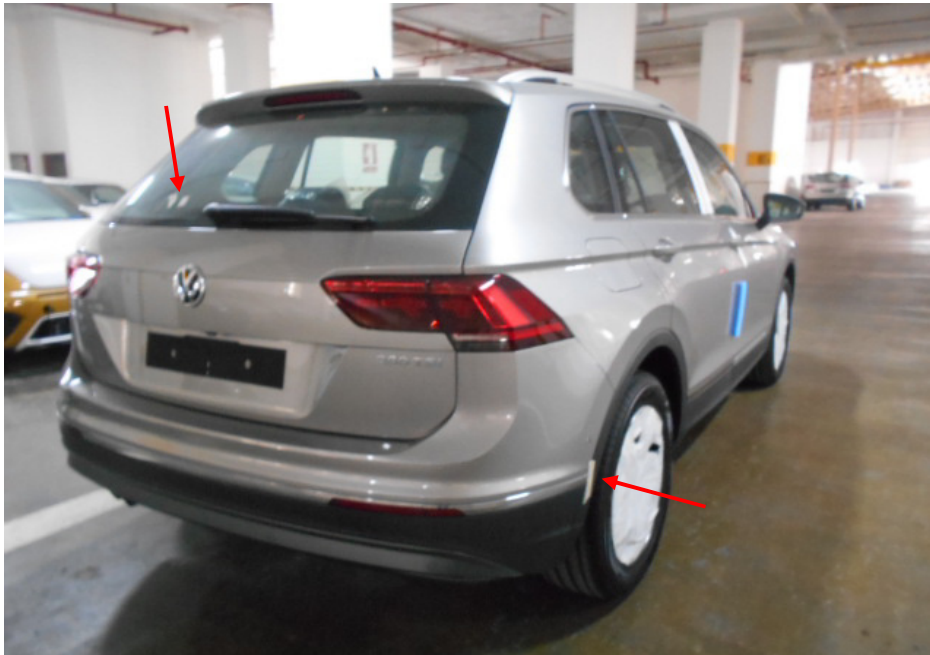
13. For this chassis number, a small chip mark was observed on the rear windscreen. The rear right fender protector pad was also found with a relatively minor cut mark. The damage pattern is consistent to a single grazed impact (hit) by glass shards. See photo 11 – 14 below.

Photo 12 shows a general view of the rear right body of the first unregistered Tiguan model Volkswagen motor car that was affected by the Incident. The rear fender right protector pad and rear windscreen were found to be damaged at the area indicated by the red arrows.

14. Volkswagen have put up an estimate cost of repair for this chassis number. I have adjusted the estimate to \$3704.00. See below for breakdown.

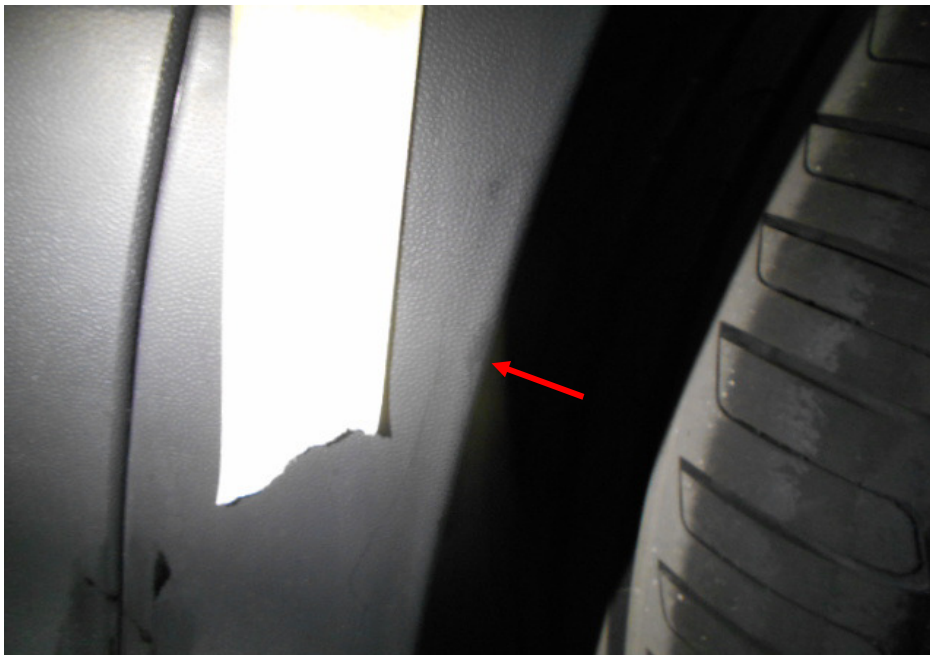
Photo 13 shows a close-up view of the relatively minor cut mark that was observed on the right side rear fender protector pad.

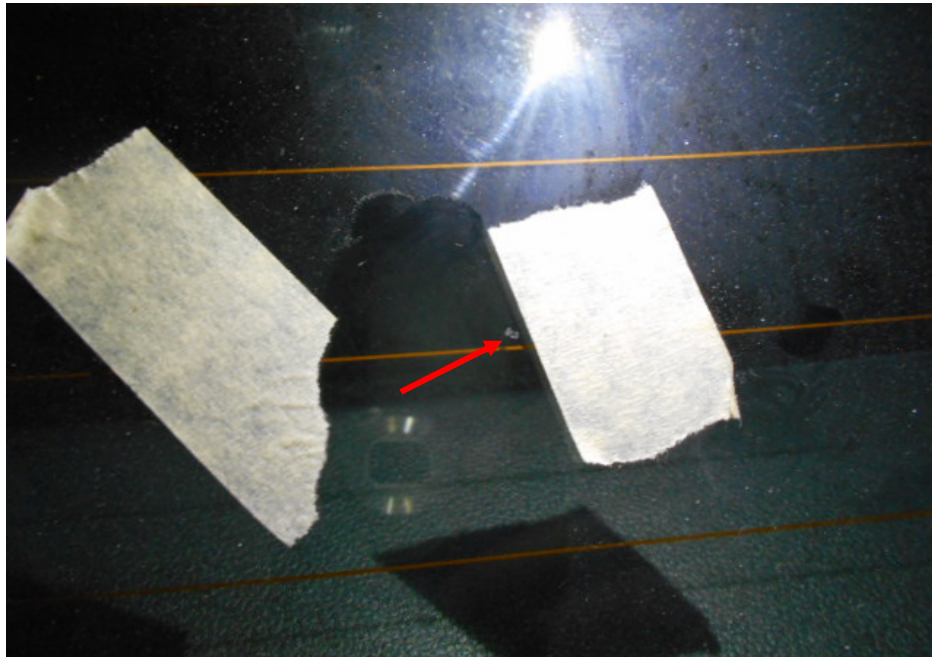
Photo 14 shows a close-up view of the small chip mark that was observed on the rear windscreen.

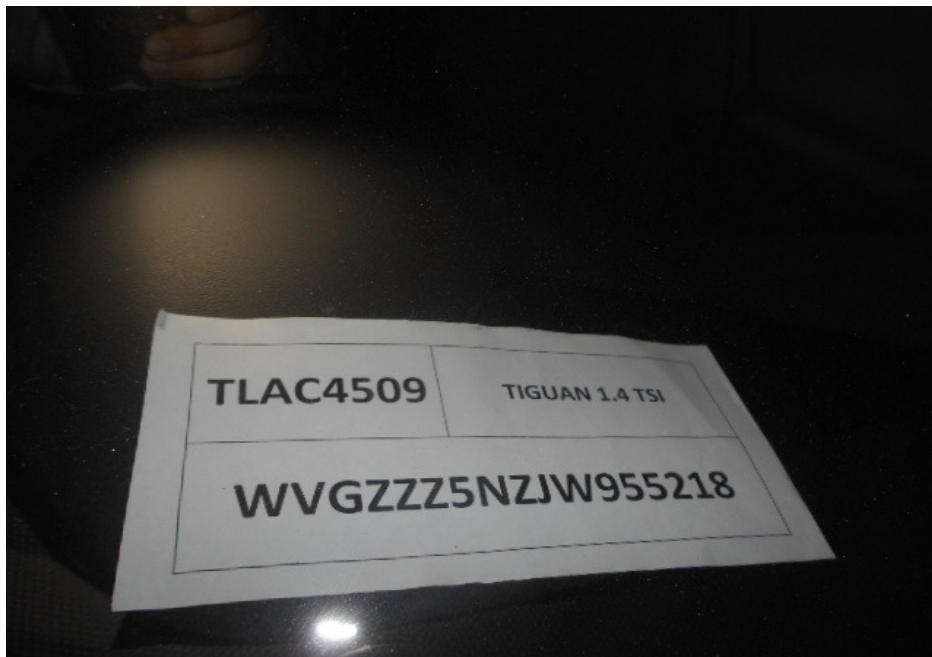
Photo 15 shows the chassis number of the second unregistered Tiguan model Volkswagen motor car that was affected by the Incident.

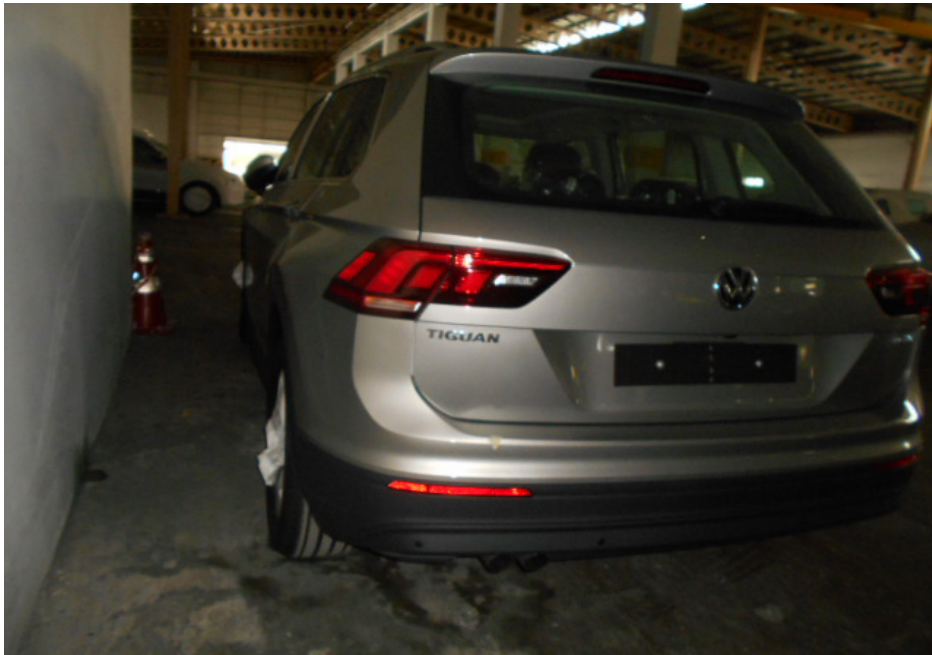
15. For this chassis, the rear bumper was found with minor cut/scratch marks at multiple areas. The rear bumper lower spoiler was cut while the cover of the rear right taillamp was also scratched. Again, the damage pattern is consistent to a single grazed impact (hit) by glass shards. See photo 15 – 20 below.

Photo 16 shows a general view of the rear body of the second unregistered Tiguan model Volkswagen motor car that was affected by the Incident. For this chassis number, the rear bumper, rear bumper lower spoiler and rear right taillamp were damaged.

16. Volkswagen have put up an estimate cost of repair for this chassis number. I have adjusted the estimate to \$4426.15. See below for breakdown.

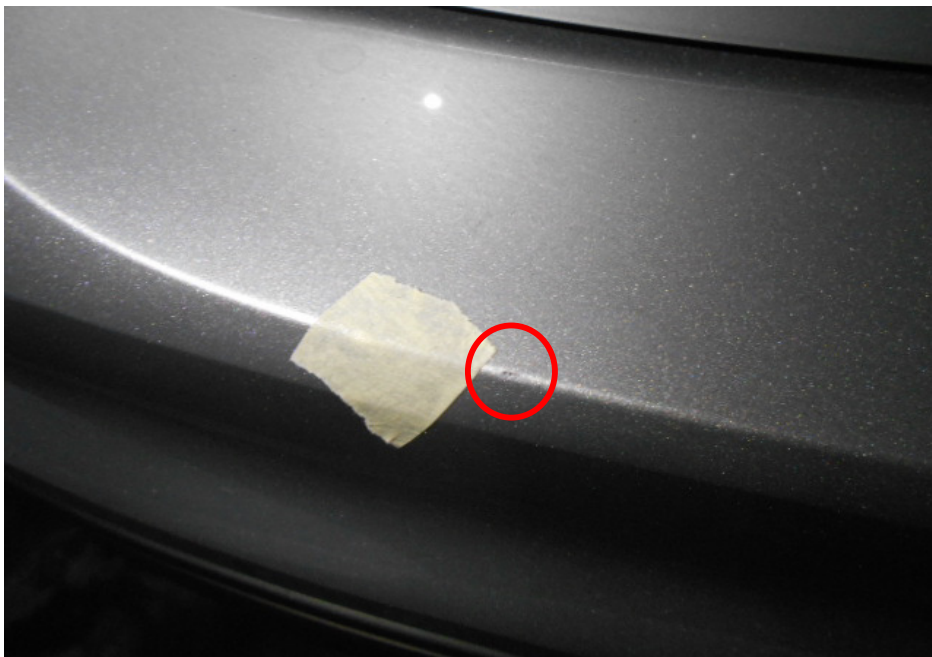
Photo 17 shows a close-up view of one of the cut marks (circled) that was observed on the rear bumper.

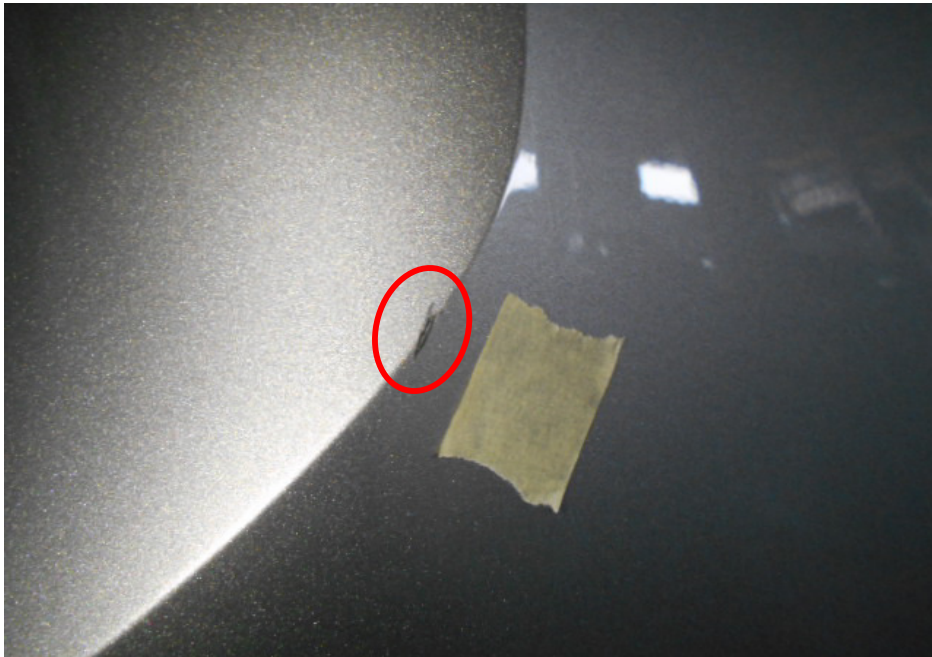
Photo 18 shows a close-up view of another cut mark (circled) that was observed on the rear bumper.

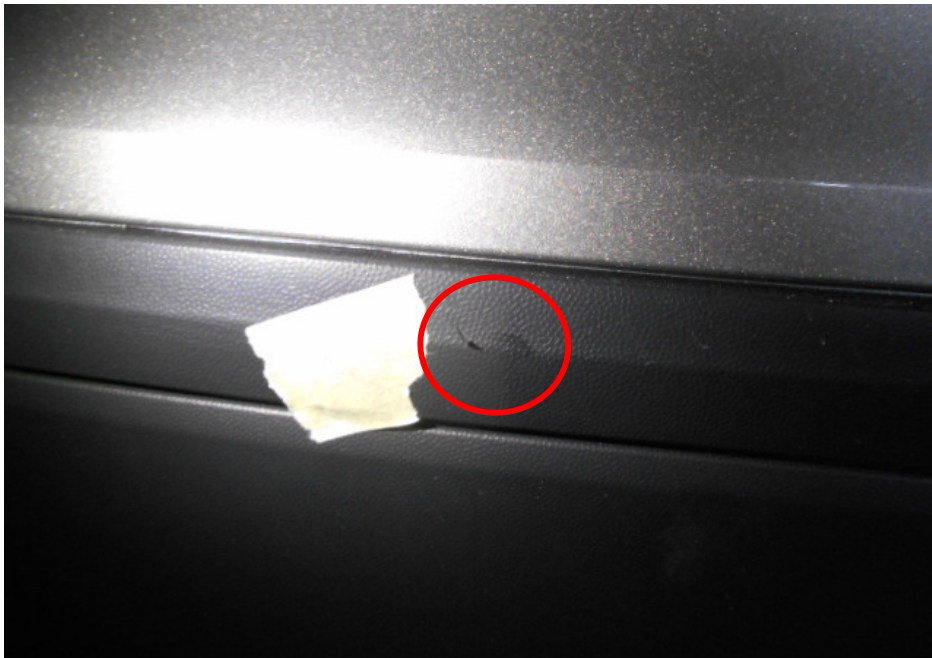
Photo 19 shows a close-up view of the cut mark (circled) that was observed on the rear bumper lower spoiler.

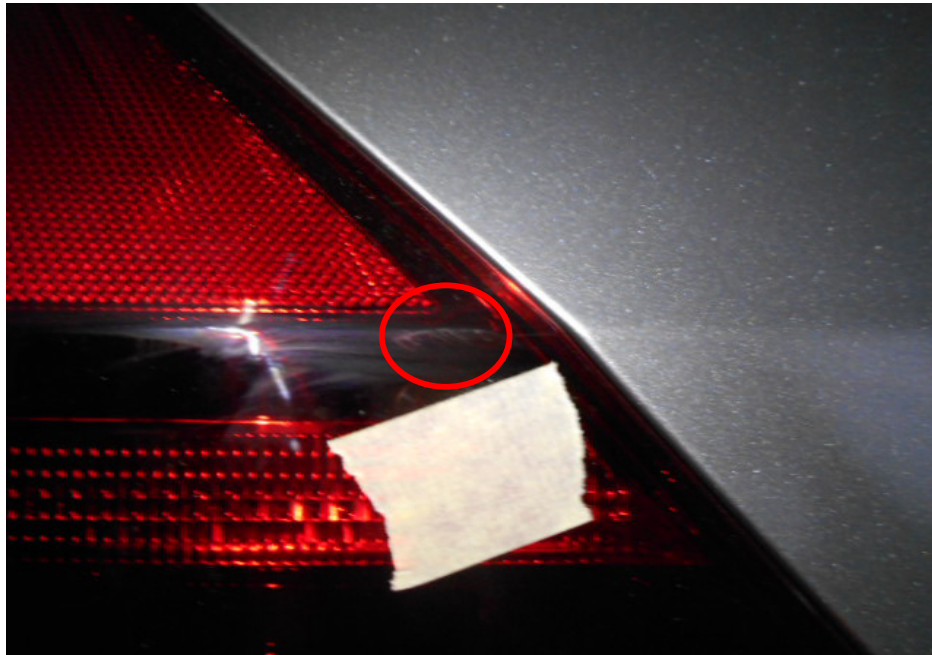
Photo 20 shows a close-up view of the scratch mark (circled) that was observed on the rear right taillamp cover.

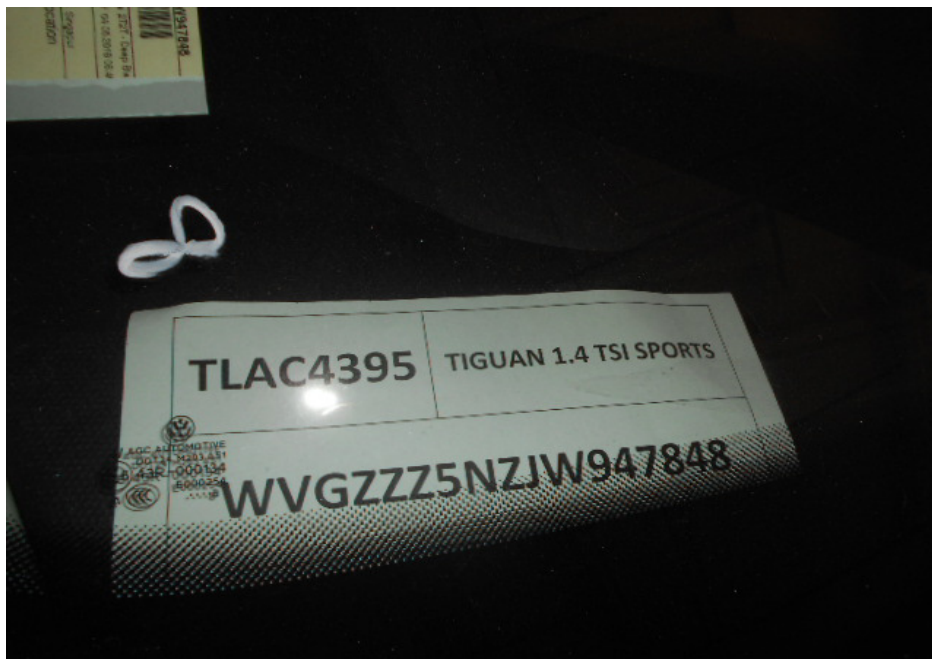
Photo 21 shows the chassis number of the third unregistered Tiguan model Volkswagen motor car that was affected by the Incident.

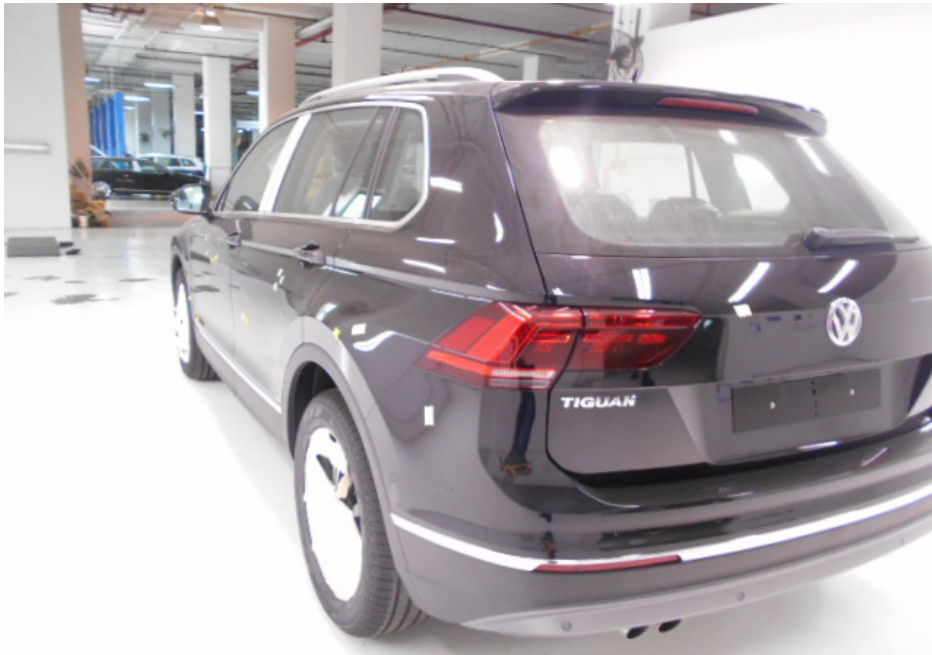
17. For this chassis, I had observed minor cut/scratch marks on several body panels. This includes the front left fender, front left door, rear left door, rear left fender, rear tailgate, rear bumper and rear right door. The front left door window and rear windscreen were also found with small chip marks. Like the other 2 unregistered Tiguan model Volkswagen motor cars that I had examined, the damage pattern to this chassis is consistent to a single grazed impact (hit) by glass shards. See photo 21 – 25 below.

Photo 22 shows a general view of the rear left body of the third unregistered Tiguan model Volkswagen motor car that was affected by the Incident.

18. Volkswagen have put up an estimate cost of repair for this chassis number. I have adjusted the estimate to \$11,731.81. See below for breakdown.

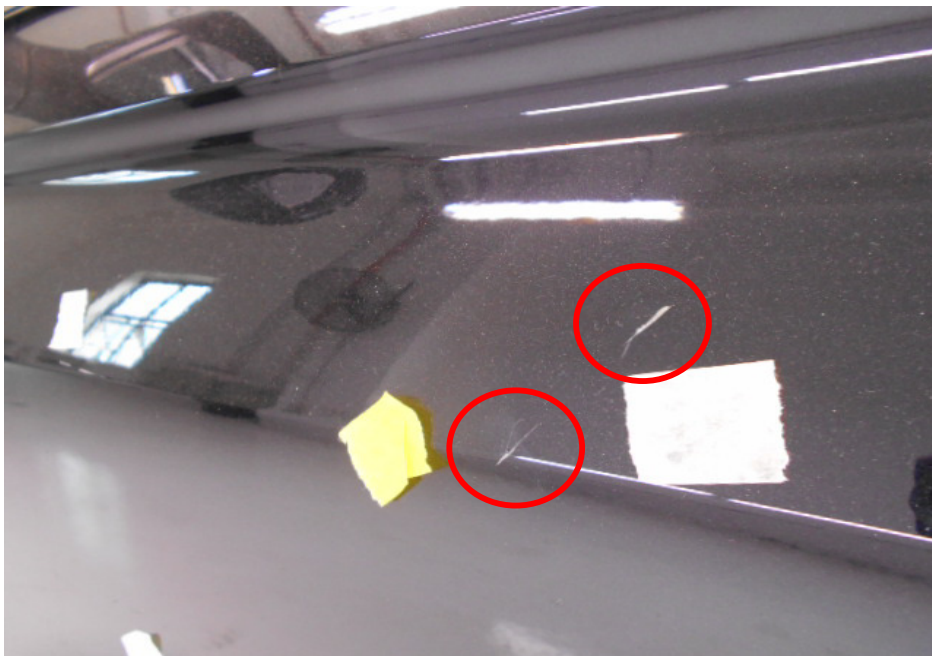
Photo 23 shows a close-up view of the scratch marks (circled) that were found on the front left door. Similar type of scratch marks was also found on the front left fender, rear left door and rear tailgate of this unregistered Tiguan model Volkswagen motor car.

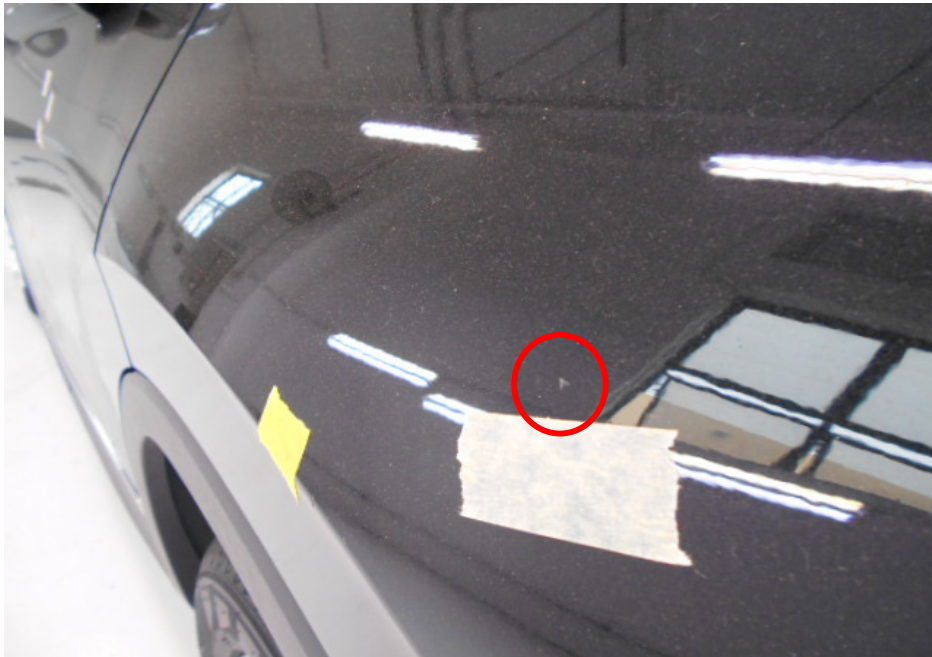
Photo 24 shows a close-up view of the scratch mark (circled) that was found on the rear left fender. Similar type of scratch marks was also found on the front left fender, rear left door, rear tailgate and rear right door of this unregistered Tiguan model Volkswagen motor car.

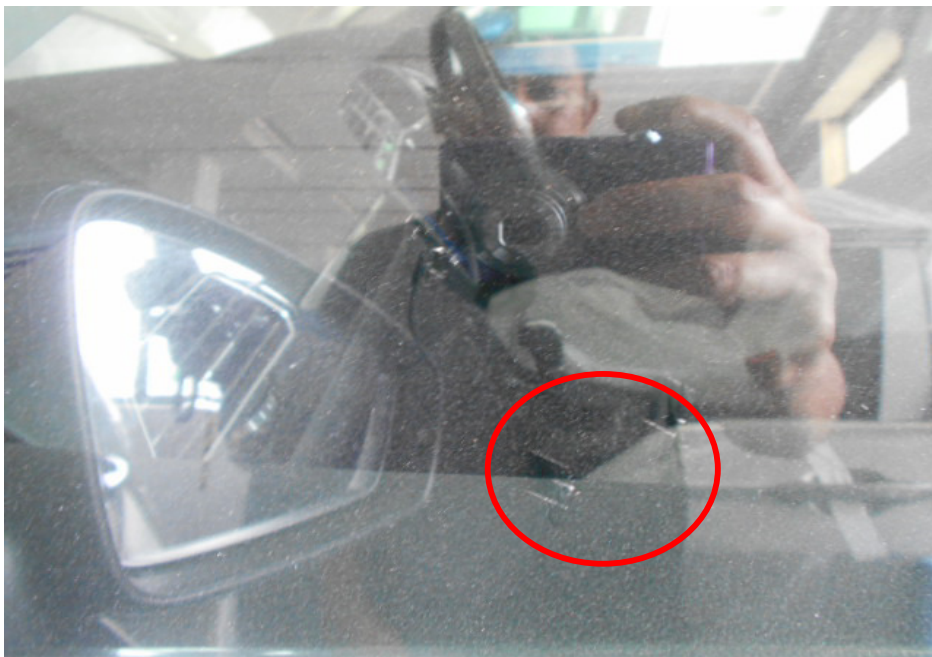
Photo 25 shows the relatively small chip marks (circled) that were found on the front left door window. Similar type of marks was also found on the rear windscreen of this unregistered Tiguan model Volkswagen motor car.
