Our Ref: CS/ASM18019339/Z

30th October 2018

TECHNICAL INVESTIGATION REPORT OF FIRE INCIDENT INVOLVING THE INSURED VEHICLE FBH 8890D ON 17th October 2018

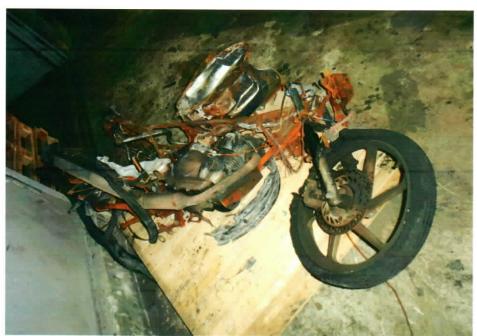
5. The Insured Vehicle was noted to have sustained fire damages that severely effected on the entire parts of the Insured Vehicle. The fire damages were observed on its engine compartment, front portion, left portion, right portion & rear portion. Rust had accumulated all over the Insured Vehicle as a result of exposure to environmental condition for a period of time. See photos 1 to 4 below.

Photo 1 shows the right portion view of the Insured Vehicle at the time of our inspection. The Insured Vehicle was noted to have sustained fire damages that severely effected on the entire parts of the Insured Vehicle.

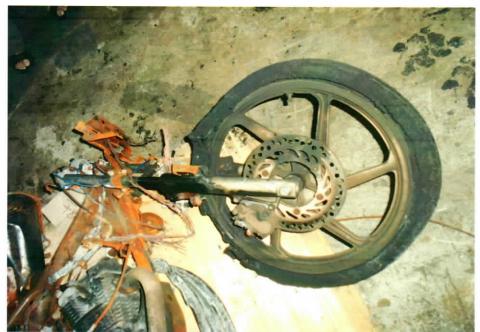
Photo 2 shows the frontal portion view of the Insured Vehicle at the time of our inspection. The Insured Vehicle was noted to have sustained fire damages that severely effected on the entire parts of the Insured Vehicle.

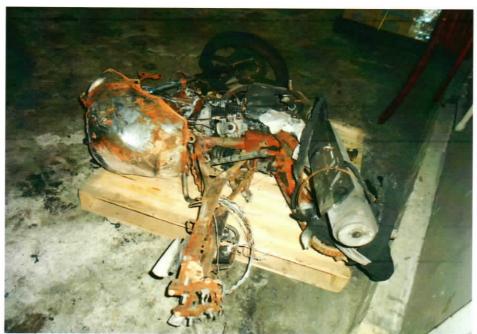
Photo 3 shows the rear left side of the Insured Vehicle at the time of our inspection. The Insured Vehicle was noted to have sustained fire damages that severely effected on the entire parts of the Insured Vehicle.

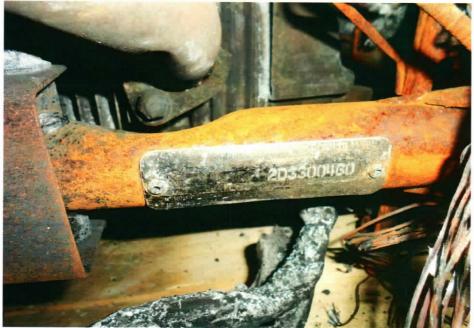
Photo 4 shows the chassis number plate that was still intact despite of the severe burnt on the entire Motor cycle.

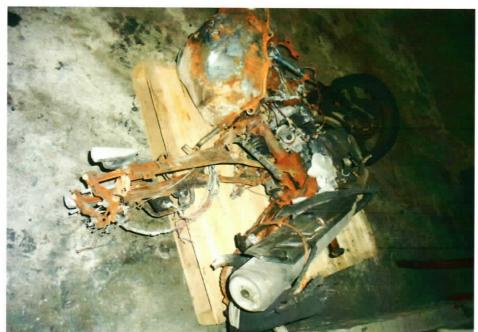
6. Rust would normally start to develop around areas soon after a fire as prolonged exposure to high heat intensity usually causes steel/metal material body parts to be exposed to natural environmental condition. The rust that had developed on the Insured Vehicle is an indication that it had sustained exposure to prolonged high heat intensity. See photo 5 below.

Photo 5 shows rust would normally start to develop around these areas soon after a fire as prolonged exposure to high heat intensity usually causes steel/metal material body parts to be exposed to natural environmental condition. The rust that had developed on the Insured Vehicle is an indication that it had sustained exposure to prolonged high heat intensity.

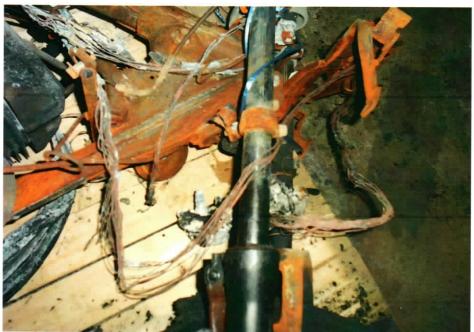
8. Upon closer examination of the area around the body structure of the engine compartment, we do not find any evidence that would relatively link the fire accident to the Insured Vehicle. However, several stretches of wiring burnt internally to its bare copper state. The wirings were likely to be the original engine wire harness which in this case was not consistent to the cause of fire. Further investigations on the cause of fire were extended & explain in the paragraphs below. See photo 6 below.

Photo 6 shows the front portion of the Insured Vehicle at the time of our inspection. Several stretches of wiring burnt internally to its bare copper state.

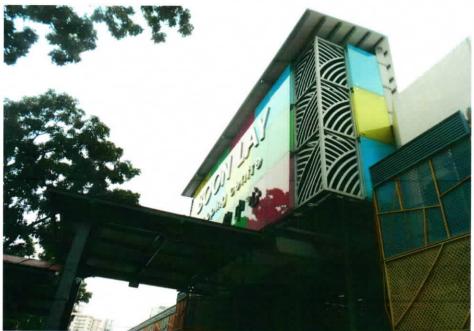
Photo 8 shows Boon Lay Shopping Centre signage where the fire incident took place.

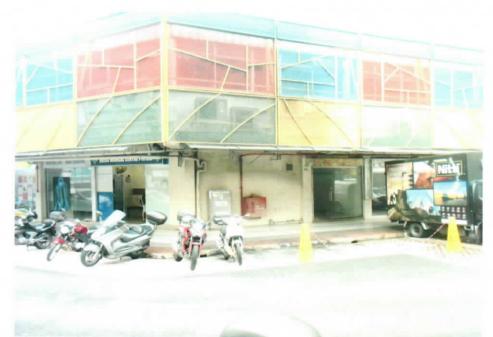
Photo 9 shows the fire incident motorcycle parking lot cordoned for further investigation.

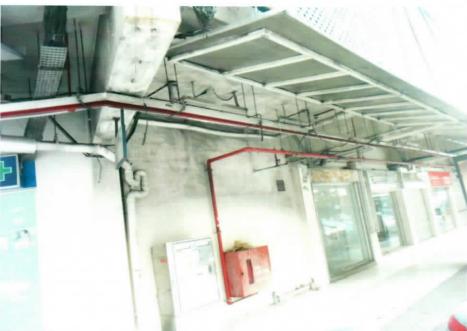
Photo 10 shows the burnt portion of the behind wall & ceiling indicates that fire incident did took place at the said location.

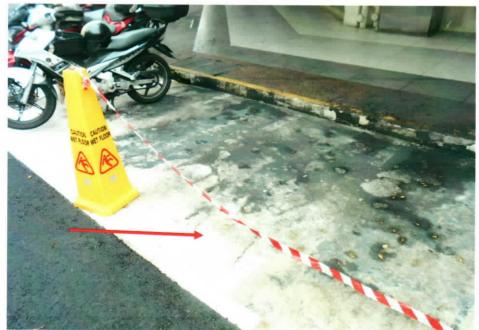
Photo 11 shows the burnt portion on the parking lot. We were able to clearly see burnt marks/ burned residual remains on the parking lot ground indicating that fire incident did took place at the said location.

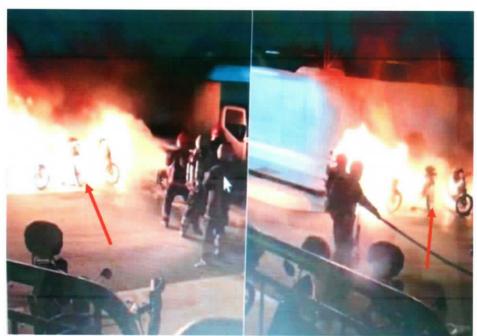
Fire Incident Site Photograph

Photo 12 shows SCDF officers in the effort of extinguishing the fire.
