Your Ref: S8M00X66  
Our Ref : CS/ASM18019433/N

1 November 2018

**TECHNICAL INVESTIGATION REPORT OF FIRE INCIDENT INVOLVING THE  
INSURED VEHICLE CB 6956G ON 8 SEPTEMBER 2018**

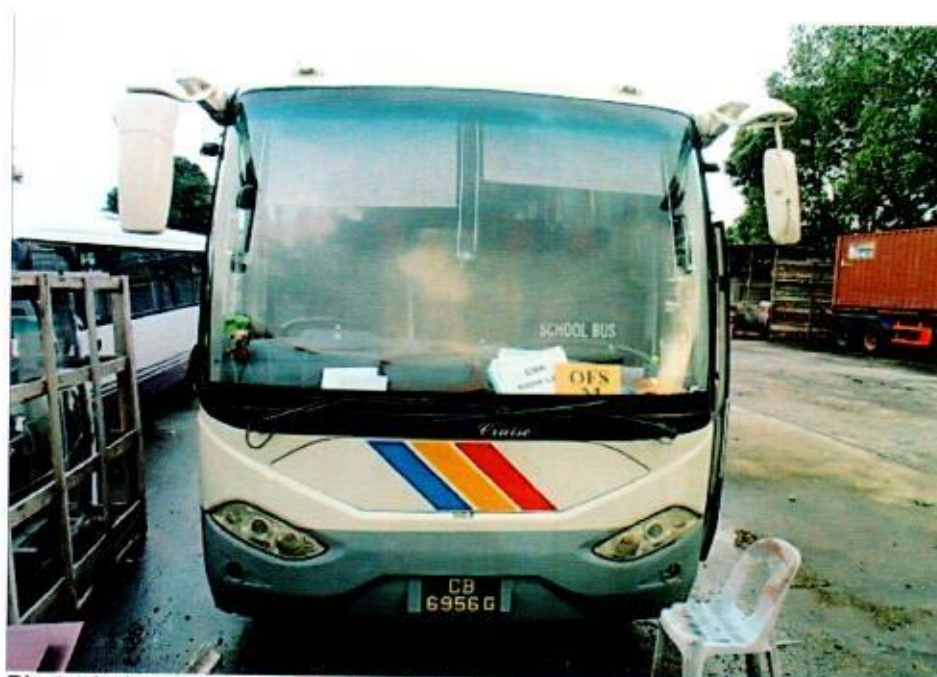
**Photo 1** shows the general view of the front portion of the Insured Vehicle at the time of our inspection. The front portion of the Insured Vehicle was relatively unaffected by the fire.

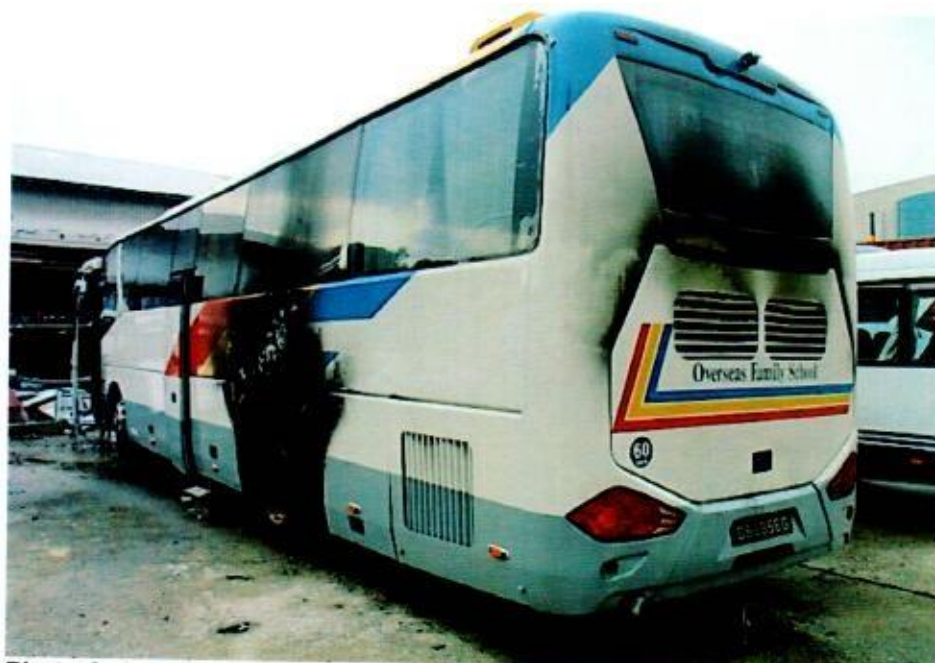
**Photo 2** shows the general view of the rear left portion of the Insured Vehicle at the time of our inspection. The exterior body of the Insured Vehicle had sustained fire damage at the centre portion as well as rear portion. Affected parts had included the side panels, rear tyres, rear wheel rims, left glass panel, rear windscreen and engine panel, amongst others.

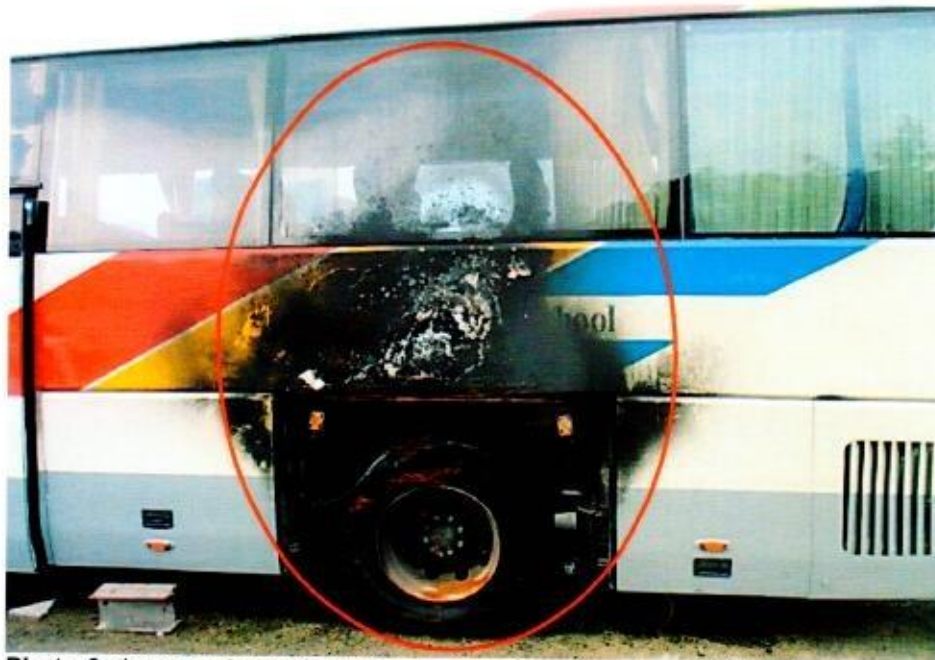
**Photo 3** shows a closer view of the left portion of the Insured Vehicle at the time of our inspection. The fire damage was observed to be most severe at its left centre portion. Affected parts had included the left side panel, left rear wheel rim, left rear tyre and left glass panel, amongst others (circled).

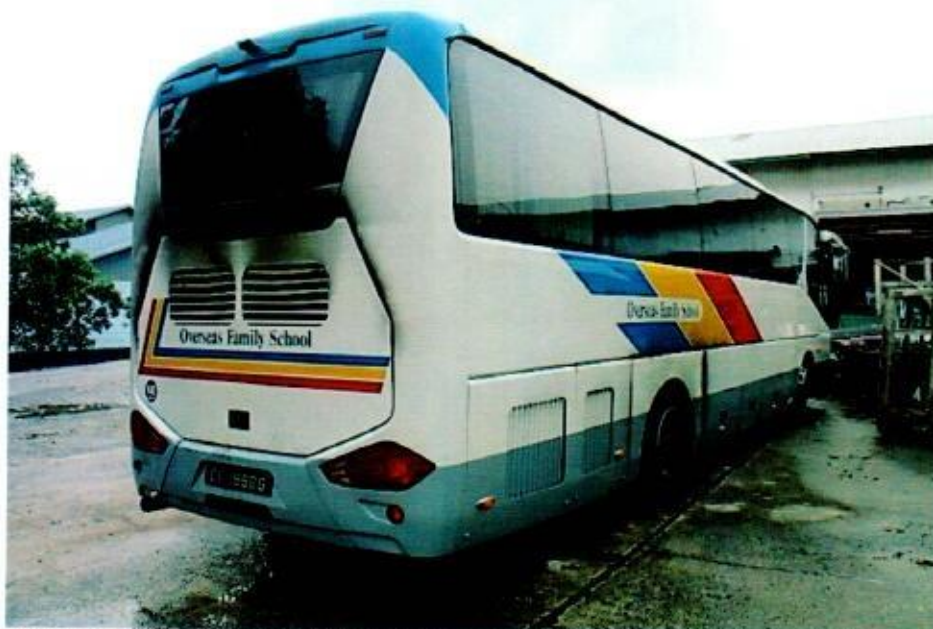
**Photo 4** shows the general view of the right rear portion of the Insured Vehicle at the time of our inspection. The exterior body of the Insured Vehicle had sustained fire damage at the centre portion as well as rear portion. Affected parts had included the side panels, rear tyres, rear wheel rim, rear windscreen and engine panel, amongst others.

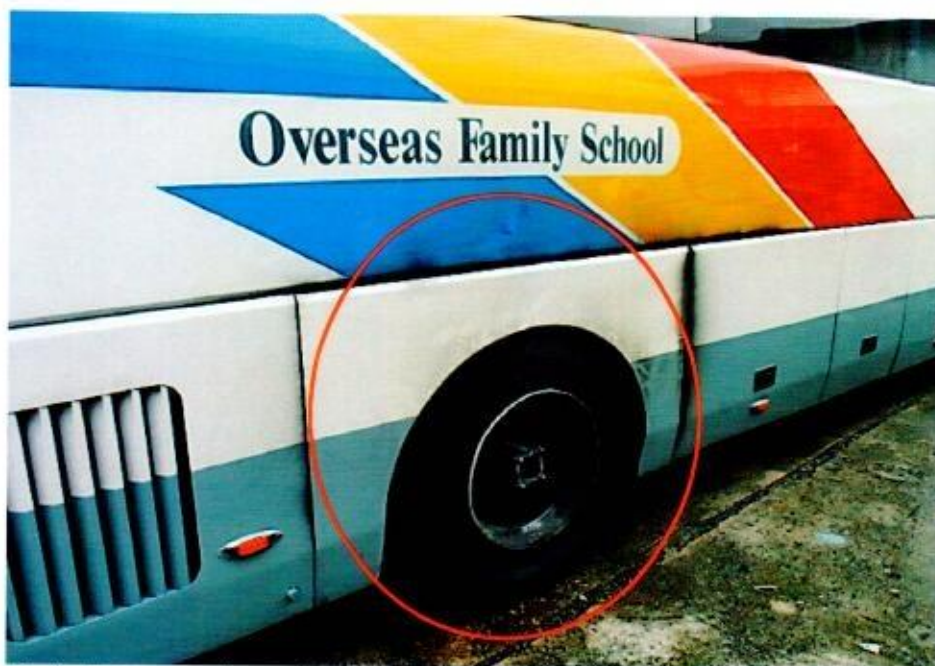
**Photo 5** shows a closer view of the right portion of the Insured Vehicle at the time of our inspection. The fire damage to the Insured Vehicle was confined to its centre portion. Affected parts had included the right side panel, right rear wheel rim and right rear tyre, amongst others (circled).

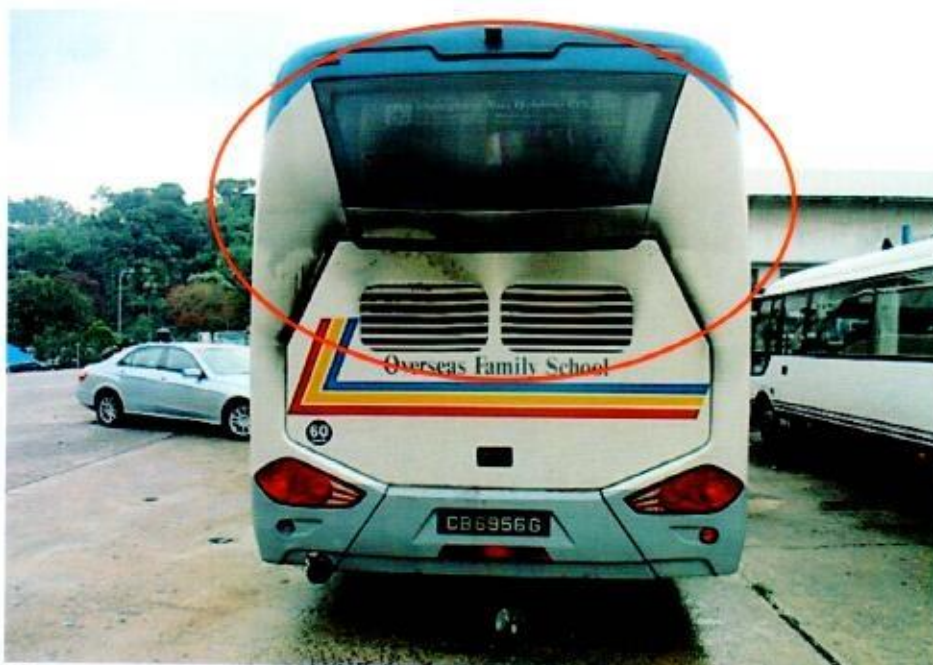
**Photo 6** shows the general view of the rear portion of the Insured Vehicle at the time of our inspection. The Insured Vehicle had sustained fire damage at the rear portion. Affected parts had included the rear windscreen and engine panel, amongst others (circled).

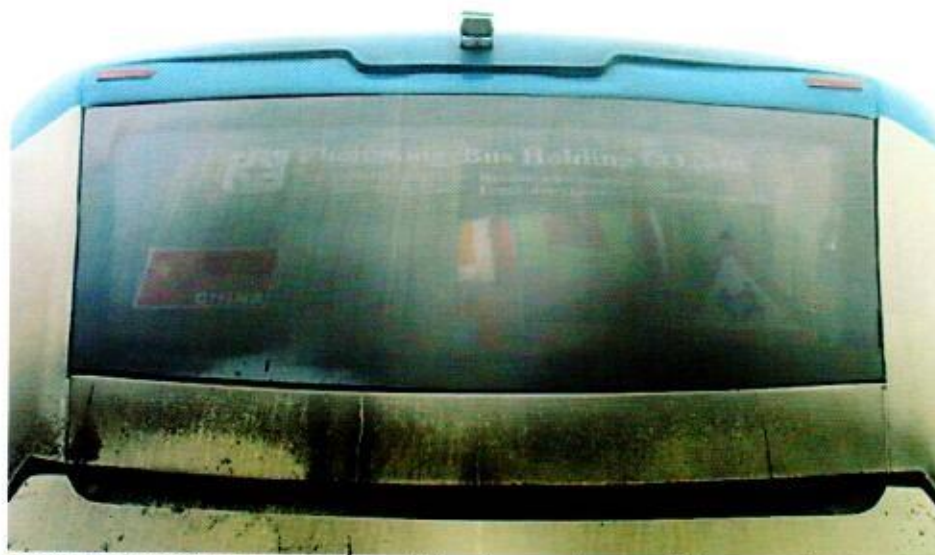
**Photo 7** shows the general view of the damaged rear windscreen of the Insured Vehicle at the time of our inspection.

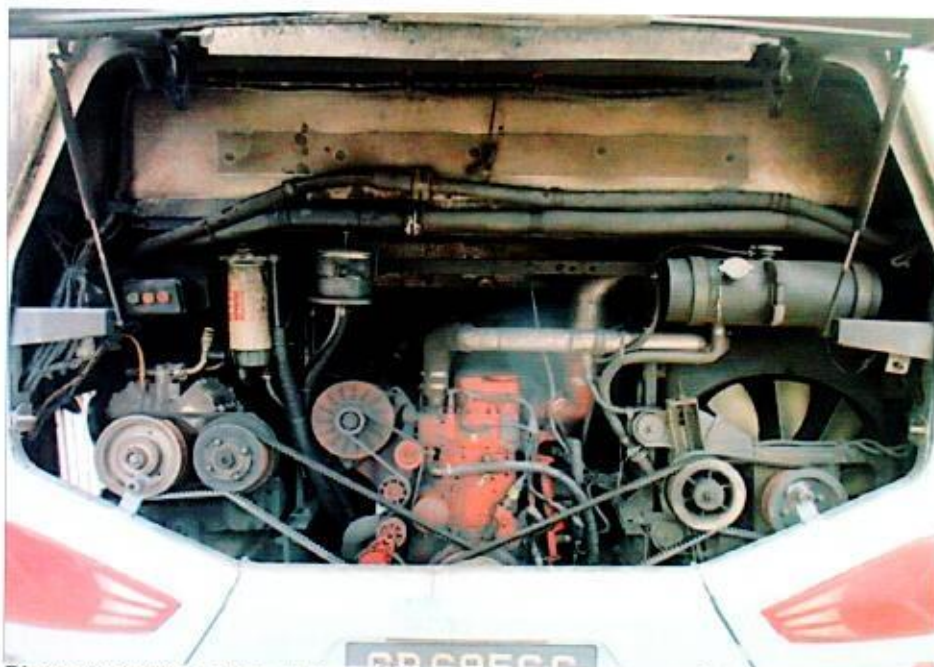
**Photo 8** shows a general view of the engine compartment of the Insured Vehicle at the time of our inspection. The engine compartment of the Insured Vehicle was significantly affected by the fire. Most of the parts inside the engine compartment were found to be partially burnt and/or melted as a result of the fire.

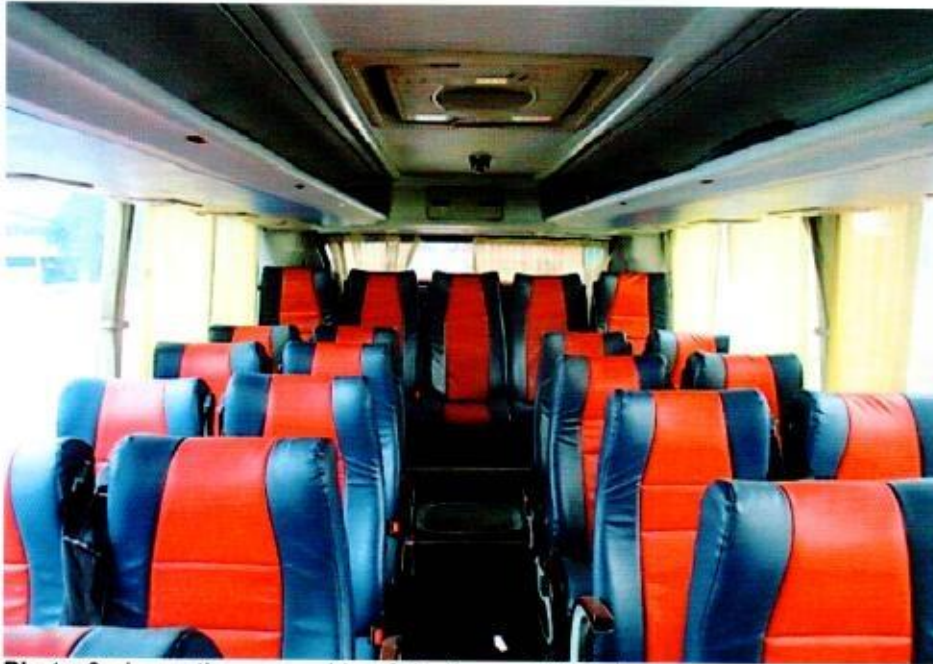
**Photo 9** shows the rear cabin of the Insured Vehicle at the time of inspection. The floorboard towards the rear portion of the rear cabin was observed to be slightly affected by the fire.

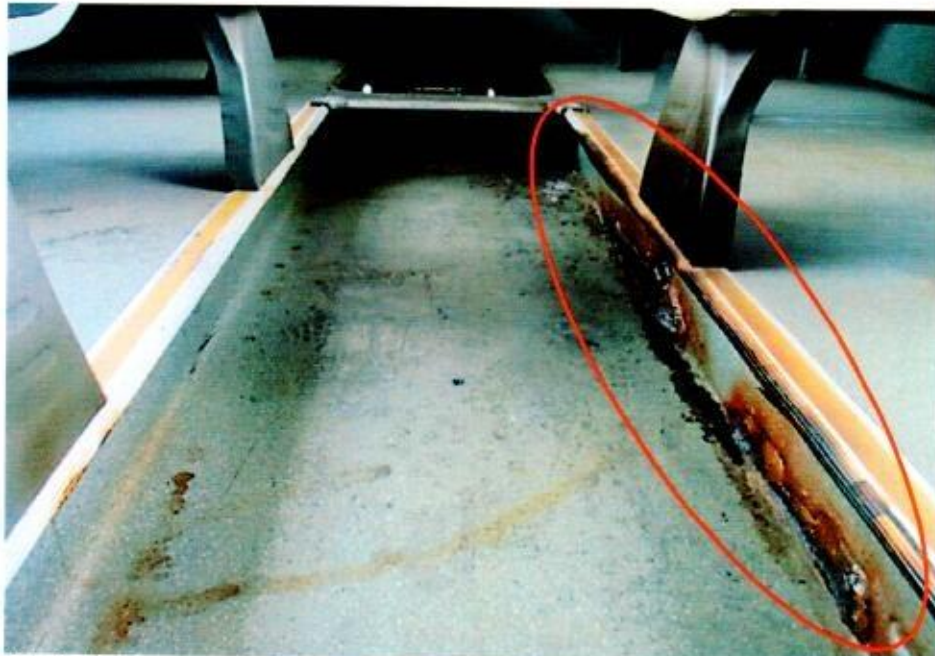
**Photo 10** shows a closer view of the floorboard towards the rear portion of the rear cabin of the Insured Vehicle which was found to be partially burnt and/or melted as a result of the fire (circled).

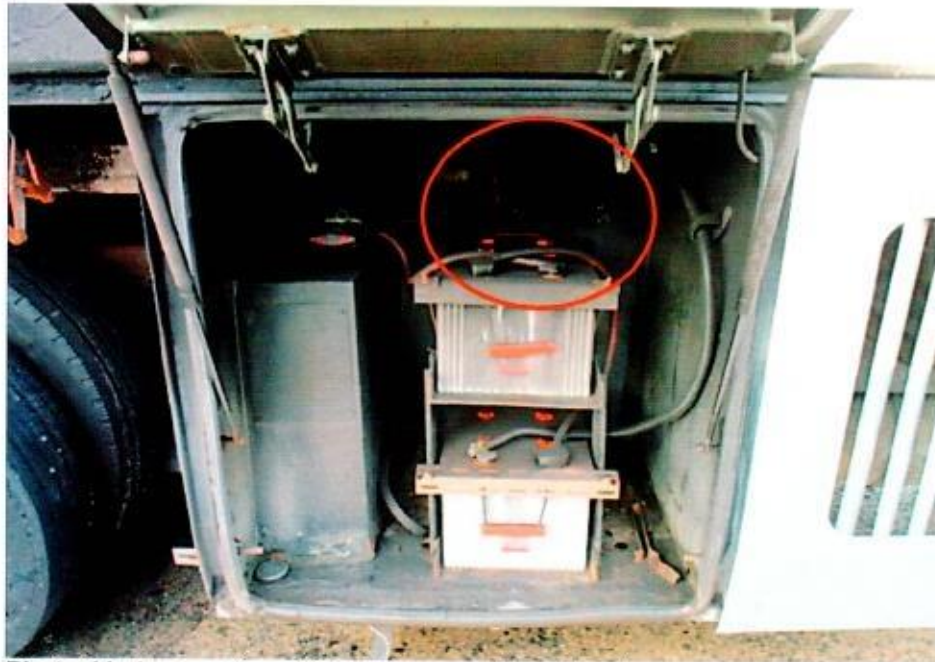
7. For this particular case, the fire appears to have originated from the left rear portion of the Insured Vehicle, near to the vicinity where the battery is located. This can be determined from the nature of the fire damage which was more extensive at the left rear portion. The right rear portion had sustained minimal fire damage. Basing on the circumstances of the fires' origin at the material time of incident as well as examining the area where the extent of fire damage was most severe, we can determine that the fire had likely started from the left rear portion of the Insured Vehicle.

**Photo 11** shows a view of the left rear portion of the Insured Vehicle, near to the vicinity where the battery is located. We had found several burnt stretches of original factory fitted wirings leading from the battery (circled).

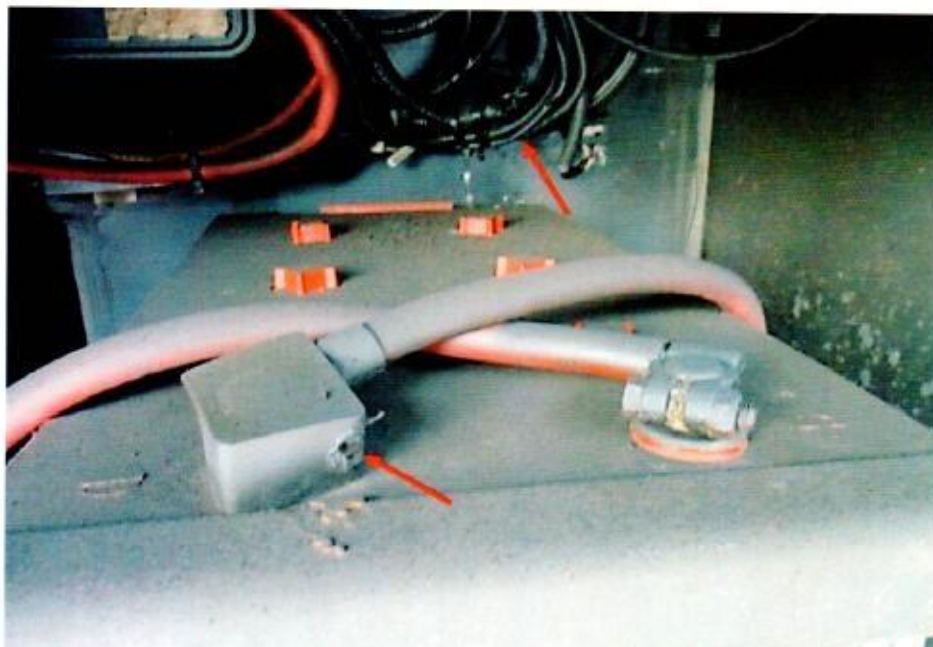
**Photo 12** shows a closer view of the several burnt stretches of original factory fitted wirings leading from the battery (arrowed).

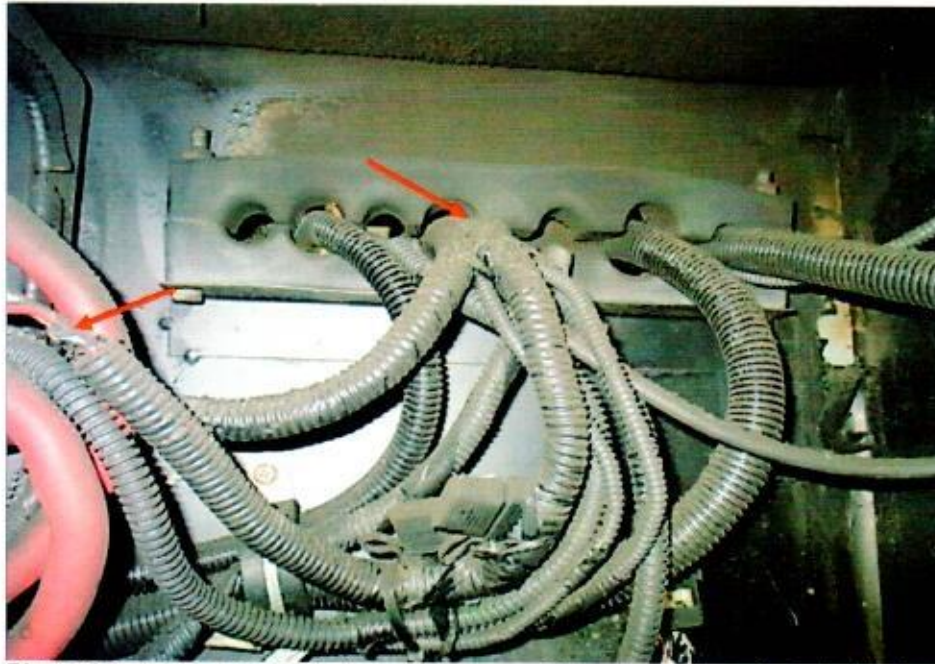
**Photo 13** shows a close up view of the several burnt stretches of original factory fitted wirings leading from the battery (arrowed).

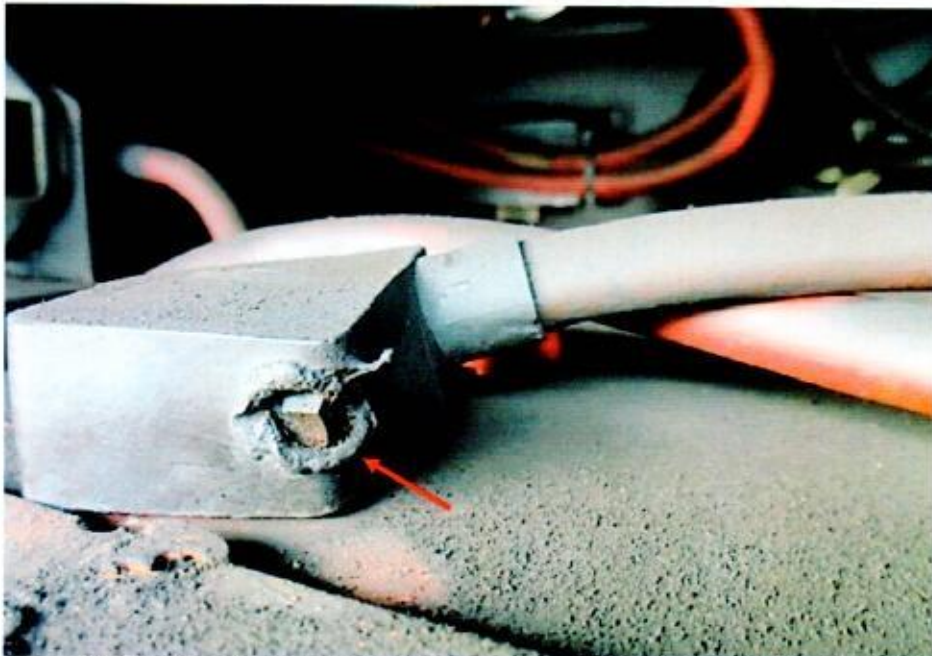
**Photo 14** shows a close up view of the several burnt stretches of original factory fitted wirings leading from the battery (arrowed).

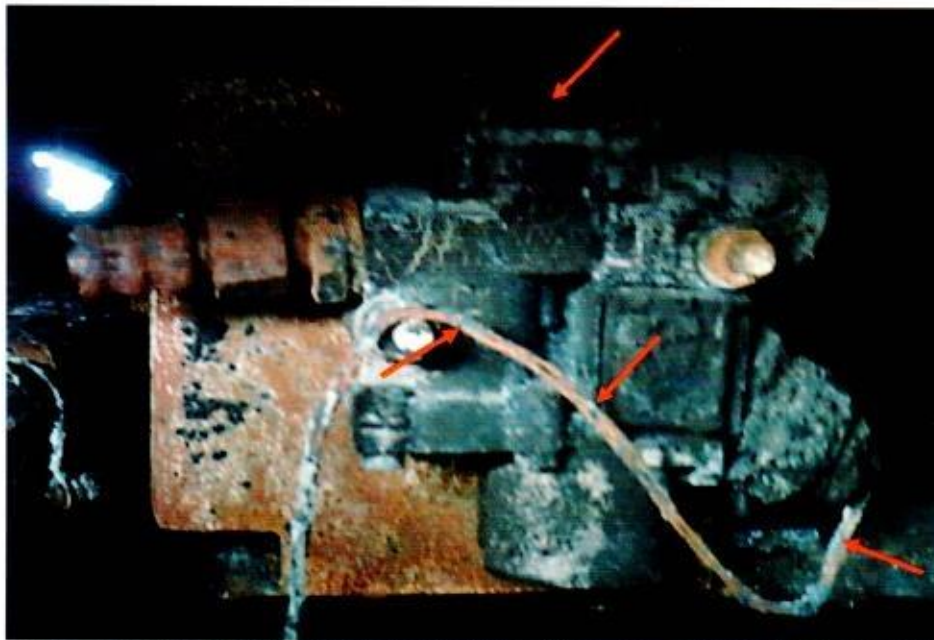
8. Upon closer examination of the left rear portion of the Insured Vehicle as well as around the immediate vicinity to where the fire had likely started, we had found greenish residue on several burnt stretches of original factory fitted wirings leading from the battery. The presence of such greenish residue indicates internal heating of copper wires, a sign of an electrical short circuit occurring. The greenish residue is normally left behind from oxidation as a result of chemical reaction involving the copper wires. This physical evidence would then appear to suggest that the cause of fire to the Insured Vehicle could have possibly been due to electrical in nature. See photos 11 - 16 below.

**Photo 15** shows upon closer examination of the area around the immediate vicinity to where the fire had likely started, we had found greenish residue on several burnt stretches of original factory fitted wirings leading from the battery (arrowed). The presence of such greenish residue indicates internal heating of copper wires, a sign of an electrical short circuit occurring. The greenish residue is normally left behind from oxidation as a result of chemical reaction involving the copper wires.

22. The possibility of the fire being due to electrical in nature would then seem more likely given that engine overheating and external factors would seem unlikely. The fire being due to electrical nature is also supported by the faint traces of greenish residue that were found on several burnt stretches of original factory fitted wirings leading from the battery of the Insured Vehicle, which was earlier discussed in paragraph 8 above.

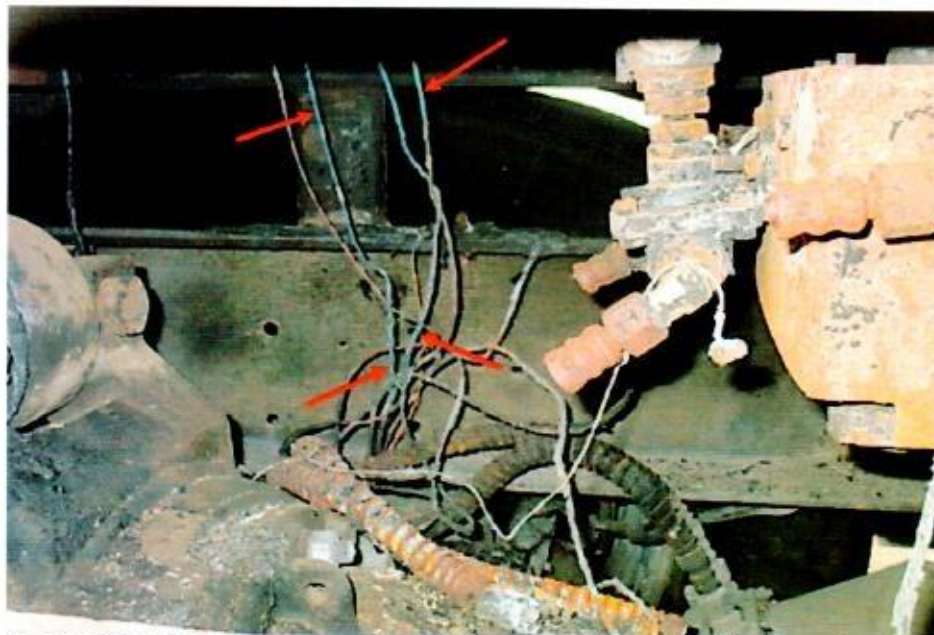
**Photo 16** shows a close up view of the greenish residue that was found on several burnt stretches of original factory fitted wirings leading from the battery (arrowed). The presence of such greenish residue suggests occurrence of an electrical short circuit.

24. Having investigated and technically analysed the damages of burnt nature to the Insured Vehicle, we are of the view that the cause of fire to the Insured Vehicle was of electrical in nature. For this particular case, the fire had originated along the original factory fitted wirings leading from the battery of the Insured Vehicle. The wirings were original factory components of the Insured Vehicle.
25. We did not find any evidence which had suggested that the cause of fire to the Insured Vehicle was due to poor maintenance and/or recurring electrical problem.
26. Our investigations had also revealed that at the time of writing this report, there is no manufacturer recall of electrical nature to similar make and model vehicle as the Insured Vehicle that may pose a fire risk.

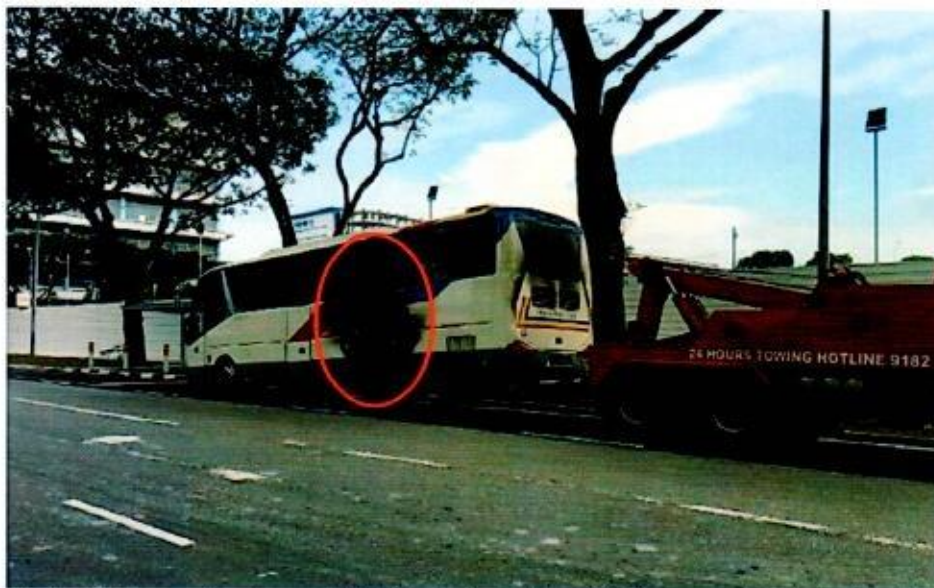
**Photo 17** shows the Insured Vehicle being prepped to be towed post- incident. In general, the information gathered from this photograph had corresponded to Mr Kwek's statement, which is the fire started while Mr Kwek was driving the Insured Vehicle on the 1st lane.

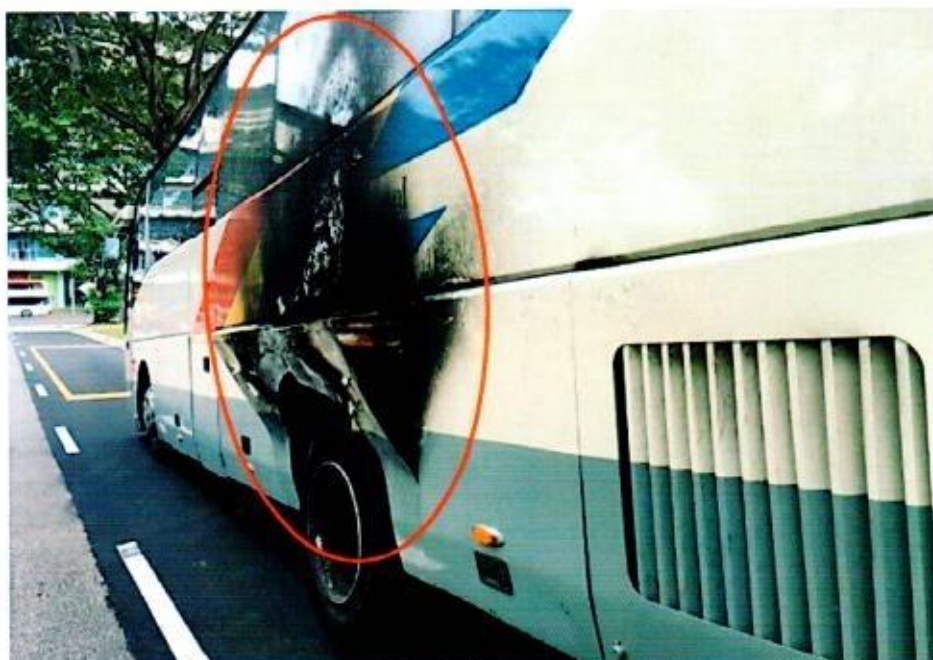
**Photo 18** shows a closer view of the left rear portion of the Insured Vehicle post-incident. In general, the information that could be gathered from this photograph pertaining to the nature of fire damage had corresponded to the events that were related to us by Mr Kwek, which is the fire had started from the left rear portion of the Insured Vehicle (circled).

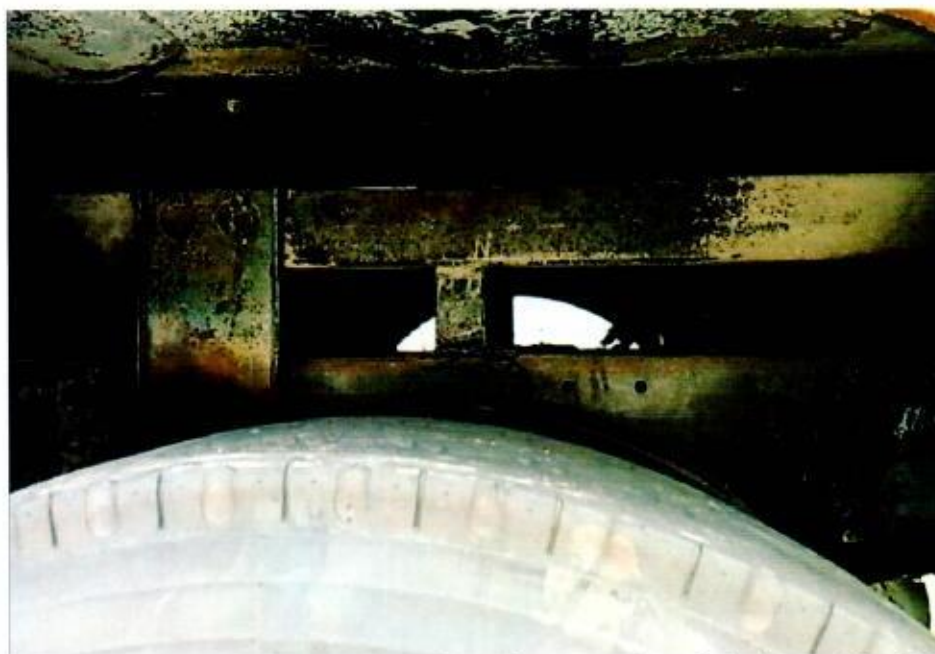
**Photo 19** shows a close up view of the left rear portion of the Insured Vehicle post- incident. In general, the extensive damages sustained to this portion of the Insured Vehicle had corresponded to the events that were related to us by Mr Kwek, which is the fire had started from the left rear portion of the Insured Vehicle.
