Your Ref : TP/IP/55759/2018
Our Ref : CI/TPD18019471/Z

31st December 2018

MECHANICAL INSPECTION REPORT OF MOTORCYCLE JRB 2580

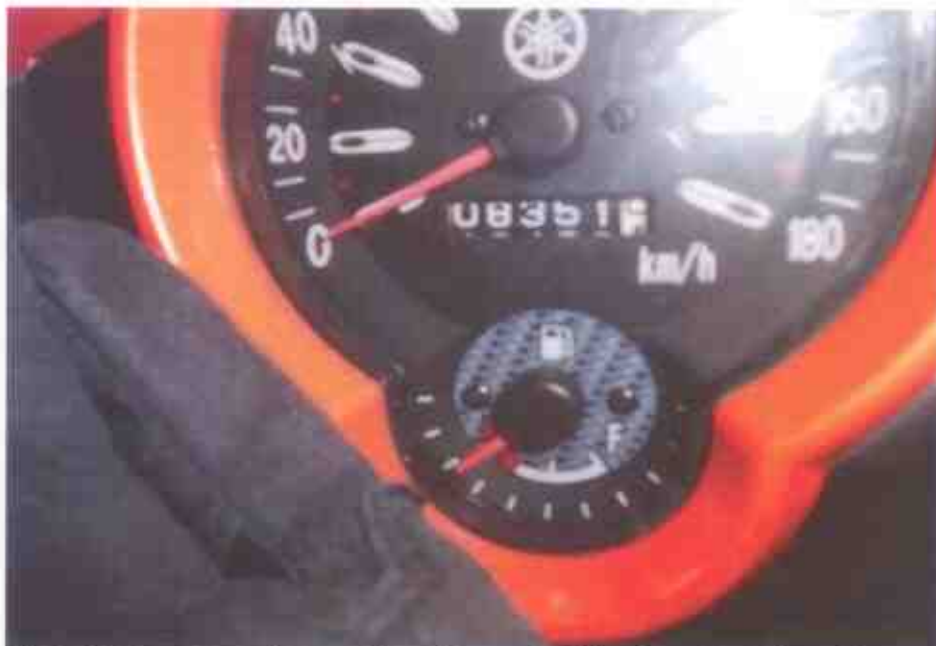
Photo 1 shows the mileage of the Motorcycle at the time of our inspection was recorded at 083510km.

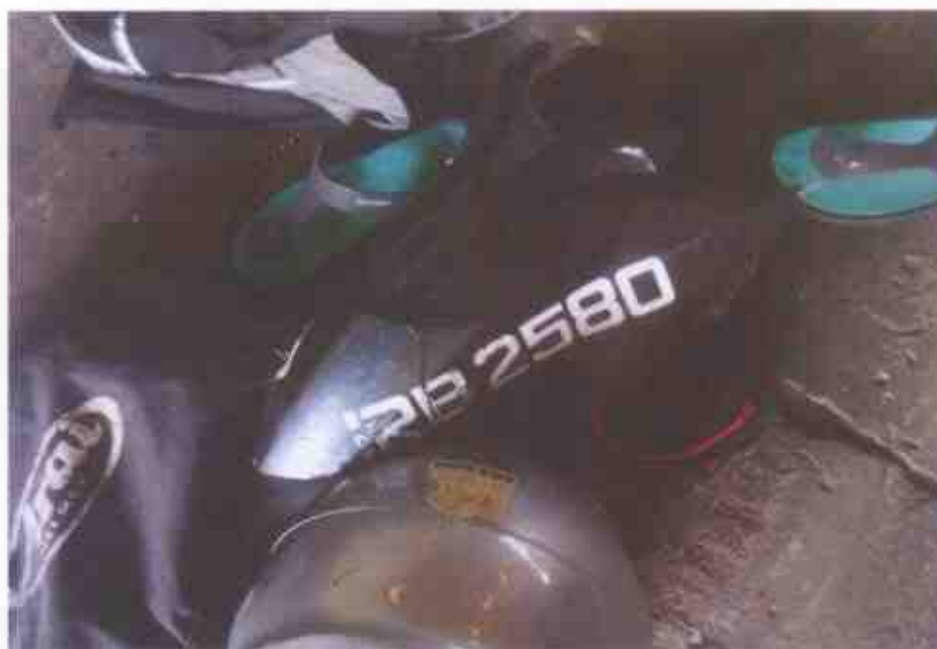
Photo 2 shows the Motorcycle number plate for identification.

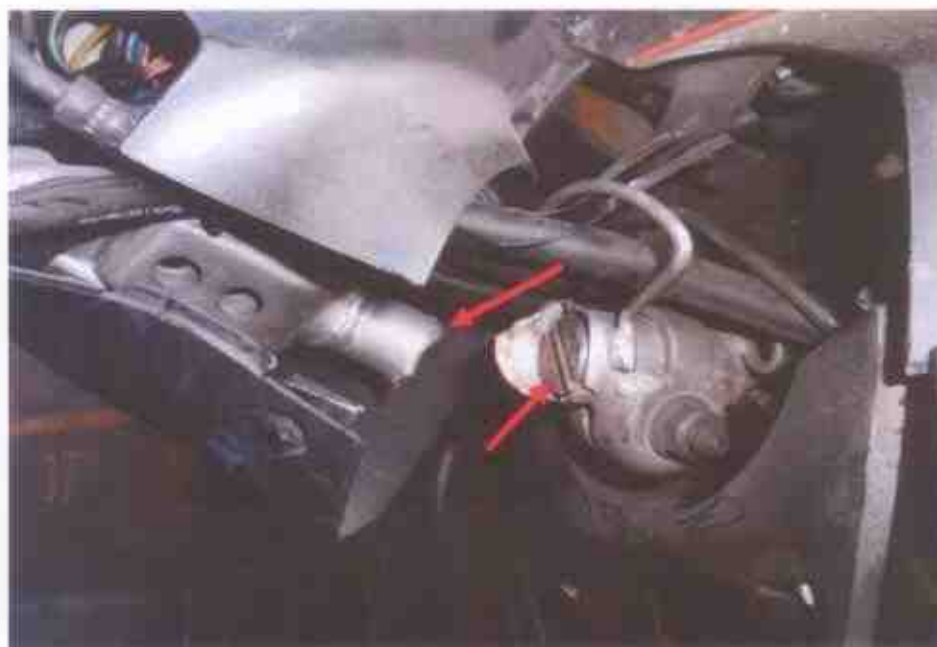
Photo 3 shows a semi close-up view of the front portion of the Motorcycle at the time of our inspection. The Motorcycle was observed to have sustained with relatively extensive impact due to the accident collision. Amongst the body parts damaged was its front steering system (arrowed), which was observed to be broken.

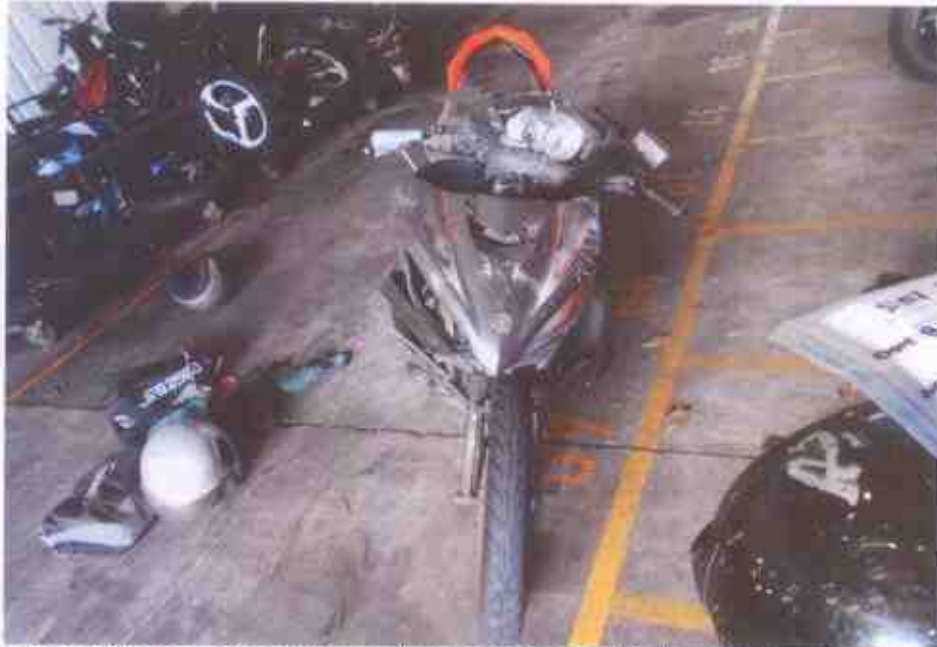
Photo 4 shows a general view of the front portion of the Motorcycle at the time of our inspection. The Motorcycle was observed to have sustained extensive damages at the frontal portion, along both its left side and right side.

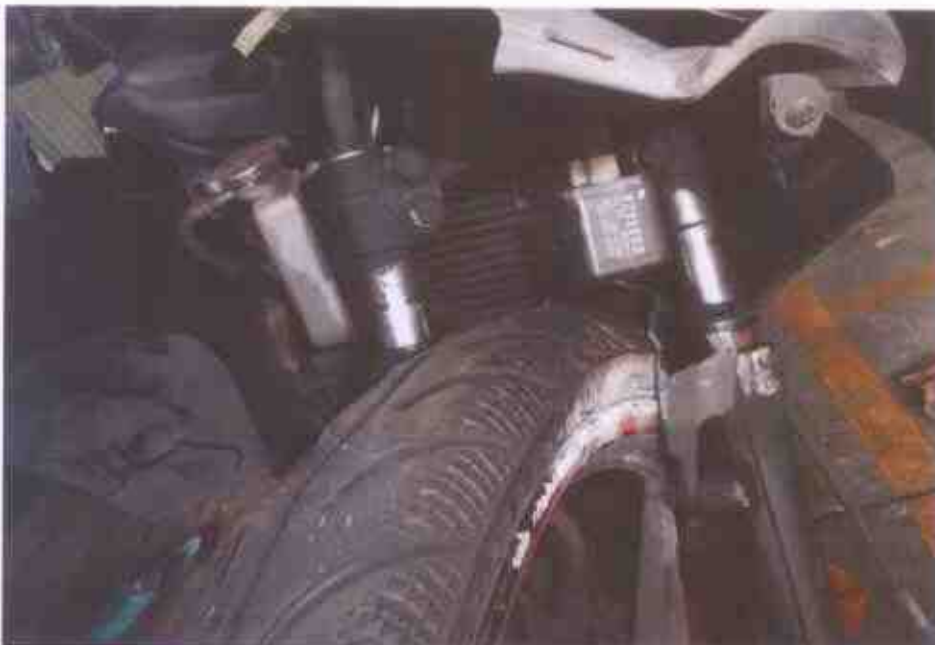
Photo 5 shows a close-up view of the front fork of the Motorcycle at the time of our inspection. It was observed to be damaged due to the accident collision.

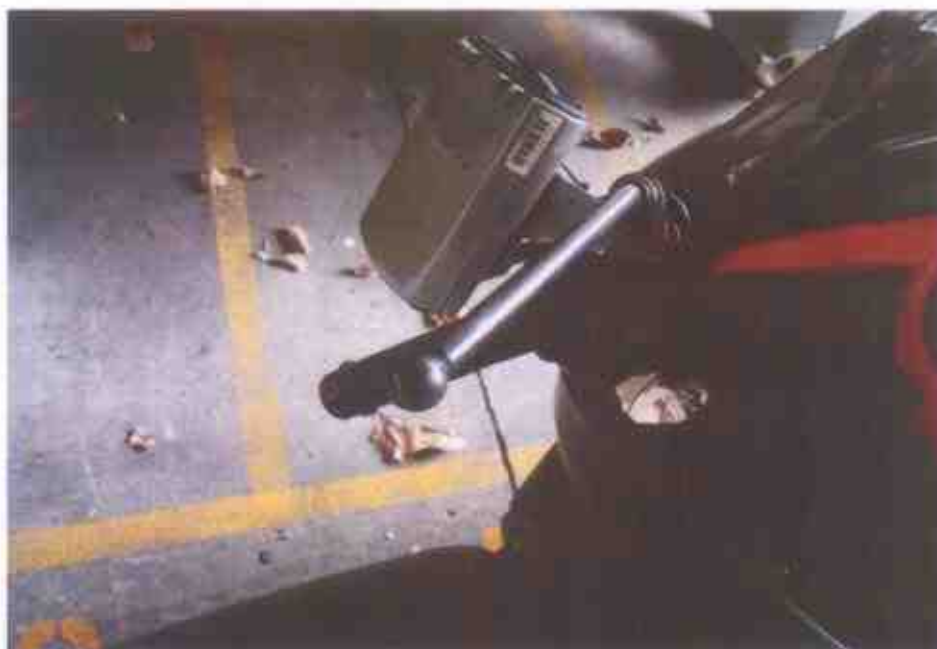
Photo 6 shows a close-up view of the front left wing mirror of the Motorcycle at the time of our inspection. It was observed to be missing likely due to the accident collision.

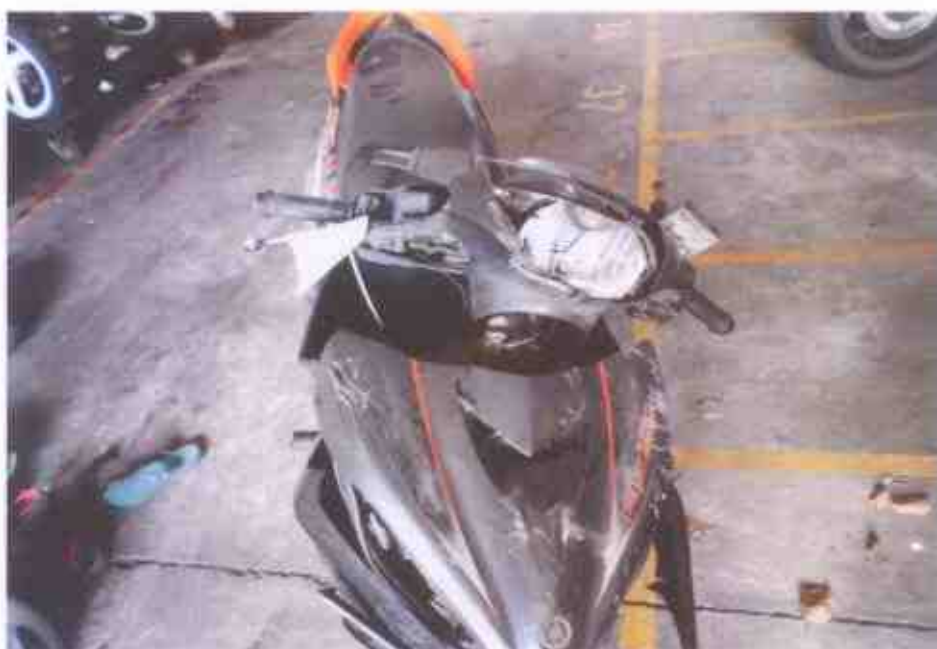
Photo 7 shows a semi close-up view of the headlamp & front portion of the Motorcycle at the time of our inspection. It was observed to be damaged due to the accident collision.

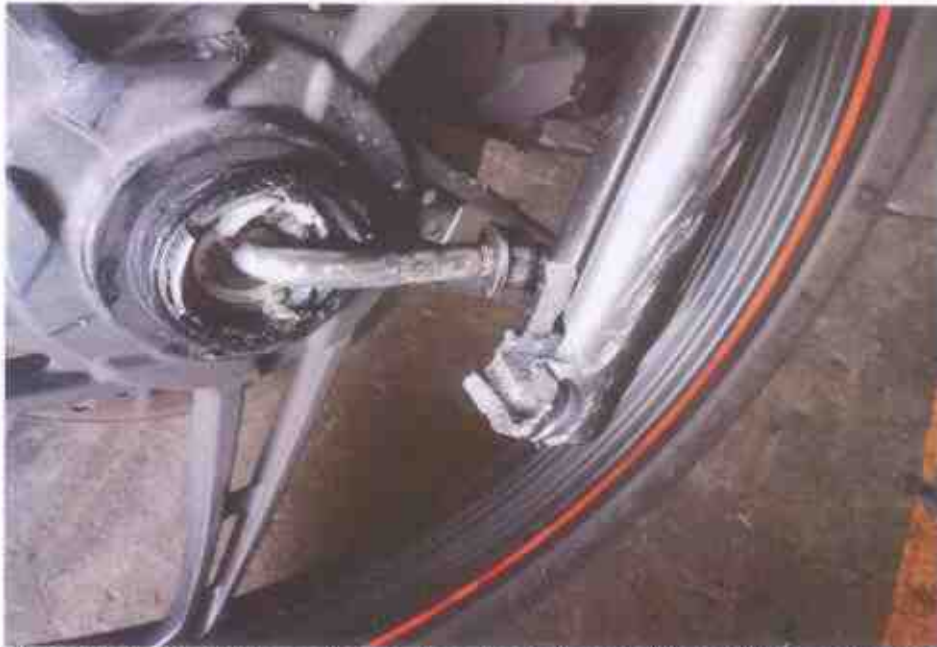
Photo 8 shows a close-up view of the front fork of the Motorcycle front wheel at the time of our inspection. It was observed to be damaged due to the accident collision.

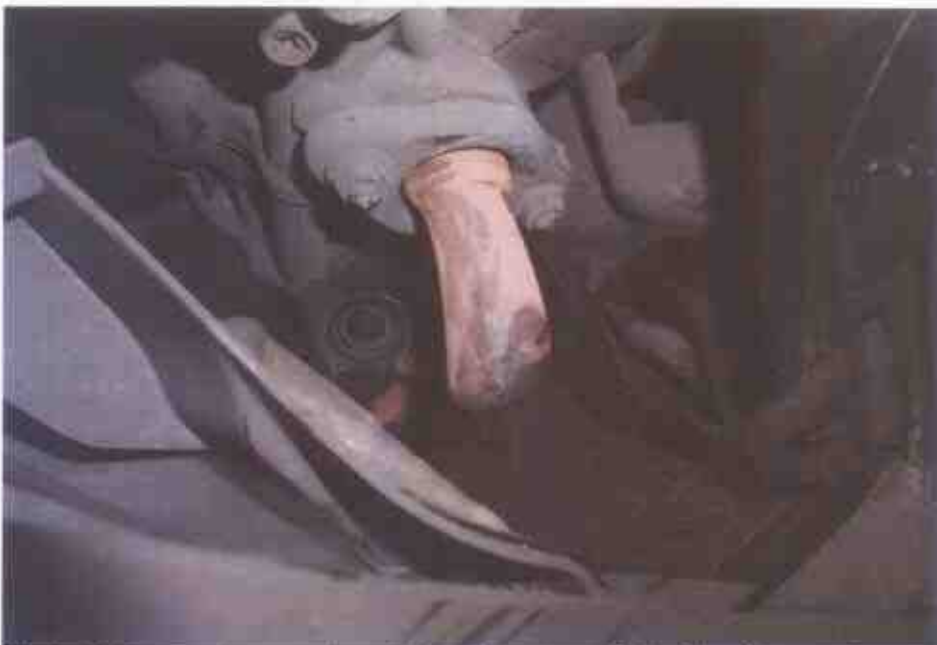
Photo 9 shows a close-up view of the exhaust manifold of the Motorcycle at the time of our inspection. It was observed to be buckled likely due to the accident collision.

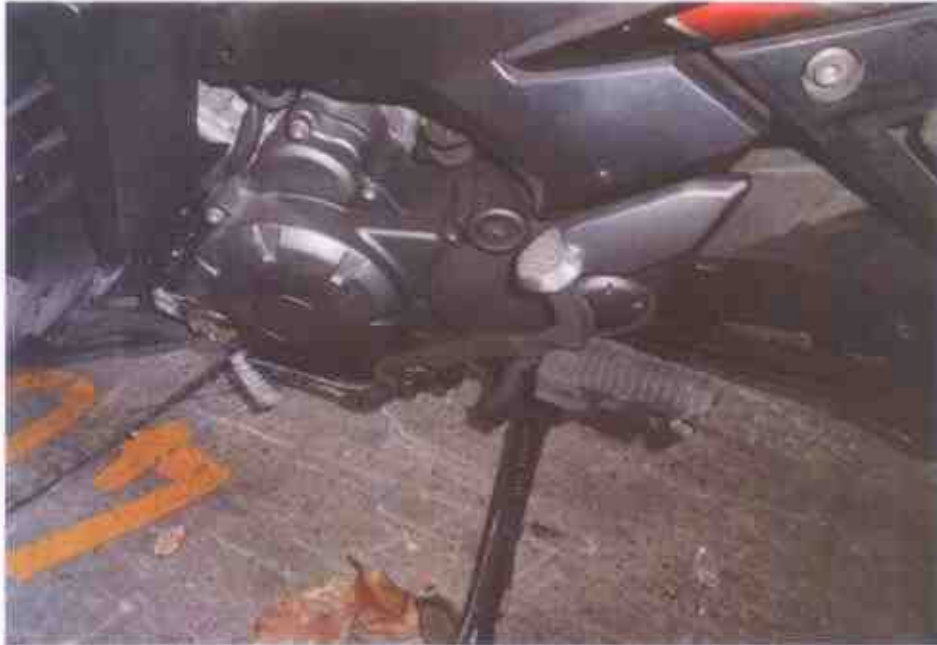
Photo 10 shows a close-up view of the left hand side of the Motorcycle at the time of our inspection. It was observed to be damaged due to the accident collision.

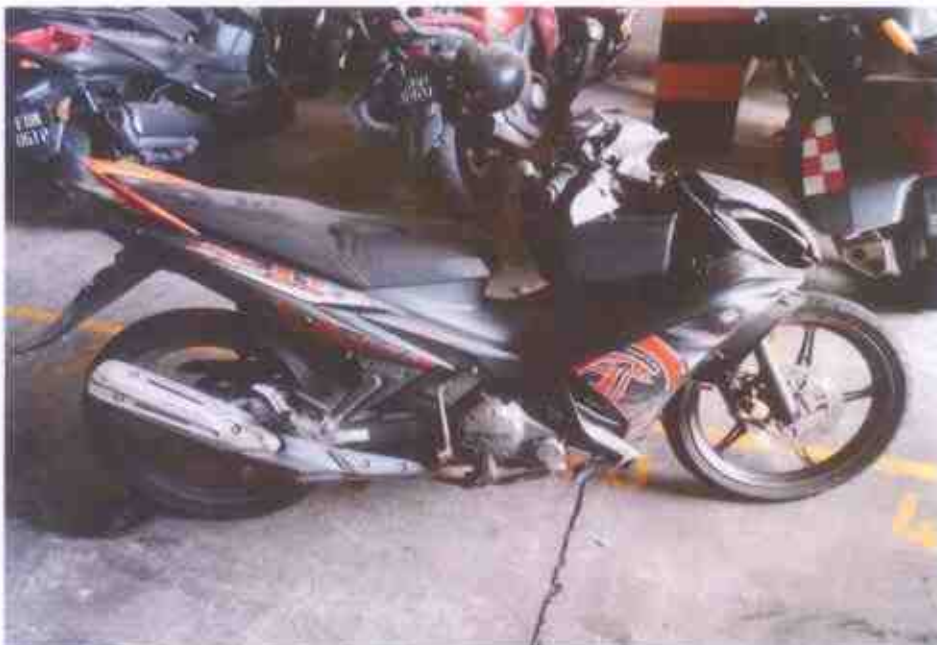
Photo 11 shows a general view of the right portion of the Motorcycle at the time of our inspection. The Motorcycle was observed to have sustained relatively extensive impact including damages to the steering system as a result of the accident collision.

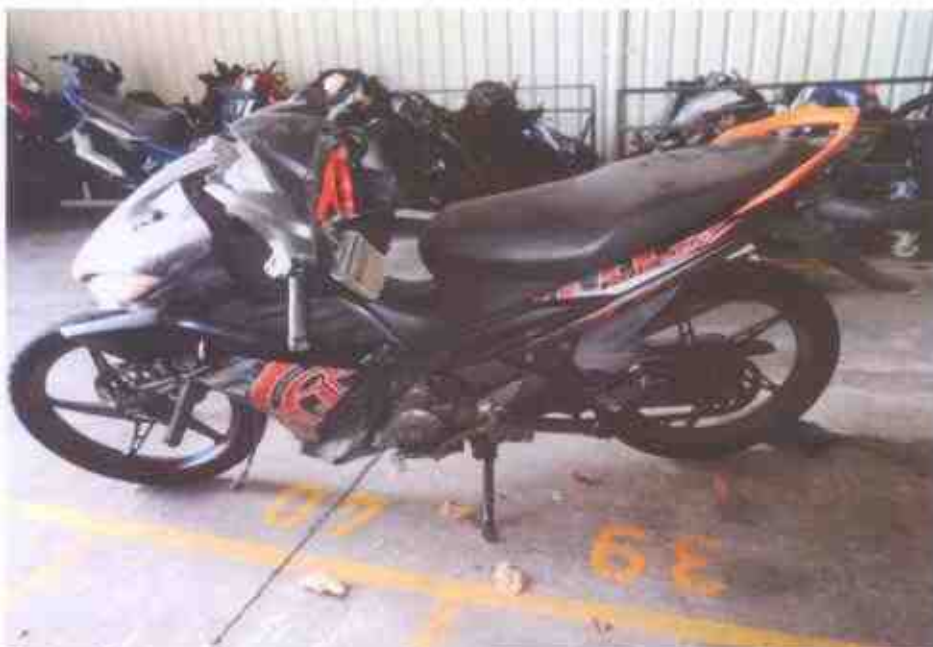
Photo 12 shows a general view of the right portion of the Motorcycle at the time of our inspection. The Motorcycle was observed to have sustained relatively extensive impact including damages to the steering system as a result of the accident collision.

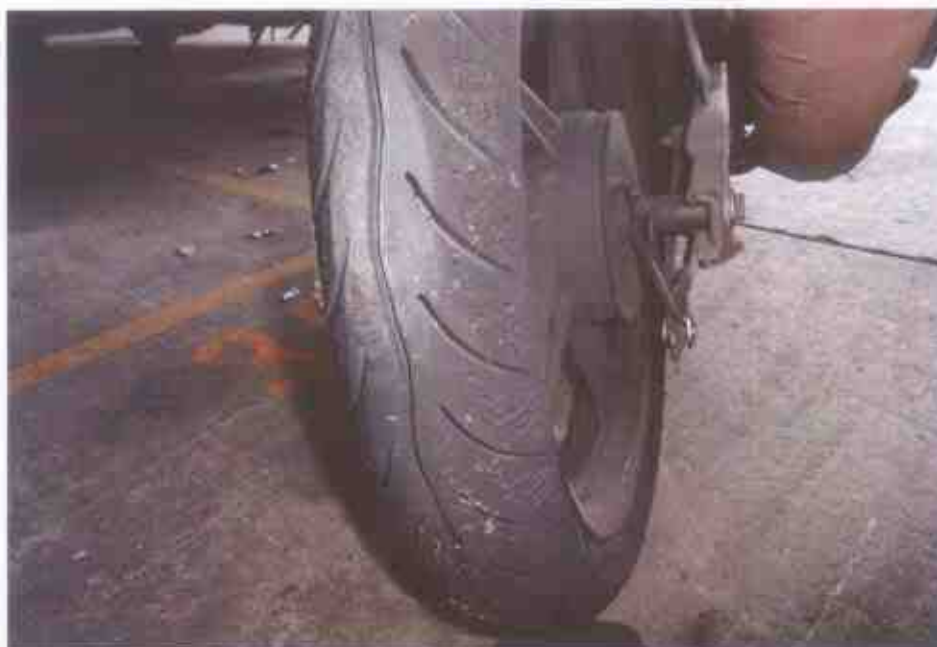
Photo 13 shows the rear tyre of the Motorcycle at the time of our inspection. The rear tyre was observed to be in serviceable condition with remaining tread depth of approximately 4mm. The tyre was also observed to be sufficiently inflated for vehicular operation. There was no significant damage observed on the rear wheel rim & tyre.

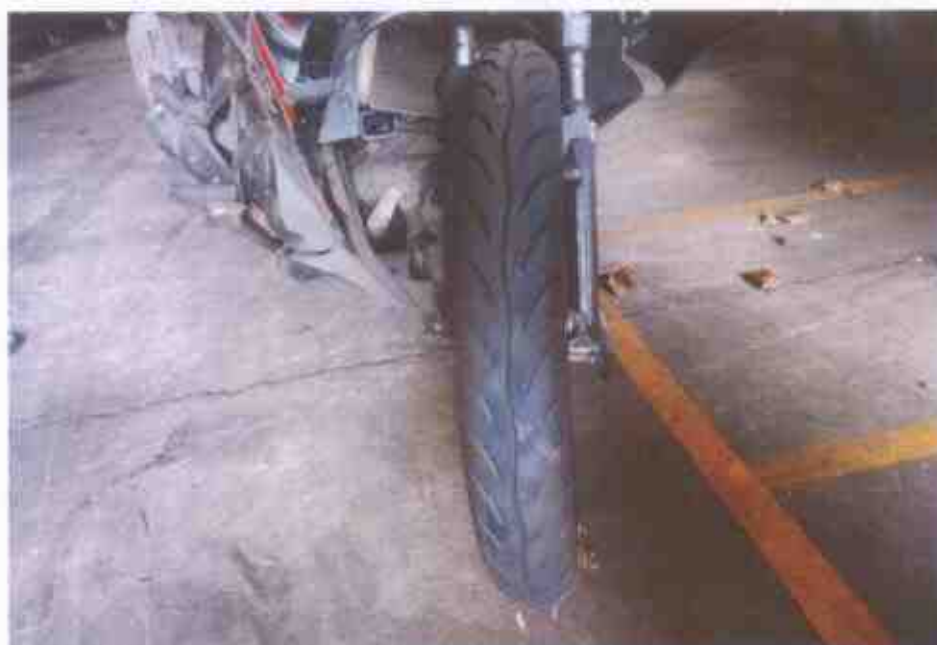
Photo 14 shows the front tyre of the Motorcycle at the time of our inspection. The pattern of the tread was clearly visible with remaining tread depth of approximately 3mm. There was no tear, burst mark(s) and/or punctured hole(s) on the sidewalls as well as across the tread of the front tyre.

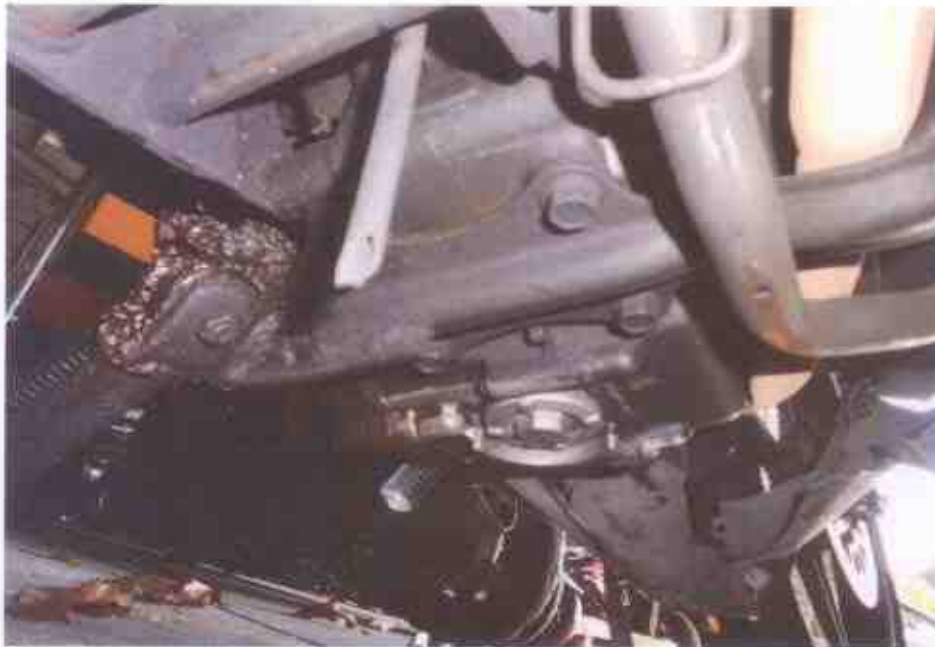
Photo 15 shows no sign(s) or indication(s) of fluid leakage observed around the engine's underside area of the Motorcycle.

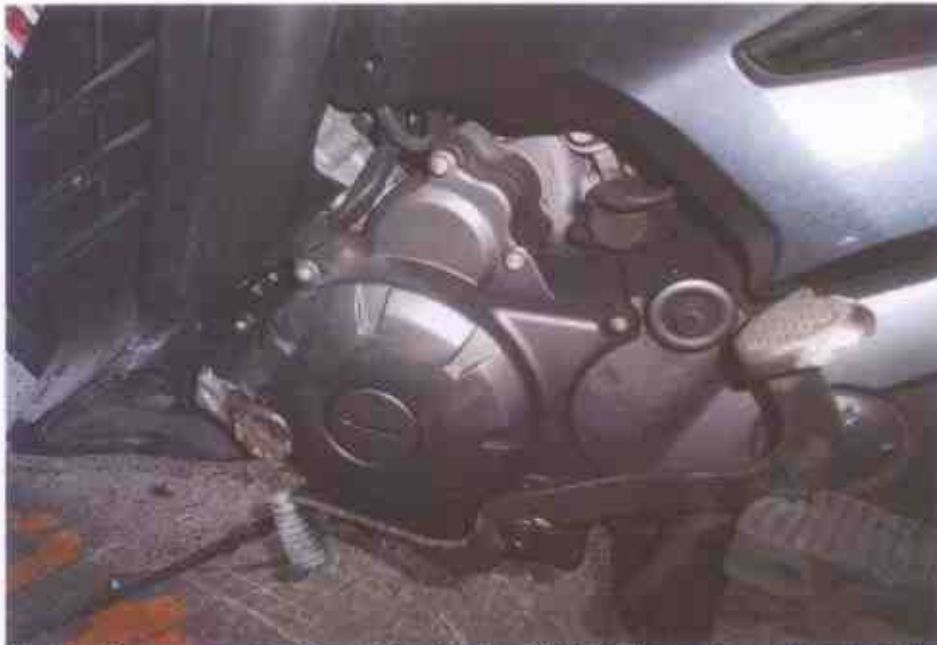
Photo 16 shows no sign(s) or indication(s) of fluid leakage observed around the engine's area of the Motorcycle.

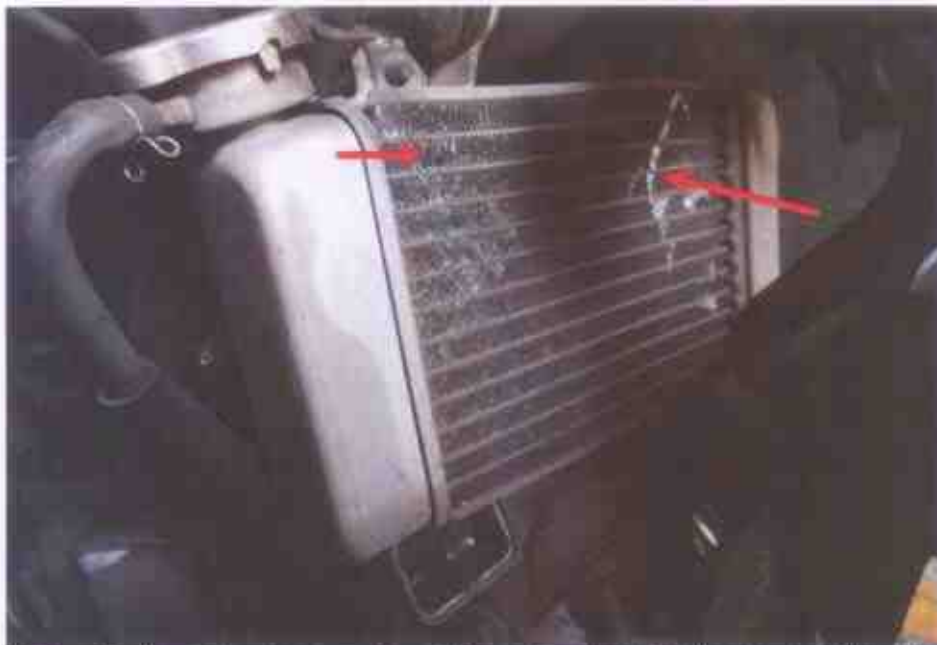
Photo 17 shows the close-up view of the corrugated radiator as a result of the accident's impact collision.

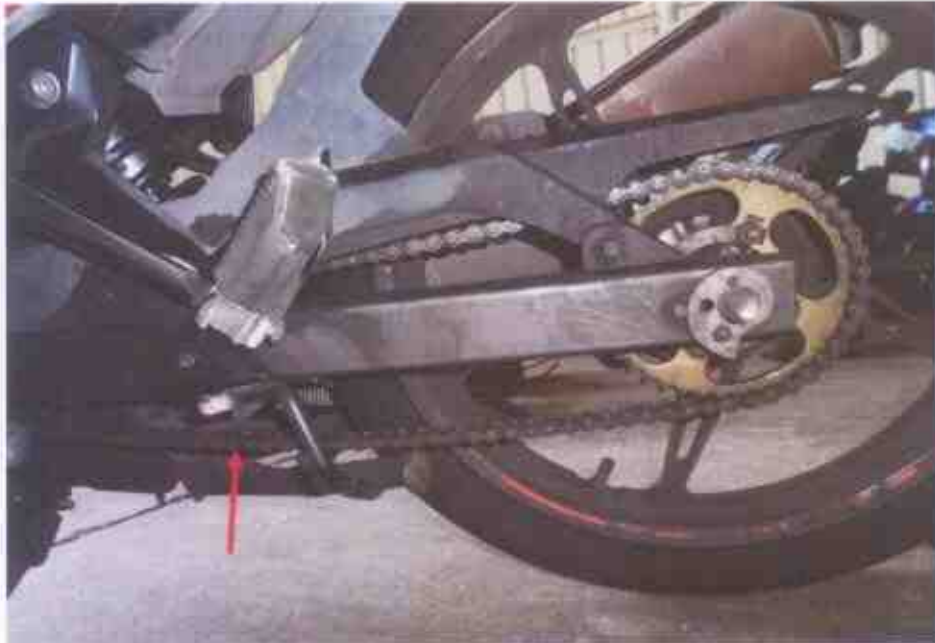
Photo 18 shows the general view of the gear train (arrowed) of the Motorcycle, which was observed to be intact with no misalignment. It was also adequately lubricated for operating purposes.

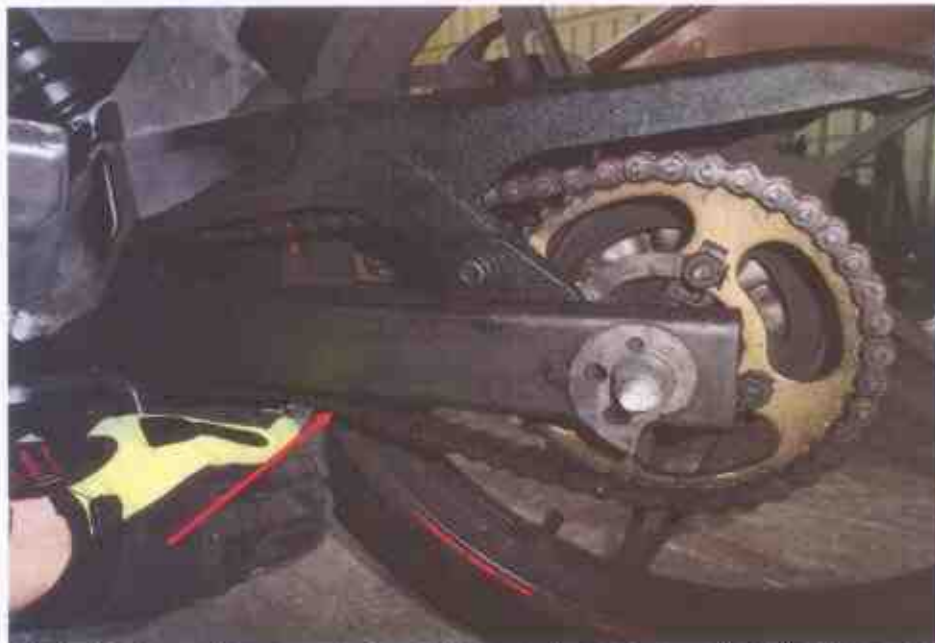
Photo 19 shows the general view of the gear train (arrowed) of the Motorcycle, which was observed to be intact with no misalignment. It was also adequately lubricated for operating purposes.

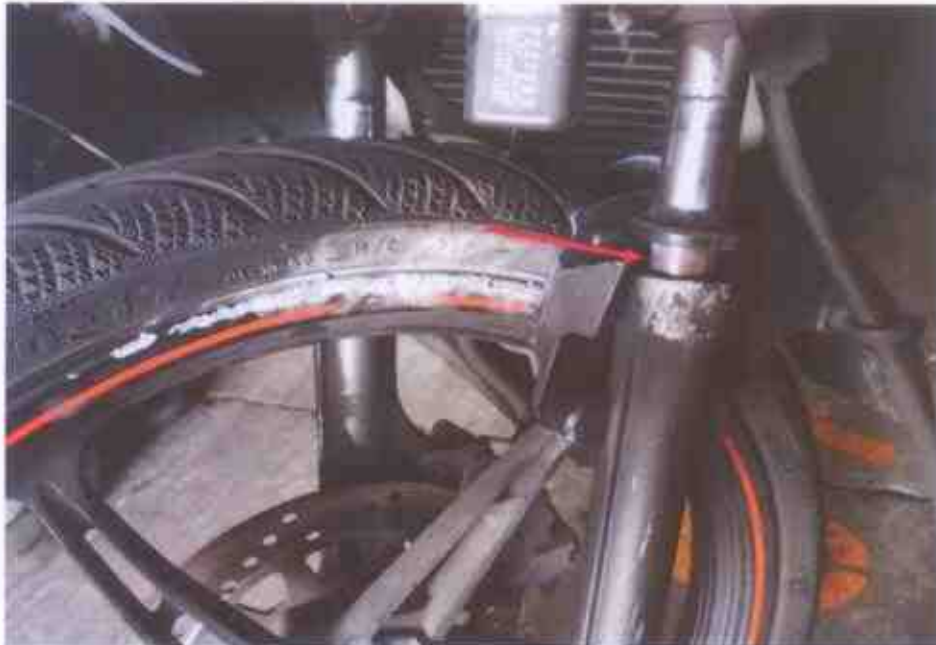
Photo 20 shows the front fork (arrowed) was observed to be damaged as a result of the accident.

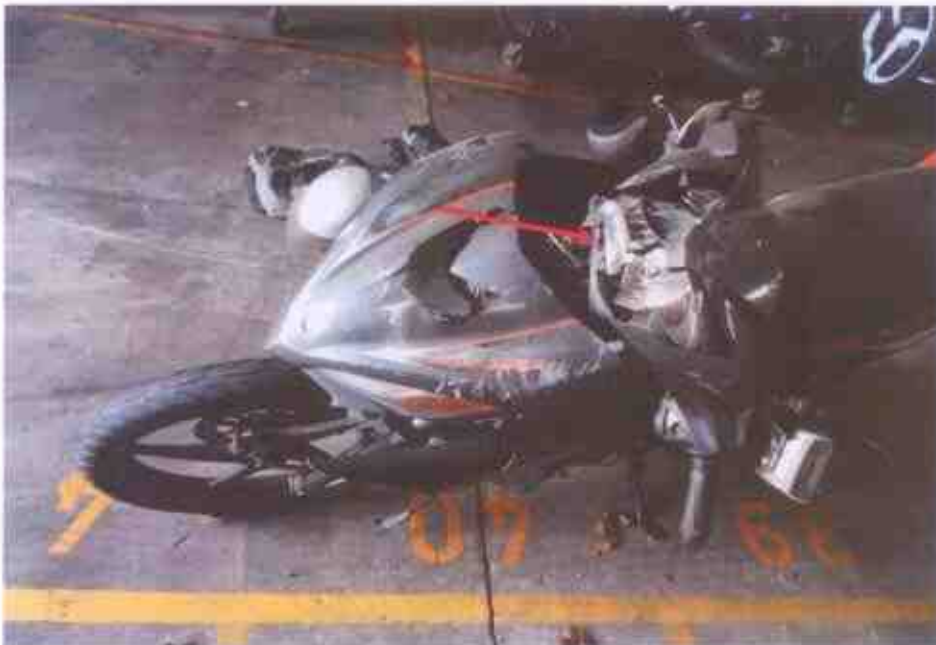
Photo 21 shows the handle bar (arrowed) was observed to be dislodged from the original installation as a result of the accident.

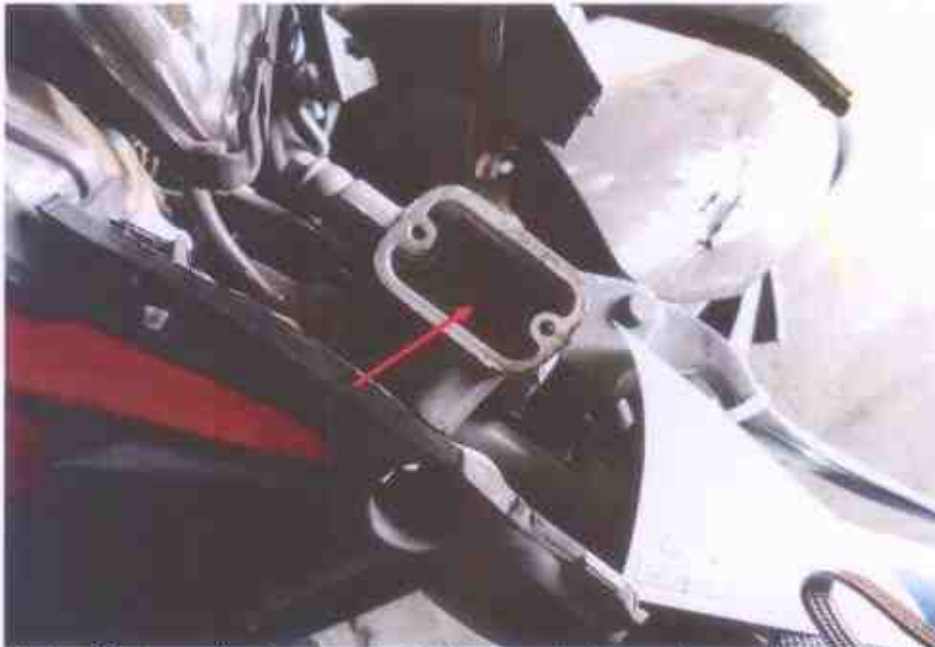
Photo 22 shows the front brake fluid reservoir (arrowed) was observed to be unaffected by the accident. It was observed to be of sufficient level & not contaminated at the time of our inspection.

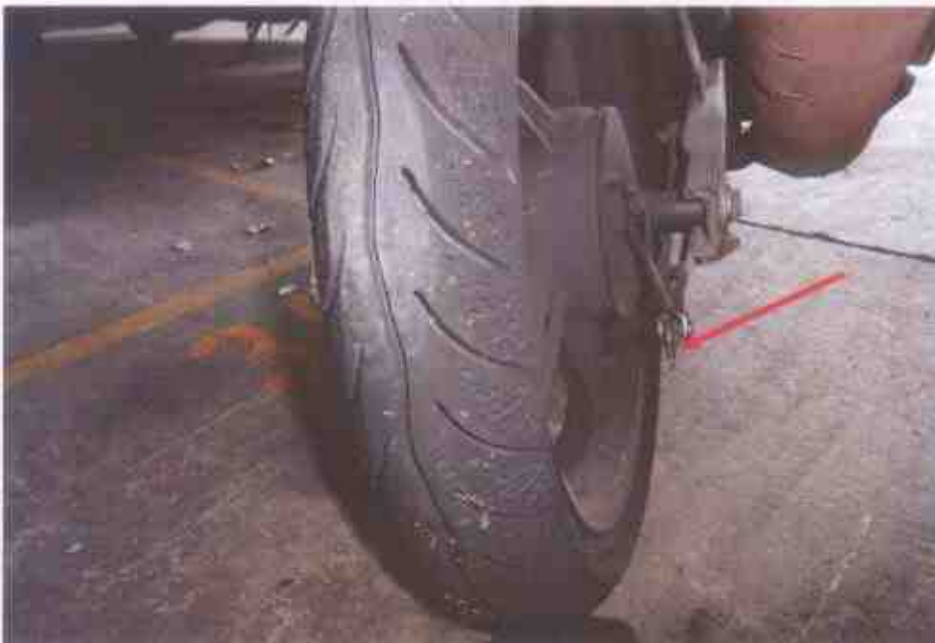
Photo 23 shows the rear foot brake pedal components (arrowed) was observed to be in serviceable condition unaffected by the accident's impact collision.

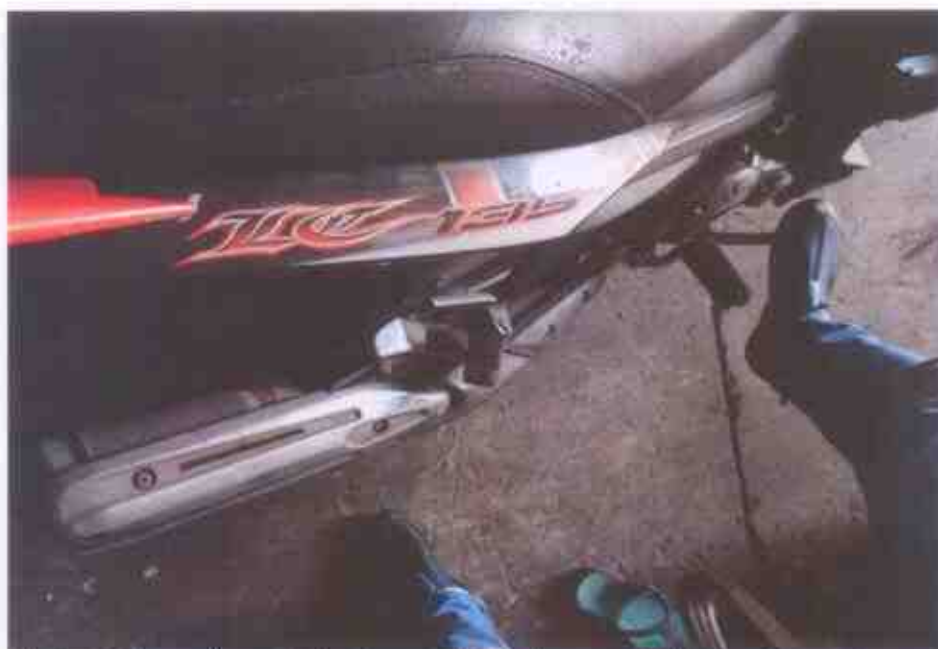
Photo 24 shows the static test conducted to the rear foot brake. It was observed to be in serviceable condition unaffected by the accident's impact.

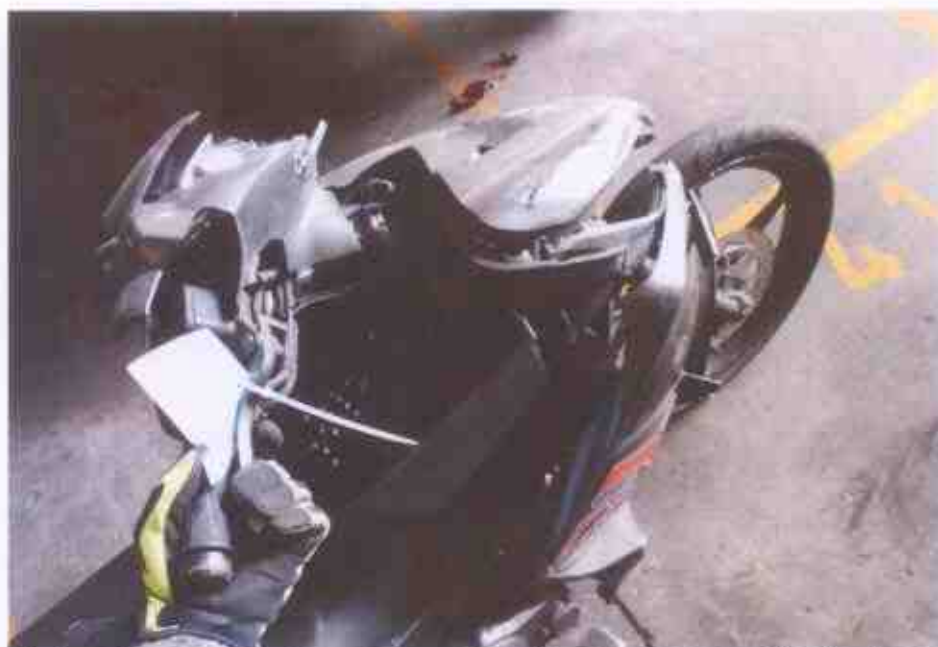
Photo 25 shows the static test conducted to the front hand brake. It was observed to be in serviceable condition unaffected by the accident's impact.

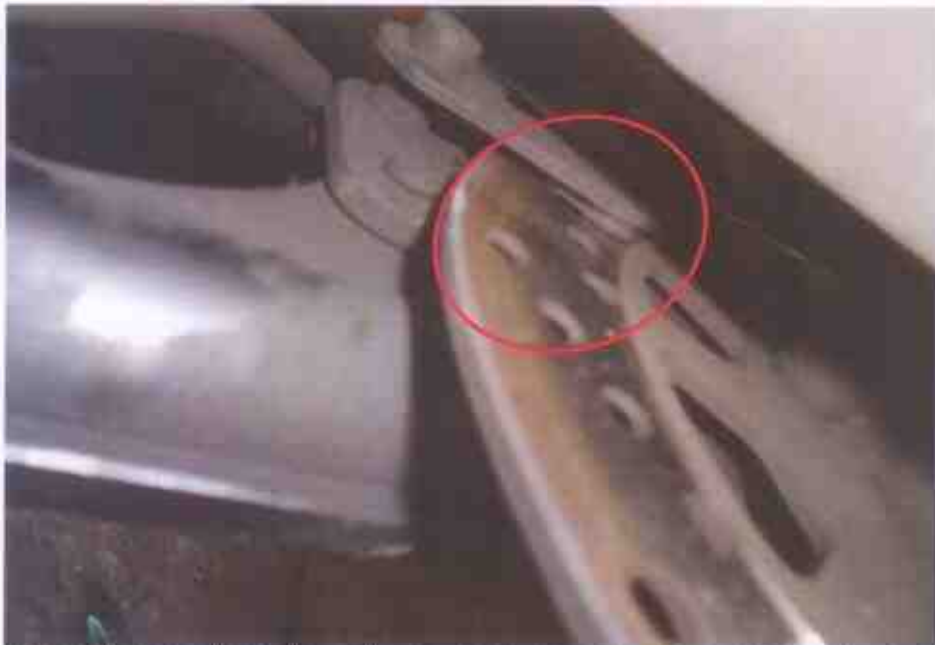
Photo 26 shows the brake pad was noted to be with sufficient frictional material at time of our inspection.

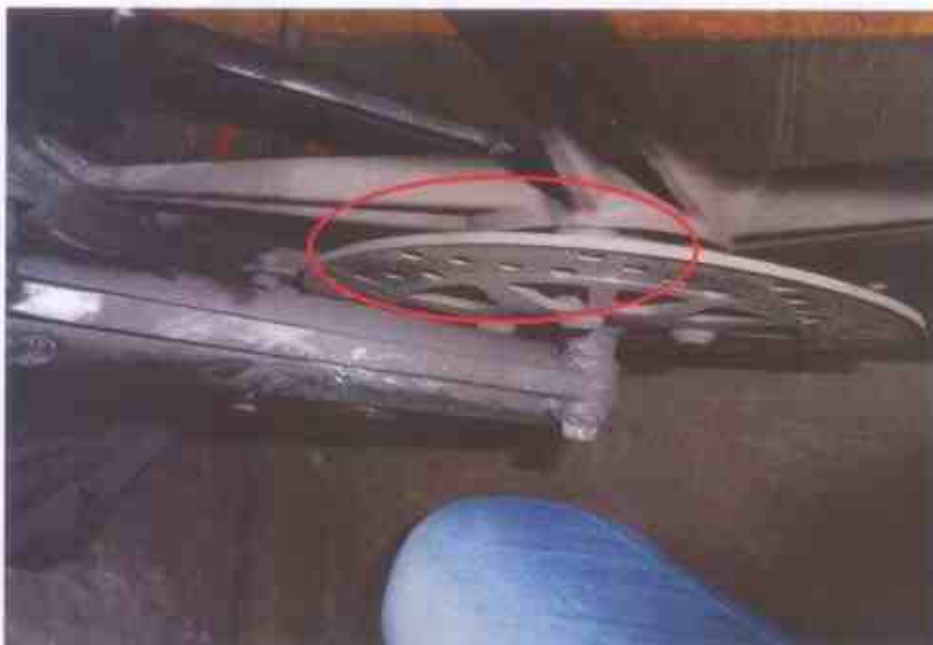
Photo 27 shows a slight bend to the brake disc at time of our inspection likely due to the accident's impact collision.
