Your Ref: TP/IP/55759/2018
Our Ref : CI/TPD18019472/Z

Fatal Accident Investigation Team

MECHANICAL INSPECTION REPORT OF MOTOR VAN GR 8267S

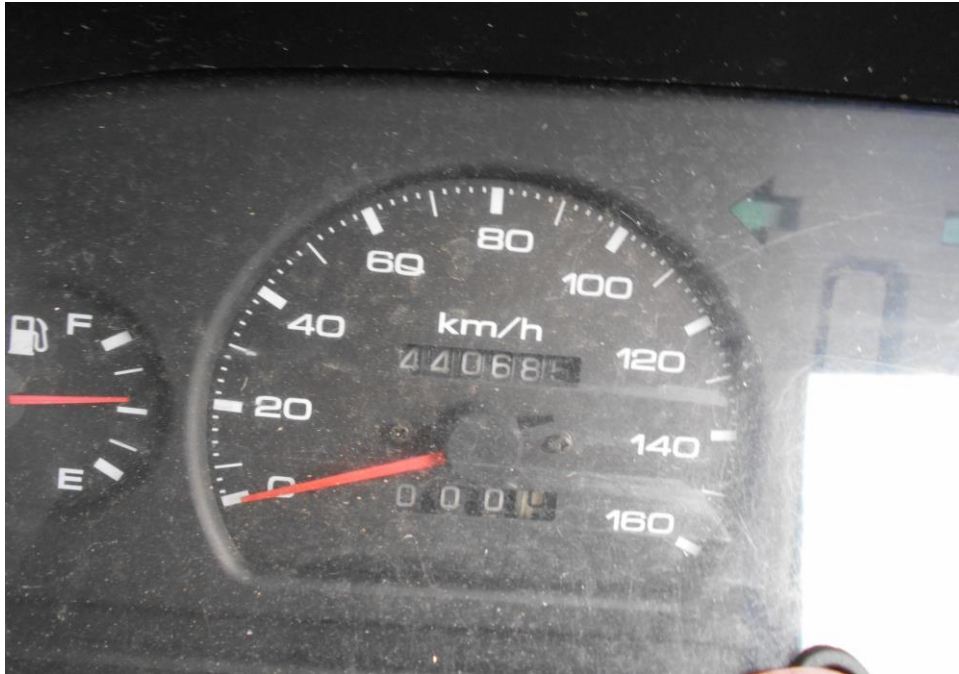
Photo 1 shows the mileage of the Motor Van at the time of our inspection was recorded as 440685km.

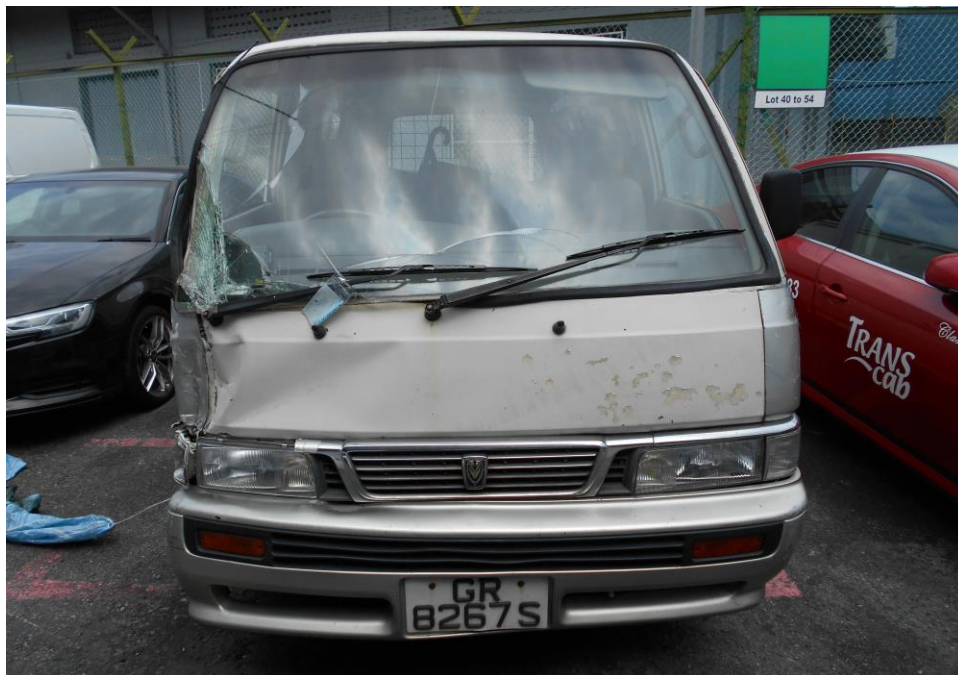
4. The mileage of the Motor Van at the time of our inspection was recorded as 440685km.
5. The Motor Van was observed to have sustained minor damages at its front right headlamp; front right lower bumper; front windshield, rear right sliding door and its front right door were amongst the body parts that were damaged as a result of the accident.
6. This was likely to be the consistency of the accident's case facts that on 29th September 2018, sometime before 1311hrs, a Motor Lorry (YN 1369K) was travelling along PIE (Tuas) on lane 2 of a 5 lanes road when he lost control of the vehicle and veered to the left. The said Motor Lorry skidded and collided onto a Motor Cycle (JRB 2580) and a Motor Van (GR 8267S). See photo 1 to 6 below.

Photo 2 shows a general view of the front portion of the Motor Van at the time of our inspection. The Motor Van was observed to have sustained extensive damages at its front right headlamp; front right lower bumper and its right driver door were amongst the body parts that were damaged as a result of the accident.

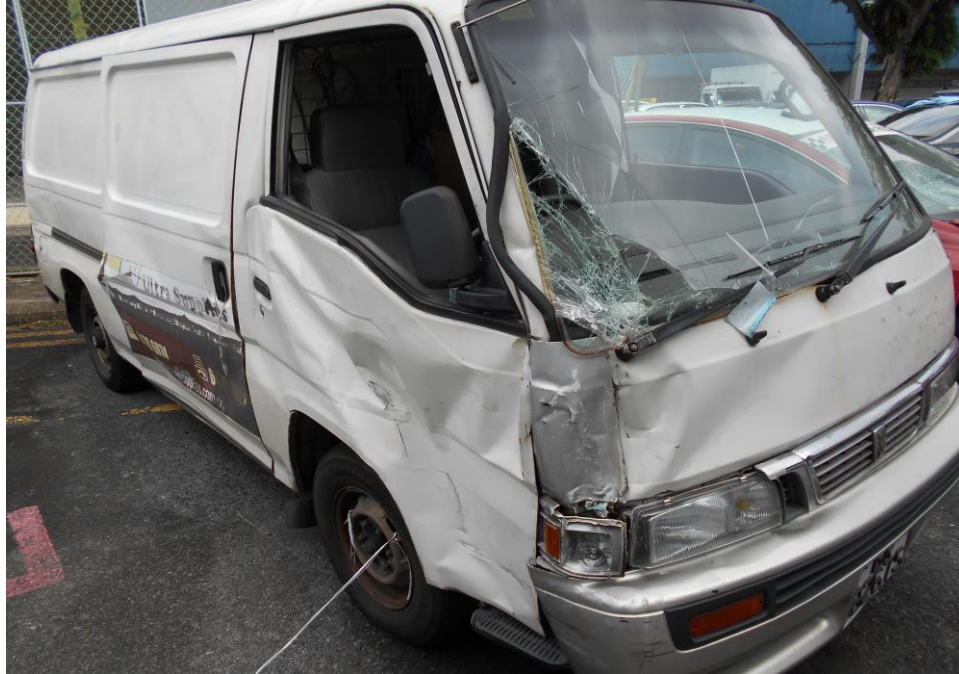
Photo 3 shows a damaged headlamp, centre panel, windshield, right sliding door and right door likely due to the accident's impact.

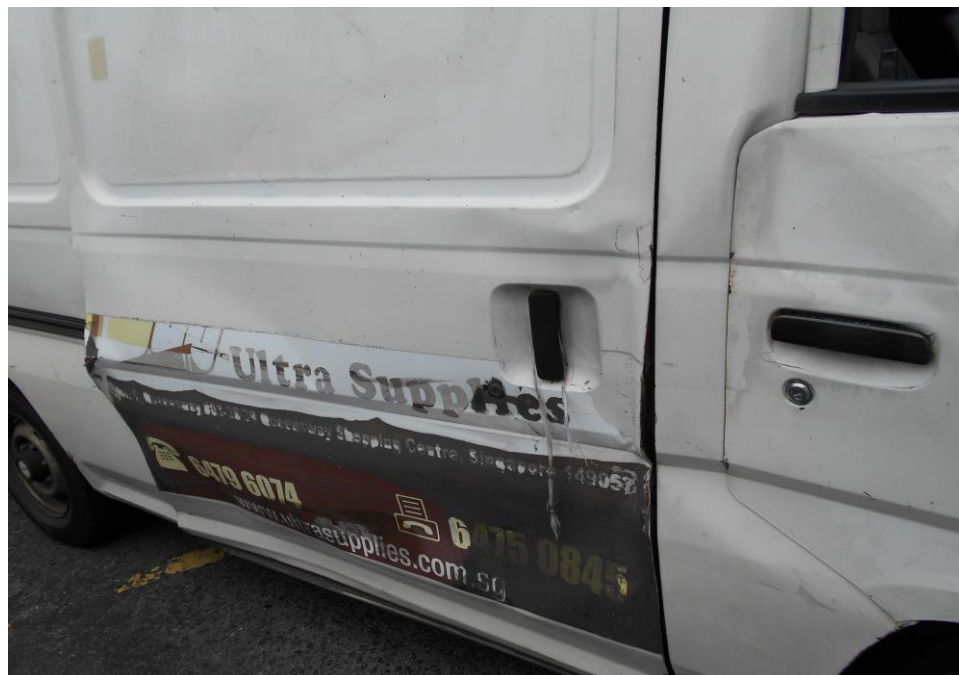
Photo 4 shows the close-up view of the damaged right sliding door of the Motor Van. It was observed to have sustained damages as a result of the accidents.

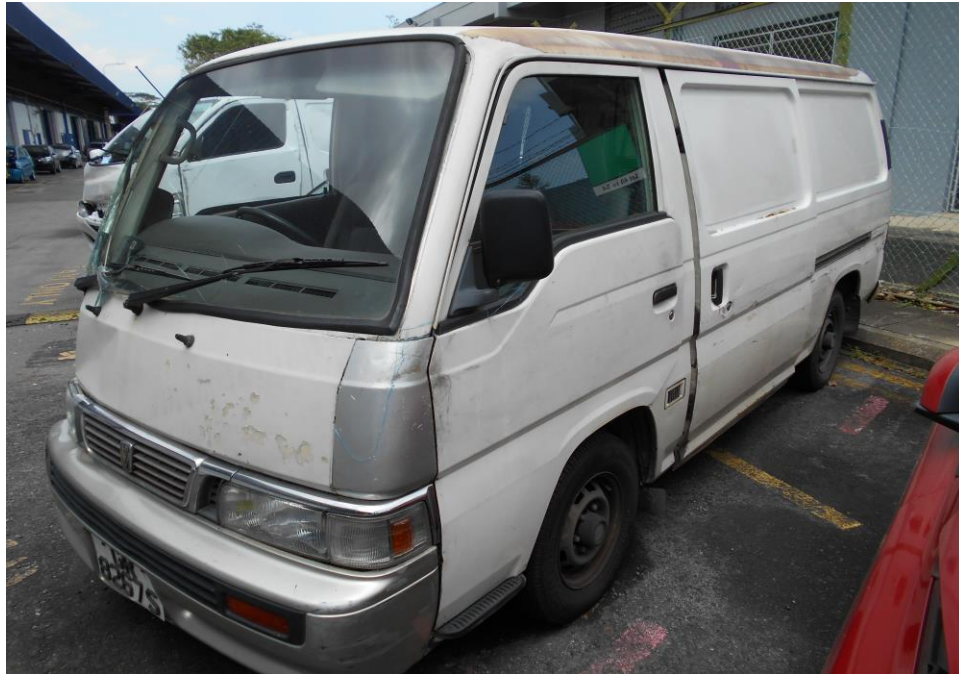
Photo 5 shows a general view of the front left portion of the Motor Van at the time of our inspection. The Motor Van was observed to be in good condition unaffected by the accident's impact.

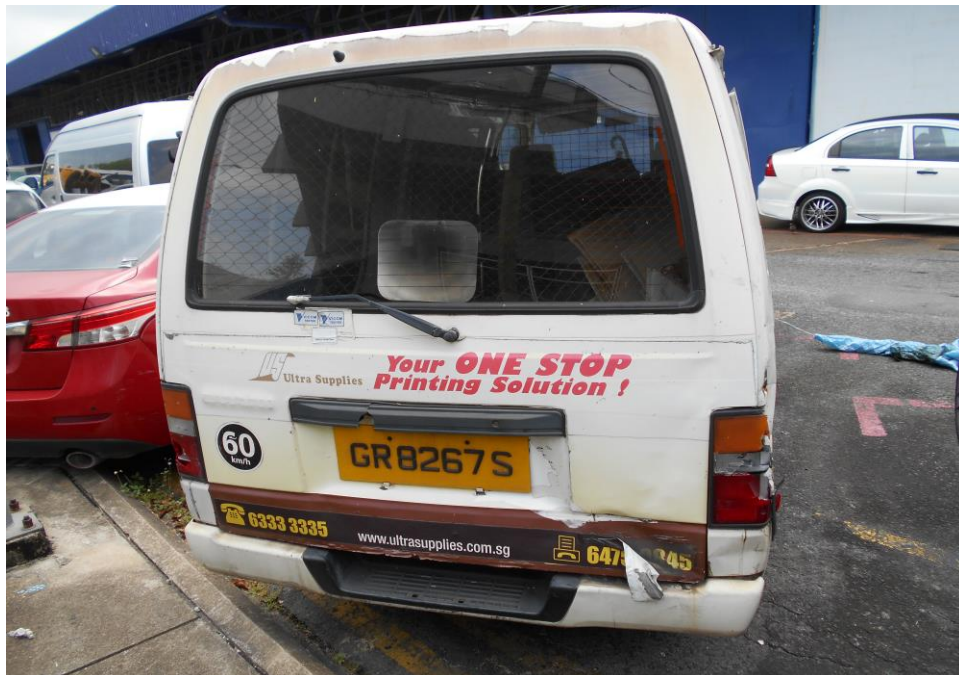
Photo 6 shows a general view of the Motor Van's rear body at the time of our inspection. There was no damage found which relates to the accident on the rear portion of the Motor Van.

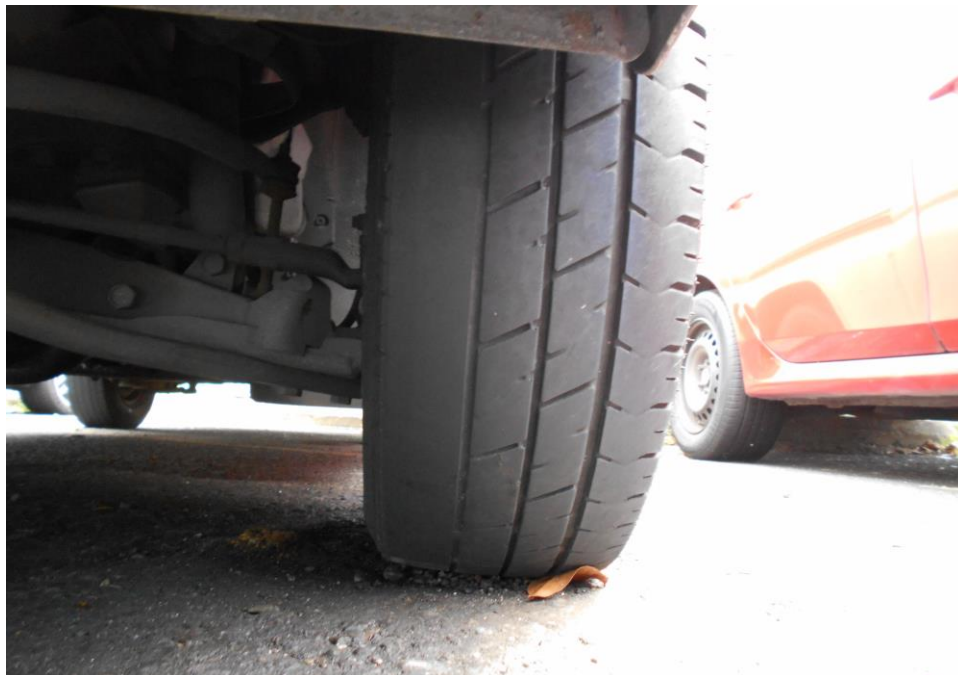
Photo 7 shows the condition of the front left tyre of the Motor Van, which was observed to be in serviceable condition with remaining tread depth of approximately 5mm. The tyre, which was wrapped around standard alloy wheel rim, was also observed to be sufficiently inflated for vehicular operation.

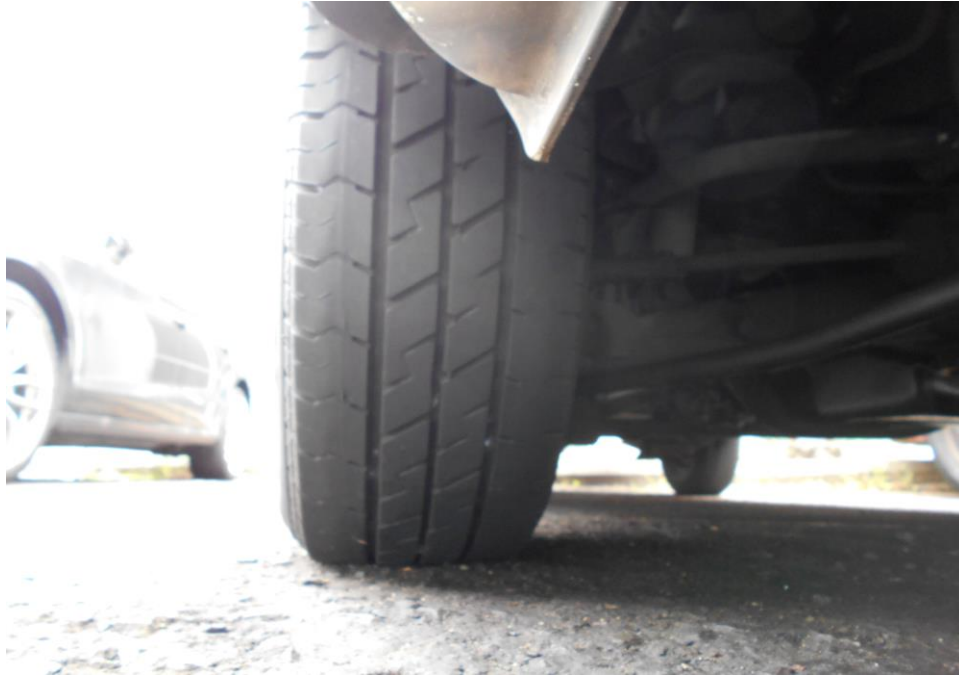
Photo 8 shows the condition of the front right tyre of the Motor Van, which was observed to be in serviceable condition with remaining tread depth of approximately 5mm. The tyre, which was wrapped around standard alloy wheel rim, was also observed to be sufficiently inflated for vehicular operation.

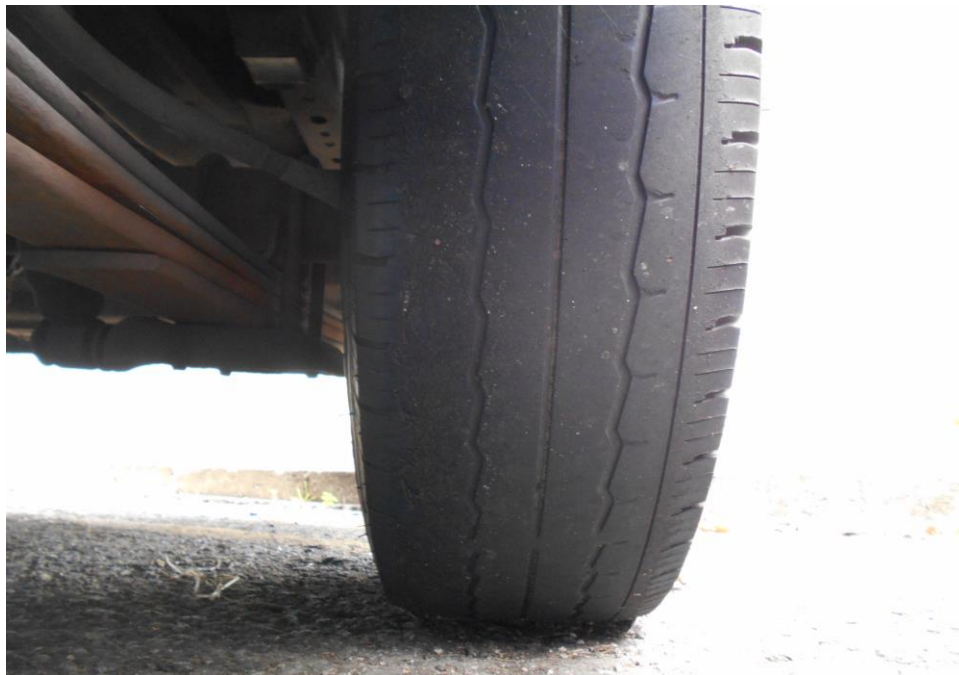
Photo 9 shows the condition of the rear left tyres of the Motor Van, which was observed to be in serviceable condition with remaining tread depth of approximately 2mm. The tyres, which were wrapped around standard alloy wheel rim, were also observed to be sufficiently inflated for vehicular operation.

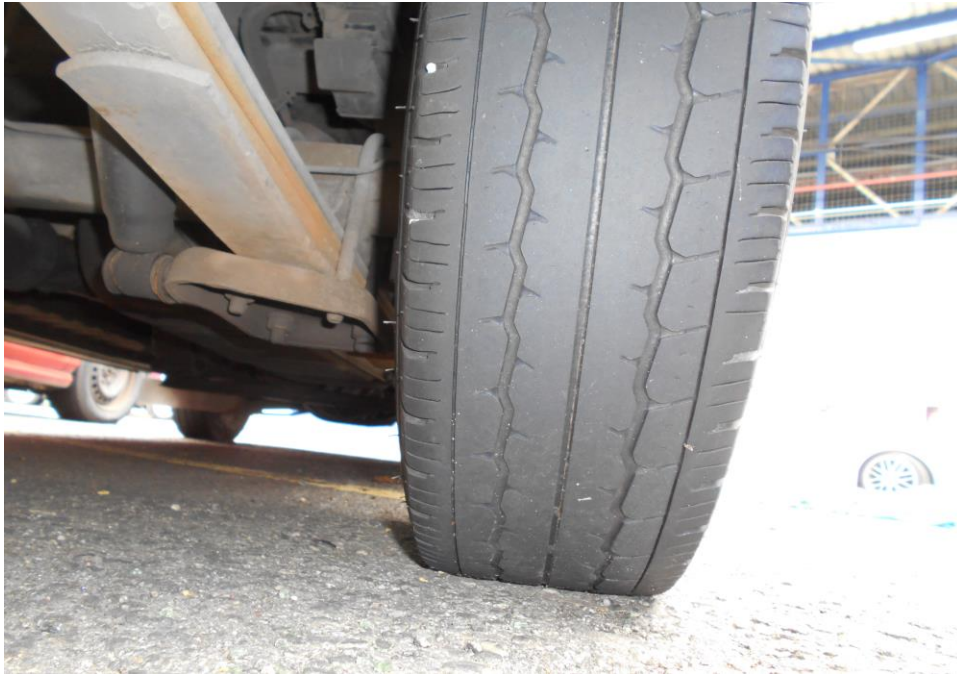
Photo 10 shows the condition of the rear right tyres of the Motor Van, which were observed to be in serviceable condition with remaining, tread depth of approximately 2mm.

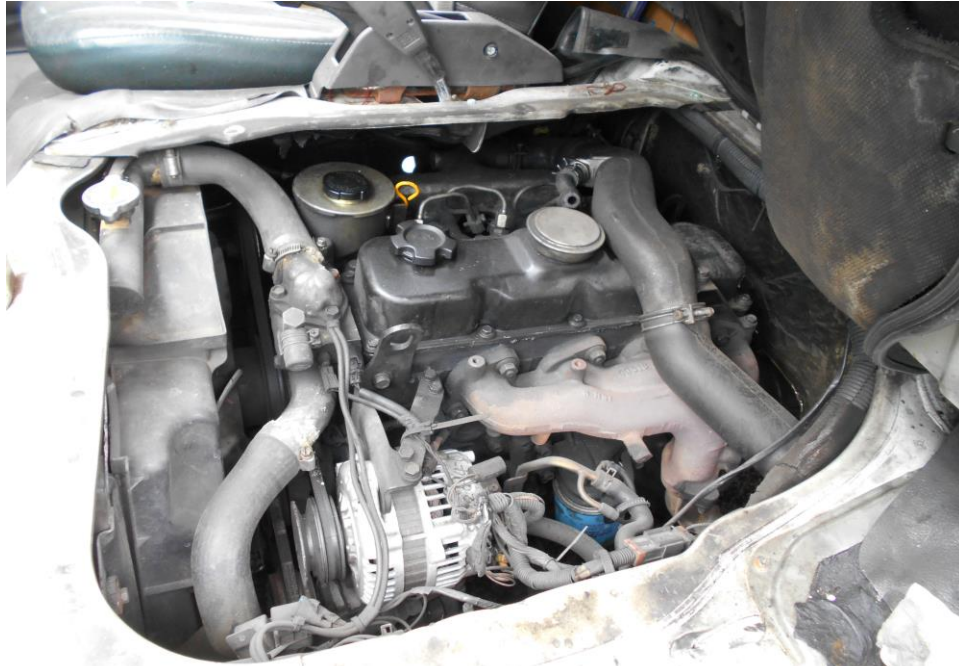
Photo 11 shows a general view of the Motor Van's engine compartment, which was accessed by lifting the front passenger seat of the Motor Van. The various parts and components inside the engine compartment were unaffected by the accident. There was also no sign(s) or indication(s) of fresh fluid leakage and/or fluid stain within the engine.

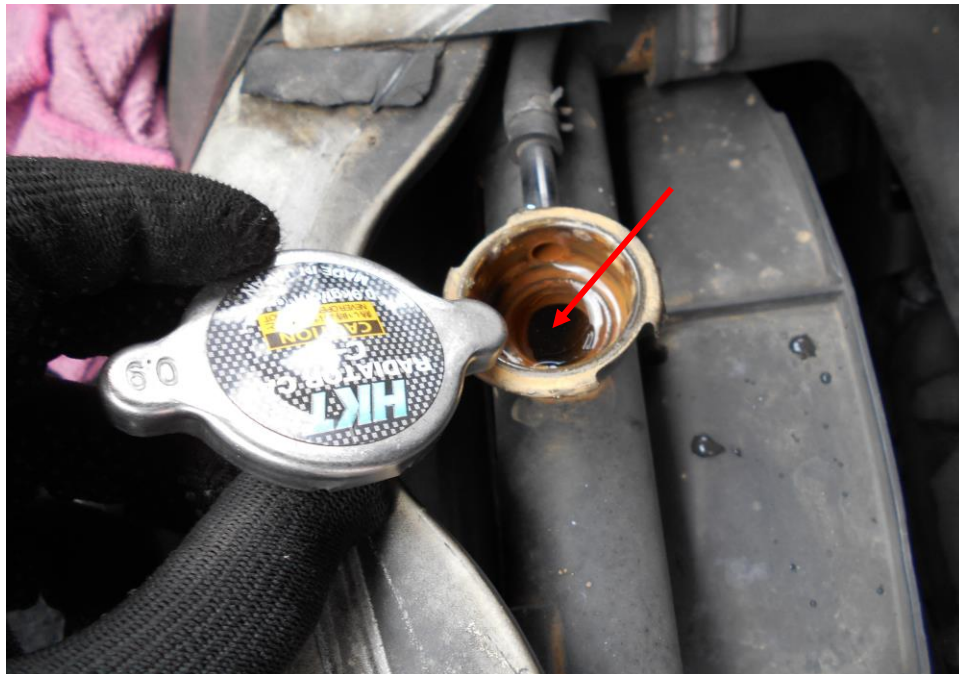
Photo 12 shows the engine coolant tank of the Motor Van at the time of our inspection. The engine coolant was observed to be of sufficient level and without any visible contamination (arrowed).

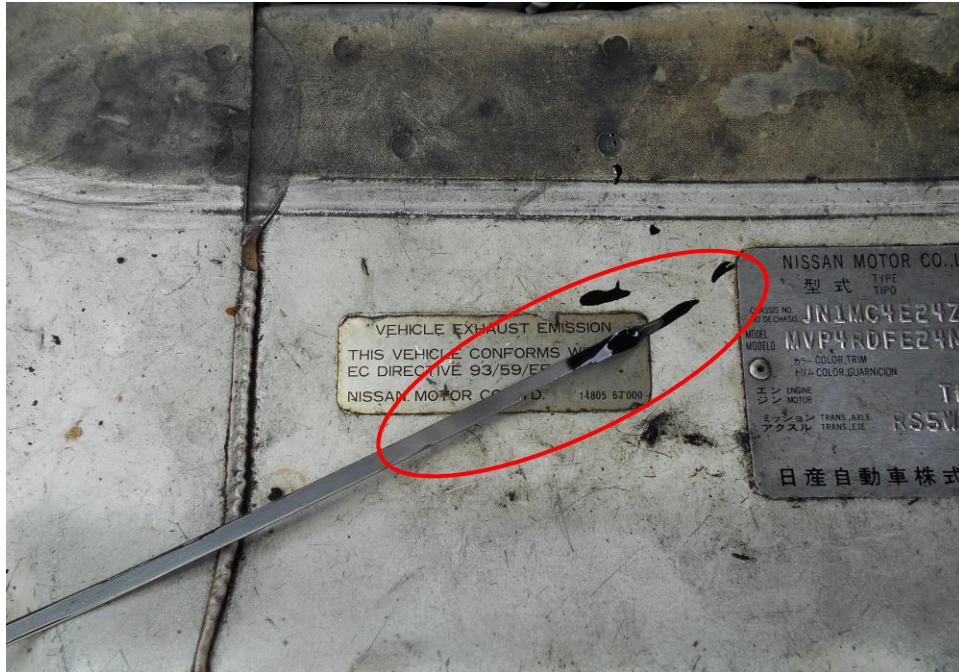
Photo 13 shows the engine dip stick of the Motor Van at the time of our inspection. The engine oil was observed to be of sufficient level and without any visible contamination (circled).

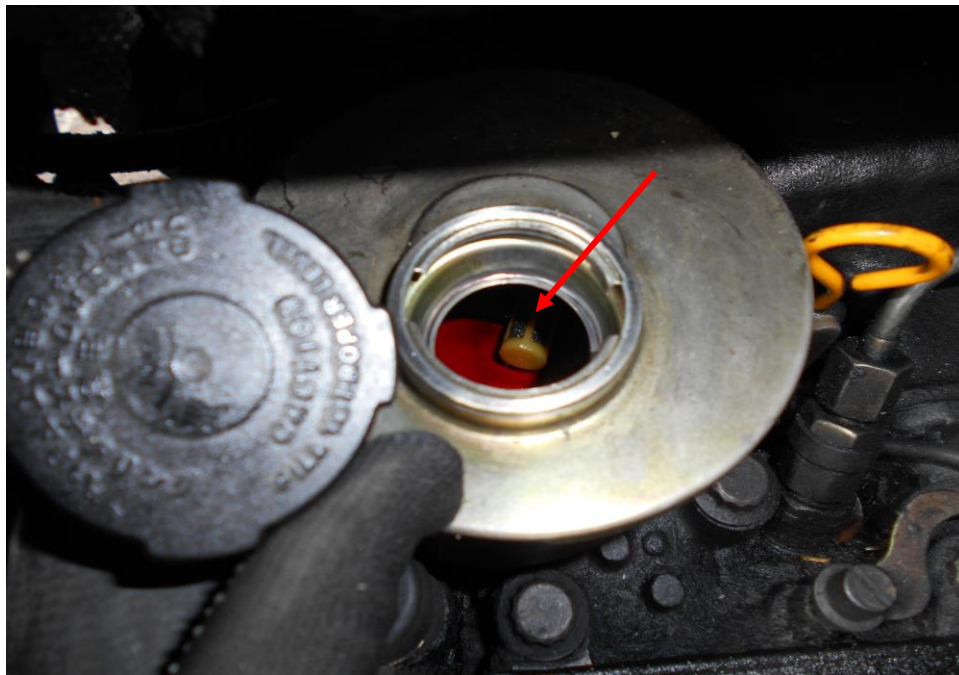
Photo 14 shows the power steering fluid of the Motor Van at the time of our inspection. The fluid was observed to be of sufficient level and without any visible contamination.

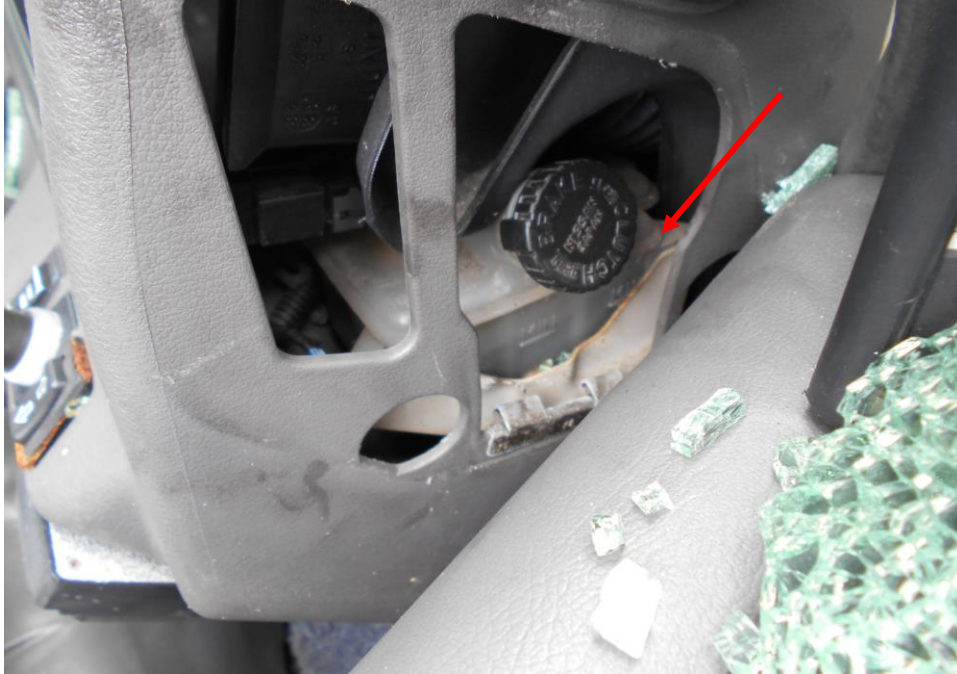
Photo 15 shows the brake fluid of the Motor Van at the time of our inspection. The fluid was observed to be of sufficient level and without any visible contamination.

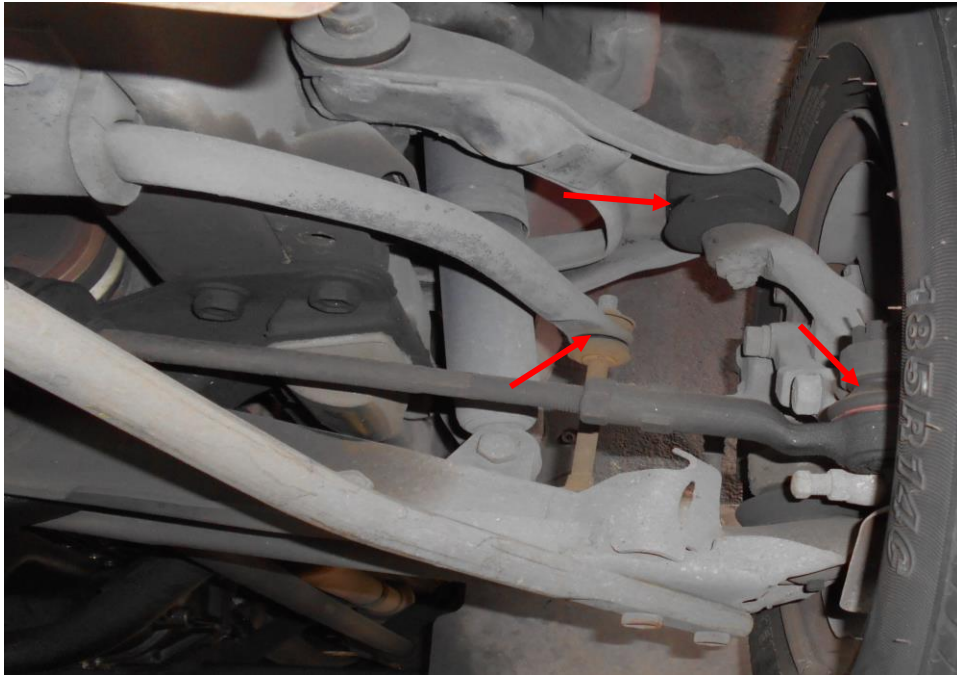
Photo 16 shows the various undercarriage components at the front left wheel of the Motor Van, in particular the steering tie rod end (arrowed). The various undercarriage components of the Motor Van were all found to be intact without any visible damage. There was also no sign of fluid stain(s) observed on the various undercarriage components.

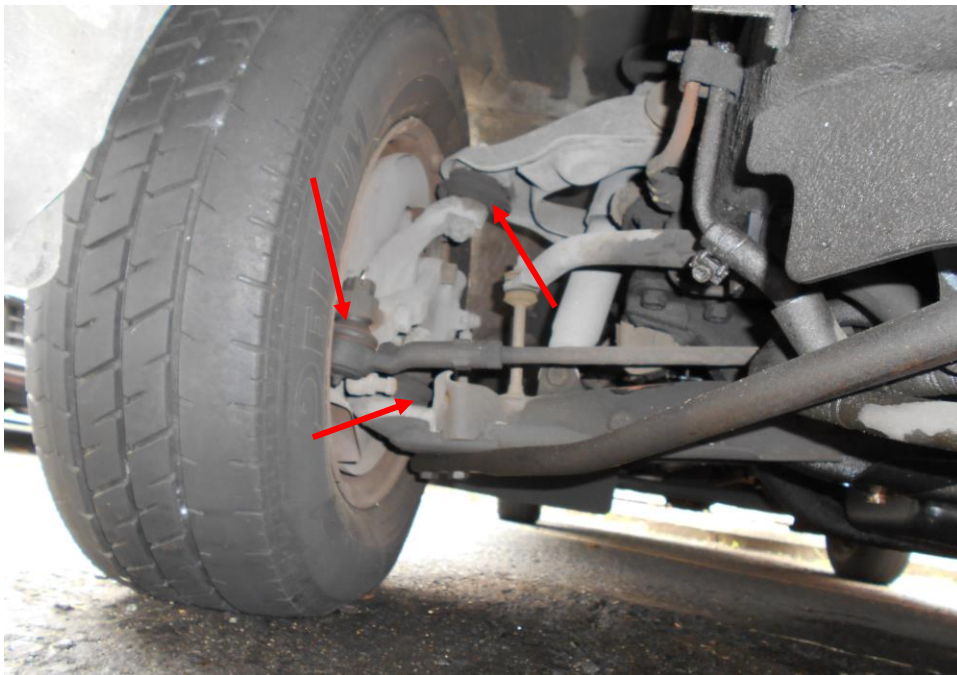
Photo 17 shows the various undercarriage components at the front right wheel of the Motor Van, in particular the steering tie rod end (arrowed). The various undercarriage components of the Motor Van were all found to be intact without any visible damage. There was also no sign of fluid stain(s) observed on the various undercarriage components.

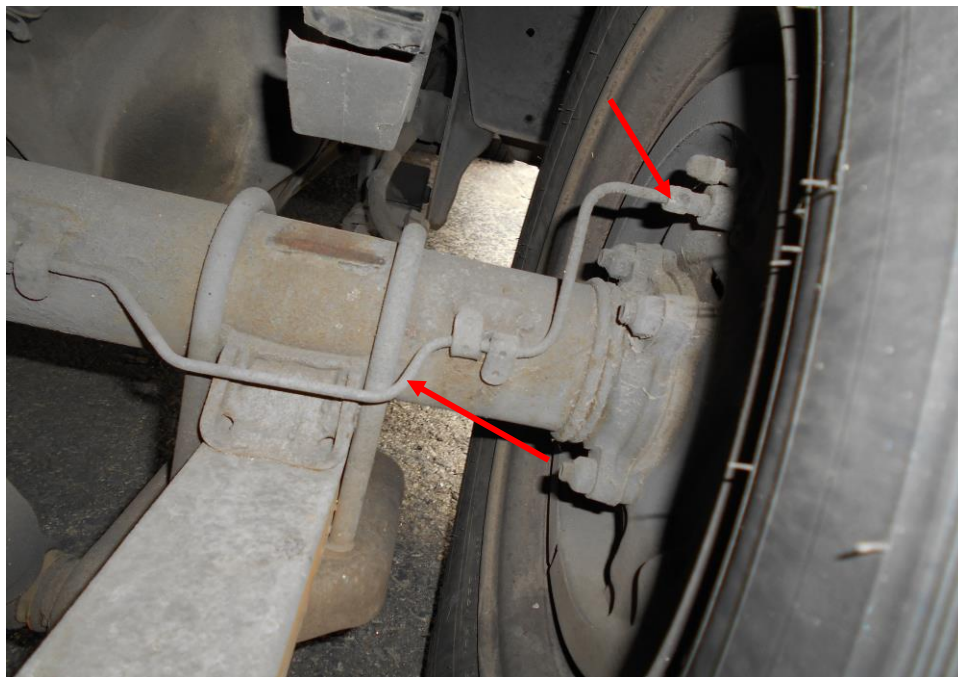
Photo 18 shows the various undercarriage components at the rear right wheels of the Motor Van. There was no sign(s) of brake fluid leakage along the brake hoses and brake pipes.

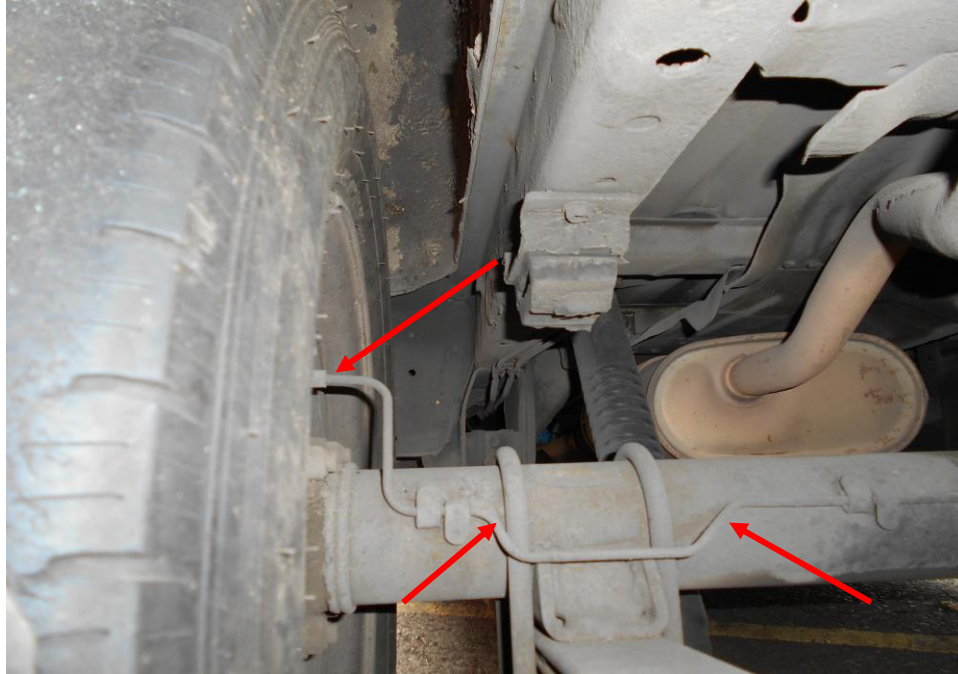
Photo 19 shows the various undercarriage components at the rear left wheels of the Motor Lorry. There was no sign(s) of brake fluid leakage along the brake hoses and brake pipes.
