Your Ref: TP/IP/55759/2018
Our Ref : CI/TPD18019473/Z

17th January 2019

Fatal Accident Investigation Team
Traffic Police Department
Singapore Police Force
10 Ubi Avenue 3
Singapore 408865

MECHANICAL INSPECTION REPORT OF MOTOR LORRY YN 1369K

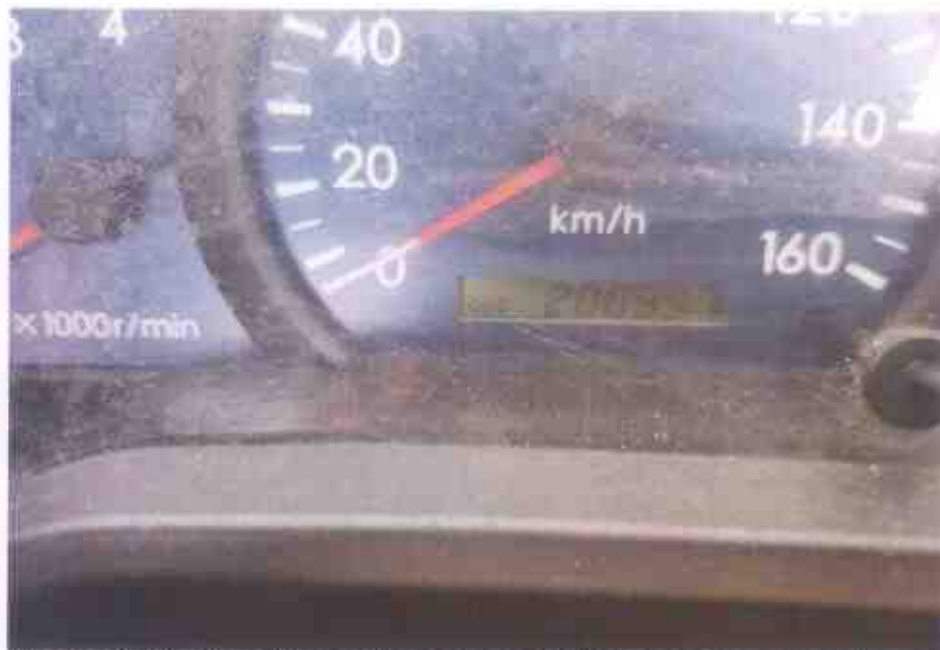
4. The mileage of the Motor Lorry at the time of our inspection was recorded as 200997 km.
5. The Motor Lorry was observed to have sustained minor impact damage at its front left headlamp; left front lower bumper, left passenger door and left passenger door window glass were amongst the body parts that were damaged as a result of the accident.
6. This was likely due to the consistency of the accident's case facts that on 29th September 2018, sometime before 1311hrs, the Motor Lorry was travelling along PIE (Tuas) on the lane 2 of a 5 lanes road when he lost control of the vehicle and veered to the left. The said Motor Lorry then skidded and collided onto a Motorcycle (JRB 2580) and a Motor Van (GR 826S). See photo 1 to 7 below.

Photo 1 shows the mileage of the Motor Lorry at the time of our inspection was recorded as 200997km.

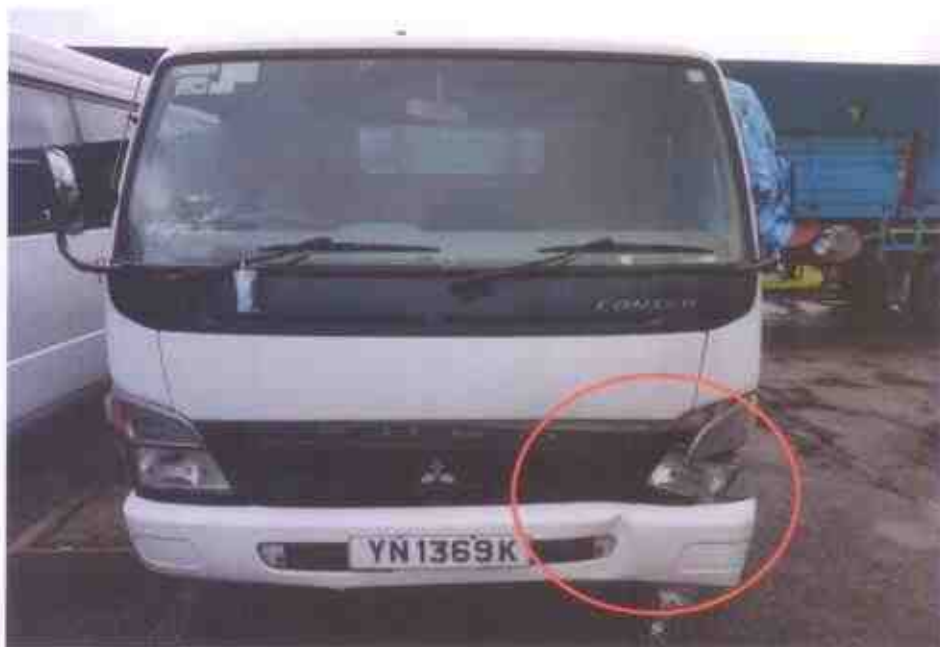
Photo 2 shows a general view of the front portion of the Motor Lorry at the time of our inspection. The Motor Lorry was observed to have sustained minor impact damages at its front left portion which includes damages to the headlamp, lower bumper amongst others as a result of the accident.

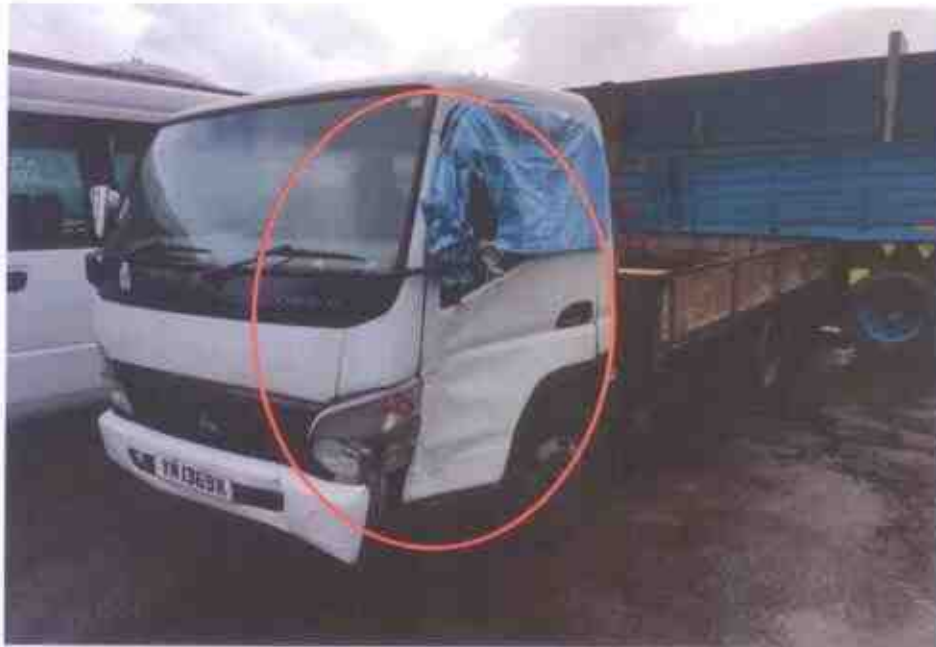
Photo 3 shows a general view of the front left portion of the Motor Lorry at the time of our inspection. The Motor Lorry was observed to have sustained minor impact damages at its front left portion which includes damages to the headlamp, lower bumper amongst others as a result of the accident.

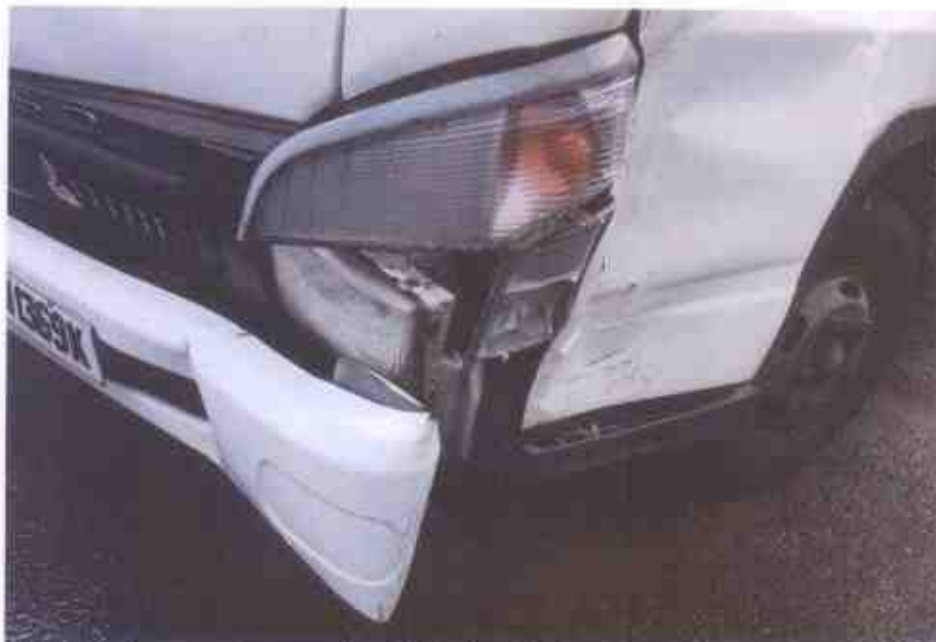
Photo 4 shows a close-up view of the front left portion that was damaged as a result of the accident.

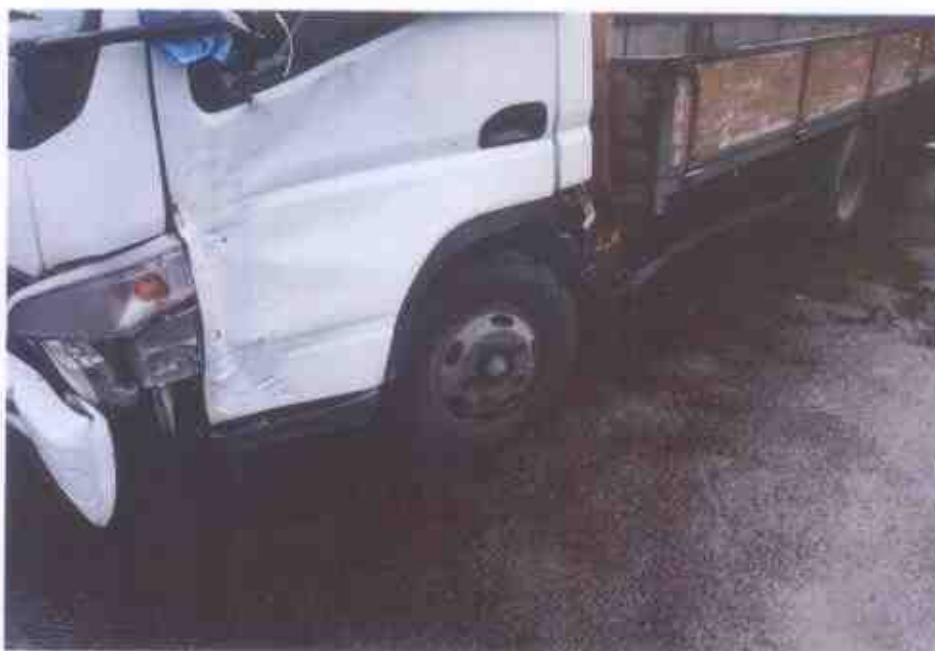
Photo 5 shows the left passenger door of the Motor Lorry. It was observed to be damage as a result of the accidents.

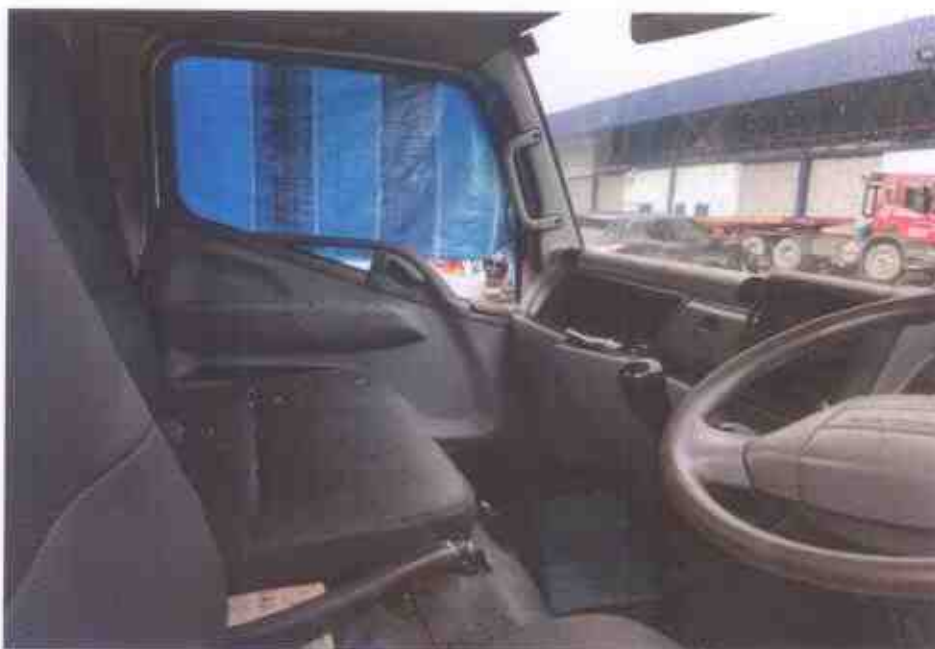
Photo 6 shows the close-up view from inside of the left passenger door window glass of the Motor Lorry. It was observed to be cracked, front dashboard was also found to be pushed inwards as a result of the accidents.

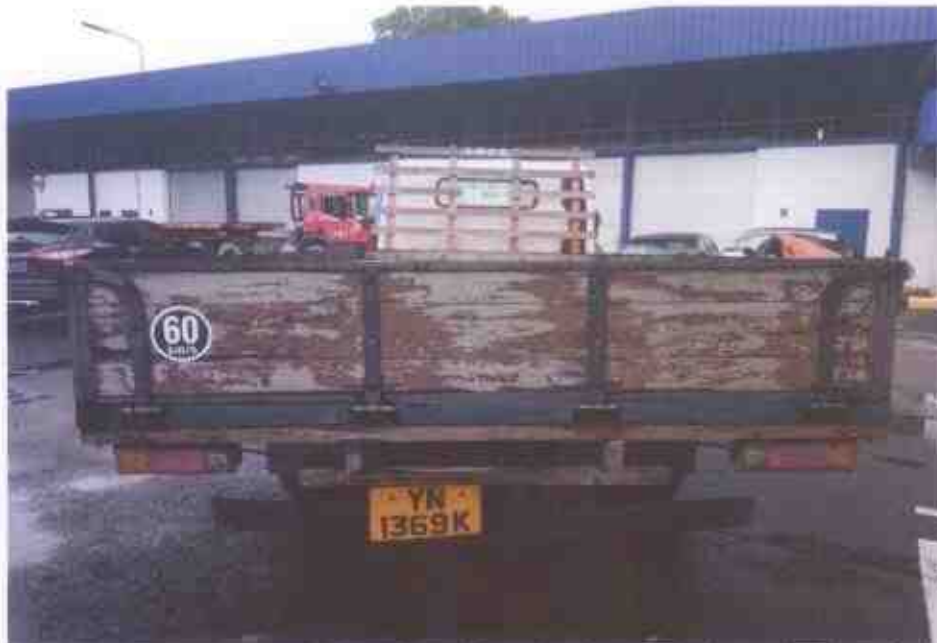
Photo 7 shows a general view of the Motor Lorry's rear body at the time of our inspection. There was no damage found to the rear portion of the Motor Lorry.

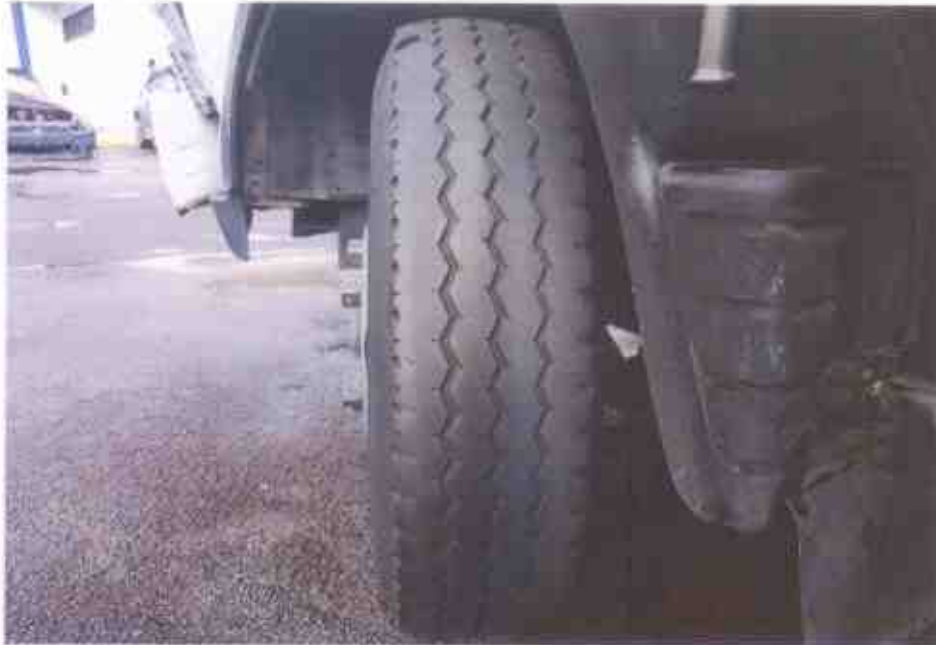
Photo 8 shows the condition of the front left tyre of the Motor Lorry, which was observed to be in serviceable condition with remaining tread depth of approximately 8mm. The tyre, which was wrapped around standard alloy wheel rim, was also observed to be sufficiently inflated for vehicular operation.

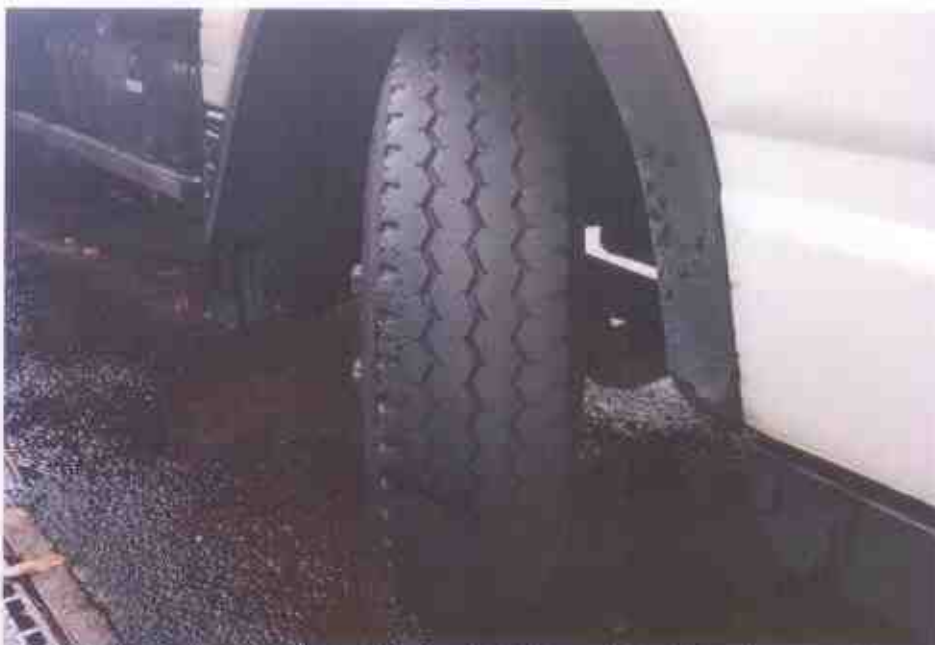
Photo 9 shows the condition of the front right tyre of the Motor Lorry, which was observed to be in serviceable condition with remaining tread depth of approximately 7mm. The tyre, which was wrapped around standard alloy wheel rim, was also observed to be sufficiently inflated for vehicular operation.

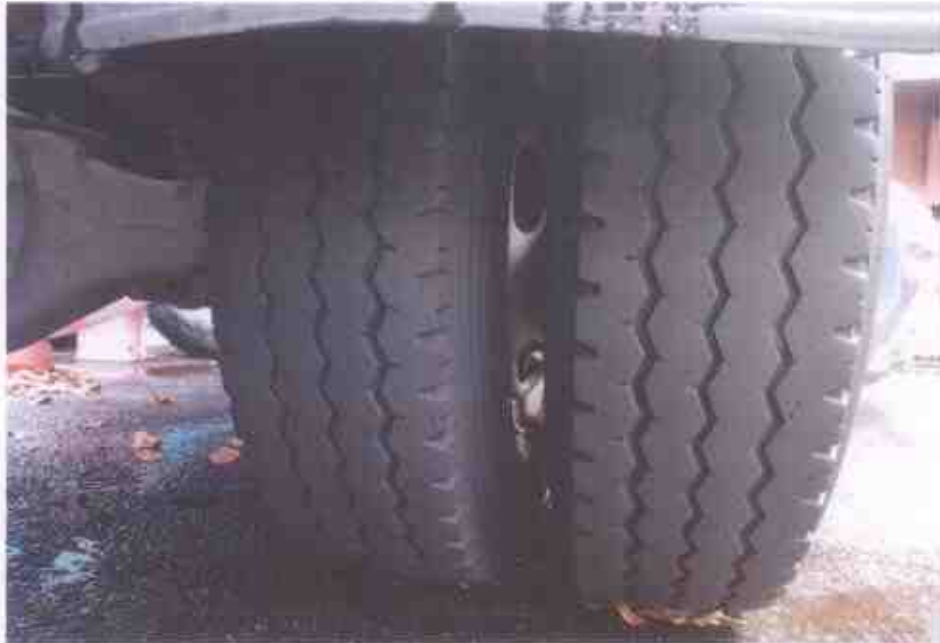
Photo 10 shows the condition of the rear left tyres of the Motor Lorry, which was observed to be in serviceable condition with remaining tread depth of approximately 7mm. The tyres, which were wrapped around standard alloy wheel rim, were also observed to be sufficiently inflated for vehicular operation.

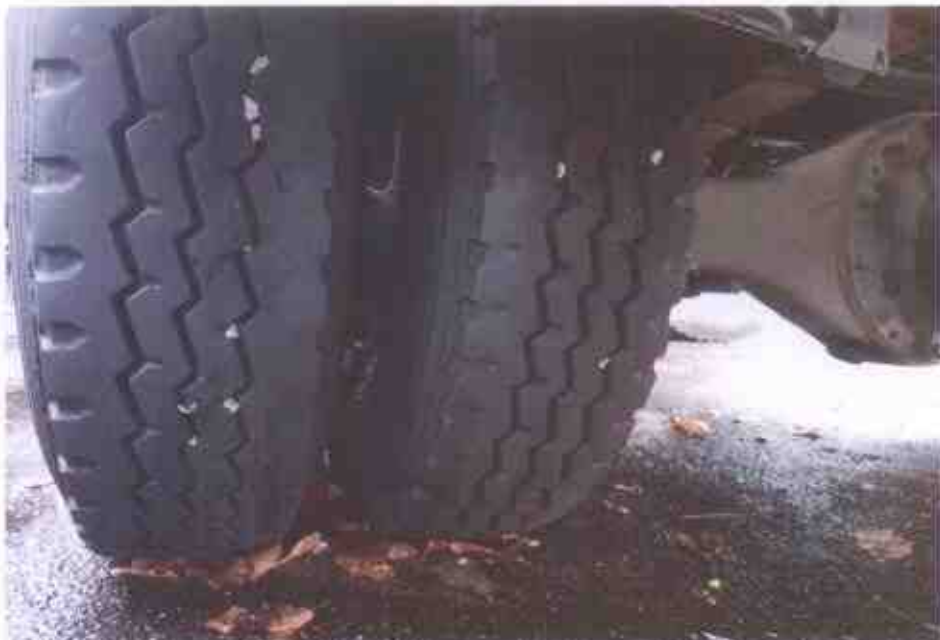
Photo 11 shows the condition of the rear right tyres of the Motor Lorry, which were observed to be in serviceable condition with remaining tread depth of approximately 9mm.

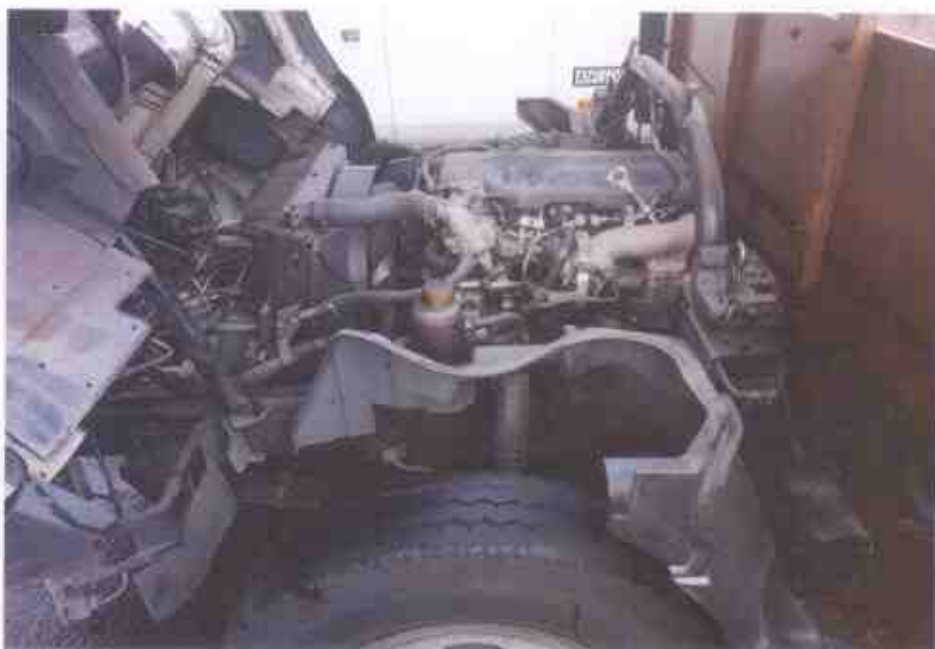
Photo 12 shows a general view of the Motor Lorry's engine compartment, which was accessed by lifting the front cabin of the Motor Lorry. The various parts and components inside the engine compartment were unaffected by the accident. There was also no sign(s) or indication(s) of fresh fluid leakage and/or fluid stain within the engine.

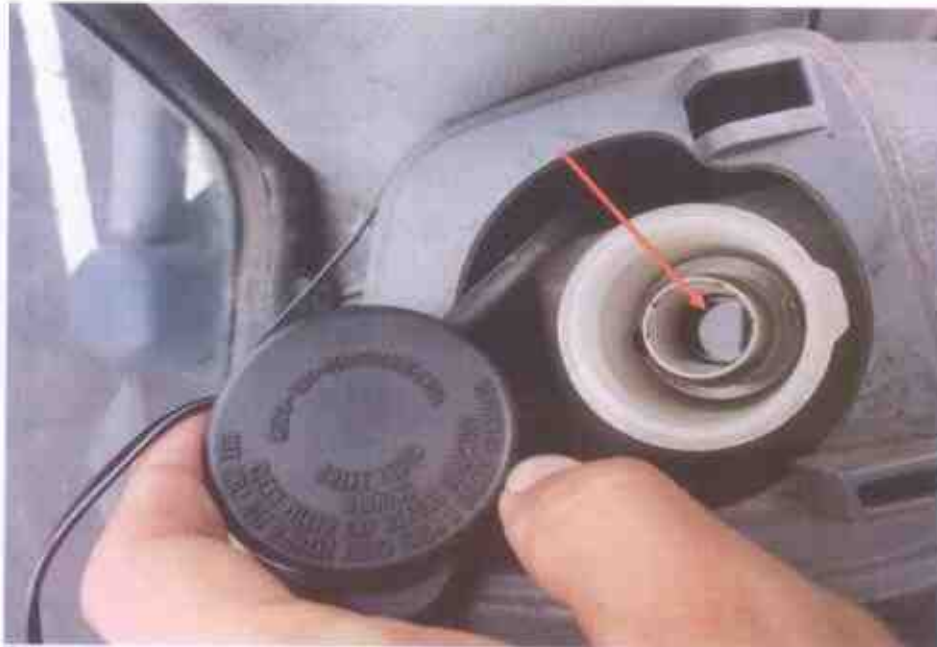
Photo 13 shows the brake fluid reservoir of the Motor Lorry at the time of our inspection. The brake fluid was observed to be of sufficient level and without any visible contamination (arrowed).

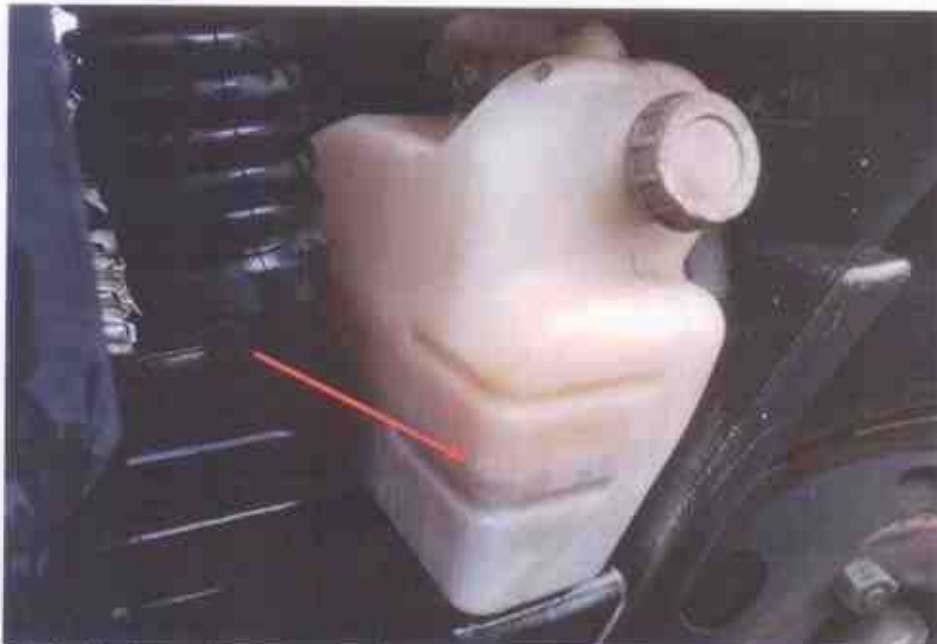
Photo 14 shows the engine coolant reservoir of the Motor Lorry at the time of our inspection. The engine coolant was observed to be of sufficient level and without any visible contamination (arrowed).

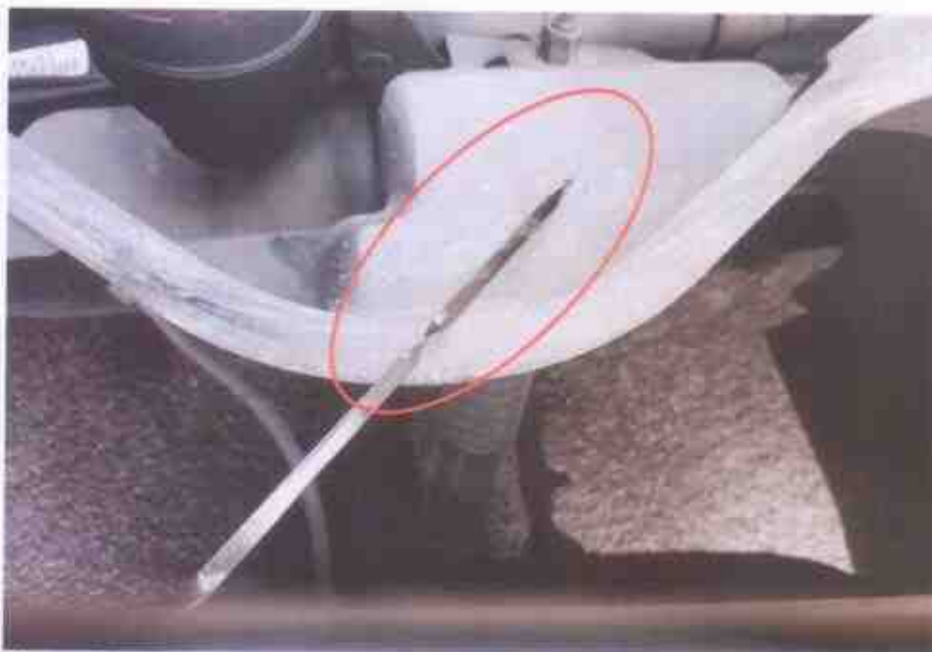
Photo 15 shows the engine dip stick of the Motor Lorry at the time of our inspection. The engine oil was observed to be of sufficient level and without any visible contamination (circled).

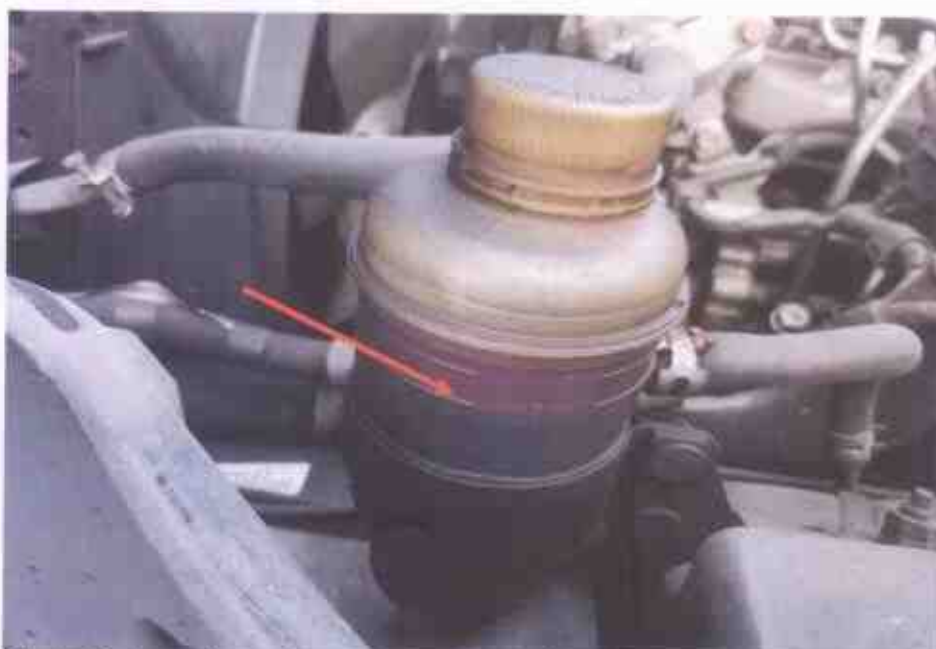
Photo 16 shows the engine coolant reservoir of the Motor Lorry at the time of our inspection. The engine coolant was observed to be of sufficient level and without any visible contamination (arrowed).

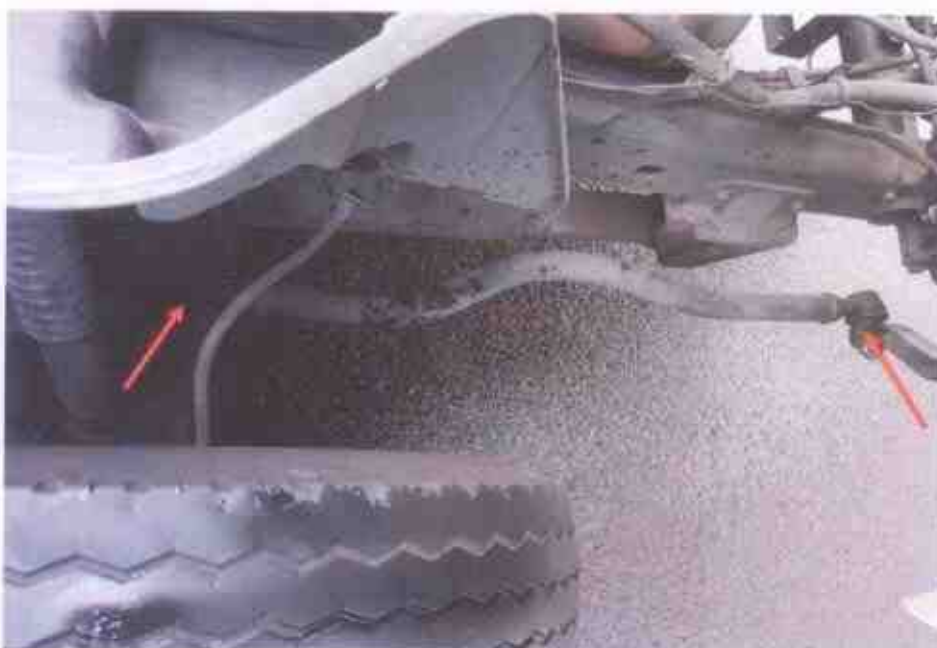
Photo 17 shows the various undercarriage components at the front left wheel of the Motor Lorry, in particular the steering tie rod end (arrowed). The various undercarriage components of the Motor Lorry were all found to be intact without any visible damage. There was also no sign of fluid stain(s) observed on the various undercarriage components.

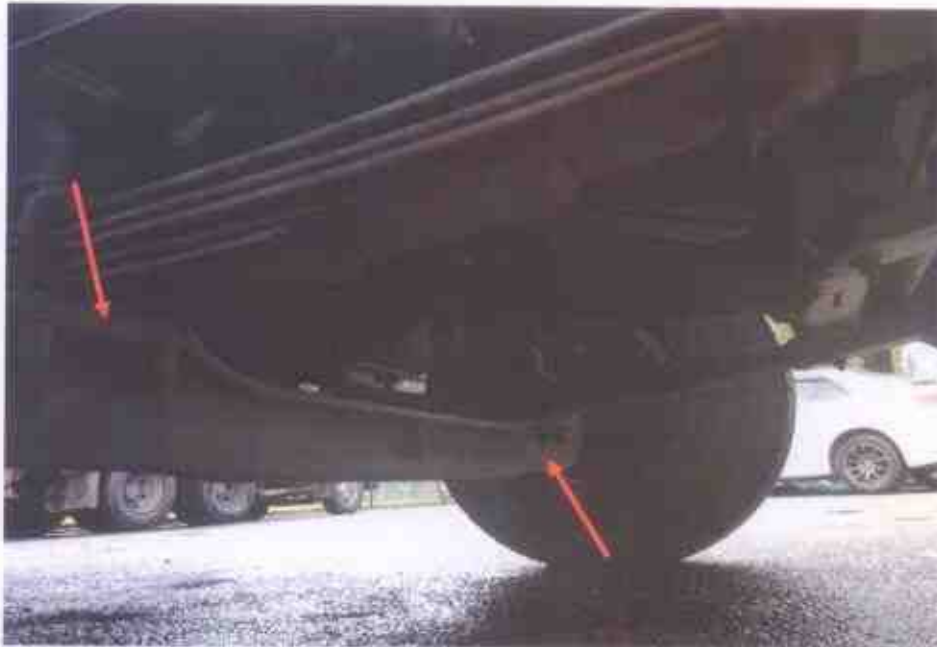
Photo 18 shows the various undercarriage components at the front right wheel of the Motor Lorry, in particular the steering rack (arrowed). The various undercarriage components of the Motor Lorry were all found to be intact without any visible damage. There was also no sign of fluid stain(s) observed on the various undercarriage components.

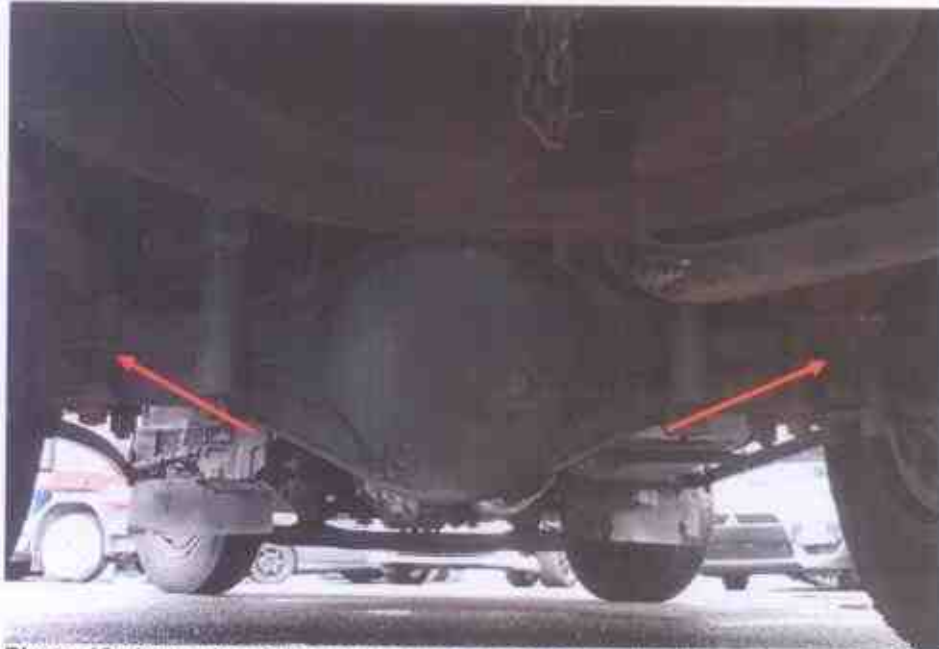
14. Static brake tests conducted on the Motor Lorry revealed no abnormality. The brake booster had responded well to the various tests conducted. There was also no abnormal movement of the brake pedal when it was depressed. In general, the static brake tests had suggested that there was no internal leakage of pressure/vacuum in the braking system of the Motor Lorry. The braking system of the Motor Lorry was likely to be in serviceable condition at the material time. This was also taking into consideration that the brake fluid was of sufficient level, and also that there was no sign(s) of brake fluid leakage along the brake hoses and brake pipes.

Photo 19 shows the various undercarriage components at the rear wheels of the Motor Lorry. There was no sign(s) of brake fluid leakage along the brake hoses and brake pipes.

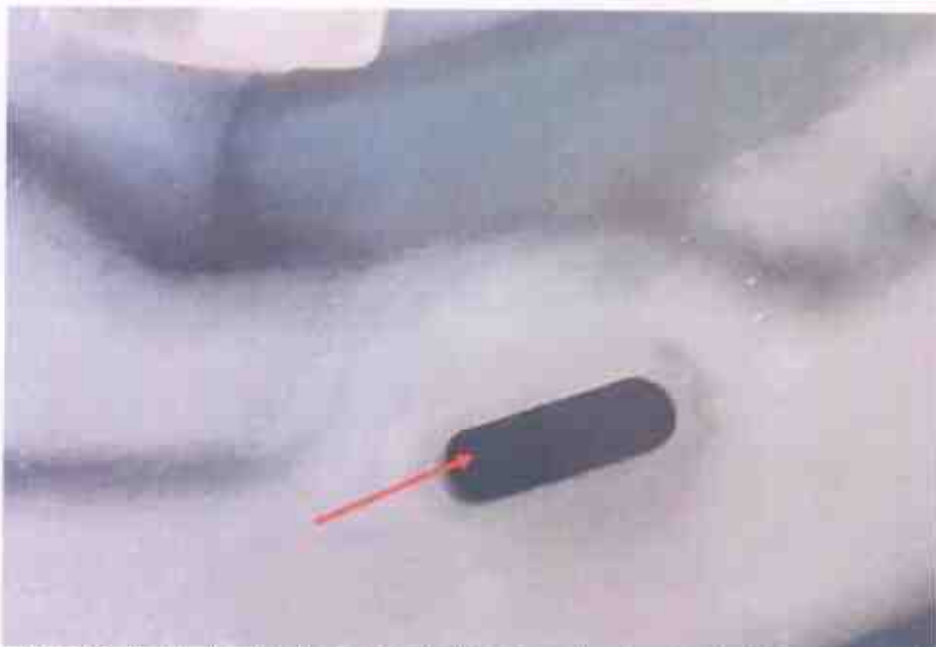
15. Checks on the brake shoes (brake pads) at the rear wheels of the Motor Lorry revealed that the brake shoes (brake pads) were in serviceable condition with sufficient frictional material for operational purposes. In general, our visual inspection of the mechanical components of the Motor Lorry's braking system appear to suggest that its braking system was in serviceable condition at the material time of accident. See photo 19 & 20 below.

Photo 20 shows the checks on the brake shoes (brake pads) at the rear wheels of the Motor Lorry revealed that the brake shoes (brake pads) were in serviceable condition with sufficient frictional material for operational purposes.

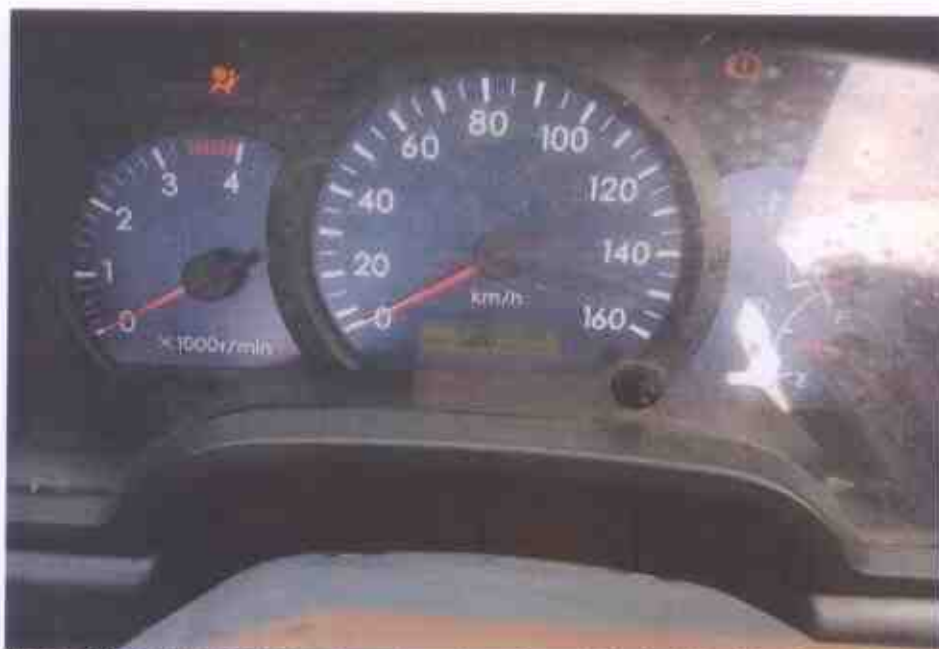
Photo 21 shows the Motor Lorry's automatic self-test of the functionality of its various electronic operating systems like the Battery Check light, Parking Light and Supplemental Restraint System (SRS) during cranking of the engine.

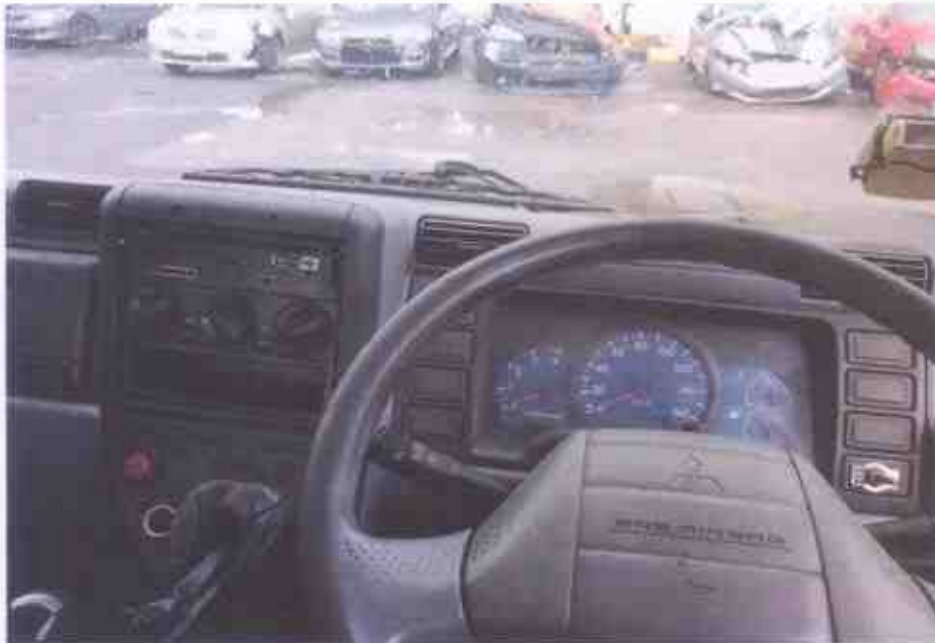
Photo 22 shows its various electronic operating systems like the Battery Check light, Parking Light and Supplemental Restraint System (SRS) during cranking of the engine had indicated that these systems were in working condition and without abnormality. This can be established from the warning lights disappearing from the instrument panel after the self-test.

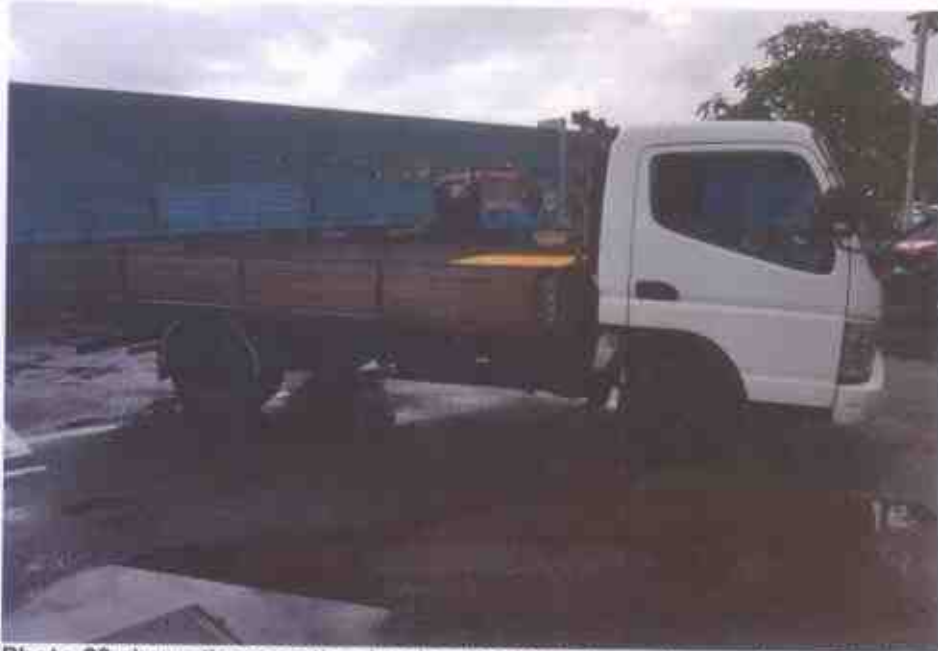
Photo 23 shows the operational test on the Motor Lorry. It was observed to be in serviceable condition. Operational test such as moving forward, turn left & right and also braking test on the Motor Lorry was conducted successfully.

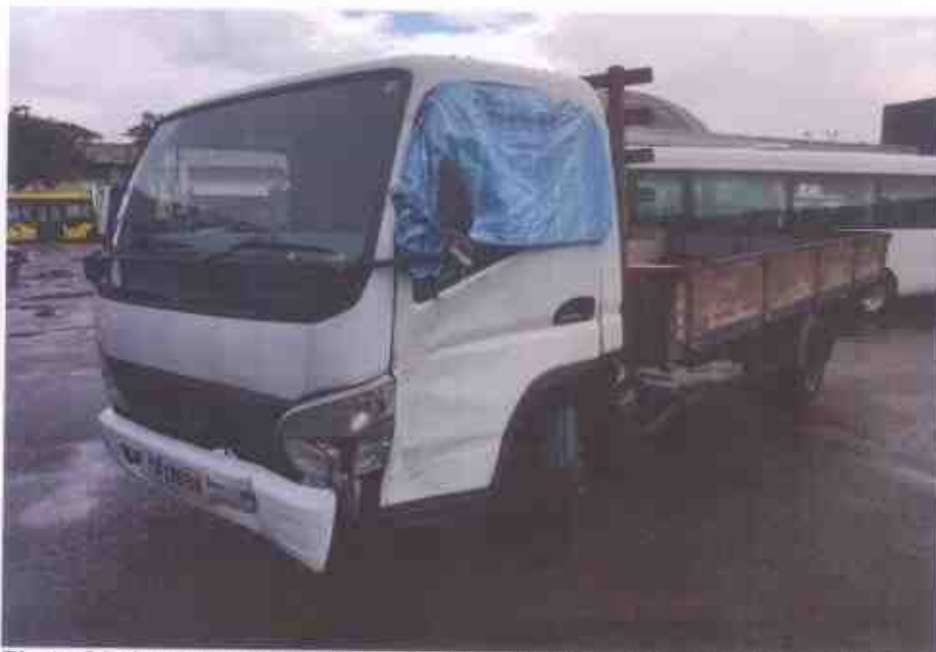
Photo 24 shows the operational test on the Motor Lorry. It was observed to be in serviceable condition. Operational test such as moving forward, turn left & right and also braking test on the Motor Lorry was conducted successfully.
