Your Ref: TP/IP/56801/2018
Our Ref : CI/TPD18019474/Z

07th February 2019

MECHANICAL INSPECTION REPORT OF MOTOR TAXI SHB 9945J

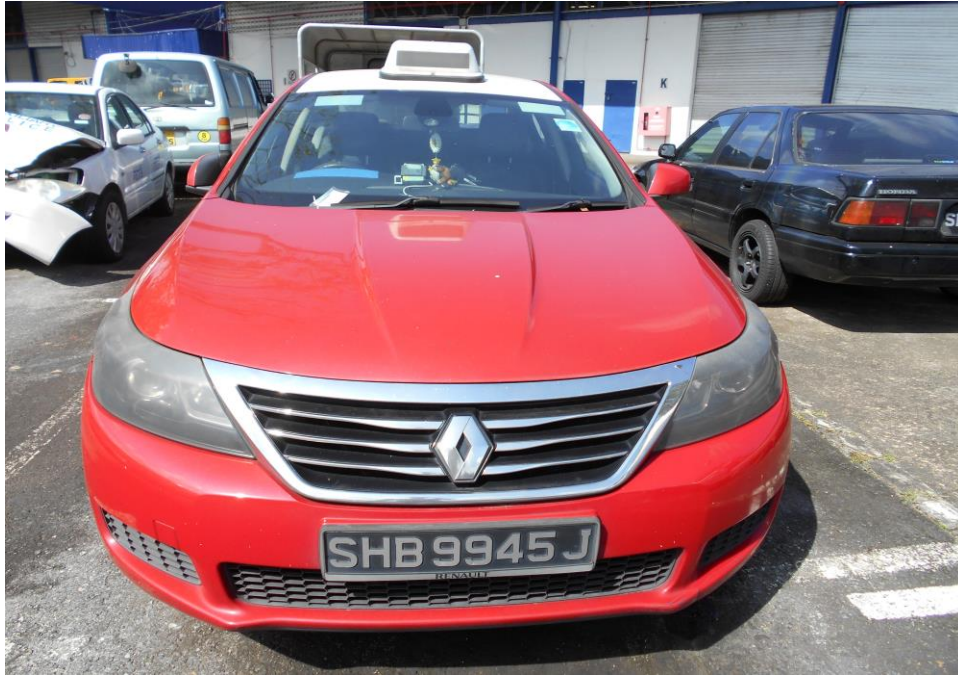
Photo 1 shows a general view of the front body of the Motor Taxi at the time of our inspection. The Motor Taxi was observed to be in good condition unaffected by the accident.

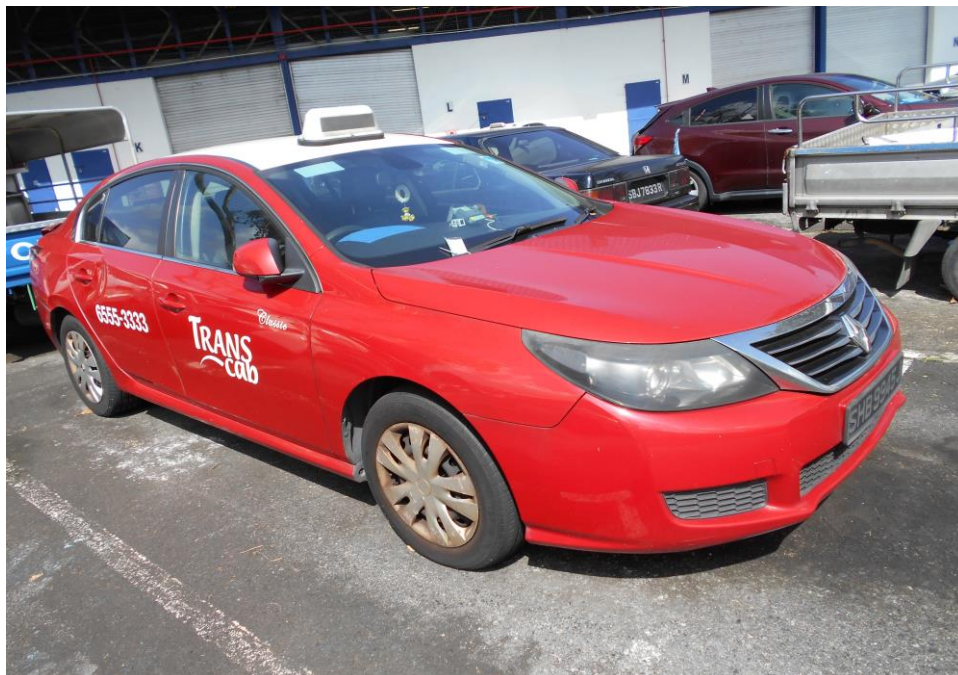
Photo 2 shows a general view of the front right body of the Motor Taxi at the time of our inspection. The Motor Taxi was observed to be in good condition unaffected by the accident.

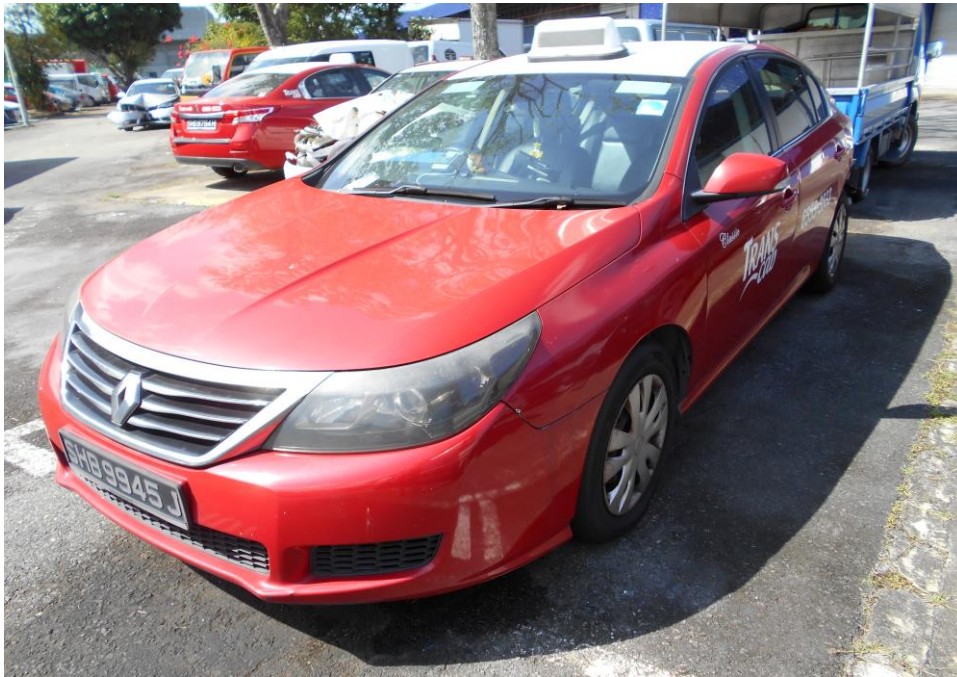
Photo 3 shows a general view of the front left body of the Motor Taxi at the time of our inspection. The Motor Taxi was observed to have sustained a relatively minor impact damages that was confined to its frontal portion.

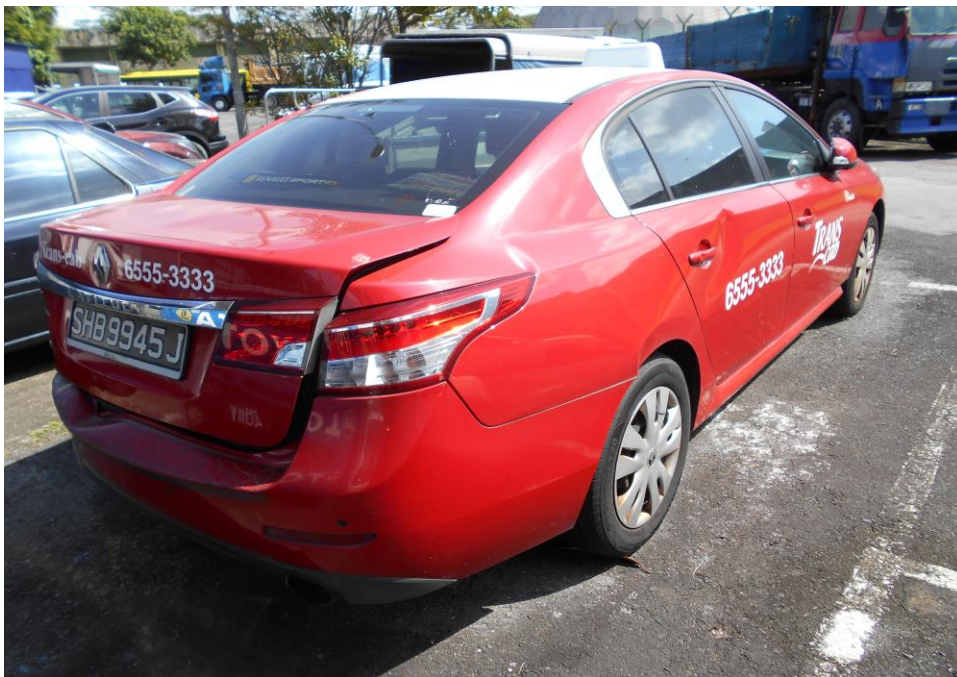
Photo 4 shows a general view of the rear right body of the Motor Taxi at the time of our inspection. The Motor Taxi was observed to have sustained with minor misalignment on the rear bonnet as a result of the accident.

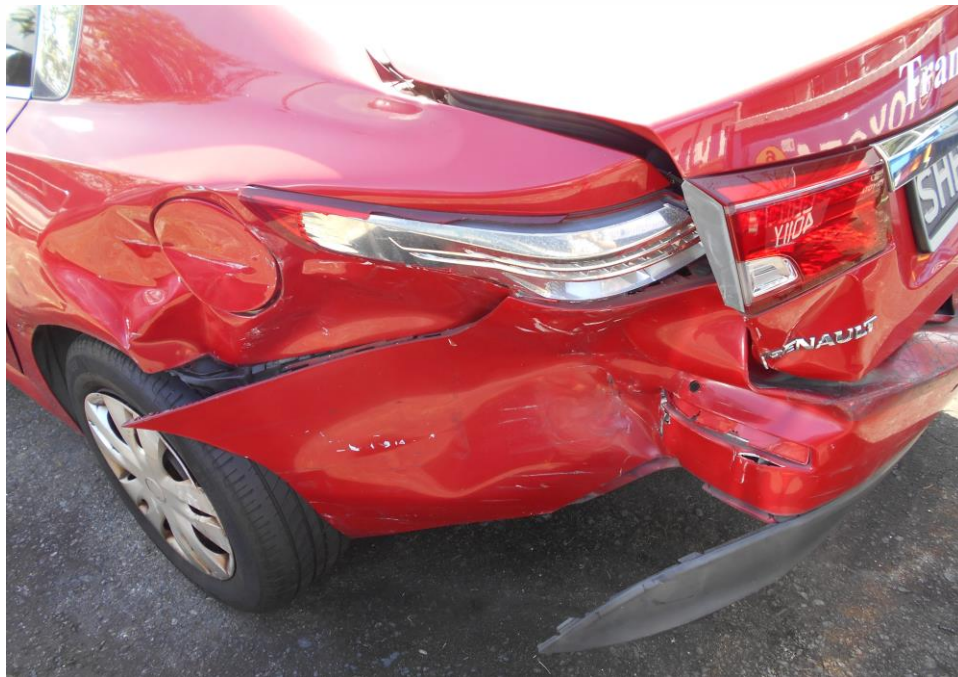
4. The mileage of the Motor taxi at the time of our inspection was not recorded due to the unavailability of the ignition key at time of our inspection.
5. The Motor taxi had sustained a relatively minor impact damages that was confined to its rear left portion. Its rear left bumper was observed to be pushed inwards and its rear bonnet was found misaligned due to the accident's collision impact.
6. This was likely due to the consistency of the accident's case facts that the driver of a Motor Taxi (SHB 9945J) had accidentally step onto the accelerator instead of the footbrake, resulted the Motor Taxi to surge forward, side-swipe onto the right Motor Car, crashed through the gantry barrier, collided onto the rear left portion of Motor Taxi (SHB 799Z) and right front side of another white Motor Car before stopping along Gleaneagles Carpark Service Road. See photo 1 to 5 below.

Photo 5 shows a close up view of the rear left of the Motor Taxi at the time of our inspection. The Motor Taxi had sustained extensive impact damages at the rear bumper as a result of the accident.

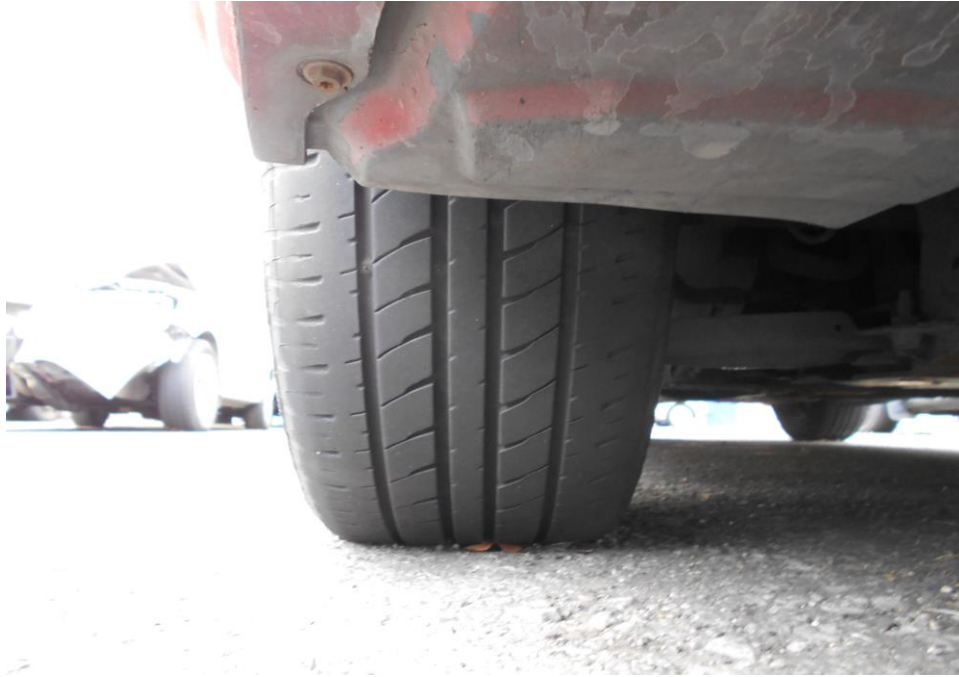
Photo 6 shows the condition of the front right tyre of the Motor Taxi, which was observed to be in serviceable condition with remaining tread depth of approximately 6mm. There was no tear, cut or burst mark(s) on the outer and the inner sidewalls.

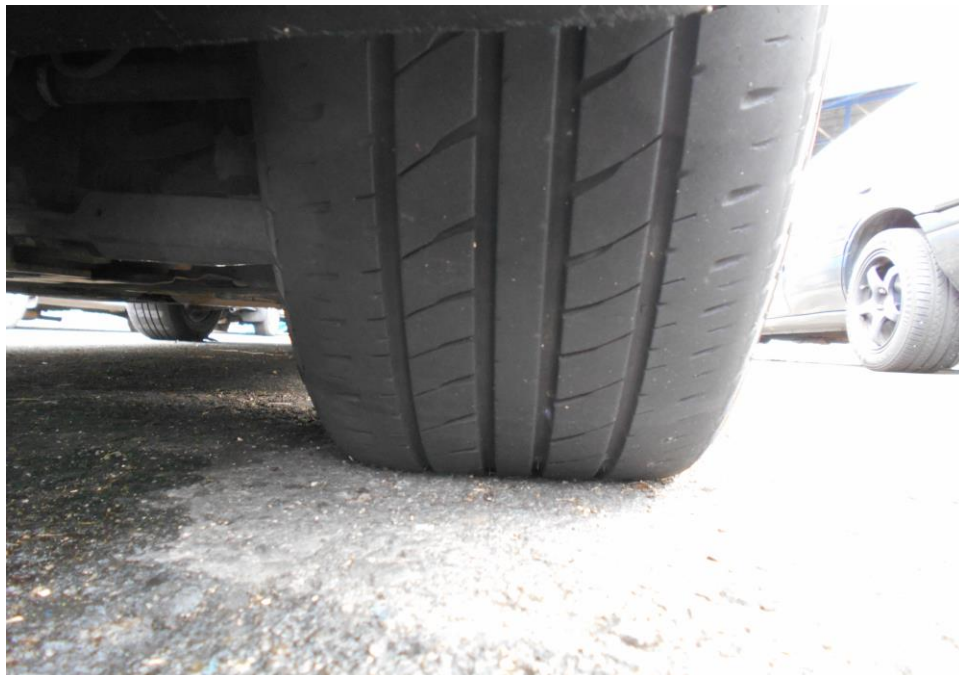
Photo 7 shows the condition of the front left tyre of the Motor Taxi, which was observed to be in serviceable condition with remaining tread depth of approximately 6mm. The tyre, which was wrapped around alloy wheel rim, was also observed to be sufficiently inflated for vehicular operation.

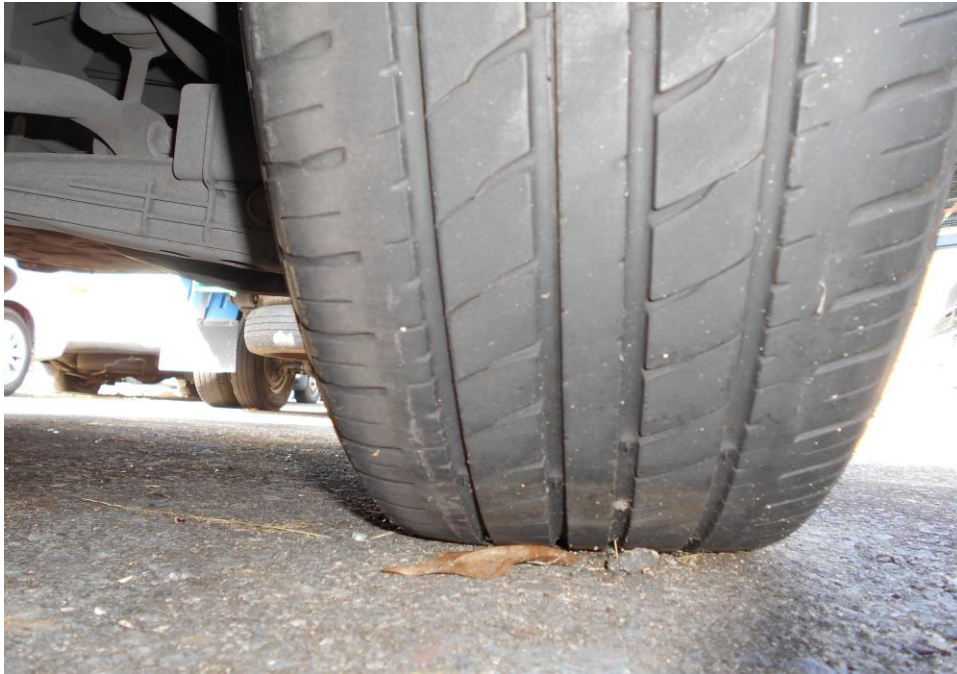
Photo 8 shows the condition of the rear left tyre of the Motor Taxi, which was observed to be in serviceable condition with remaining tread depth of approximately 5mm.

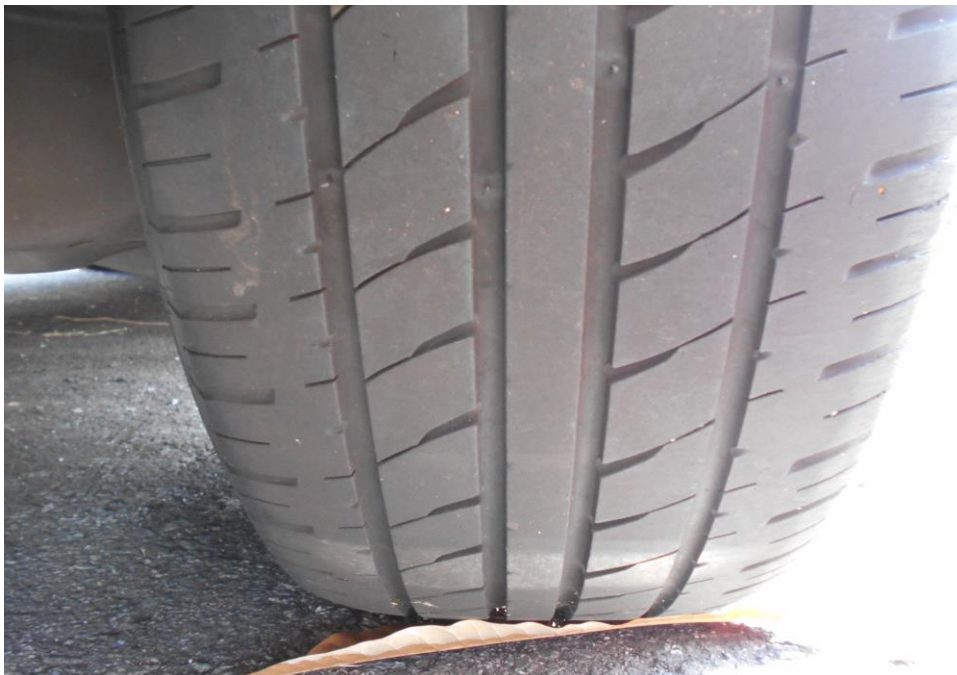
Photo 9 shows the condition of the rear right tyre of the Motor Taxi, which was observed to be in serviceable condition with remaining tread depth of approximately 6mm.

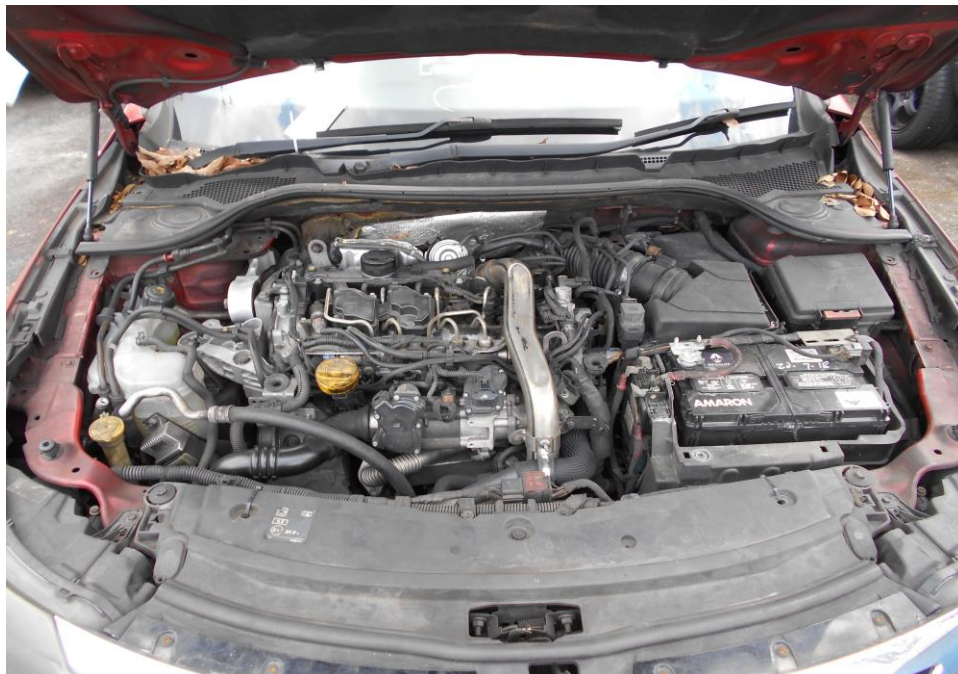
Photo 10 shows a general view of the Motor Car's engine compartment. The various parts and components inside the engine compartment were unaffected by the accident. There was also no sign(s) or indication(s) of fluid leakage and/or fluid stain within the engine compartment.

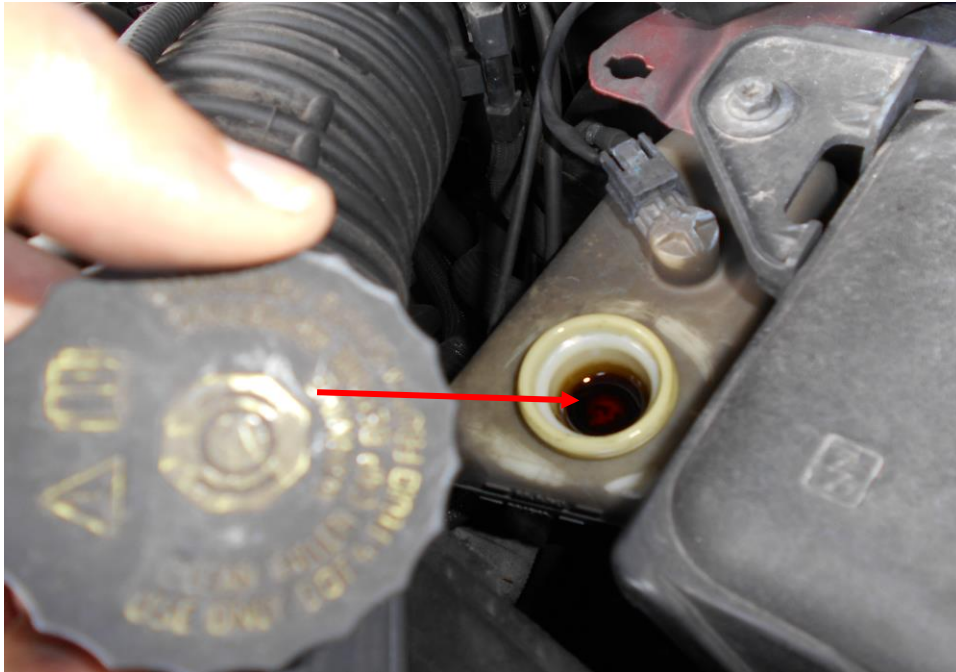
Photo 11 shows the brake fluid reservoir of the Motor Taxi at the time of our inspection. The brake fluid was observed to be of sufficient level (arrowed) and without any visible contamination.

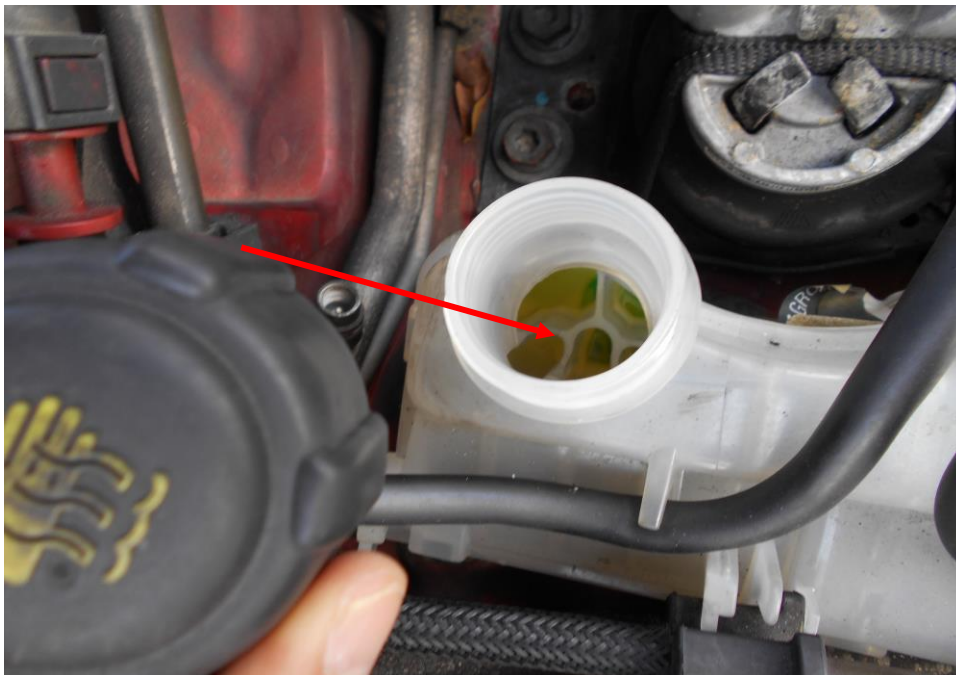
Photo 12 shows the engine coolant fluid reservoir of the Motor Taxi at the time of our inspection. The engine coolant fluid was observed to be of sufficient level and without any visible contamination.

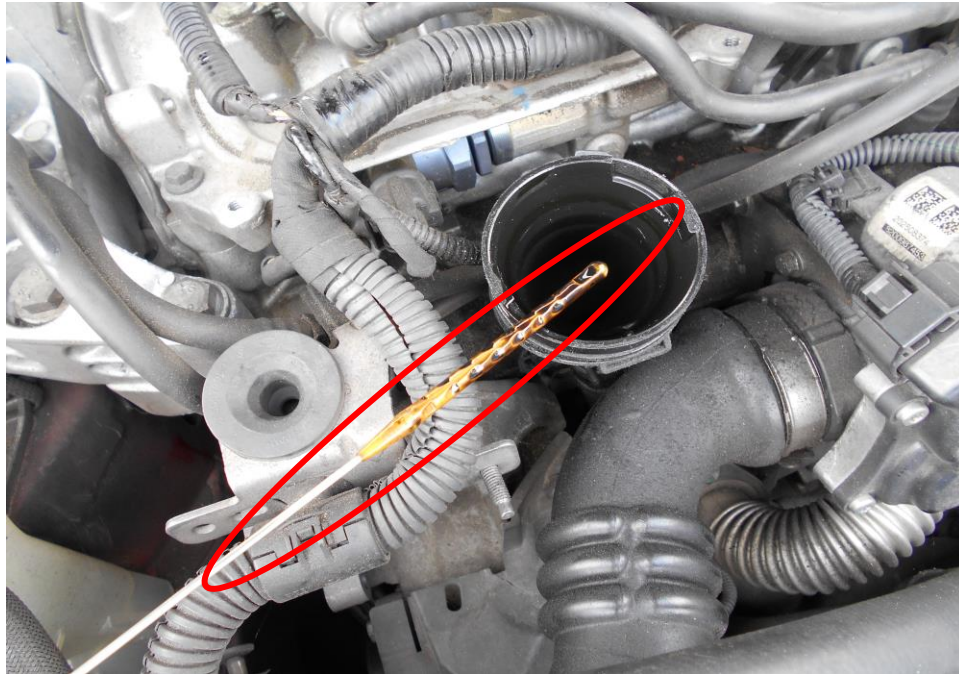
Photo 13 shows the engine oil dip stick of the Motor Taxi at the time of our inspection. The engine oil was observed to be of sufficient level and without any visible contamination.

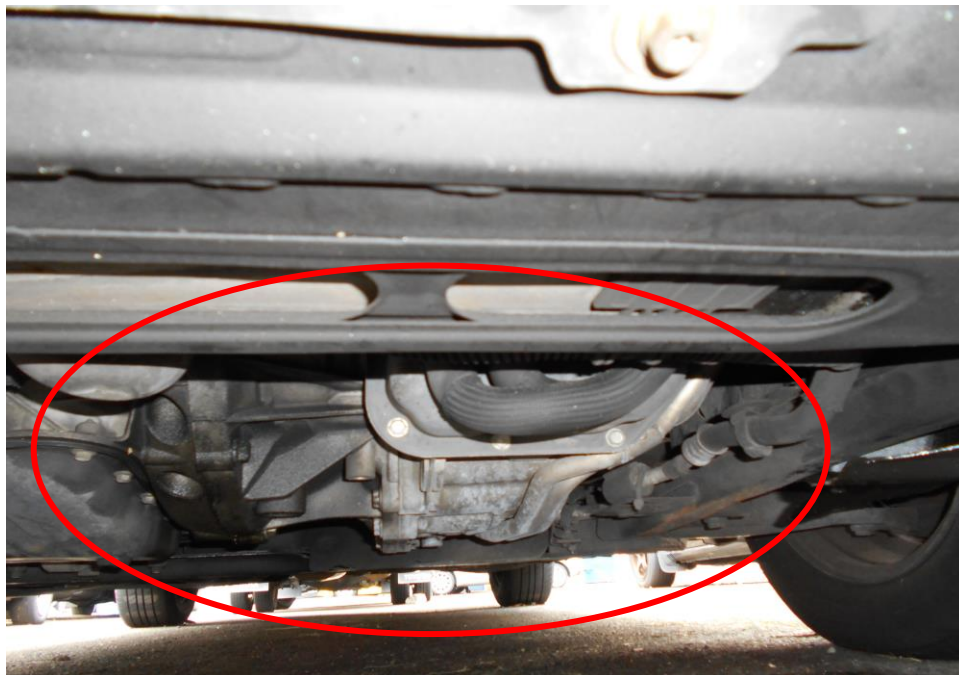
11. Our subsequent checks on the underside of the Motor Taxi revealed fluid stain observed to be pre-existed prior the accident looking at the dust accumulated with it. Our checks on the engine fluid had also indicated that the engine fluid was of sufficient level for operational purposes, and without contamination. Visually, the various undercarriage components of the Motor Taxi were all observed to be intact and without any visible damage. See photo 10 – 14 below.

Photo 14 shows the engine underside of the Motor Taxi engine at the time of our inspection. The engine was observed to be with a pre-existed oil stain prior the accident. This was based on the dust that associated with the fluid stain.

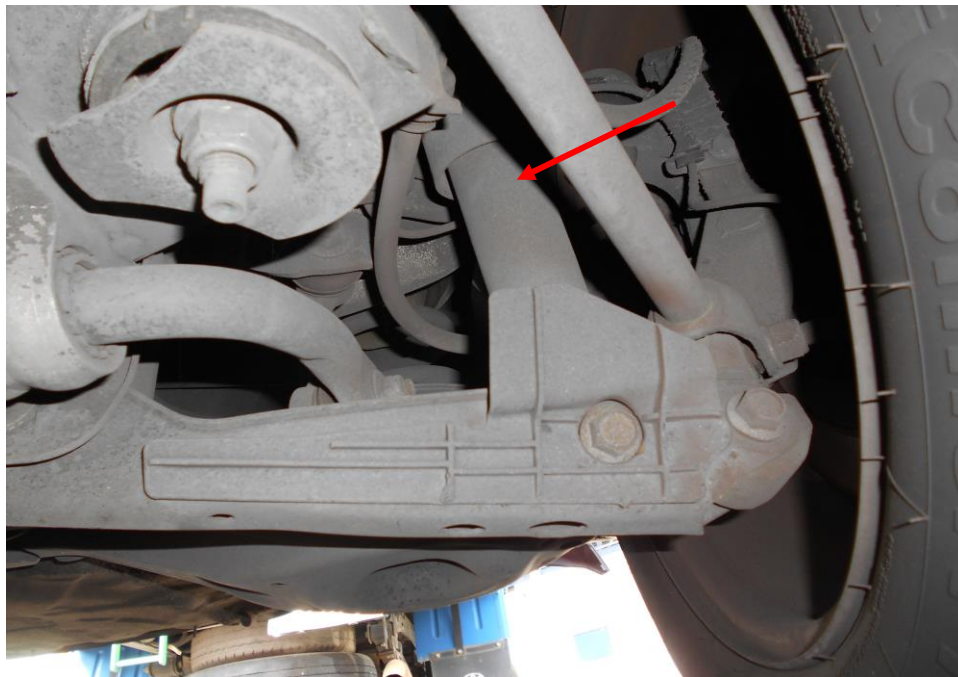
Photo 15 shows the brake hose (arrowed) at the rear left wheel of the Motor Taxi. We did not observe any leakage of brake fluid at the time of our inspection of the Motor Taxi. Our visual inspection of the various mechanical components of the Motor Taxi's braking system revealed all to be intact without visible damage.

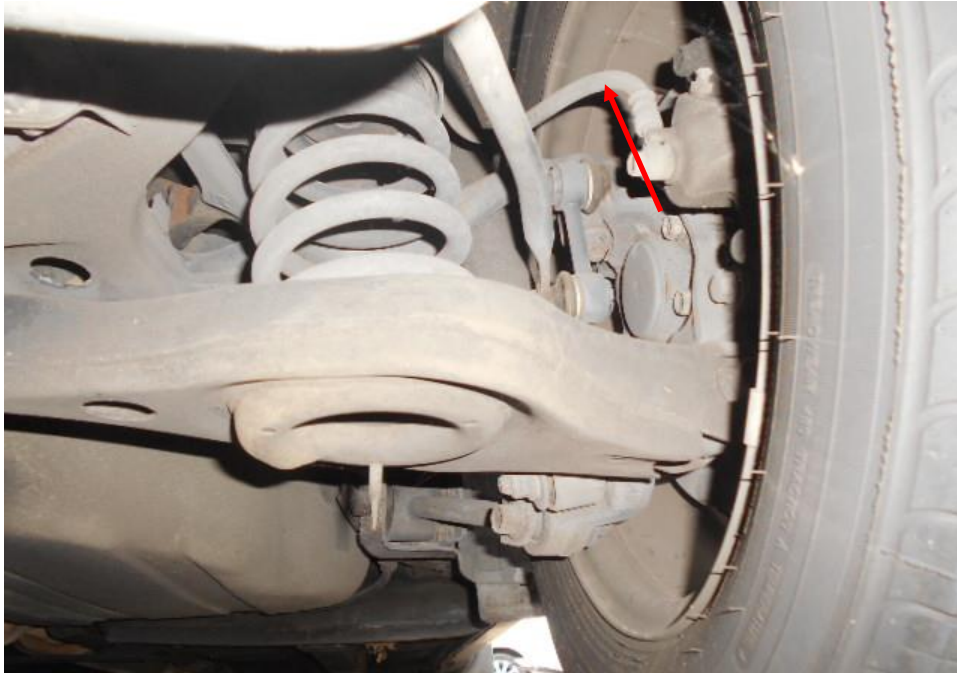
Photo 16 shows the brake hose (arrowed) at the rear right wheel of the Motor Taxi. We did not observe any leakage of brake fluid at the time of our inspection of the Motor Taxi. Our visual inspection of the various mechanical components of the Motor Taxi's braking system revealed all to be intact without visible damage.

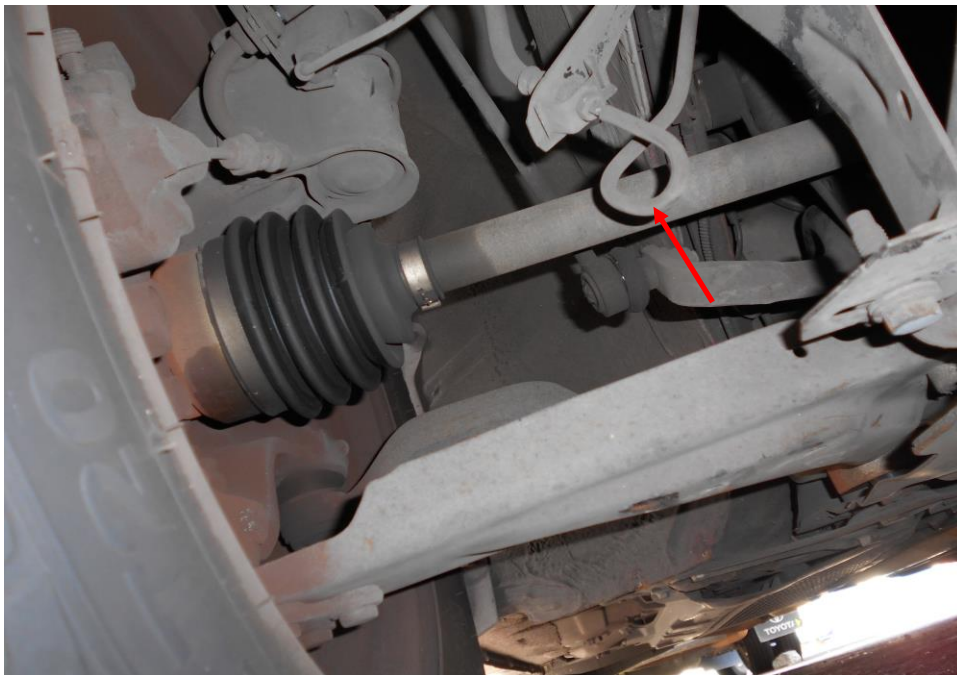
Photo 17 shows the various undercarriage components at the front right wheel of the Motor Taxi, in particular the steering tie rod (arrowed). The various steering components were all found to be intact, suggesting that the steering system of the Motor Taxi was likely to be in serviceable condition.

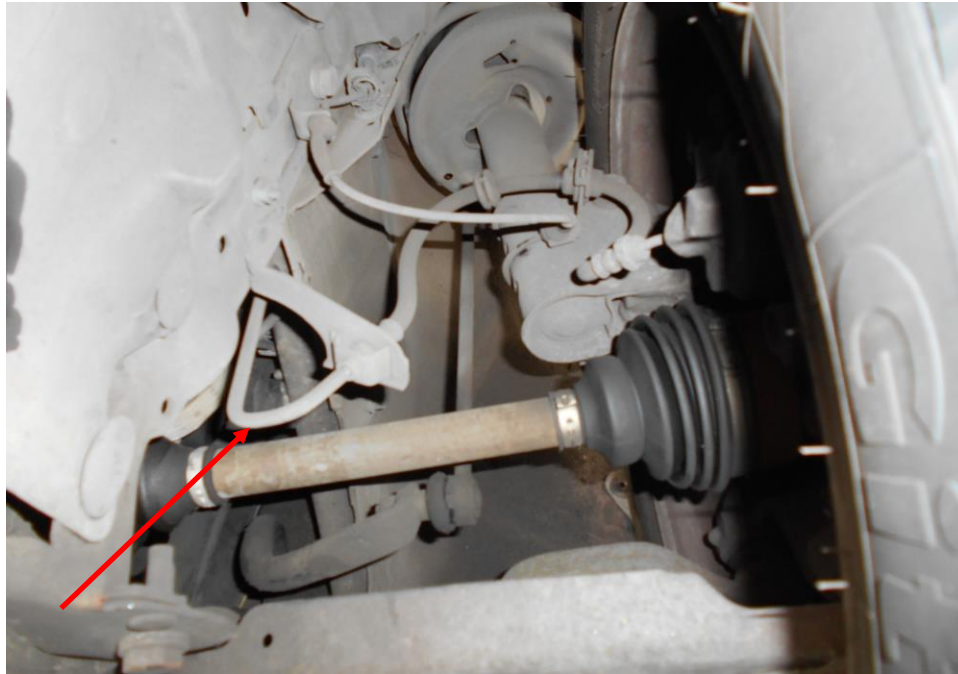
Photo 18 shows the various undercarriage components at the front left wheel of the Motor Taxi. We did not observe any leakage of brake fluid (arrowed) at the time of our inspection of the Motor Taxi. Our visual inspection of the various mechanical components of the Motor Taxi's braking system revealed all to be intact and without visible damage, indicating that the braking system was likely to be in serviceable condition at the material time of accident.
