Your Ref: TP/IP/56801/2018  
Our Ref : CI/TPD18019475/Z

07<sup>th</sup> February 2019

**MECHANICAL INSPECTION REPORT OF MOTOR TAXI SHB 799Z**

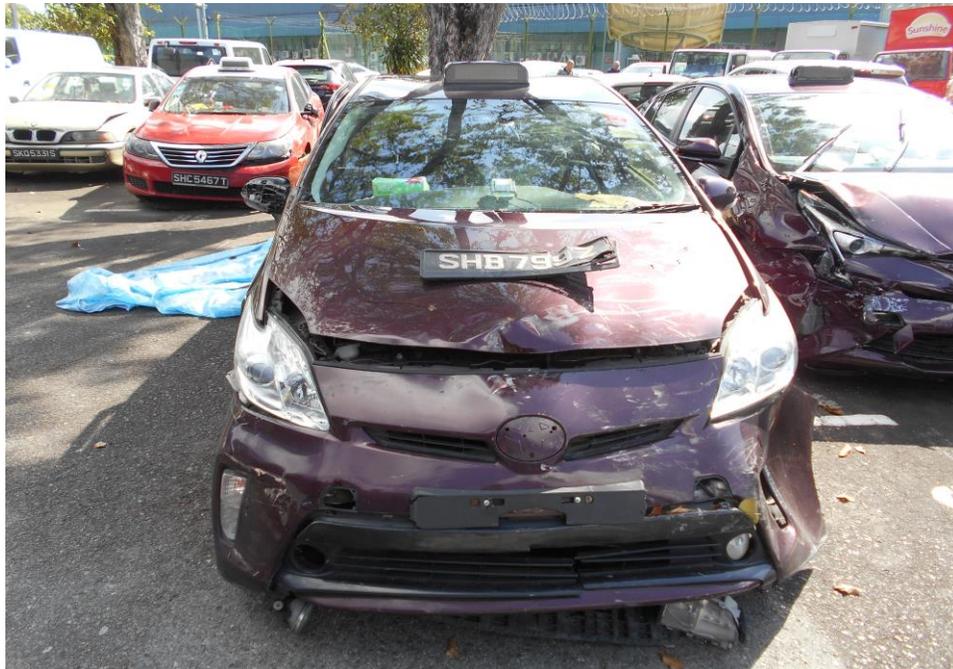
**Photo 1** shows a general view of the frontal portion of the Motor Taxi at the time of our inspection. The Motor Taxi was observed to have sustained extensive impact damage at its frontal, left & rear portion. The impact force was significant, causing the various parts and components to be damaged as a result of the accident.

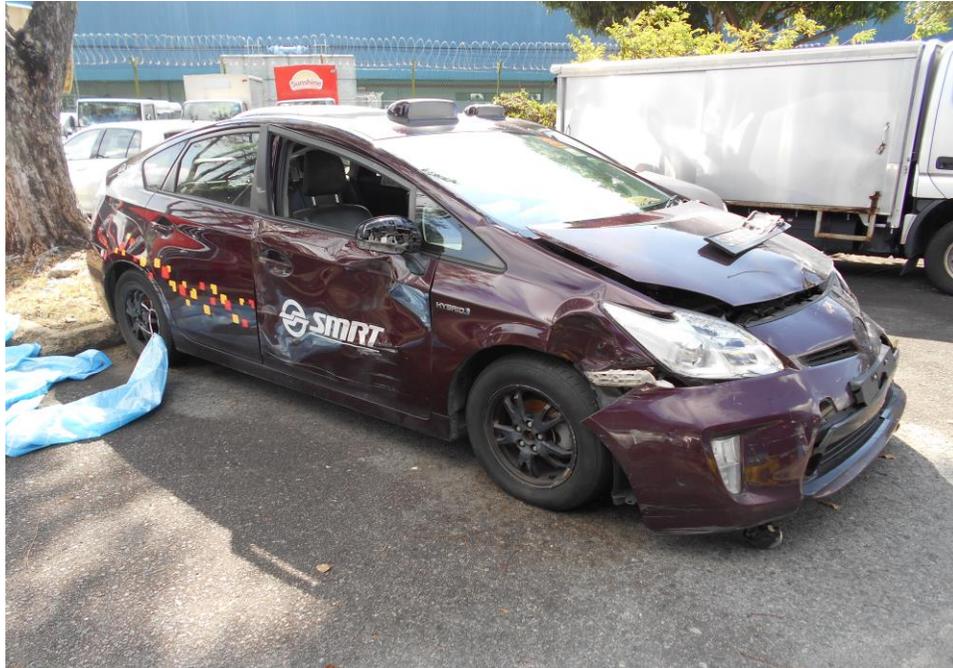
**Photo 2** shows a general view of the front right portion of the Motor Taxi at the time of our inspection. The Motor Taxi was observed to have sustained extensive impact damage at its right hand side portion.

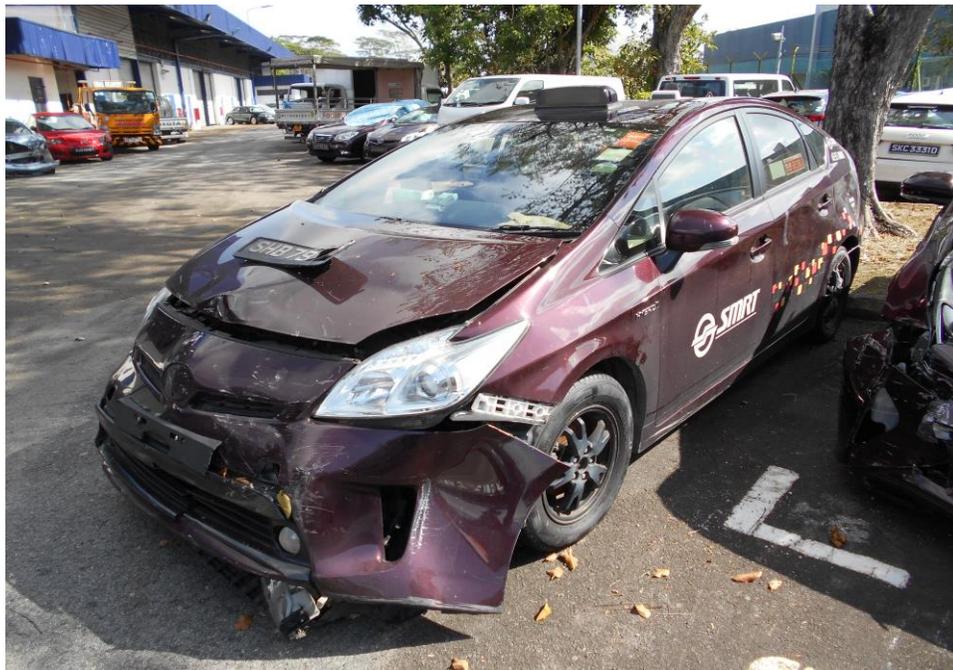
**Photo 3** shows a general view of the front left portion of the Motor Taxi at the time of our inspection. The Motor Taxi was observed to have sustained extensive impact damage at its front left portion.

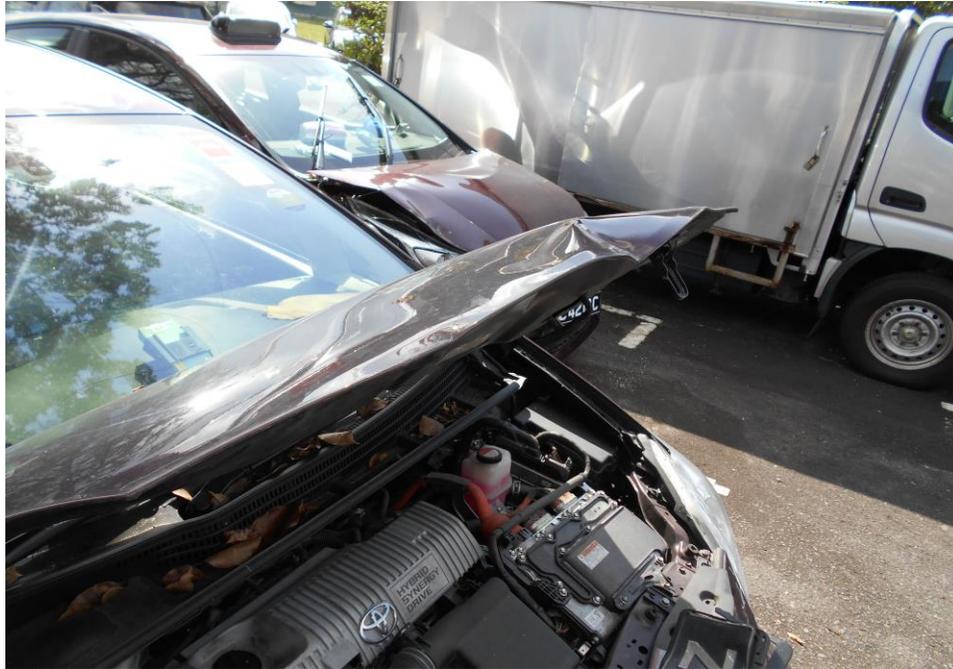
**Photo 4** shows a closer view of the damage front bumper of the Motor Taxi. The impact force was significant, causing the front bumper of the Motor Taxi to be buckled as a result of the accident.

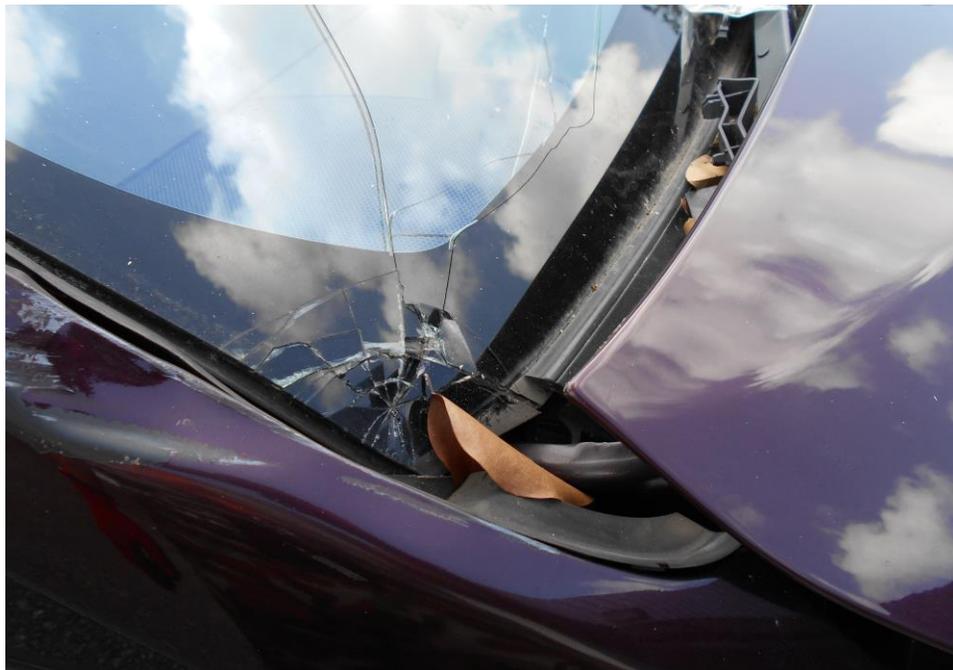
**Photo 5** shows a closer view of the cracked front windshield of the Motor Taxi as a result of the accident.

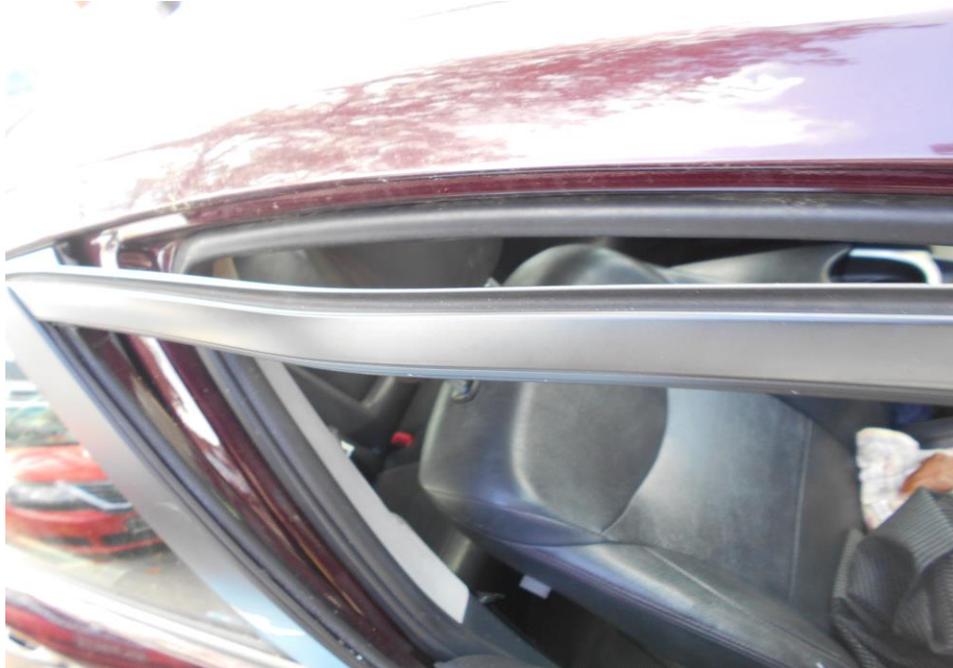
**Photo 6** shows a closer view of the Motor Taxi driver side door. The impact force was significant, causing it to be damaged.

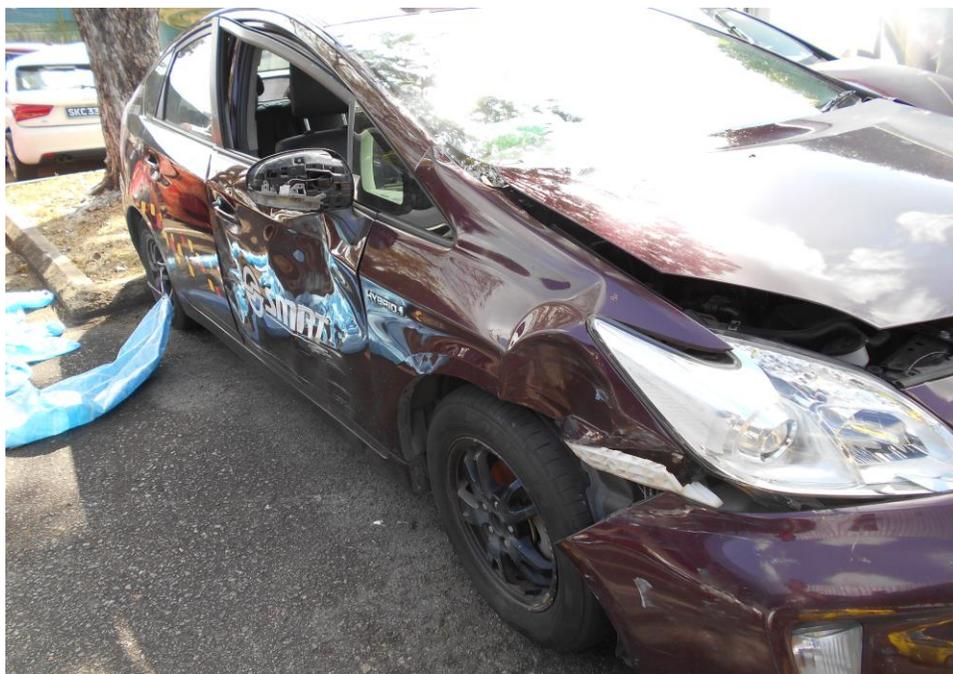
**Photo 7** shows a closer view of the damaged right side of the Motor Taxi. The impact force was significant, causing it to be pushed inwards due to the accident's impact.

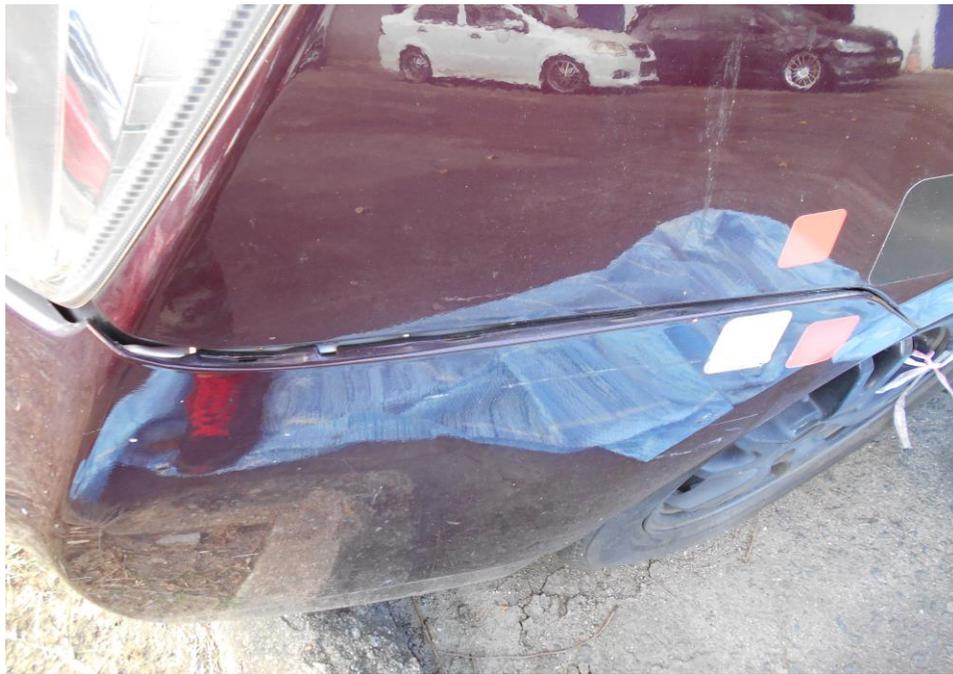
**Photo 8** shows a closer view of the damaged rear lower right bumper. The impact force was significant, causing it to be misaligned due to the accident's impact.

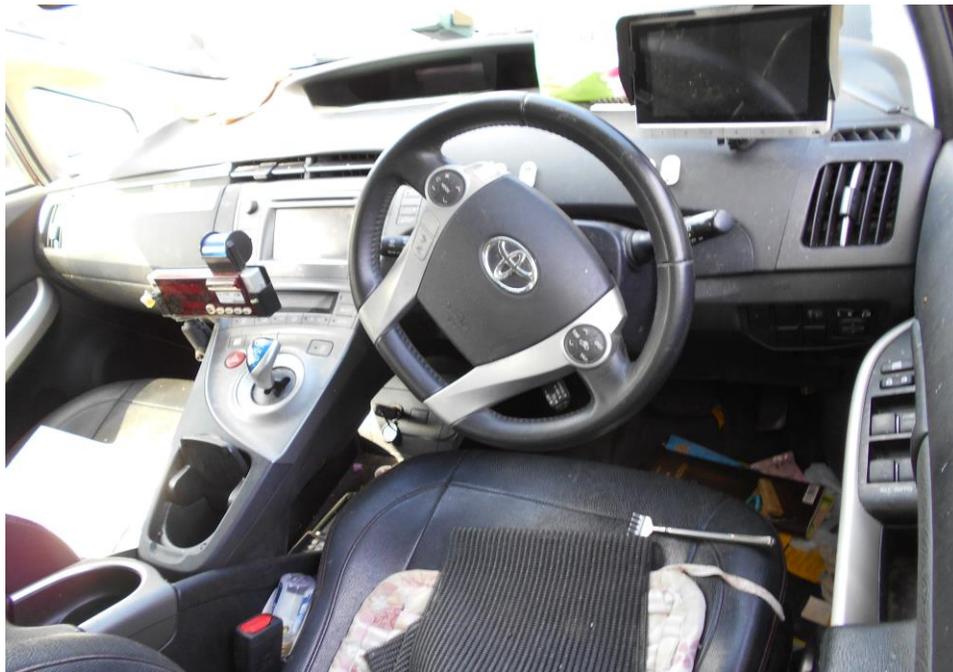
**Photo 9** shows the interior portion of the Motor Taxi. The impact force did not affect the interior portion.

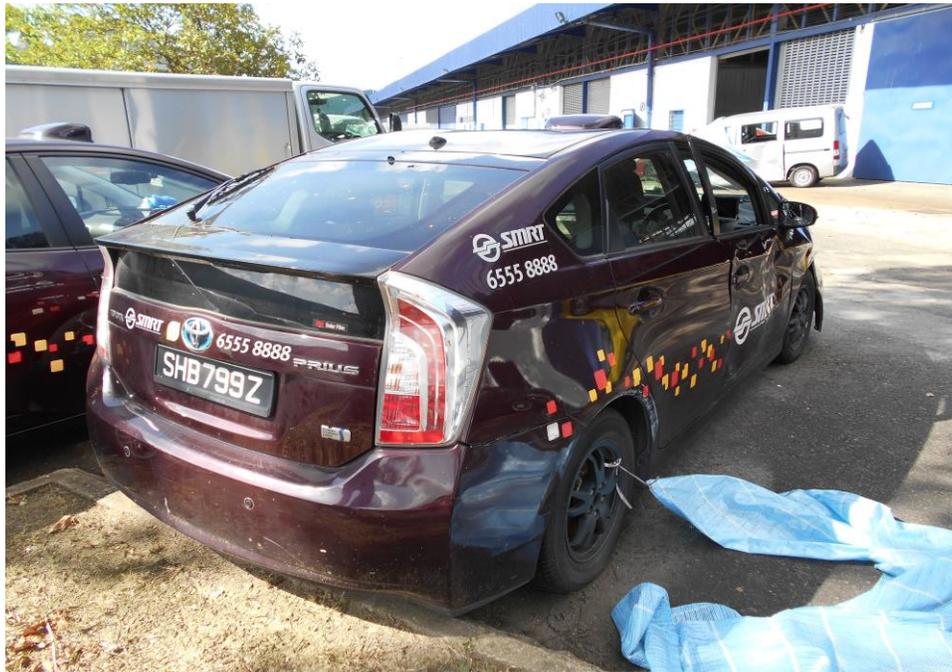
**Photo 10** shows a general view of the rear right portion of the Motor Taxi at the time of our inspection. The rear portion was observed to have minor misalignment by the accident.

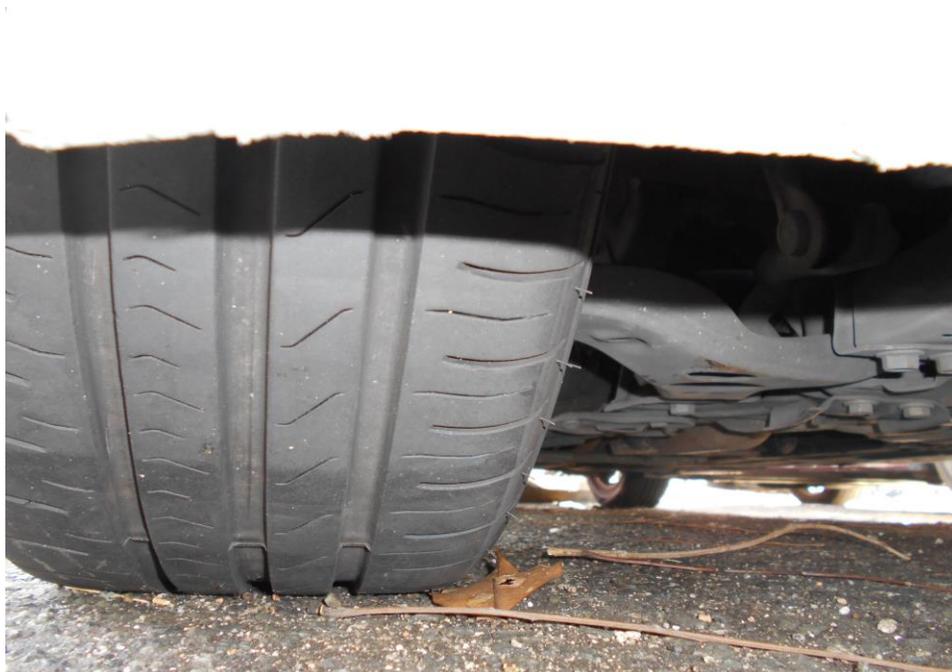
**Photo 11** shows the condition of the front right tyre of the Motor Taxi, which was observed to be in serviceable condition with remaining tread depth of approximately 7mm. There was no tear, cut or burst mark(s) on the outer and the inner sidewalls as well as across the tread of this tyre.

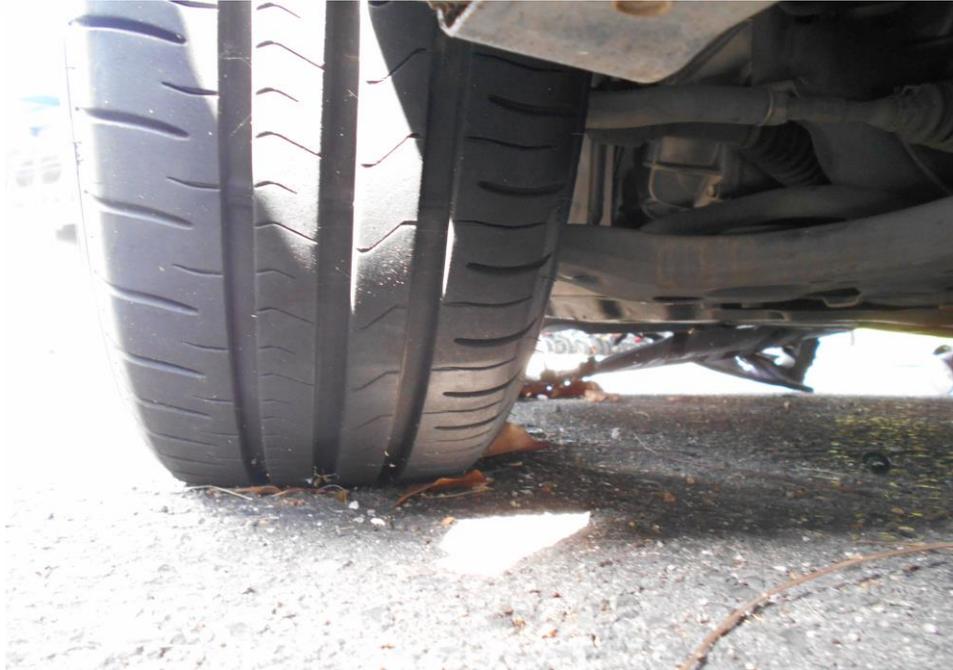
**Photo 12** shows the condition of the front left tyre of the Motor Taxi, which was observed to be in serviceable condition with remaining tread depth of approximately 7mm. There was no tear, cut or burst mark(s) on the outer and the inner sidewalls as well as across the tread of this tyre, which was also sufficiently inflated for vehicular operation.

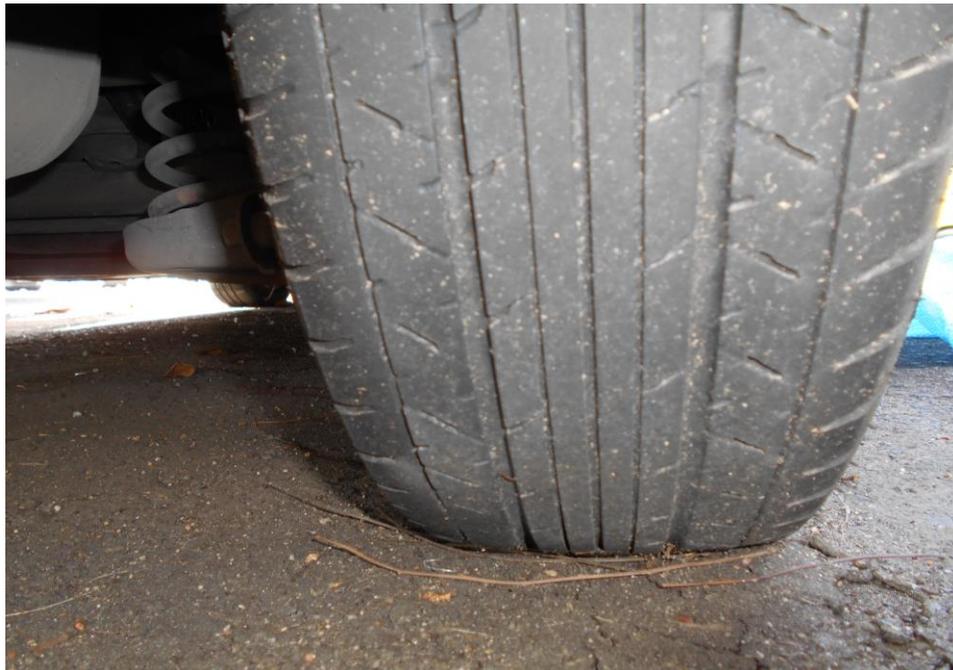
**Photo 13** shows the condition of the rear right tyre of the Motor Taxi, which was observed to be in serviceable condition with remaining tread depth of approximately 6mm. There was also no tear, cut or burst mark(s) on the outer and the inner sidewalls as well as across the tread of this tyre.

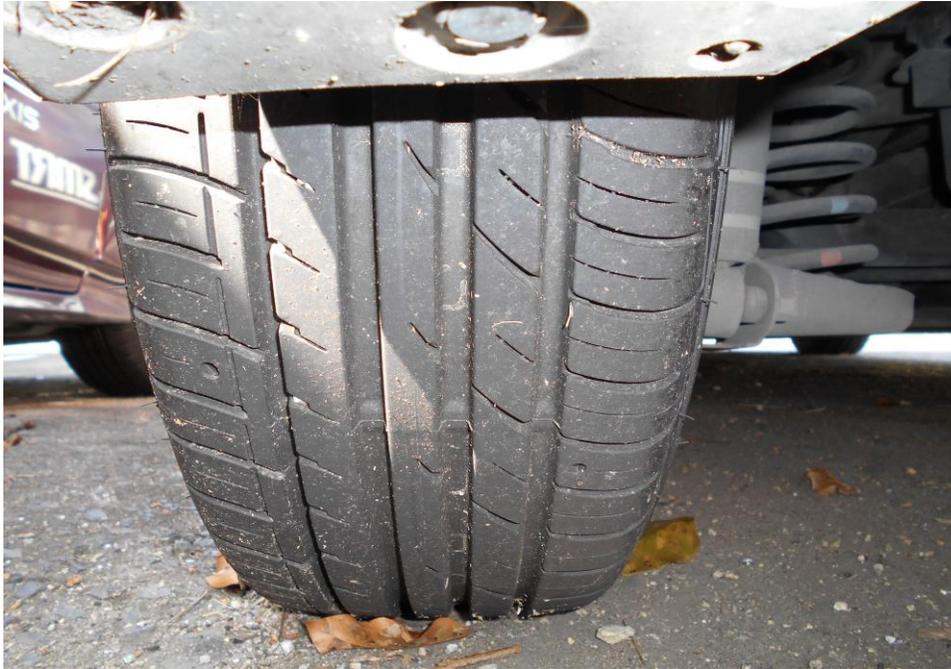
**Photo 14** shows the condition of the rear left tyre of the Motor Taxi, which was observed to be in serviceable condition with remaining tread depth of approximately 8mm. There was also no tear, cut or burst mark(s) on the outer and the inner sidewalls as well as across the tread of this tyre.

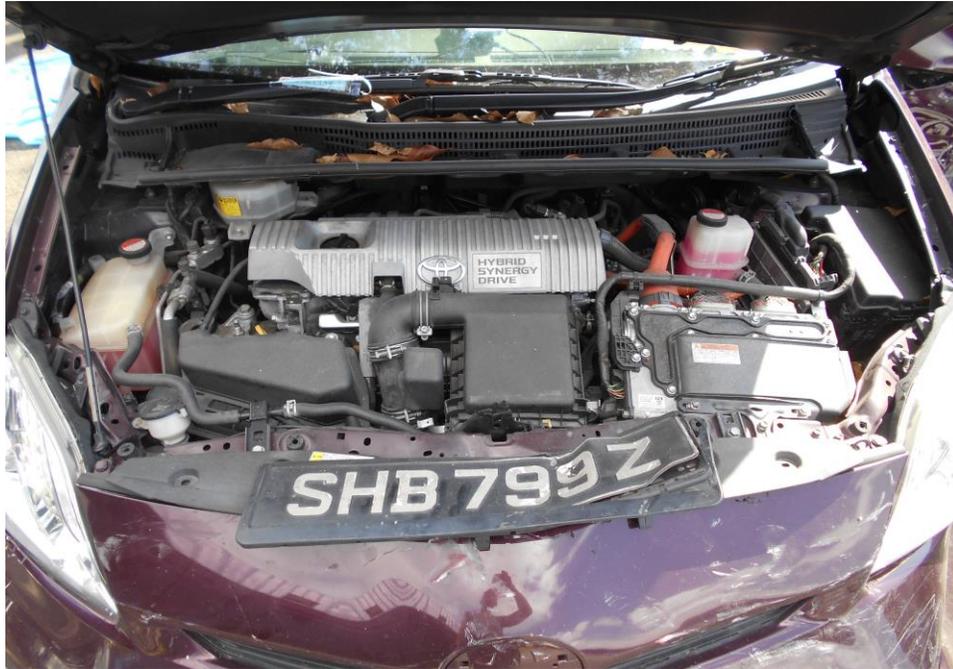
**Photo 15** shows a general view of the Motor Car's engine compartment. The various parts and components inside the engine compartment were unaffected by the accident from top view.

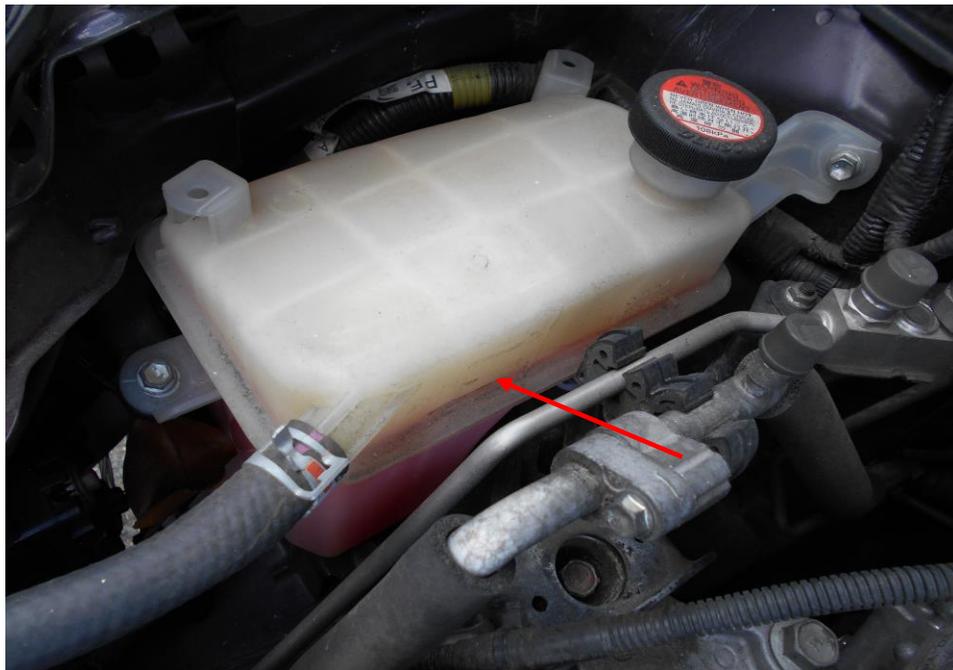
**Photo 16** shows the close up view of the engine coolant that was seen with sufficient level not affected by the accident's impact

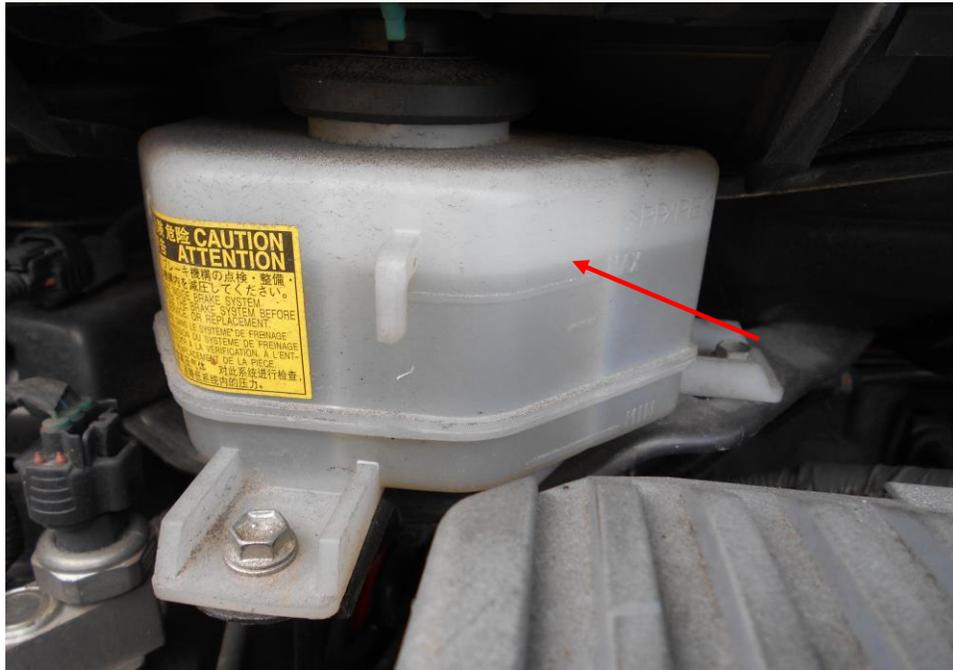
**Photo 17** shows the close up view of the brake fluid that was seen with sufficient level not affected by the accident's impact.

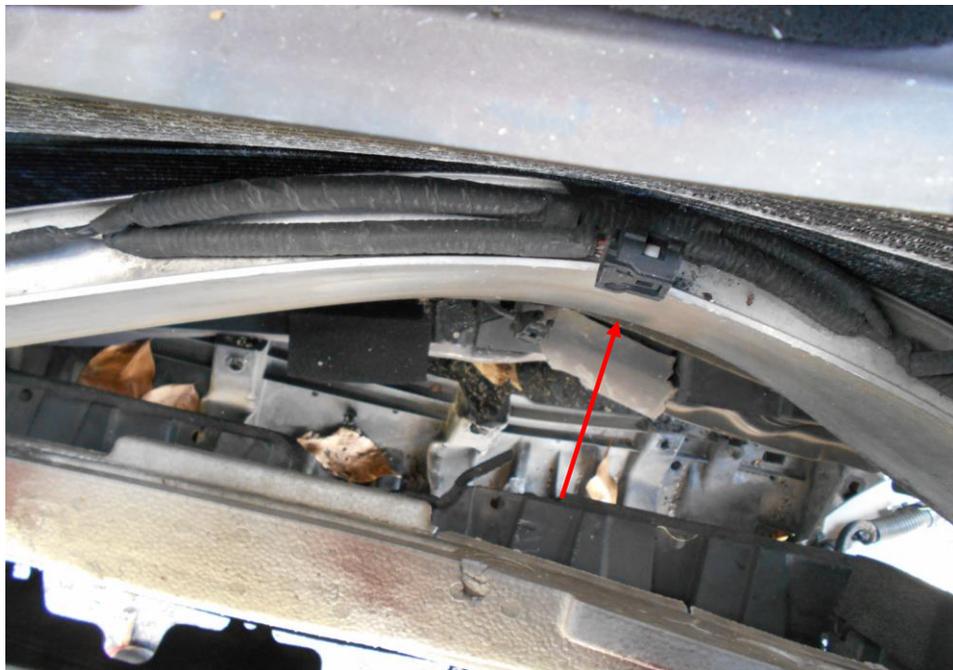
**Photo 18** shows the close up view of the radiator that was visually pushed inwards due to the accident's impact

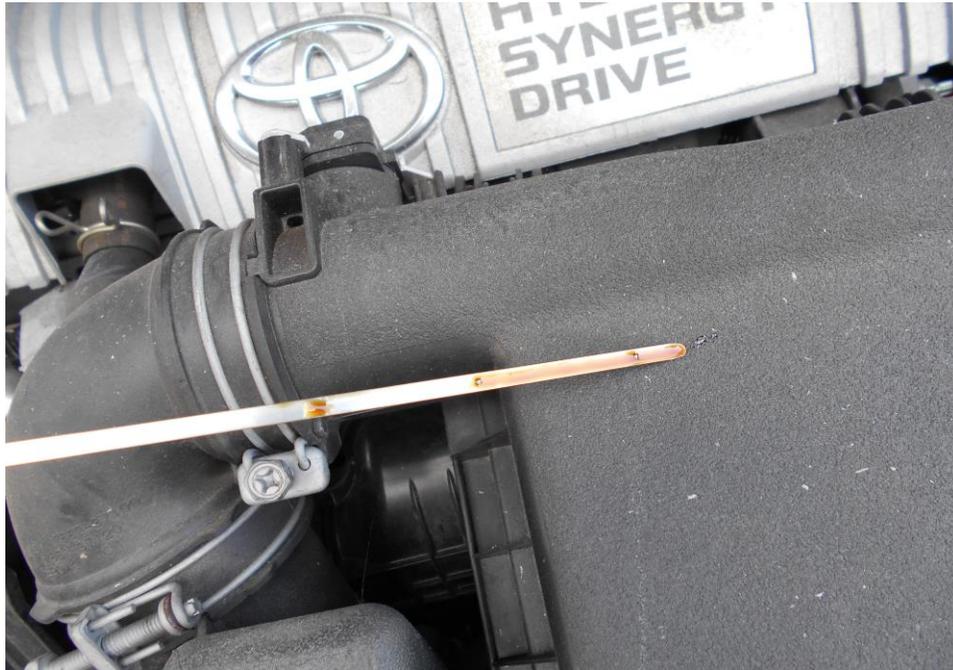
**Photo 19** shows the engine oil dip stick of the Motor Taxi at the time of our inspection. The engine oil was observed to be of sufficient level and without any visible contamination.

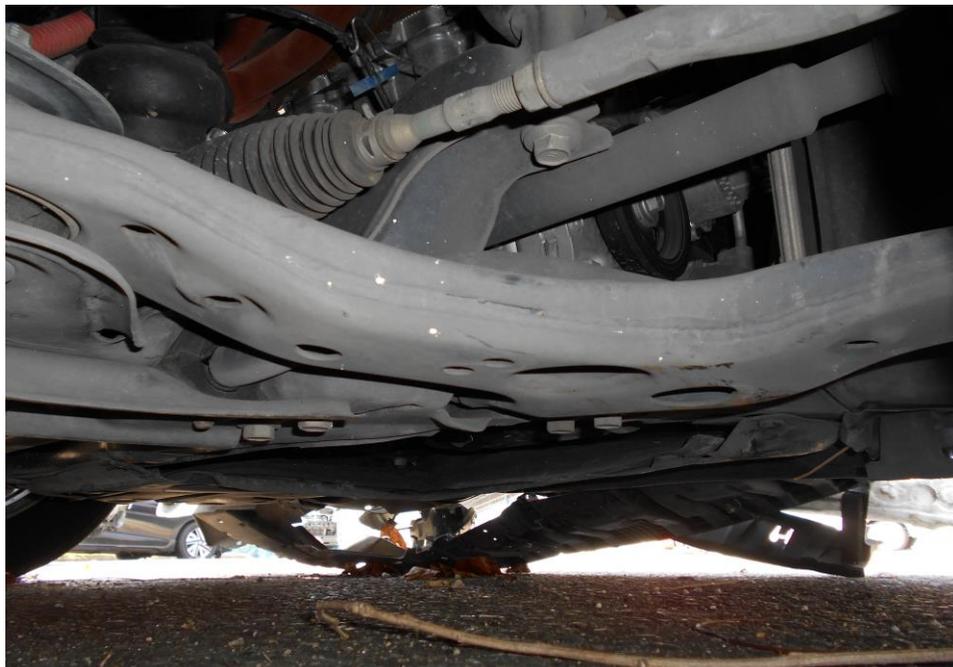
**Photo 20** shows the undercarriage of the engine area. Visually there's no sign of fluid leakage at time of our inspection. However, its undercarriage was observed to be affected by the accident's impact.

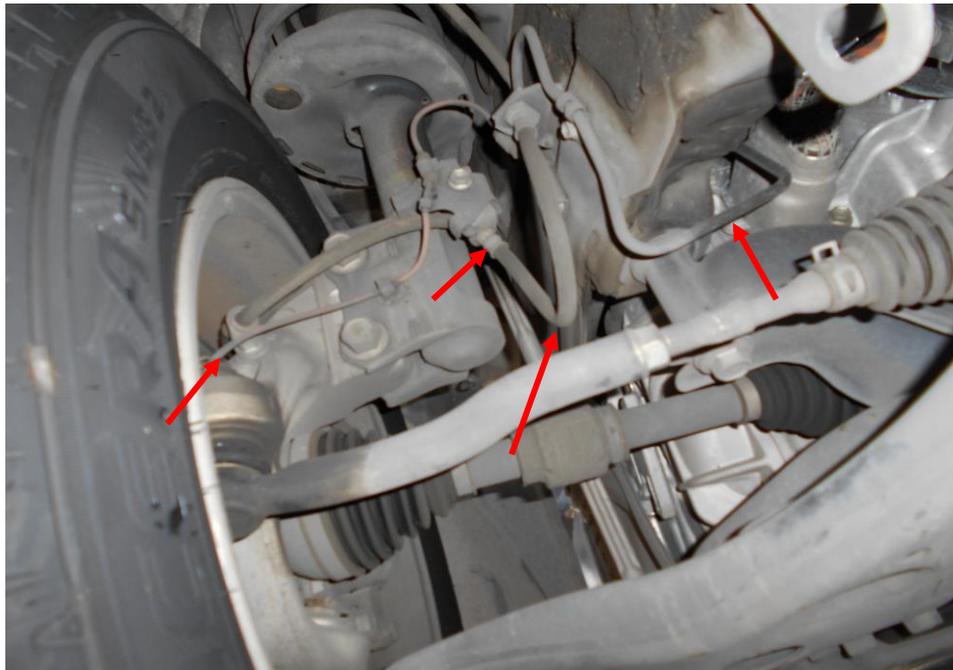
**Photo 21** shows the braking components at the front left wheel of the Motor Taxi. We did not observe any leakage of brake fluid at the time of our inspection of the Motor Car.

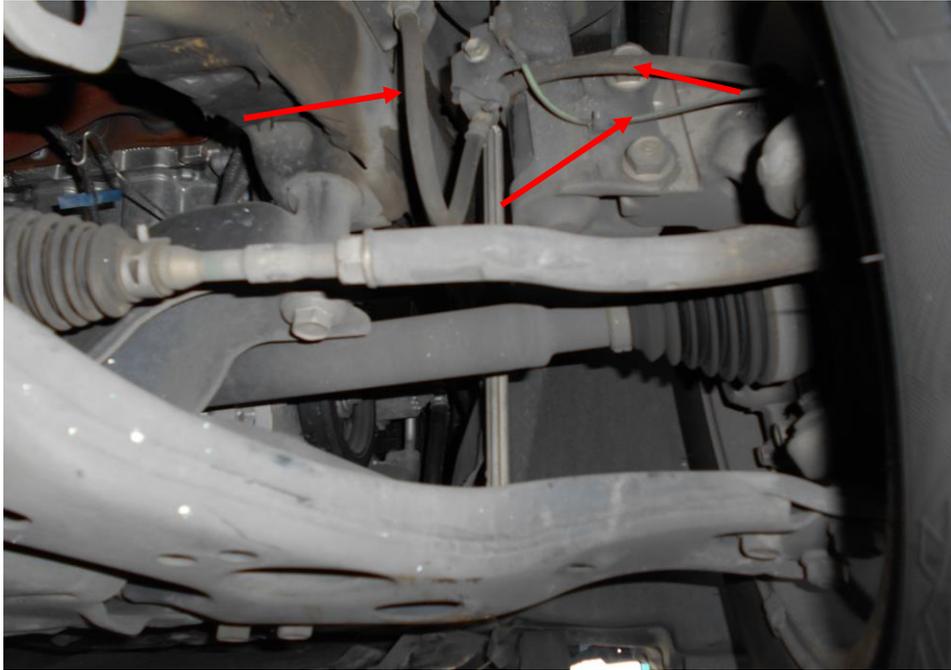
**Photo 22** shows the braking components at the front right wheel of the Motor Taxi. We did not observe any leakage of brake fluid at the time of our inspection of the Motor Taxi.

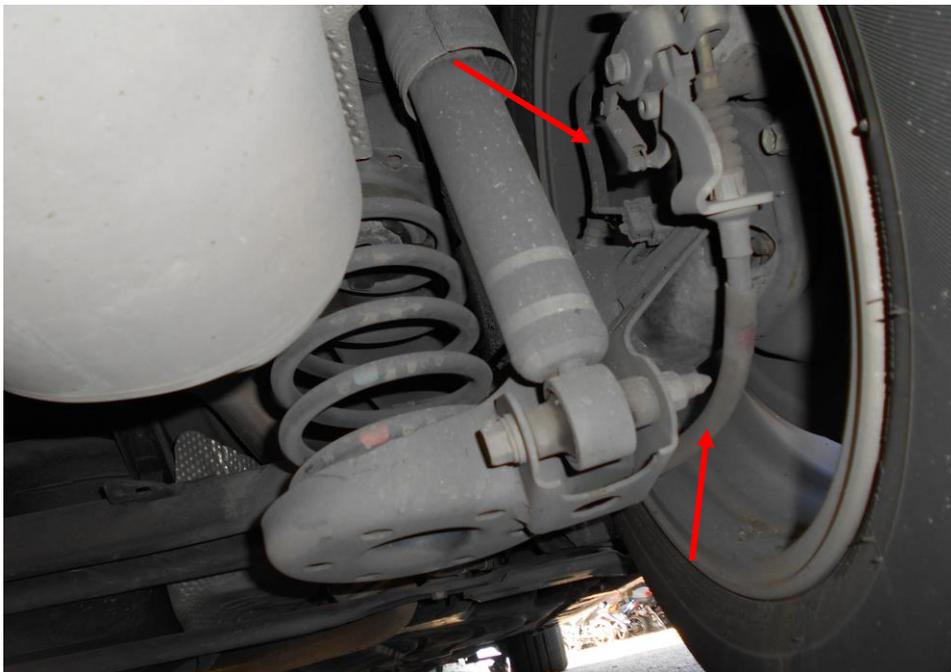
**Photo 23** shows the braking components at the rear right wheel of the Motor Taxi. We did not observe any leakage of brake fluid at the time of our inspection of the Motor Taxi.

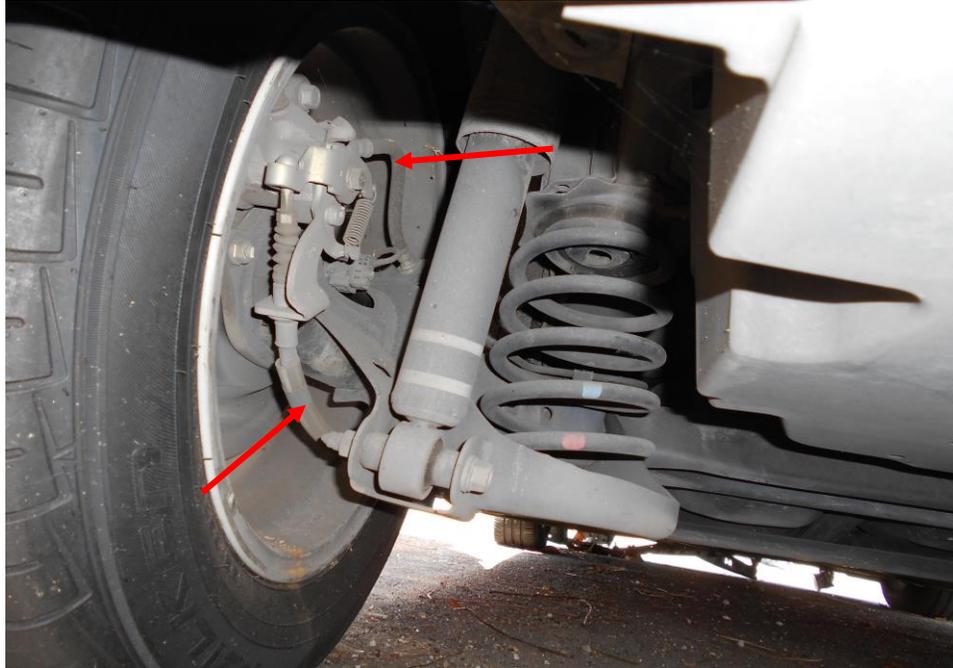
**Photo 24** shows the braking components at the rear left wheel of the Motor Taxi. We did not observe any leakage of brake fluid at the time of our inspection of the Motor Taxi.
