Your Ref: TP/IP/52309/2018
Our Ref : CI/TPD18019476/Z

11th March 2019

MECHANICAL INSPECTION REPORT OF TIPPER TRUCK XD 4360D

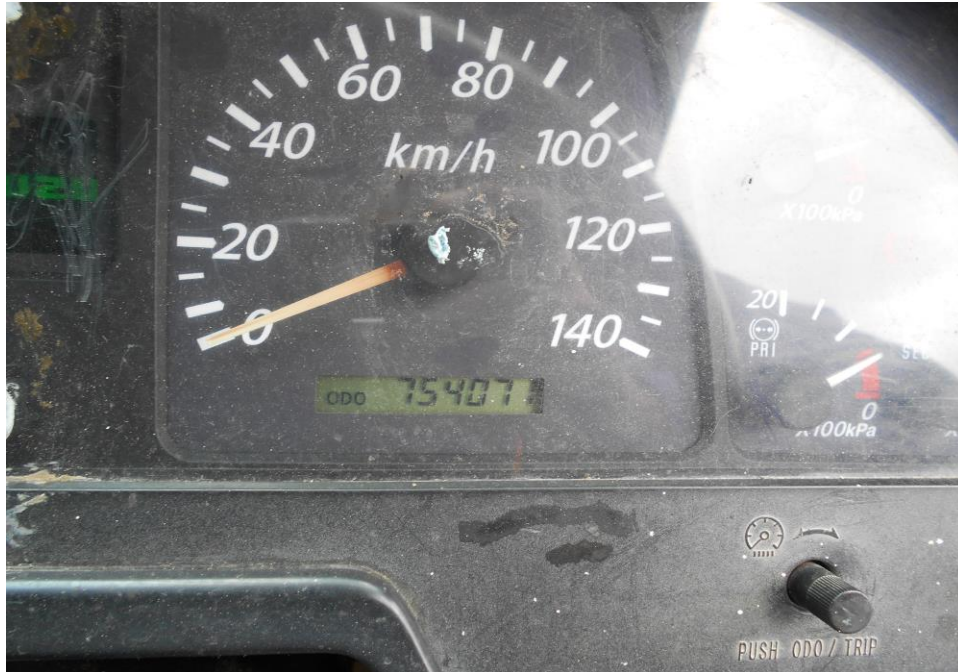
Photo 1 shows the mileage of the Tipper Truck at the time of our inspection was recorded as 754071km.

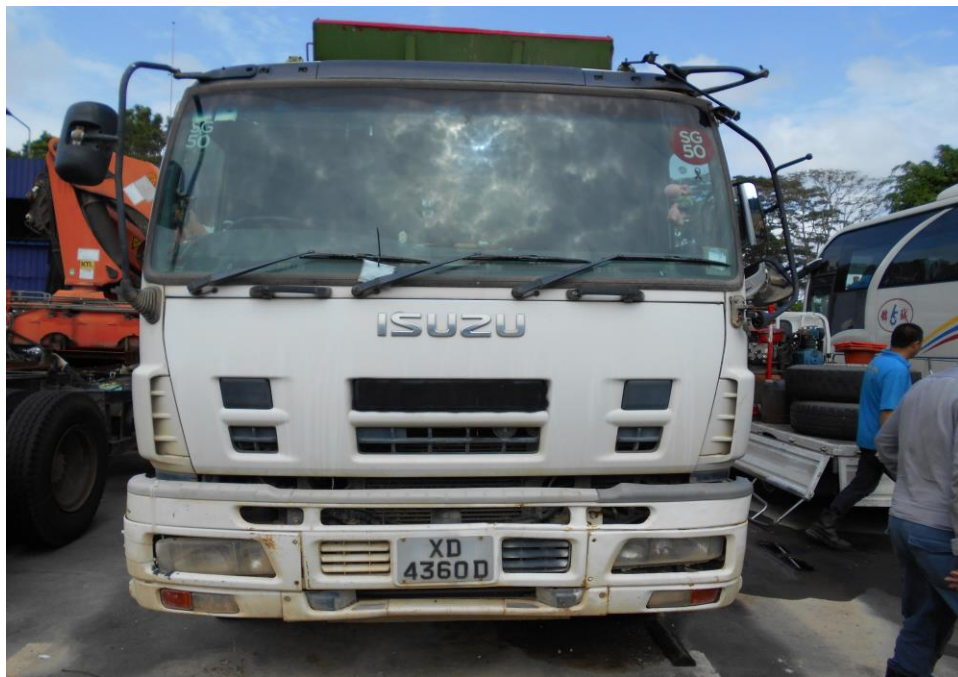
Photo 2 shows a general view of the front body of the Tipper Truck at the time of our inspection. The Tipper Truck was observed to sustain minor damages at its top left portion due to the accident impact.

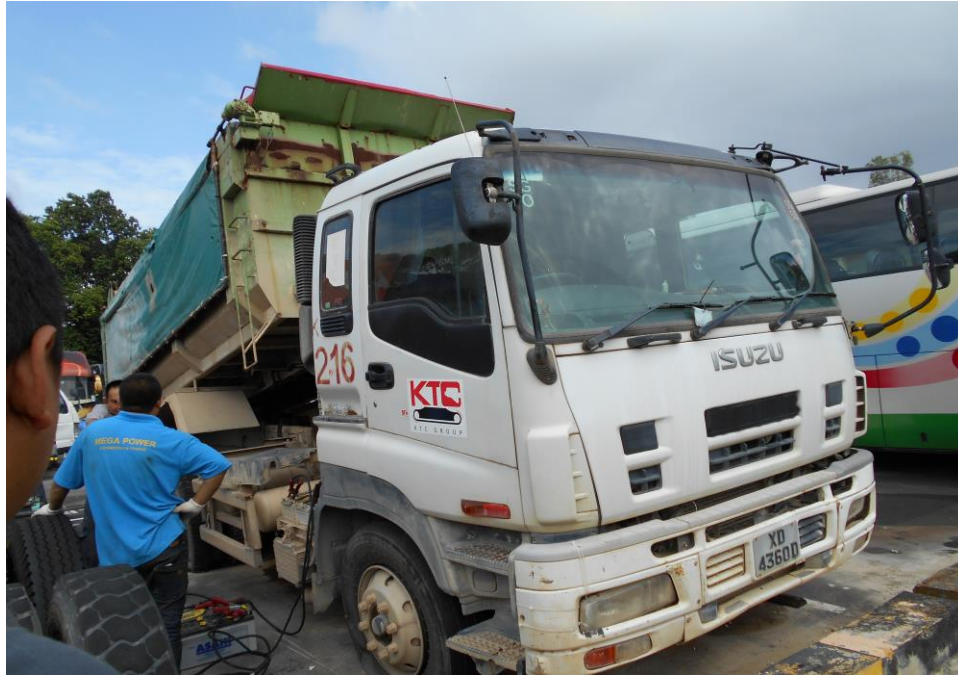
Photo 3 shows a general view of the front right body of the Tipper Truck at the time of our inspection. The Tipper Truck was observed to have no signs of fresh damages on its front portion except for rear container in recline condition due to the accident's impact.

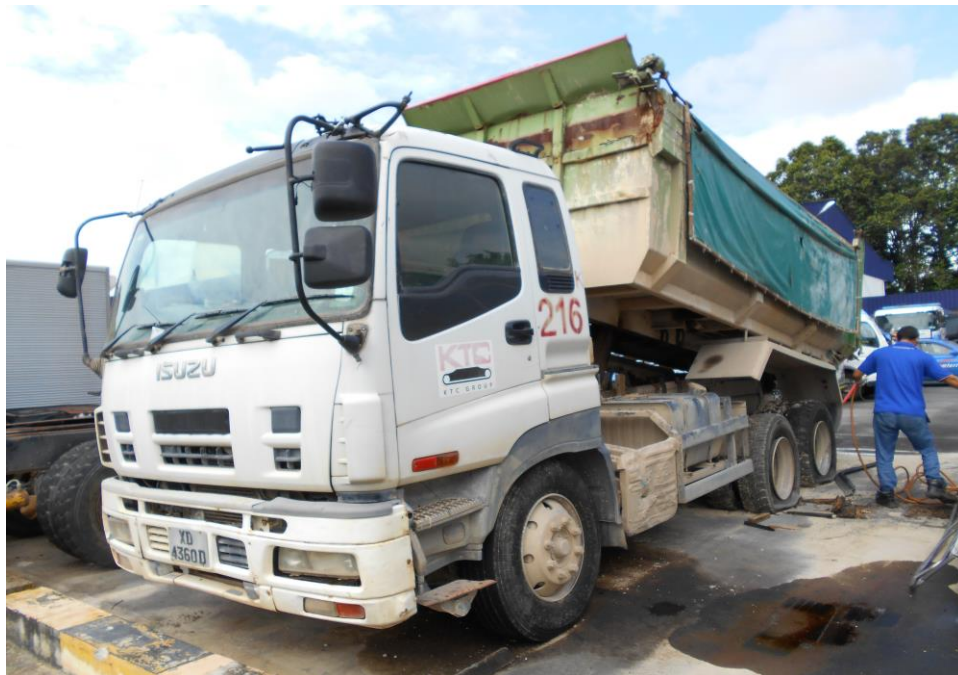
Photo 4 shows a general view of the front left body of the Tipper Truck at the time of our inspection. . The Tipper Truck was observed to have no signs of fresh damages on its front portion except for rear container in recline condition due to the accident's impact.

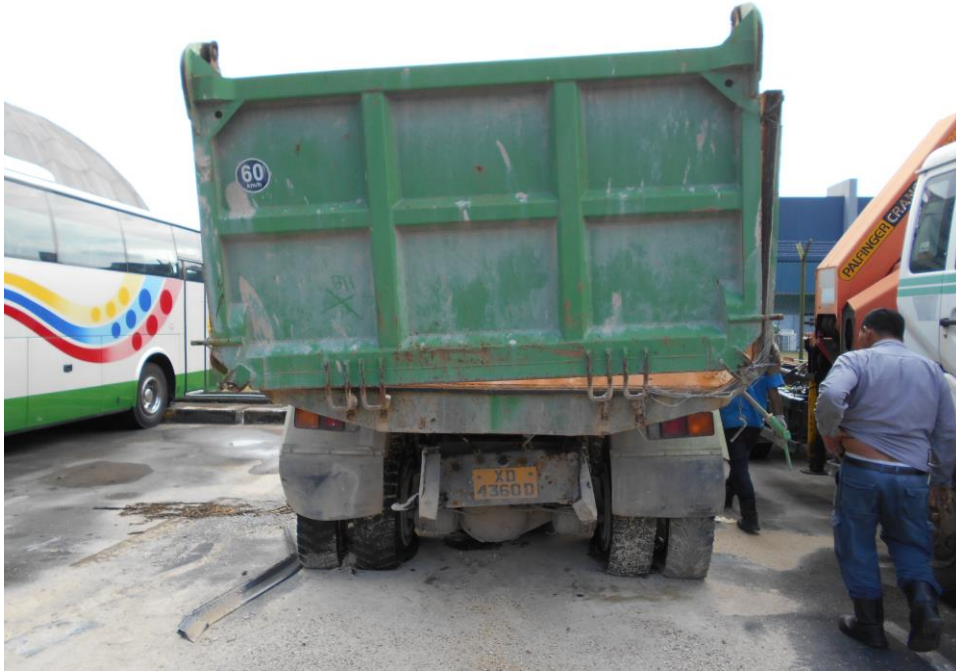
Photo 5 shows a general view of the rear body of the Tipper Truck at the time of our inspection. The Tipper Truck's rear container was observed to sustain misalignment due to the accident.

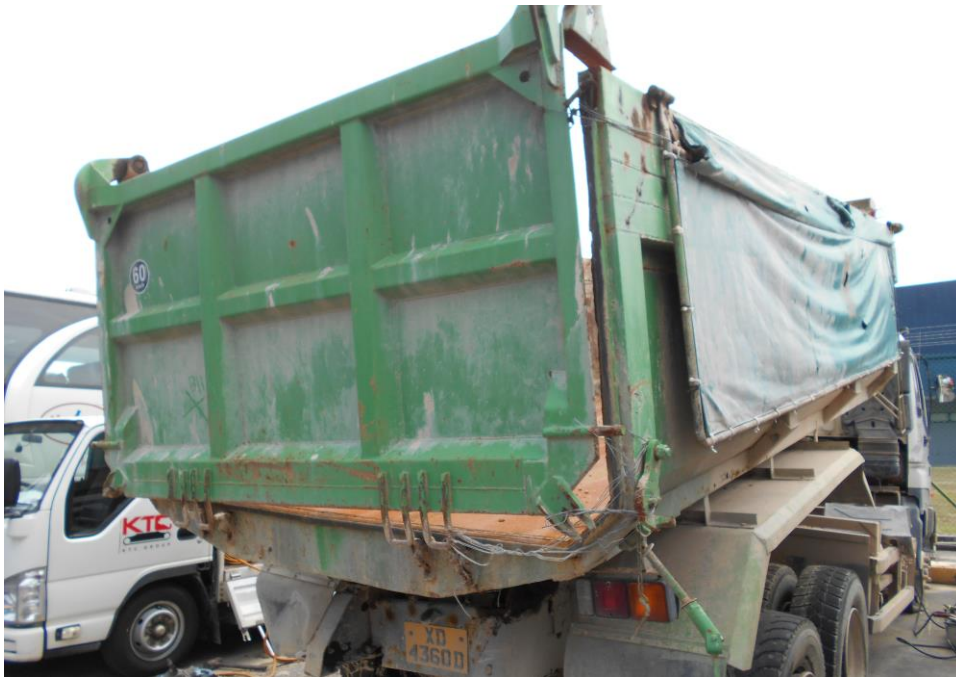
Photo 6 shows a general view of the rear right body of the Tipper Truck at the time of our inspection. The Tipper Truck was observed to have no signs of fresh damages on its front portion except for rear container in recline condition and misaligned due to the accident's impact.

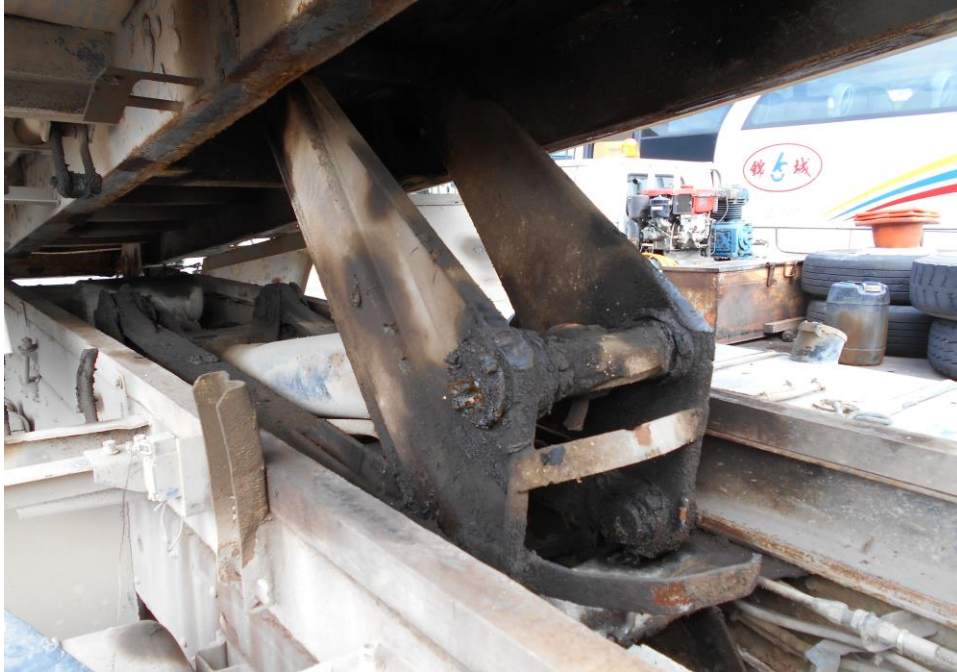
Photo 7 shows a semi close-up view of the damaged bracket for the rear container due to the accident's impact.

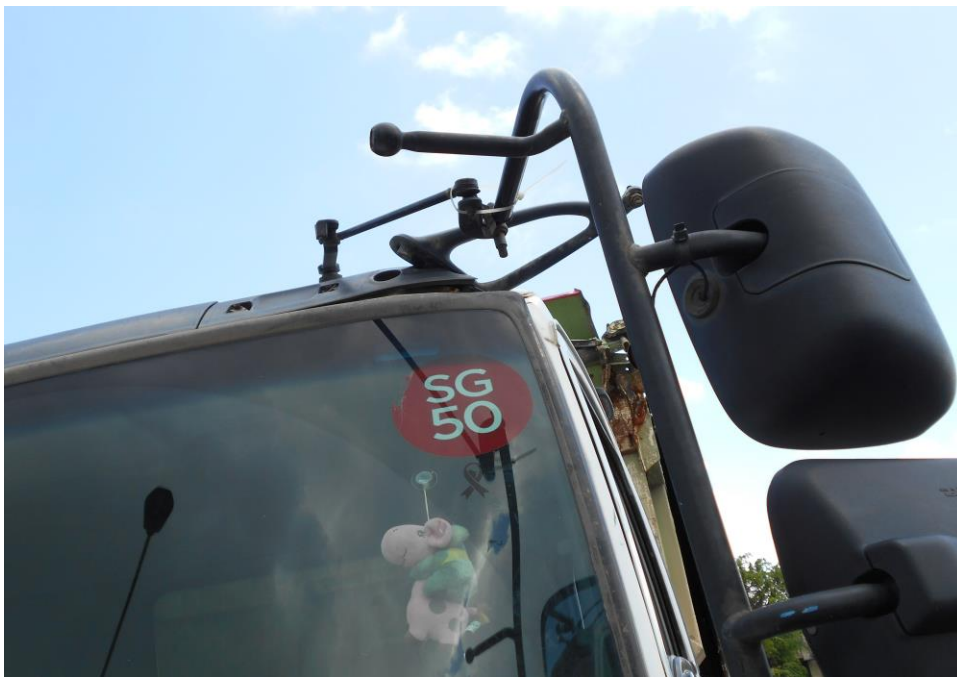
Photo 8 shows a semi close-up view of the damaged top left portion due to the accident's impact.

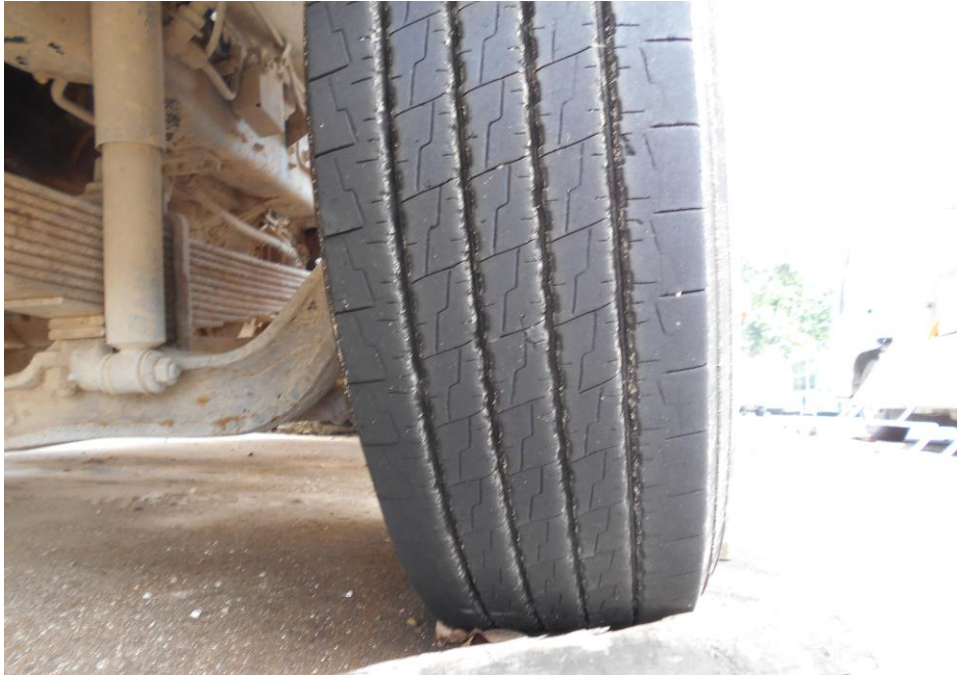
Photo 9 shows the condition of the front left tyre of the Tipper Truck, which was observed to be in serviceable condition with remaining tread depth of approximately 7mm.

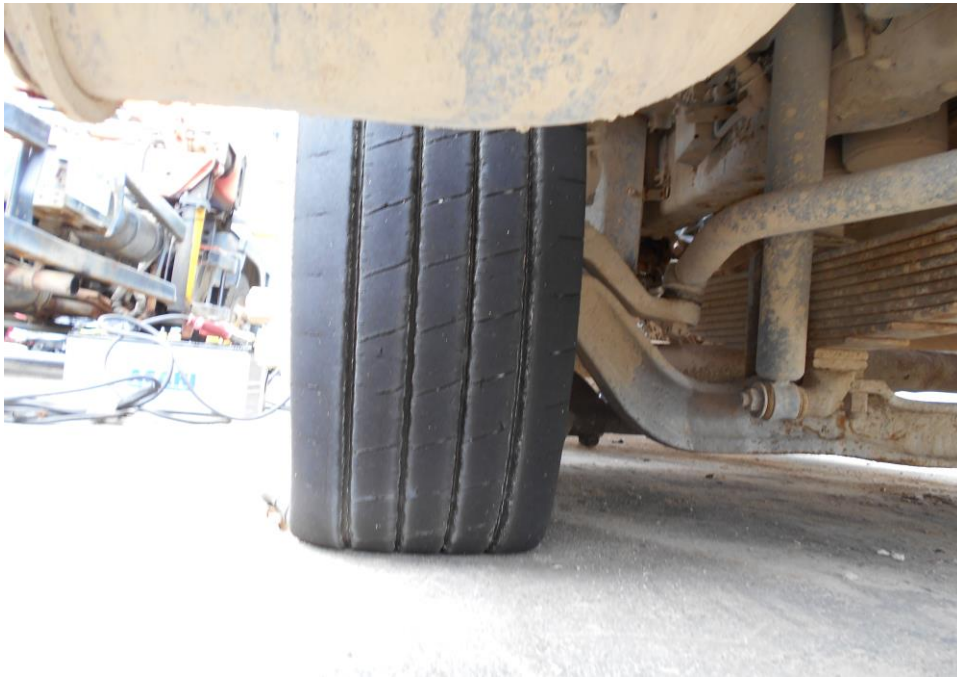
Photo 10 shows the condition of the front right tyre of the Tipper Truck, which was observed to be in serviceable condition with remaining tread depth of approximately 7mm.

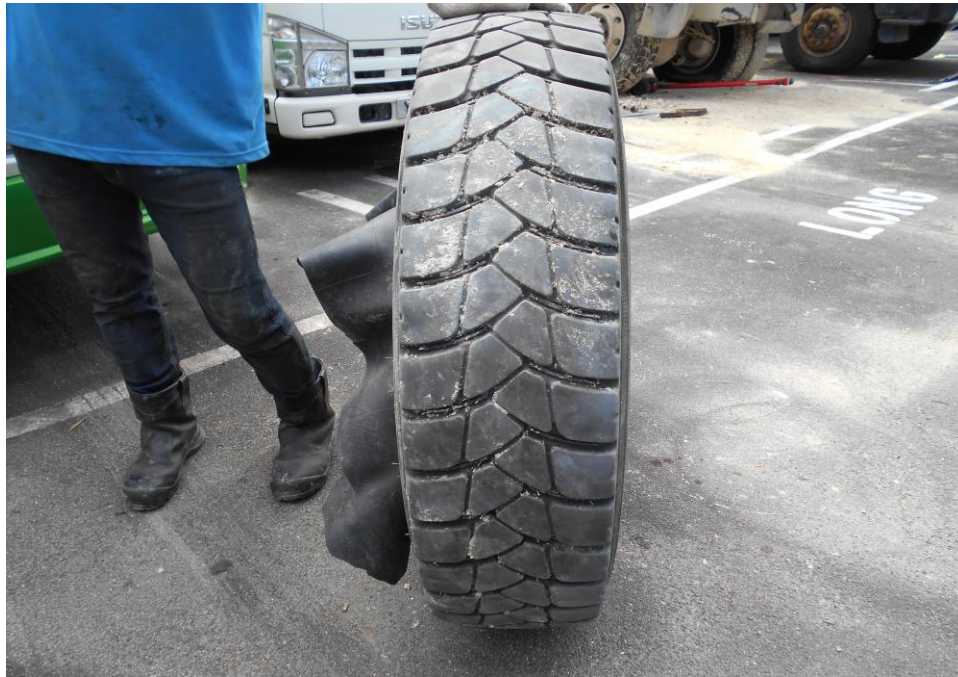
Photo 11 shows the condition of the rear left tyres of the Tipper Truck, which were observed to be in serviceable condition with remaining tread depth of approximately 8mm. The tyres were also observed to be sufficiently inflated for vehicular operation.

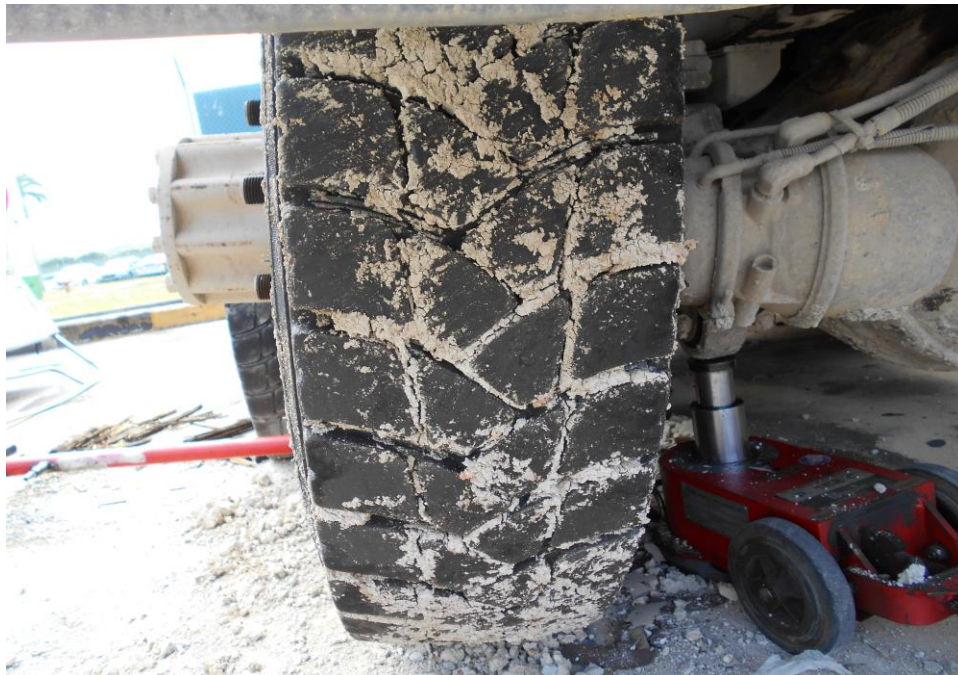
Photo 12 shows the condition of the rear left tyres of the Tipper Truck, which were observed to be in serviceable condition with remaining tread depth of approximately 8mm. The tyres were also observed to be sufficiently inflated for vehicular operation.

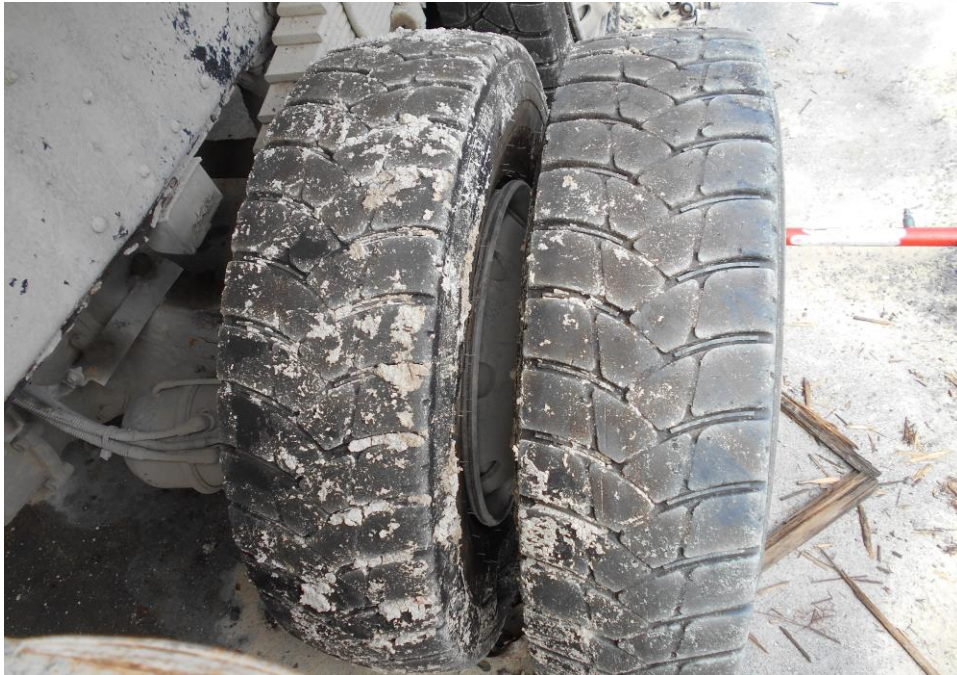
Photo 13 shows the condition of the rear left tyres (centre axle) of the Tipper Truck, which were observed to be in serviceable condition with remaining tread depth of approximately 7mm. The tyres were also observed to be sufficiently inflated for vehicular operation.

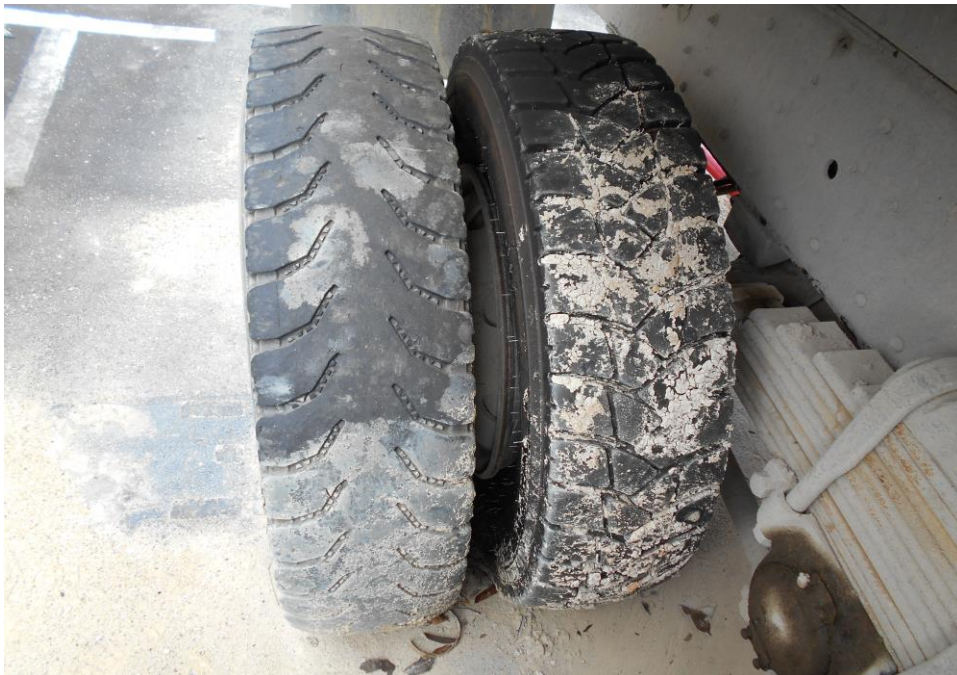
Photo 14 shows the condition of the rear right tyres of the Tipper Truck, which were observed to be in serviceable condition with remaining, tread depth of approximately 6mm. The tyres were also observed to be sufficiently inflated for vehicular operation with no tear, cut or burst mark(s) on the outer and the inner sidewalls.

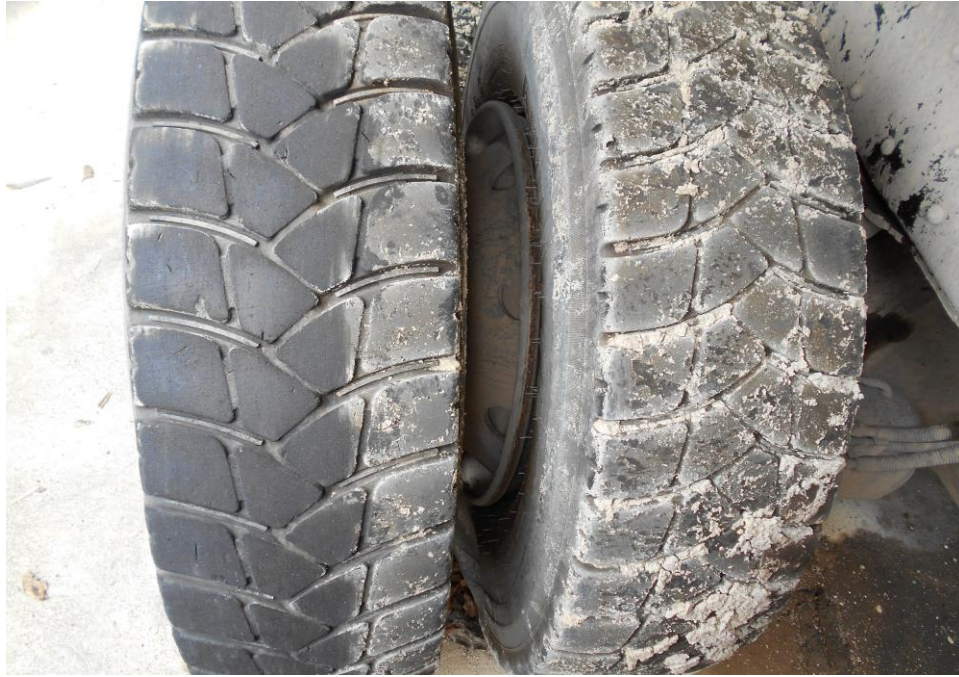
Photo 15 shows the condition of the rear right tyres (centre axle) of the Tipper Truck, which were observed to be in serviceable condition with remaining, tread depth of approximately 8mm. The tyres, which were wrapped around standard alloy wheel rims, were also observed to be sufficiently inflated for vehicular operation.

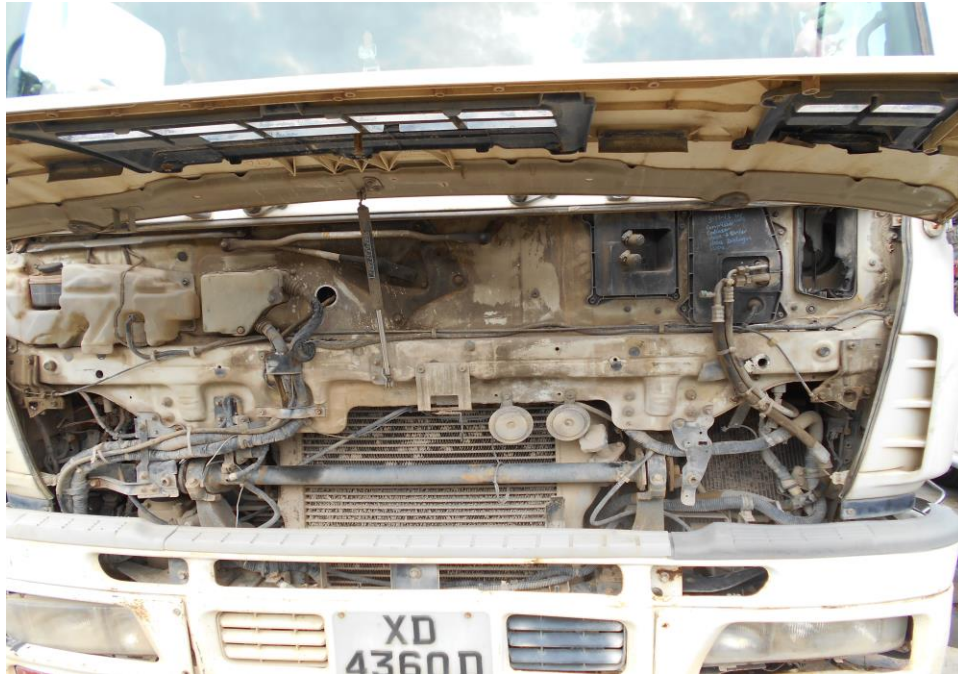
Photo 16 shows a general view of the engine compartment area from the front bonnet of the Tipper Truck. It was observed to be intact and unaffected by the collision. There was also no sign(s) or indication(s) of fluid leak and/or fluid stain found.

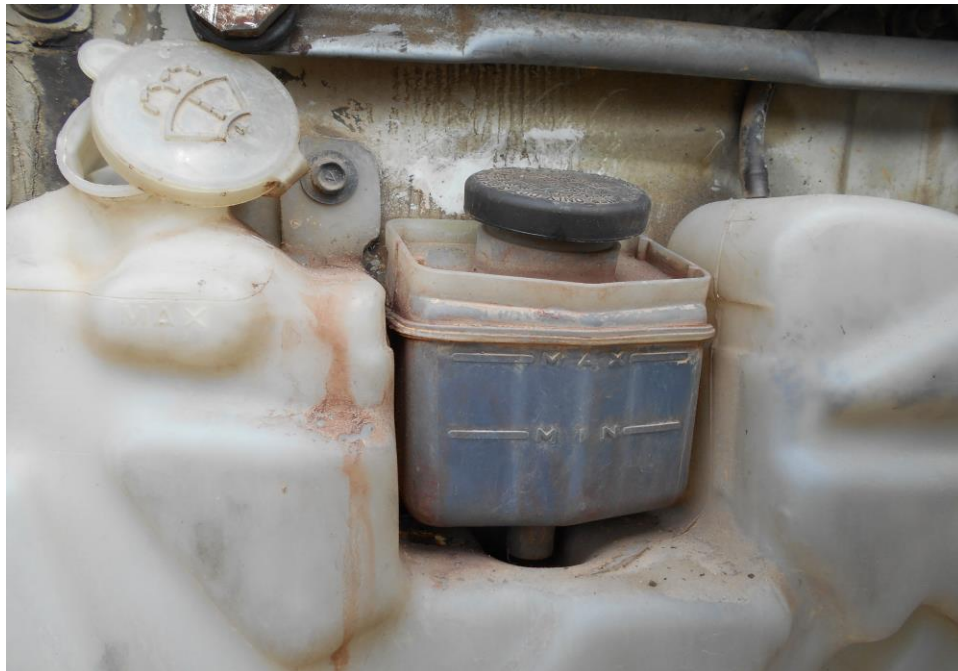
Photo 17 shows a close-up view of the clutch fluid. It was observed to be at sufficient level without any contamination.

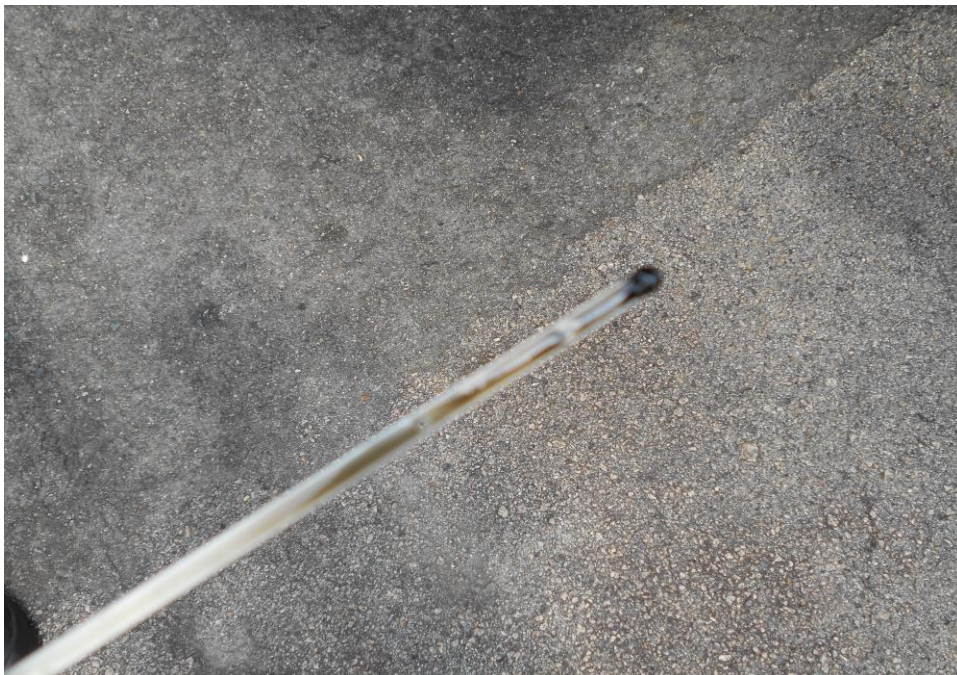
Photo 19 shows a close-up view of the dip stick which indicated the engine fluid was at a sufficient level for operational purposes.

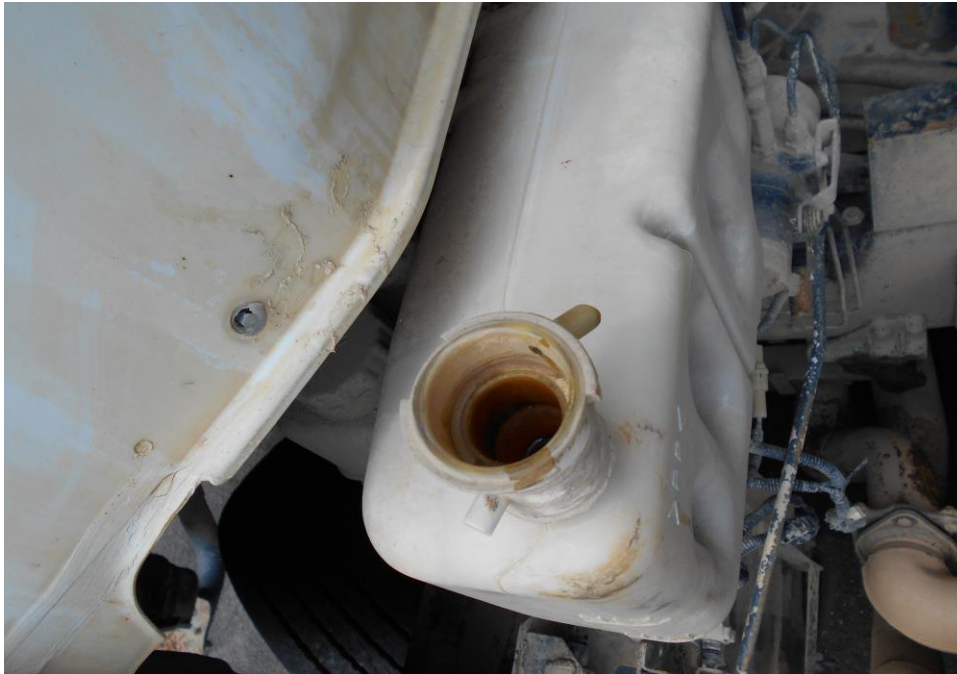
Photo 20 shows the engine coolant reservoir of the Tipper Truck at the time of our inspection. The engine coolant was observed to be of sufficient level and without any visible contamination for operational purposes.

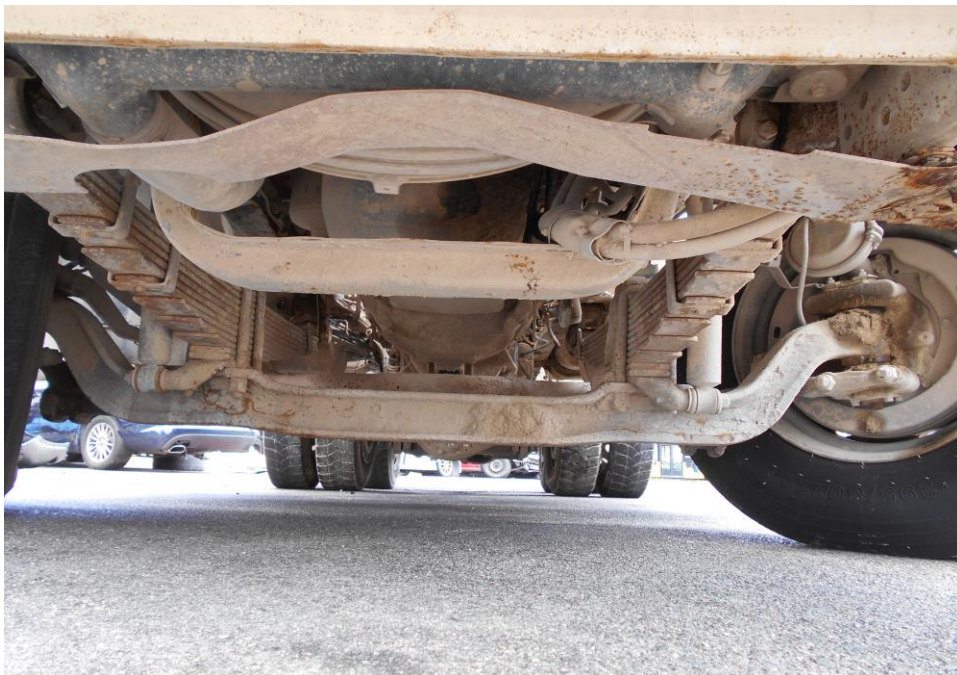
Photo 21 shows a general view of the undercarriage at the engine compartment area of the Tipper Truck. It was observed to be intact and unaffected by the collision. There was also no sign(s) or indication(s) of fluid leak and/or fluid stain found.

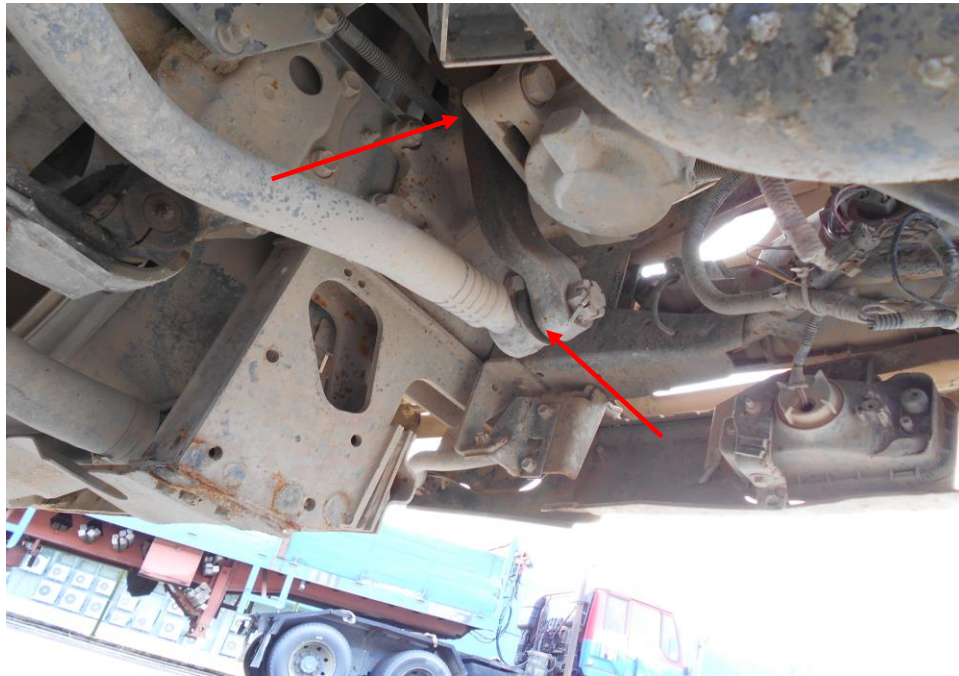
Photo 22 shows some of the mechanical components (arrowed) of the Tipper Truck's steering system. Our visual checks on the various mechanical components of the steering system revealed all to be intact and in good condition. The steering system of the Tipper Truck is hence likely to be in serviceable condition at the time of accident.

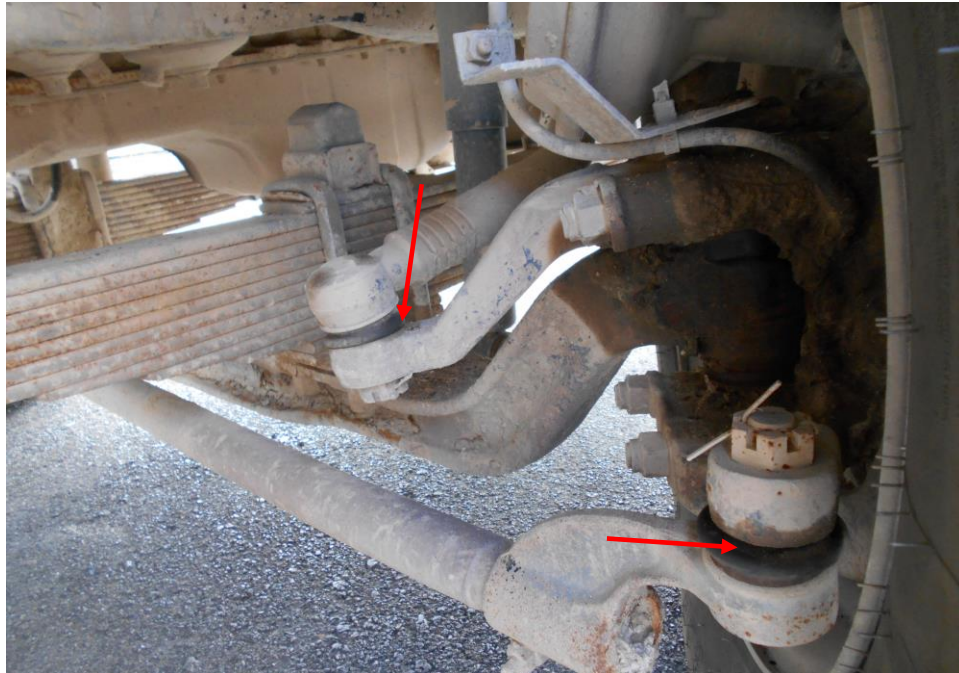
Photo 23 shows the undercarriage components at the front right wheel of the Tipper Truck. The various undercarriage components of the Tipper Truck were all observed to be intact and without any visible damage. This had included the steering rack and steering linkages (arrowed) of the Tipper Truck.

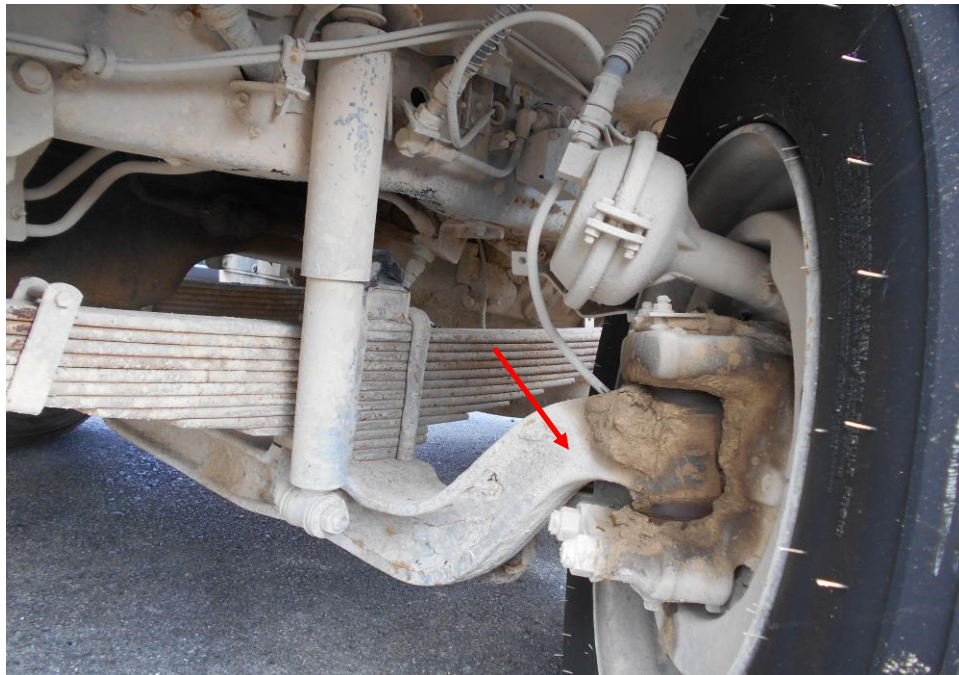
Photo 24 shows the undercarriage components at the front left wheel of the Tipper Truck. The various undercarriage components of the Tipper Truck were all observed to be intact and without any visible damage. This had included the steering rack (arrowed) of the Tipper Truck, which was observed to be securely attached to the front left wheel and front right wheel.

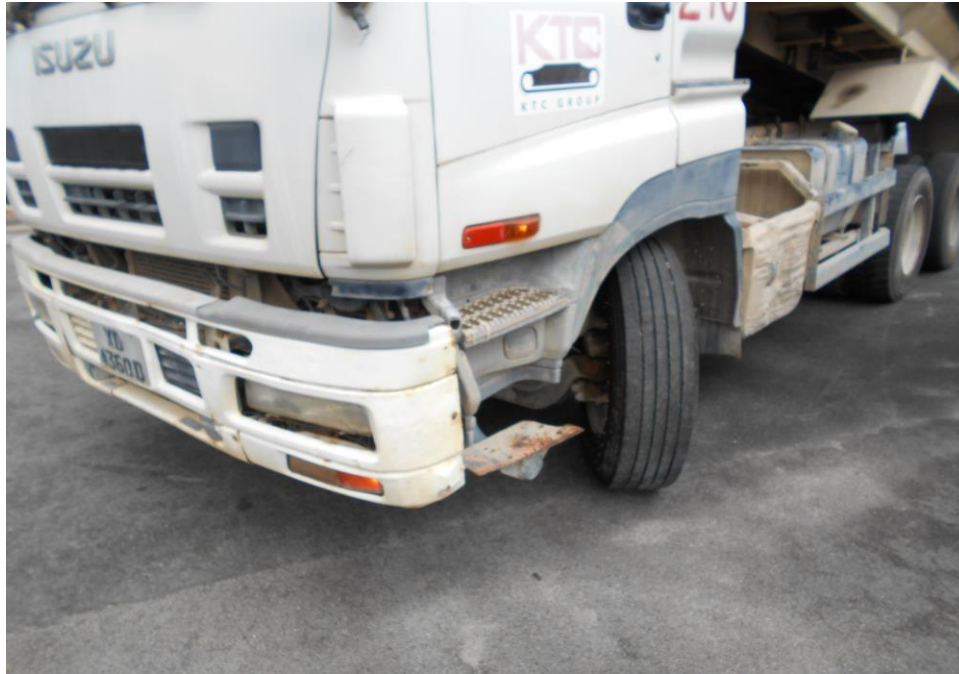
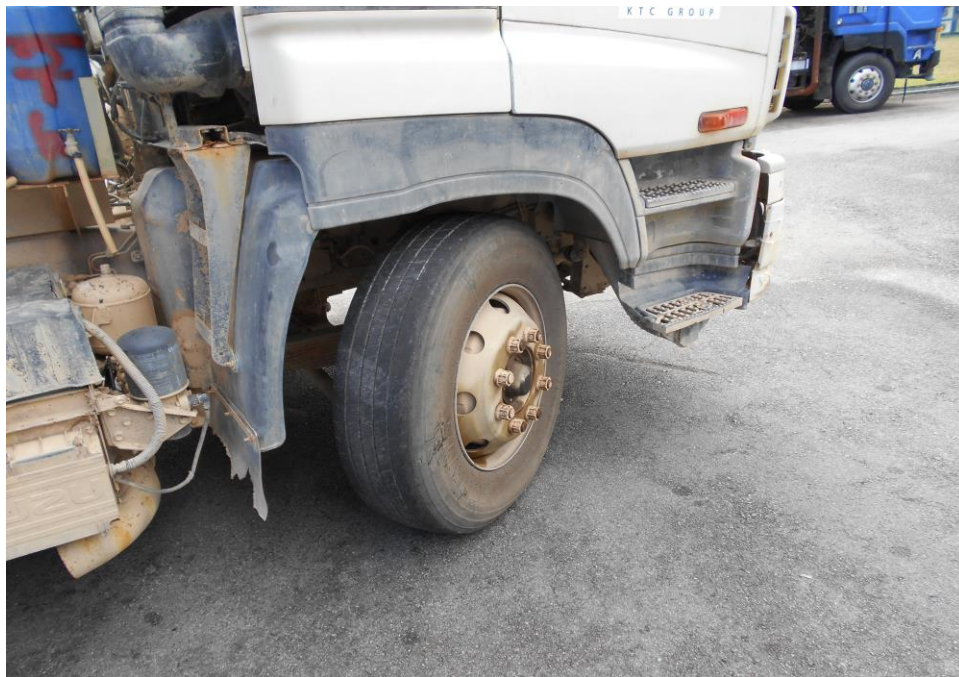
Photo 25 shows that we did not experience any abnormal free play and/or other resistance when turning the steering wheel left and right to full lock positions.

Photo 26 shows that we did not experience any abnormal free play and/or other resistance when turning the steering wheel left and right to full lock positions.

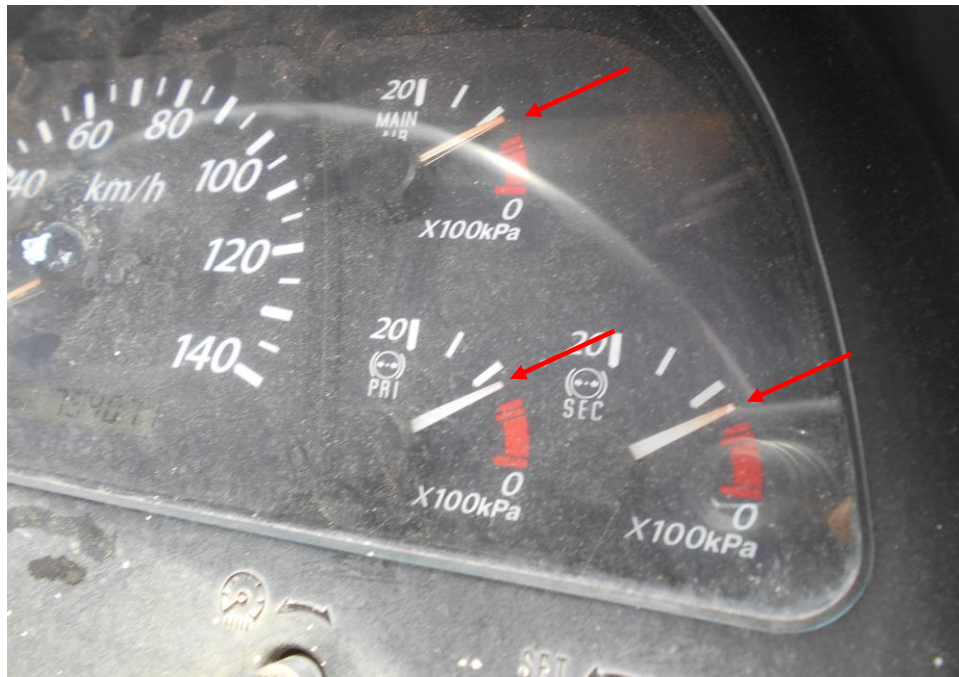
Photo 27 shows the compressed air meters for braking system. This shows that there's no dropped of pressure. Hence, revealed that no air leakage at the time of our inspection.

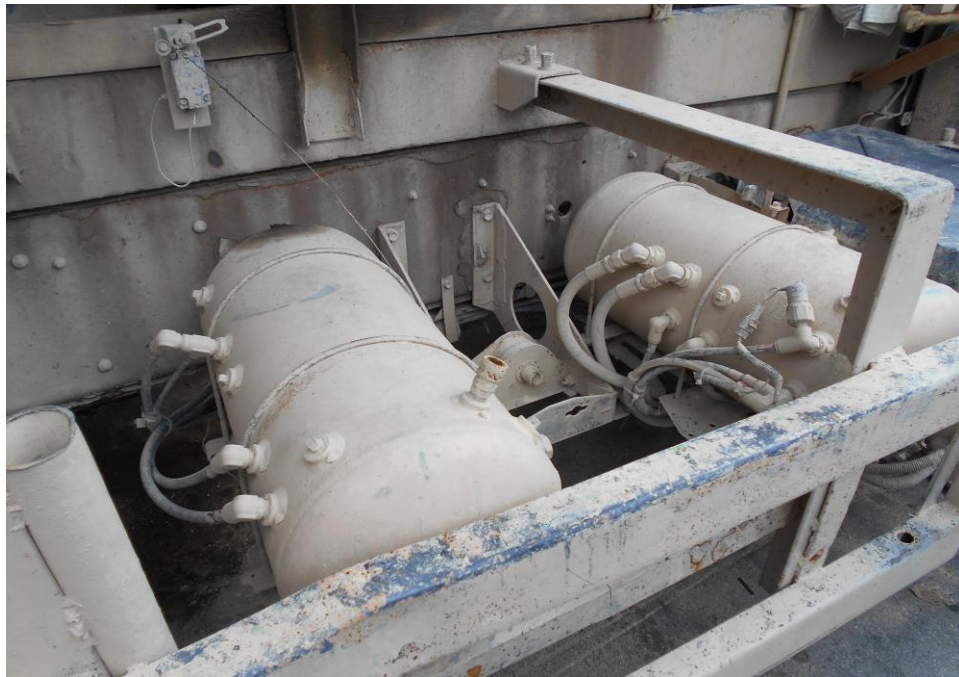
Photo 28 shows the air tanks, valves, pipes and hoses, which are some of the components for the air-assisted braking system of the Tipper Truck. These components were mainly located around the right centre body of the Tipper Truck, and were unaffected by the accident.

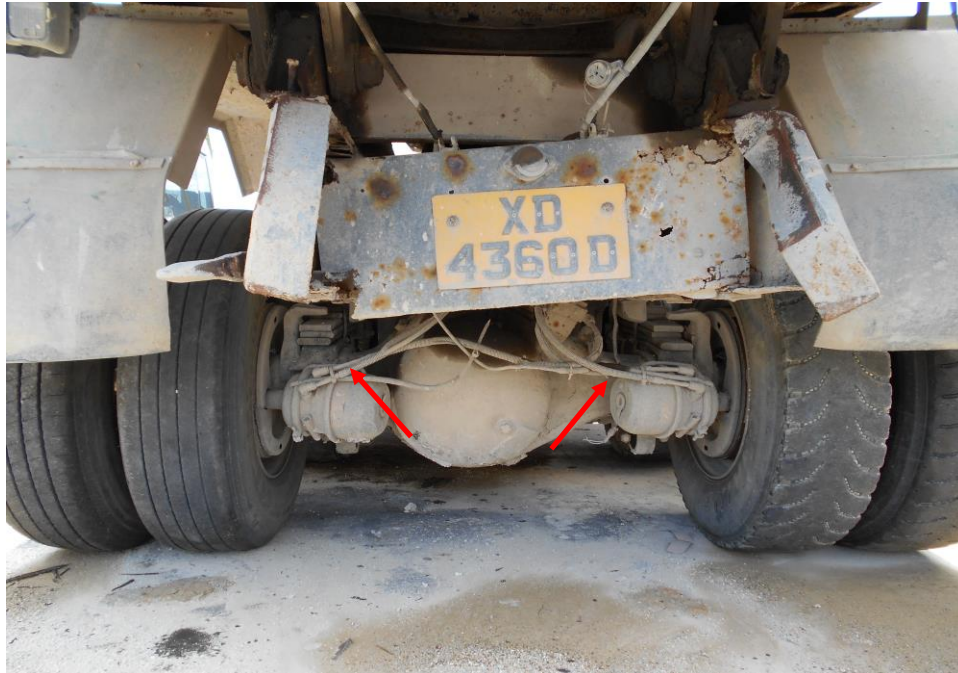
Photo 29 shows the brake hoses (arrowed) leading to the rear left wheel and rear right wheel of the Tipper Truck. At the time of our inspection, the various mechanical components of the air-assisted hydraulic braking system of the Tipper Truck were all found to be in good general condition and securely fitted.

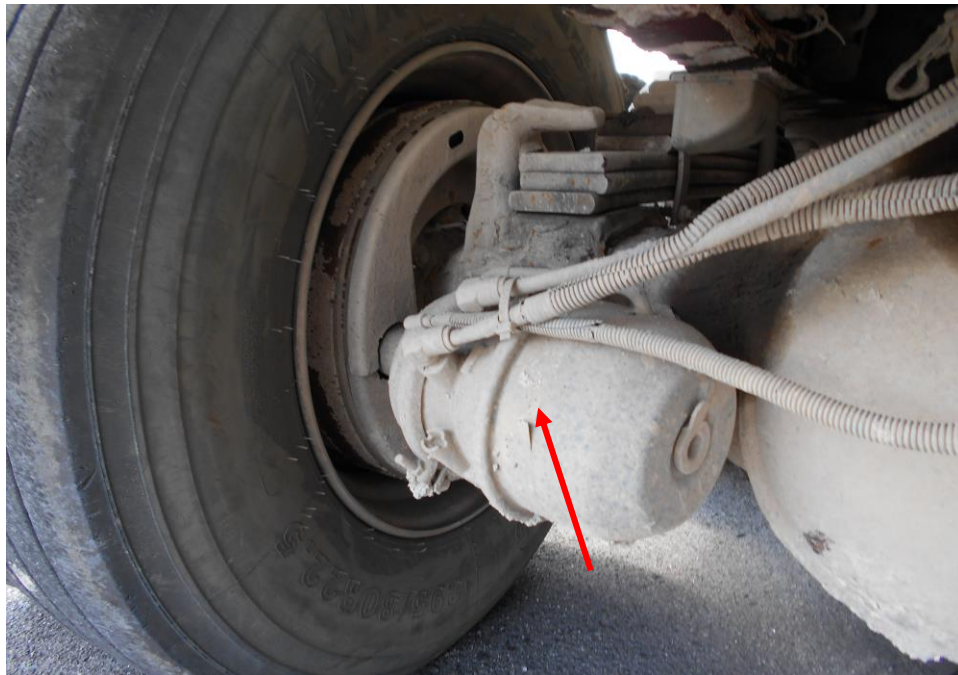
Photo 30 shows the brake air cylinder (arrowed) at the rear left rear wheel of the Tipper Truck. Such air cylinder, which is amongst the various components for the air-assisted hydraulic braking system, can be found attached to all the front wheels and all the rear wheels of the Tipper Truck. Upon our checks, we had found all the brake air cylinders to be undamaged and securely fitted to all the wheels of the Tipper Truck.

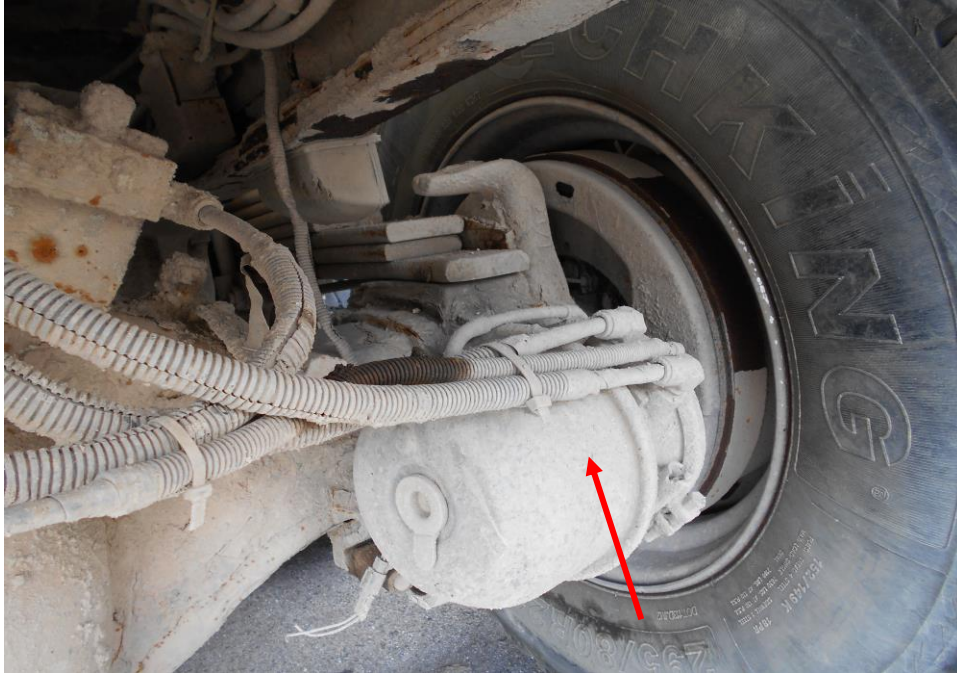
Photo 31 shows the brake air cylinder (arrowed) at the rear right rear wheel of the Tipper Truck. Such air cylinder, which is amongst the various components for the air-assisted hydraulic braking system, can be found attached to all the front wheels and all the rear wheels of the Tipper Truck. Upon our checks, we had found all the brake air cylinders to be undamaged and securely fitted to all the wheels of the Tipper Truck.

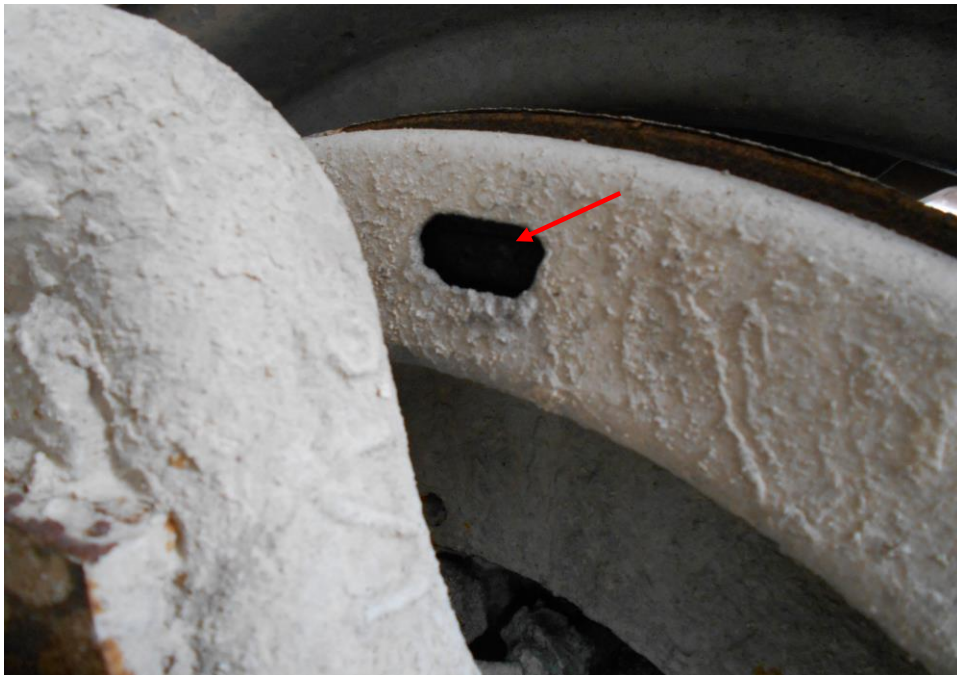
Photo 32 shows the brake shoes (brake pads) at the rear left wheel (rear axle) of the Tipper Truck. The brake shoes (brake pads) of the Tipper Truck were all found to be in serviceable condition with sufficient frictional material for operational purposes.
