Your Ref: TP/IP/52309/2018
Our Ref : CI/TPD18019476/Z

11th March 2019

MECHANICAL INSPECTION REPORT OF TIPPER TRUCK XD 4360D

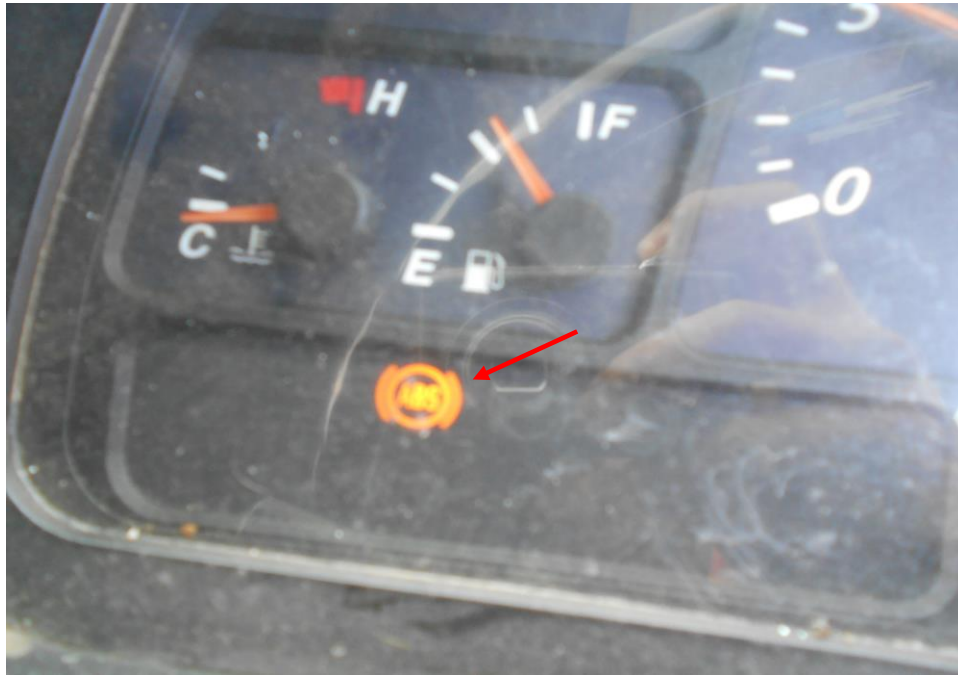
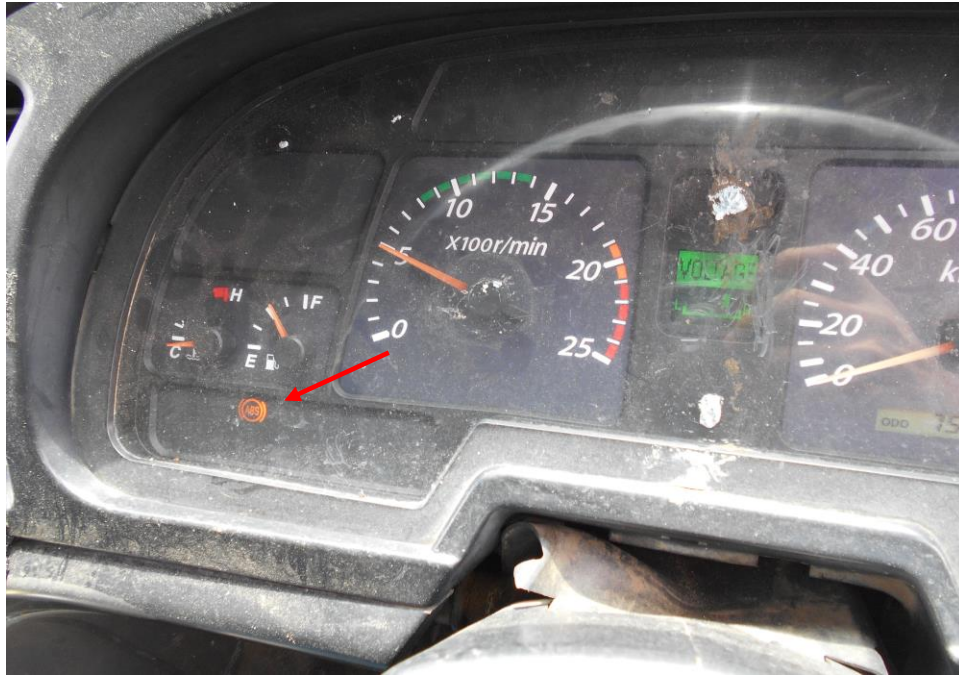
Photo 33 shows the warning indicator for Anti-Brake Lock System (ABS) was observed to be lighted up during cranking & after engine was in idling speed.

Photo 34 shows the warning indicator for Anti-Brake Lock System (ABS) was observed to be lighted up during cranking & after engine was in idling speed.

27. The Anti-Brake Lock System (ABS) indicator was noted to stay lighted up even after the engine was in idling speed. This would indicate that there was an electronic fault to the Anti-Brake Lock System (ABS). Further investigation found that the ABS wiring which was located at the rear area was noted to be cut off likely due to the daily heavy operations and environment. However, we are of the opinion that this did not cause and/or contributed to the accident as the braking system was still able to function normally.

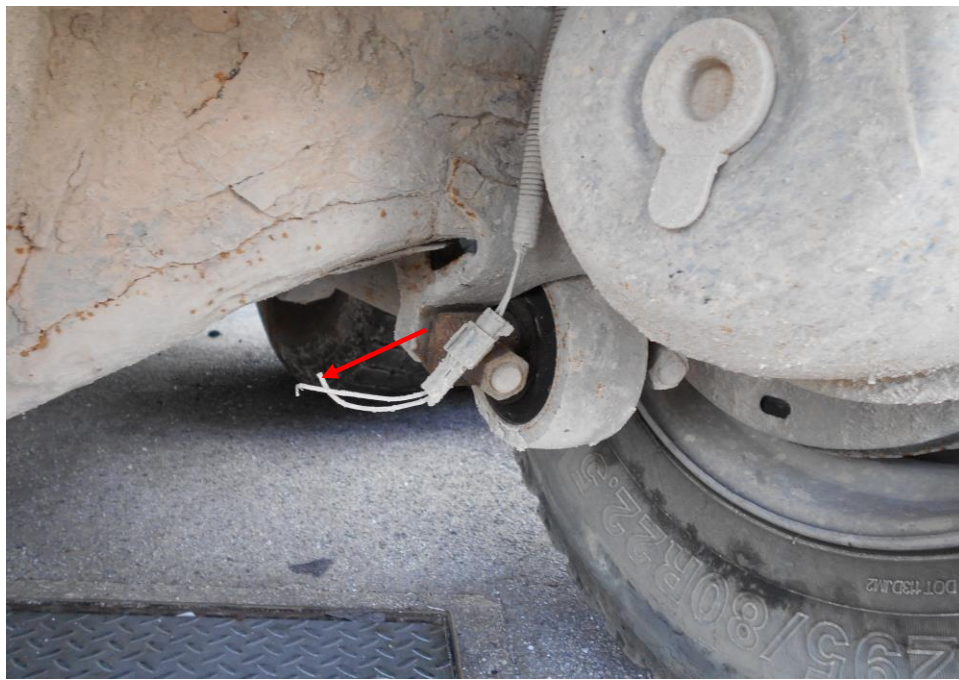
Photo 35 shows the cut off ABS wires found dangling at the rear right wheel area of the Tipper Truck.

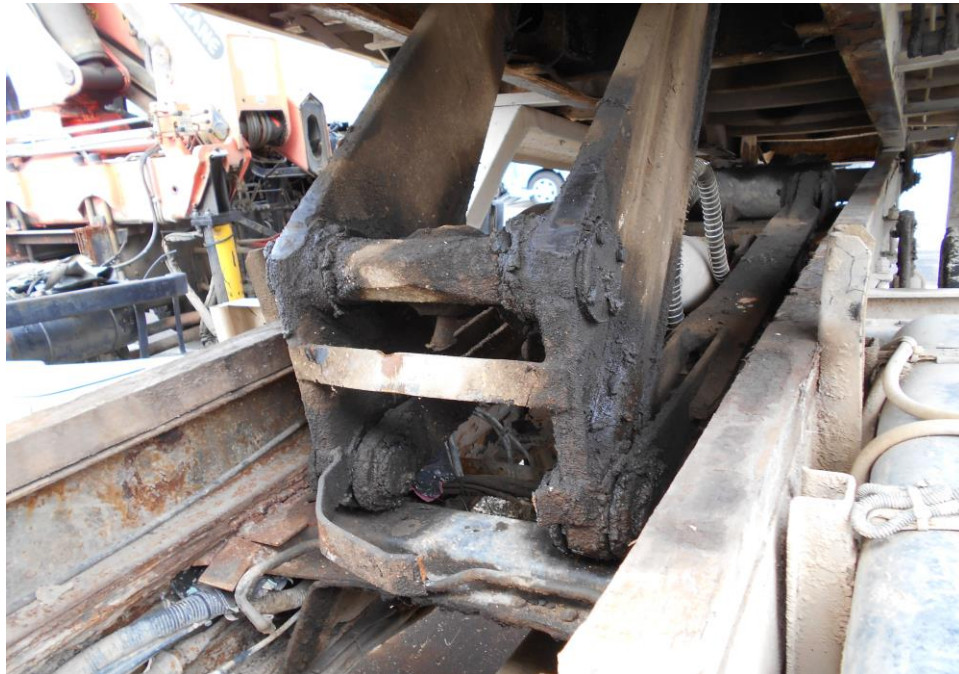
24. Further investigation reveals that the rear compartment hydraulic system & supporting mechanical compartment was damaged due to the accident's impact. We were hence unable to conduct any test on the operational of the rear compartment. The accident had caused the rear compartment hydraulic system to be in a state of immobility. See photo 37 below.

Photo 37 shows a close-up view of the damaged hydraulic system which immobilized the operational of the rear compartment.
