Your Ref: TP/IP/43847/2018
Our Ref : CI/TPD18019477/Z

08th March 2019

MECHANICAL INSPECTION REPORT OF MOTOR LORRY YM 5327K

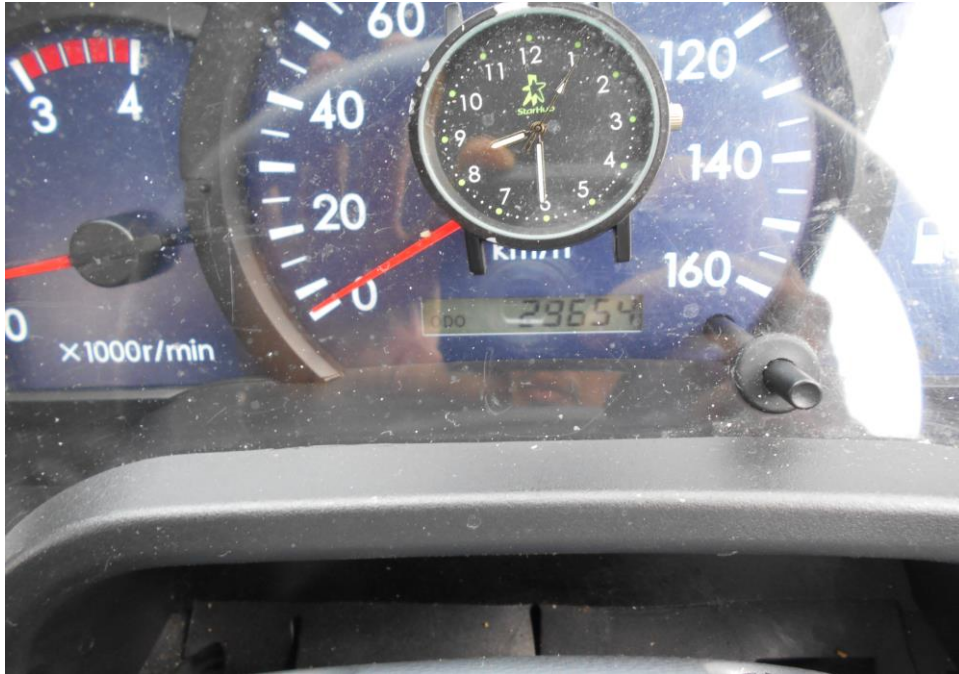
4. The mileage of the Motor Lorry at the time of our inspection was recorded as 29654km.
5. The Motor Lorry was observed to have sustained minor damages at the rear left portion of the Motor Lorry due to the accident's impact collision. The damages were consists of rear tail lamp, rear wooden panel, rear wooden panel structure frame and rear crash bar amongst others.
6. This was likely due to the consistency of the accident's case facts that a Motor Car was driving along Nicoll Highway towards Guillemard Road on the 1st lane of 3 lanes road when his front right portion collided onto the rear left of stationary Motor Lorry whom had stopped for traffic related works at L/P 23/1. See photo 1 to 6 below.

Photo 1 shows the mileage of the Motor Lorry at the time of our inspection was recorded as 29654km.

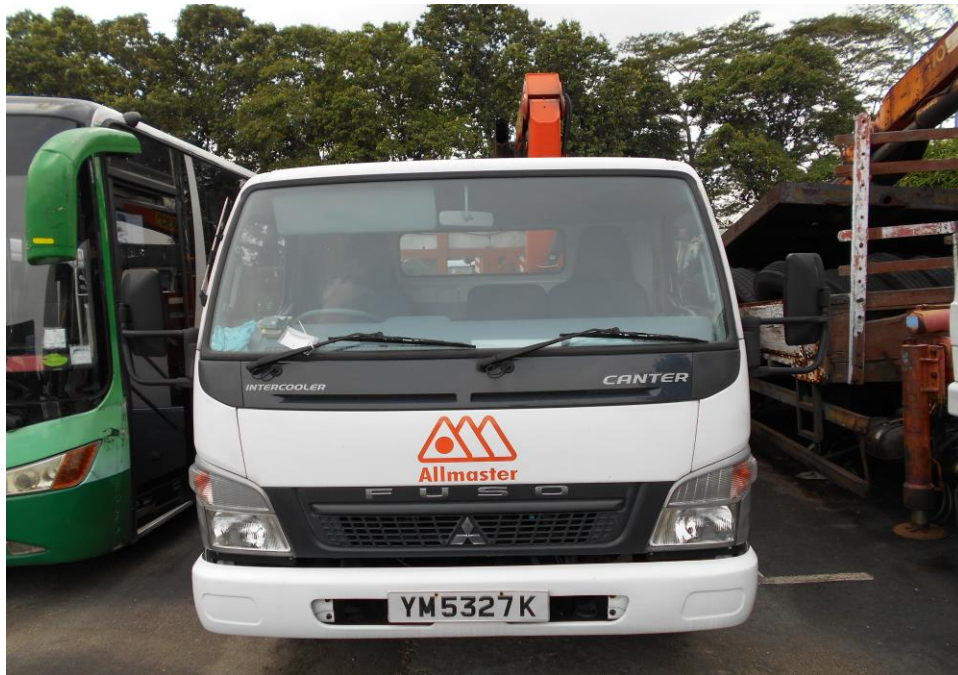
Photo 2 shows a general view of the front portion of the Motor Lorry at the time of our inspection. The Motor Lorry's front portion was observed to be in good condition unaffected by the accident.

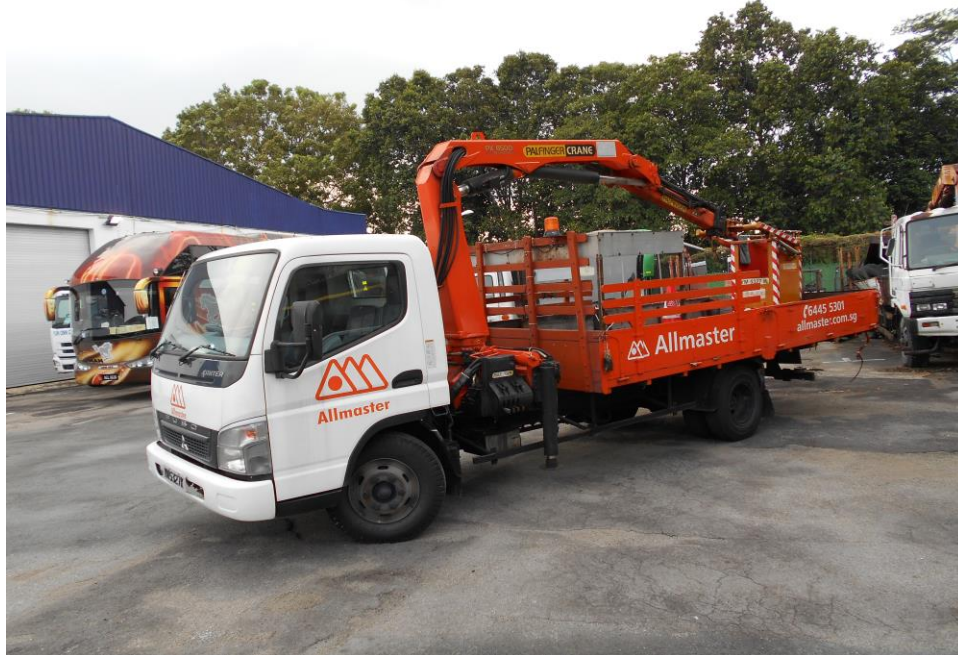
Photo 3 shows a general view of the front left of the Motor Lorry at the time of our inspection. The Motor Lorry was observed to be in good condition unaffected by the accident.

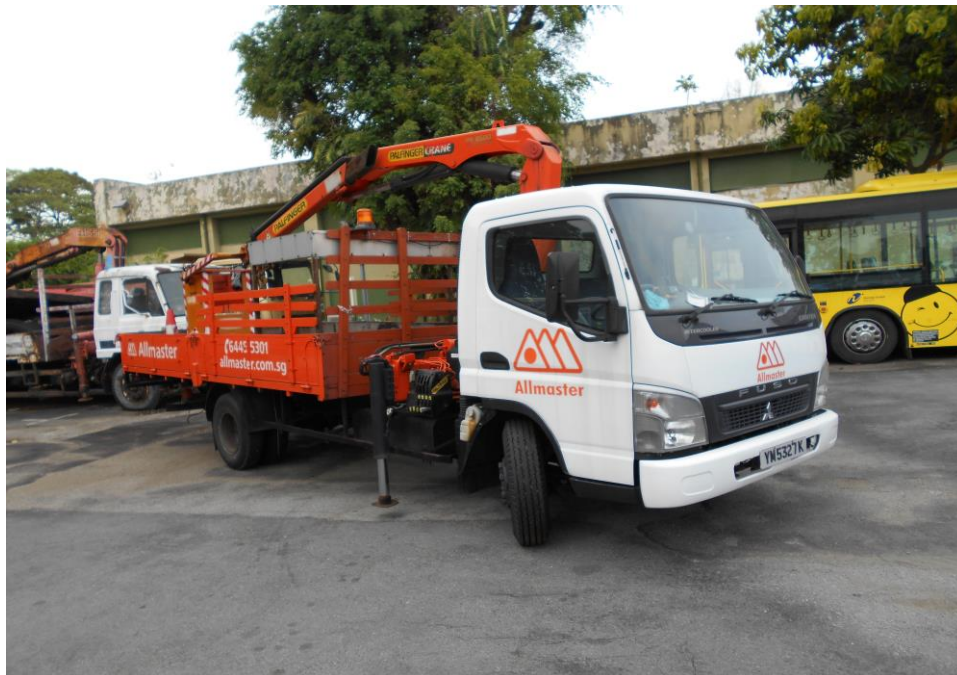
Photo 4 shows a general view of the front right of the Motor Lorry at the time of our inspection. The Motor Lorry was observed to be in good condition unaffected by the accident.

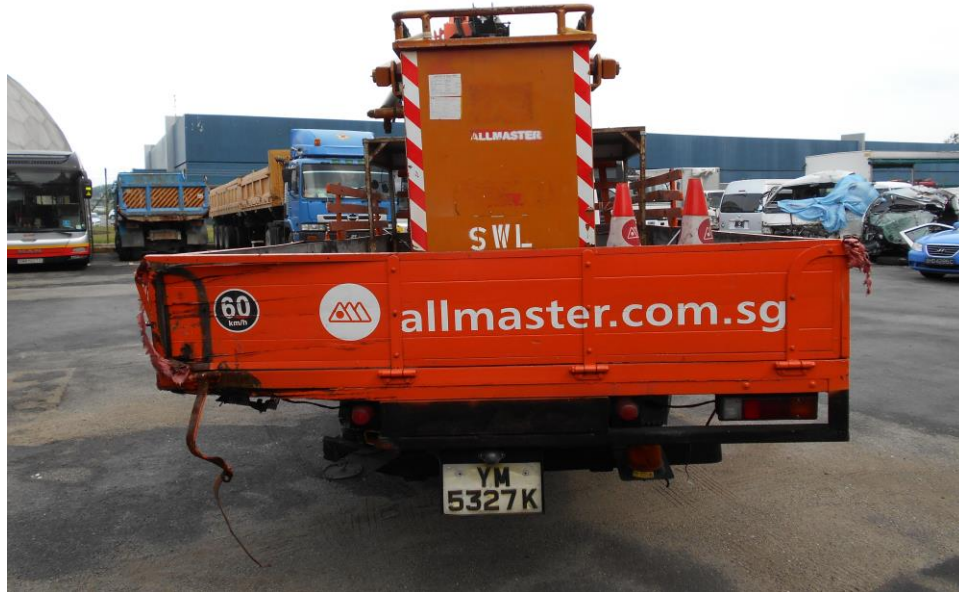
Photo 5 shows a general view of the Motor Lorry's rear body at the time of our inspection. It was observed to sustained damages at the rear left portion of Motor Lorry as a result of the accident.

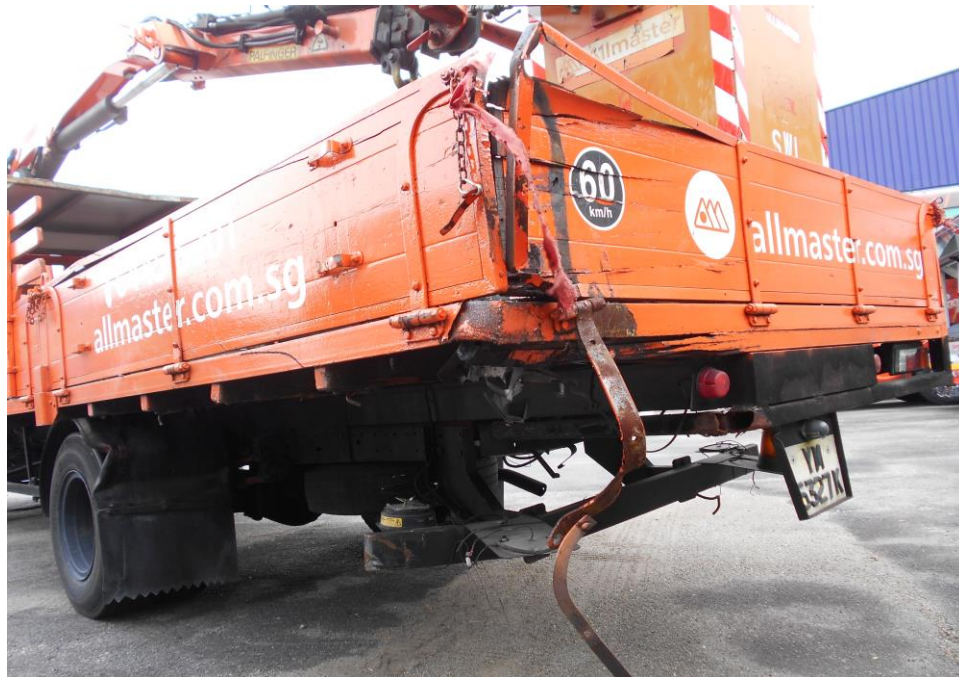
Photo 6 shows a general view of the Motor Lorry's rear body at the time of our inspection. It was observed to sustained damages at the rear left portion of Motor Lorry as a result of the accident.

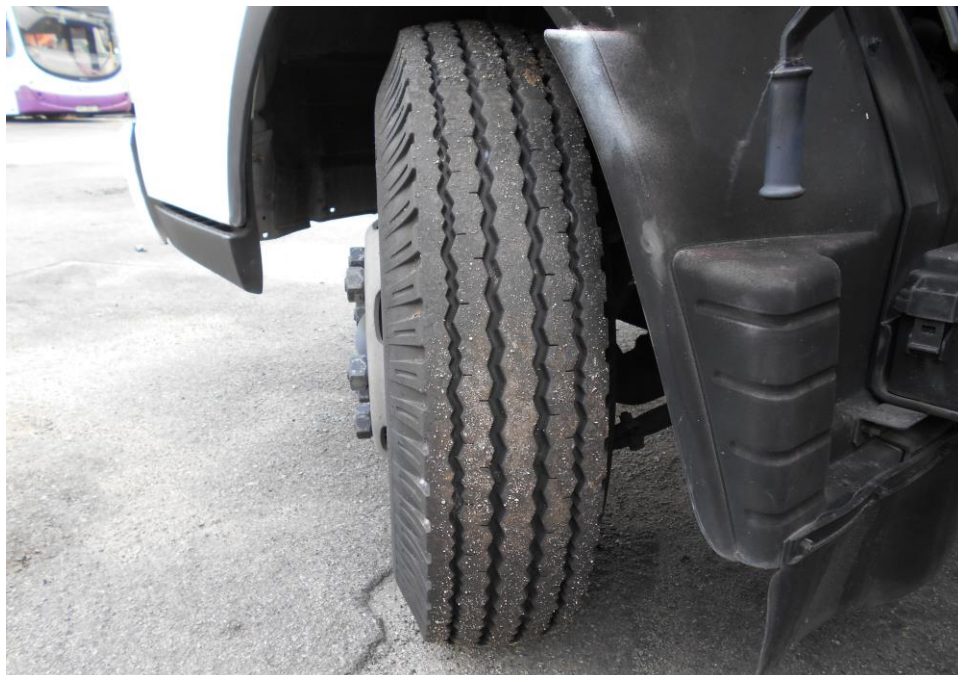
7. The 2 front tyres and 4 rear tyres of the Motor Lorry were observed to be in serviceable condition and sufficiently inflated for vehicular operation. We did not find any tear, cut or burst mark(s) on the outer and the inner sidewalls as well as across the tread of the 6 tyres. The tyre brand, tyre size and remaining tread depth of the 6 tyres of the Motor Lorry were recorded as follows:-

Photo 7 shows the condition of the front left tyre of the Motor Lorry, which was observed to be in serviceable condition with remaining tread depth of approximately 9mm.

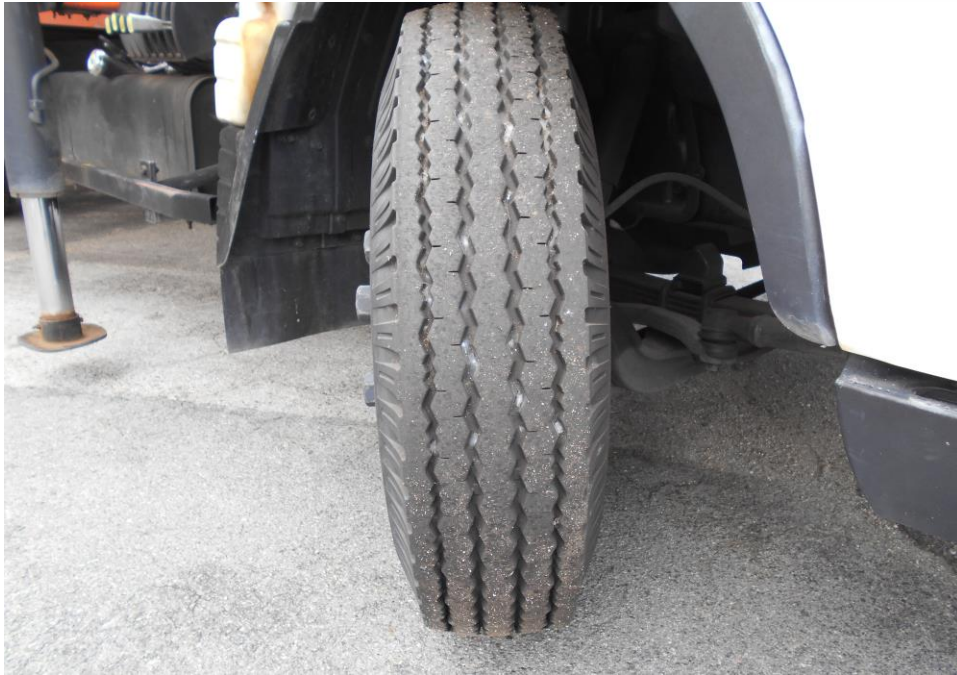
Photo 8 shows the condition of the front right tyre of the Motor Lorry, which was observed to be in serviceable condition with remaining tread depth of approximately 9mm. The tyre was also observed to be sufficiently inflated for vehicular operation.

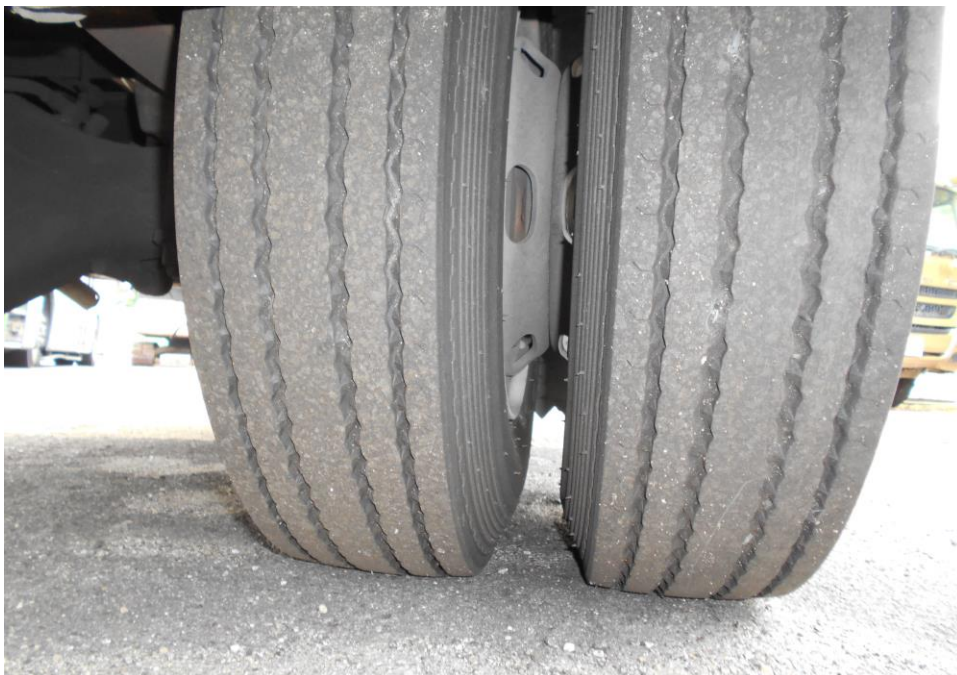
Photo 9 shows the condition of the rear left tyres of the Motor Lorry, which was observed to be in serviceable condition with remaining tread depth of approximately 7mm. The tyres were also observed to be sufficiently inflated for vehicular operation.

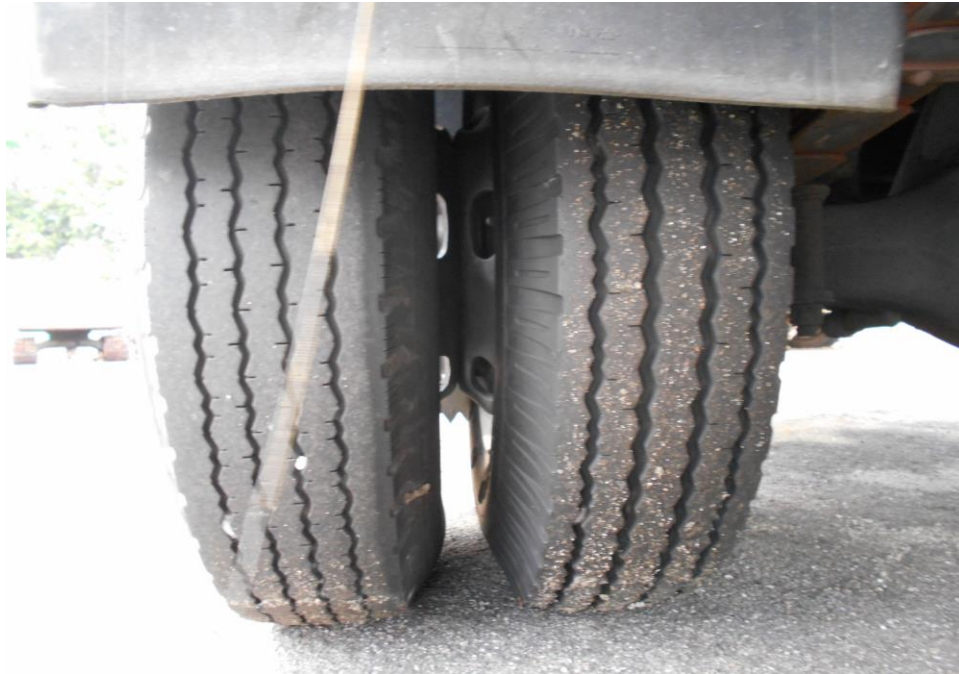
8. The 6 tyres were observed to be wrapped around standard steel wheel rims that were found to be without any damages. See photo 7 to 10 below.

Photo 10 shows the condition of the rear right tyres of the Motor Lorry, which were observed to be in serviceable condition with remaining, tread depth of approximately 8mm.

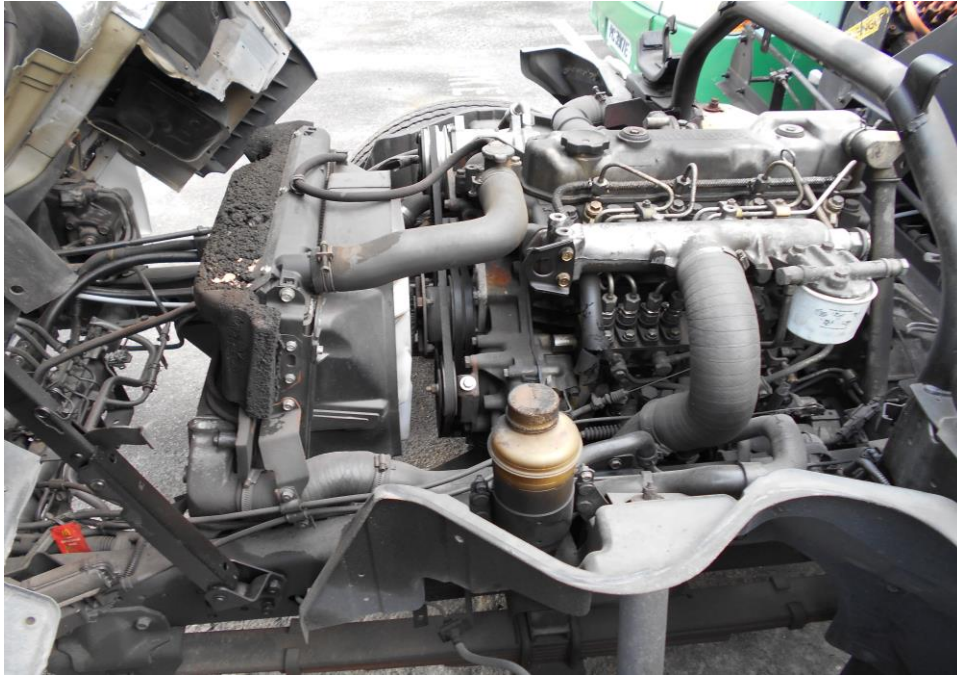
9. Upon examination of the Motor Lorry's engine compartment, we had observed that all the parts and components inside the engine compartment to be intact and unaffected by the accident. The brake fluid, engine oil and engine coolant were all found to be of sufficient level for operating purposes. Visually, there was also no contamination found to these fluids.
10. Further examination of the engine compartment found that there was no sign(s) or indication(s) of fresh fluid leakage and/or fluid stain within the engine compartment of the Motor Lorry.
11. Our subsequent checks on the underside of the Motor Lorry also revealed no sign of fluid stain. Visually, the various undercarriage components of the Motor Lorry were all observed to be intact and without any visible damage. See photo 11 – 14 below.

Photo 11 shows a general view of the Motor Lorry's engine compartment, which was accessed by lifting the front cabin of the Motor Lorry. The various parts and components inside the engine compartment were unaffected by the accident. There was also no sign(s) or indication(s) of fresh fluid leakage and/or fluid stain within the engine.

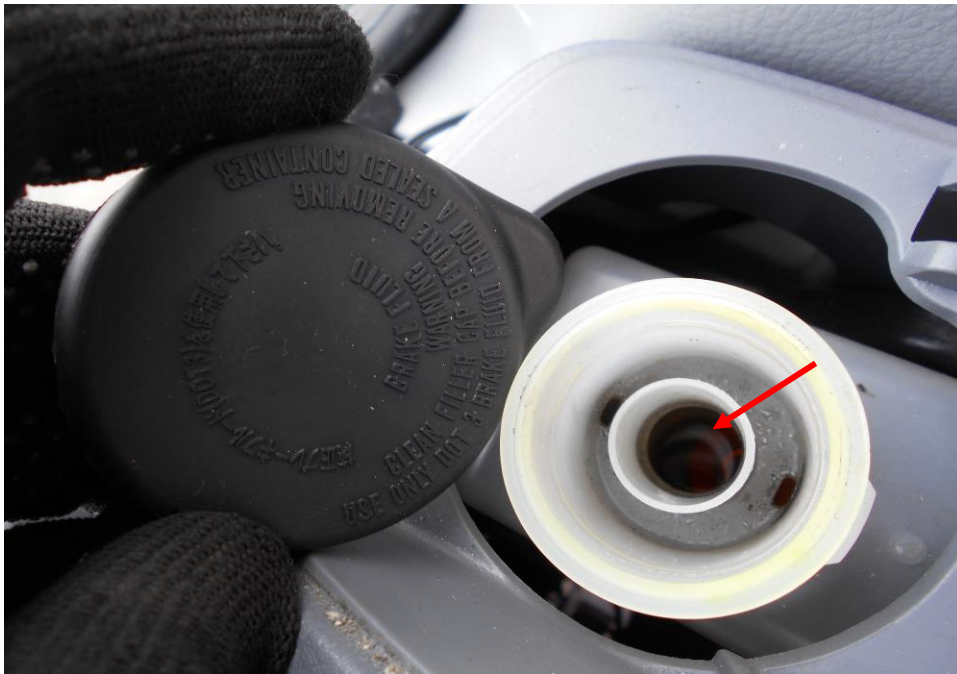
Photo 12 shows the brake fluid reservoir of the Motor Lorry at the time of our inspection. The brake fluid was observed to be of sufficient level and without any visible contamination (arrowed).

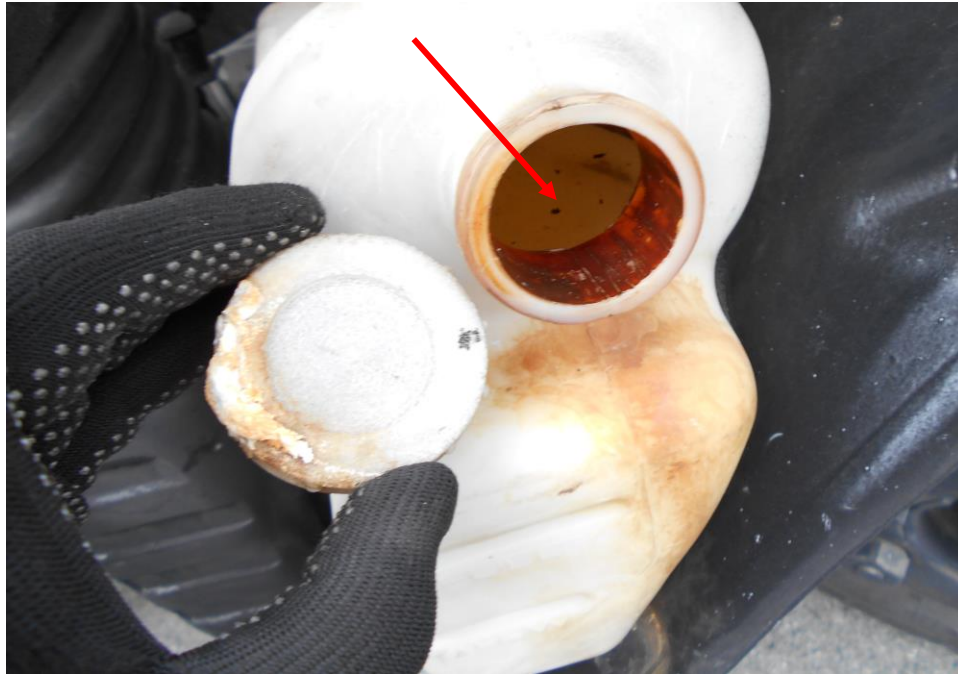
Photo 13 shows the engine coolant reservoir of the Motor Lorry at the time of our inspection. The engine coolant was observed to be of sufficient level and without any visible contamination (arrowed).

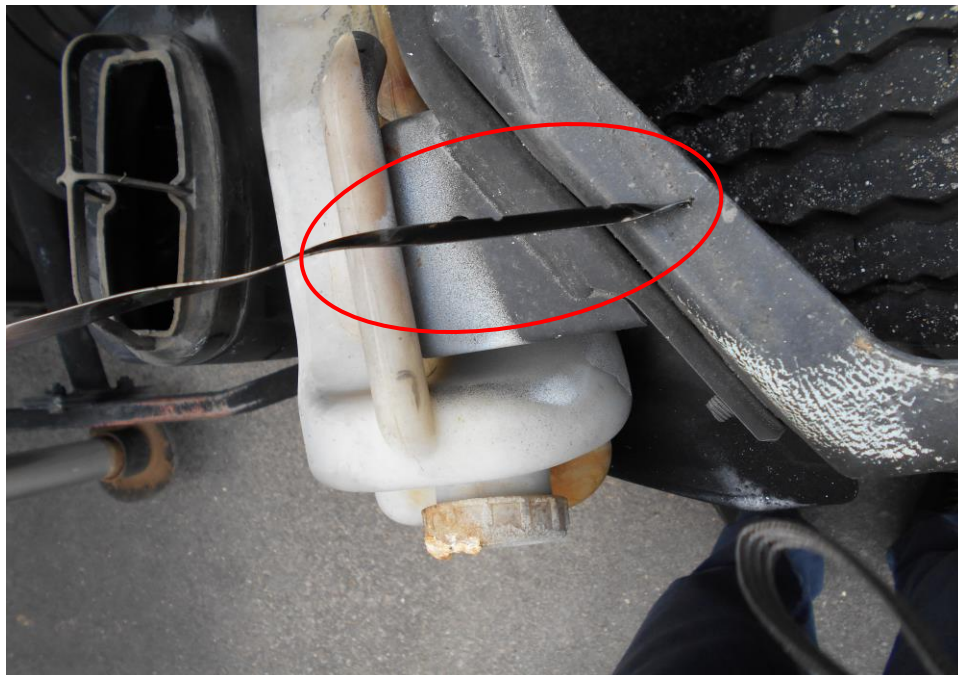
Photo 14 shows the engine dip stick of the Motor Lorry at the time of our inspection. The engine oil was observed to be of sufficient level and without any visible contamination (circled).

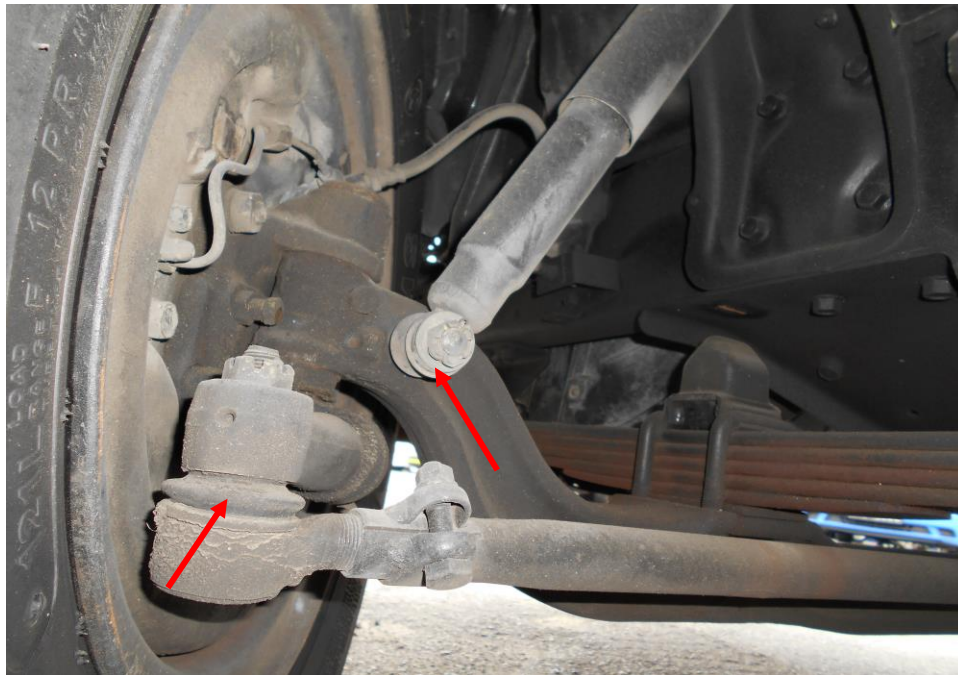
12. The mechanical components of the Motor Lorry steering system were all found to be visually intact and undamaged. The steering wheel, steering tie rods, drive shafts and ball joints of the Motor Lorry were observed to be intact and securely attached to the front left wheel and front right wheel.
13. Static test on the steering system of the Motor Lorry also revealed no abnormality to the steering system. We did not experience any abnormal free play and/or other resistance when turning the steering wheel left and right to full lock positions. Our visual examination of the various steering components which had included the rack and pinion, tie rods, tie rod ends and ball joints had revealed that these components were all generally in good condition. See photo 15 & 16 below.

Photo 15 shows the various undercarriage components at the front left wheel of the Motor Lorry, in particular the steering tie rod end (arrowed). The various undercarriage components of the Motor Lorry were all found to be intact without any visible damage. There was also no sign of fluid stain(s) observed on the various undercarriage components.

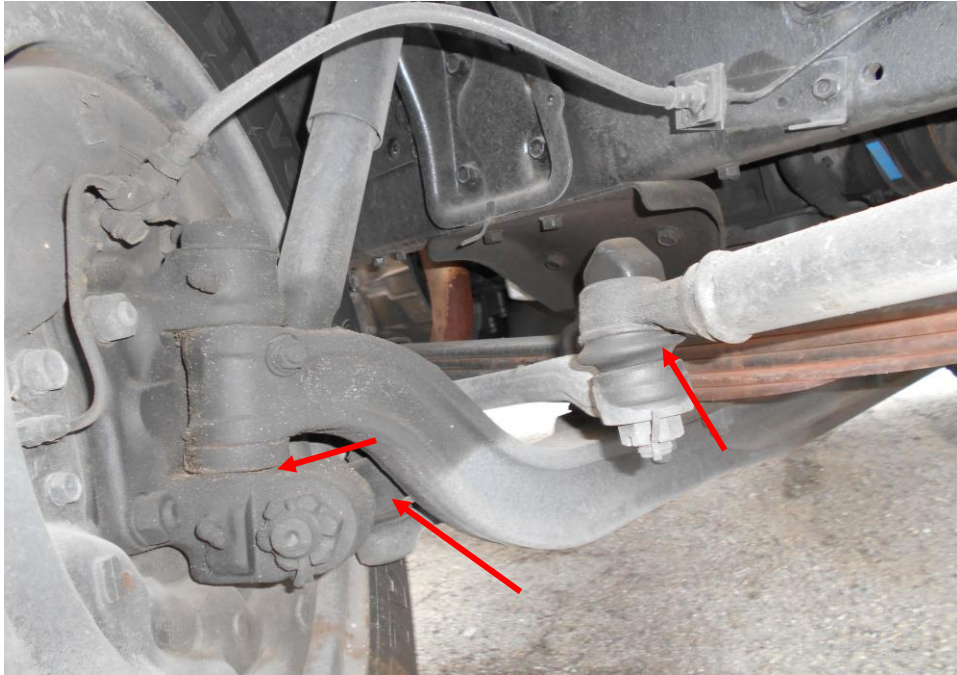
Photo 16 shows the various undercarriage components at the front right wheel of the Motor Lorry, in particular the steering tie rod end (arrowed). The various undercarriage components of the Motor Lorry were all found to be intact without any visible damage. There was also no sign of fluid stain(s) observed on the various undercarriage components.

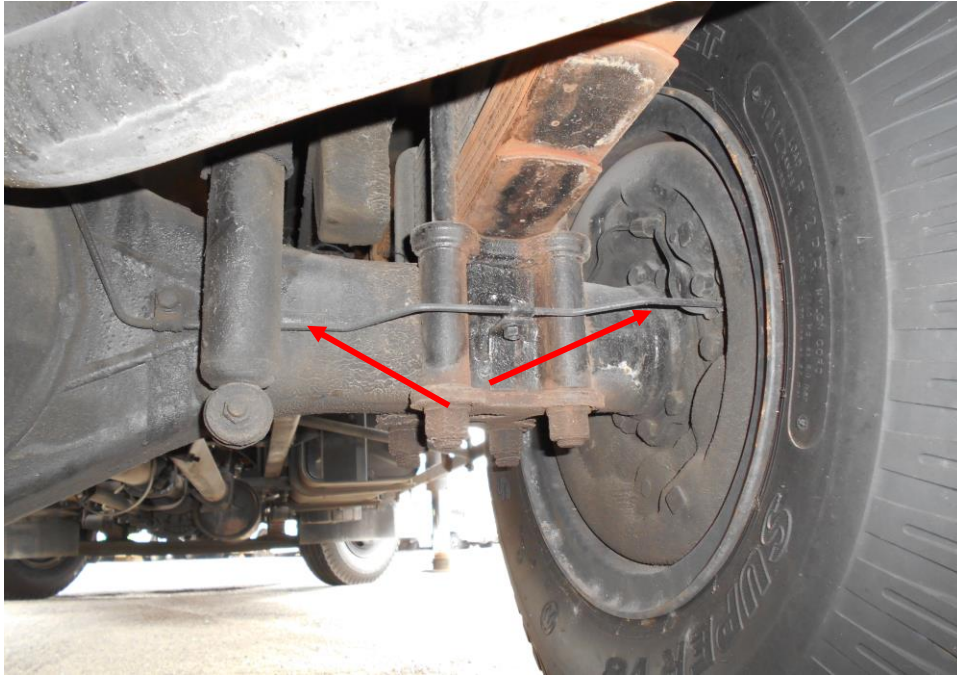
14. Static brake tests conducted on the Motor Lorry revealed no abnormality. The brake booster had responded well to the various tests conducted. There was also no abnormal movement of the brake pedal when it was depressed. In general, the static brake tests had suggested that there was no internal leakage of pressure/vacuum in the braking system of the Motor Lorry. The braking system of the Motor Lorry was likely to be in serviceable condition at the material time. This was also taking into consideration that the brake fluid was of sufficient level, and also that there was no sign(s) of brake fluid leakage along the brake hoses and brake pipes.

15. Checks on the brake shoes (brake pads) at the rear wheels of the Motor Lorry revealed that the brake shoes (brake pads) were in serviceable condition with sufficient frictional material for operational purposes. In general, our visual inspection of the mechanical components of the Motor Lorry's braking system appear to suggest that its braking system was in serviceable condition at the material time of accident. See photo 17 & 18 below.

Photo 17 shows the various undercarriage components at the rear right wheels of the Motor Lorry. There was no sign(s) of brake fluid leakage along the brake hoses and brake pipes.

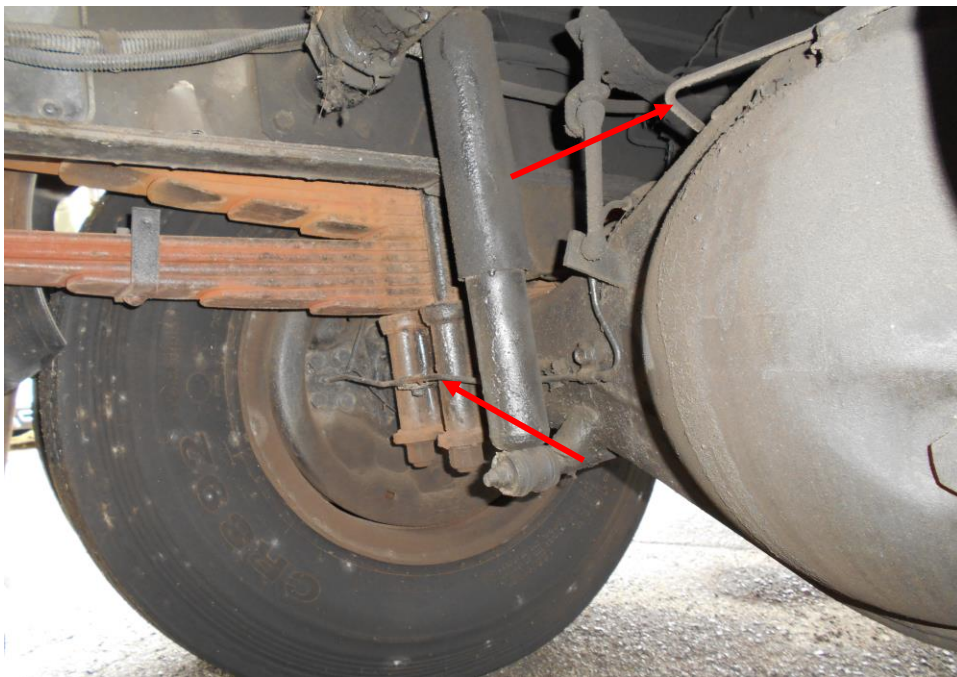
Photo 18 shows the various undercarriage components at the rear left wheels of the Motor Lorry. There was no sign(s) of brake fluid leakage along the brake hoses and brake pipes.

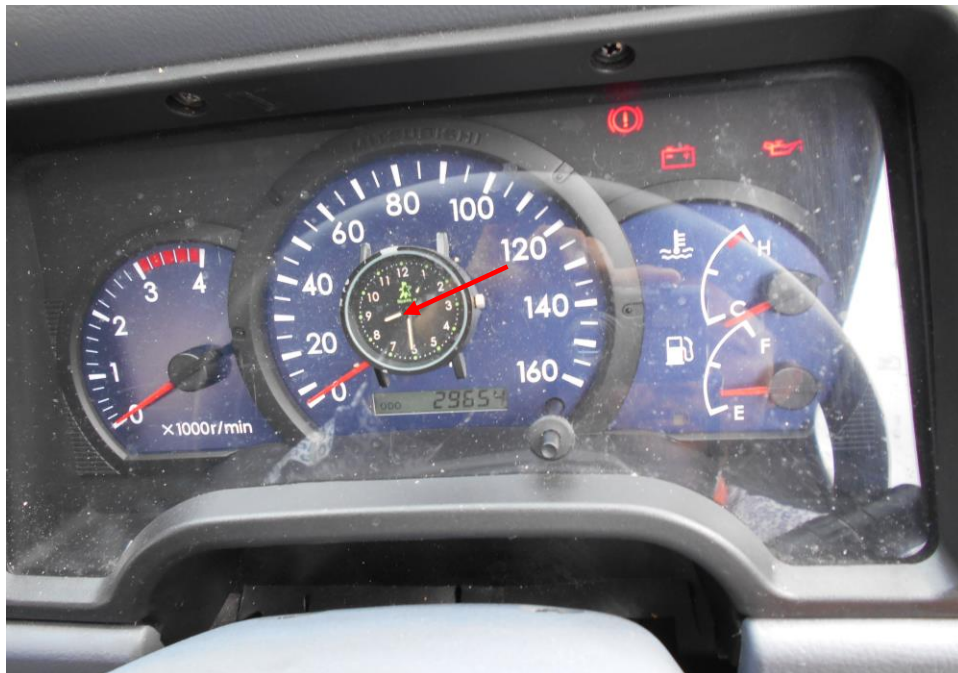
16. The Motor Lorry was not fitted with any electronic safety feature(s) like Anti-Brake Lock System (ABS), Supplemental Restraint System (SRS) etc. There was hence no test carried out on the functionality of these systems. However, warning indicators such as battery check light, engine fluid check light & parking check light was observed to be lighted up upon ignitioning of engine. During cranking of the engine had indicated that these systems were in working condition and without abnormality. This can be established from the warning indicators disappearing from the instrument panel after the self-test. See photo 19 & 20 below.

Photo 19 shows the warning lights for the various electronic operating systems of the Motor Car appearing on its instrument panel during the self-test when the engine was cranked.

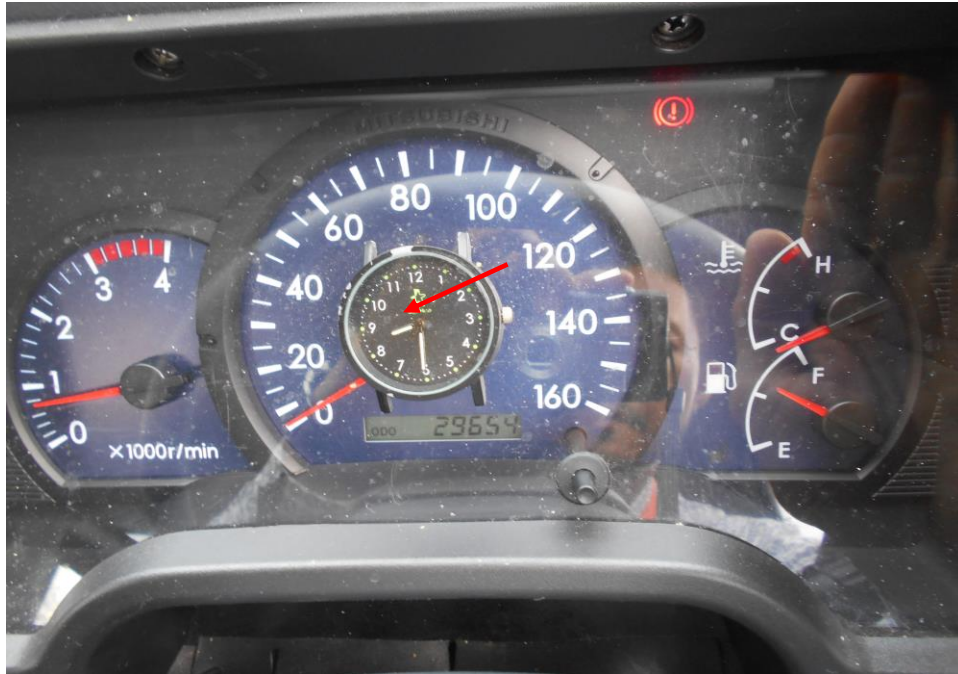
Photo 20 shows the warning lights disappearing after cranking of the engine.

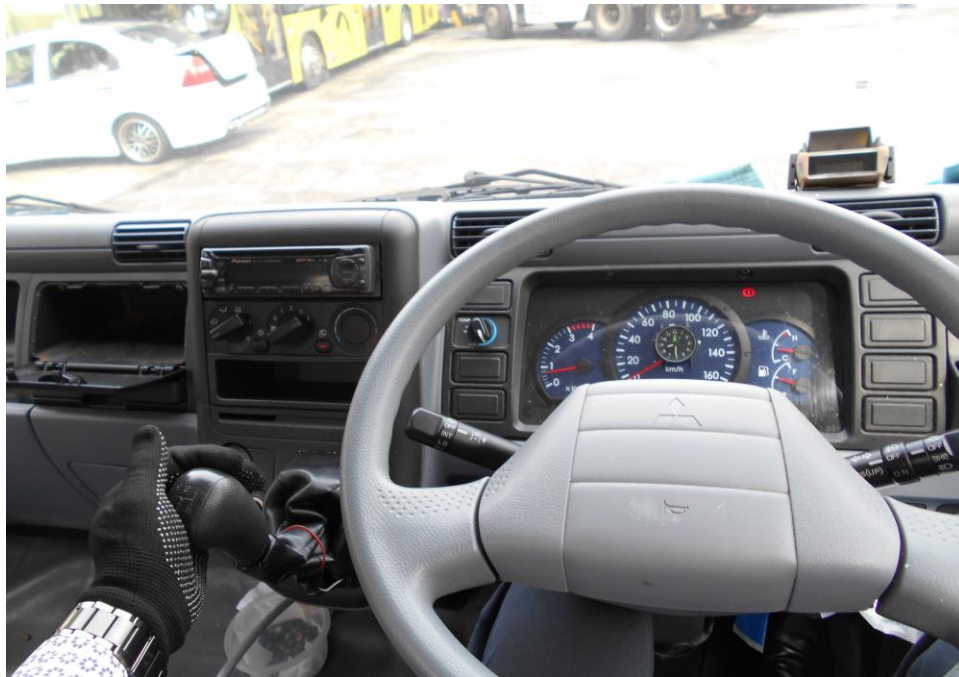
18. During the operational test, the various transmission gears of the Motor Lorry were able to be engaged without any difficulty by stepping on the clutch pedal and manually shifting the gear lever. There were no abnormal sound heard and/or abnormal behaviour of the Motor Lorry's engine system. It was able to move forward and backward normally. The braking system was also found to be in working condition as the Motor Lorry was able to slow down and come to a complete stop upon depressing of the brake pedal. See photo 21 & 22 below.

Photo 21 shows the operational test on the Motor Lorry. It was observed to be in serviceable condition. Operational test such as moving forward, turn left & right and also braking test on the Motor Lorry was conducted successfully.

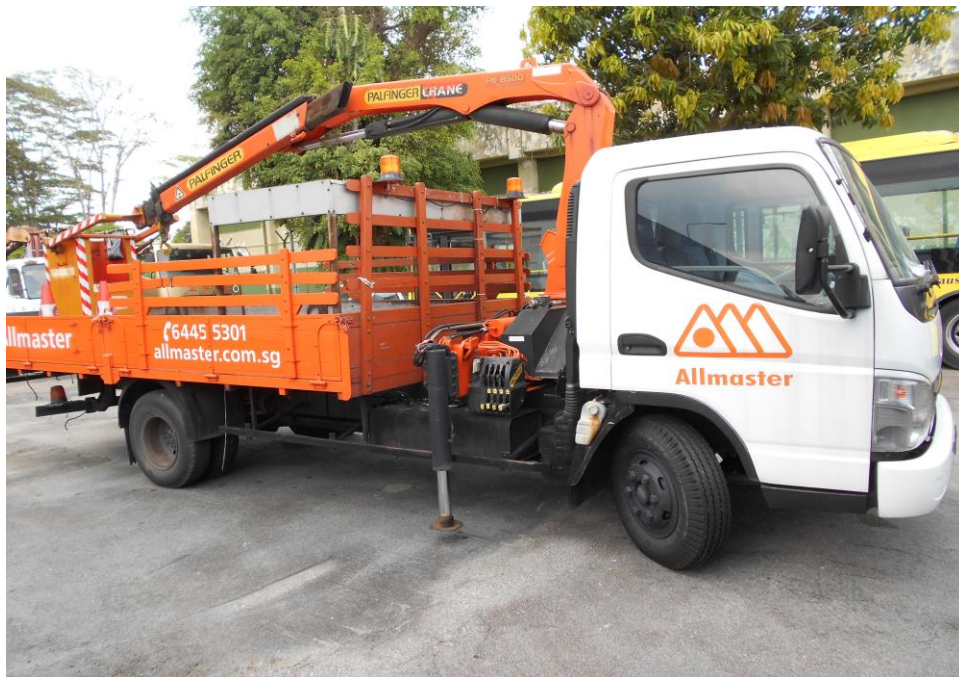
Photo 22 shows the operational test on the Motor Lorry. It was observed to be in serviceable condition. Operational test such as moving forward, turn left & right and also braking test on the Motor Lorry was conducted successfully.
