Your Ref: TP/IP/52477/2018  
Our Ref : CI/TPD18019478/Z

**Fatal Accident Investigation Team**  
Traffic Police Department  
Singapore Police Force  
10 Ubi Avenue 3  
Singapore 408865

### **MECHANICAL INSPECTION REPORT OF MOTOR LORRY YN 4673L**

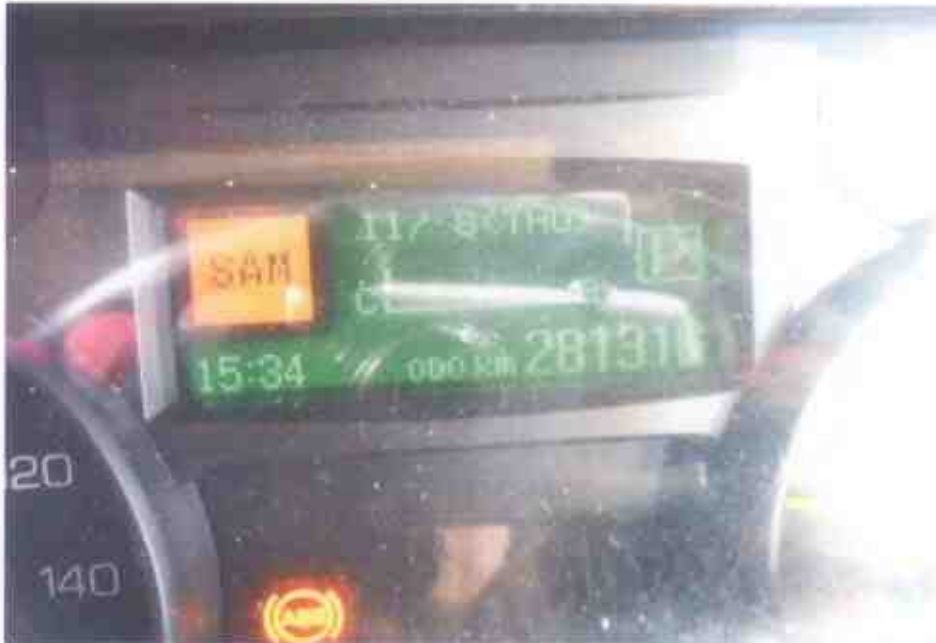
**Photo 1** shows the mileage of the Motor Lorry at the time of our inspection was recorded as 281316km.

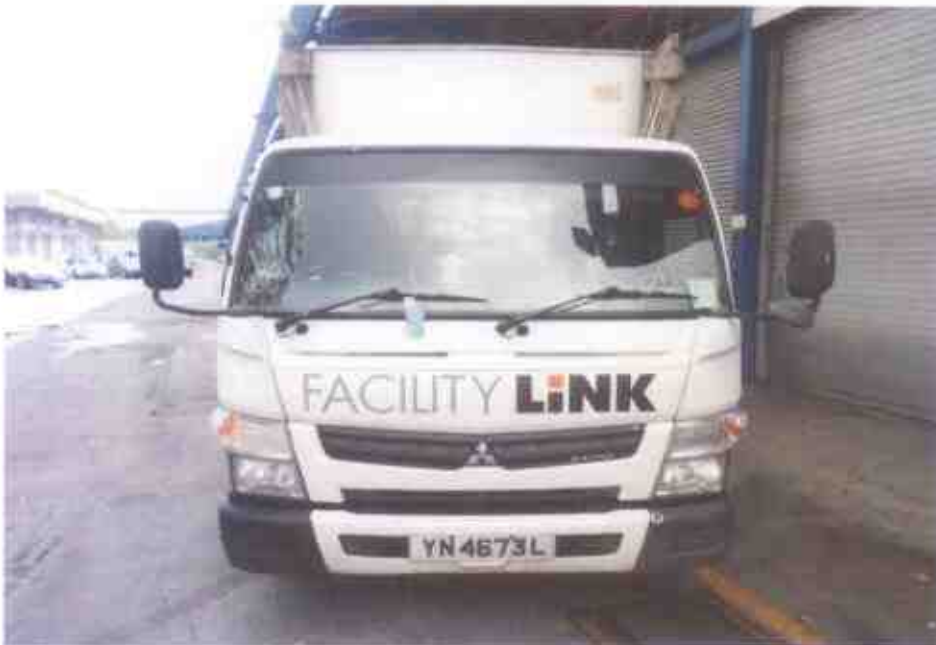
**Photo 2** shows a general view of the front portion of the Motor Lorry at the time of our inspection. The Motor Lorry was observed to be in good condition unaffected by the accident.

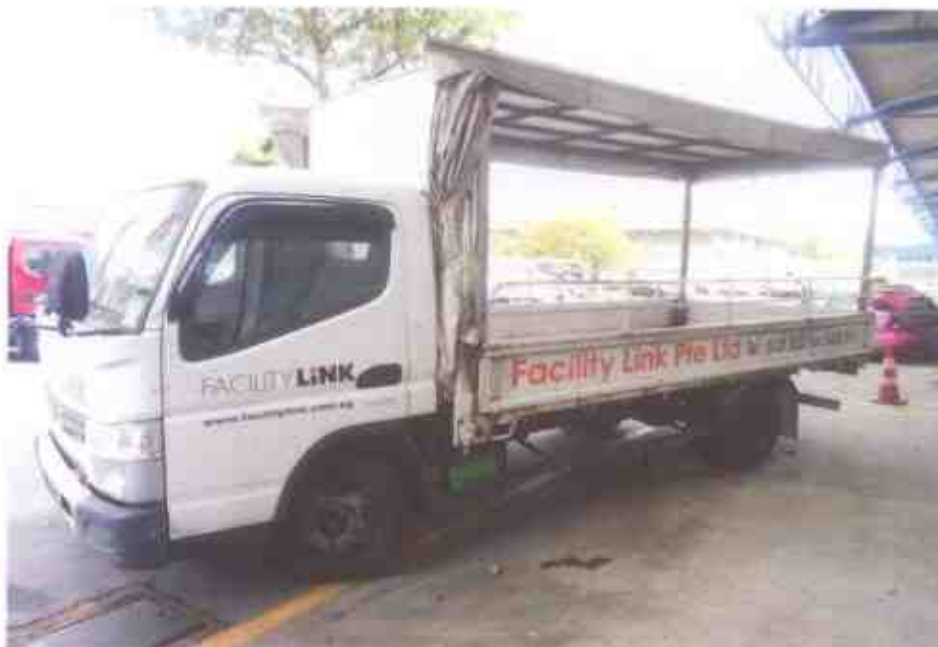
**Photo 3** shows a general view of the front left of the Motor Lorry at the time of our inspection. The Motor Lorry was observed to be in good condition unaffected by the accident.

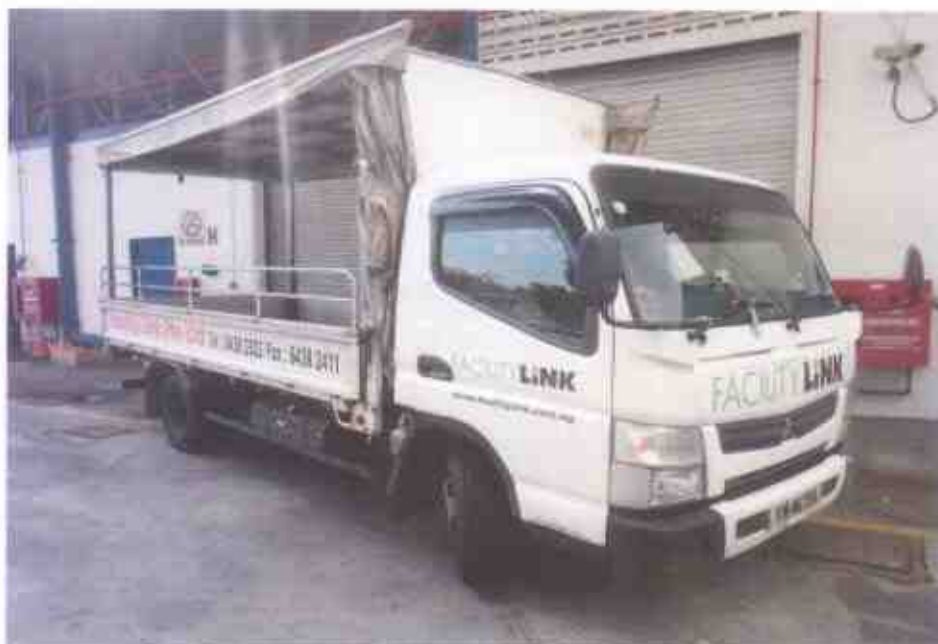
**Photo 4** shows a general view of the front right of the Motor Lorry at the time of our inspection. The Motor Lorry was observed to be in good condition unaffected by the accident.

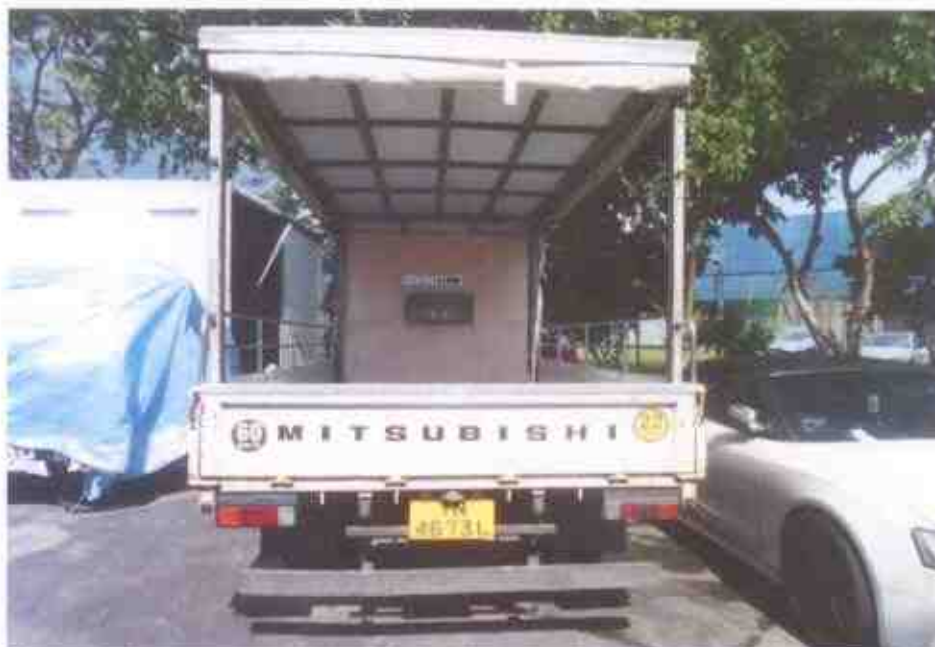
Photo 5 shows a general view of the Motor Lorry's rear body at the time of our inspection. There was no damage found to the rear portion of the Motor Lorry.

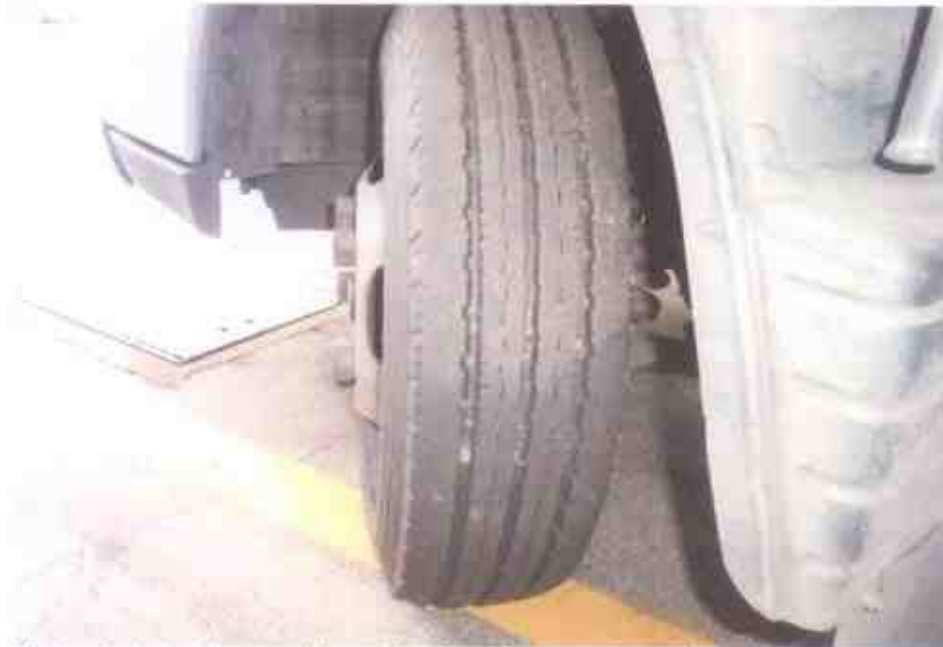
**Photo 6** shows the condition of the front left tyre of the Motor Lorry, which was observed to be in serviceable condition with remaining tread depth of approximately 8mm.

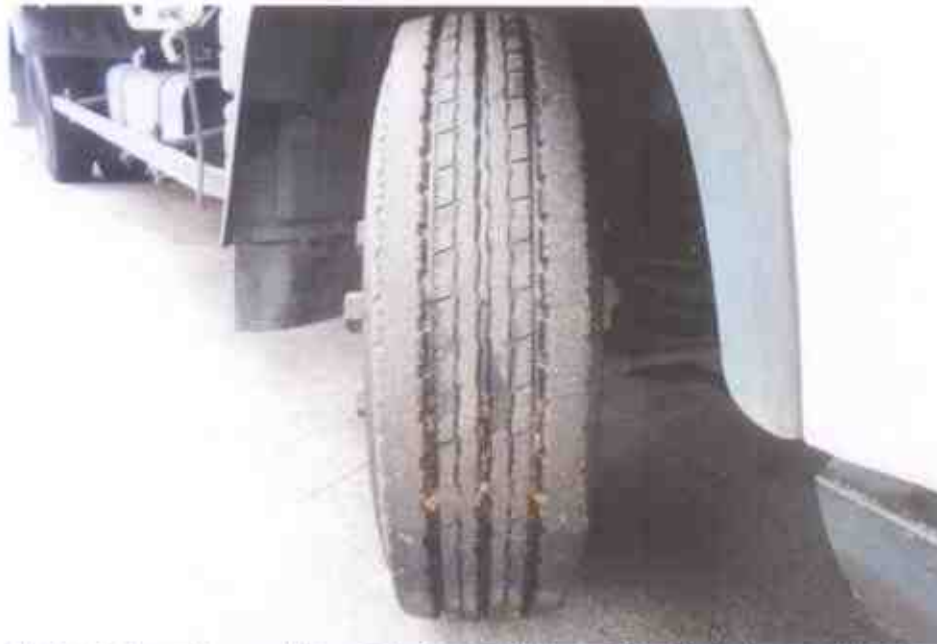
**Photo 7** shows the condition of the front right tyre of the Motor Lorry, which was observed to be in serviceable condition with remaining tread depth of approximately 7mm. The tyre was also observed to be sufficiently inflated for vehicular operation.

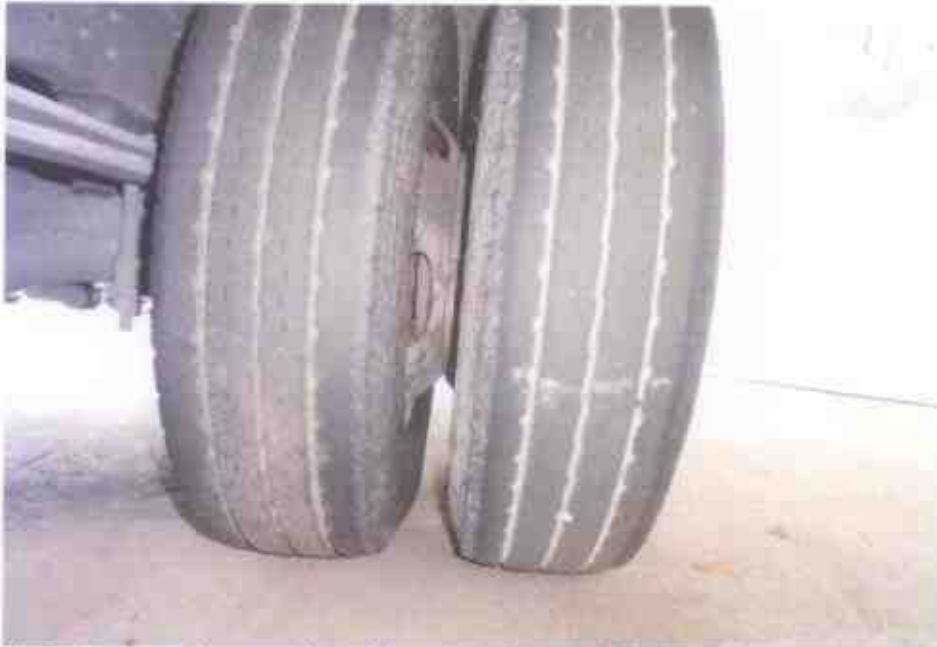
**Photo 8** shows the condition of the rear left tyres of the Motor Lorry, which was observed to be in serviceable condition with remaining tread depth of approximately 4mm. The tyres were also observed to be sufficiently inflated for vehicular operation.

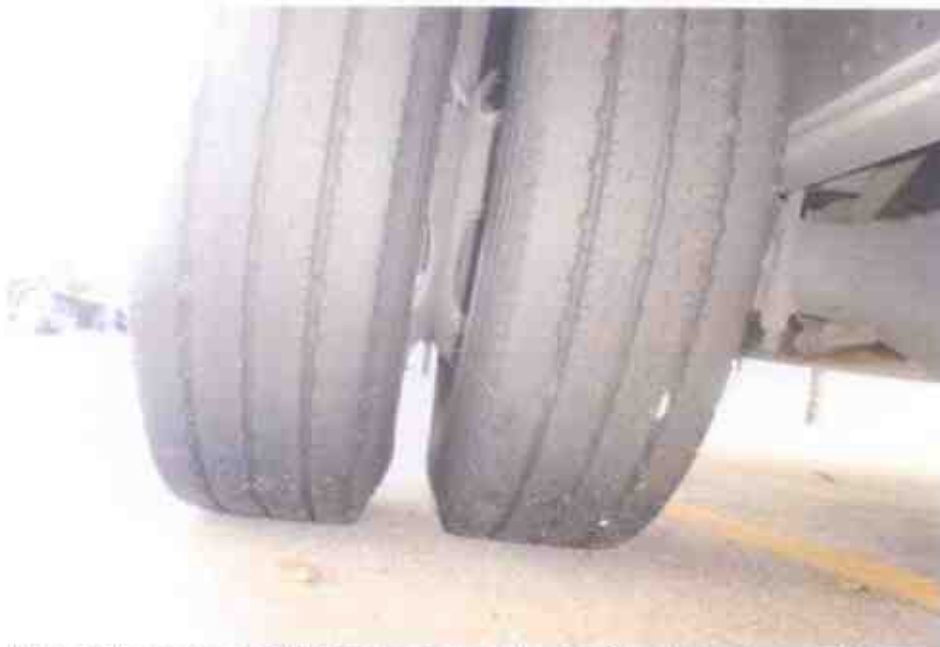
**Photo 9** shows the condition of the rear right tyres of the Motor Lorry, which were observed to be in serviceable condition with remaining tread depth of approximately 7mm.

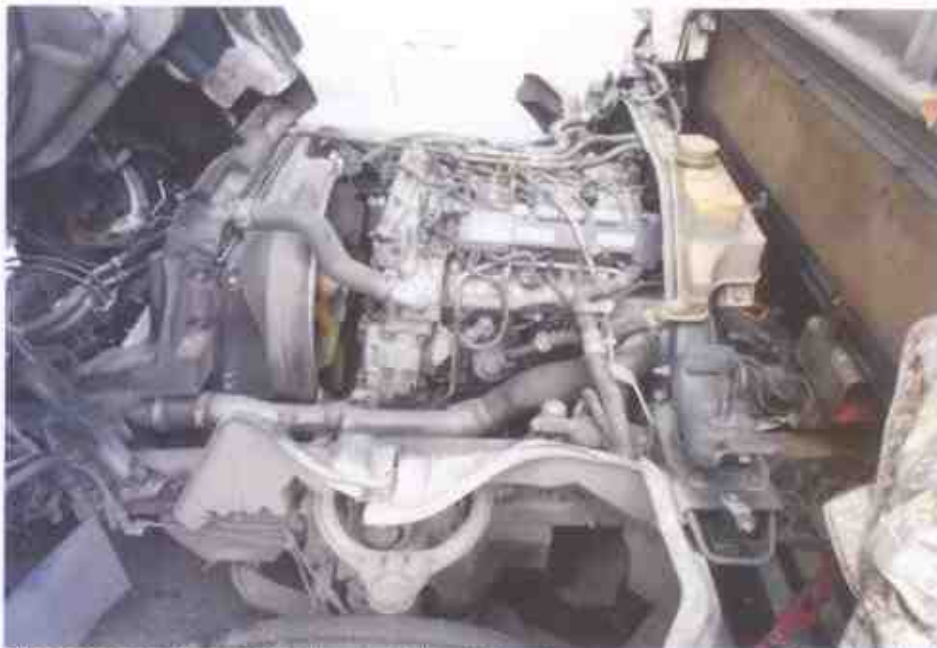
**Photo 10** shows a general view of the Motor Lorry's engine compartment, which was accessed by lifting the front cabin of the Motor Lorry. The various parts and components inside the engine compartment were unaffected by the accident. There was also no sign(s) or indication(s) of fresh fluid leakage and/or fluid stain within the engine.

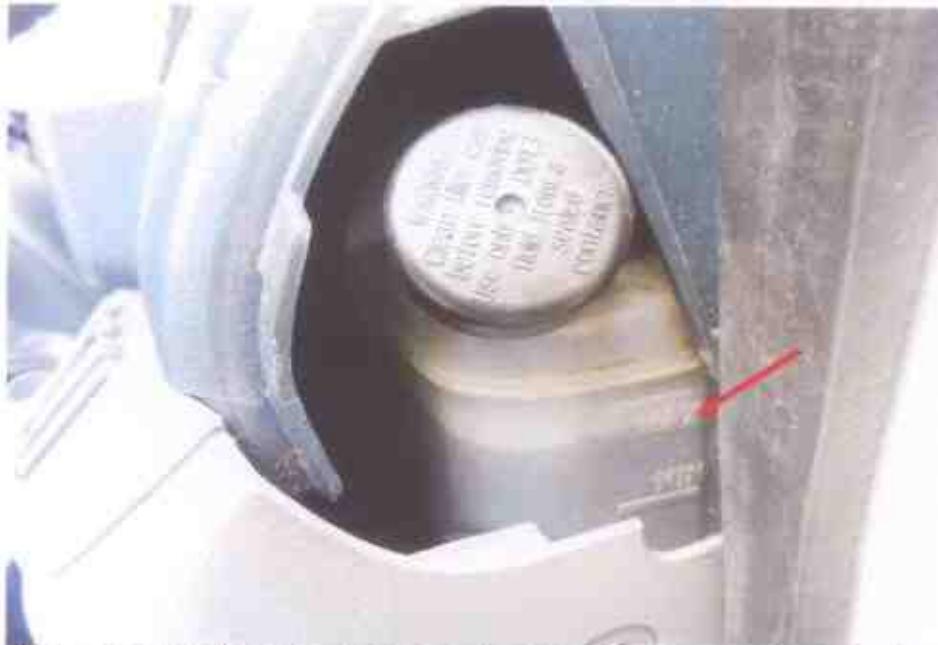
**Photo 11** shows the brake fluid reservoir of the Motor Lorry at the time of our inspection. The brake fluid was observed to be of sufficient level and without any visible contamination (arrowed).

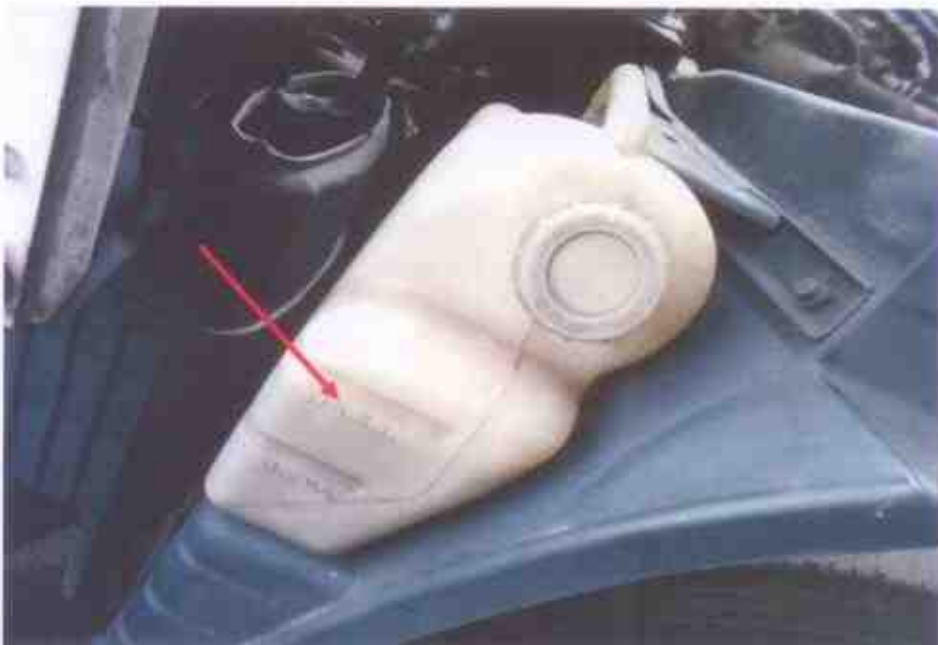
**Photo 12** shows the engine coolant reservoir of the Motor Lorry at the time of our inspection. The engine coolant was observed to be of sufficient level and without any visible contamination (arrowed).

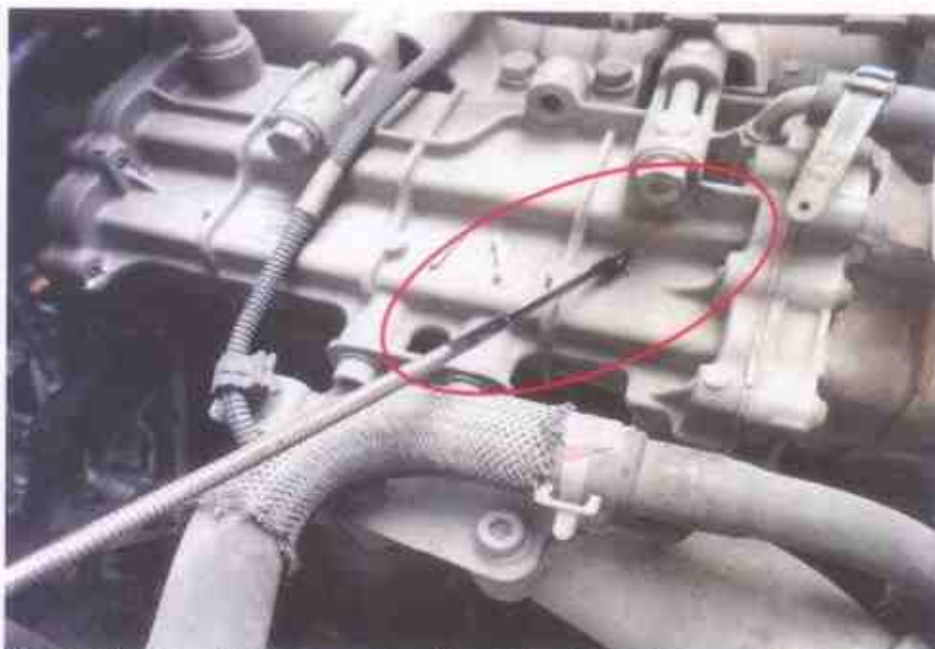
Photo 13 shows the engine dip stick of the Motor Lorry at the time of our inspection. The engine oil was observed to be of sufficient level and without any visible contamination (circled).

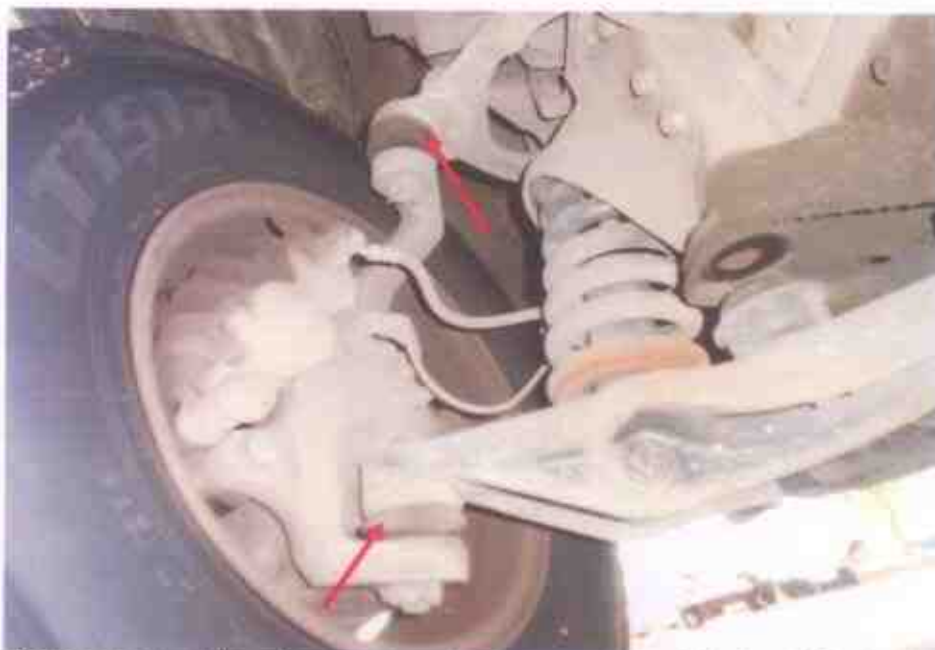
**Photo 14** shows the various undercarriage components at the front left wheel of the Motor Lorry, in particular the steering tie rod end (arrowed). The various undercarriage components of the Motor Lorry were all found to be intact without any visible damage. There was also no sign of fluid stain(s) observed on the various undercarriage components.

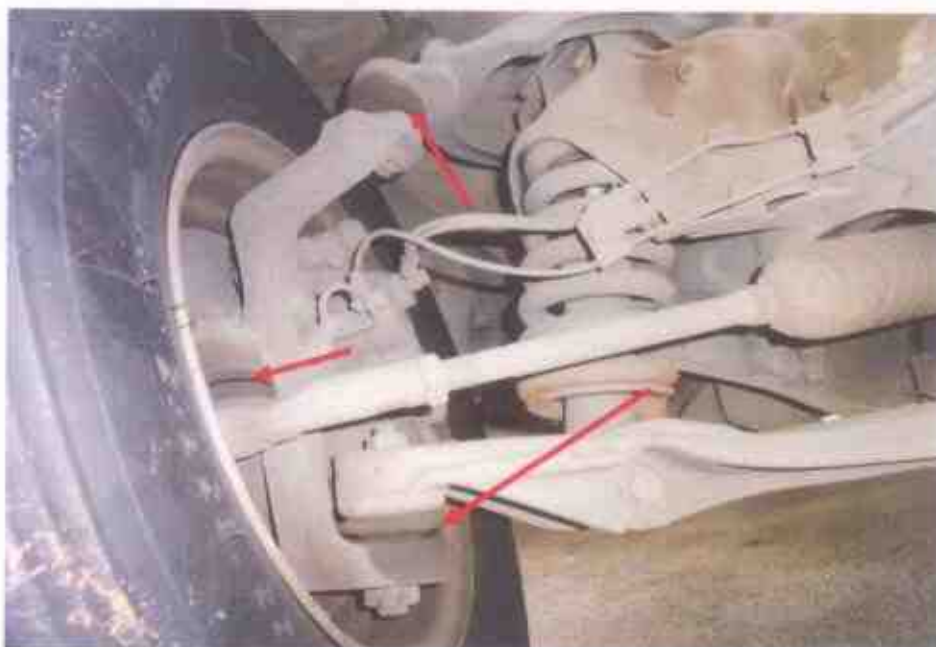
**Photo 15** shows the various undercarriage components at the front right wheel of the Motor Lorry, in particular the steering tie rod end (arrowed). The various undercarriage components of the Motor Lorry were all found to be intact without any visible damage. There was also no sign of fluid stain(s) observed on the various undercarriage components.

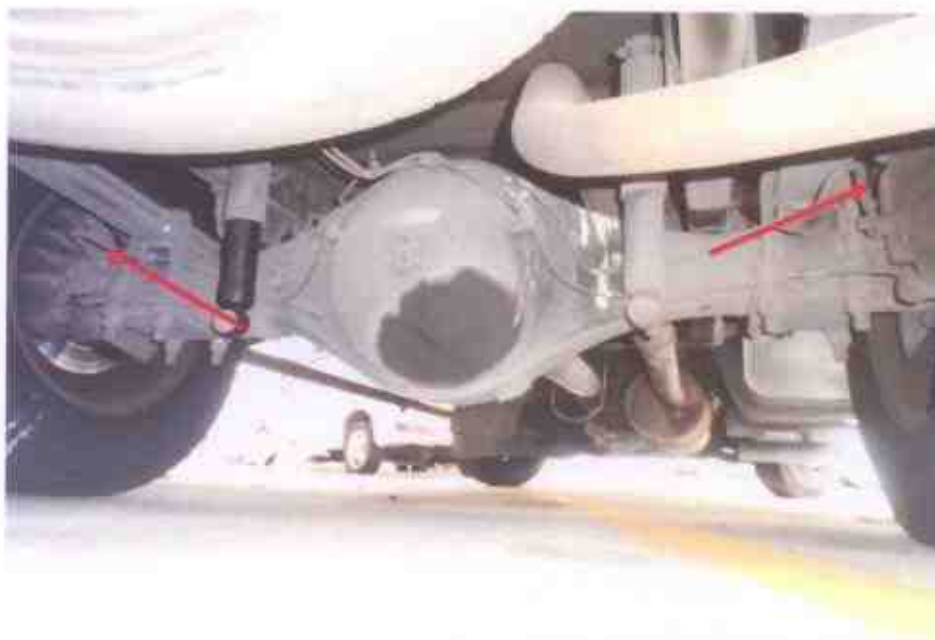
15. Checks on the brake shoes (brake pads) at the rear wheels of the Motor Lorry revealed that the brake shoes (brake pads) were in serviceable condition with sufficient frictional material for operational purposes. In general, our visual inspection of the mechanical components of the Motor Lorry's braking system appear to suggest that its braking system was in serviceable condition at the material time of accident. See photo 16 below.

**Photo 16** shows the various undercarriage components at the rear wheels of the Motor Lorry. There was no sign(s) of brake fluid leakage along the brake hoses and brake pipes.

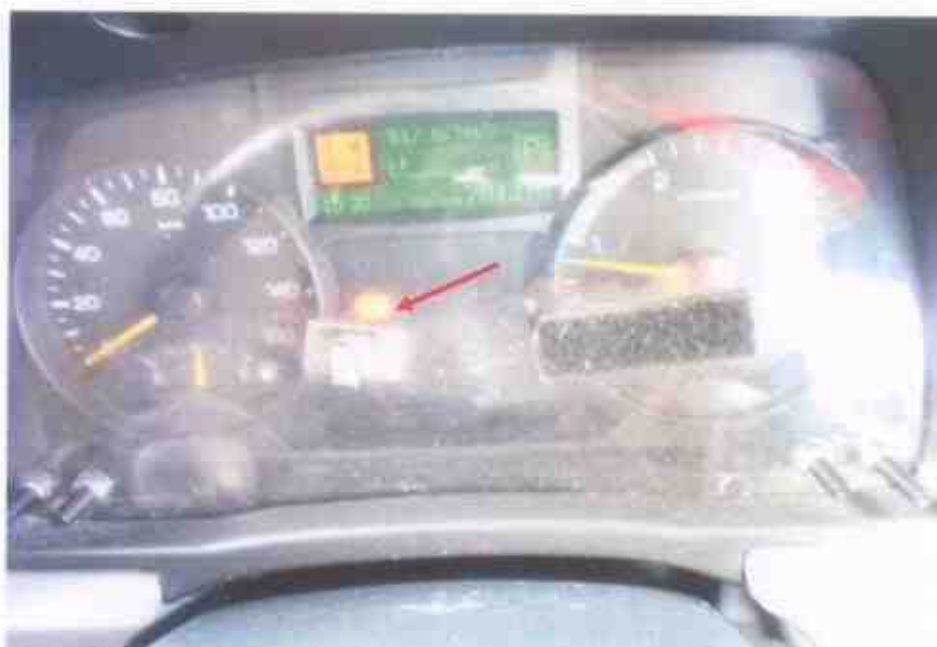
16. The Motor Lorry's automatic self-test of the functionality of its electronic operating systems such as the Anti-Brake Lock System (ABS) during cranking of the engine was observed to be lighted up. The indicator was noted to stay lighted up even after the engine was in idling speed. See photo 17 below.

Photo 17 shows the warning indicator for Anti-Brake Lock System (ABS) was observed to be lighted up during cranking & after engine was in idling speed.

20. The Anti-Brake Lock System (ABS) indicator was noted to stay lighted up even after the engine was in idling speed. This would indicate that there was an electronic fault to the Anti-Brake Lock System (ABS). However, we are of the opinion that this did not cause and/or contributed to the accident as the braking system was still able to function normally as per our operational test conducted, explained in paragraph 17 & 18 above.

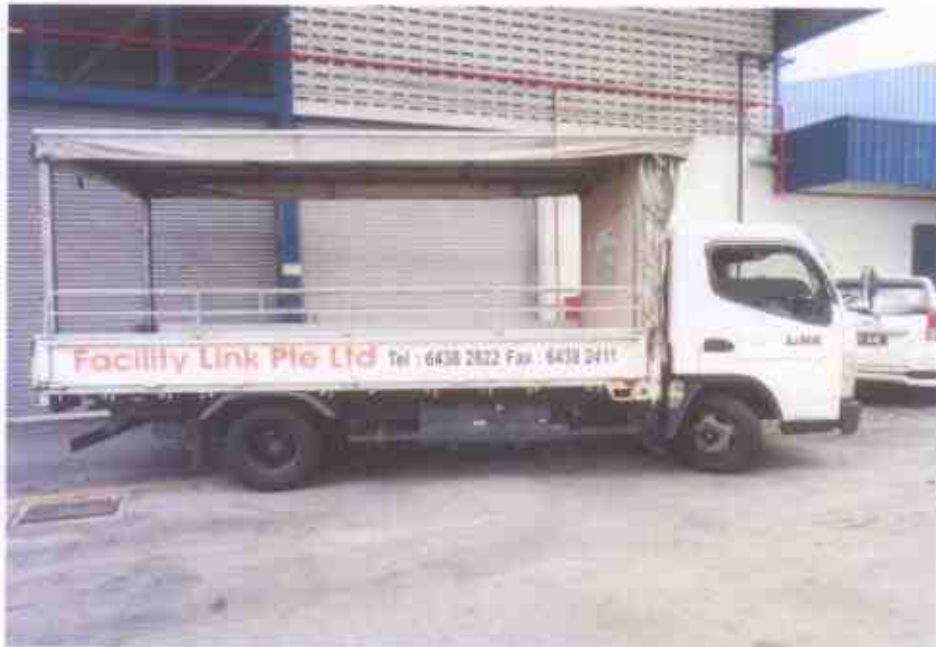
17. A short operational test of the Motor Lorry, to primarily determine whether there was any abnormality to its various operating systems like its engine system, its transmission system, steering system and braking system was subsequently carried out. The test was conducted by driving the Motor Lorry forward, stopping, before reversing and coming to a stop again.
18. During the operational test, the various transmission gears of the Motor Lorry were able to be engaged without any difficulty by stepping on the clutch pedal and manually shifting the gear lever. There were no abnormal sound heard and/or abnormal behaviour of the Motor Lorry's engine system. It was able to move forward and backward normally. The braking system was also found to be in working condition as the Motor Lorry was able to slow down and come to a complete stop upon depressing of the brake pedal. See photo 18 below.

**Photo 18** shows the operational test on the Motor Lorry. It was observed to be in serviceable condition. Operational test such as moving forward, turn left & right and also braking test on the Motor Lorry was conducted successfully.
