Your Ref: TP/IP/56801/2018
Our Ref : CI/TPD18019481/Z

Fatal Accident Investigation Team
Traffic Police Department
Singapore Police Force
10 Ubi Avenue 3
Singapore 408865

MECHANICAL INSPECTION REPORT OF MOTOR CAR SKZ 3194L

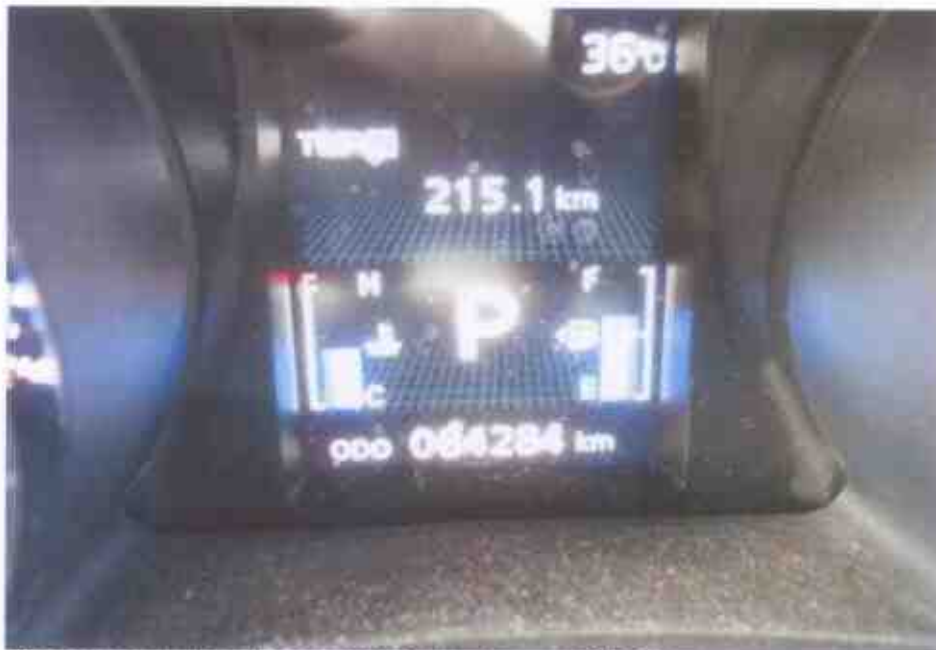
Photo 1 shows the mileage of the Motor Car was 084284 km.

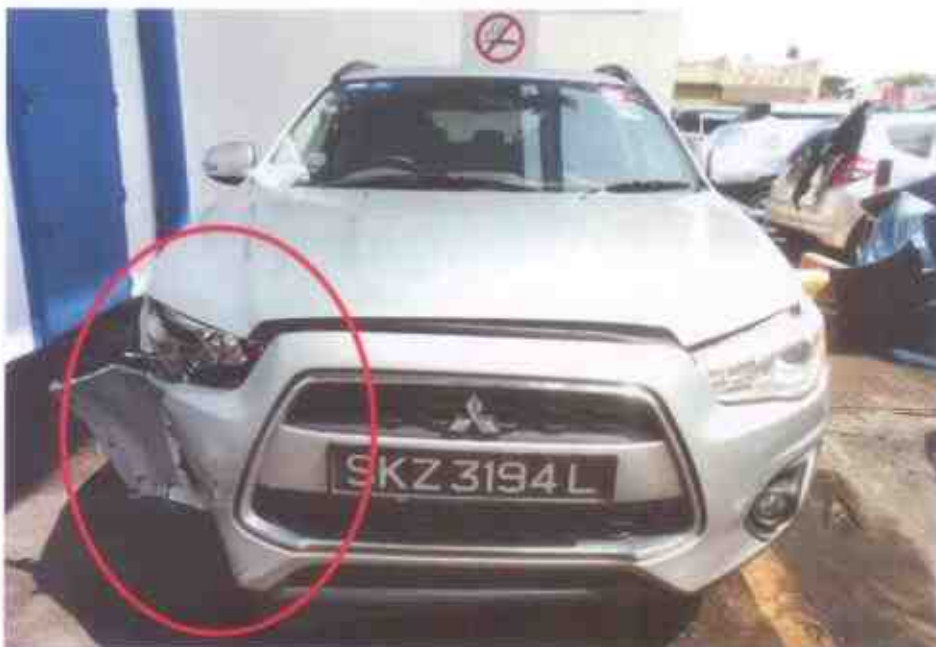
Photo 2 shows a general view of the front body of the Motor Car at the time of our inspection. The Motor Car was observed to have sustained for a damages at the frontal right portion.

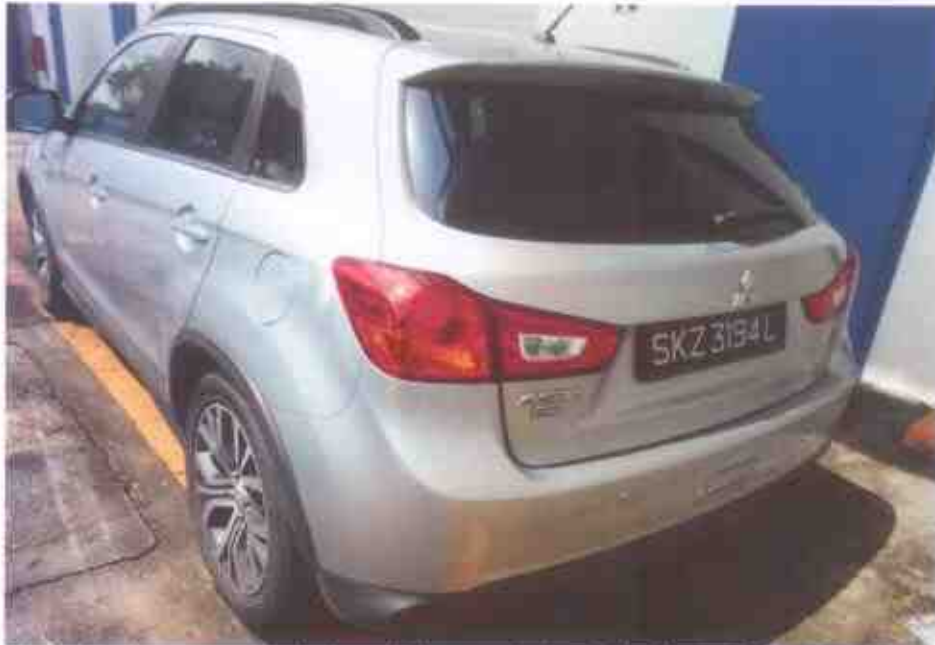
Photo 3 shows a general view of the rear body of the Motor Car at the time of our inspection. The Motor Car was observed to be in good general condition.

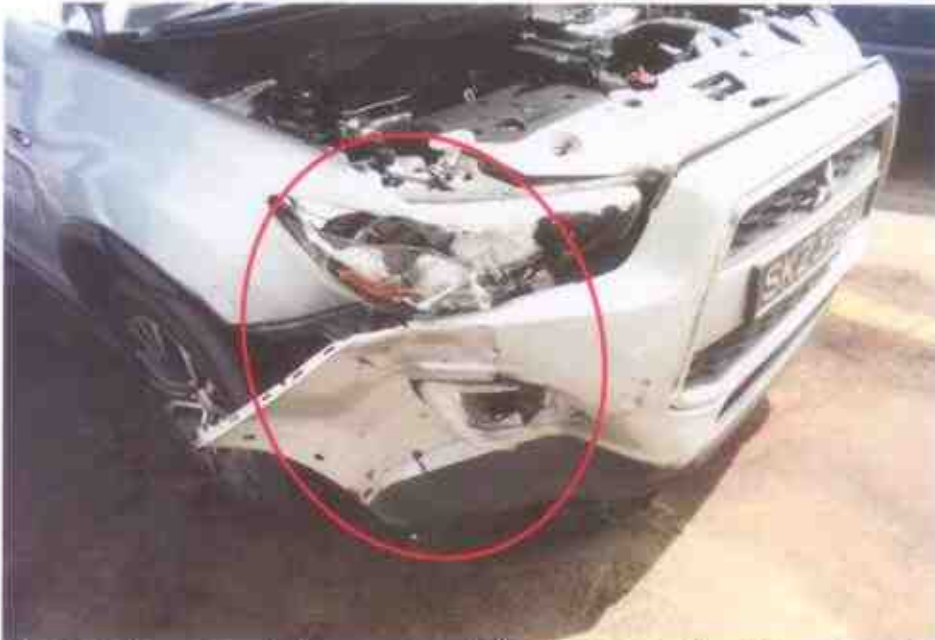
Photo 4 shows a semi close up view of the front right of the Motor Car at the time of our inspection. The Motor Car had sustained damages at the front right of the Motor Car as a result of the accident.

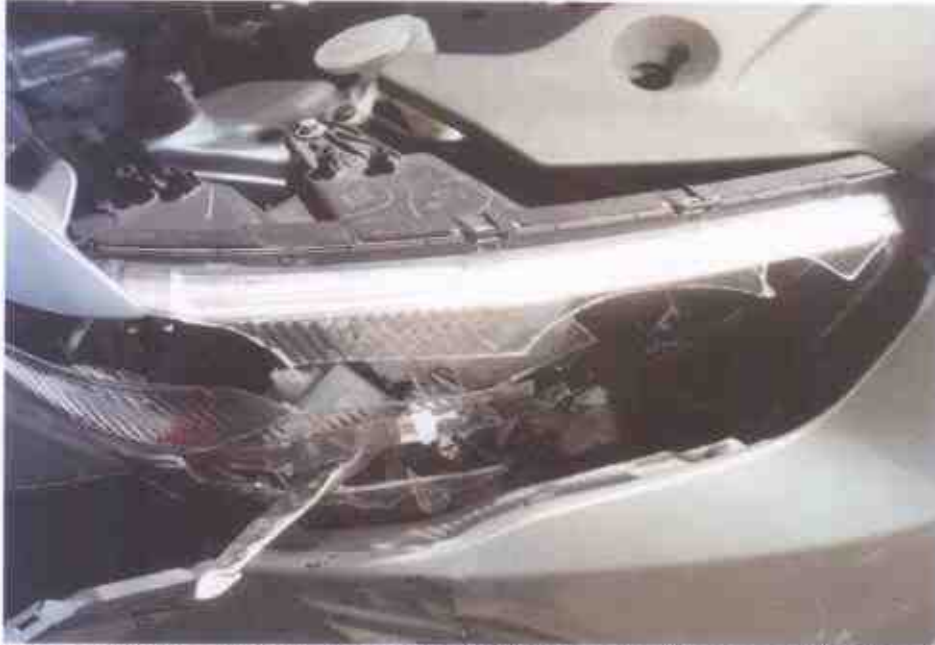
Photo 5 shows a close up view of the headlamp of the Motor Car at the time of our inspection. It was observed to have sustained with damages consistent to the accident's case fact.

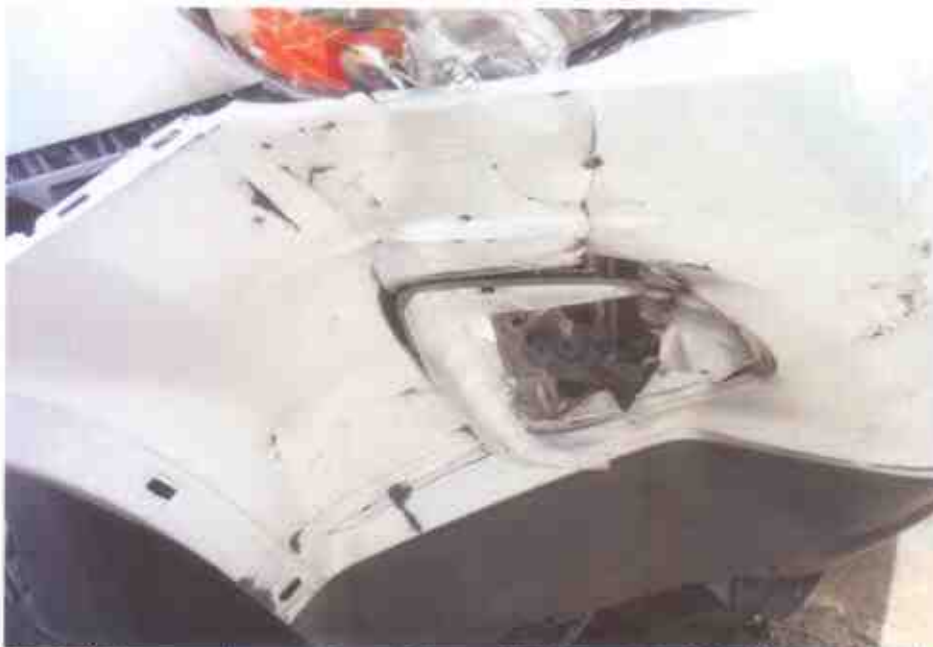
Photo 6 shows a close up view of the spot light garnish of the Motor Car at the time of our inspection. It was observed to be dislodged from its original installation.

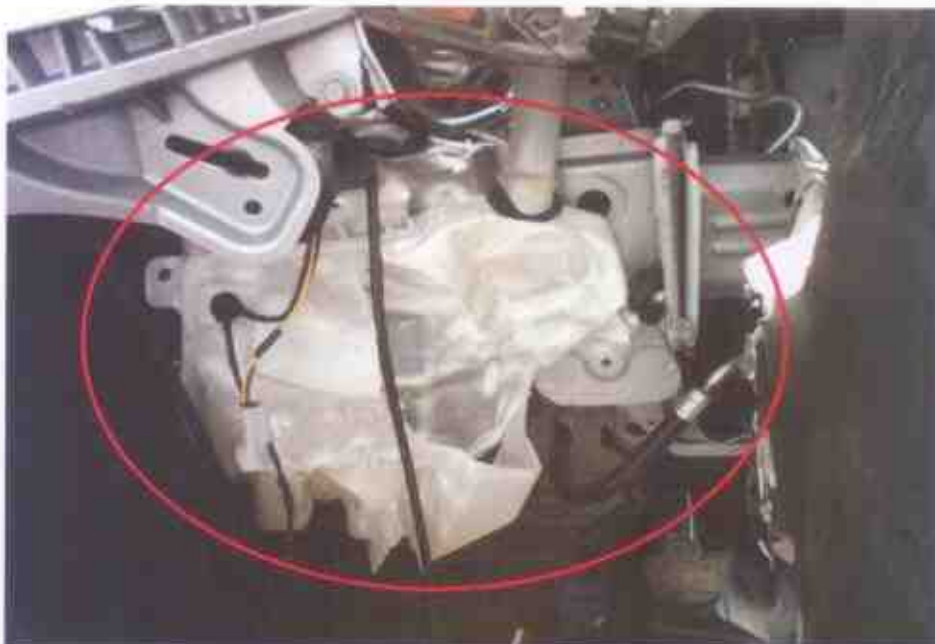
Photo 7 shows a close up view of the crushed wiper fluid reservoir of the Motor Car at the time of our inspection. It was observed to be damaged as a result of the accident.

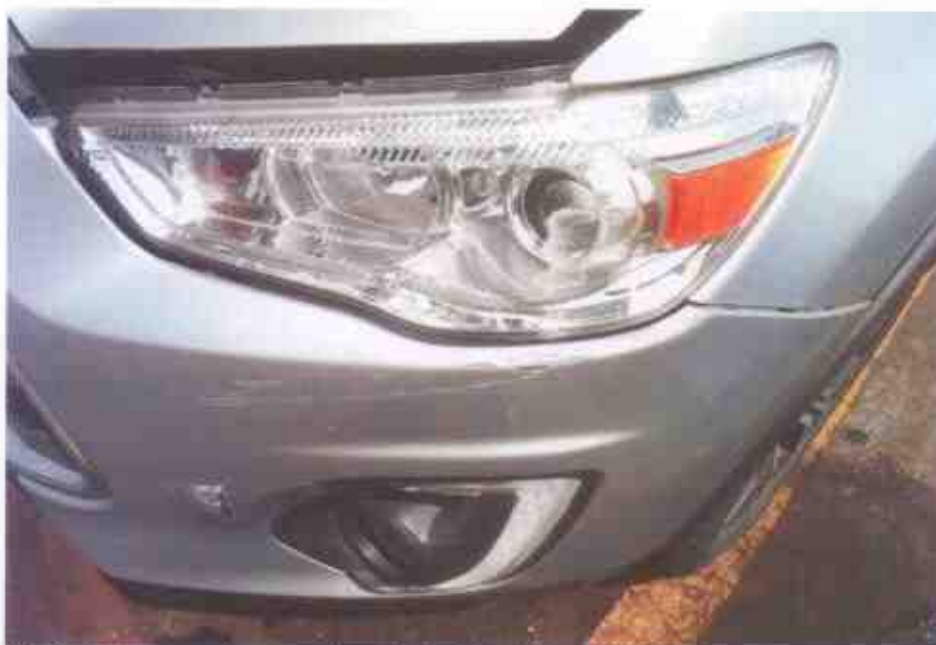
Photo 8 shows a close up view of the front bumper of the Motor Car at the time of our inspection. It was observed to be misaligned.

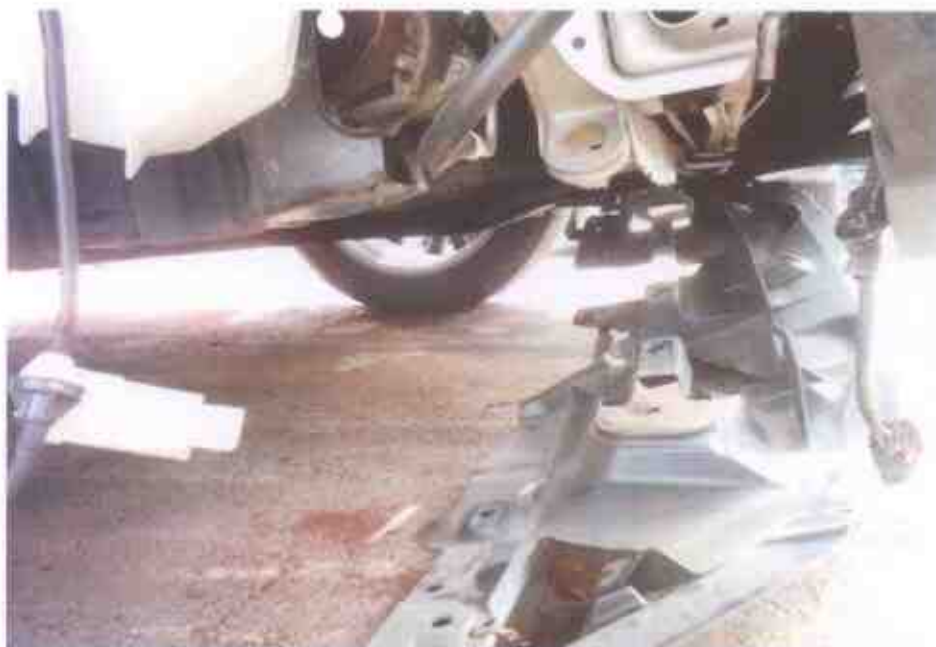
Photo 9 shows a close up view of the front undercarriage cover of the Motor Car at the time of our inspection. It was observed to be dislodged from the original installation likely due to the accident.

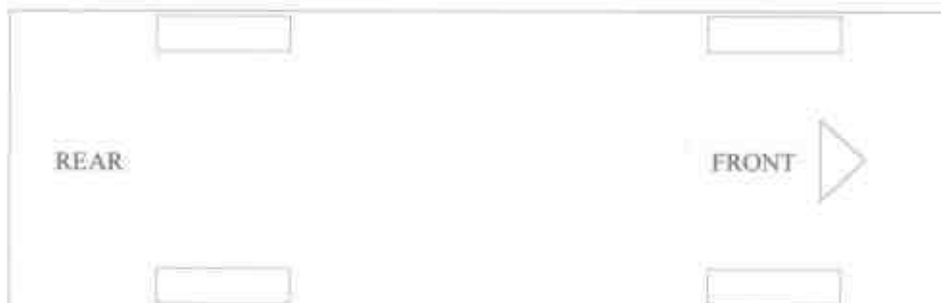
7. The condition of the Motor Car's 4 tyres was observed to be in serviceable condition. We did not find any tear, cut or burst mark(s) on the outer and the inner sidewalls as well as across the tread of the 4 tyres. The 4 tyres were also observed to be sufficiently inflated for vehicular operation. The tyre brand, tyre size and remaining tread depth of the 4 tyres were recorded as follows:-

Bridgestone Dueler H/T 684
225/55R18 (5mm)

Bridgestone Dueler H/T 684
225/55R18 (6mm)

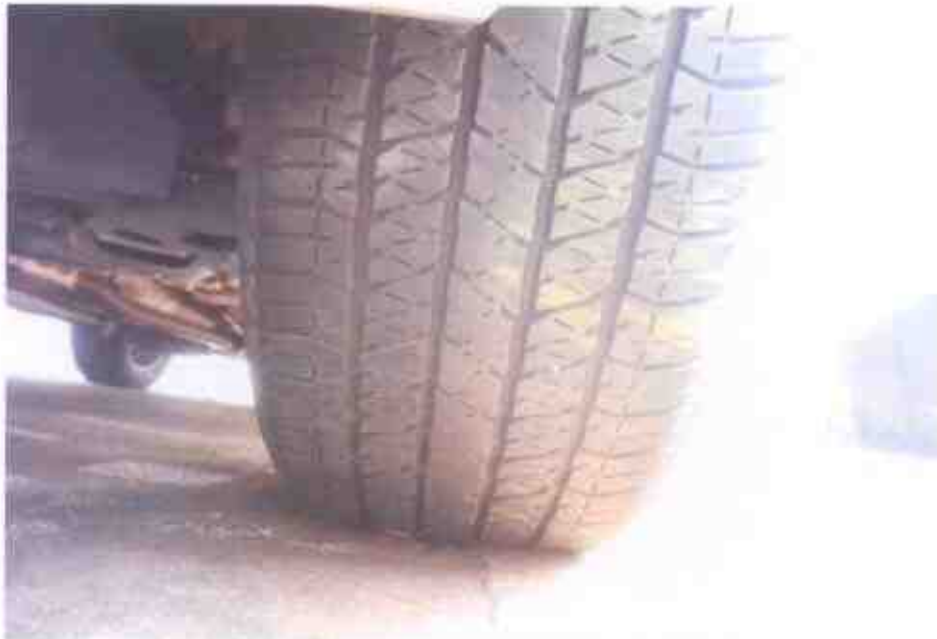
Photo 10 shows the condition of the front left tyre of the Motor Car, which was observed to be in serviceable condition with remaining tread depth of approximately 6mm.

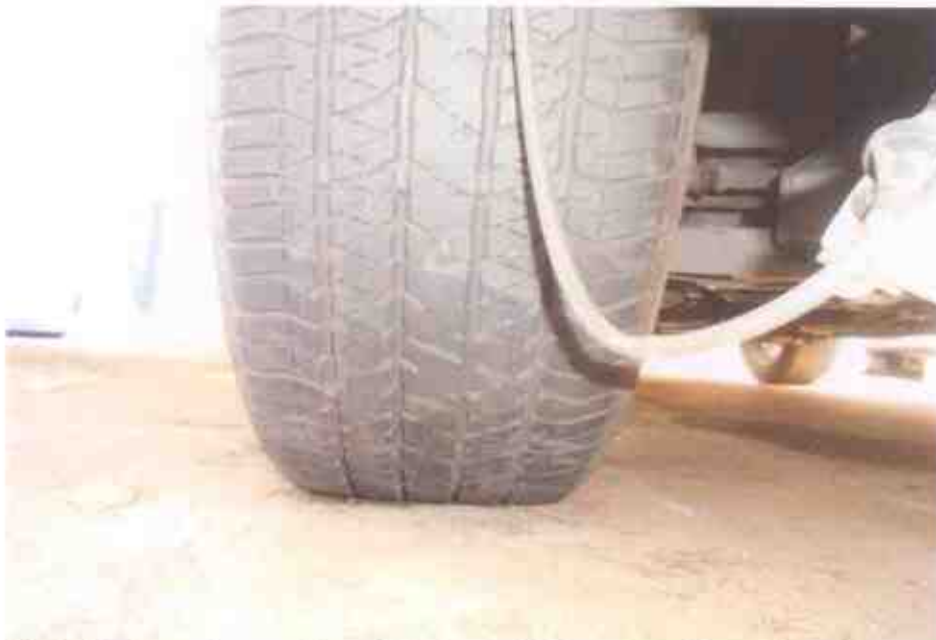
Photo 11 shows the condition of the front right tyre of the Motor Car, which was observed to be in serviceable condition with remaining tread depth of approximately 6mm.

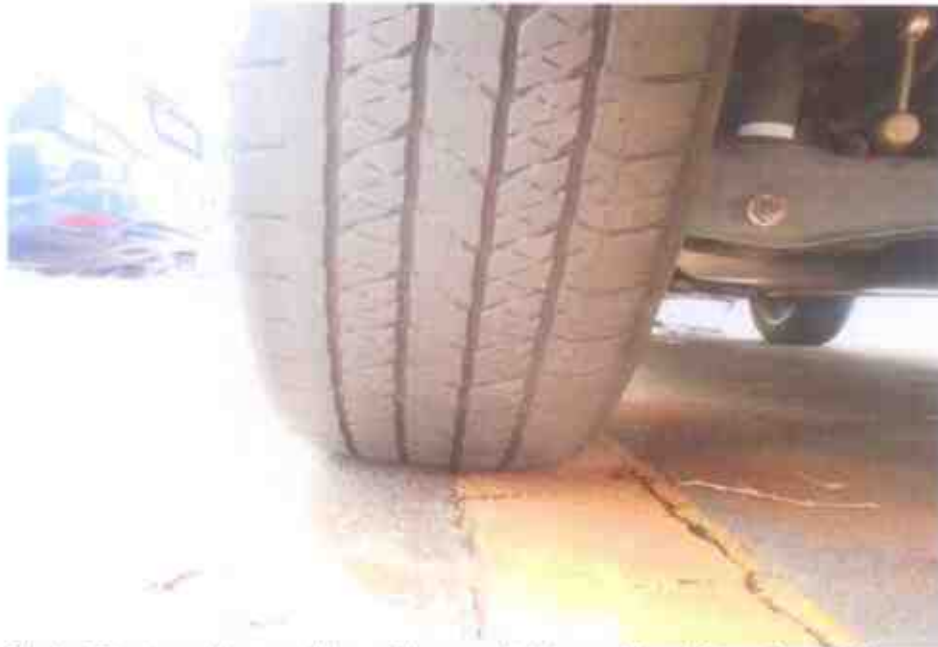
Photo 12 shows the condition of the rear left tyre of the Motor Car, which was observed to be in serviceable condition with remaining tread depth of approximately 5mm. The tyre, which was wrapped around alloy wheel rim, was also observed to be sufficiently inflated for vehicular operation.

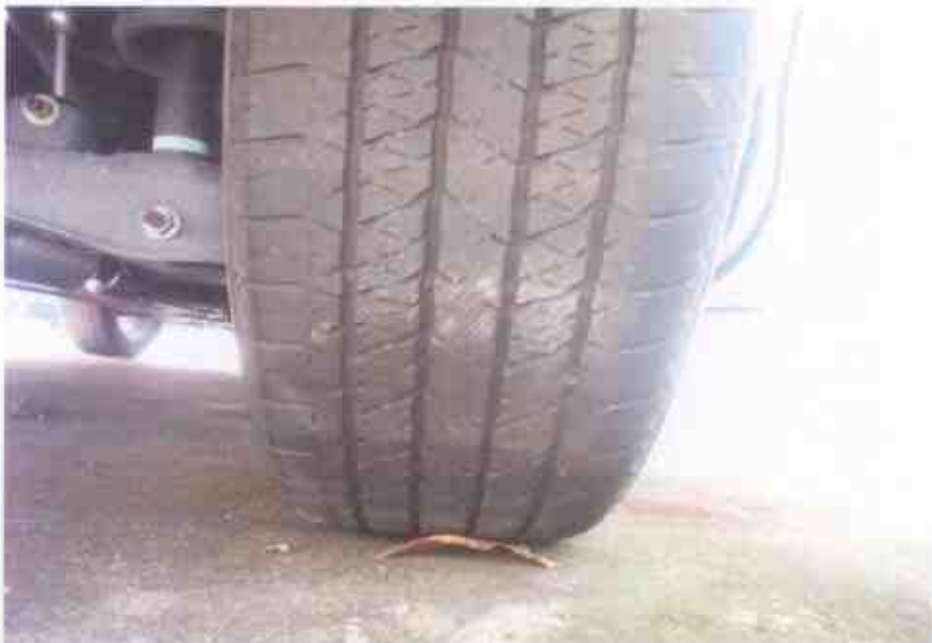
Photo 13 shows the condition of the rear right tyre of the Motor Car, which was observed to be in serviceable condition with remaining tread depth of approximately 5mm. There was also no tear, cut or burst mark(s) on the outer and the inner sidewalls as well as across the tread of the 4 tyres.

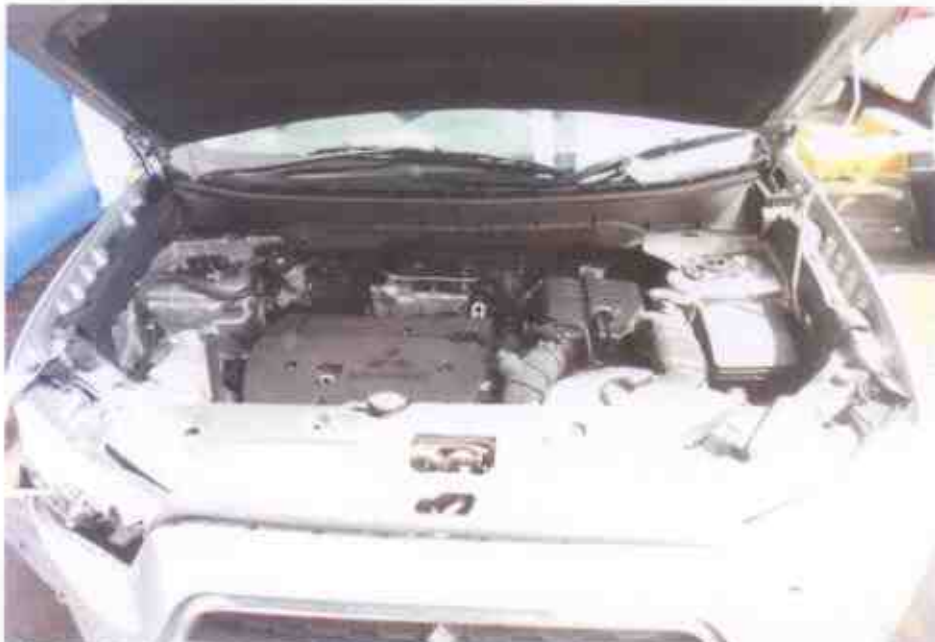
Photo 14 shows a general view of the Motor Car's engine compartment. The various parts and components inside the engine compartment were unaffected by the accident. There was also no sign(s) or indication(s) of fluid leakage and/or fluid stain within the engine compartment.

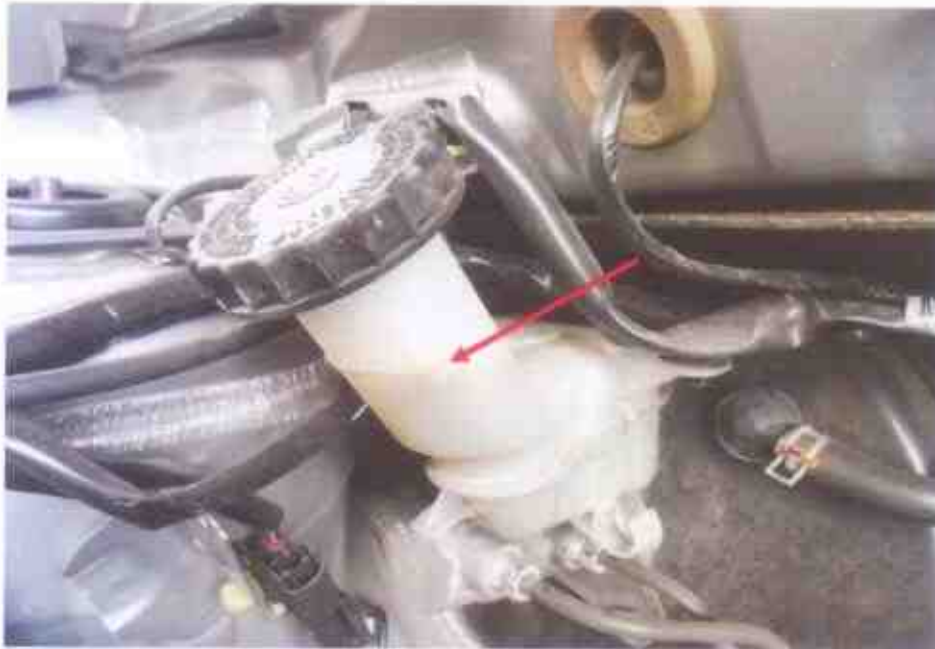
Photo 15 shows the brake fluid reservoir of the Motor Car at the time of our inspection. The brake fluid was observed to be of sufficient level (arrowed) and without any visible contamination.

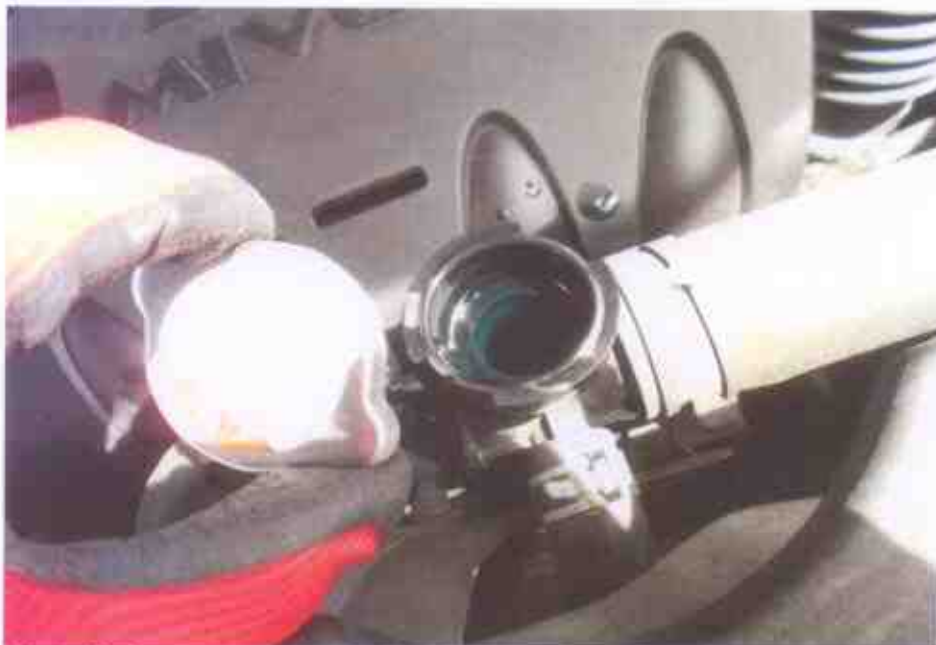
Photo 16 shows the coolant fluid in the radiator tank of the Motor Car at the time of our inspection. The coolant fluid was observed to be of sufficient level and without any visible contamination.

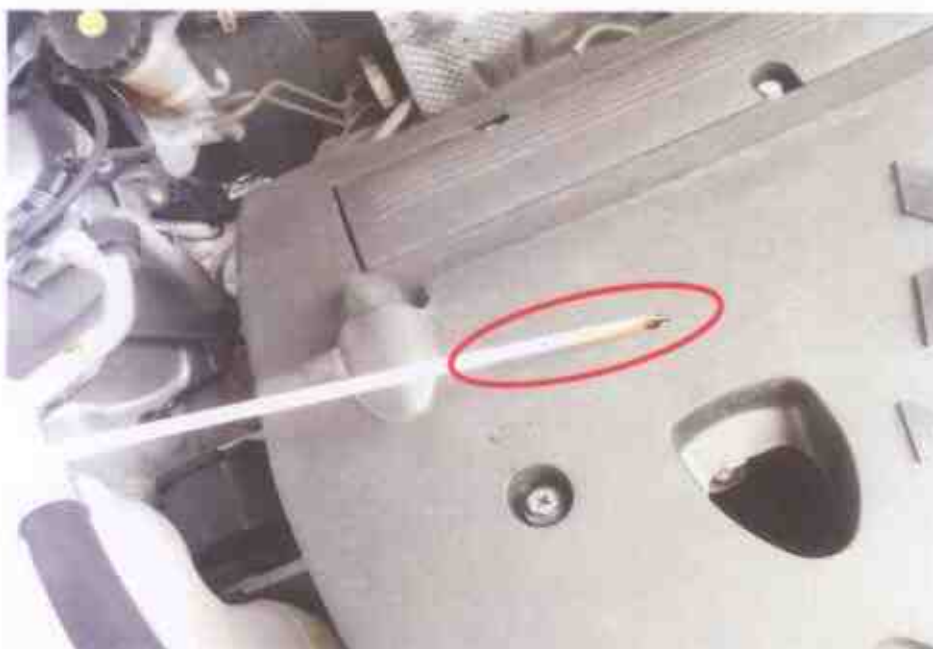
Photo 17 shows the engine oil dip stick of the Motor Car at the time of our inspection. The engine oil was observed to be of sufficient level and without any visible contamination.

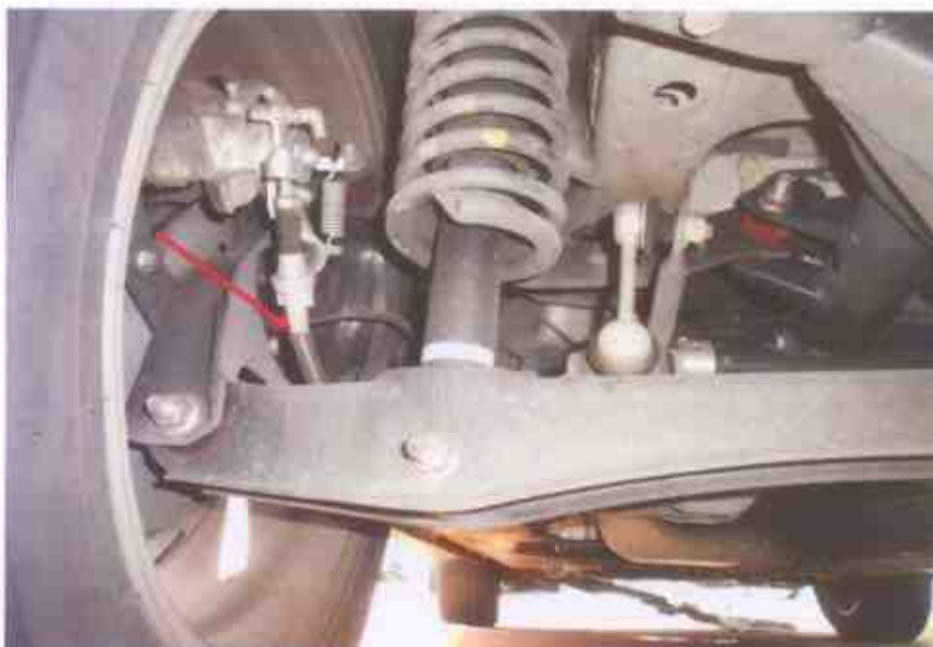
Photo 18 shows the brake hose (arrowed) at the rear left wheel of the Motor Car. We did not observe any leakage of brake fluid at the time of our inspection of the Motor Car. Our visual inspection of the various mechanical components of the Motor Car's braking system revealed all to be intact and without visible damage.

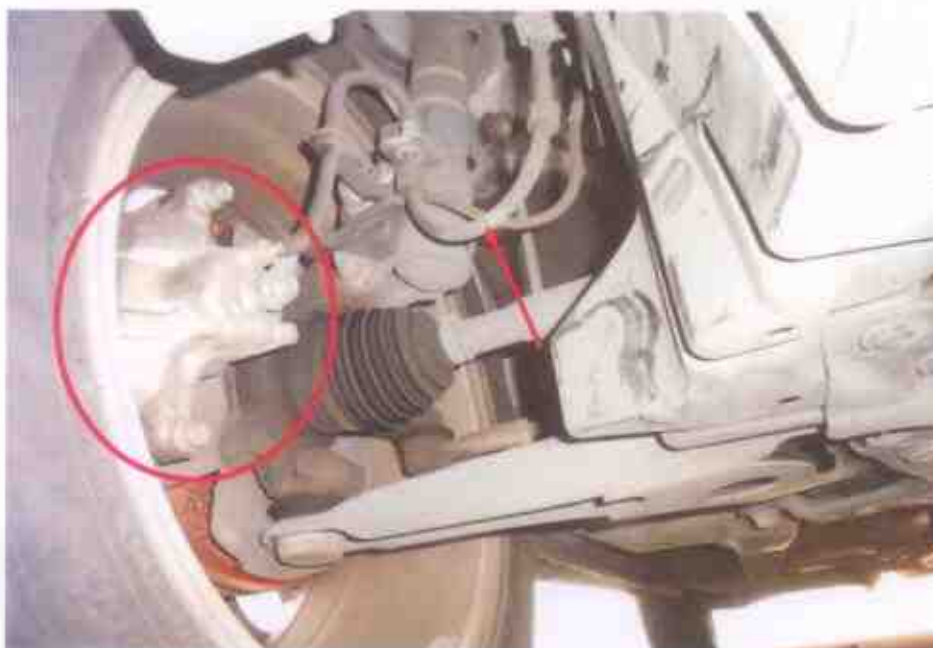
Photo 19 shows the brake hose (arrowed) at the front right wheel of the Motor Car. We did not observe any leakage of brake fluid at the time of our inspection of the Motor Car. Our visual inspection of the various mechanical components of the Motor Car's braking system, including its brake calliper (circled), revealed all to be intact and without visible damage, indicating that the braking system was likely to be in serviceable condition at the material time of accident.

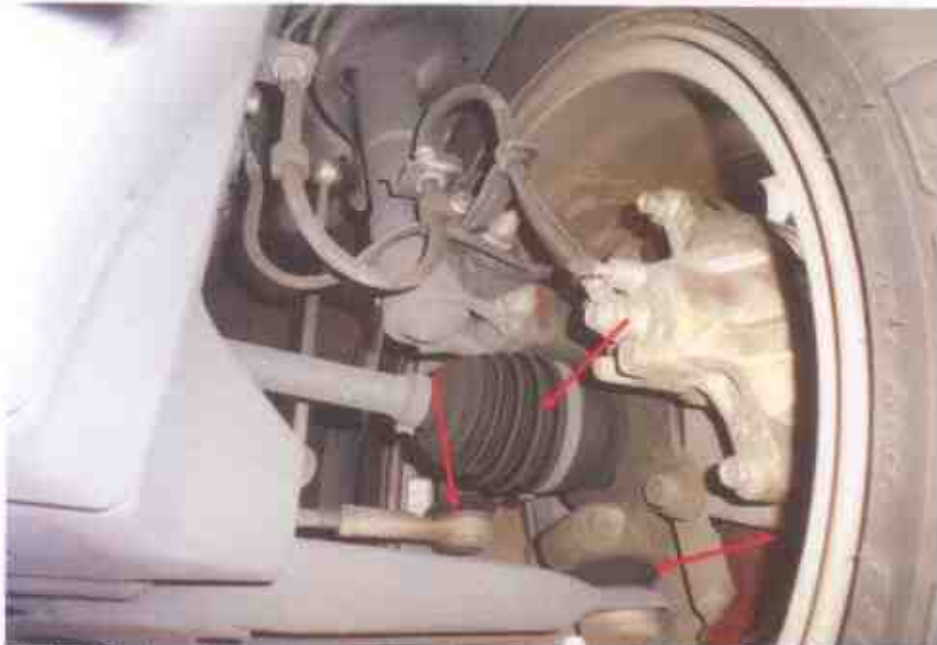
Photo 20 shows the various undercarriage components at the front left wheel of the Motor Car, in particular the steering tie rod (arrowed). The various steering components were all found to be intact, suggesting that the steering system of the Motor Car was likely to be in serviceable condition.

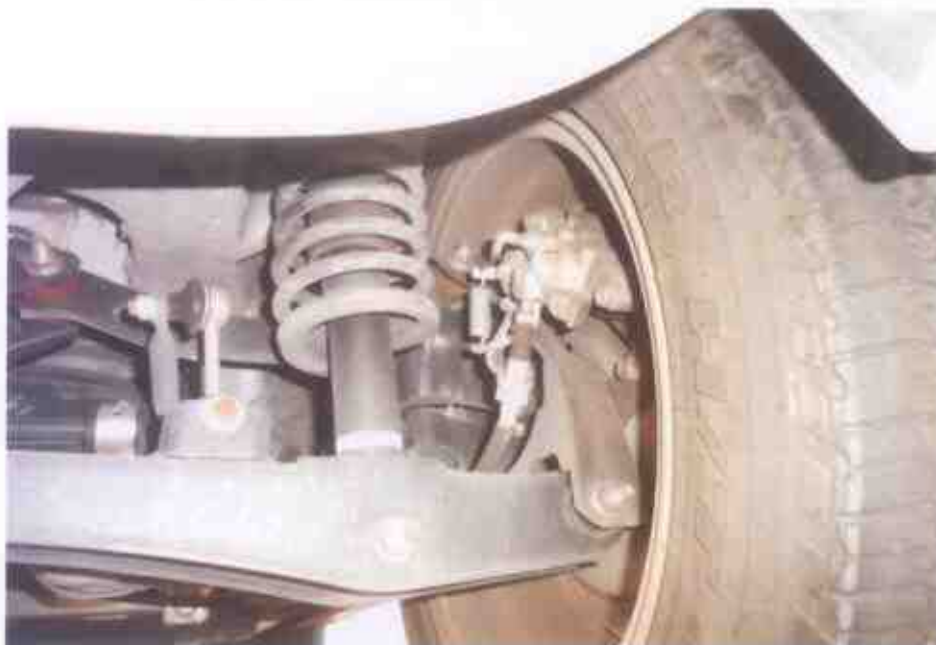
Photo 21 shows the various undercarriage components at the rear right wheel of the Motor Car. We did not observe any leakage of brake fluid at the time of our inspection of the Motor Car. Our visual inspection of the various mechanical components of the Motor Car's braking system revealed all to be intact and without visible damage, indicating that the braking system was likely to be in serviceable condition at the material time of accident.

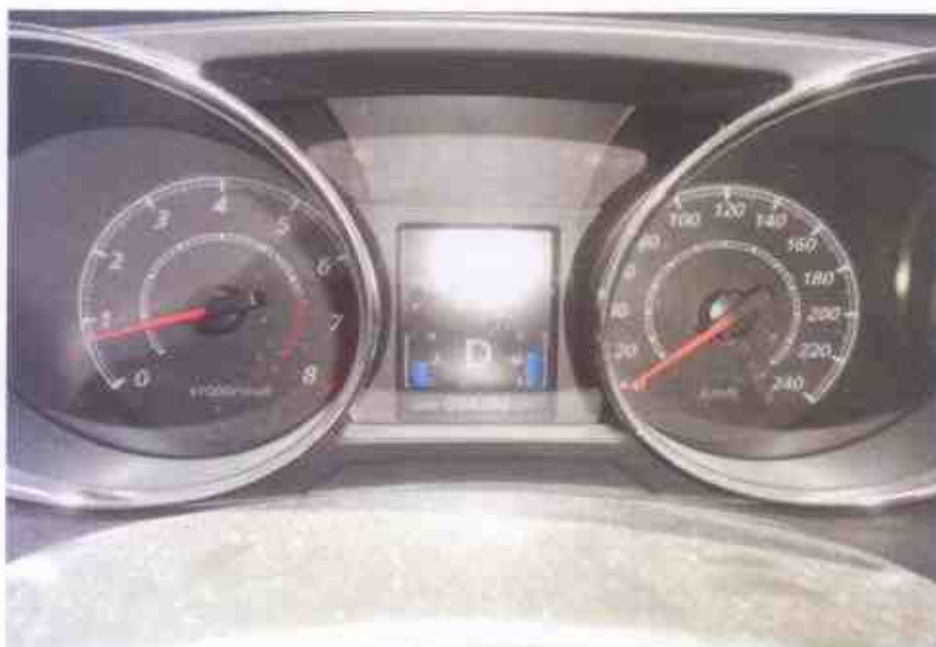
Photo 22 shows no warning lights illuminated on the instrument panel of the Motor Car after the engine was cranked. This would suggest that there was no abnormality to the various electronic operating systems of the Motor Car, like the ABS and SRS.

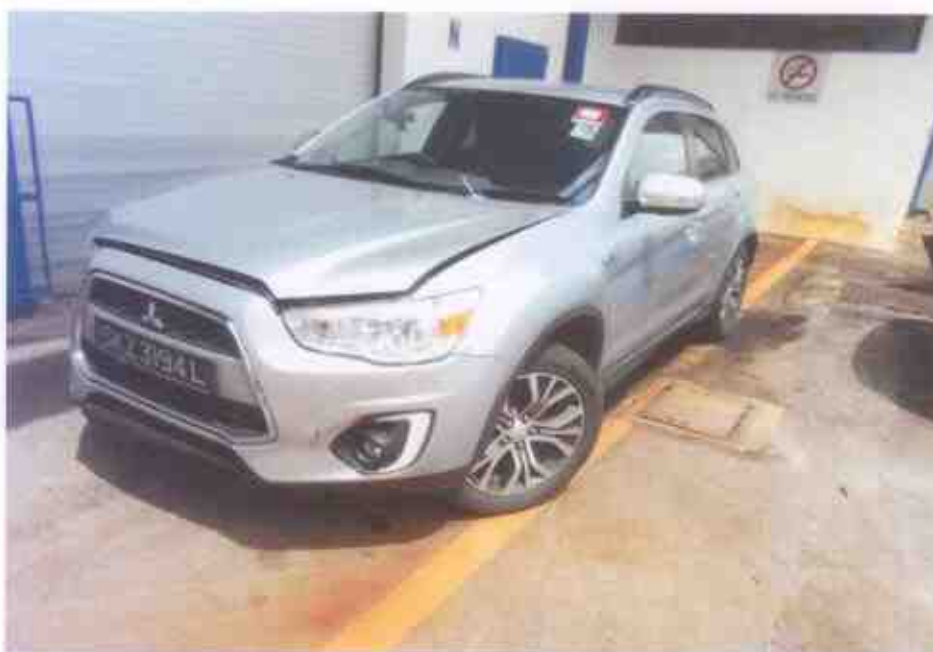
Photo 23 shows the operational test conducted to the Motor Car's engine system, transmission system & braking system.

15. A short operational test of the Motor Car, to primarily determine whether there was any abnormality to its engine system, its transmission system and braking system was subsequently carried out.
16. During the operational test, the transmission system of the Motor Car was able to be shifted to drive mode and reverse mode without any difficulty. There were no abnormal sounds heard and/or abnormal behaviour of the Motor Car's engine system. It was able to move forward and backward normally. The braking system was also found to be in working condition as the Motor Car was able to slow down and come to a complete stop upon depressing of the brake pedal.
