Your Ref: TP/IP/57145/2018
Our Ref : CI/TPD18019482/Z

11th February 2019

MECHANICAL INSPECTION REPORT OF MOTOR TAXI SH 7434T

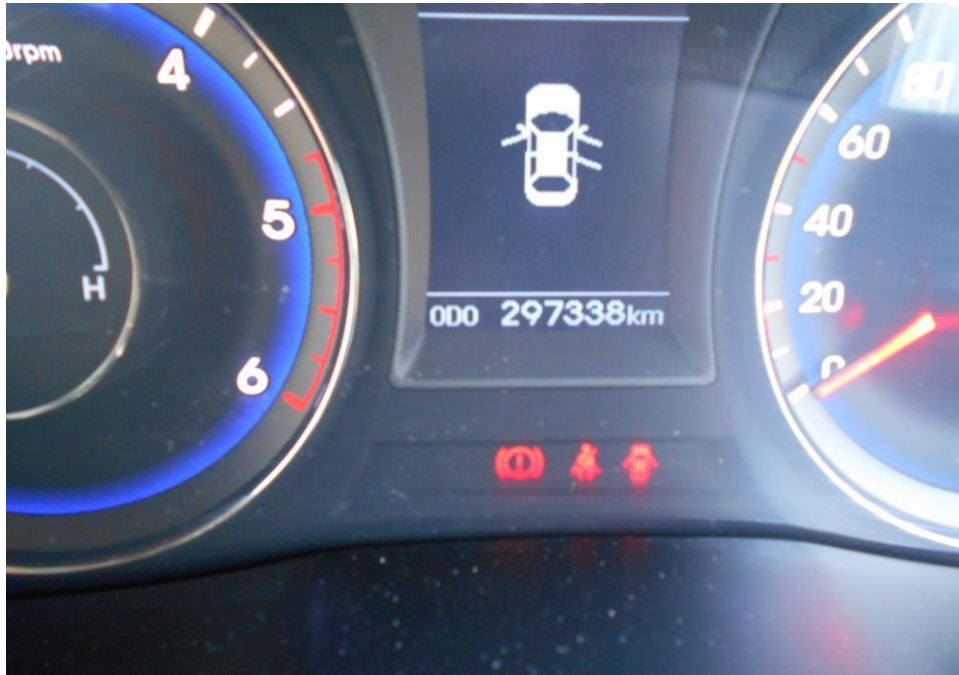
Photo 1 shows the mileage of the Motor taxi at the time of our inspection was recorded at 297338km.

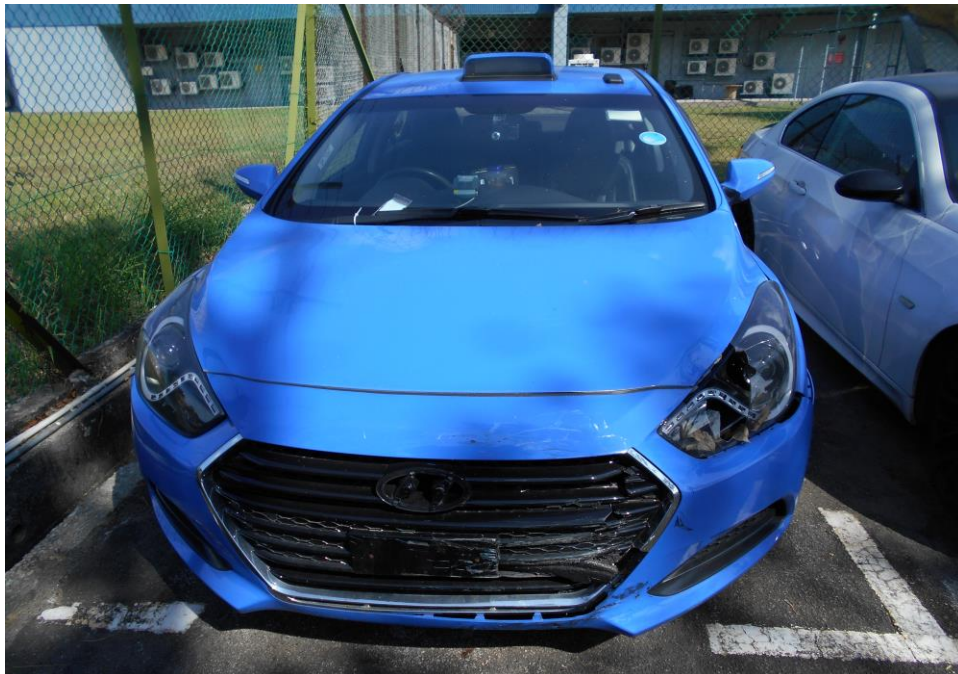
Photo 2 shows a general view of the front body of the Motor Taxi at the time of our inspection. The Motor Taxi was observed to have sustained a relatively minor impact damages that was confined to its frontal left portion. Its front lower bumper was observed to be pushed inwards likely due to the accident's collision impact.

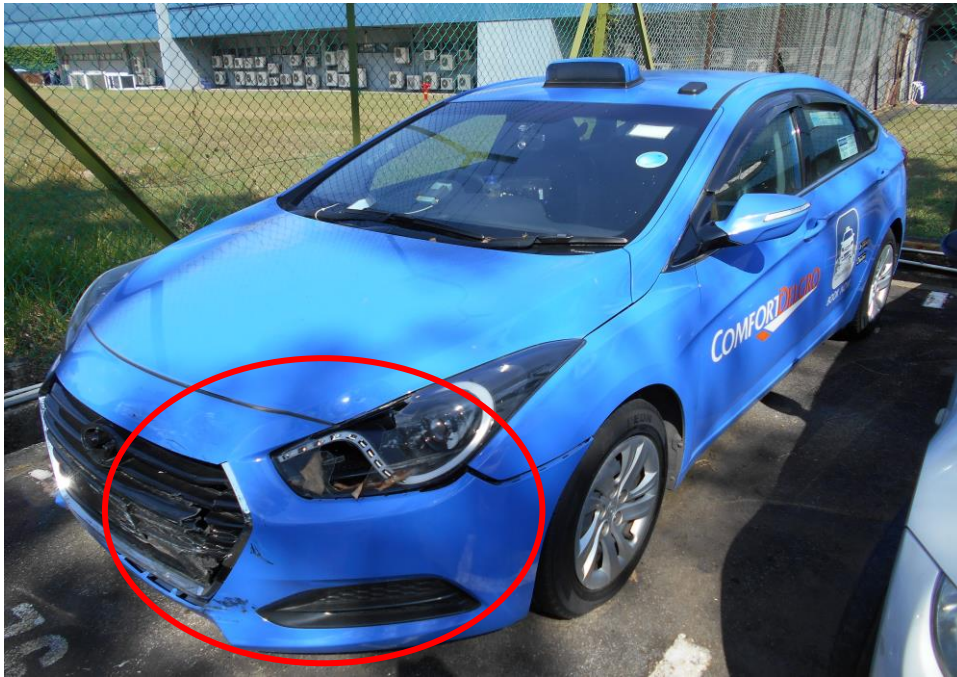
Photo 3 shows a general view of the front left body of the Motor Taxi at the time of our inspection. The Motor Taxi was observed to have sustained a relatively minor impact damages that was confined to its frontal left portion.

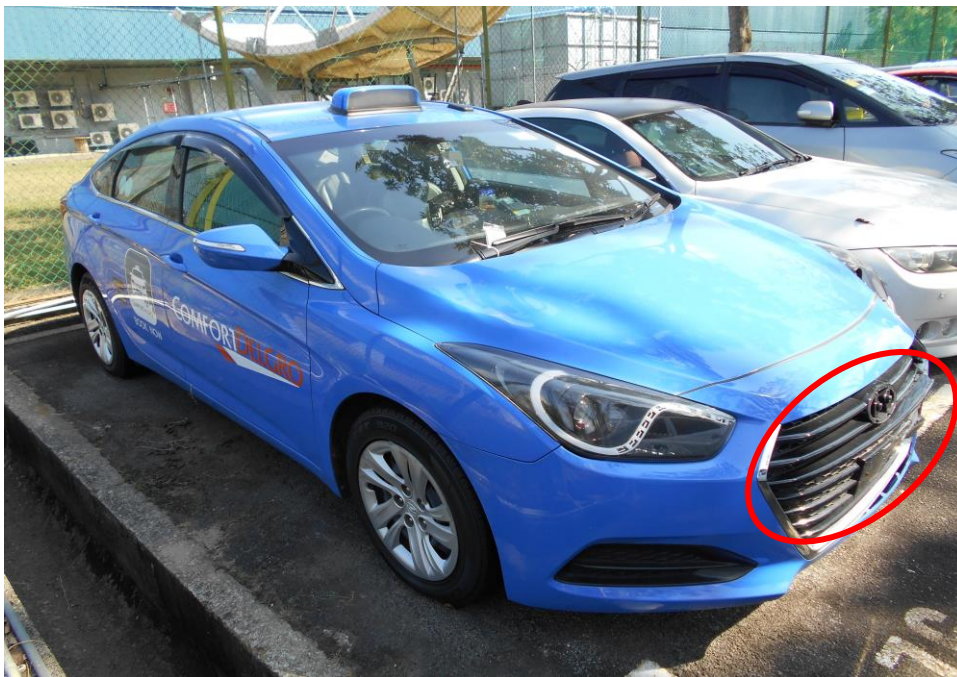
Photo 4 shows a general view of the front right body of the Motor Taxi at the time of our inspection. The Motor Taxi was observed to have sustained a relatively minor impact damages that was confined to its frontal left portion.

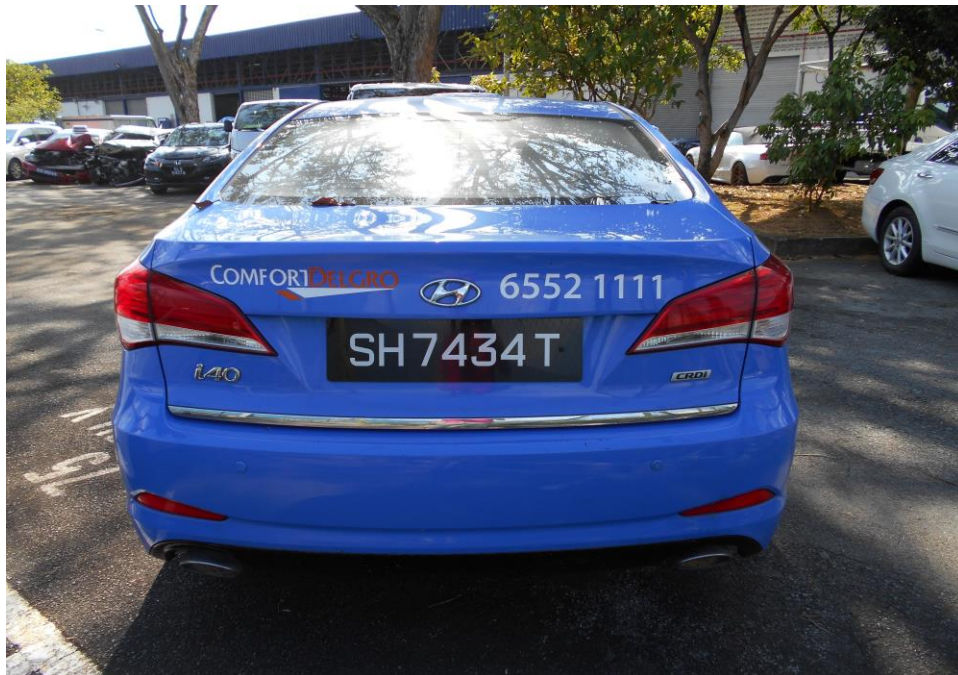
Photo 5 shows a general view of the rear body of the Motor Taxi at the time of our inspection. The Motor Taxi was observed to be in good general condition.

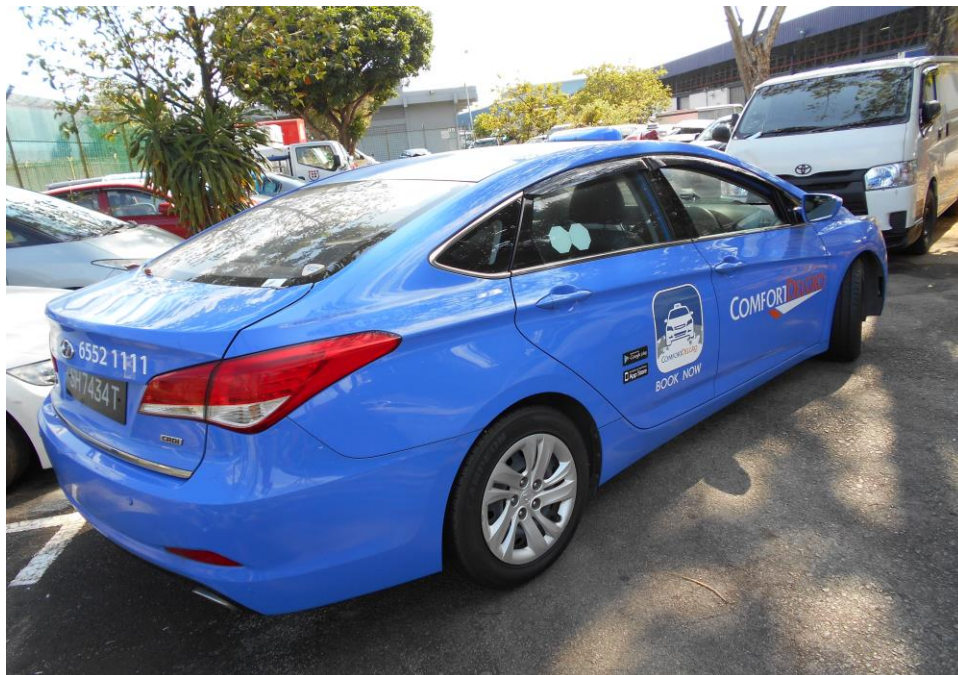
Photo 6 shows a general view of the rear right body of the Motor Taxi at the time of our inspection. The Motor Taxi was observed to be in good general condition.

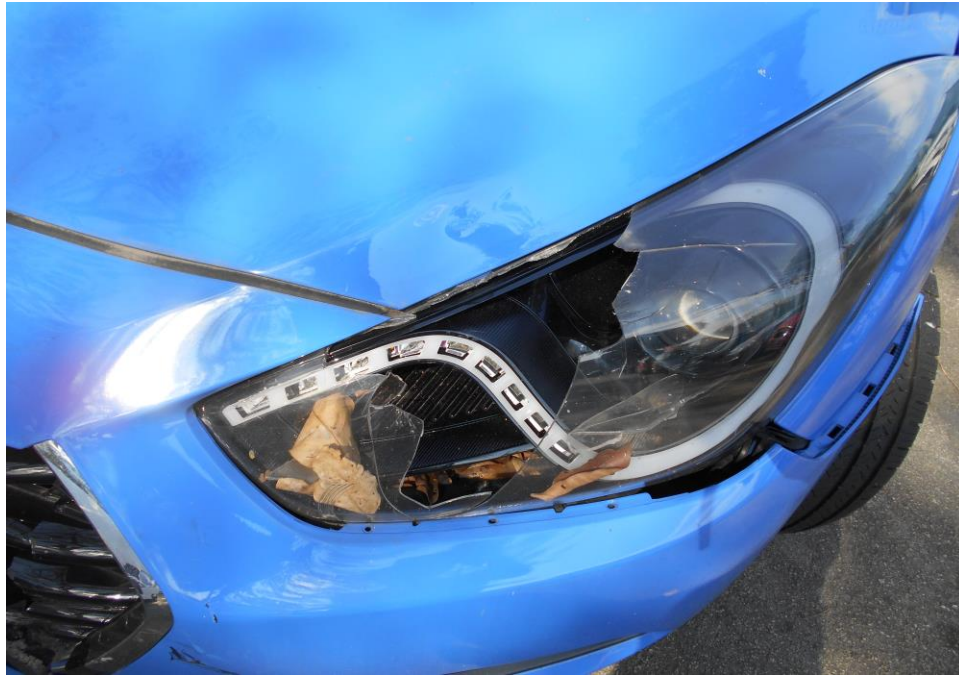
Photo 7 shows a semi close up view of the front left headlamp of the Motor Taxi at the time of our inspection. It had sustained damages likely due to the accident.

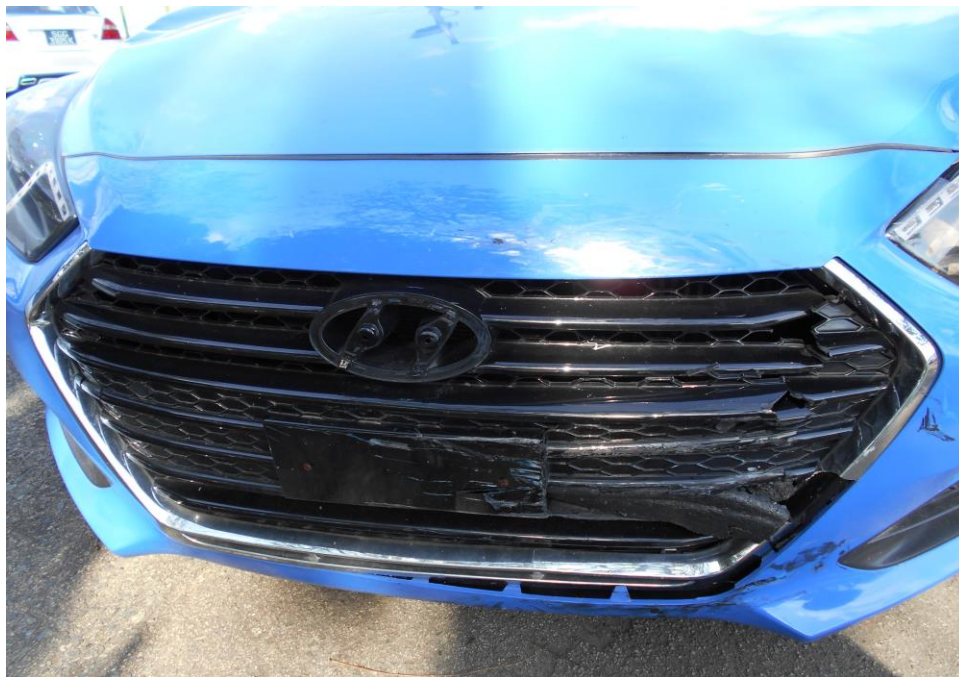
Photo 8 shows a close up view of the front portion of the Motor Taxi. Missing licence plate & damaged bumper was observed at the time of our inspection.

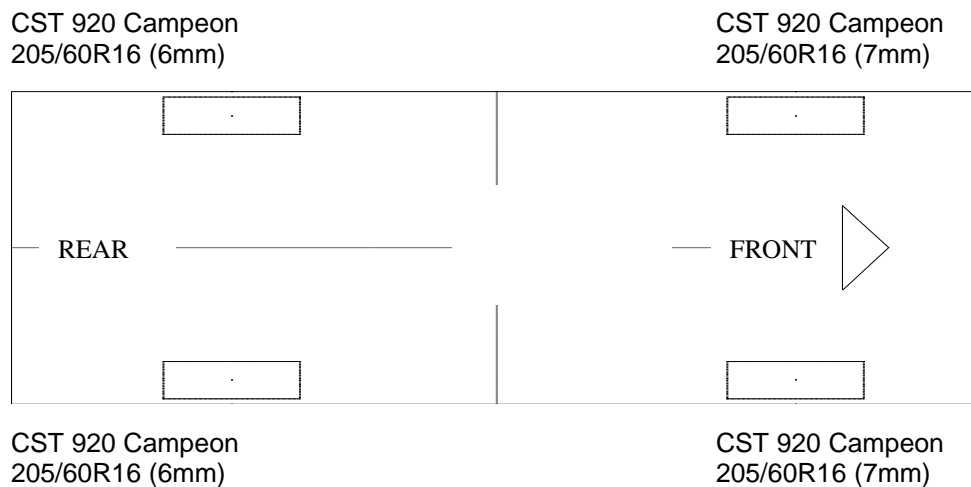
7. The condition of the Motor Taxi's 4 tyres was observed to be in serviceable condition. We did not find any tear, cut or burst mark(s) on the outer and the inner sidewalls as well as across the tread of the 4 tyres. The 4 tyres were also observed to be sufficiently inflated for vehicular operation. The tyre brand, tyre size and remaining tread depth of the 4 tyres were recorded as follows:-

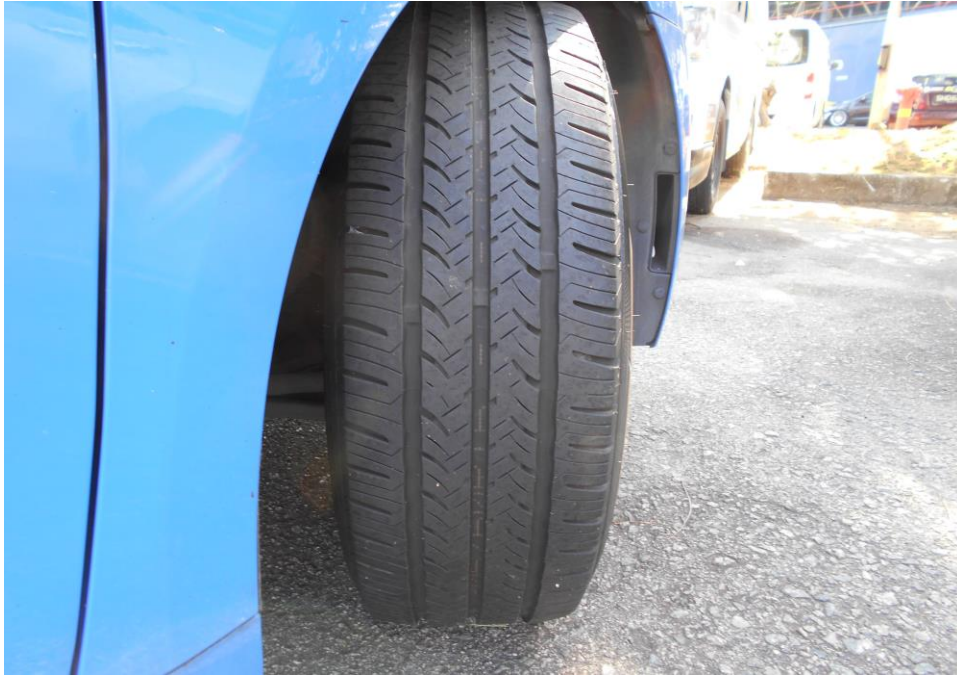
Photo 9 shows the condition of the front right tyre of the Motor Taxi, which was observed to be in serviceable condition with remaining tread depth of approximately 7mm. There was no tear, cut or burst mark(s) on the outer and the inner sidewalls.

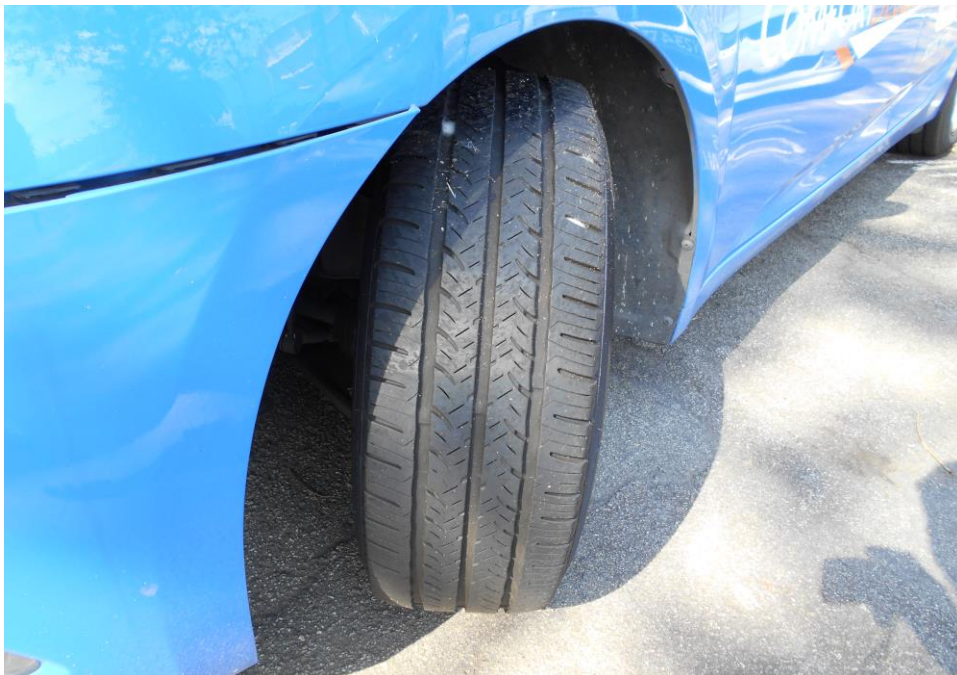
Photo 10 shows the condition of the front left tyre of the Motor Taxi, which was observed to be in serviceable condition with remaining tread depth of approximately 7mm. The tyre, which was wrapped around alloy wheel rim, was also observed to be sufficiently inflated for vehicular operation.

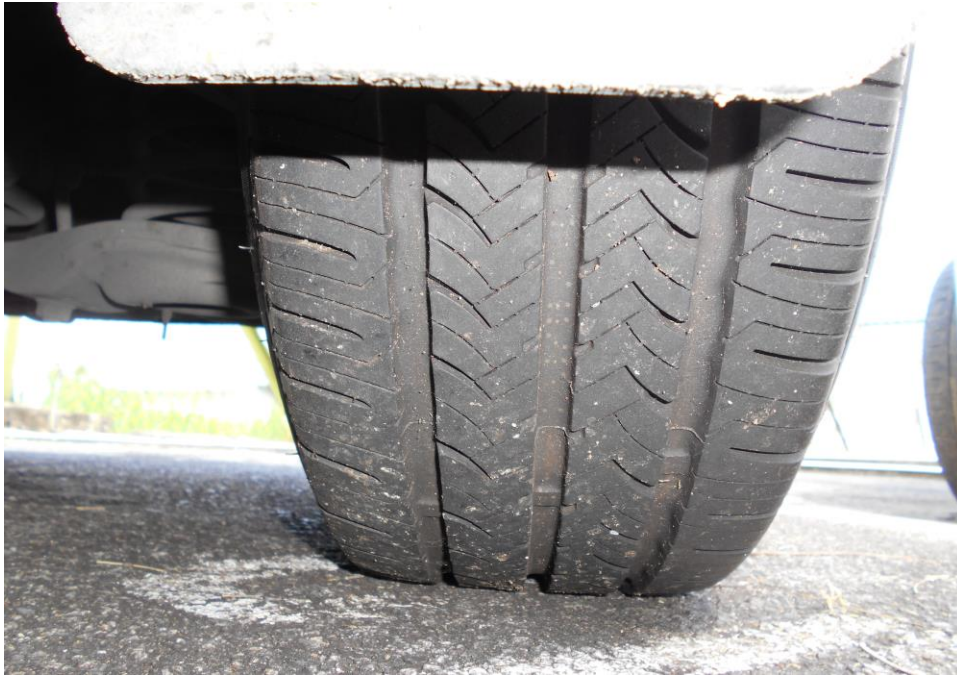
Photo 11 shows the condition of the rear left tyre of the Motor Taxi, which was observed to be in serviceable condition with remaining tread depth of approximately 6mm.

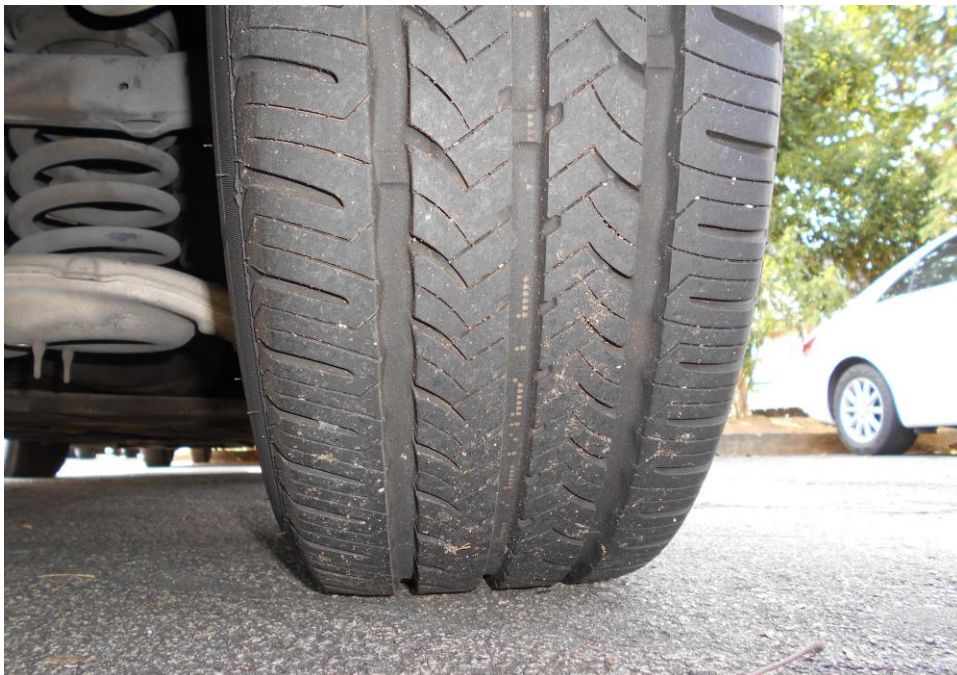
Photo 12 shows the condition of the rear right tyre of the Motor Taxi, which was observed to be in serviceable condition with remaining tread depth of approximately 6mm.

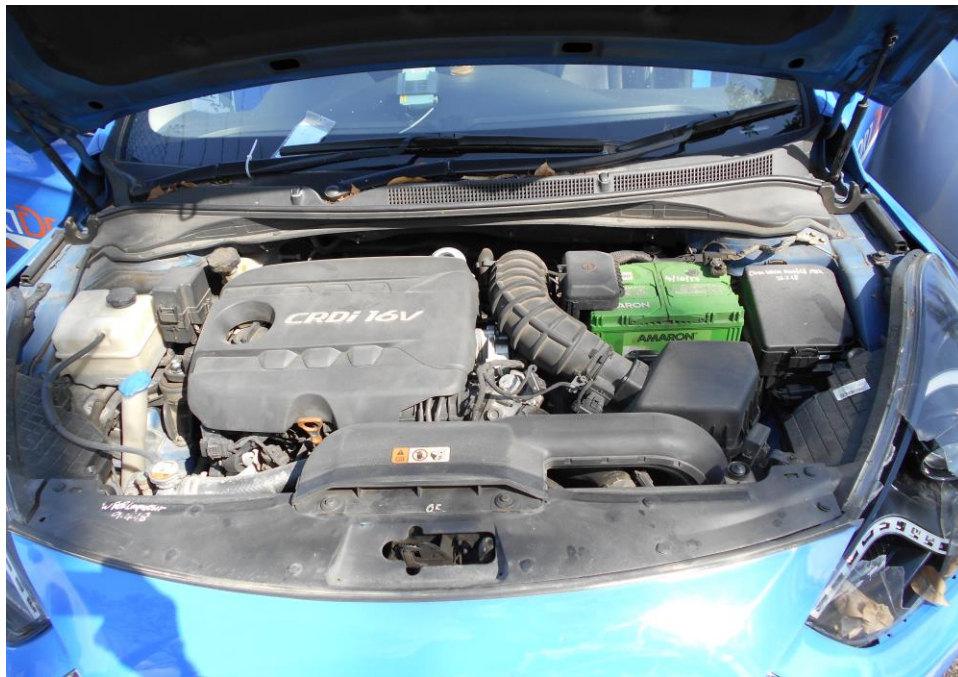
Photo 13 shows a general view of the Motor Car's engine compartment. The various parts and components inside the engine compartment were unaffected by the accident. There was also no sign(s) or indication(s) of fluid leakage and/or fluid stain within the engine compartment.

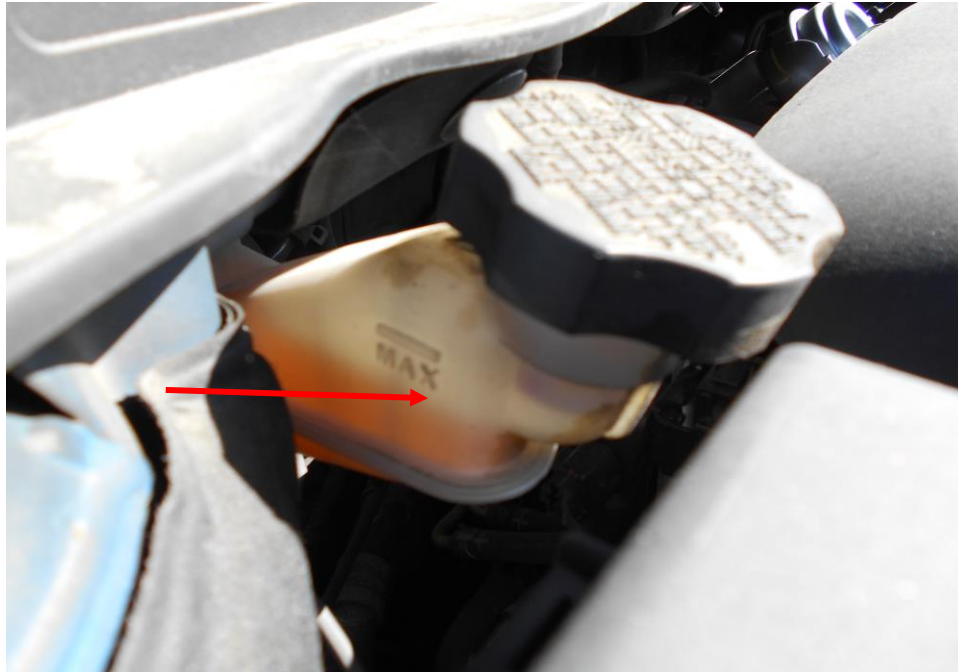
Photo 14 shows the brake fluid reservoir of the Motor Taxi at the time of our inspection. The brake fluid was observed to be of sufficient level (arrowed) and without any visible contamination.

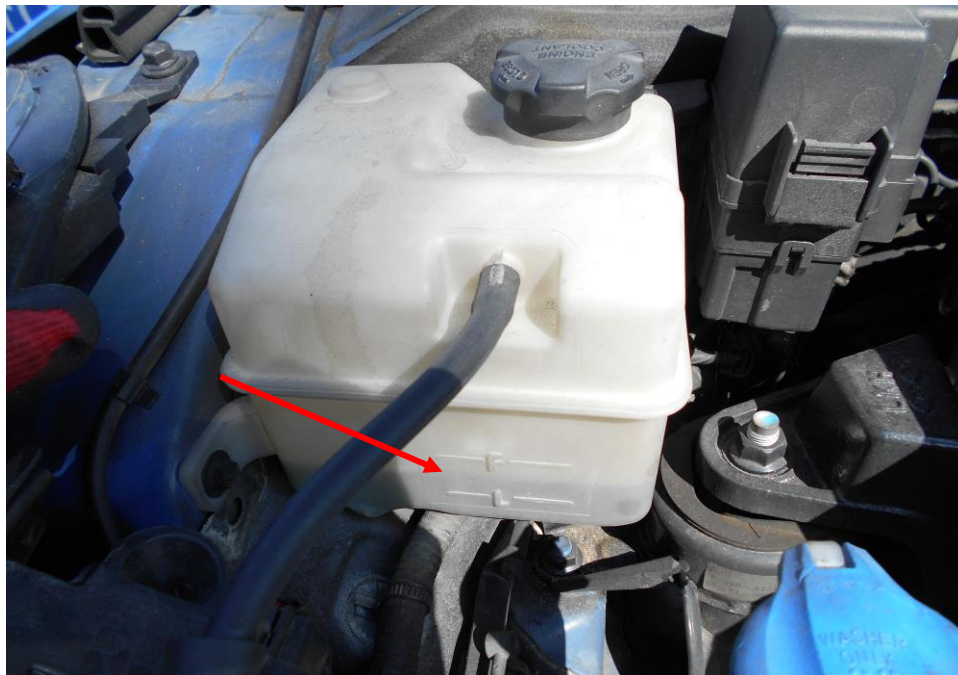
Photo 15 shows the engine coolant fluid reservoir of the Motor Taxi at the time of our inspection. The engine coolant fluid was observed to be of sufficient level and without any visible contamination.

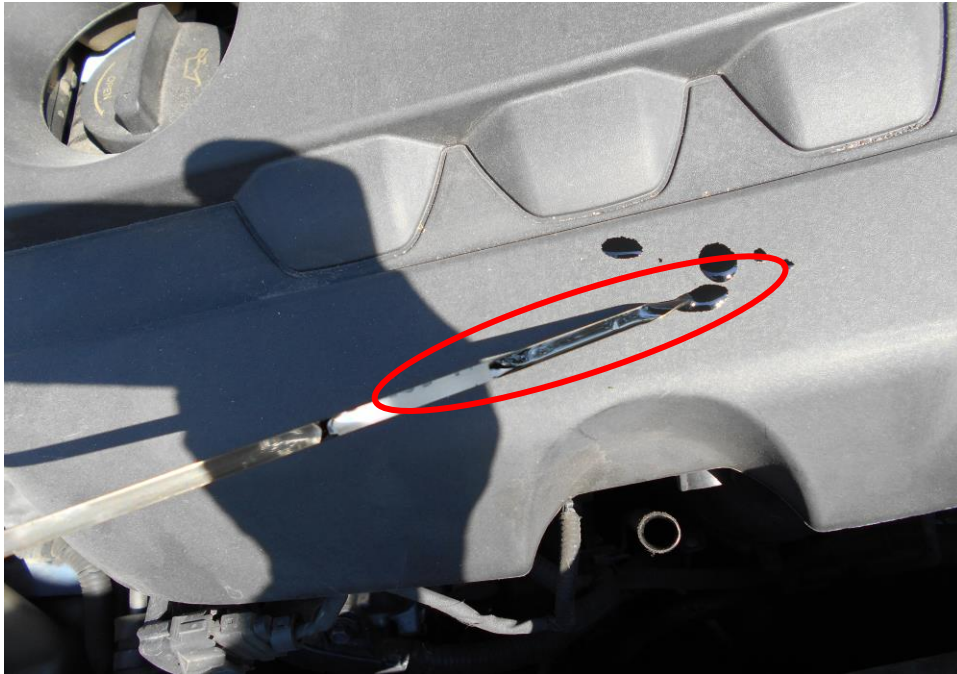
Photo 16 shows the engine oil dip stick of the Motor Taxi at the time of our inspection. The engine oil was observed to be of sufficient level and without any visible contamination.

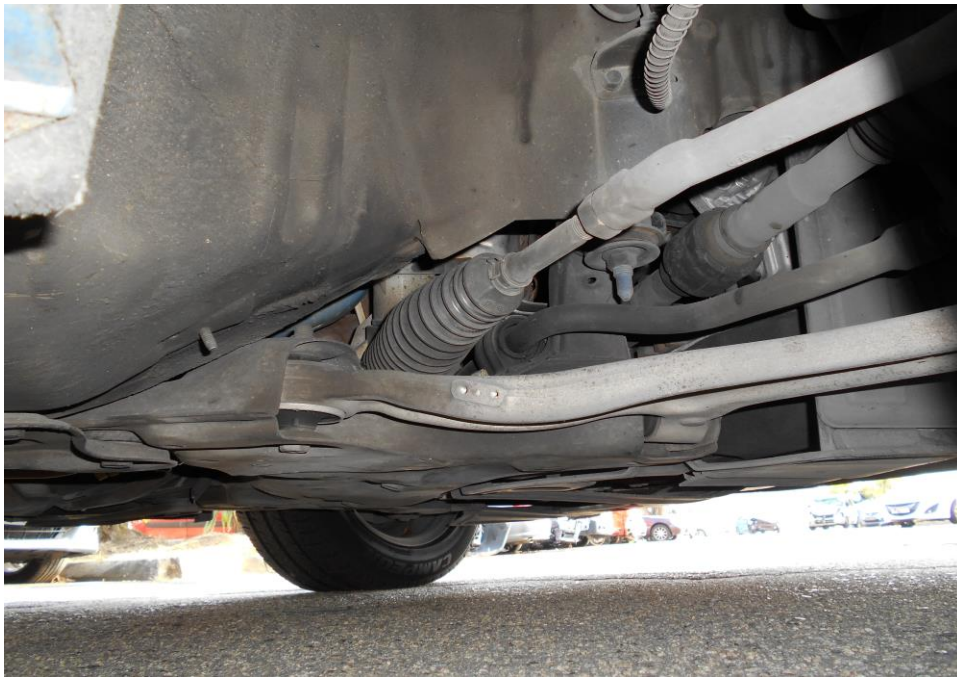
Photo 17 shows the engine underside of the Motor Taxi engine. The engine was observed to be free from fluid leakage at time of our inspection.

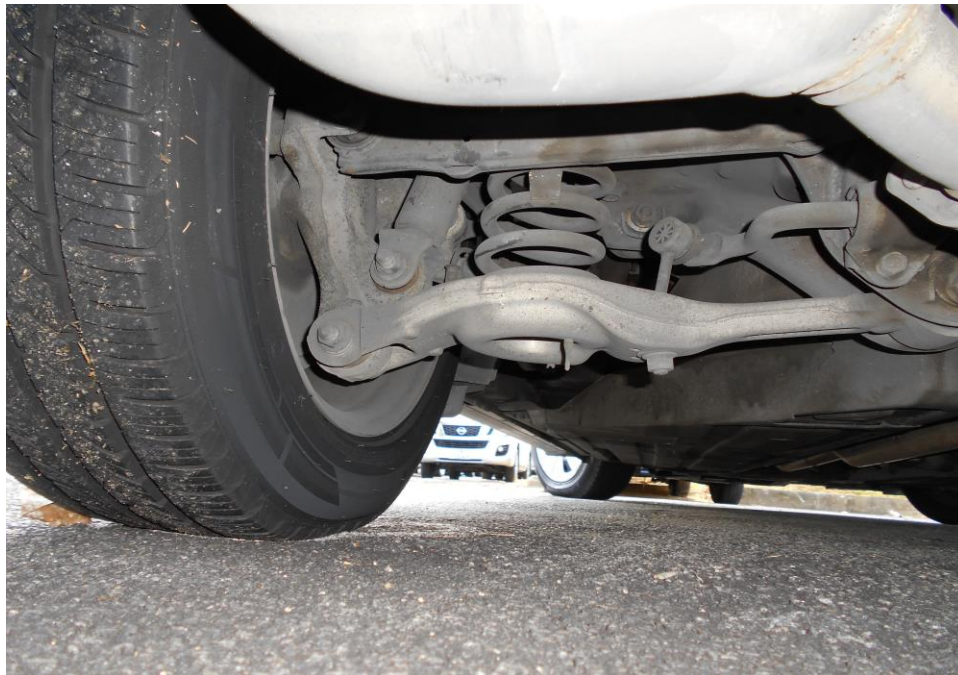
Photo 18 shows the rear left wheel of the Motor Taxi. We did not observe any leakage of brake fluid at the time of our inspection of the Motor Taxi. Our visual inspection of the various mechanical components of the Motor Taxi's braking system revealed all to be intact without visible damage.

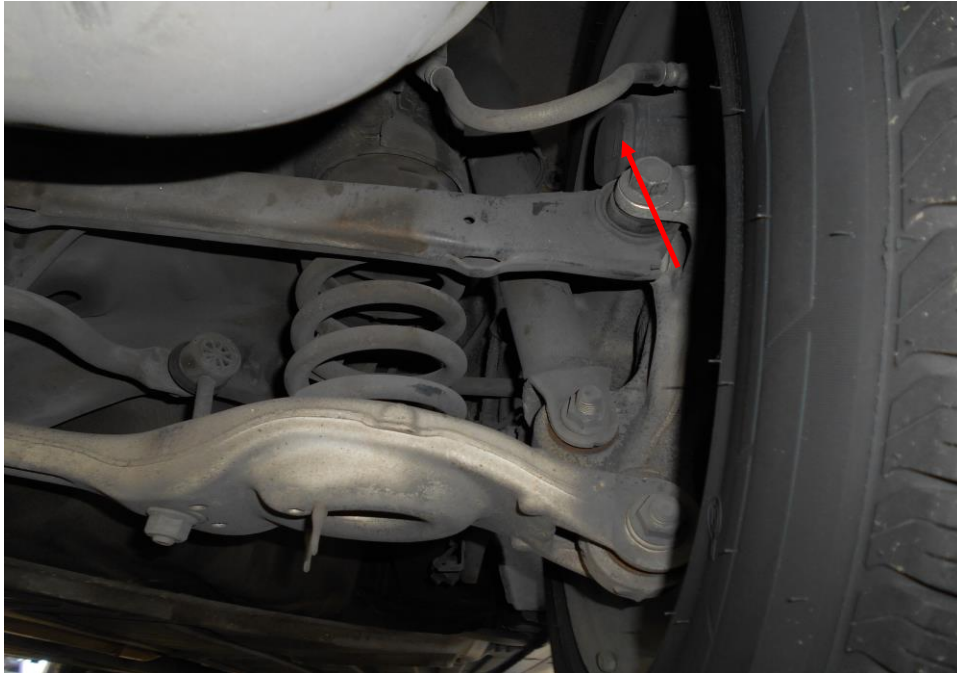
Photo 19 shows the brake hose (arrowed) at the rear right wheel of the Motor Taxi. We did not observe any leakage of brake fluid at the time of our inspection of the Motor Taxi. Our visual inspection of the various mechanical components of the Motor Taxi's braking system revealed all to be intact without visible damage.

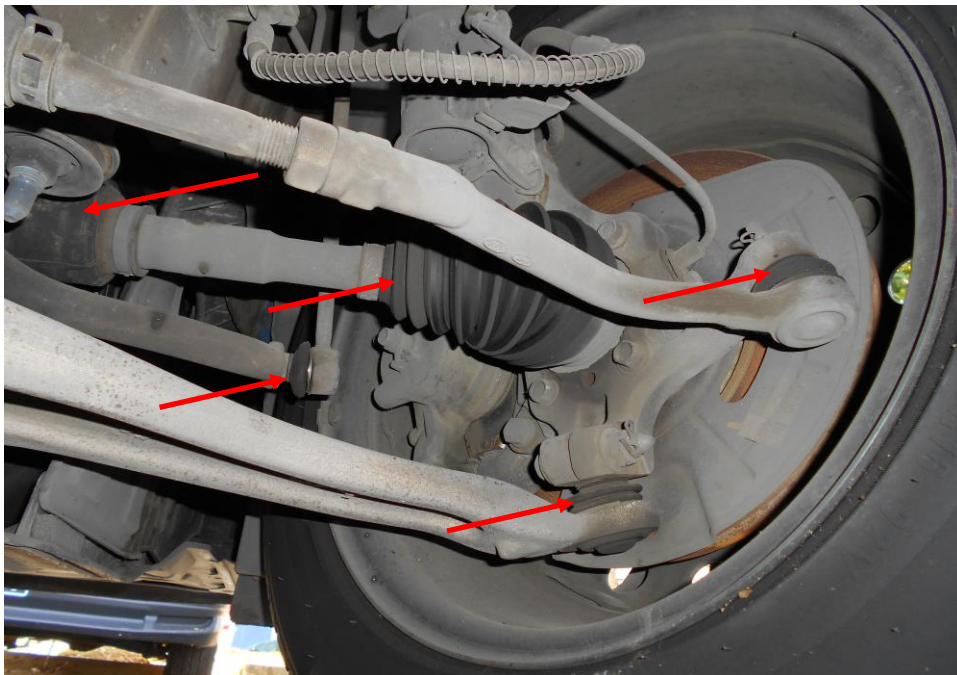
Photo 20 shows the various undercarriage components at the front right wheel of the Motor Taxi, in particular the steering tie rod (arrowed). The various steering components were all found to be intact, suggesting that the steering system of the Motor Taxi was likely to be in serviceable condition.

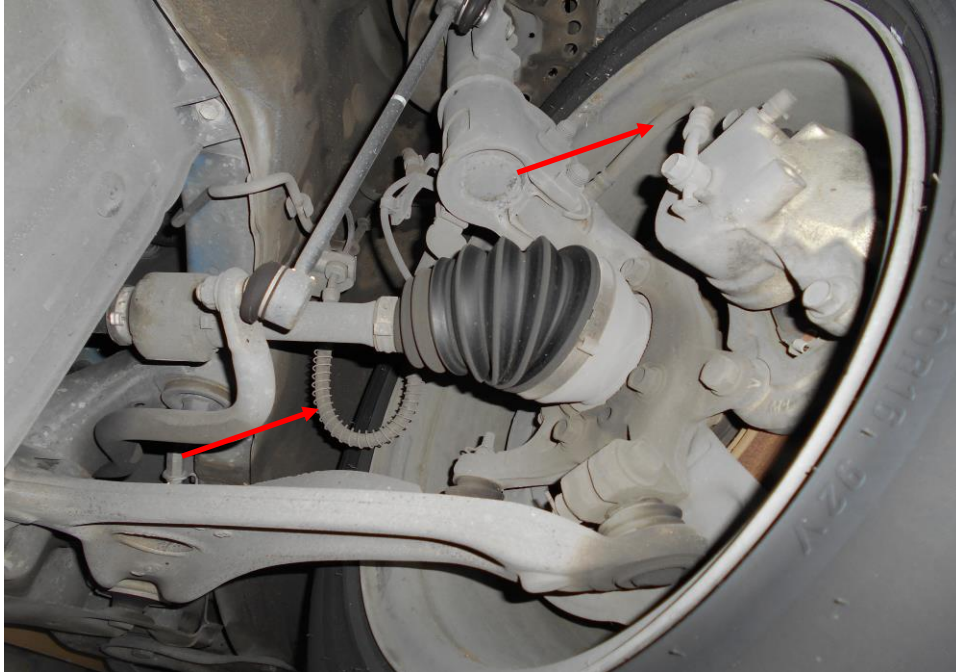
Photo 21 shows the various undercarriage components at the front left wheel of the Motor Taxi. We did not observe any leakage of brake fluid (arrowed) at the time of our inspection of the Motor Taxi. Our visual inspection of the various mechanical components of the Motor Taxi's braking system revealed all to be intact and without visible damage, indicating that the braking system was likely to be in serviceable condition at the material time of accident.

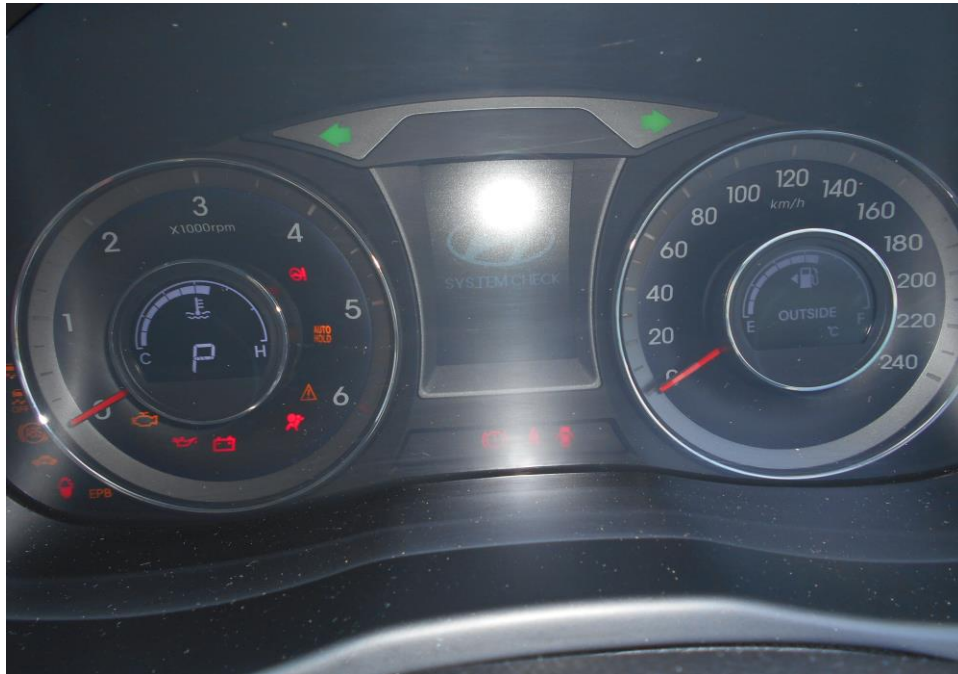
Photo 22 shows the warning lights for the various electronic operating systems of the Motor Taxi appearing on its instrument panel during the self-test when the engine is cranked, in particular the ABS light, SRS light, engine check light, battery light and diesel glow plug amongst others.

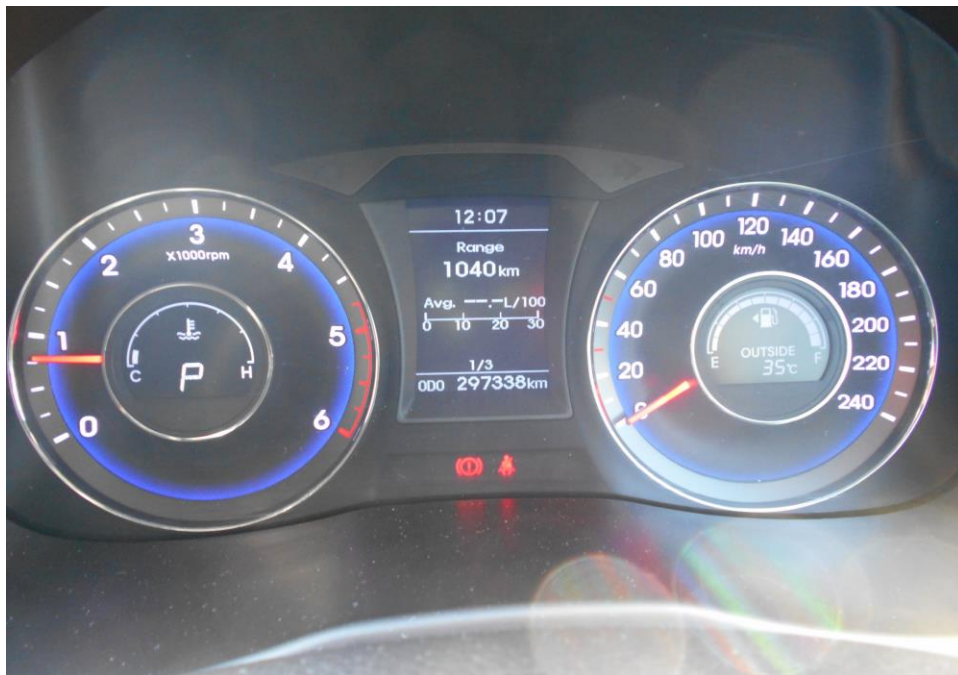
Photo 23 shows no warning lights illuminated on the instrument panel of the Motor Taxi after the engine was cranked. This would suggest that there was no abnormality to the various electronic operating systems of the Motor Taxi, like the ABS light engine check light, battery light and diesel glow plug.

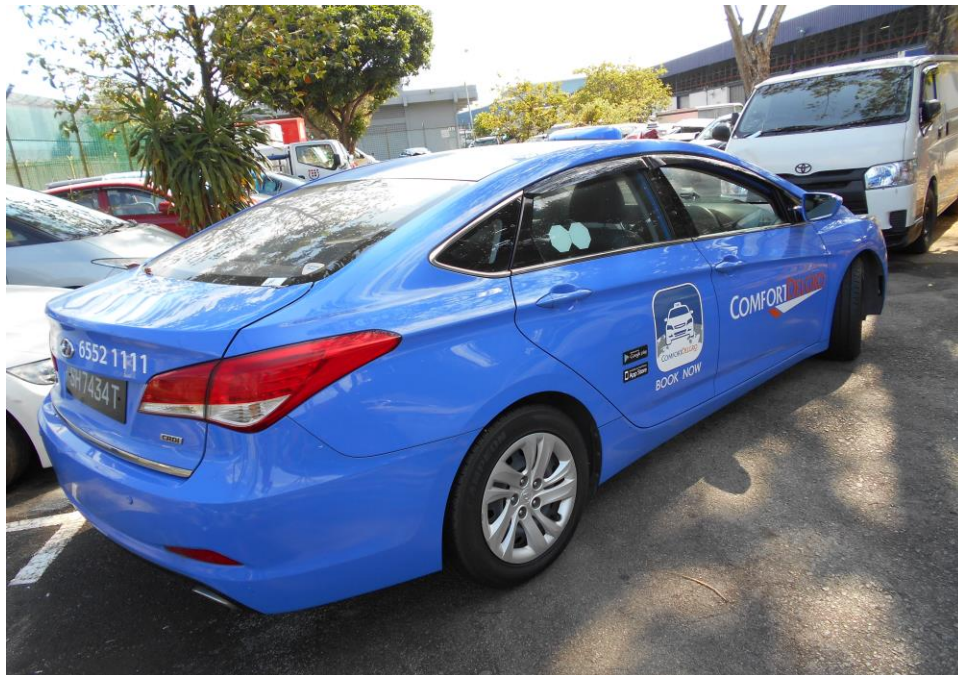
Photo 24 shows an operational test of the Motor Taxi. We were able to move the vehicle reverse, forward and backward normally.

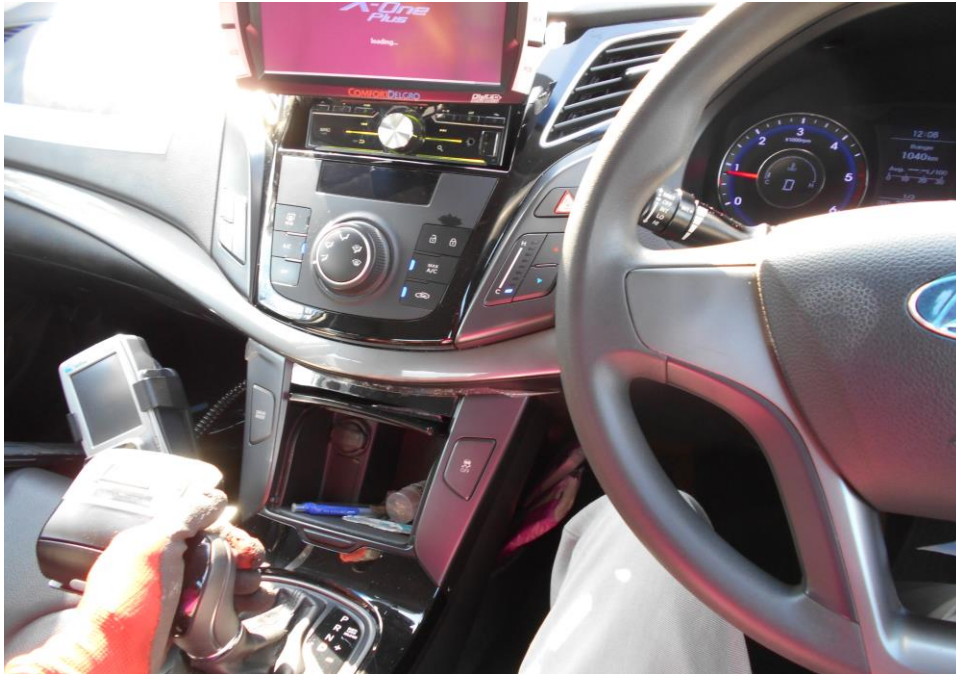
Photo 25 shows an operational test of the Motor Taxi. We were able to move the vehicle reverse, forward and backward normally.
