Your Ref: TP/IP/57103/2018
Our Ref : CI/TPD18019565/Z

22nd February 2019

MECHANICAL INSPECTION REPORT OF MOTOR CAR SJU 4355X

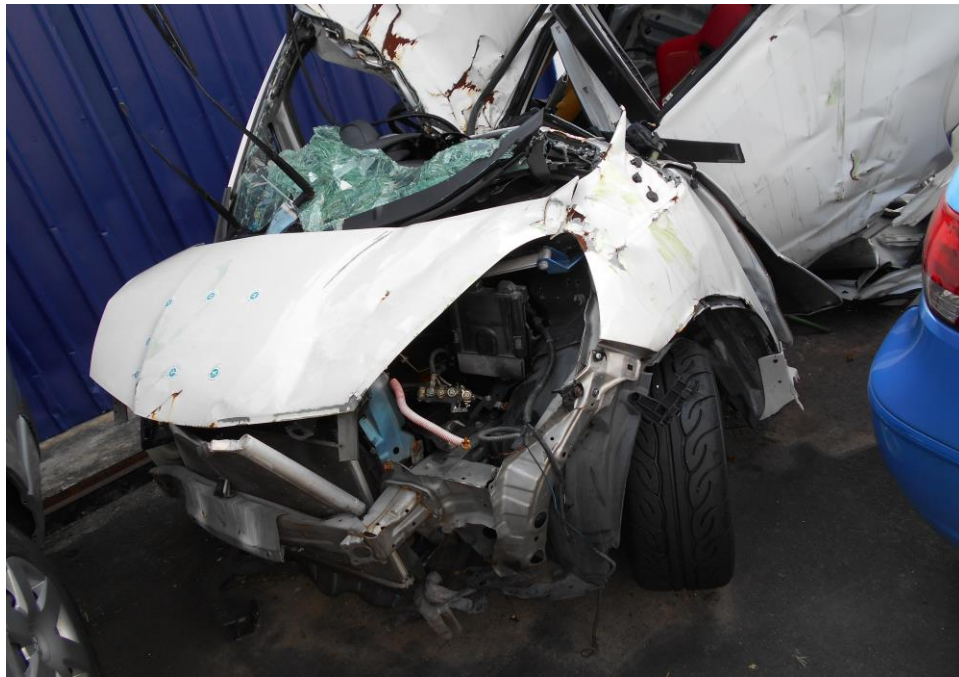
Photo 1 shows a general view of the frontal portion of the Motor Car at the time of our inspection. The Motor Car was observed to have sustained extensive impact damage at its frontal portion. The impact force was significant, causing the various parts and components inside the engine compartment to be damaged.

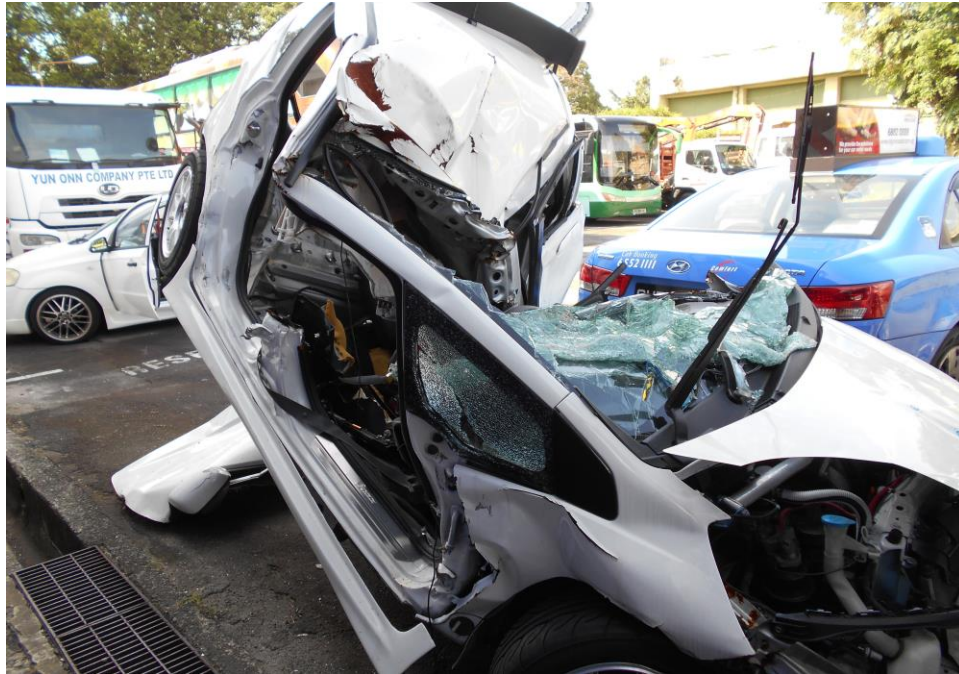
Photo 2 shows a general view of the front right portion of the Motor Car at the time of our inspection. The Motor Car was observed to have sustained extensive impact damage at its frontal, left, right, top and rear portion.

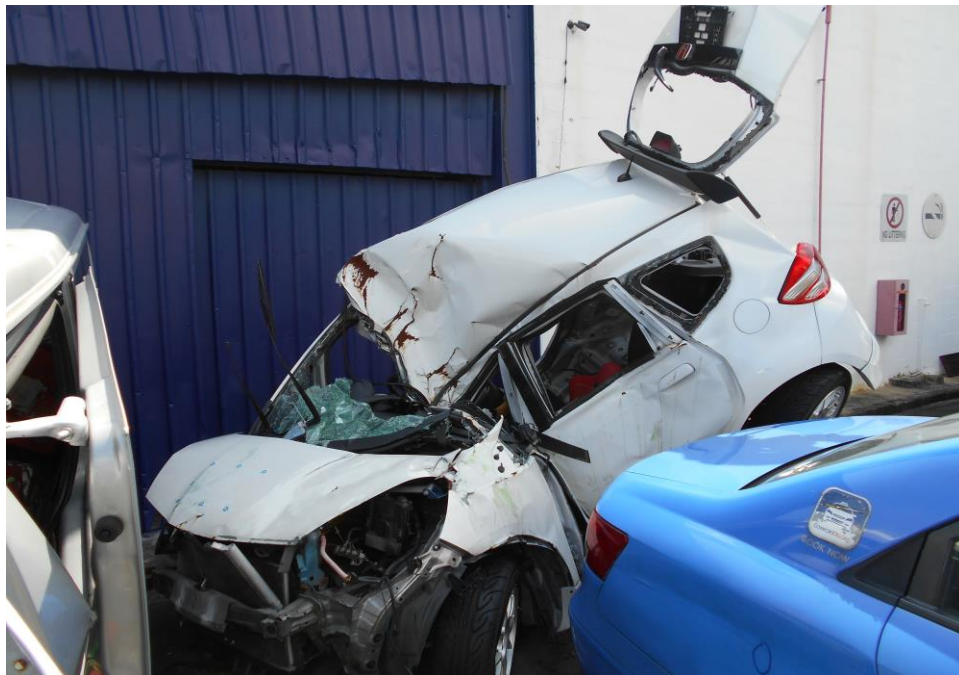
Photo 3 shows a general view of the front left portion of the Motor Car at the time of our inspection. The Motor Car was observed to have sustained with extensive impact damage at its frontal, left, right, top and rear portion.

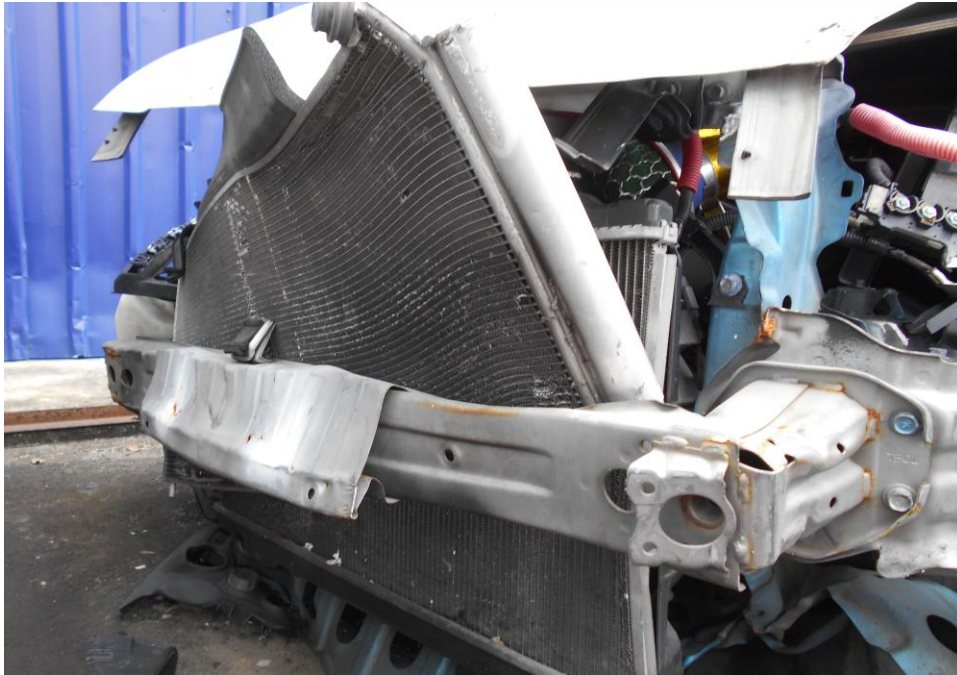
Photo 4 shows a closer view of the damage at the frontal portion of the Motor Car's engine. The impact force was significant, causing the various parts and components inside the engine compartment to be damaged.

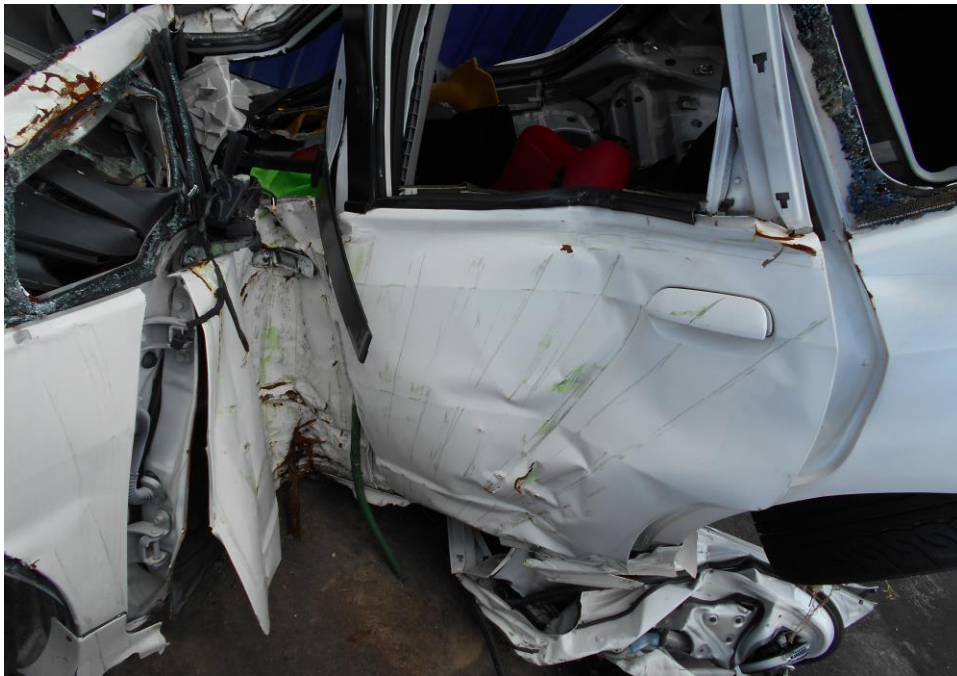
Photo 5 shows a closer view of the damage at the frontal left portion of the Motor Car. The impact force was significant, causing the various parts and components inside the engine compartment to be pushed inwards from left, towards the right of the Motor Car.

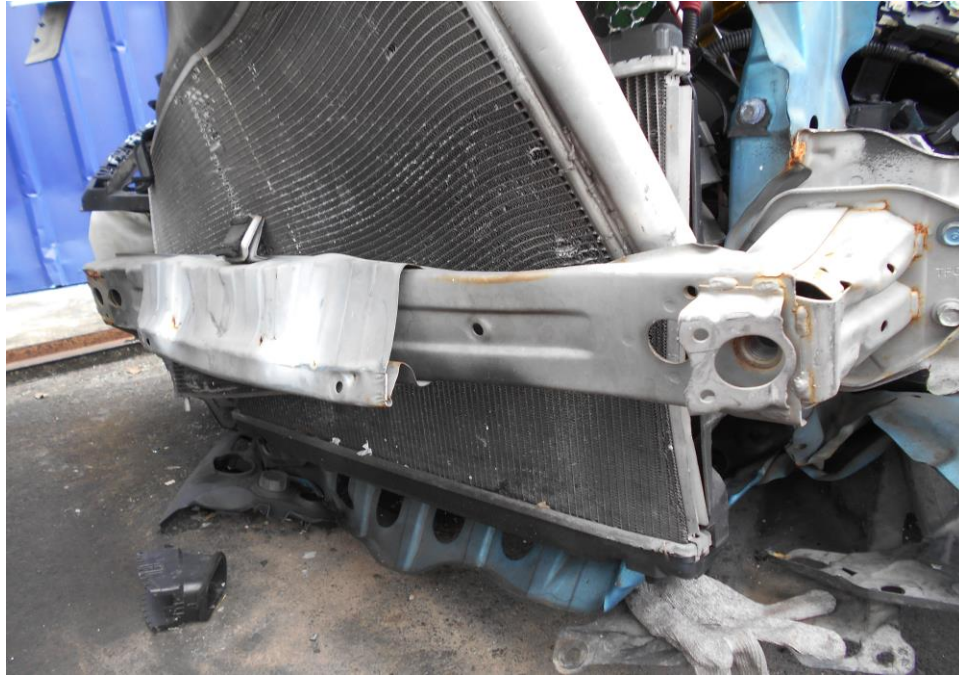
Photo 6 shows a closer view of the damage at the frontal left portion of the Motor Car. The impact force was significant, causing the various parts and components inside the engine compartment to be damaged as a result of the accident.

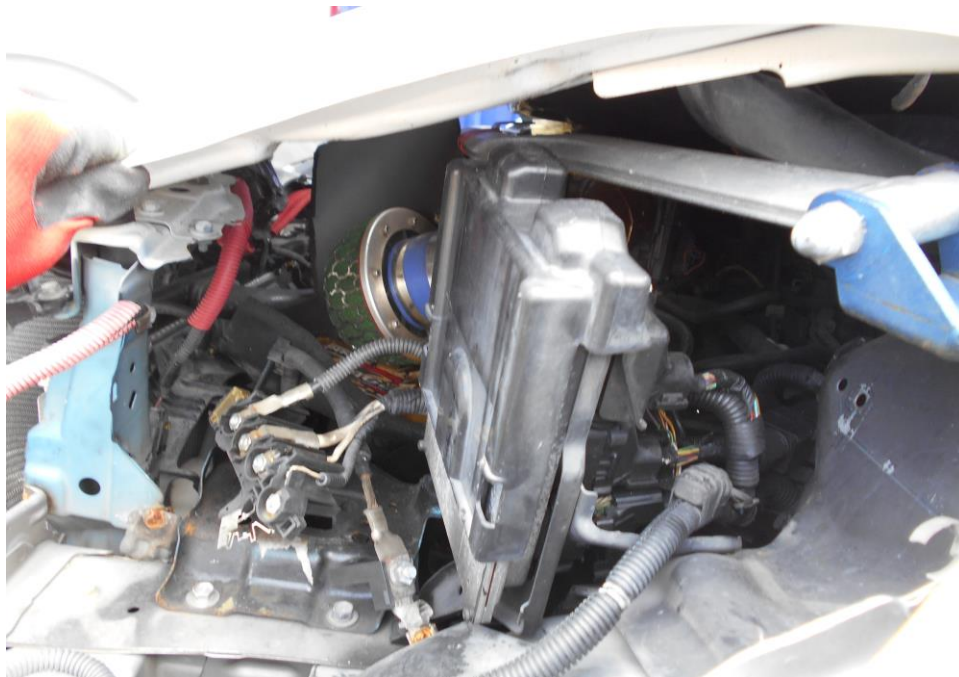
Photo 7 shows a closer view of the damage at the engine portion of the Motor Car. The impact force was significant, causing the various parts and components inside the engine compartment to be damaged as a result of the accident.

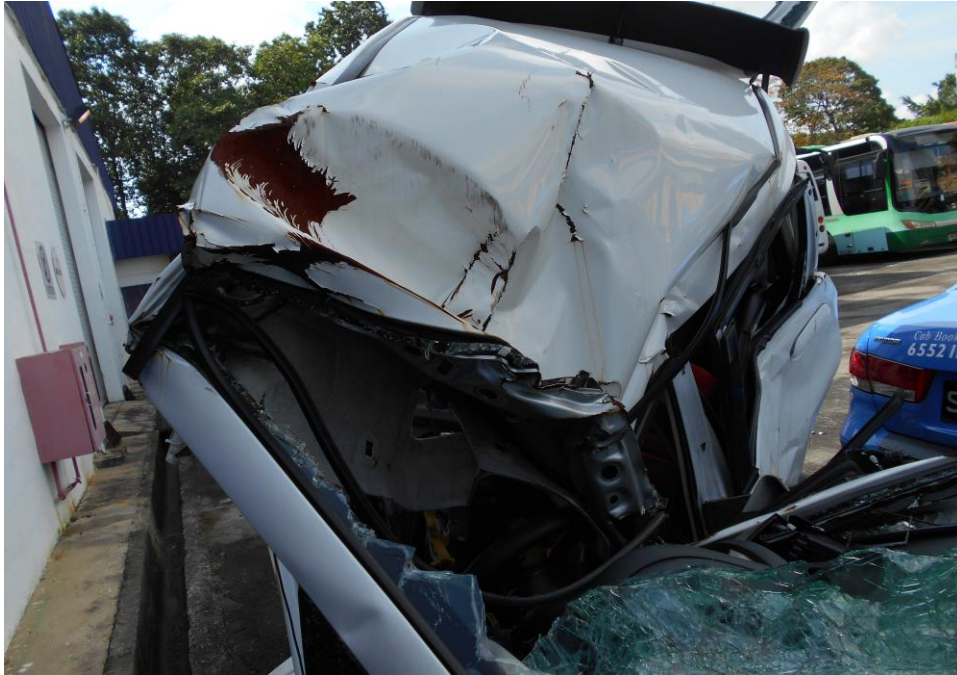
Photo 8 shows a semi-close up view of the damaged roof top of the Motor Car. The impact force was significant, causing the roof portion to be buckled as a result of the accident.

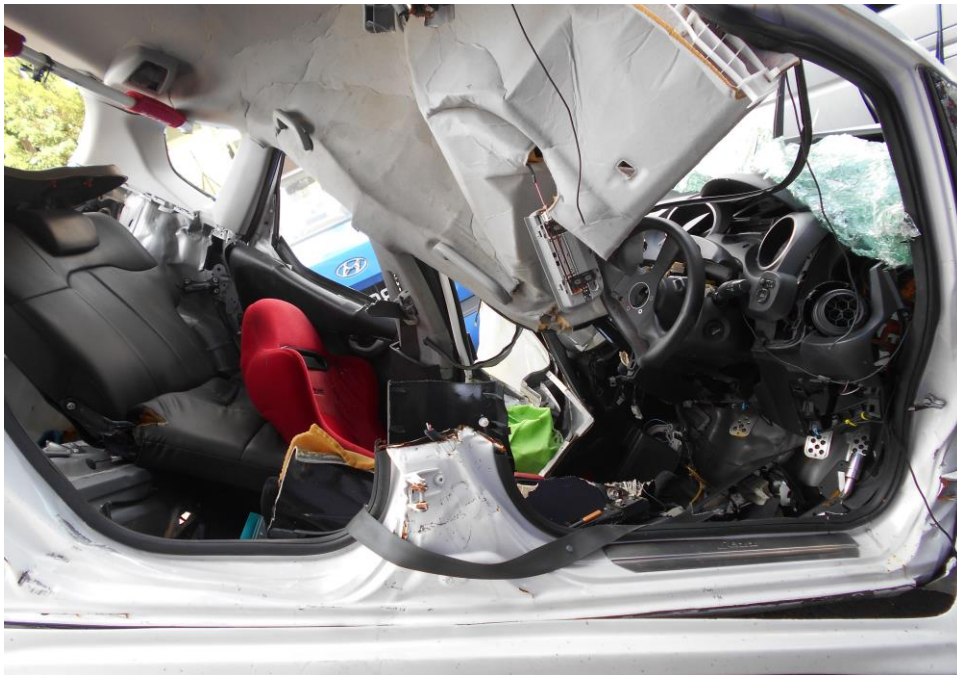
Photo 9 shows a closer view of the right driver & passenger seat of the Motor Car. The impact force was significant, causing the interior cabin to sustained extensive damages as a result of the accident.

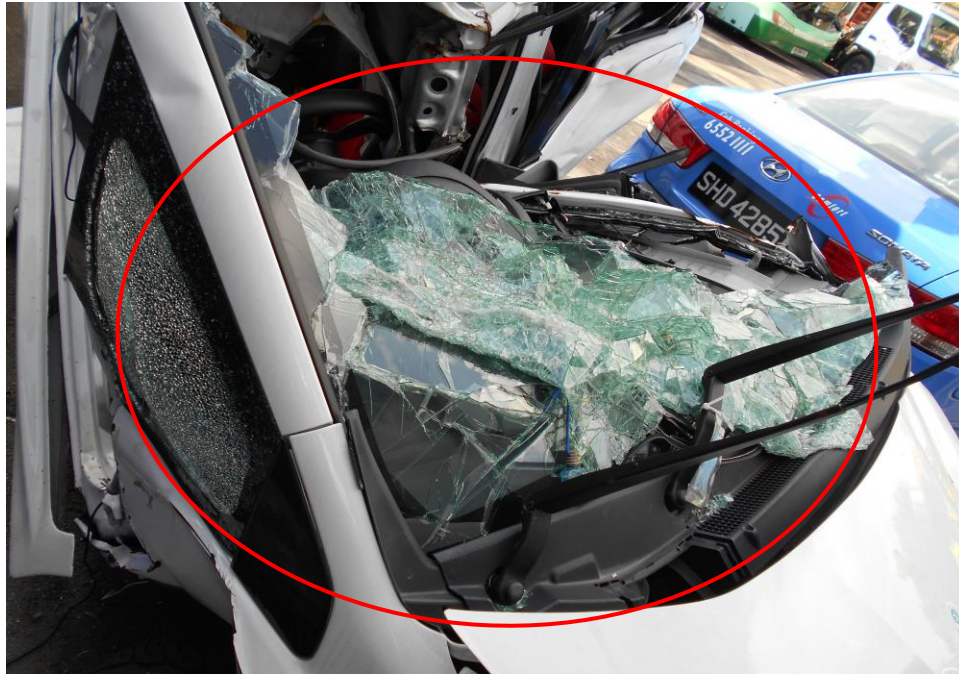
Photo 10 shows a closer view of the damage at the windscreen area of the Motor Car. The impact force was significant, causing the windscreen to sustain a shattering cracked.

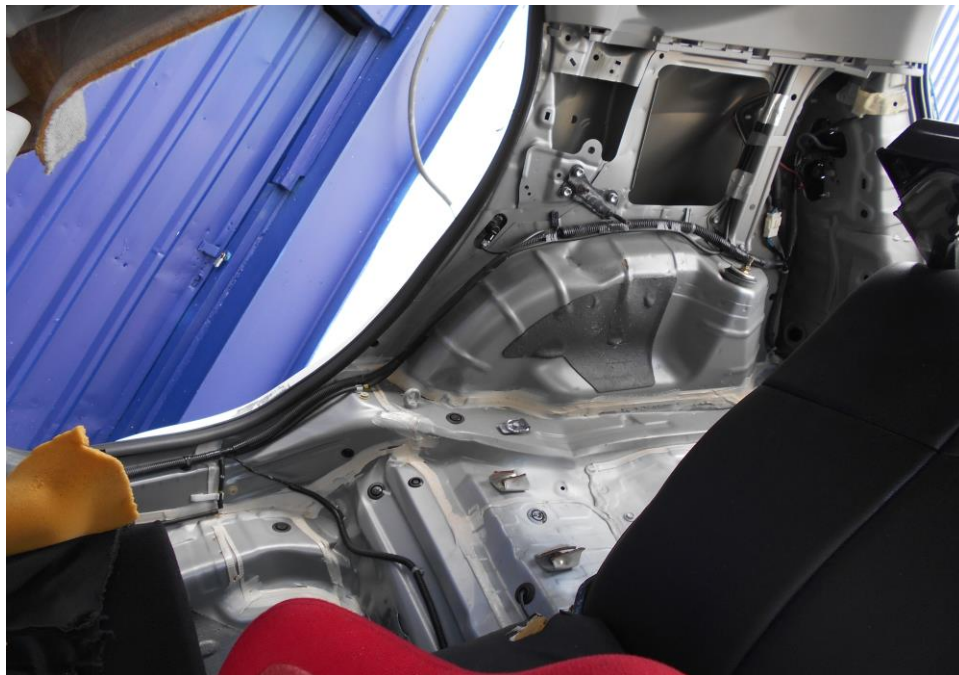
Photo 11 shows a closer view of the damages at the interior portion of the Motor Car due to the extensive impact collision at time of the accident.

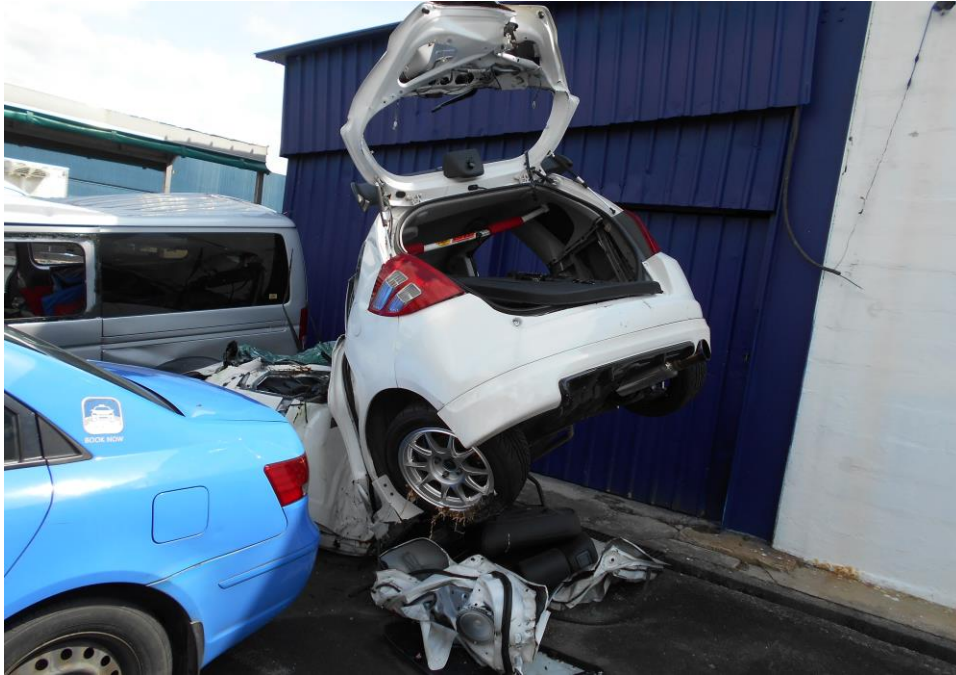
Photo 12 shows a general view of the rear left portion of the Motor Car at the time of our inspection. The rear portion was observed to have sustained with major impact by the accident that caused the rear portion body structure to be distorted.

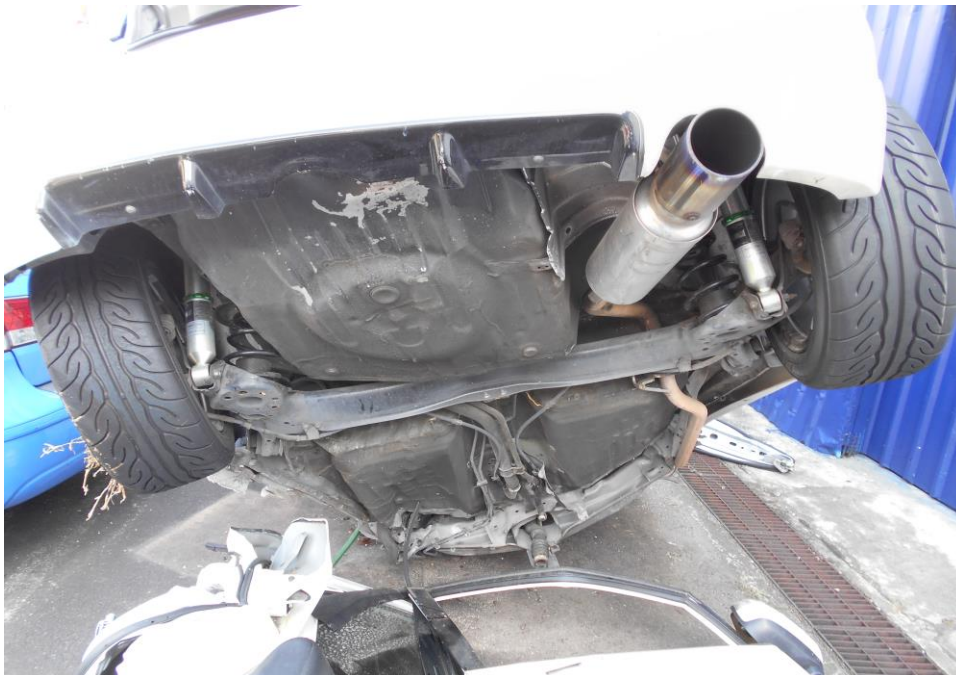
Photo 13 shows a general view of the rear undercarriage portion of the Motor Car at the time of our inspection. The body structure was observed to be distorted and buckled as a result of the accident.

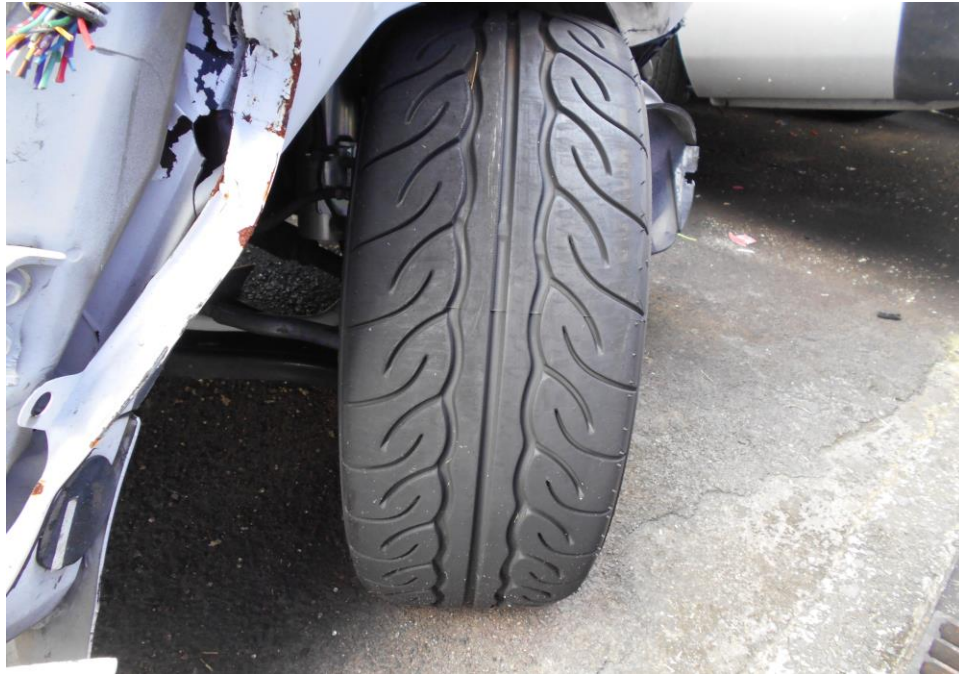
8. The Motor Car's front right tyre was found deflated due to the damaged rim as a result of the accident's impact collision.
9. As for the condition of the other 3 Motor Car's tyres, it was observed to be in serviceable condition. We did not find any tear, cut or burst mark(s) on the outer and the inner sidewalls as well as across the tread of the 3 tyres. The 3 tyres were also observed to be sufficiently inflated for vehicular operation. The tyre brand, tyre size and remaining tread depth of the 3 tyres were recorded as follows:-

Photo 14 shows the condition of the front right portion of the Motor Car, which was observed to be deflated due to the damages on the wheel rim as a result of the accident's impact.

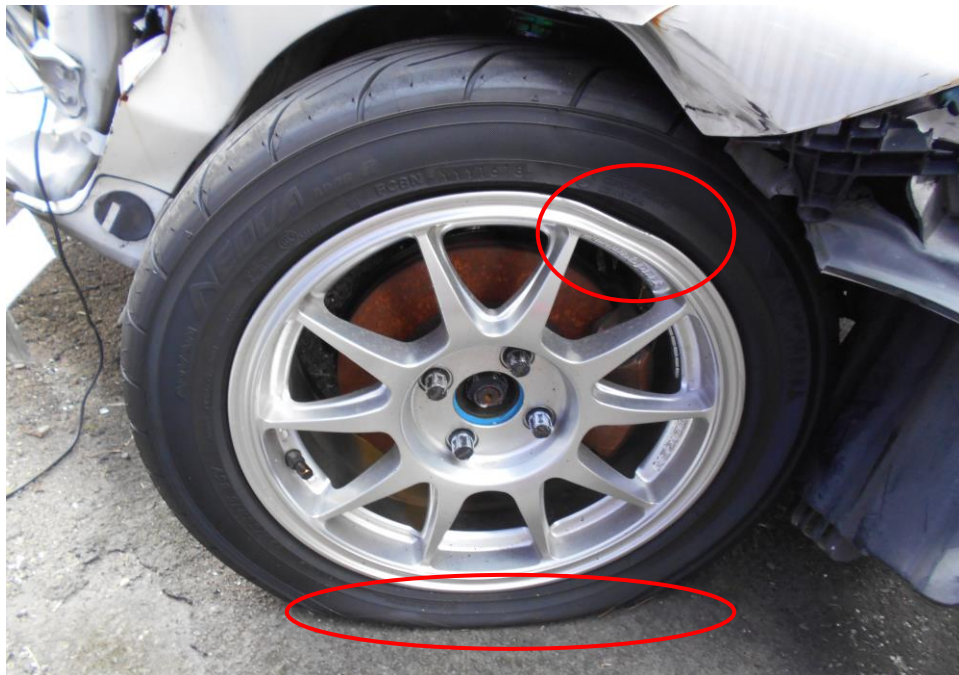
Photo 15 shows the condition of the front right portion of the Motor Car, which was observed to be deflated due to the damages on the wheel rim as a result of the accident's impact.

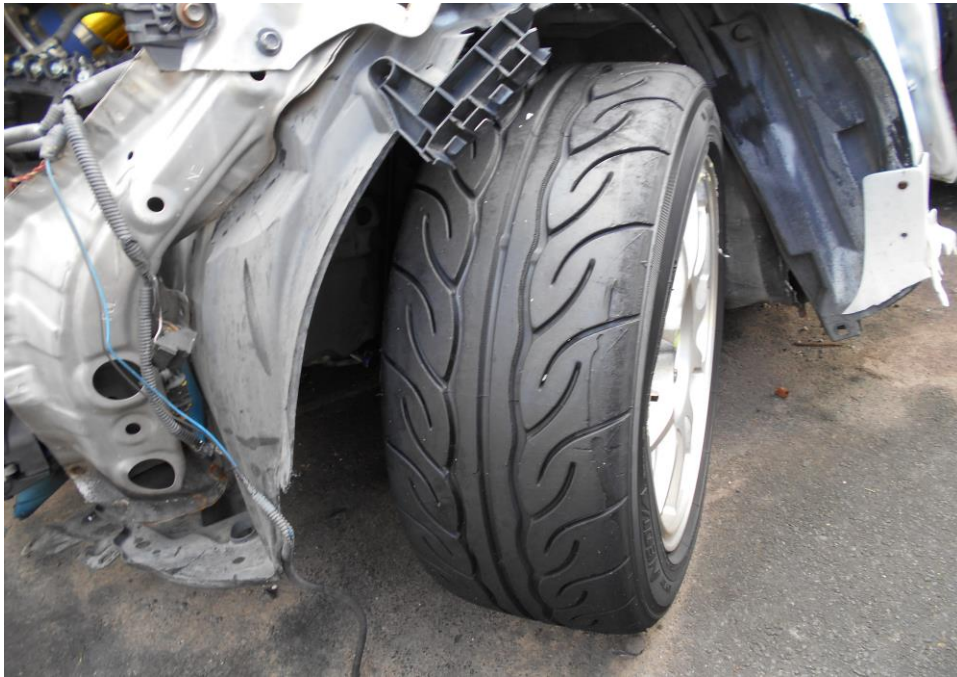
Photo 16 shows the condition of the front left tyre of the Motor Car, which was observed to be in serviceable condition. The 4 tyres were also observed to be sufficiently inflated for vehicular operation.

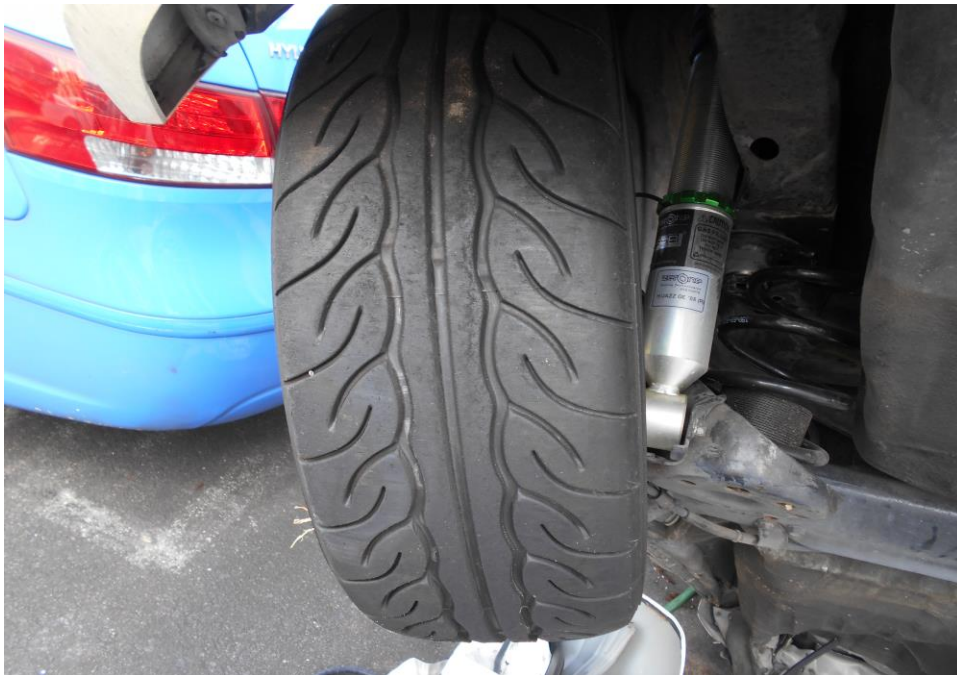
Photo 17 shows the condition of the rear left tyre of the Motor Car, which was observed to be in serviceable condition. The 4 tyres were also observed to be sufficiently inflated for vehicular operation.

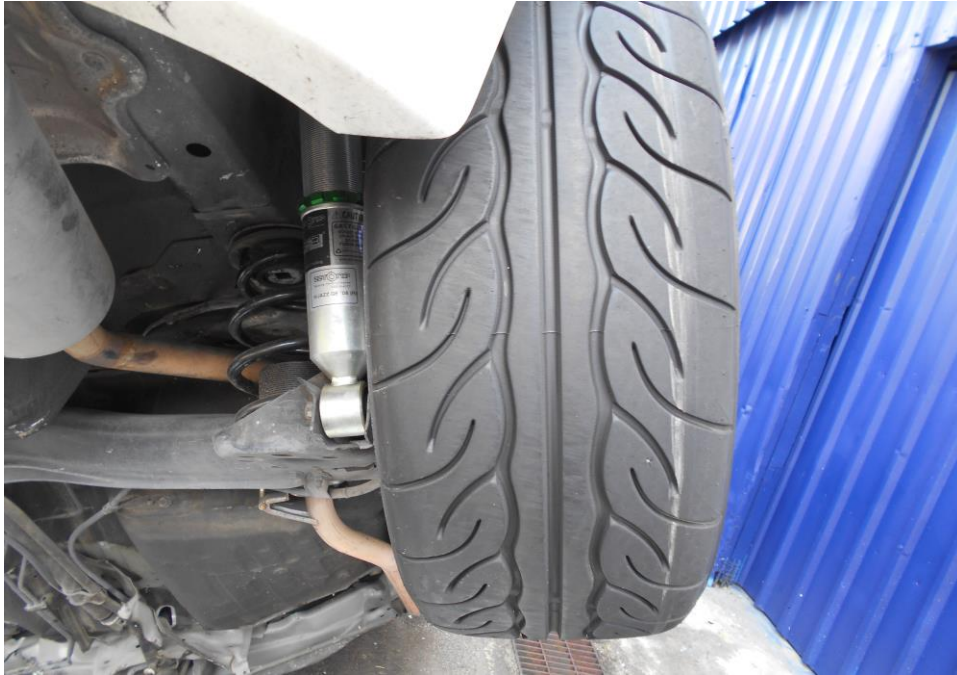
Photo 18 shows the condition of the rear right tyre of the Motor Car, which was observed to be in serviceable condition. The 4 tyres were also observed to be sufficiently inflated for vehicular operation.

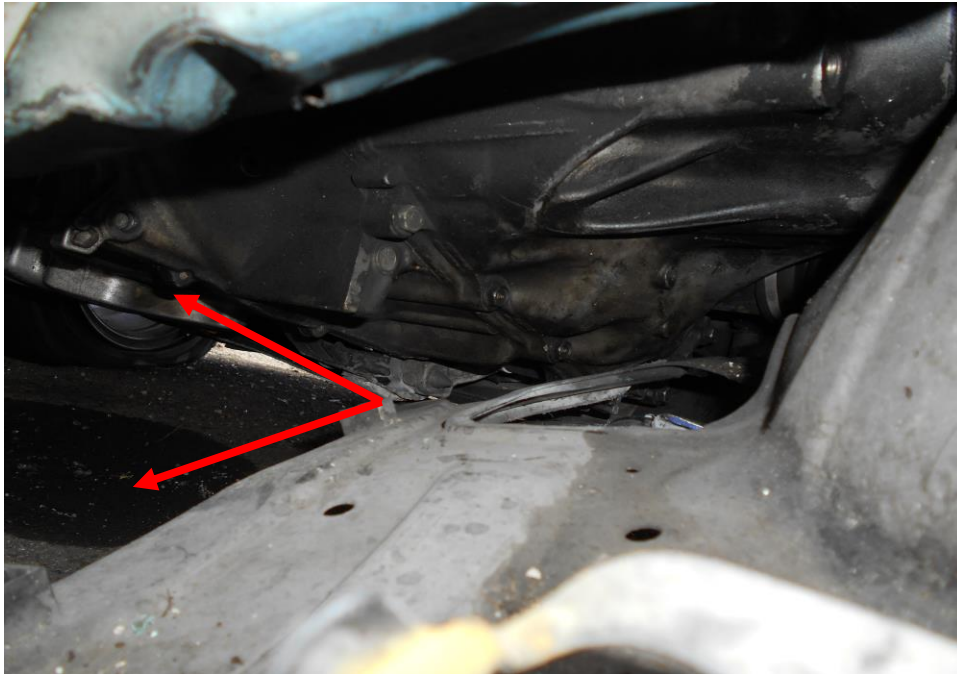
13. Leakage of the various operating fluids like the engine oil, engine coolant, power steering fluid and brake fluid was also noted. Given the extent of damages to the engine compartment, the leakages were likely due to the accident. The engine undercarriage was however observed to be covered with fluid, suggesting leakage of fluid. There was no accumulation of dust and/or dirt particles on the engine housing where the fluid stains had formed. This would indicate that the fluid leakage was a fresh leak and likely to be a result of the accident. We were therefore unable to comment whether these operating fluids were of sufficient level and without contamination for vehicular operation prior to the accident. See photo 19 to 22 below.

Photo 19 shows the close up view of the undercarriage of the Motor Car. Signs of fluid leakage were observed due to the accident's impact.

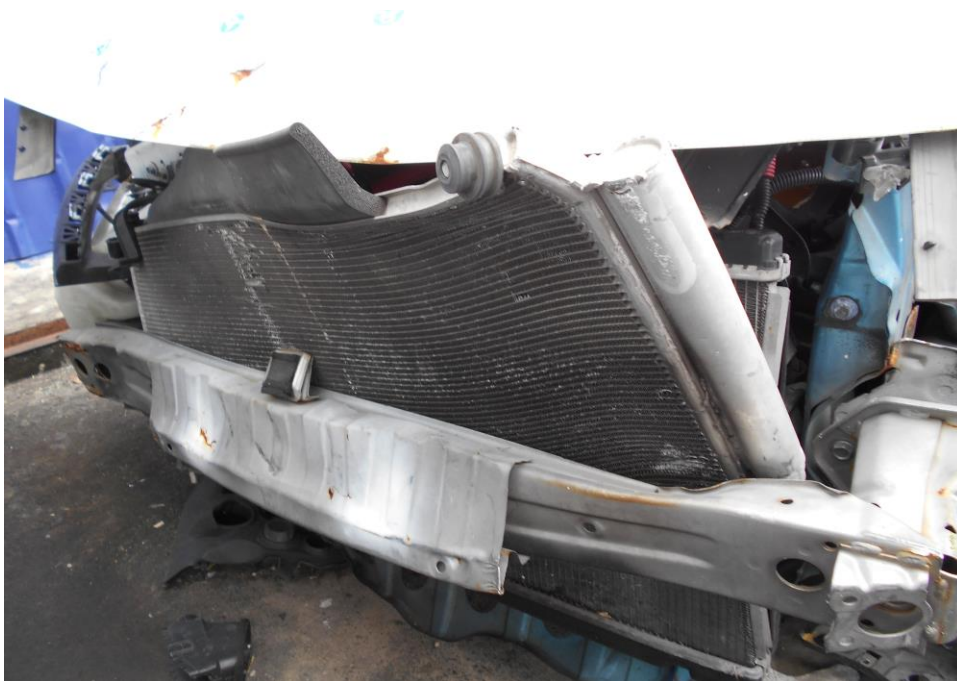
Photo 20 shows the close up view of the radiator's tank that was observed to be damaged likely due to the accident impact.

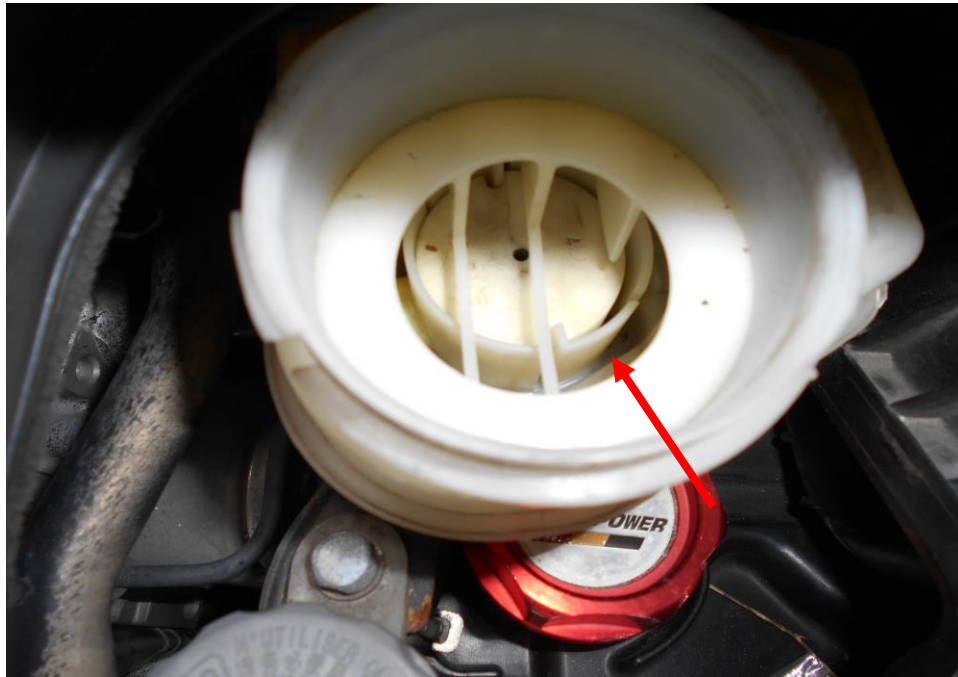
Photo 21 shows the close up view of the empty brake fluid reservoir due to the accident impact.

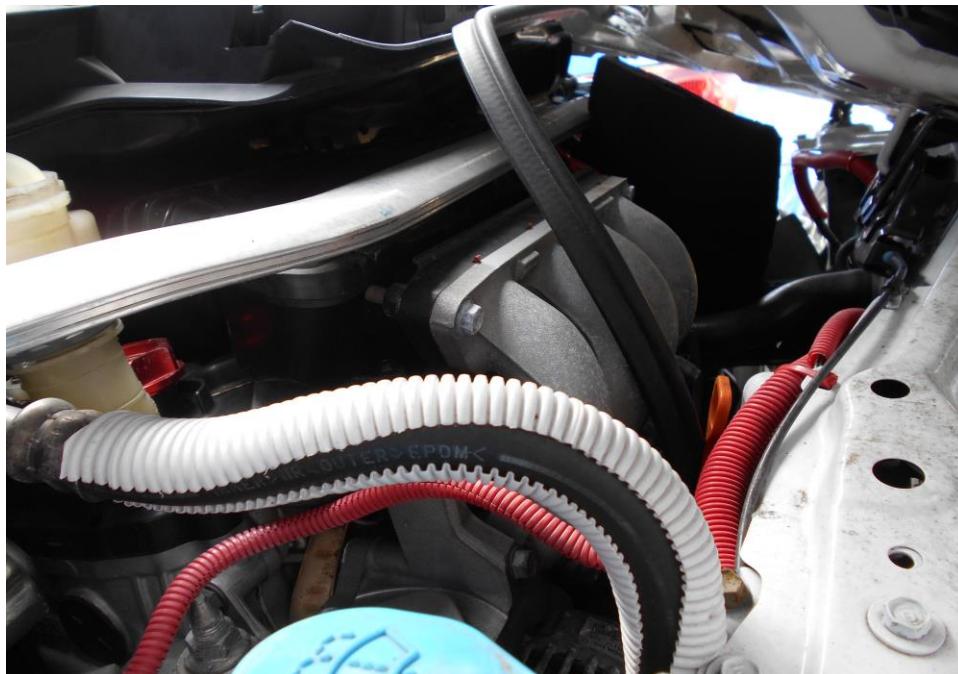
12. The engine compartment of the Motor Car was severely affected by the collision. Almost all the parts and components inside the engine compartment were badly damaged. Parts like the radiator, air intake system, fuel rails, exhaust manifold, fuse box and control modules amongst others were found to be damaged.

Photo 22 shows the close up view of the damage engine compartment due to the accident impact.

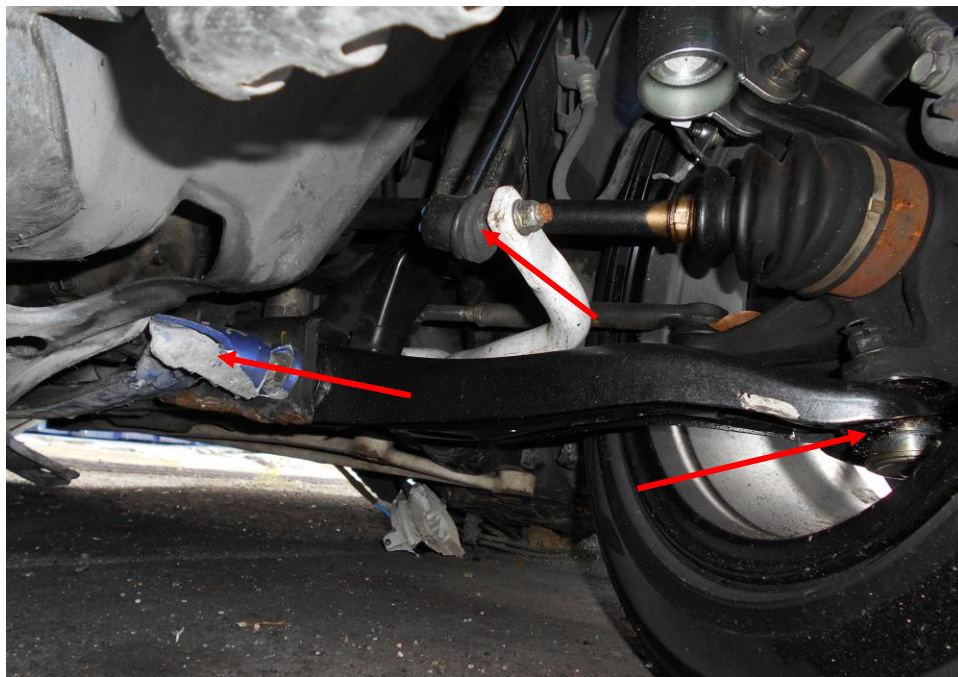
Photo 23 shows a close up view on the front right drive shaft of the Motor Car. We were not able to conduct any tests on the steering system of the Motor Car due to the damage to these components.

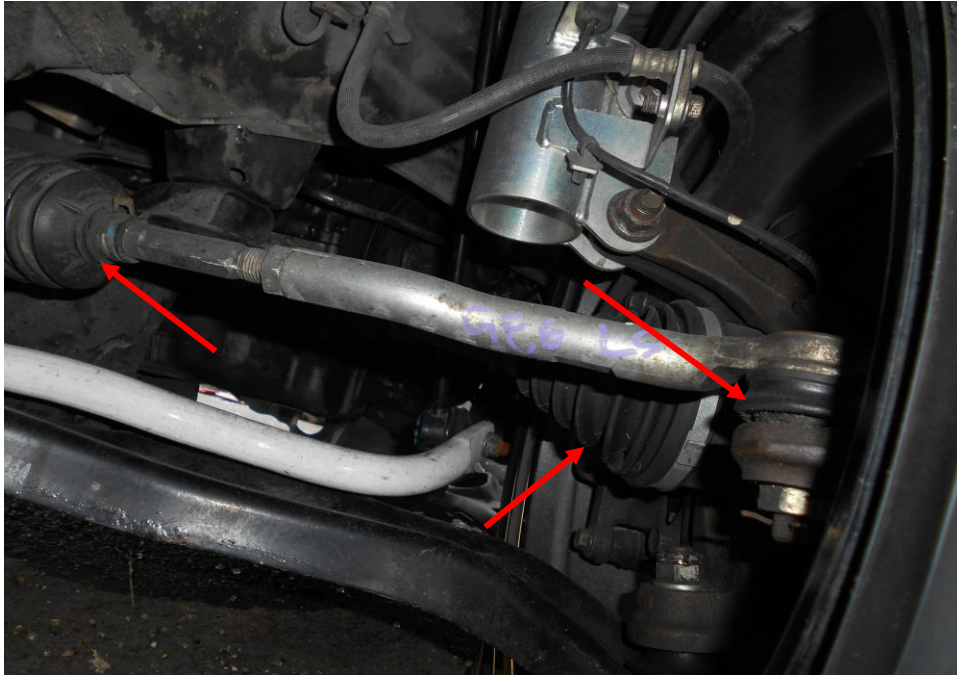
Photo 24 shows the damaged on the front left drive shaft of the Motor Car. We were not able to conduct any tests on the steering system of the Motor Car due to the damage to this components, as well as leakage of fluids due to the accident.

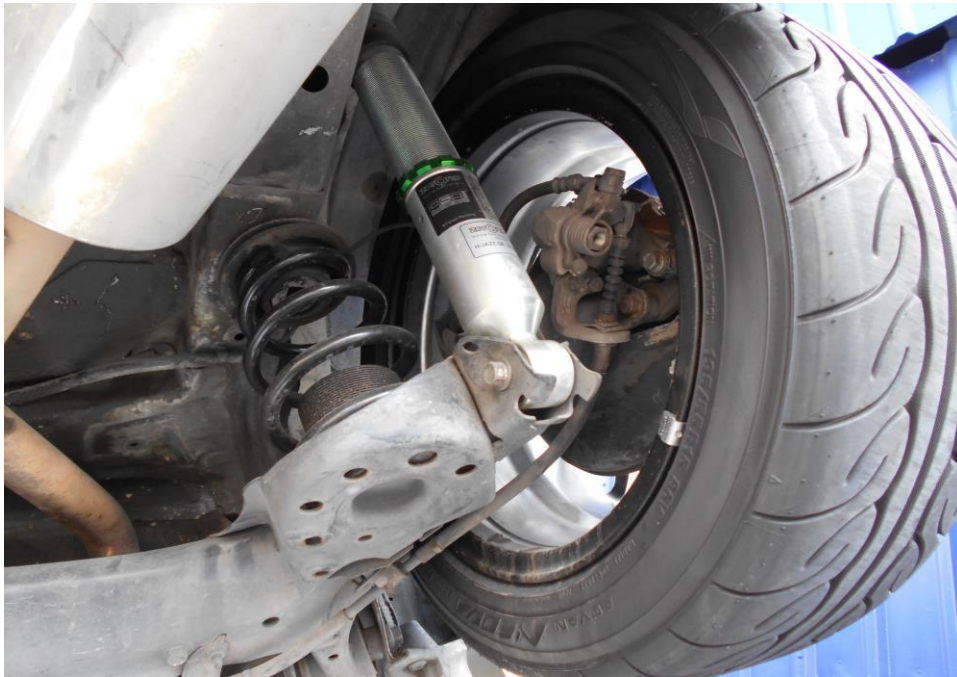
Photo 25 shows the braking & steering components at the rear right wheel of the Motor Car. We did not observe any leakage of brake fluid at the time of our inspection of the Motor Car.

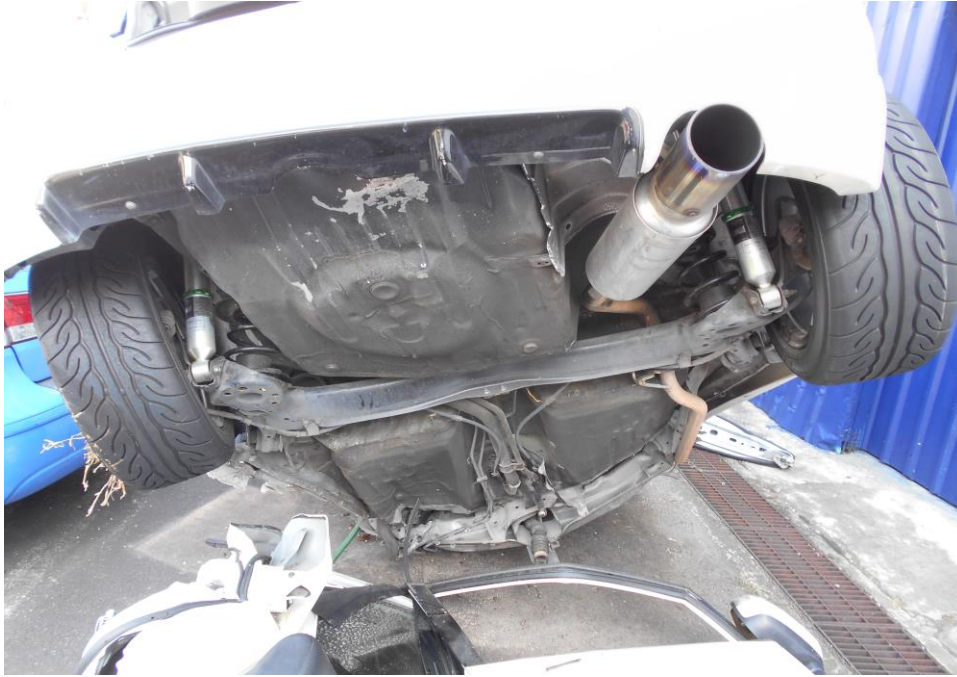
Photo 26 shows the undercarriage components of the Motor Car. It was observe to sustain an extensive damage inclusively affects the body structure of the Motor Car due to the accident.

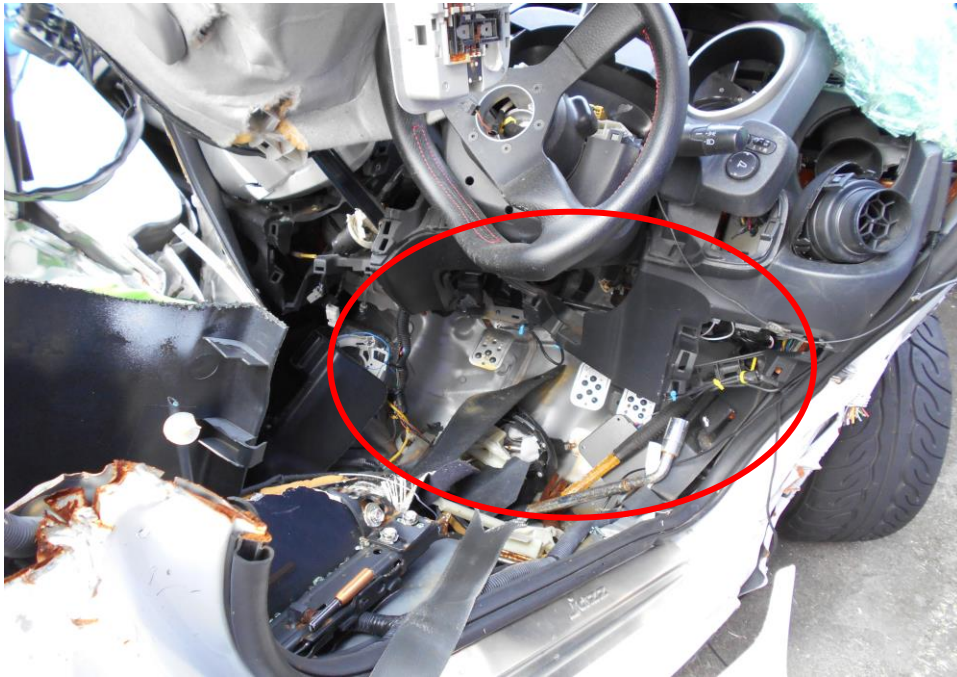
Photo 27 shows the damaged brake pedal of the Motor Car. It was observe to sustained extensive damages at the time of our inspection of the Motor Car due to the accident.

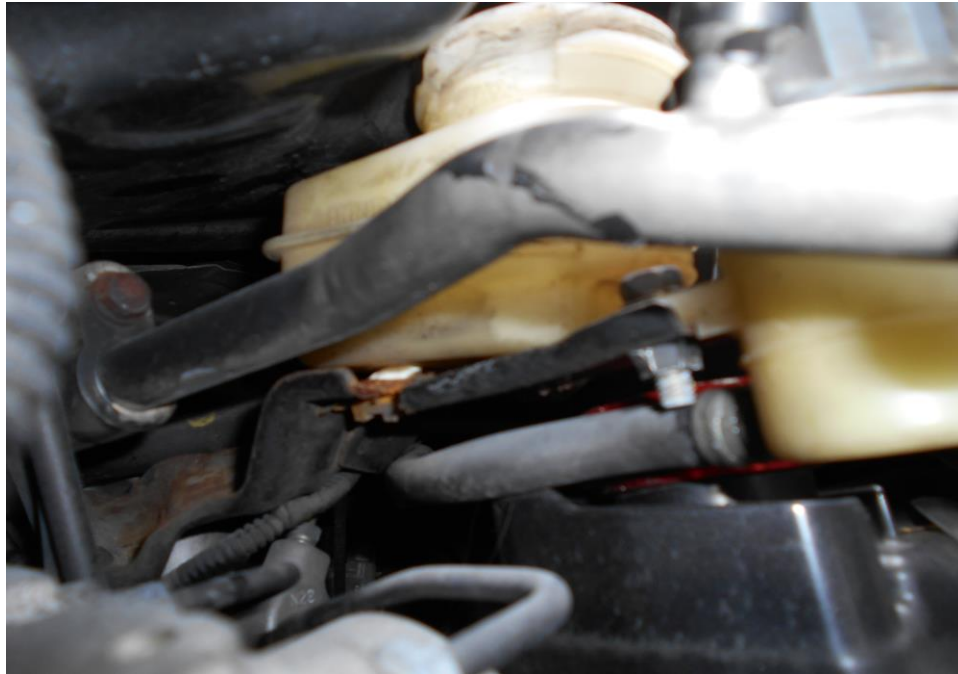
Photo 28 shows the brake fluid reservoir of the Motor Car. We observe the brake fluid reservoir was empty at the time of our inspection due to the accident.
