Your Ref: TP/IP/59407/2018  
Our Ref :CI/TPD18019566/Z

**Fatal Accident Investigation Team**  
Traffic Police Department  
Singapore Police Force  
10 Ubi Avenue 3  
Singapore 408865

### **MECHANICAL INSPECTION REPORT OF MOTORCYCLE JRU 5542**

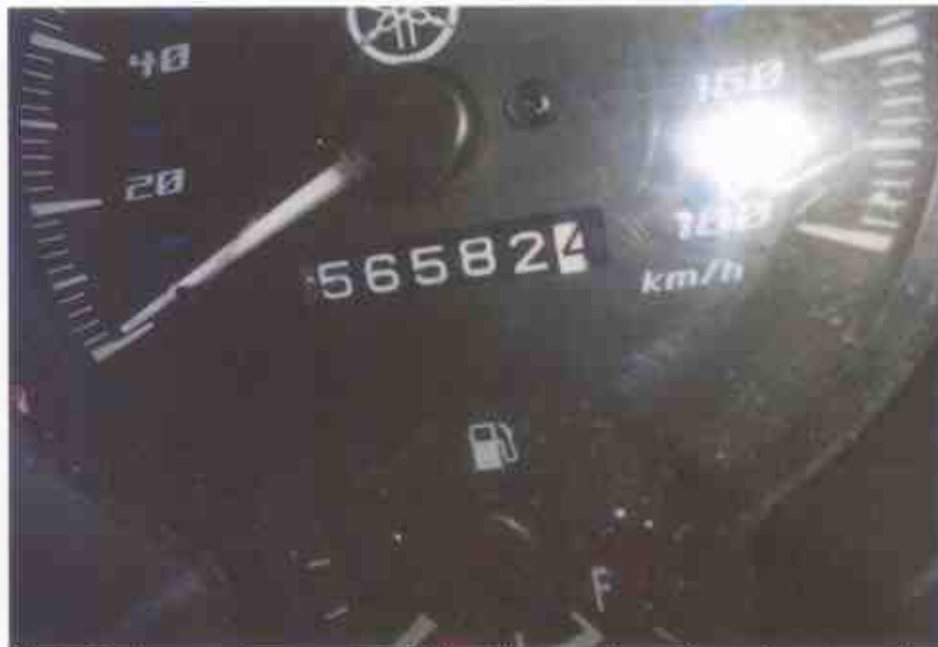
**Photo 1** shows a close-up view of the mileage meter at time of our inspection. The mileage was recorded at 565824km.

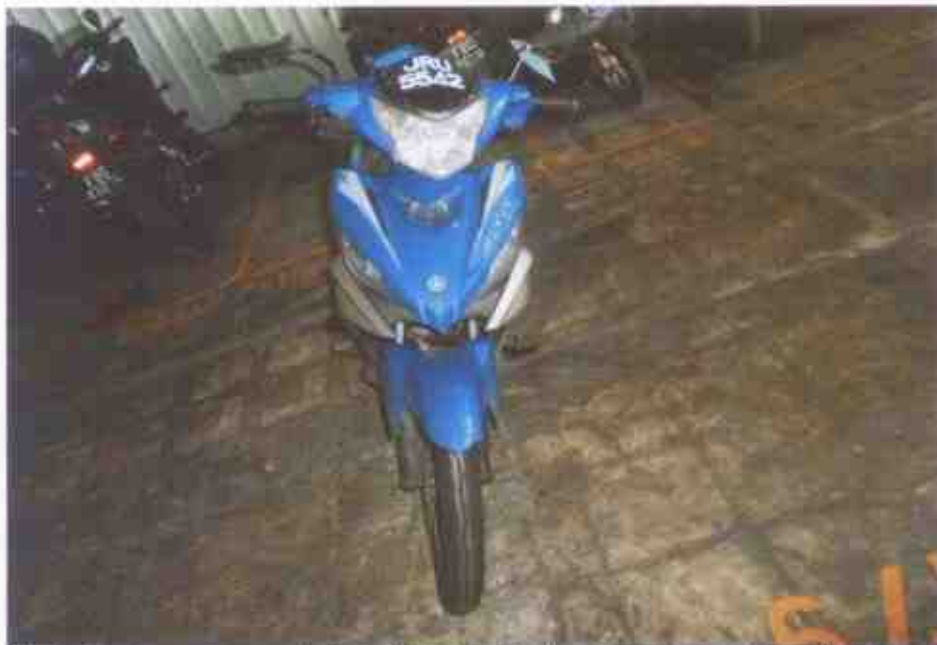
**Photo 2** shows a general view of the front body of the Motorcycle at the time of our inspection. The Motorcycle was observed to have sustained relatively minor damages at time of inspection. The damages were observed to be confined to its left side which includes scratches on the left fairing & foot rest.

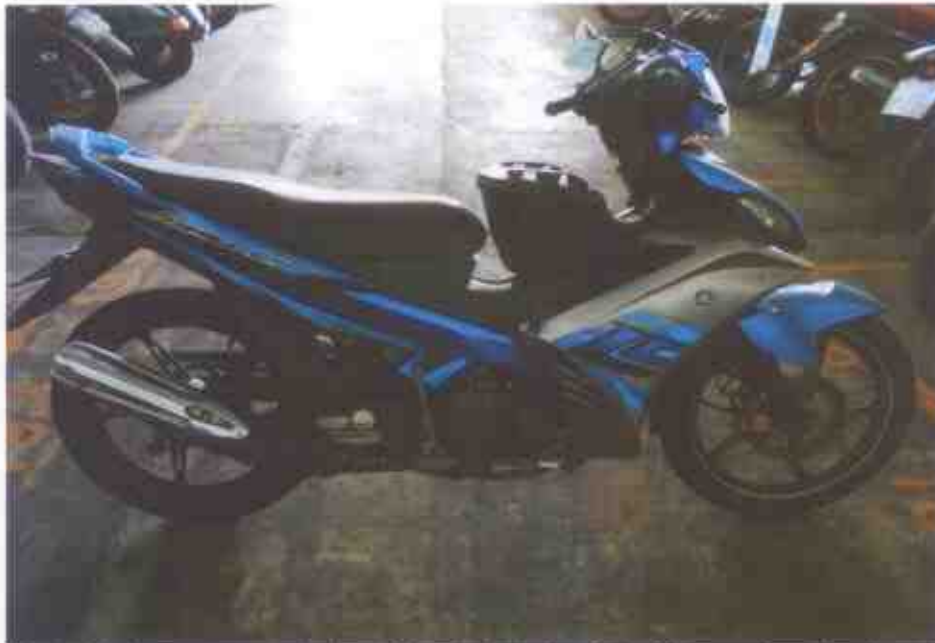
**Photo 3** shows a general view of the right body of the Motorcycle at the time of our inspection. The Motorcycle was observed to have sustained relatively minor damages on the right side fairing at time of our inspection.

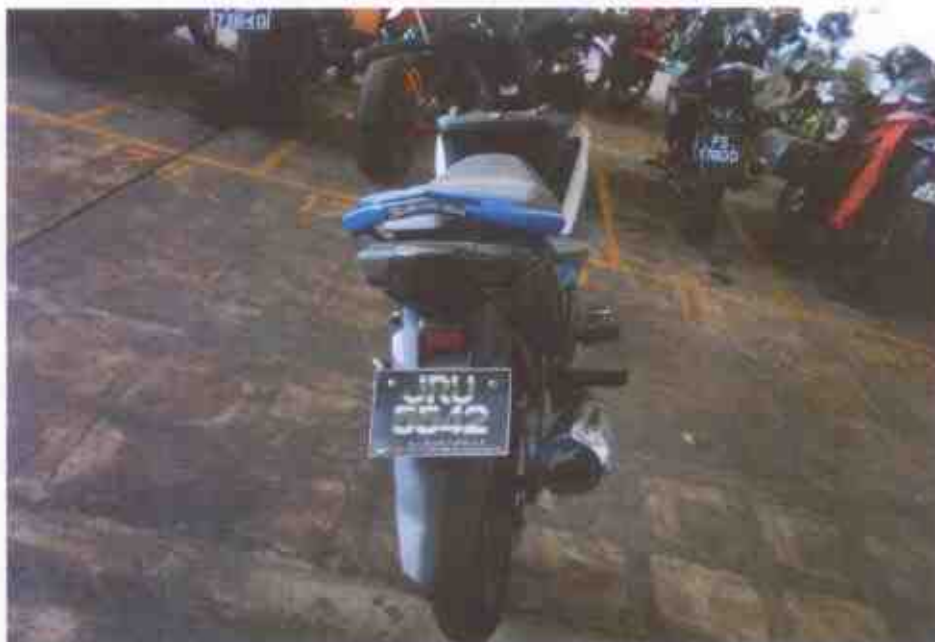
**Photo 4** shows a general view of the rear body of the Motorcycle at the time of our inspection. The Motorcycle was observed to be in good condition unaffected by the accident.

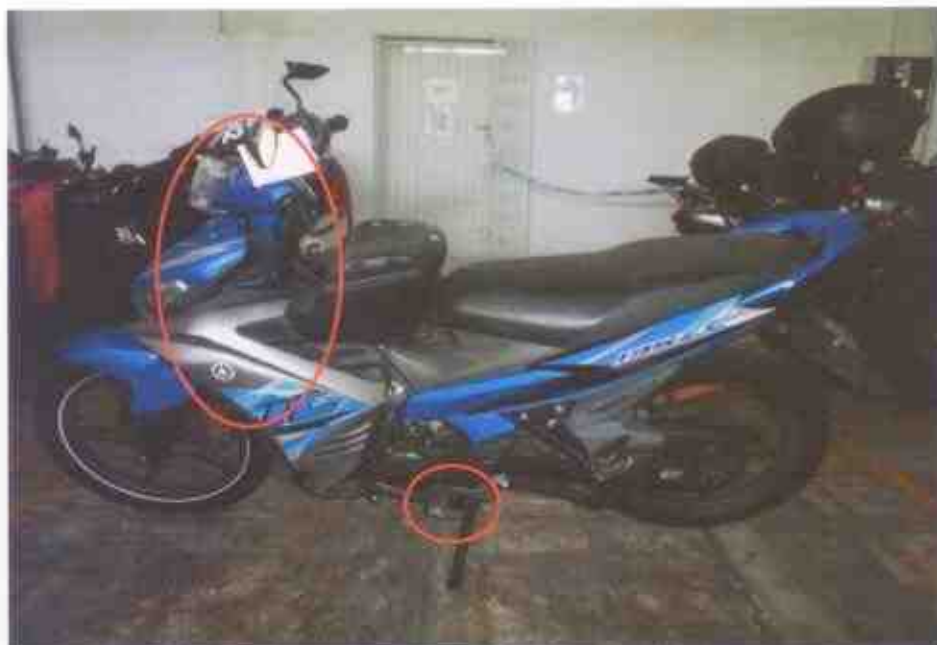
Photo 5 shows a general view of the left body of the Motorcycle at the time of our inspection. The Motorcycle was observed to have sustained relatively minor damages on the left side at time of our inspection.

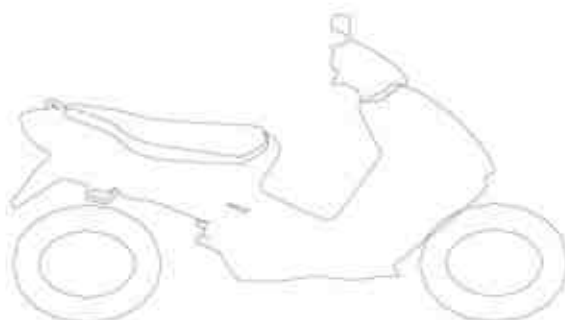
7. The condition of the Motorcycle's 2 tyres was observed to be in serviceable condition. The tread pattern of the 2 tyres was clearly visible. We did not observe any tear, burst mark(s) and/or punctured hole(s) on the sidewalls as well as across the tread of the 2 tyres. The 2 tyres were both observed to be sufficiently inflated for vehicular operation. The tyre brand, tyre size and remaining tread depth of the 2 tyres were recorded as follows:-

Maxxis Diamond MA-3D 80/90 - R17 (3mm)

Maxxis Diamond MA-3D 70/90 - R17 (4mm)

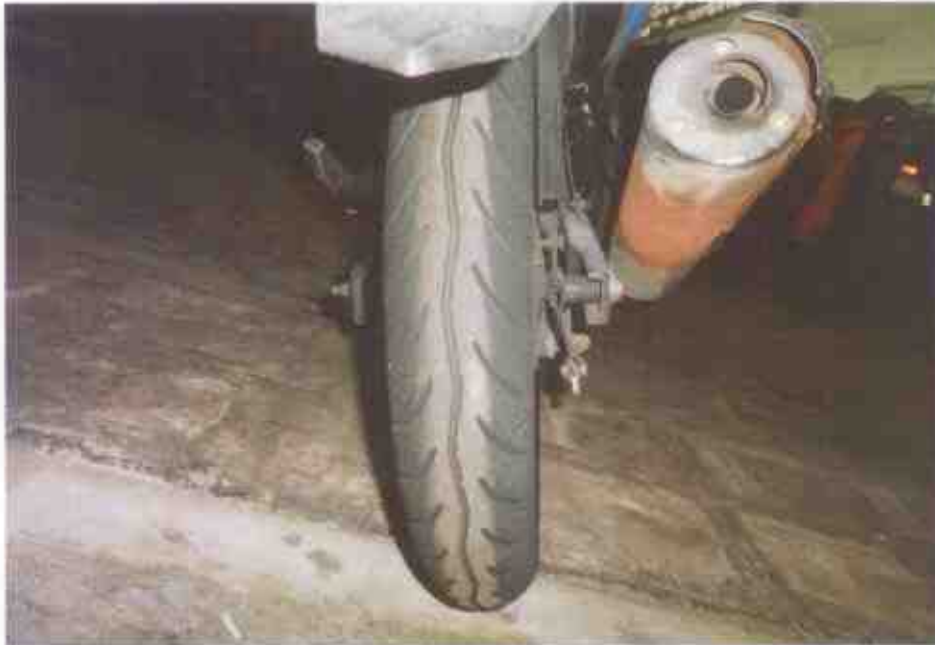
**Photo 6** shows the rear tyre of the Motorcycle. The rear tyre was observed to be in serviceable condition with remaining tread depth of approximately 3mm. The tyre was also observed to be sufficiently inflated for vehicular operation.

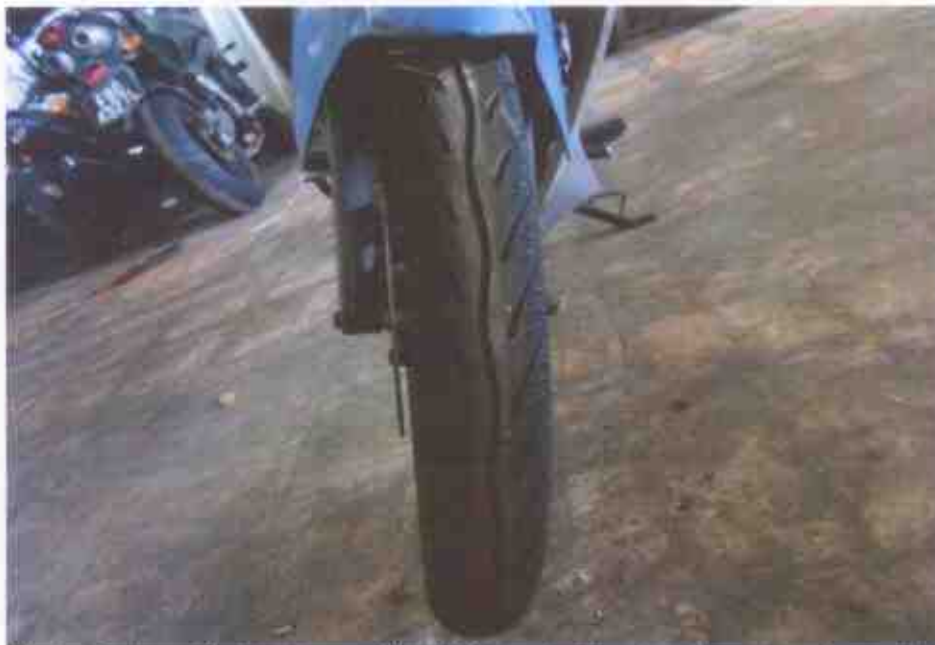
**Photo 7** shows the front tyre of the Motorcycle. The front tyre was observed to be in serviceable condition with remaining tread depth of approximately 4mm. The tyre was also observed to be sufficiently inflated for vehicular operation.

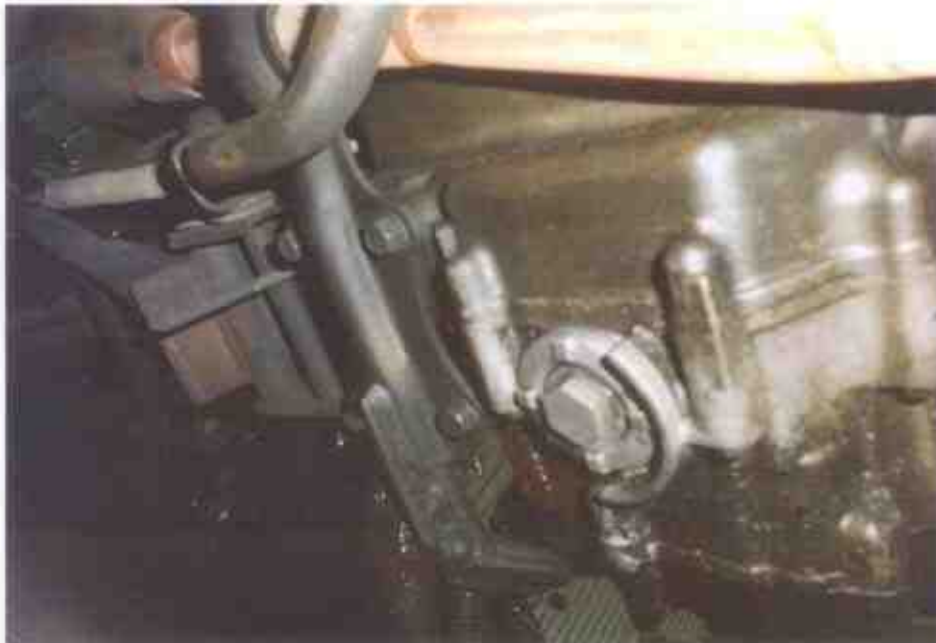
**Photo 8** shows no sign(s) or indication(s) of fluid leak observed around the underside of the engine area of the Motorcycle.

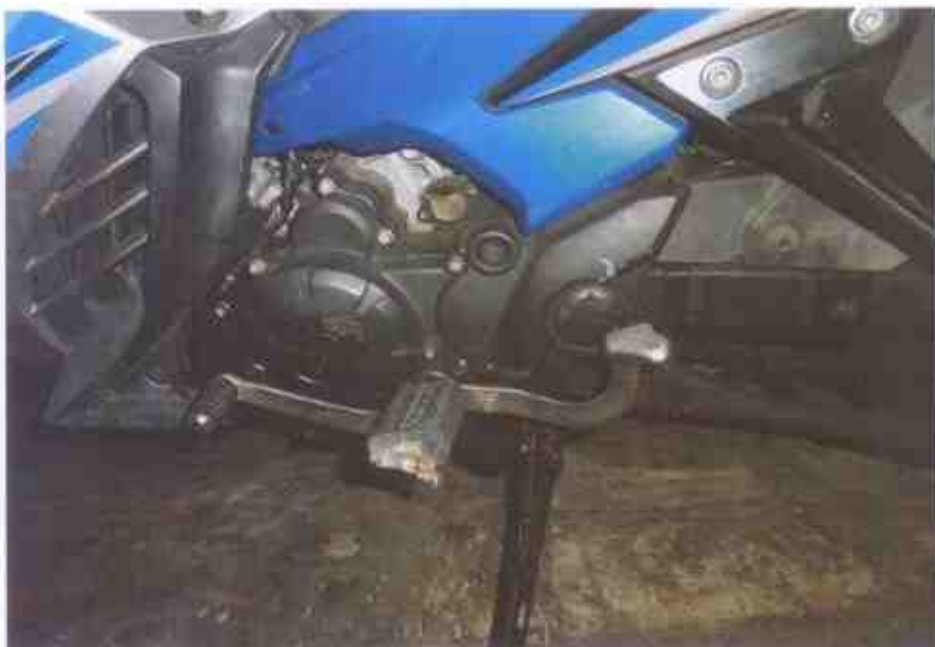
Photo 9 shows no sign(s) or indication(s) of fluid leakage stain observed around the engine area of the Motorcycle.

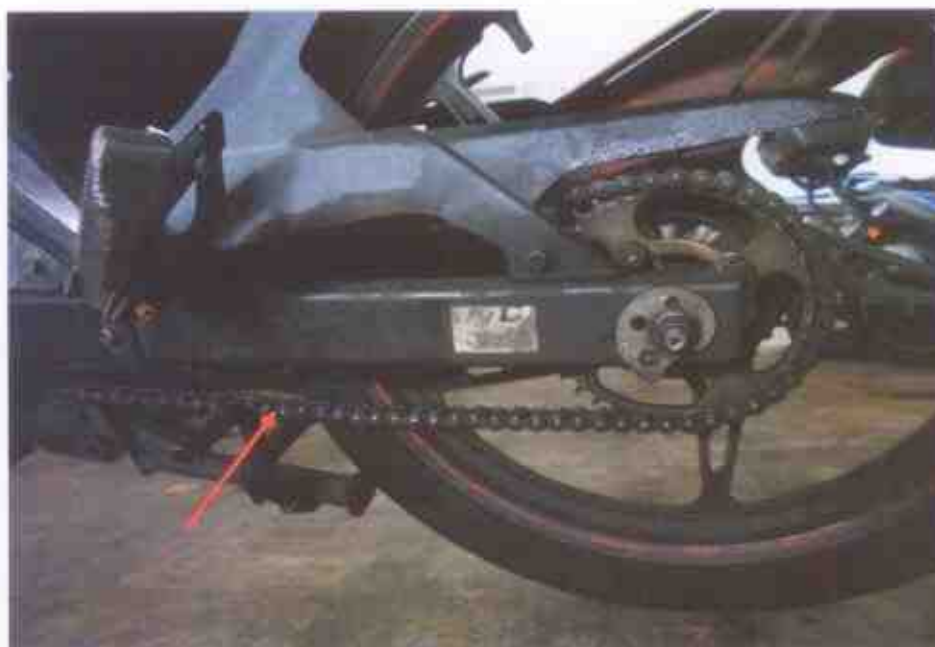
Photo 10 shows the general view of the gear train (arrowed) of the Motorcycle, which was observed to be intact with no misalignment. It was also adequately lubricated for operating purposes.

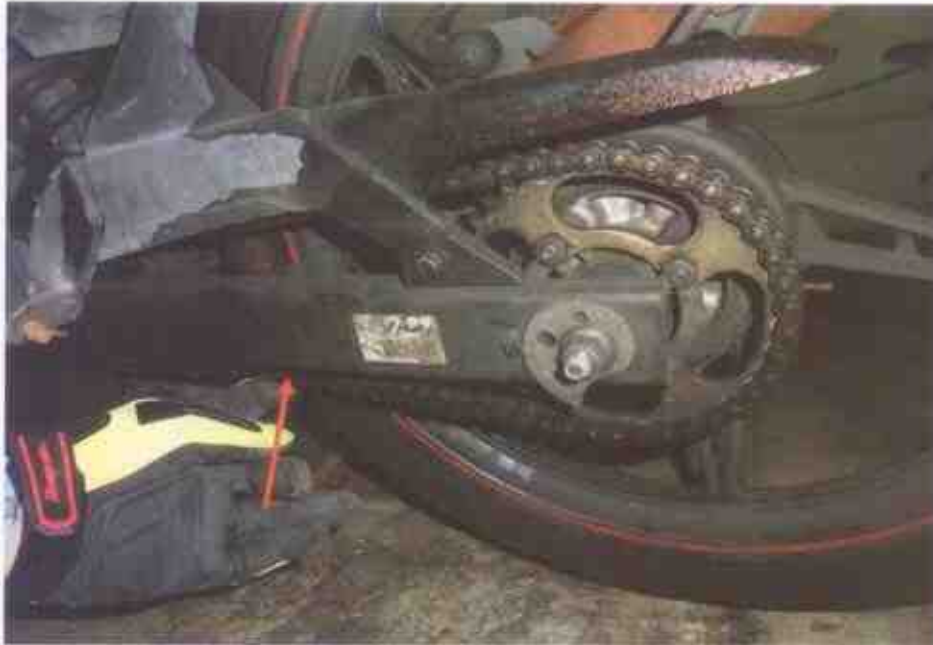
Photo 11 shows the general view of the gear train (arrowed) of the Motorcycle, which was observed to be intact with no misalignment. It was also adequately lubricated for operating purposes. Free play tension was also observed & found adequately acceptable.

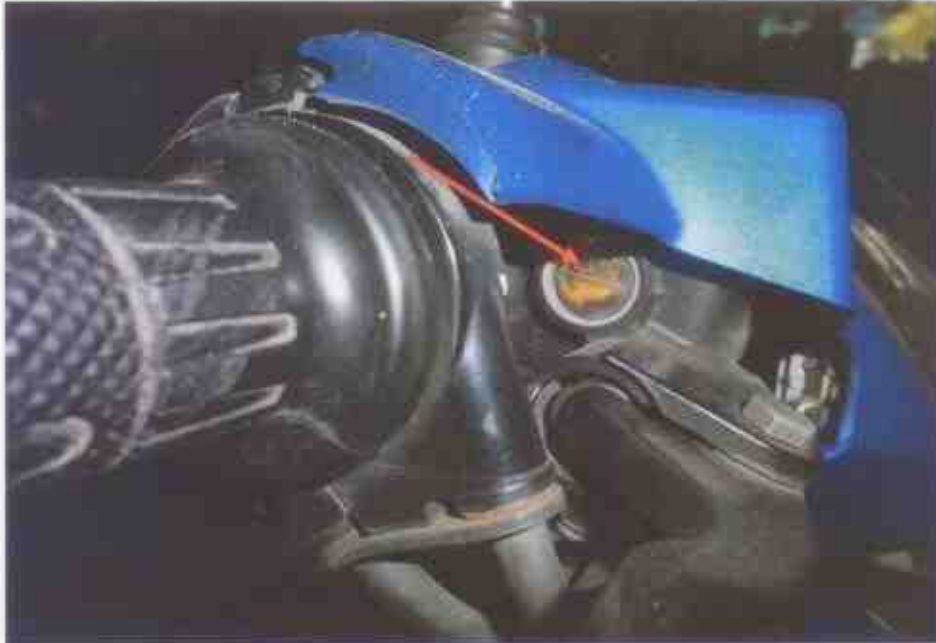
**Photo 12** shows our checks on the brake fluid (front) reservoir had also indicated that the brake fluid was of sufficient level for operational purposes, and without contamination.

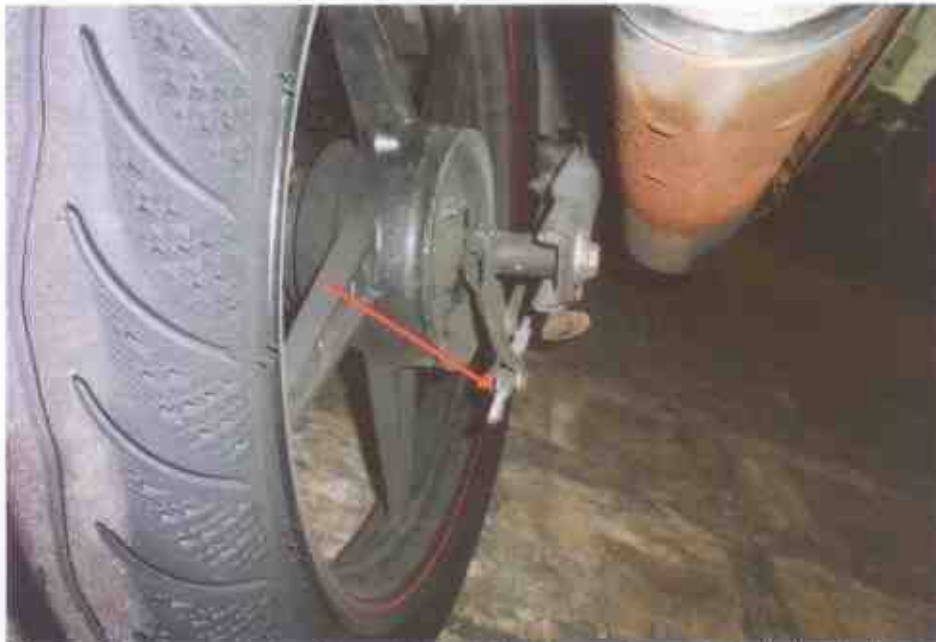
**Photo 13** shows our checks on the rear brake components had also indicated that the brake mechanism was in serviceable condition at the material time of the accident.

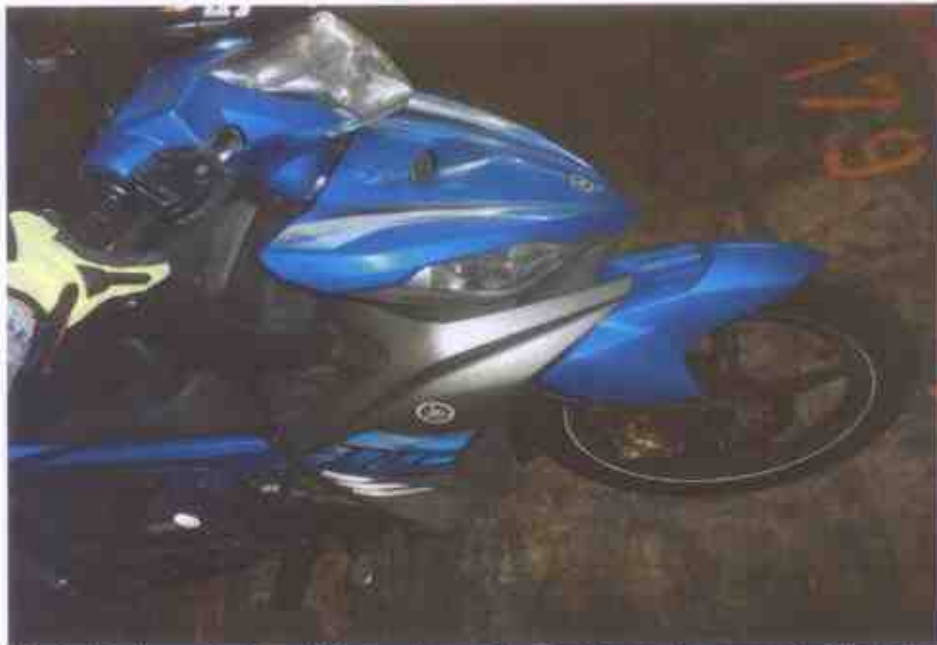
Photo 14 shows testing of the braking of the front brake in progress. There was some resistance felt (spongy like feel) upon pressing the brake lever.

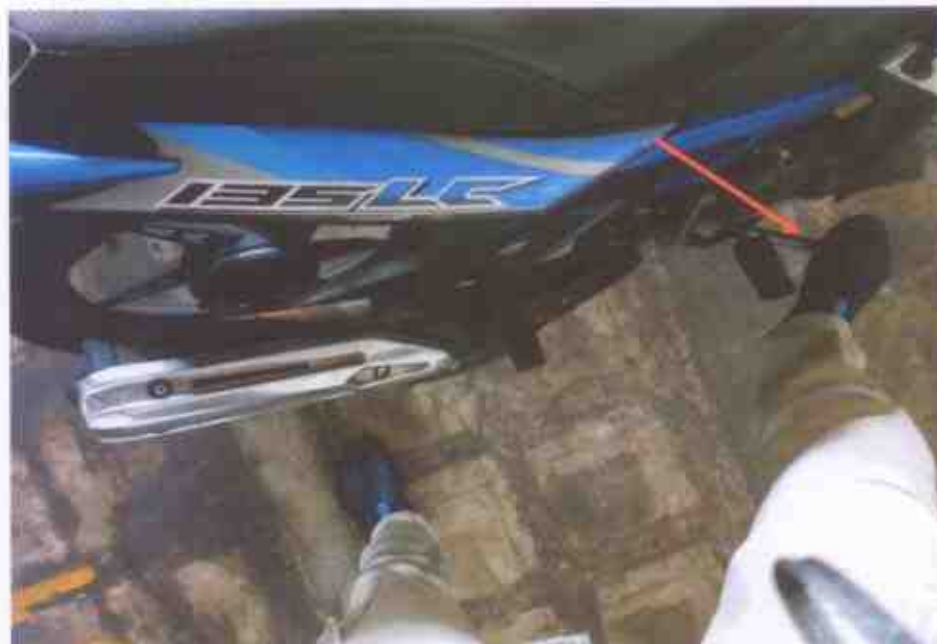
Photo 15 shows testing of the braking of the rear brake in progress. There was some resistance felt (spongy like feel) upon stepping on the brake pedal.

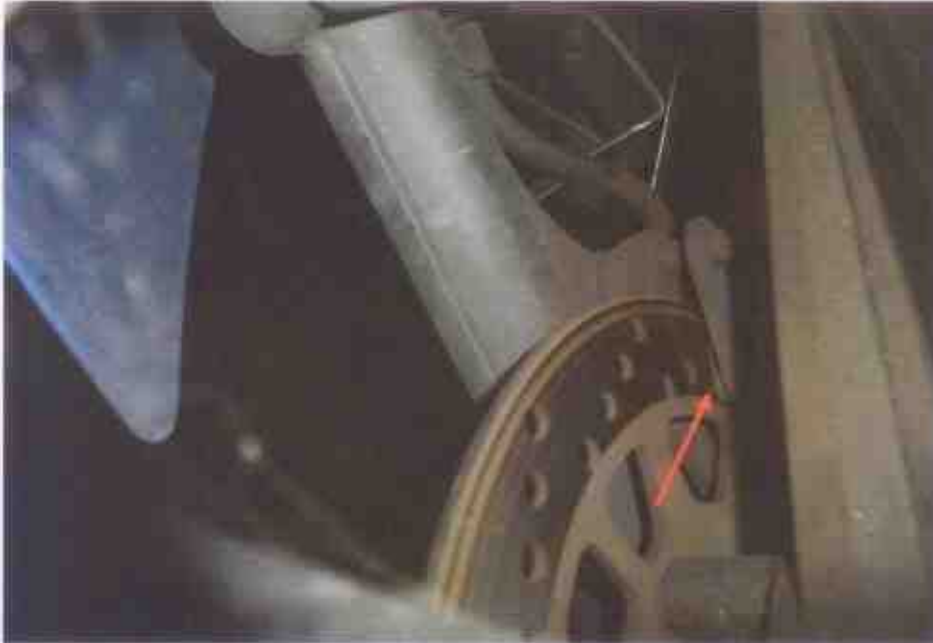
Photo 16 shows the front brake pad at time of our inspection. The frictional material was observed to be sufficient for operational purposes.
