Your Ref: TP/IP/59537/2018
Our Ref : CI/TPD18019567/Z

18th February 2019

MECHANICAL INSPECTION REPORT OF MOTOR VAN GBH 2532C

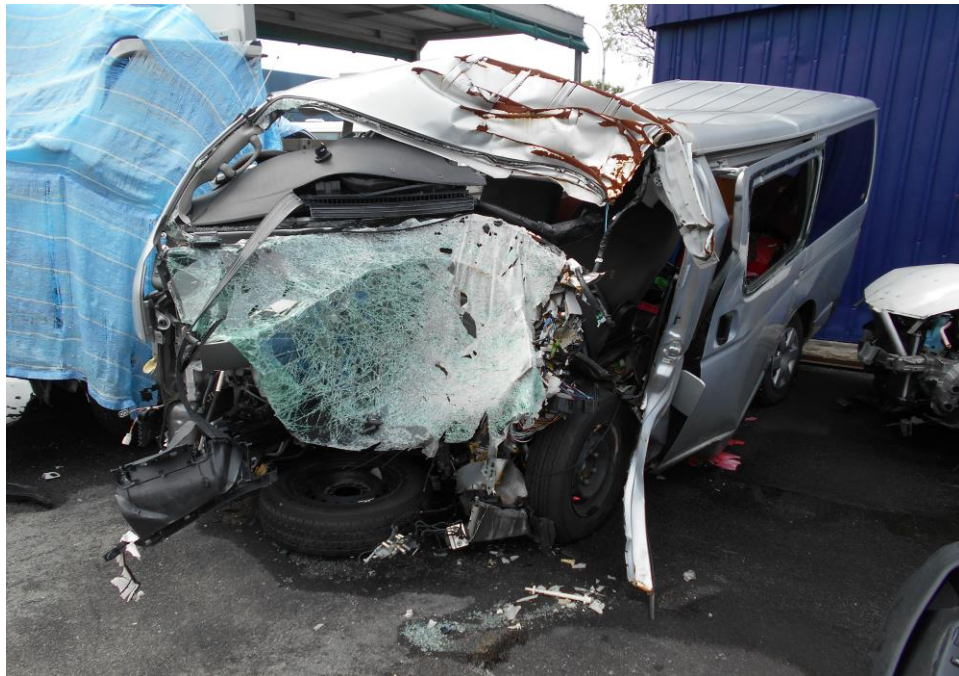
Photo 1 shows a general view of the frontal portion of the Motor Van at the time of our inspection. The Motor Van was observed to have sustained extensive impact damage at its frontal portion. The impact force was significant, causing the various parts and components inside the engine compartment to be damaged.

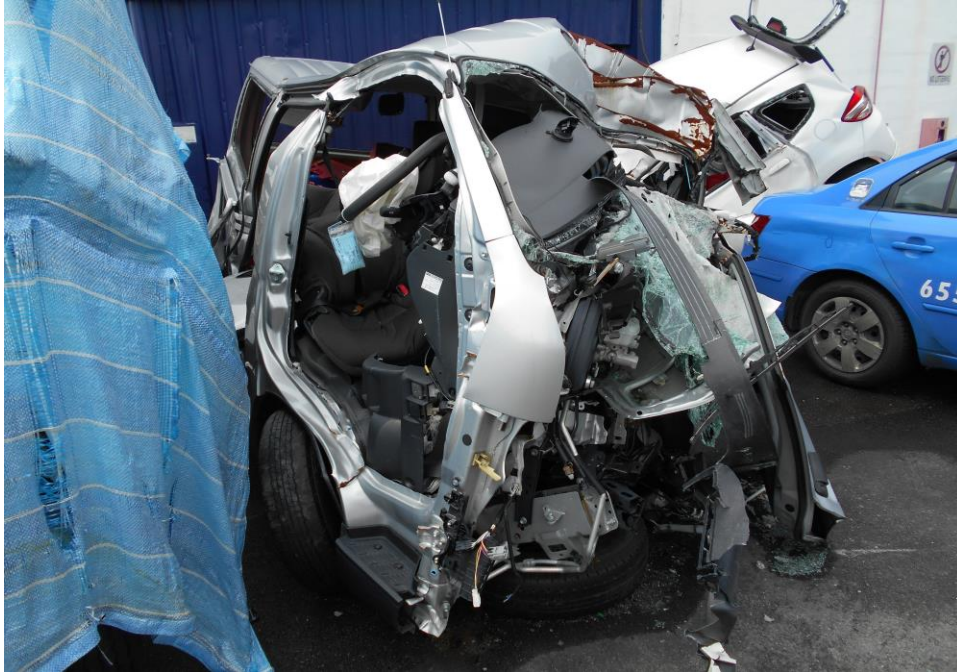
Photo 2 shows a general view of the front right portion of the Motor Van at the time of our inspection. The Motor Van was observed to have sustained extensive impact damage at its frontal portion.

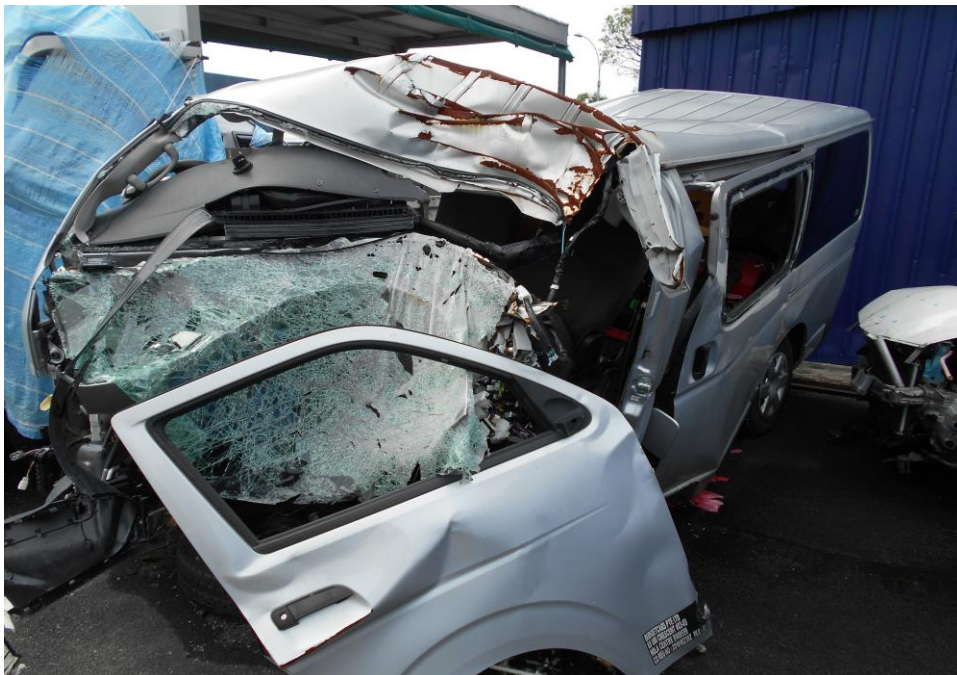
Photo 3 shows a general view of the front left portion of the Motor Van at the time of our inspection. The Motor Van was observed to have sustained with extensive impact damage at its frontal portion.

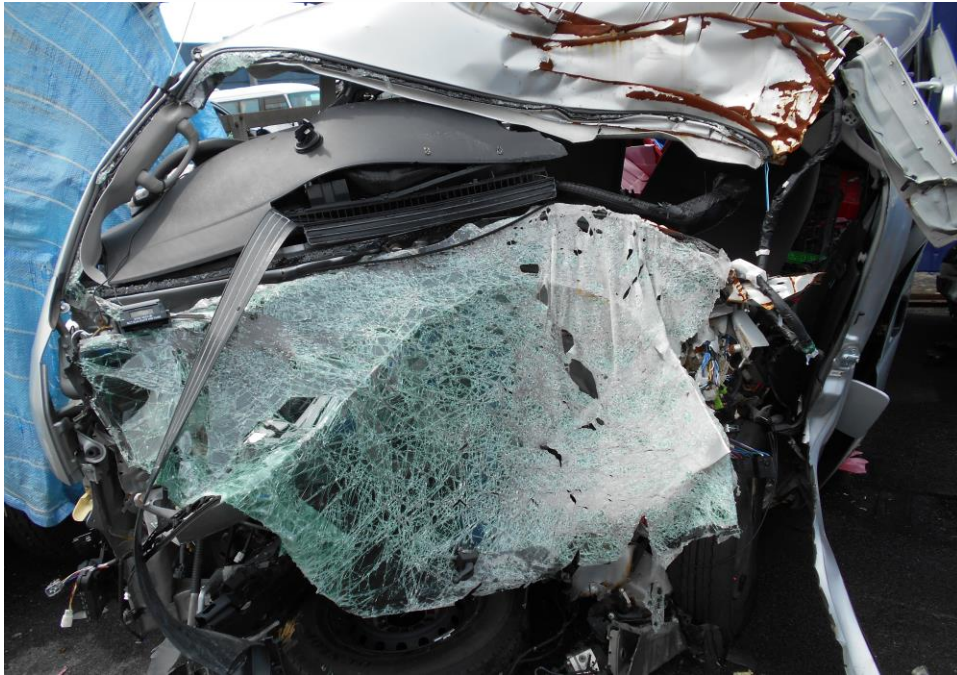
Photo 4 shows a closer view of the damage at the frontal portion of the Motor Van's engine. The impact force was significant, causing the various parts and components inside the engine compartment to be pushed inwards, towards the rear of the Motor Van.

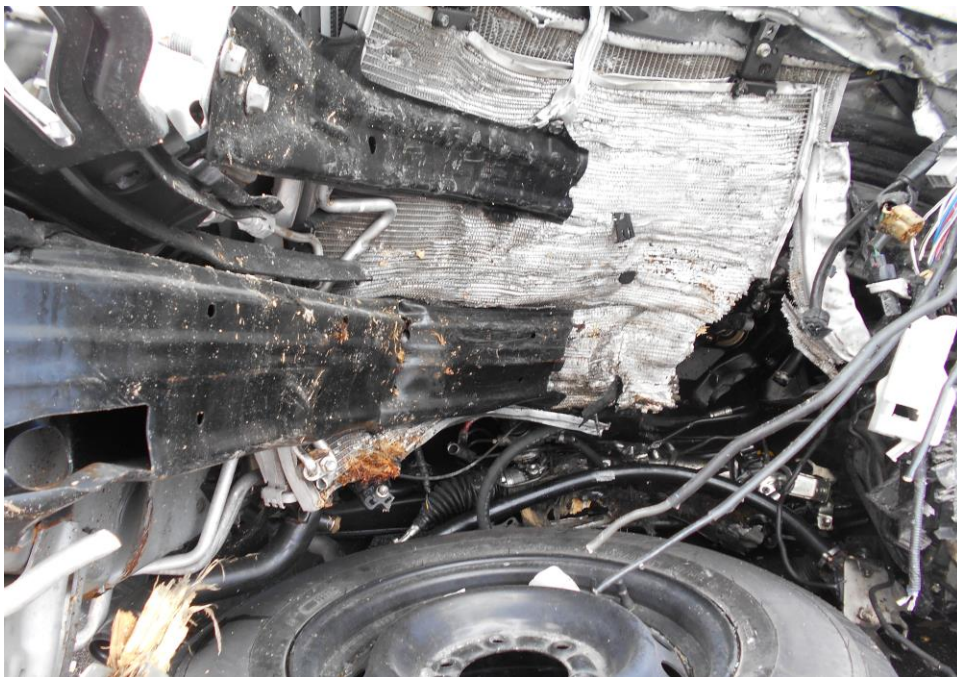
Photo 5 shows a closer view of the damage at the frontal right portion of the Motor Van. The impact force was significant, causing the various parts and components inside the engine compartment to be pushed inwards, towards the rear of the Motor Van.

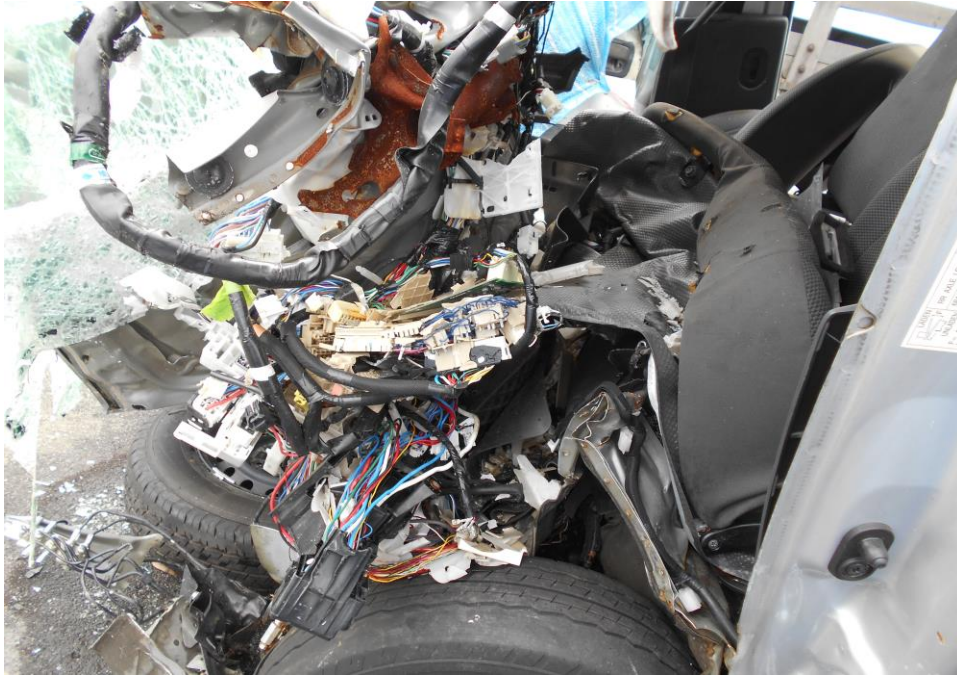
Photo 6 shows a closer view of the damage at the frontal left portion of the Motor Van. The impact force was significant, causing the various parts and components inside the engine compartment to be pushed inwards, towards the rear of the Motor Van.

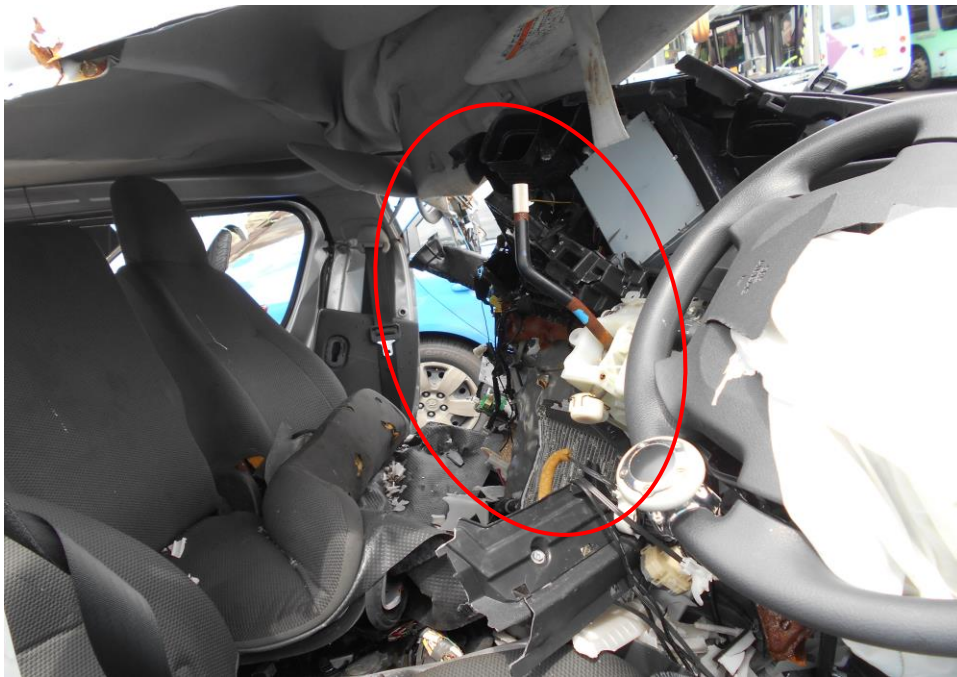
Photo 7 shows a closer view of the damage gear knob at the interior portion of the Motor Van. The impact force was significant, causing the various parts and components inside the engine compartment to be pushed inwards, towards the rear of the Motor Van including its transmission system.

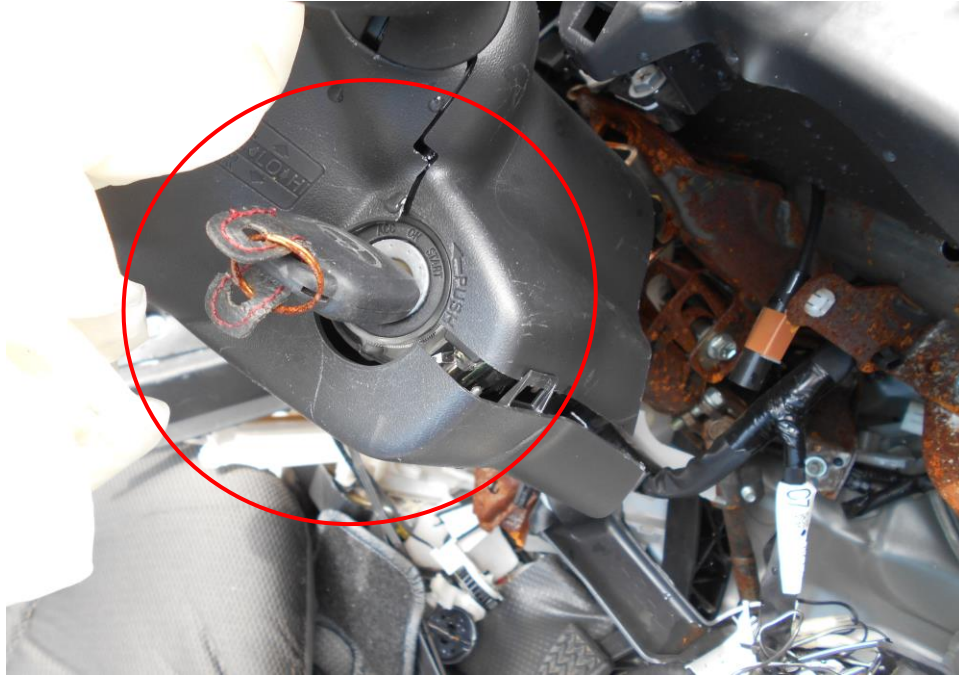
Photo 8 shows a closer view of the damage at the ignition section of the Motor Van. The impact force was significant, causing the various parts and components inside the interior compartment to be pushed inwards, including its ignition system.

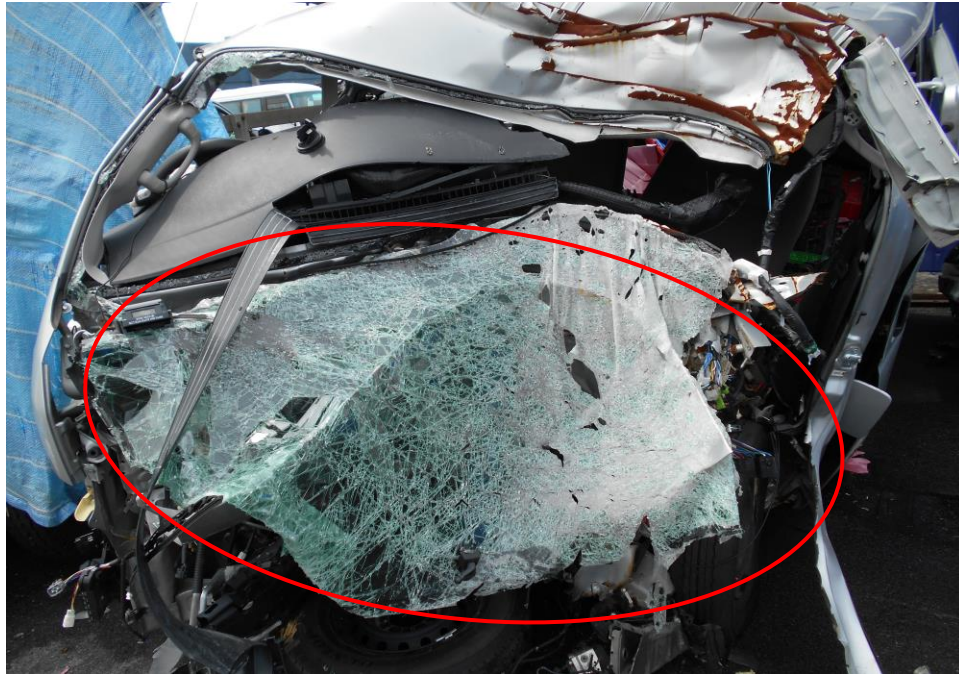
Photo 10 shows a closer view of the damage at the windscreen area of the Motor Van. The impact force was significant, causing the windscreen to sustain a shattering cracked.

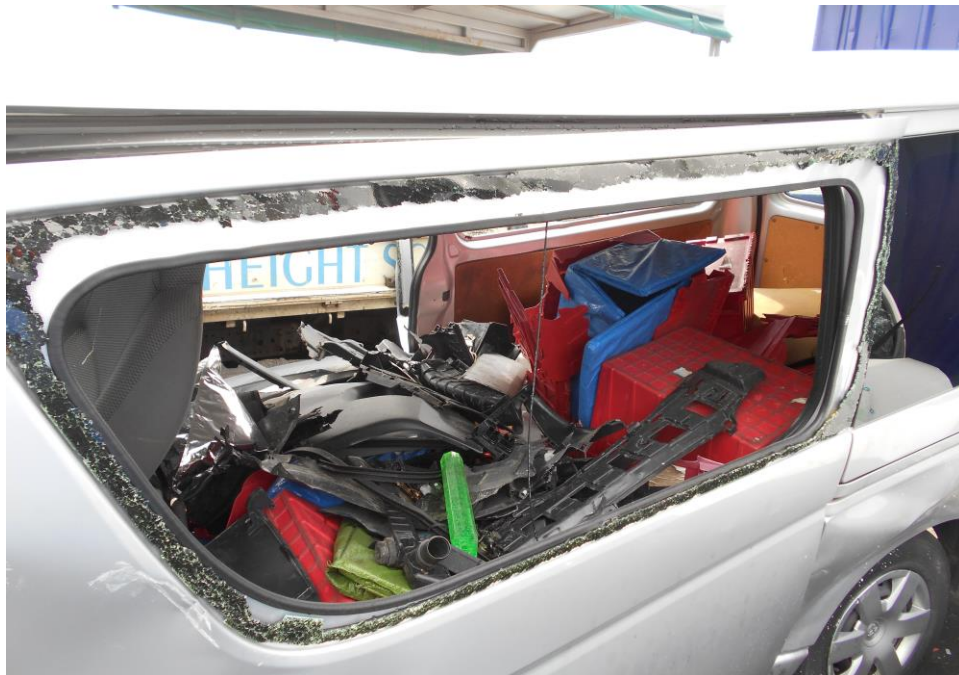
Photo 11 shows a closer view of the damaged left passenger door of the Motor Van. The impact force was significant, causing the window glass to be shattered.

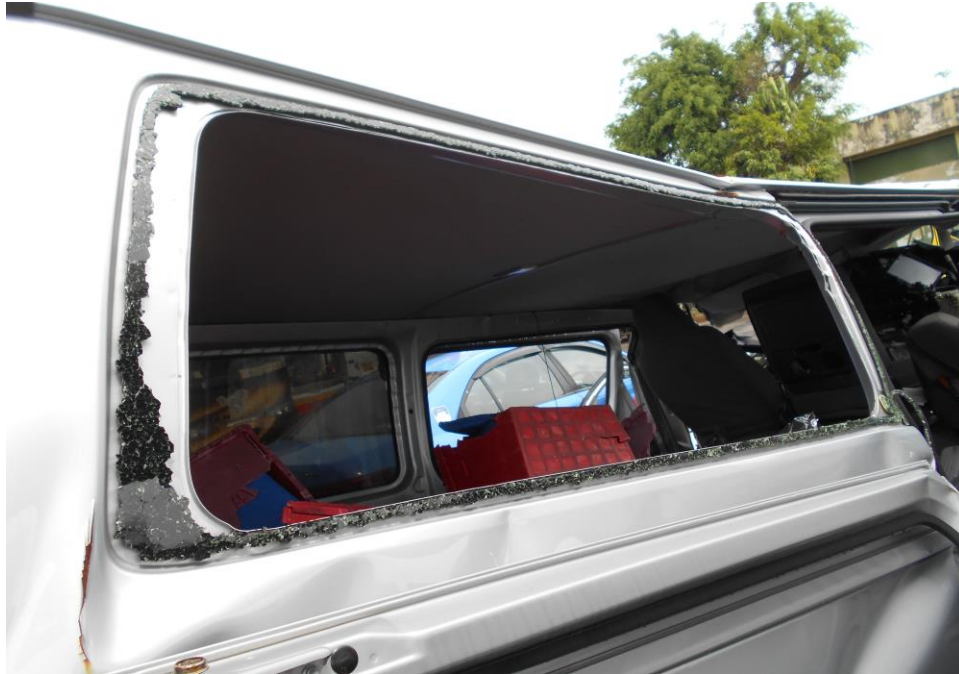
Photo 12 shows a closer view of the damaged left passenger door of the Motor Van. The impact force was significant, causing the window glass to be shattered.

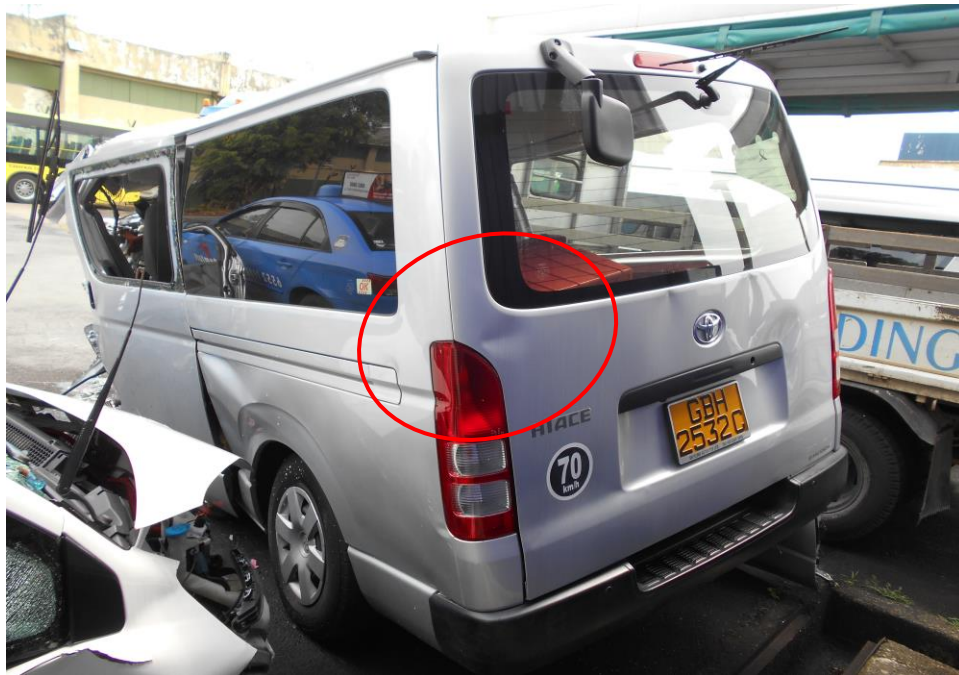
Photo 13 shows a general view of the rear left portion of the Motor Van at the time of our inspection. The rear portion was observed to have sustained with minor damages as a result of the accident.

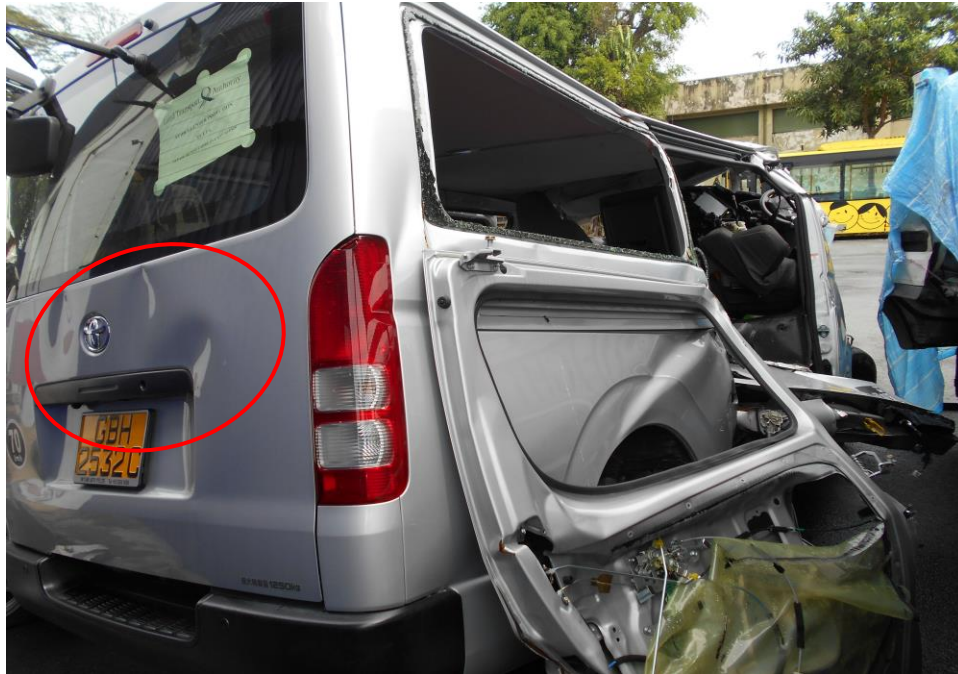
Photo 14 shows a general view of the rear right portion of the Motor Van at the time of our inspection. The rear portion was observed to have sustained with minor damages likely not related to the accident.

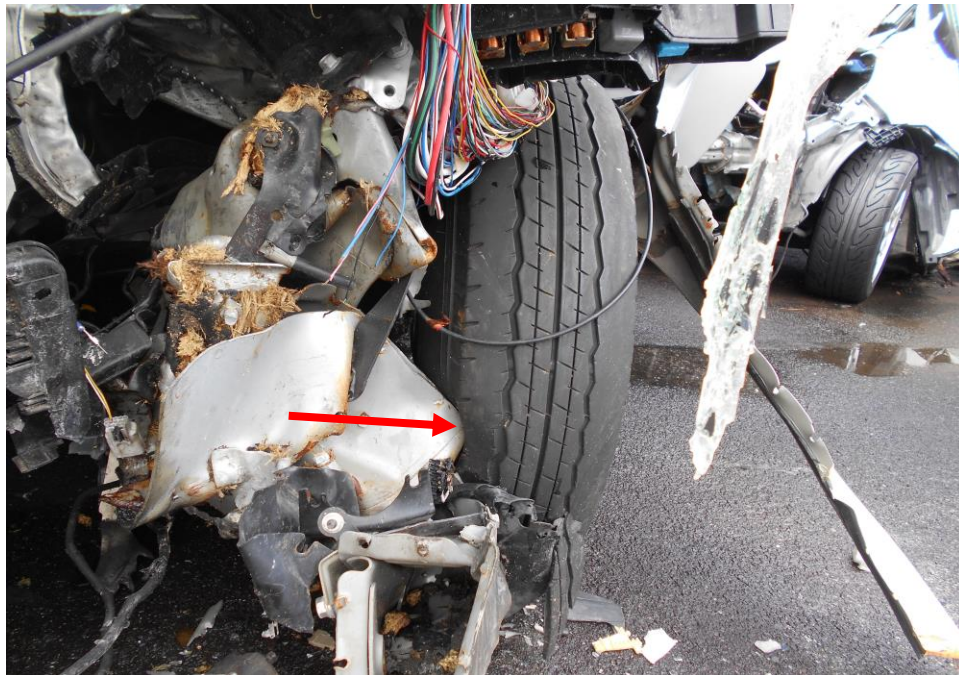
Photo 15 shows the condition of the front left tyre of the Motor Van, which was found to be punctured by the Motor Van's body metal part & deflated. However, the tread pattern was still visible (4mm).

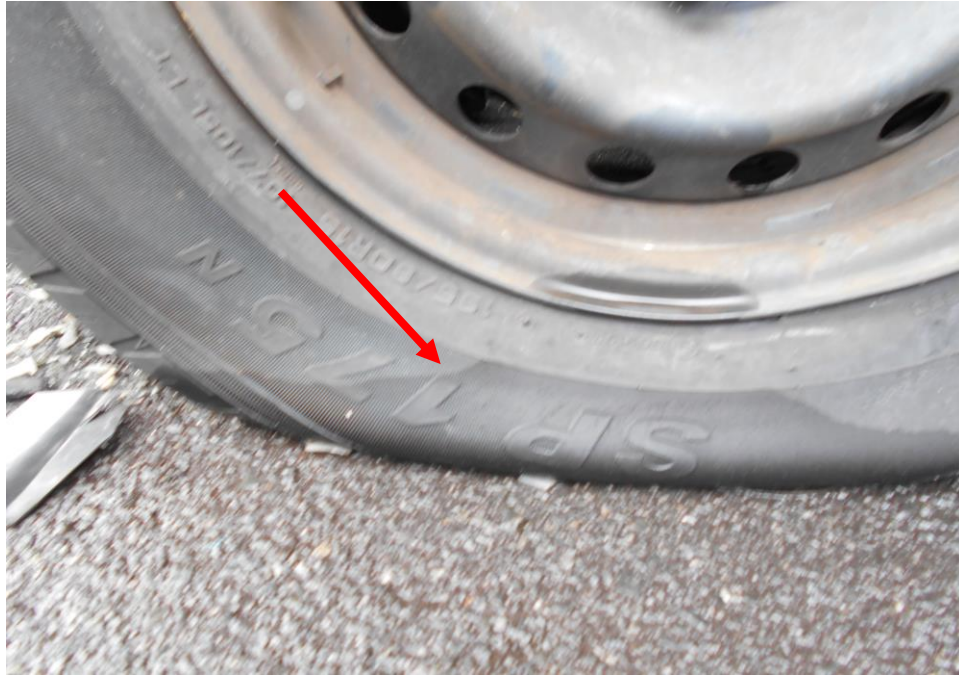
Photo 16 shows the condition of the front left tyre of the Motor Van, which was found to be punctured by the Motor Van's body metal part & deflated as a result of the accident.

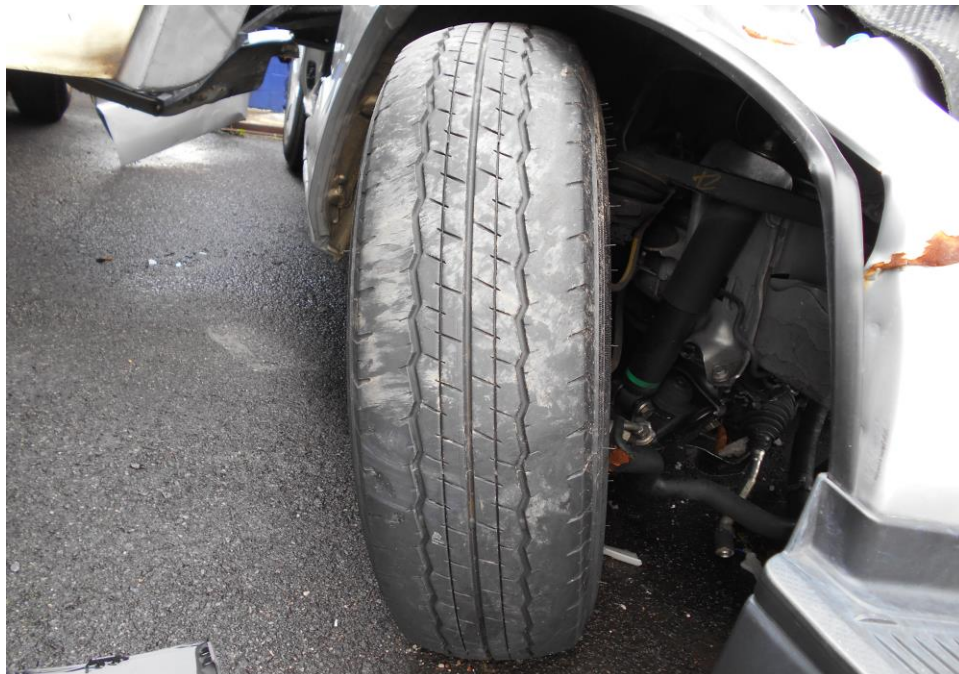
Photo 17 shows the condition of the front right tyre of the Motor Van, which was observed to be in serviceable condition with remaining tread depth of approximately 4mm. The tyre, which was wrapped around standard steel wheel rim, was also observed to be sufficiently inflated for vehicular operation.

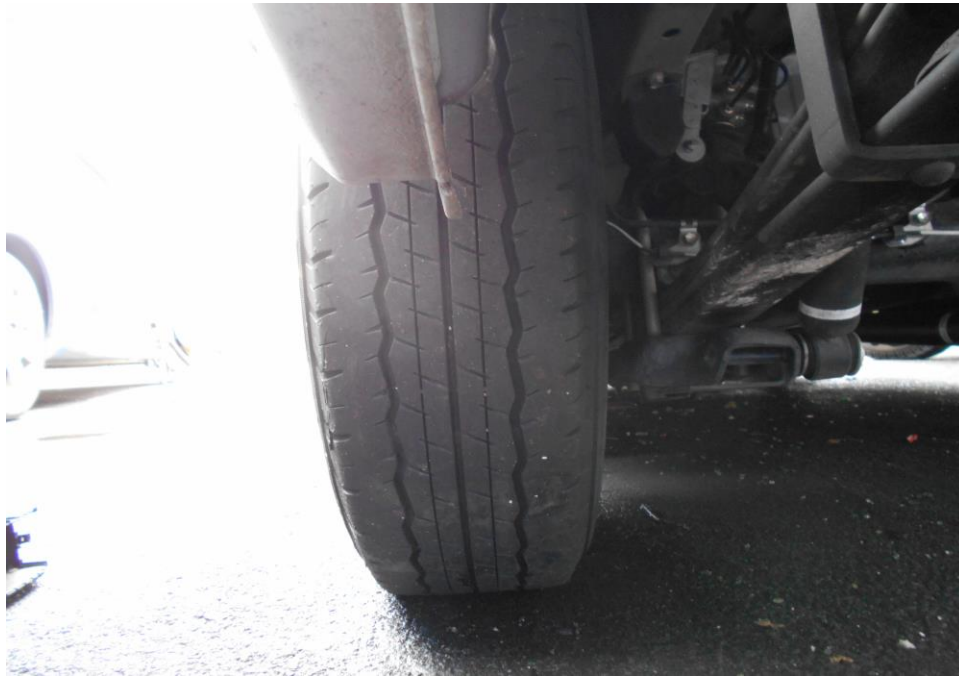
Photo 18 shows the condition of the rear left tyres of the Motor Van, which was observed to be in serviceable condition with remaining tread depth of approximately 5mm. The tyres, which were wrapped around standard alloy wheel rim, were also observed to be sufficiently inflated for vehicular operation.

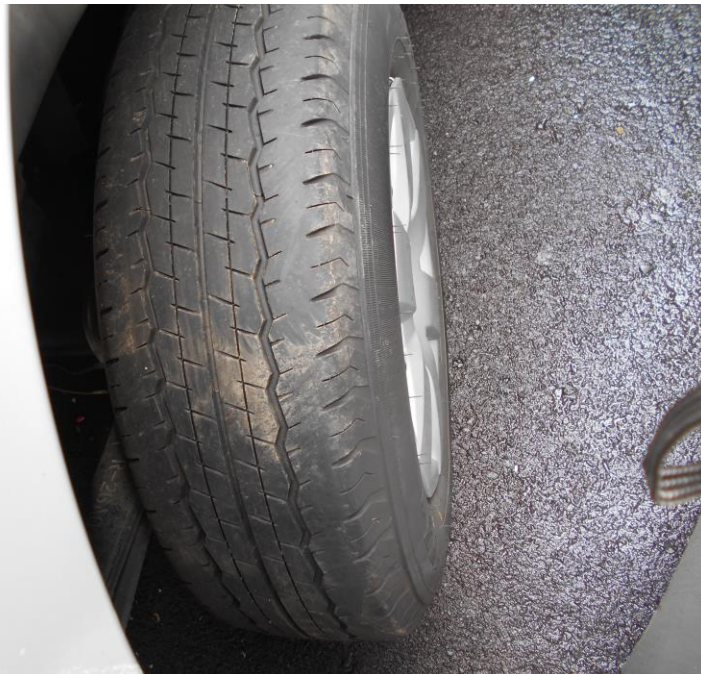
Photo 19 shows the condition of the rear right tyres of the Motor Lorry, which were observed to be in serviceable condition with remaining, tread depth of approximately 5mm.

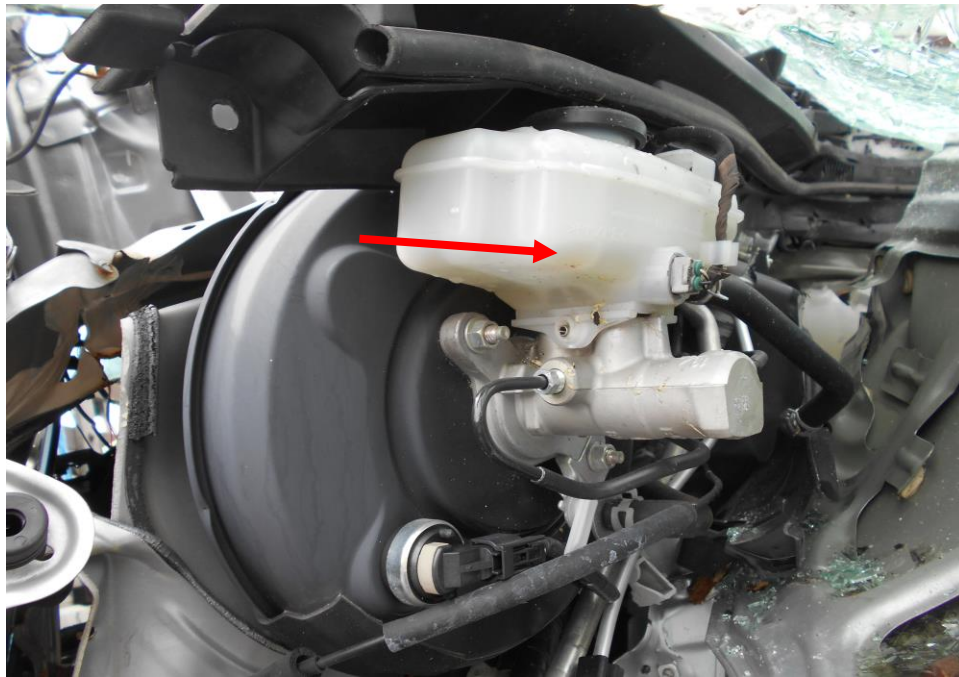
Photo 20 shows the close up view of the brake fluid reservoir that indicates empty content likely due to the accident impact.

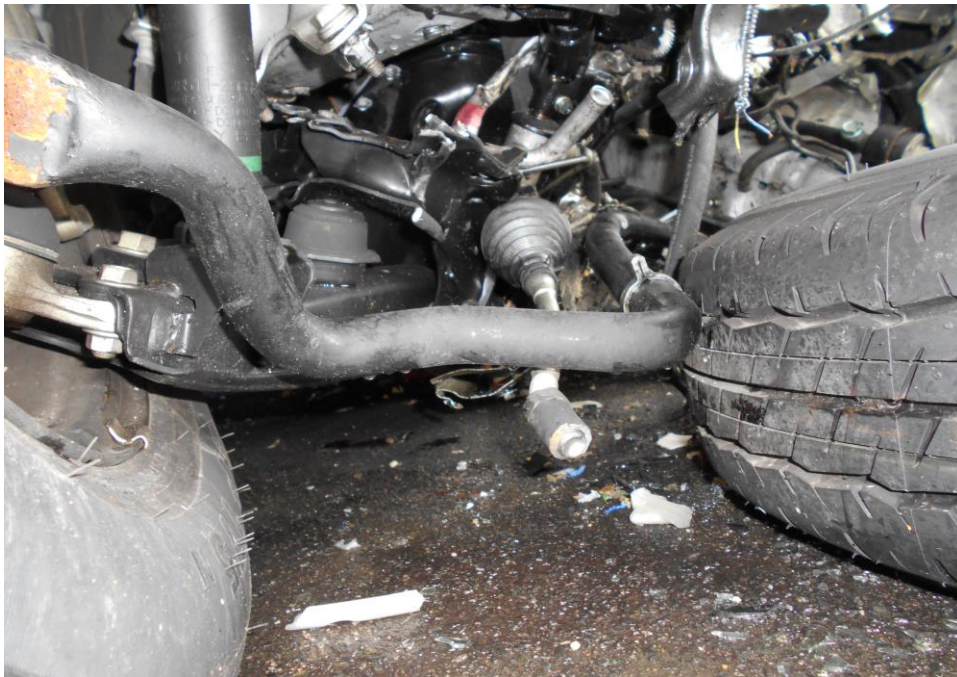
Photo 21 shows the close up view of the undercarriage which was observed to be damaged and fluid leakage observed as a result of the accident.

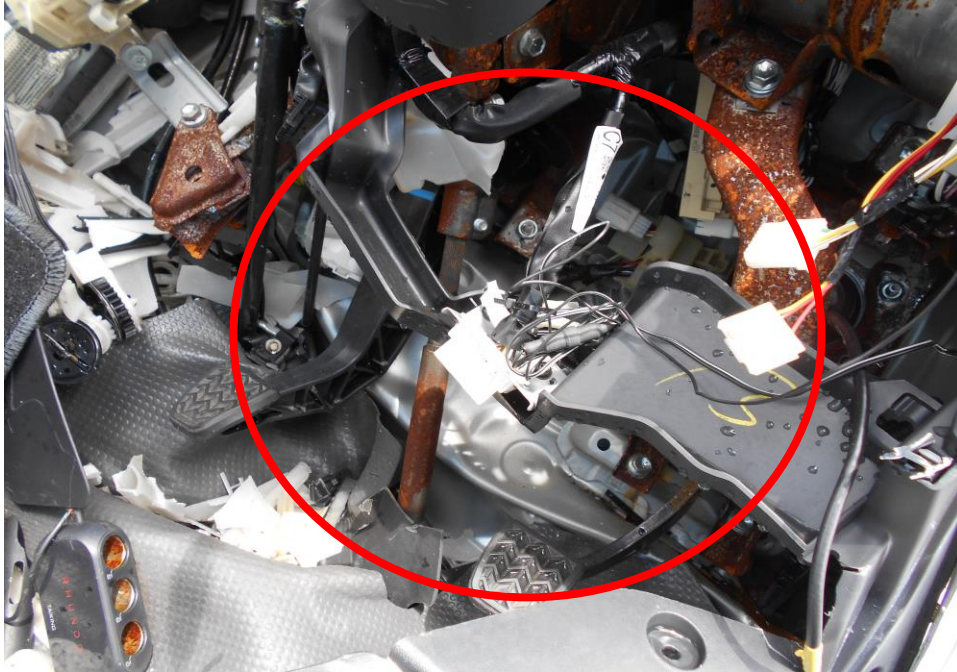
Photo 22 shows the close up view of the brake pedal & steering shaft that was observed to be damaged due to the accident's impact.

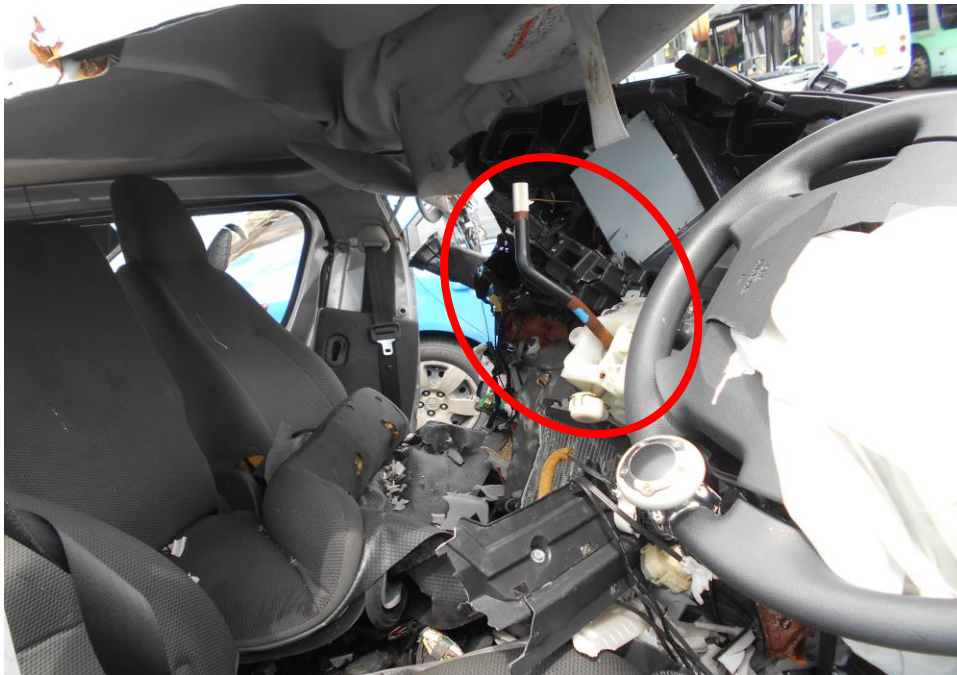
Photo 23 shows the close up view of the gear knob that was observed to be damaged due to the accident's impact.

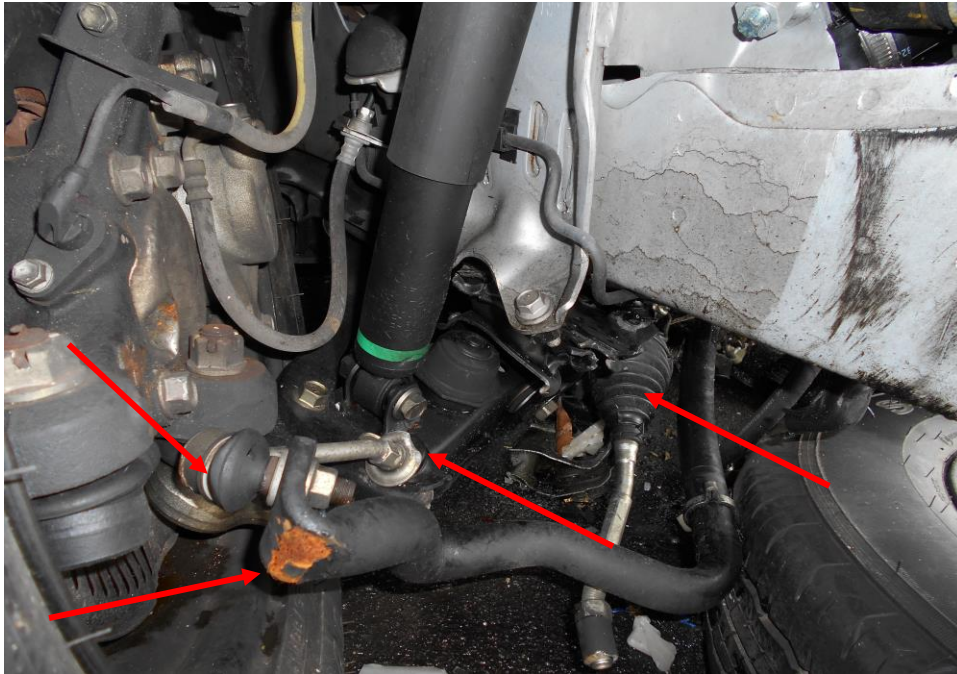
Photo 24 shows the front right steering rack & steering components of the Motor Van. It was observed to be severely damaged by the accident.

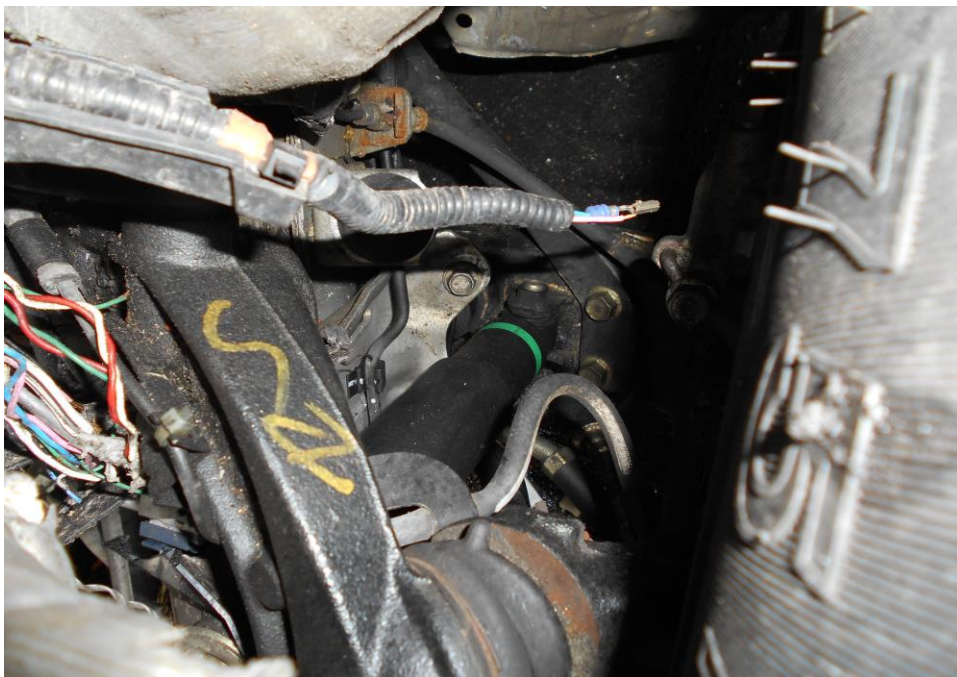
Photo 25 shows the front left steering system of the Motor Van. It was observed to be severely damaged by the accident.

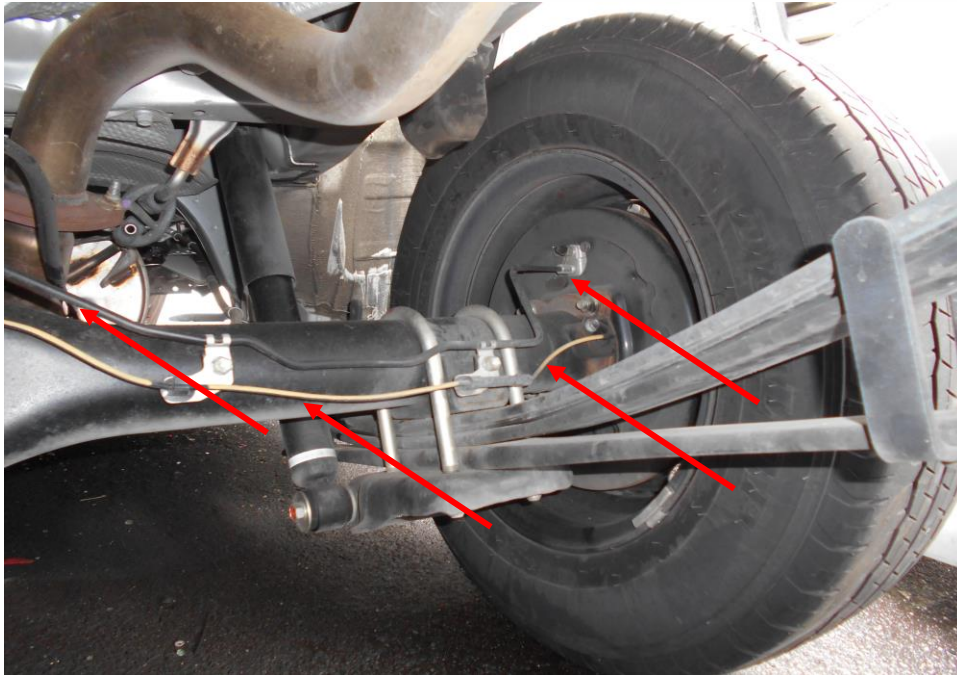
Photo 26 shows the braking components at the rear right wheel of the Motor Van. We did not observe any leakage of brake fluid at the time of our inspection of the Motor Van.

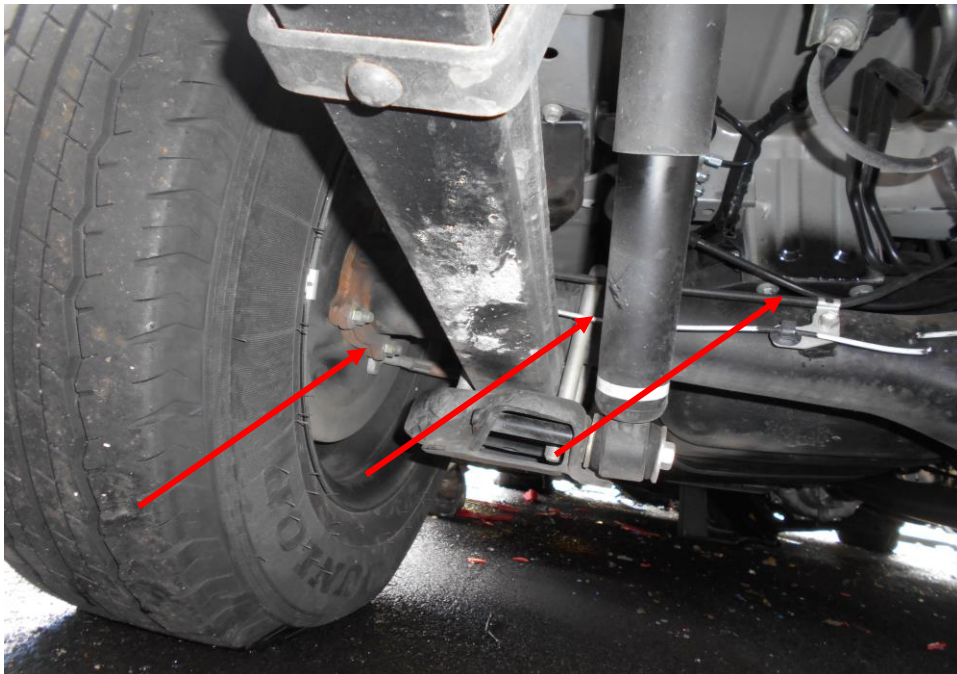
Photo 27 shows the braking component at the left right wheel of the Motor Van. We did not observe any leakage of brake fluid at the time of our inspection of the Motor Van.

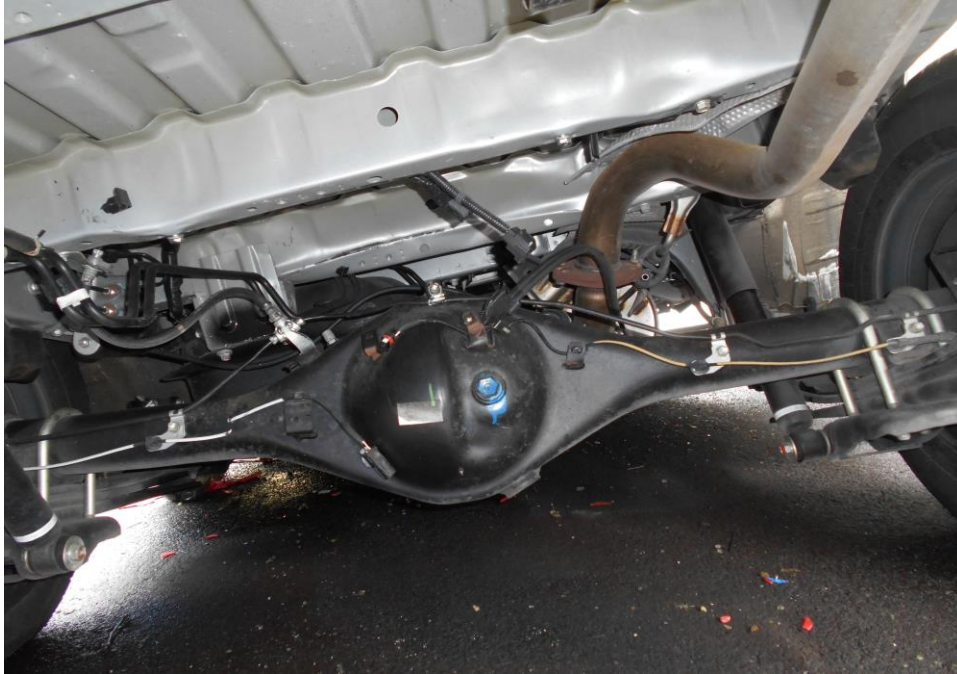
Photo 28 shows the rear axle of the Motor Van. It was observed to be in good condition at the time of our inspection of the Motor Van.

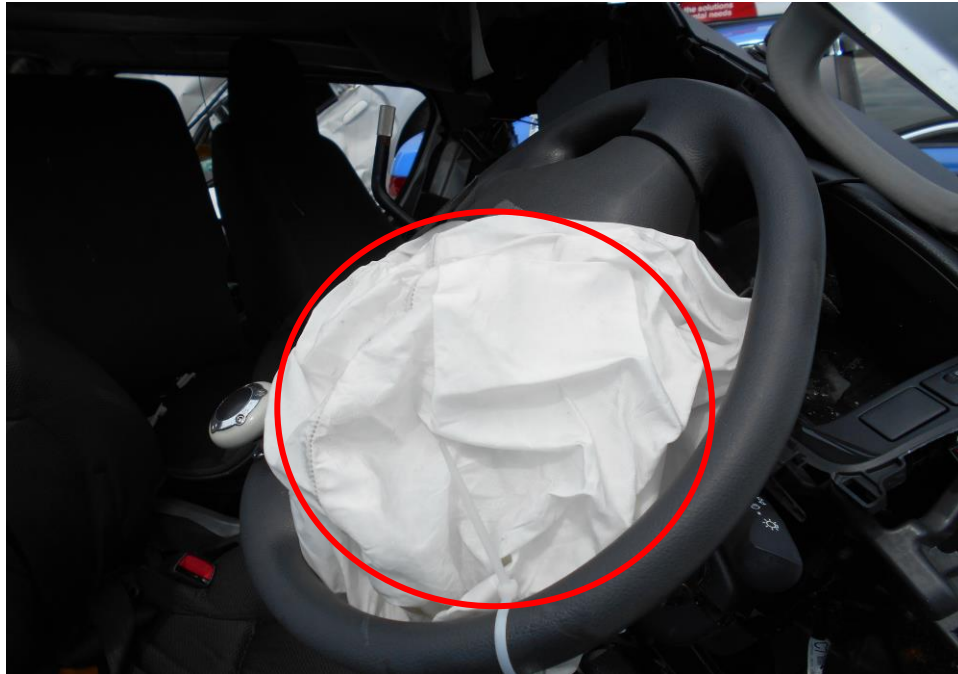
15. The Motor Van's automatic self-test of the functionality of its various operating systems like the Anti-Brake Lock System (ABS) and Supplemental Restraint System (SRS) was not able to be initiated due to major mechanical damages which includes its ignition system and engine system of the Motor Van.
16. The Supplemental Restraint System (SRS) of the Motor Van was however likely to be in normal operating condition at the material time of the accident. The evidence of the deployed driver's airbag indicates that the impact sensors and control module of the Motor Van's SRS were all in serviceable condition at the material time of accident. See photo 29 below.

Photo 35 shows the Supplemental Restraint System (SRS) of the Motor Van was however likely to be in normal operating condition at the material time of the accident. The evidence of the deployed front passenger's airbag indicates that the impact sensors and control module of the Motor Van's SRS were all in serviceable condition at the material time of accident.
