Your Ref: TP/IP/52969/2018
Our Ref : CI/TPD18019568/Z

Fatal Accident Investigation Team

MECHANICAL INSPECTION REPORT OF MOTOR CAR SLS 9401A

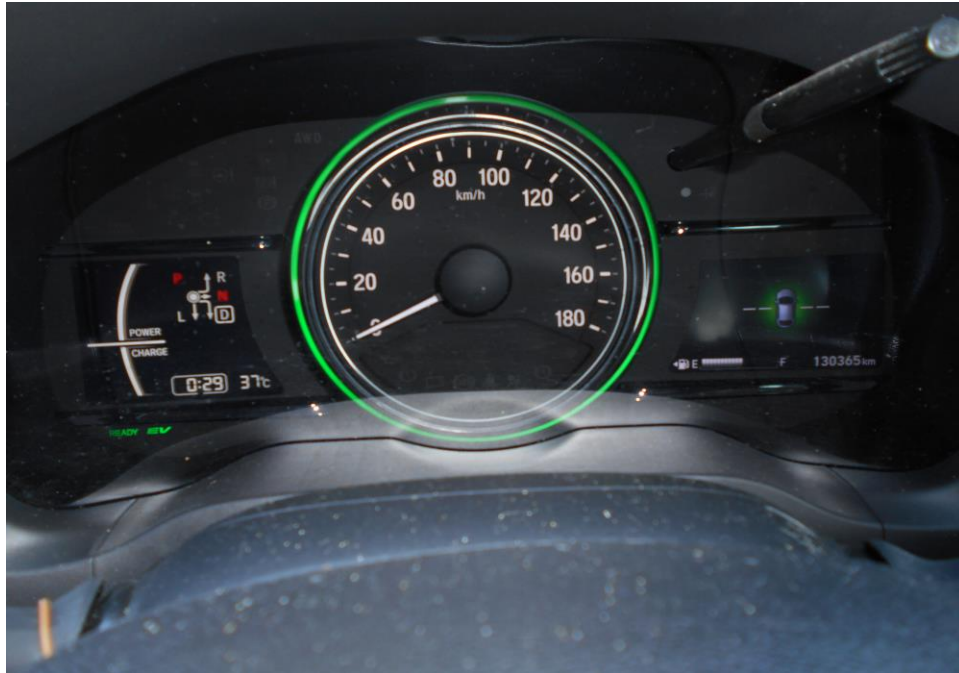
4. The mileage of the Motor Car at the time of our inspection was 130365 km.
5. The Motor Car had sustained a relatively minor impact damages that was confined to its right portion. Its right side portions (door & wing mirror) were observed to have sustained with minor scratches.
6. This was likely due to the consistency of the accident's case facts that a Motor Car (SLS 9401A) was travelling along the slip road of Changi South Avenue 3 and subsequently made a lane changed from the slip road into PIE (Tuas), 1.4km. While the Motor Car was doing so, the right wing mirror of the said Motor Car side-swiped onto a motorcycle that was travelling straight along PIE (Tuas), 1.4km on lane 3 of a 3 lanes road. Due to the impact, the motorcyclist fell face down and landed on lane 2. See photo 1 to 7 below.

Photo 1 shows the mileage of the Motor Car was 130365 km.

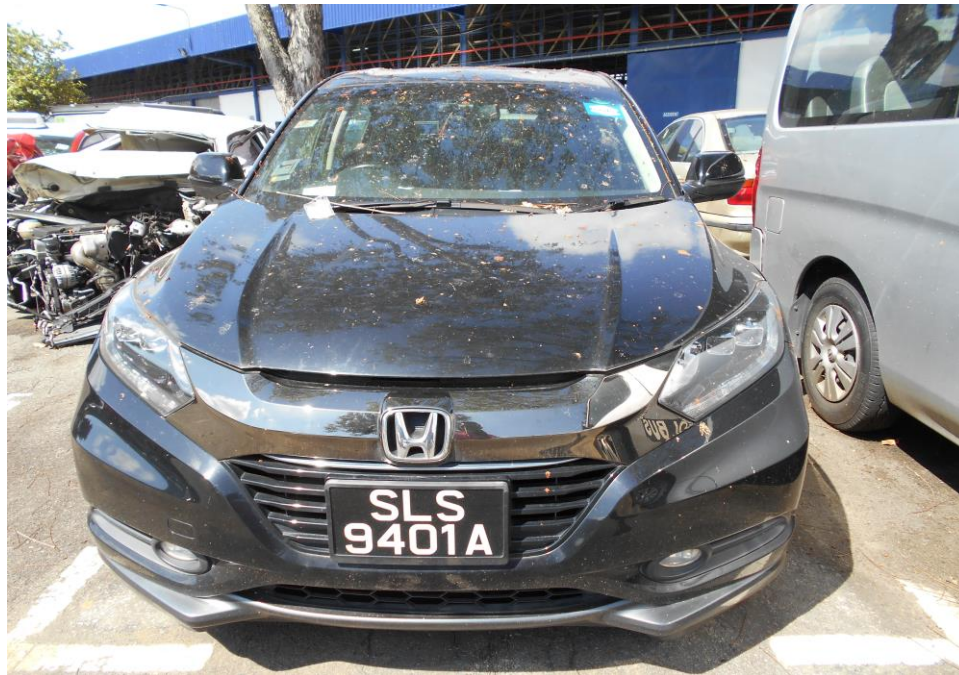
Photo 2 shows a general view of the front body of the Motor Car at the time of our inspection. The Motor Car was observed to be in good general condition except for minor scratches at the right side portion.

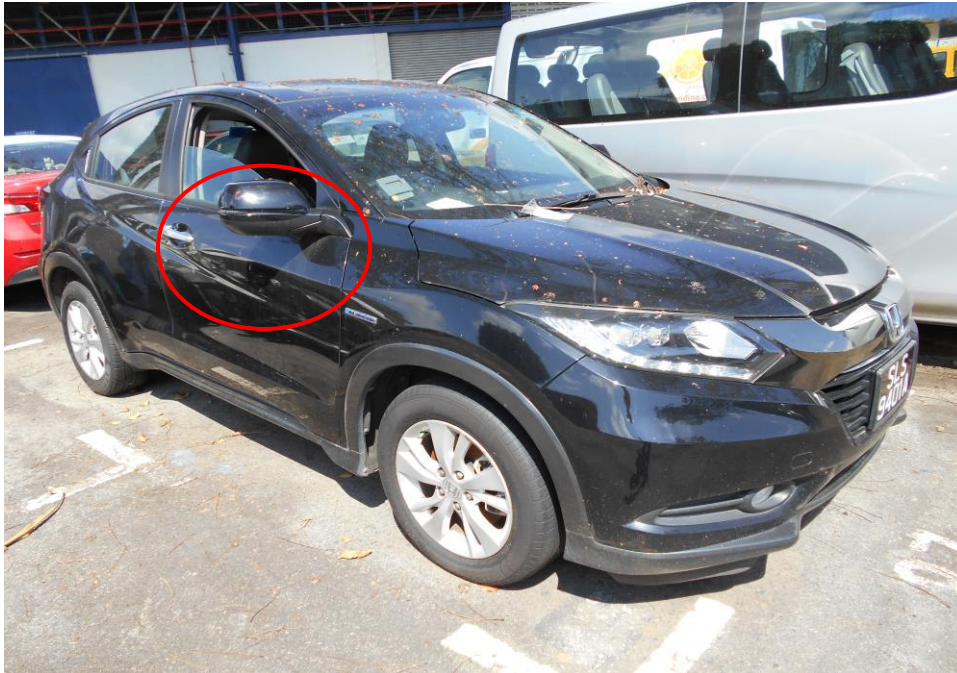
Photo 3 shows a general view of the right front body of the Motor Car at the time of our inspection. The Motor Car was observed to be in good general condition except for minor scratches at the right side portion.

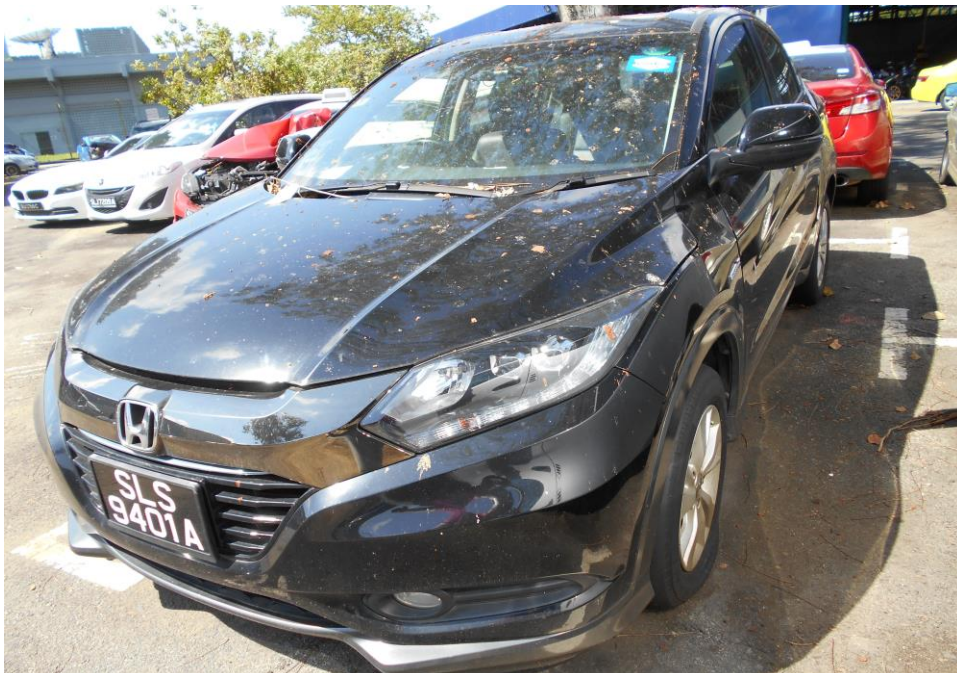
Photo 4 shows a general view of the front left body of the Motor Car at the time of our inspection. The Motor Car was observed to be in good condition unaffected by the accident.

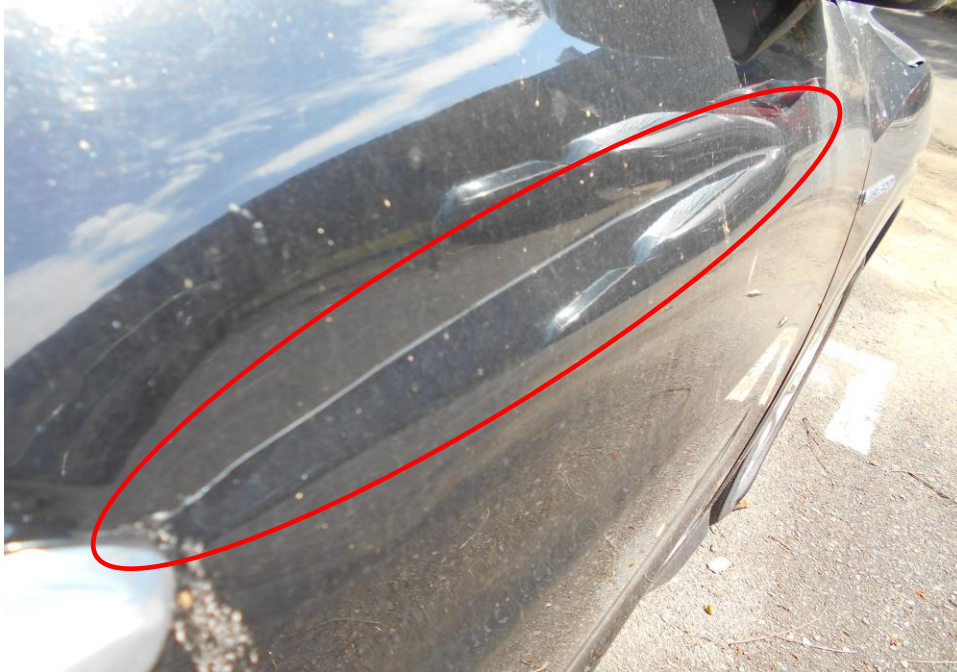
Photo 5 shows a semi-close up view of the right driver's & passenger's door of the Motor Car at the time of our inspection. It had sustained minor scratches at the right side portion due to the accident.

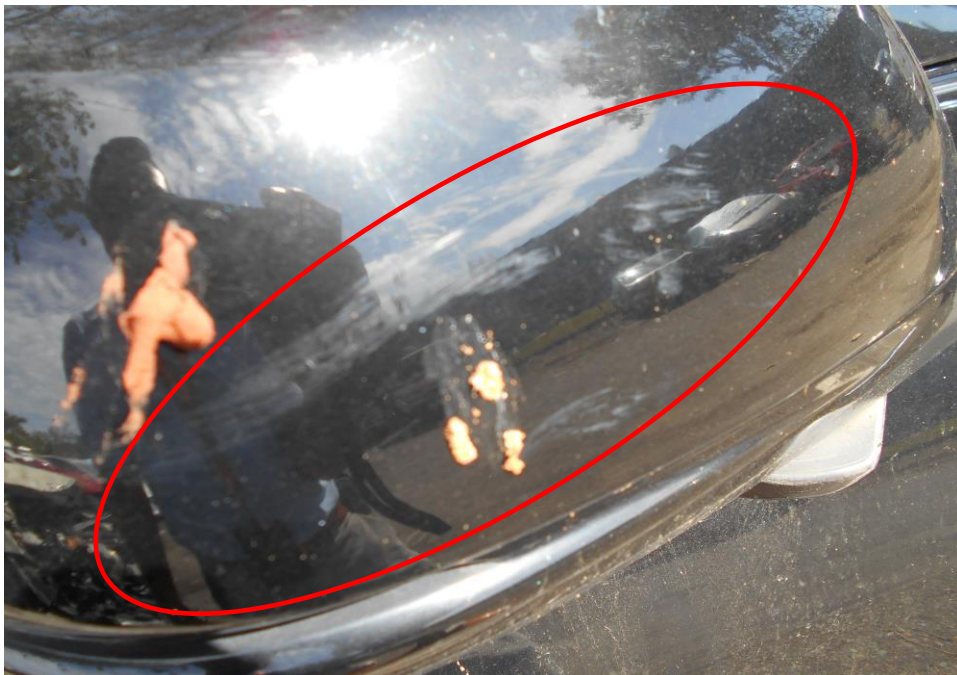
Photo 6 shows a close up view of the right wing mirror at the time of our inspection. It had sustained minor scratches at the right side portion due to the accident.

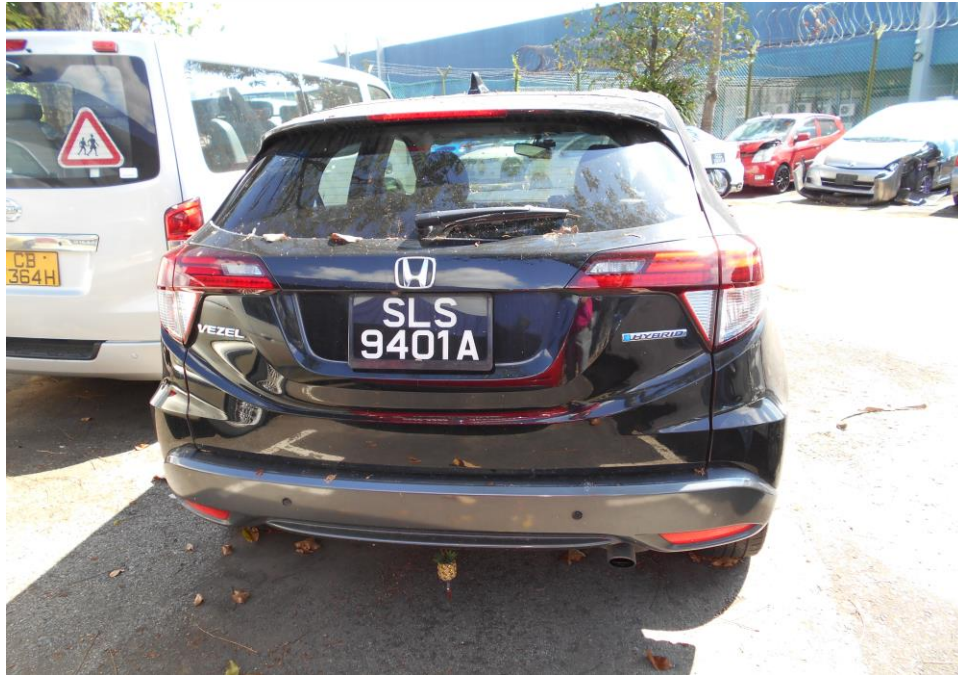
Photo 7 shows a general view of the rear body of the Motor Car at the time of our inspection. The Motor Car was observed to be in good general condition.

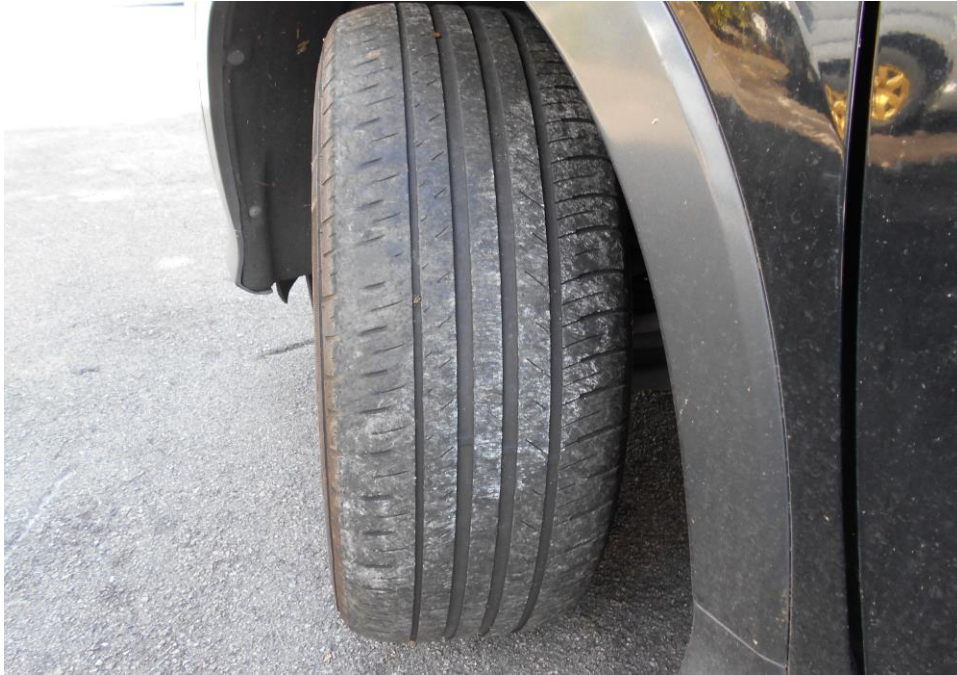
8. The 4 tyres were observed to be wrapped around alloy wheel rims that were found to be without any significant damage except for some marks of grazing nature on the outer spokes of the wheel rims, which are commonly associated to grazing against a road kerb. See photo 8 – 11 below.

Photo 8 shows the condition of the front left tyre of the Motor Car, which was observed to be in serviceable condition with remaining tread depth of approximately 4mm. The tyre was also observed to be sufficiently inflated for vehicular operation.

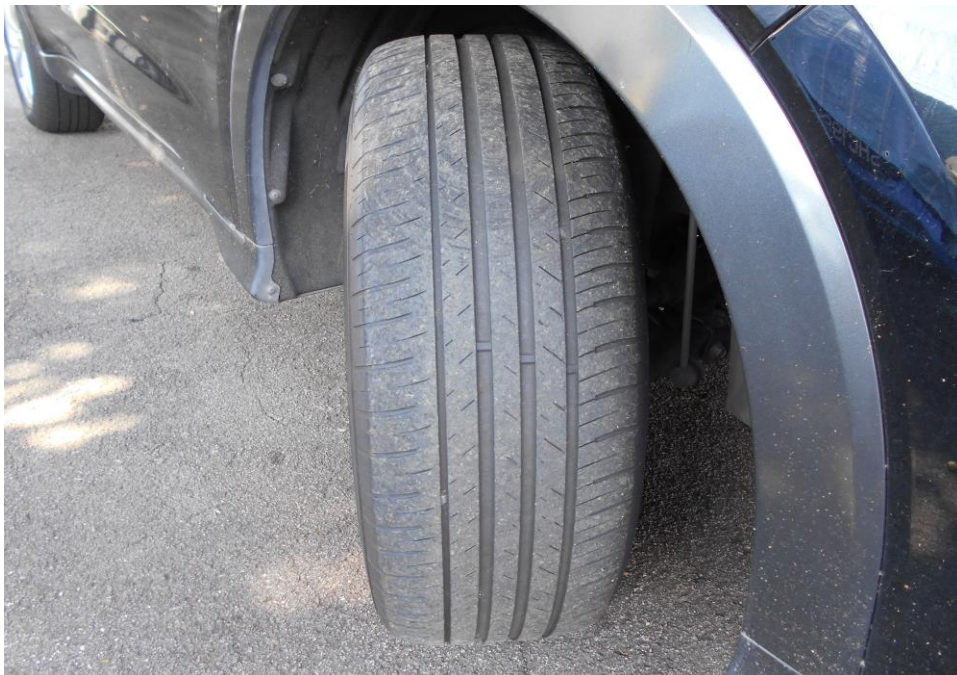
Photo 9 shows the condition of the front right tyre of the Motor Car, which was observed to be in serviceable condition with remaining tread depth of approximately 4mm. The tyre was also observed to be sufficiently inflated for vehicular operation.

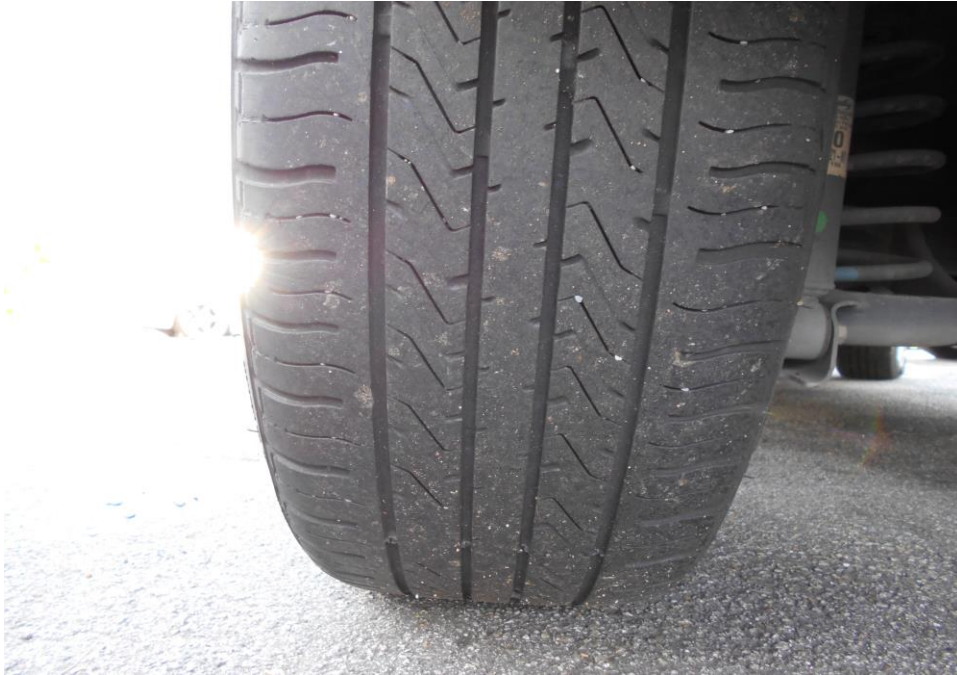
Photo 10 shows the condition of the rear left tyre of the Motor Car, which was observed to be in serviceable condition with remaining tread depth of approximately 7mm. The tyre was also observed to be sufficiently inflated for vehicular operation.

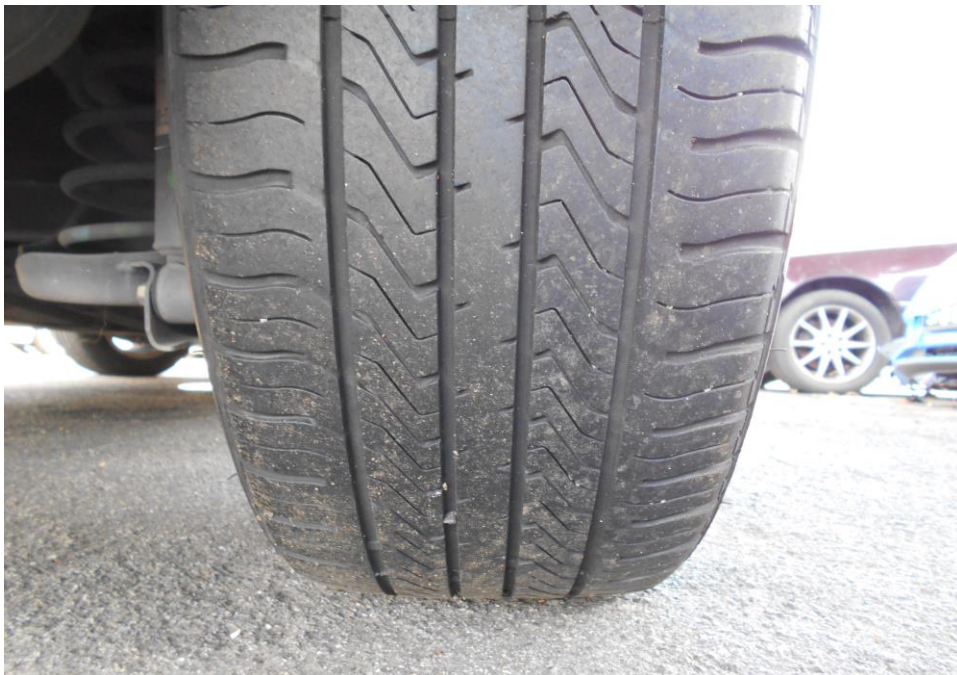
Photo 11 shows the condition of the rear right tyre of the Motor Car, which was observed to be in serviceable condition with remaining tread depth of approximately 7mm.

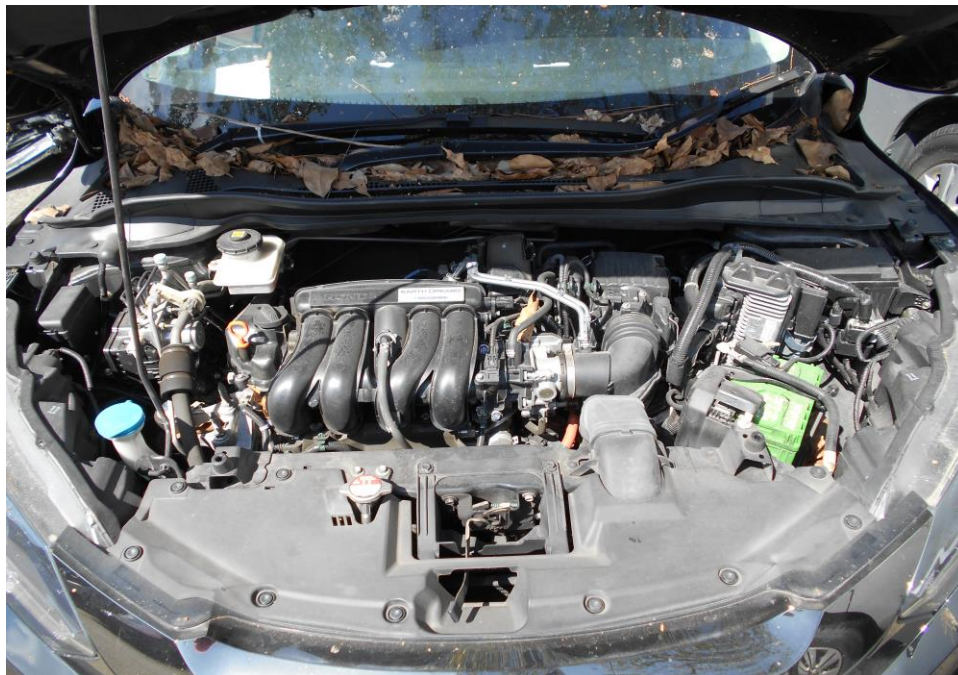
9. Upon examination of the engine compartment of the Motor Car, we had observed all the parts and components inside the engine compartment to be intact and unaffected by the accident. The brake fluid, engine oil and engine coolant were all found to be of sufficient level for operating purposes. Visually, there was also no contamination found to these fluids.
10. Further examination of the engine compartment revealed no sign(s) or indication(s) of fluid leakage and/or fluid stain within the engine compartment of the Motor Car.
11. Our subsequent checks on the underside of the Motor Car also revealed no fluid stain. Visually, the various undercarriage components of the Motor Car were all observed to be intact and without any visible damage. See photo 12 – 15 below.

Photo 12 shows a general view of the Motor Car's engine compartment. The various parts and components inside the engine compartment were unaffected by the accident. There was also no sign(s) or indication(s) of fluid leakage and/or fluid stain within the engine compartment.

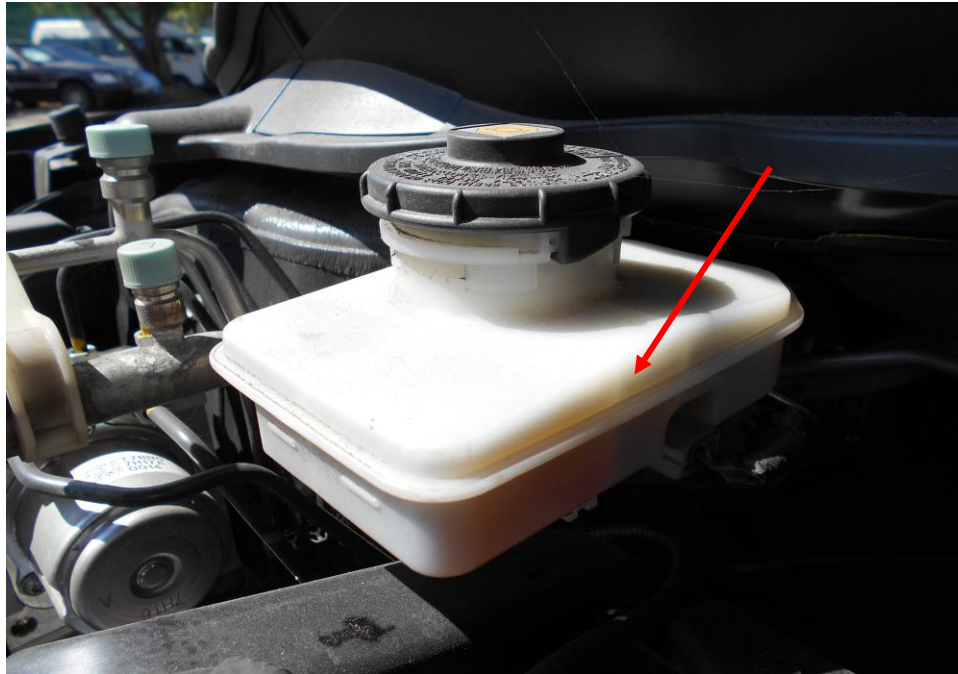
Photo 13 shows the brake fluid reservoir of the Motor Car at the time of our inspection. The brake fluid was observed to be of sufficient level (arrowed) and without any visible contamination.

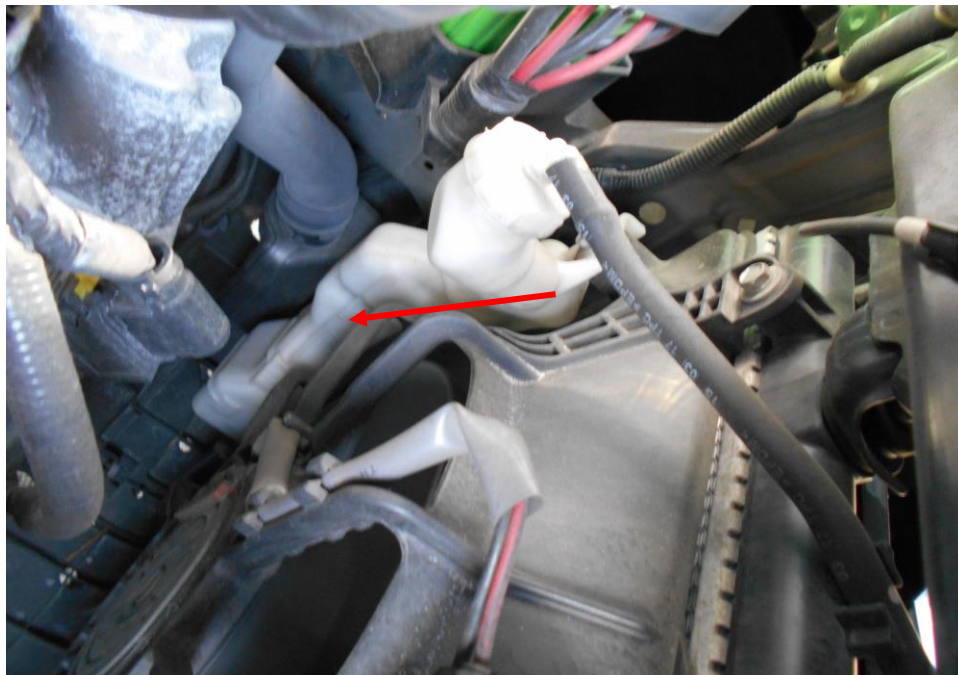
Photo 14 shows the coolant fluid reservoir of the Motor Car at the time of our inspection. The coolant fluid was observed to be of sufficient level and without any visible contamination.

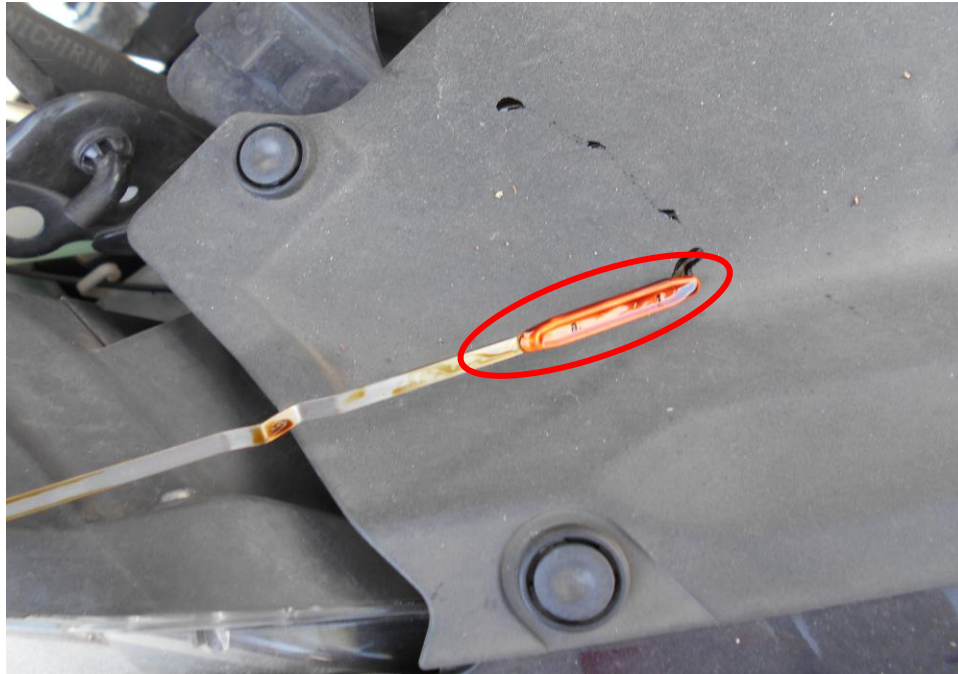
Photo 15 shows the engine oil dip stick of the Motor Car at the time of our inspection. The engine oil was observed to be of sufficient level and without any visible contamination.

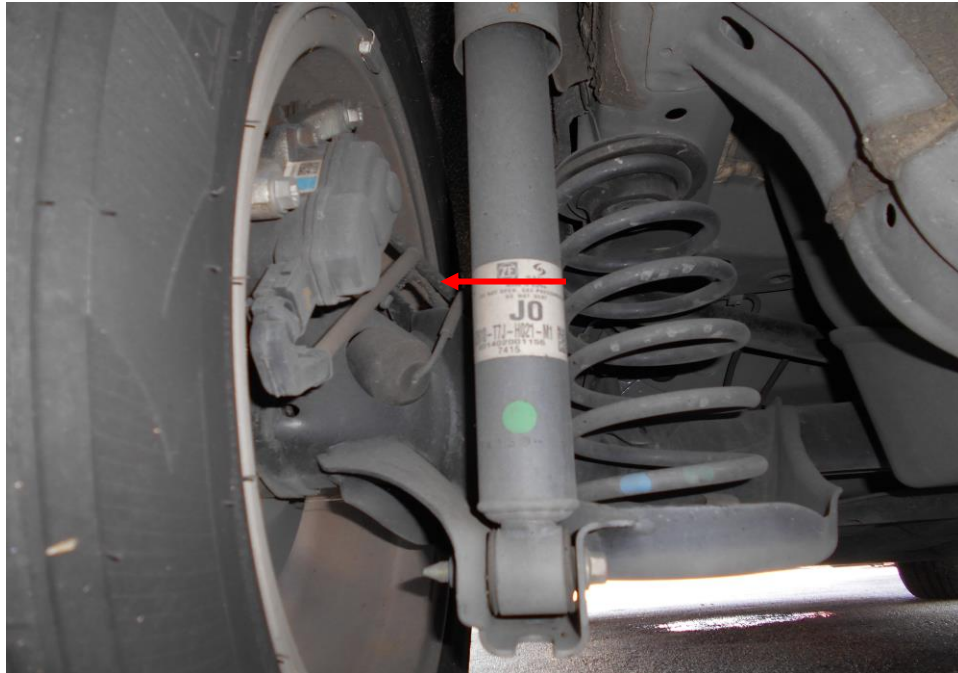
12. The mechanical components of the Motor Car's steering system and braking system were all found to be visually intact and undamaged. Our visual examination of the various steering components, which had included the rack and pinion, tie rods, tie rod ends and ball joints, revealed that these components were all generally in good condition. Components of the braking system like the brake master pump, brake booster, brake callipers and brake hoses amongst others were also found to be without any damage upon our visual inspection.

Photo 16 shows the brake hose (arrowed) at the rear left wheel of the Motor Car. Our visual inspection of the various mechanical components of the Motor Car's braking system revealed all to be intact and without visible damage, indicating that the braking system was likely to be in serviceable condition at the material time of accident.

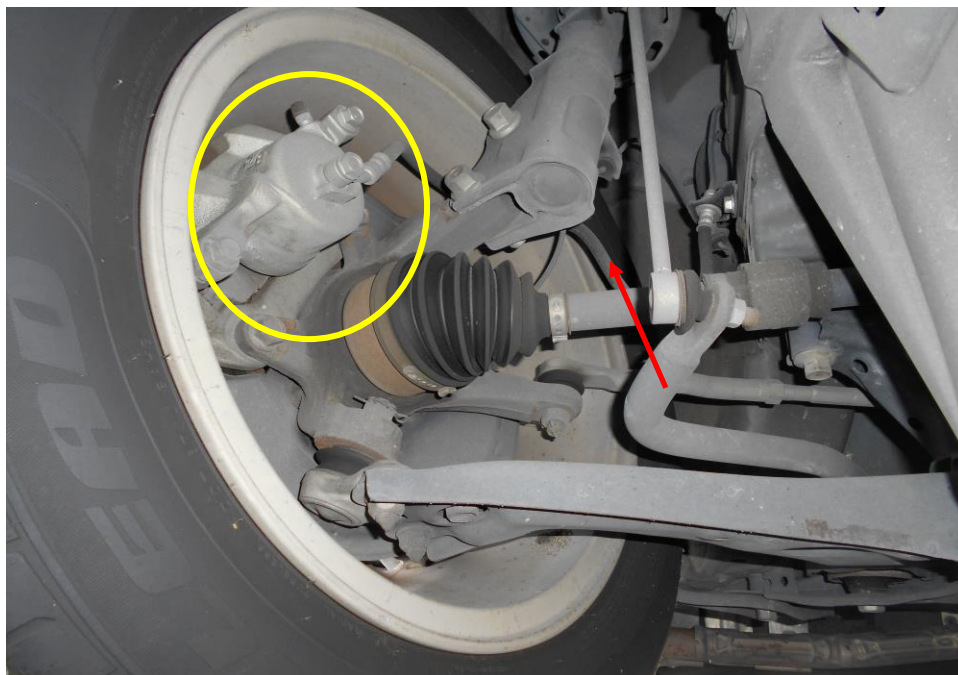
Photo 17 shows the brake hose (arrowed) at the front right wheel of the Motor Car. Our visual inspection of the various mechanical components of the Motor Car's braking system, including its brake calliper (circled), revealed all to be intact and without visible damage, indicating that the braking system was likely to be in serviceable condition at the material time of accident.

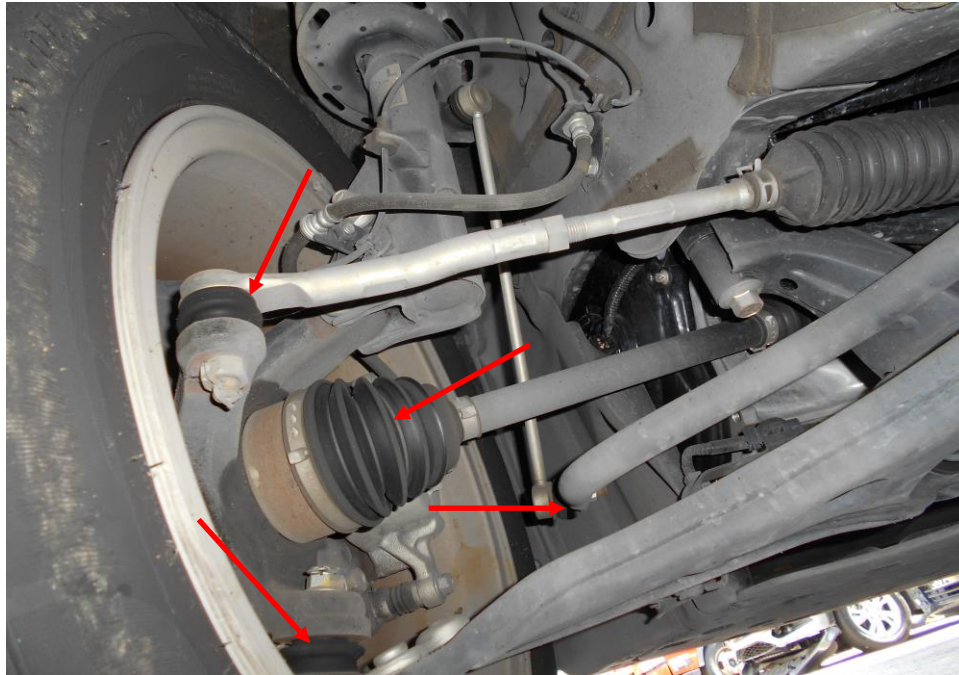
13. Static test on the steering system of the Motor Car also revealed no abnormality to the steering system. We did not experience any abnormal free play and/or other resistance when turning the steering wheel left and right to full lock positions. Our visual examination of the various steering components which had included the steering rack and pinion, tie rods, tie rod ends and ball joints revealed that these components were all generally in good condition. See photo 16 - 19 below.

Photo 18 shows the various undercarriage components at the front left wheel of the Motor Car, in particular the steering tie rod (arrowed). The various steering components were all found to be intact, suggesting that the steering system of the Motor Car was likely to be in serviceable condition.

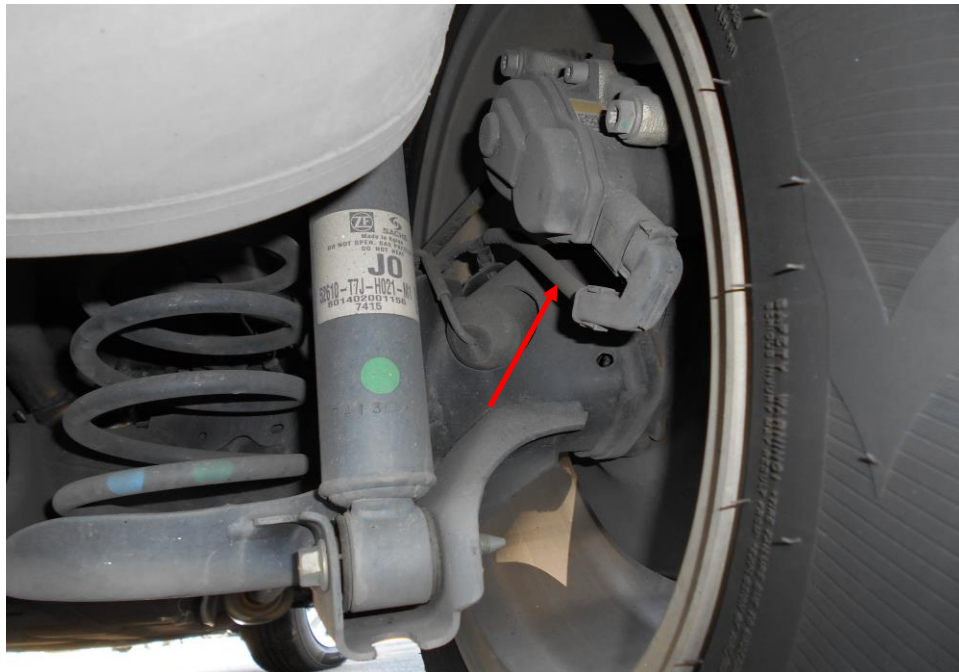
Photo 19 shows the various undercarriage components at the rear right wheel of the Motor Car. We did not observe any leakage of brake fluid at the time of our inspection of the Motor Car. Our visual inspection of the various mechanical components of the Motor Car's braking system revealed all to be intact and without visible damage, indicating that the braking system was likely to be in serviceable condition at the material time of accident.

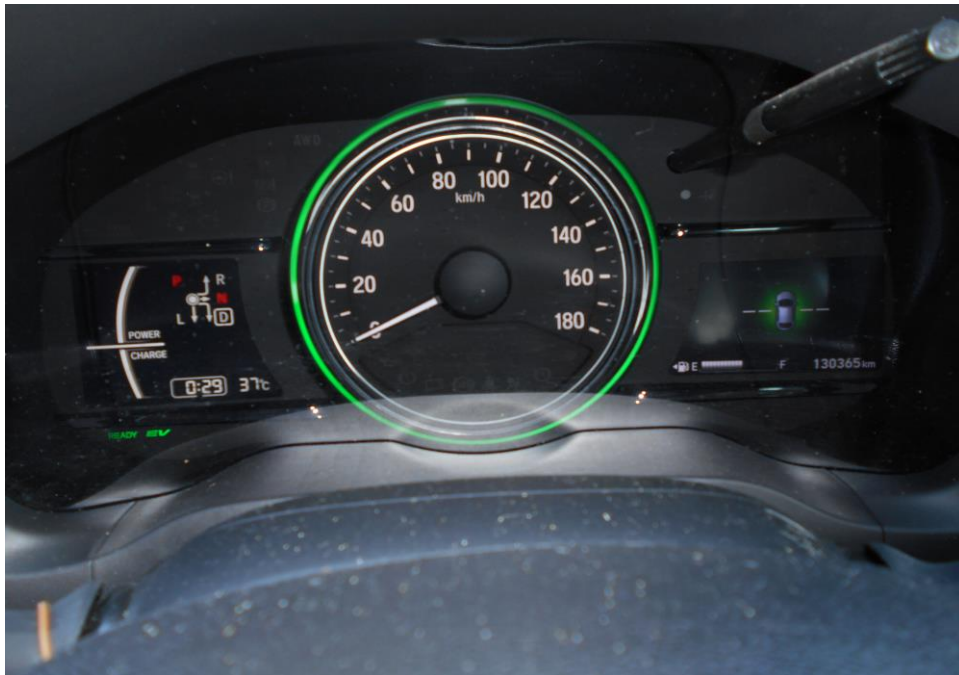
14. The Motor Car's automatic self-test of the functionality of its various electronic operating systems like the Anti-Brake Lock System (ABS) and Supplemental Restraint System (SRS) during cranking of the engine had indicated that these systems were in working condition and without abnormality. This can be established from the warning lights disappearing from the instrument panel after the self-test. See photo 20 below.

Photo 20 shows no warning lights illuminated on the instrument panel of the Motor Car after the engine was cranked. This would suggest that there was no abnormality to the various electronic operating systems of the Motor Car, like the ABS and SRS.

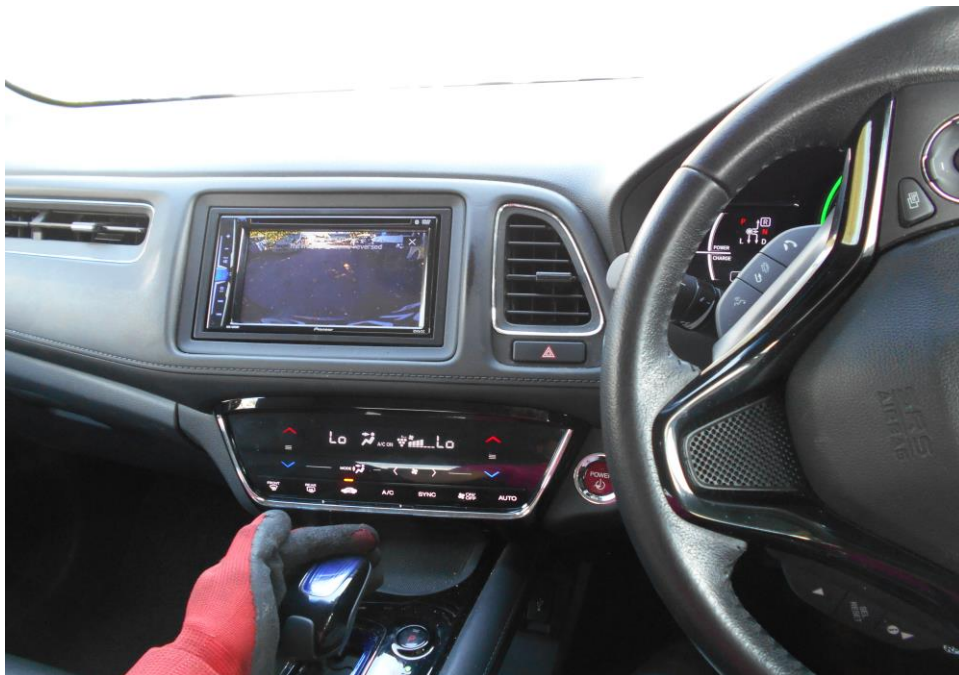
15. A short operational test of the Motor Car, to primarily determine whether there was any abnormality to its engine system, its transmission system and braking system was subsequently carried out.
16. During the operational test, the transmission system of the Motor Car was able to be shifted to drive mode and reverse mode without any difficulty. There were no abnormal sounds heard and/or abnormal behaviour of the Motor Car's engine system. It was able to move forward and backward normally. The braking system was also found to be in working condition as the Motor Car was able to slow down and come to a complete stop upon depressing of the brake pedal. See photo 21 & 22 below.

Photo 21 shows a short operational test of the Motor Car, to primarily determine whether there was any abnormality to its engine system, its transmission system and braking system was subsequently carried out.

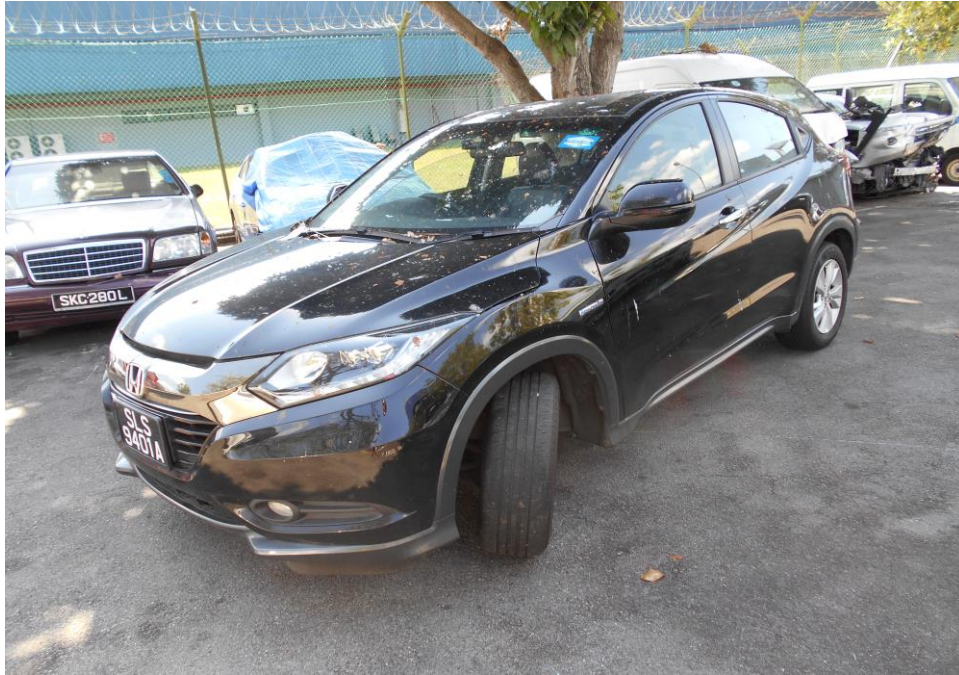
Photo 22 shows a short operational test of the Motor Car, to primarily determine whether there was any abnormality to its engine system, its transmission system and braking system was subsequently carried out.
