Your Ref: TP/IP/57061/2018
Our Ref : CI/TPD18019569/Z

12th February 2019

MECHANICAL INSPECTION REPORT OF MOTOR BUS PA 8420Z.

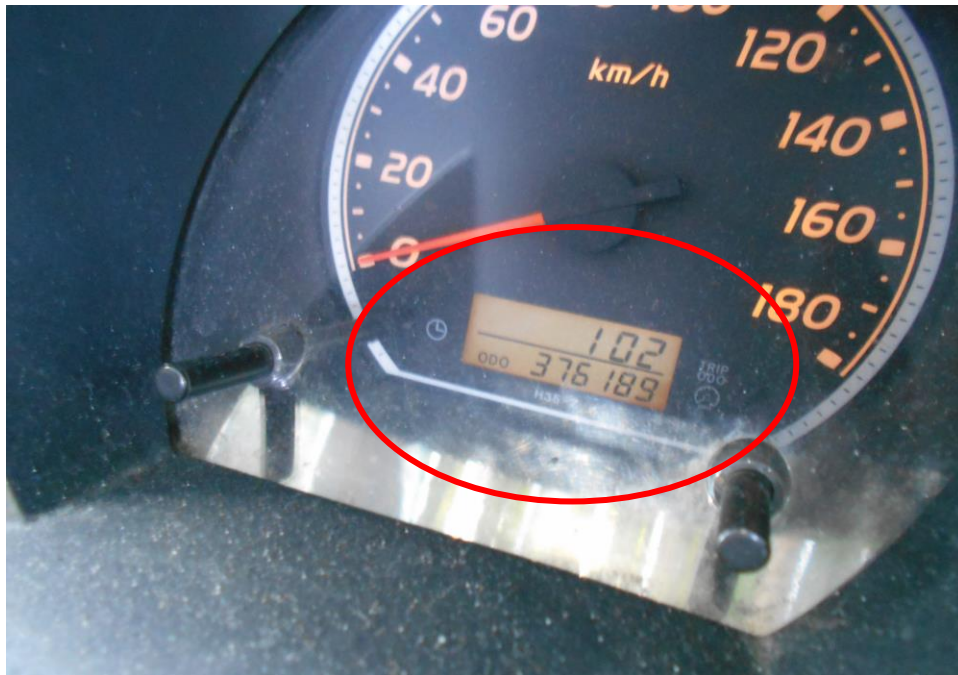
4. The mileage of the Motor Bus at the time of our inspection was 376189km.
5. The Motor Bus was observed to have sustained minor dent at its front left panel & a dislodged front grille amongst others likely due to the accident.
6. This was likely due to the consistency of the accident's case facts that the Motor Bus was travelling on lane 1 of a 2 lanes road along Bedok Reservoir Road towards Bedok North Avenue 3. While nearing Jalan Lembah Bedok, a pedestrian was seen walking across the road with a walking cane and subsequently was knocked down by the Motor Bus frontal left portion. See photo 1 to 7 below.

Photo 1 shows the mileage of the Motor Bus was 376189km.

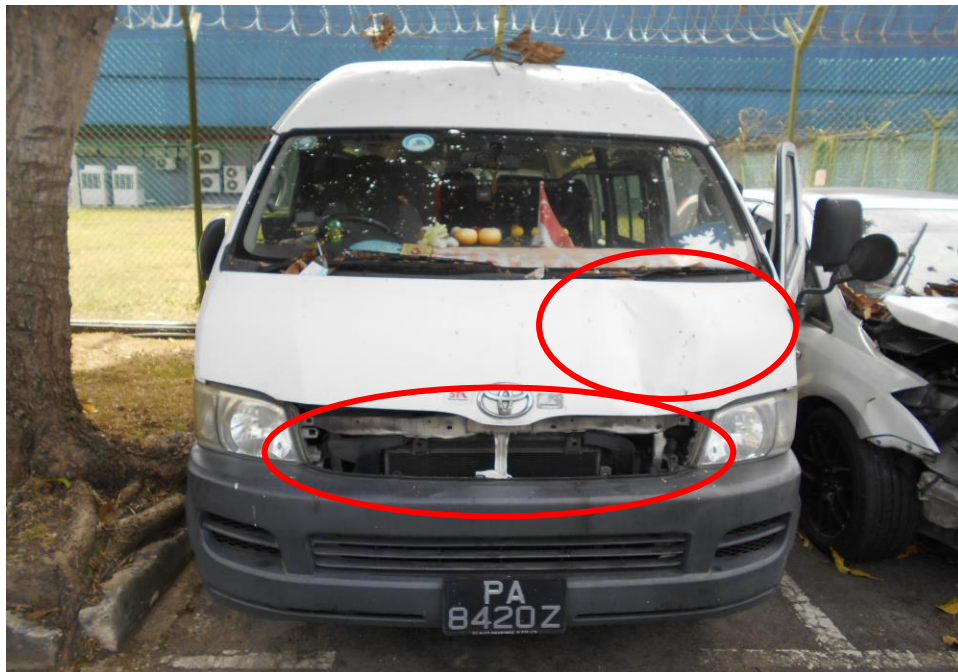
Photo 2 shows a general view of the front right body of the Motor Bus at the time of our inspection. The Motor Bus was observed to sustained minor damage at the front left panel & front grille.

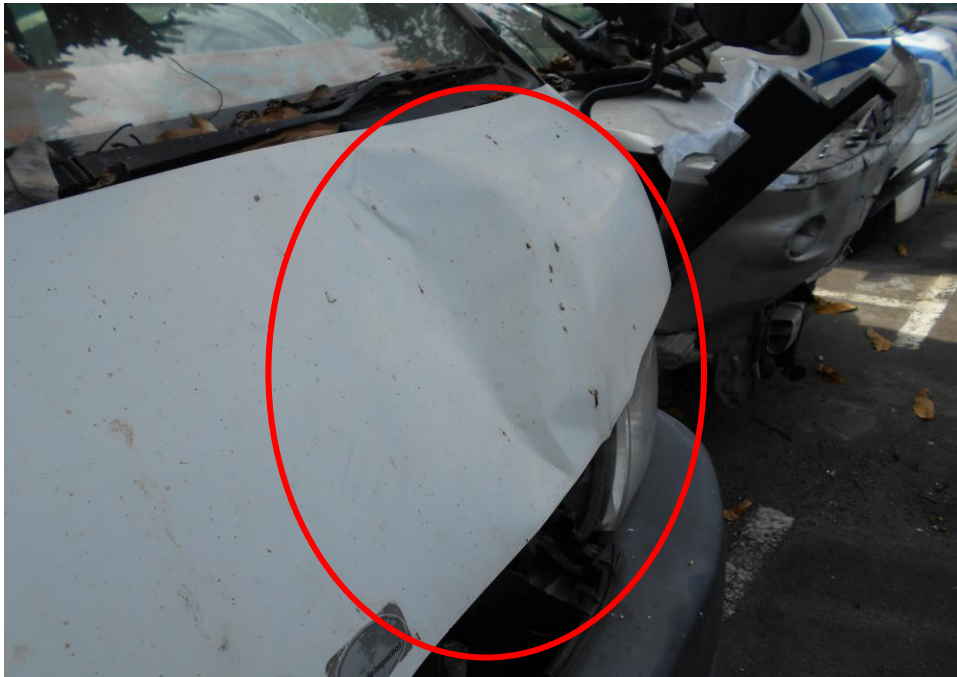
Photo 3 shows a close-up view of the dent on the front left panel of the Motor Bus at the time of our inspection. It was observed to have sustained with minor damage likely due to the accident.

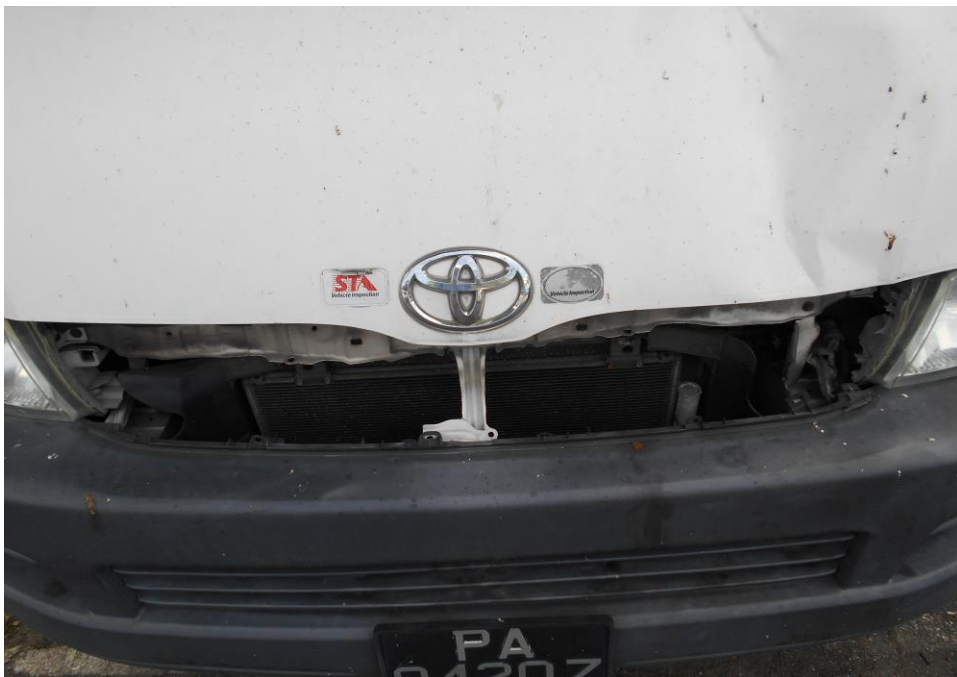
Photo 4 shows a close-up view of the dislodged front grille of the Motor Bus at the time of our inspection. It was observed to have sustained with minor damage likely due to the accident.

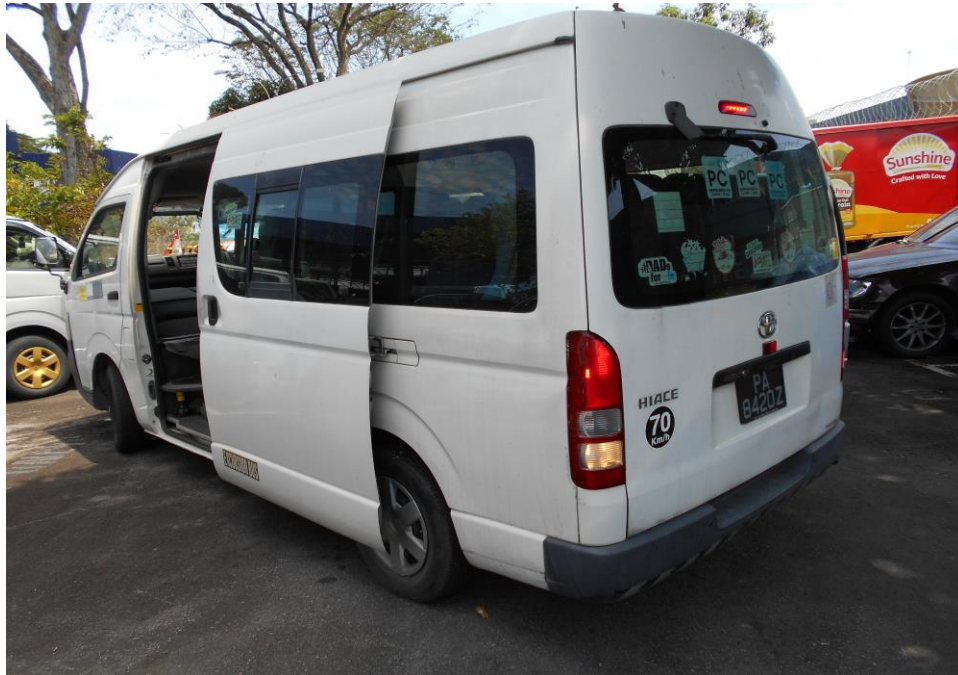
Photo 5 shows a general view of the rear left body of the Motor Bus at the time of our inspection. The Motor Bus was observed to be in good general condition at time of inspection.

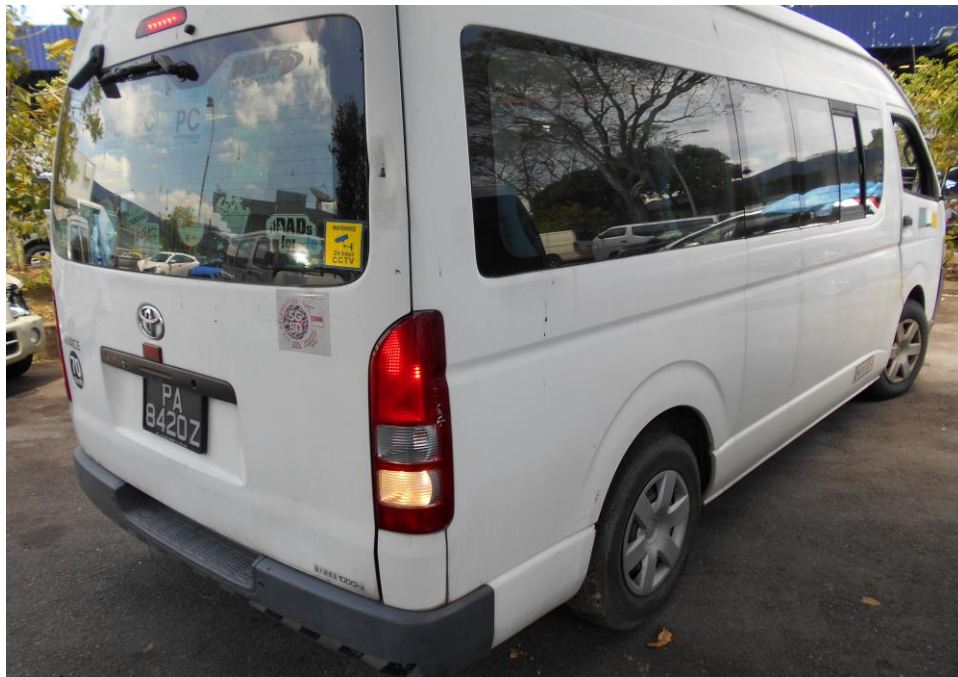
Photo 6 shows a general view of the rear right body of the Motor Bus at the time of our inspection. The Motor Bus was observed to be in good general condition at time of inspection.

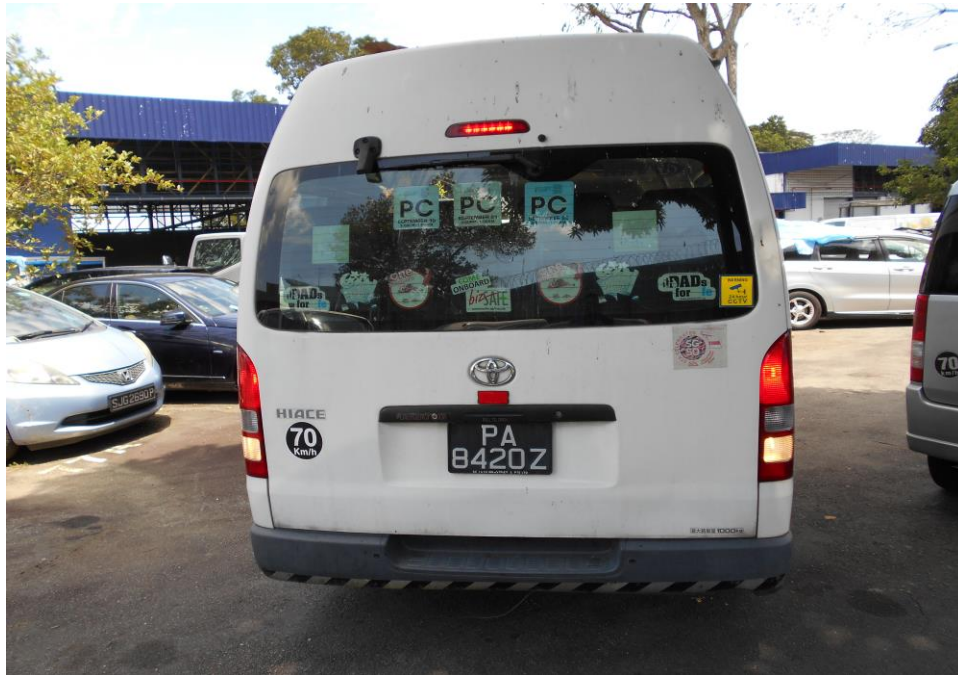
Photo 7 shows a general view of the rear body of the Motor Bus at the time of our inspection. The Motor Bus was observed to be in good general condition at time of inspection.

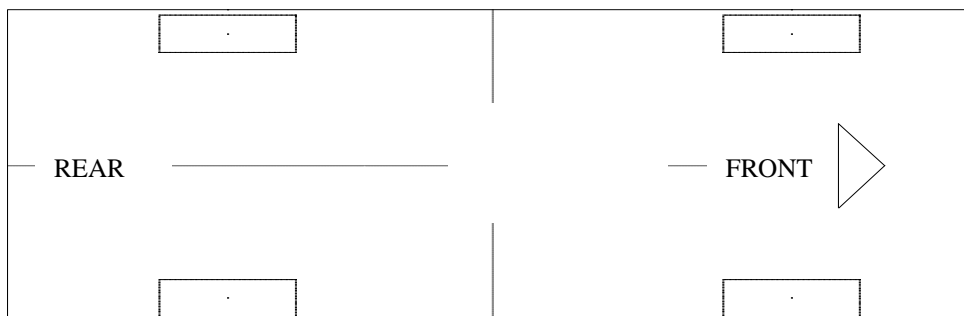
7. The 4 tyres were observed to be in serviceable condition and sufficiently inflated for vehicular operation. We did not find any tear, cut or burst mark(s) on the outer and the inner sidewalls as well as across the tread of the 4 tyres. The tyre brand, tyre size and remaining tread depth of the 4 tyres of the Motor Bus were recorded as follows:-

Bridgestone R623
195 R 15 C 8PR(5mm)

Bridgestone R623
195 R 15 C 8PR(7mm)

Bridgestone R623
195 R 15 C 8PR(3mm)

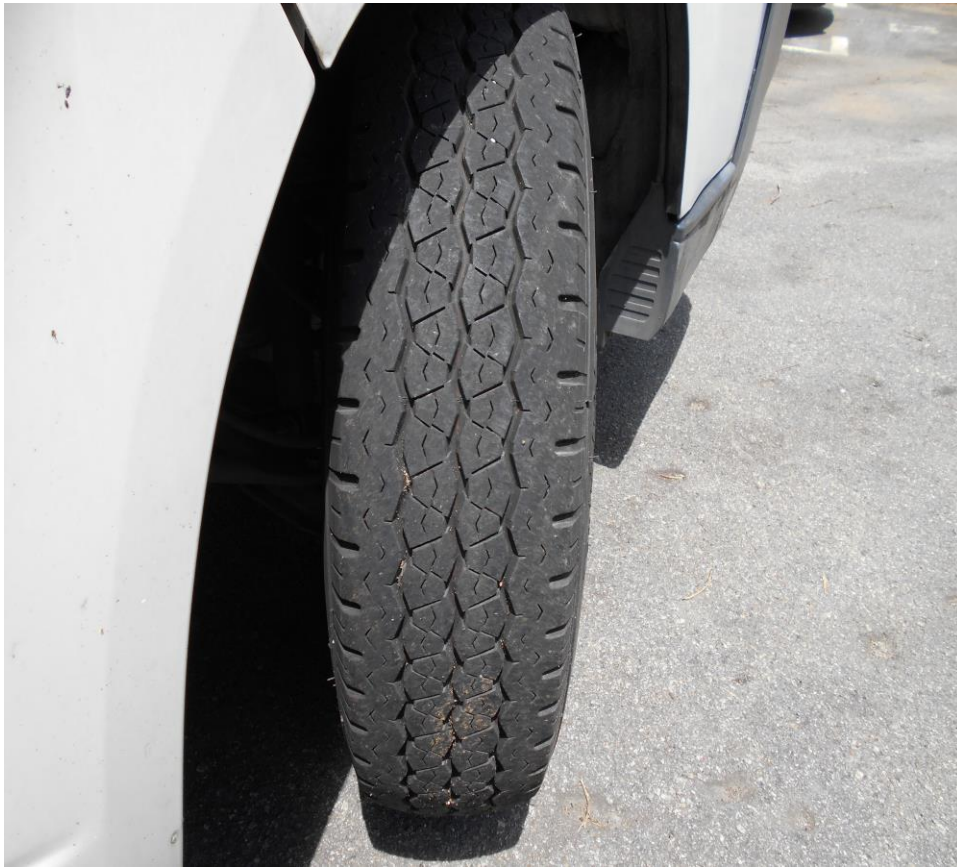
Photo 8 shows the condition of the front right tyre of the Motor Bus, which was observed to be in serviceable condition with remaining tread depth of approximately 8mm. The tyres were all observed to be sufficiently inflated for vehicular operation with no tear, cut or burst mark(s) on the outer and the inner sidewalls as well as across the tread.

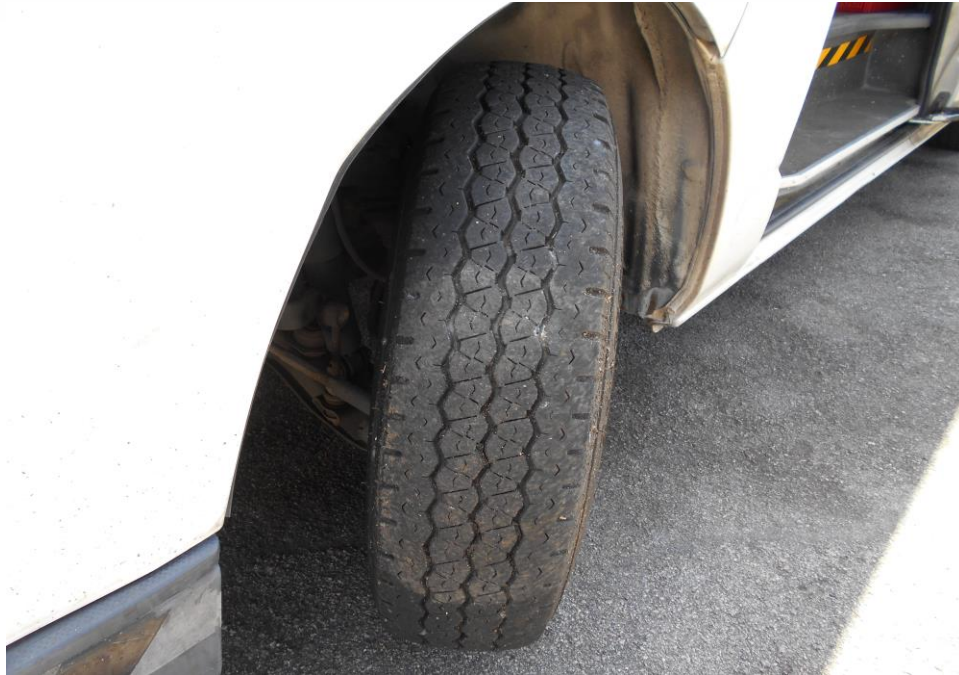
Photo 9 shows the condition of the front left tyre of the Motor Bus, which was observed to be in serviceable condition with remaining tread depth of approximately 7mm. The tyre, which was wrapped around standard wheel rim, was also observed to be sufficiently inflated for vehicular operation.

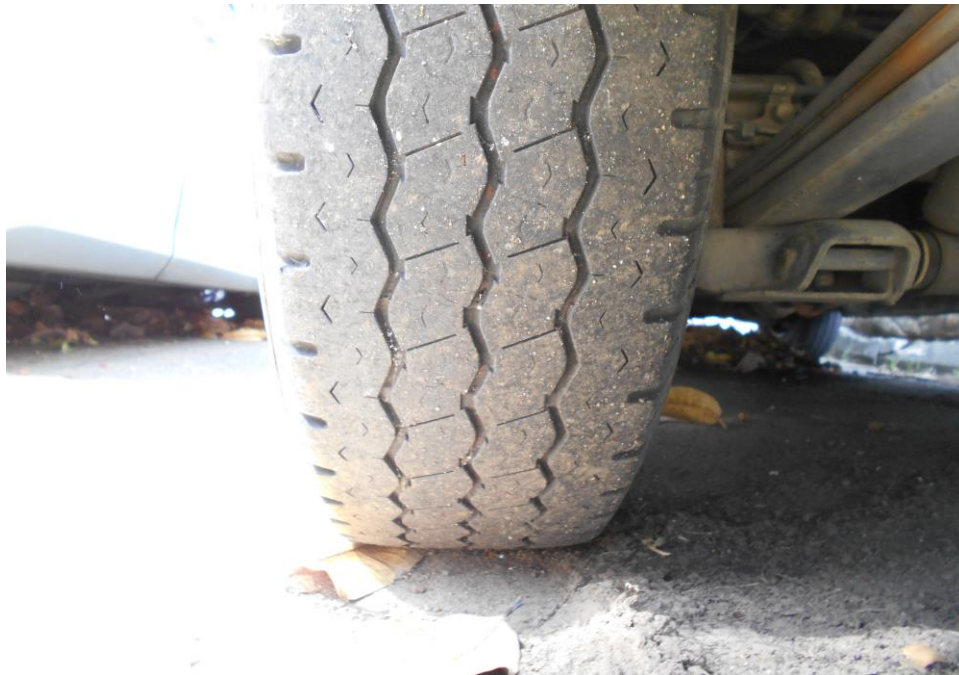
Photo 10 shows the condition of the rear left tyre of the Motor Bus, which was observed to be in serviceable condition with remaining tread depth of approximately 5mm. The tyre, which was wrapped around standard wheel rim, was also observed to be sufficiently inflated for vehicular operation. There was also no significant damage found on the 4 wheel rims of the Motor Bus.

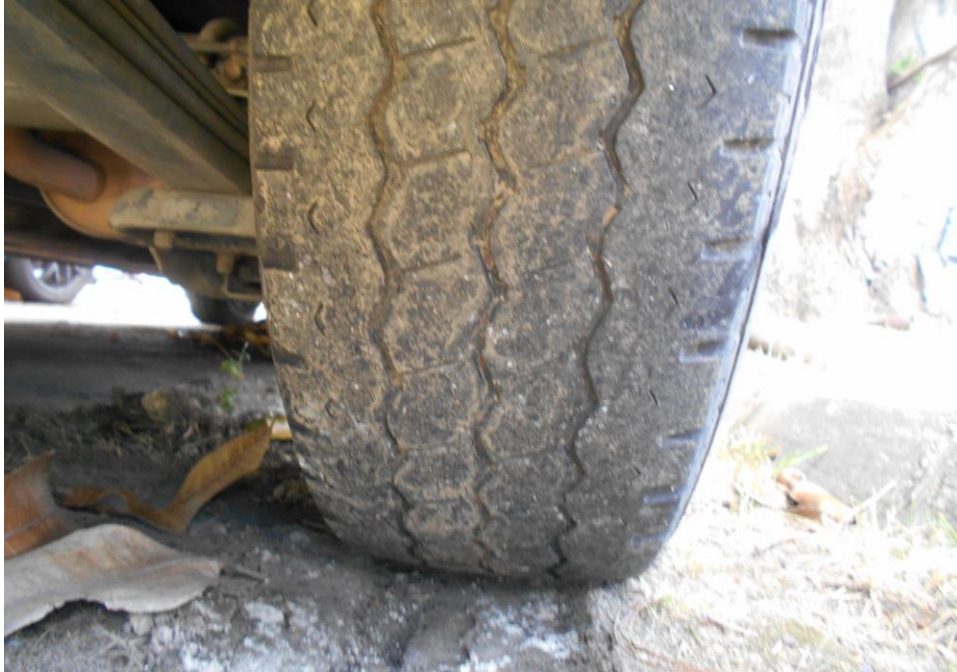
Photo 11 shows the condition of the rear right tyre of the Motor Bus, which was observed to be in serviceable condition with remaining tread depth of approximately 3mm. There was also no tear, cut or burst mark(s) on the outer and the inner sidewalls as well as across the tread of the tyre, which was also sufficiently inflated for vehicular operation.

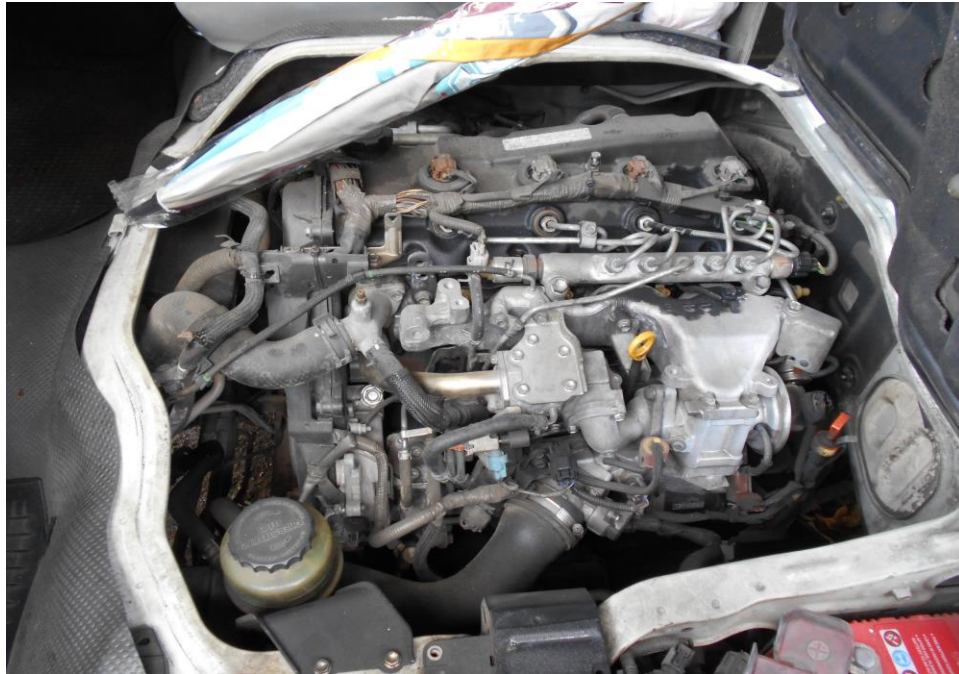
Photo 12 shows a general view of the Motor Bus's engine compartment. The various parts and components inside the engine compartment were unaffected by the accident. There was also no sign(s) or indication(s) of fluid leakage and/or fluid stain within the engine compartment.

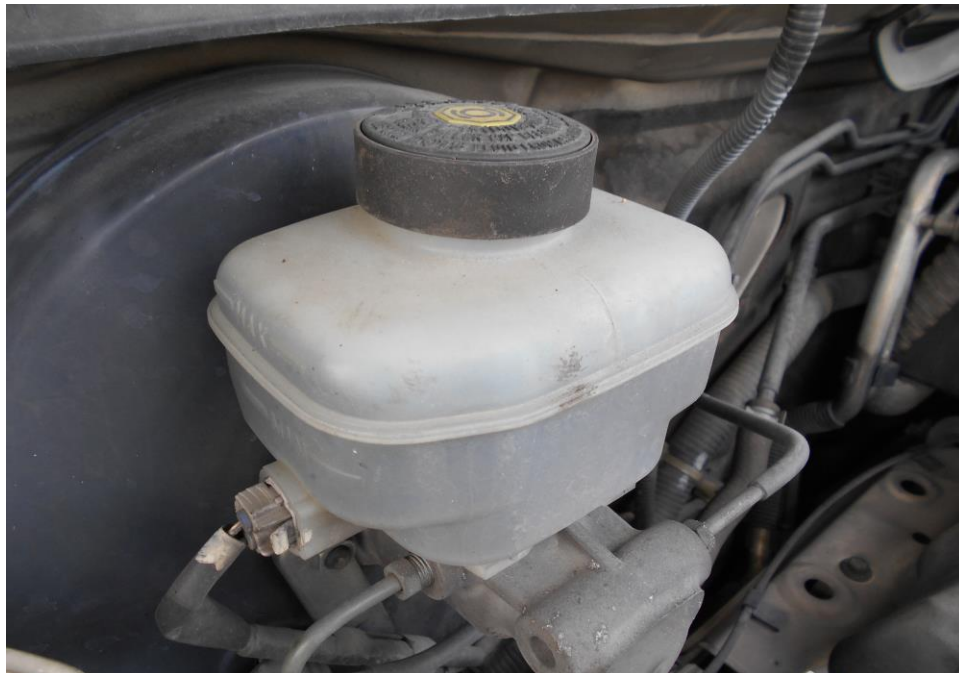
Photo 13 shows the brake fluid reservoir of the Motor Bus at the time of our inspection. The brake fluid was observed to be of sufficient level and without any visible contamination.

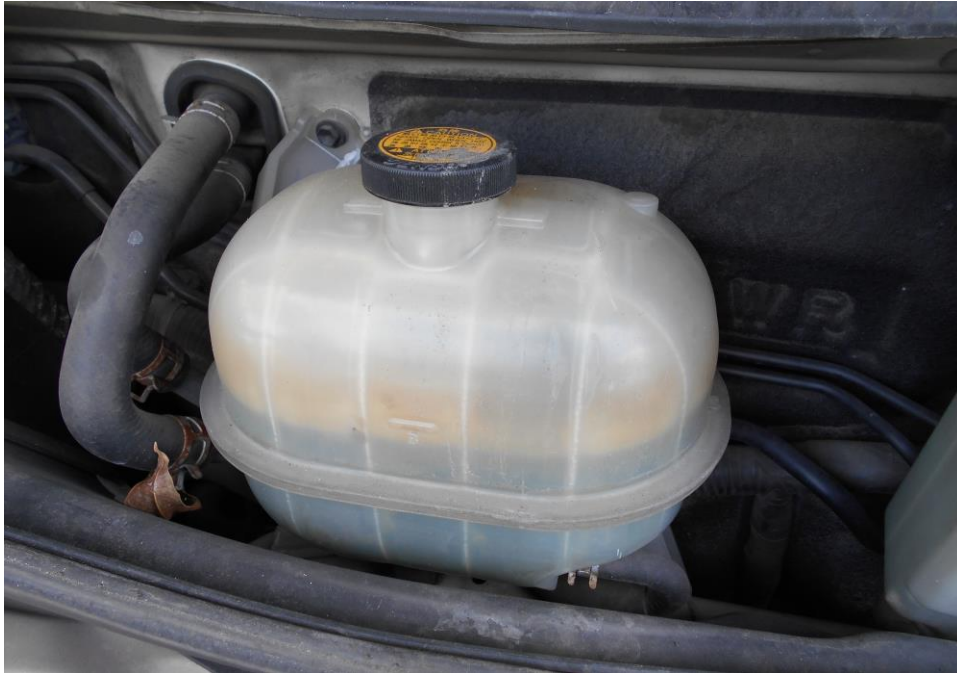
Photo 14 shows the engine coolant reservoir of the Motor Bus at the time of our inspection. The engine coolant was observed to be of sufficient level and without any visible contamination.

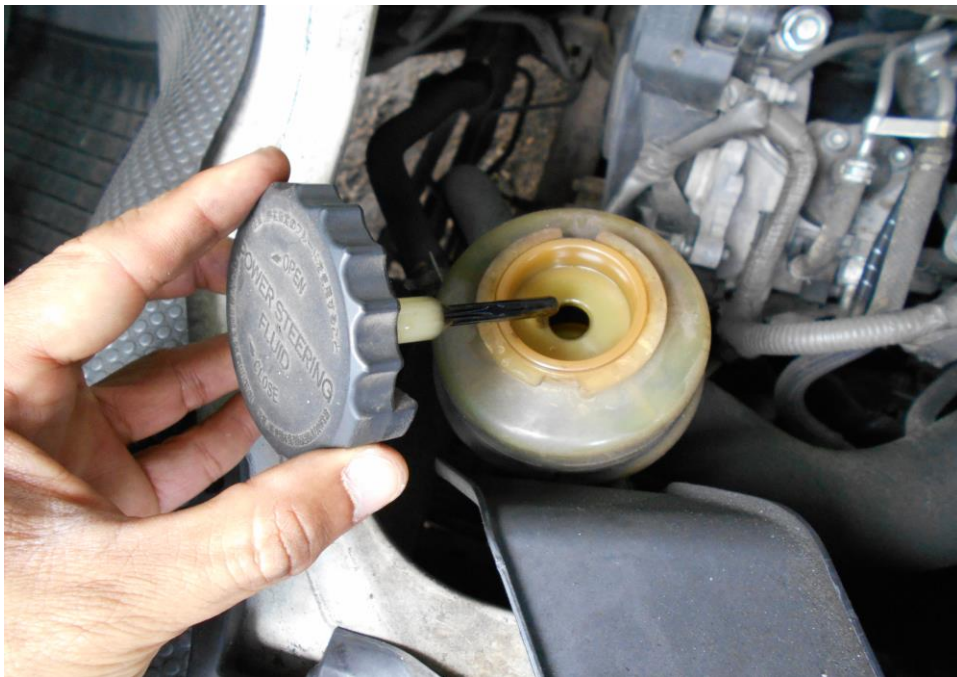
Photo 15 shows the power steering reservoir of the Motor Bus at the time of our inspection. It was observed to be of sufficient level and without any visible contamination.

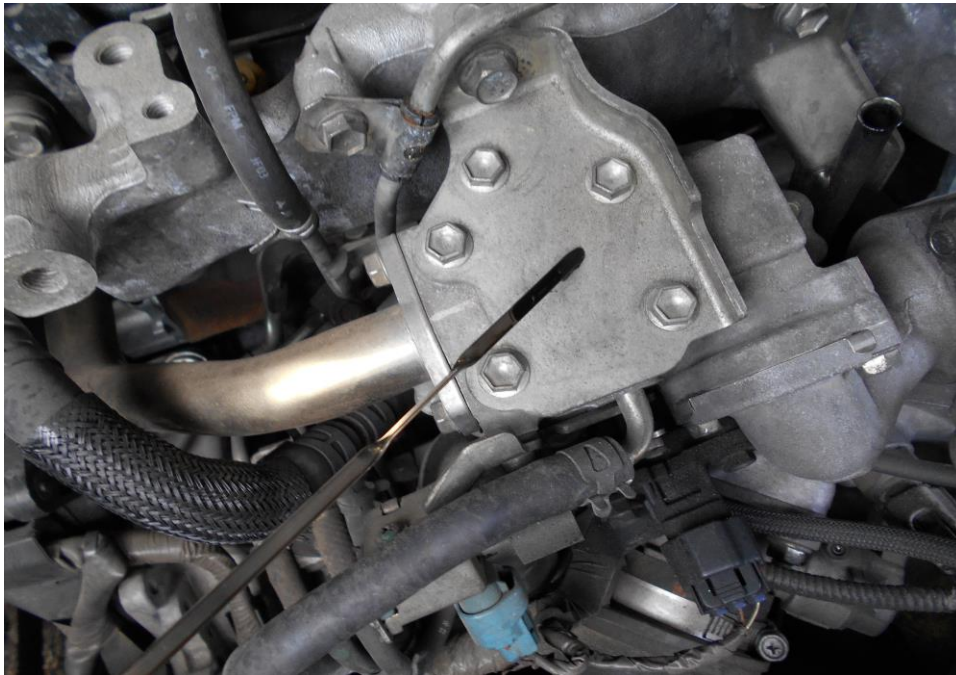
Photo 16 shows the engine dip stick of the Motor Bus at the time of our inspection. The engine oil was observed to be of sufficient level and without any visible contamination.

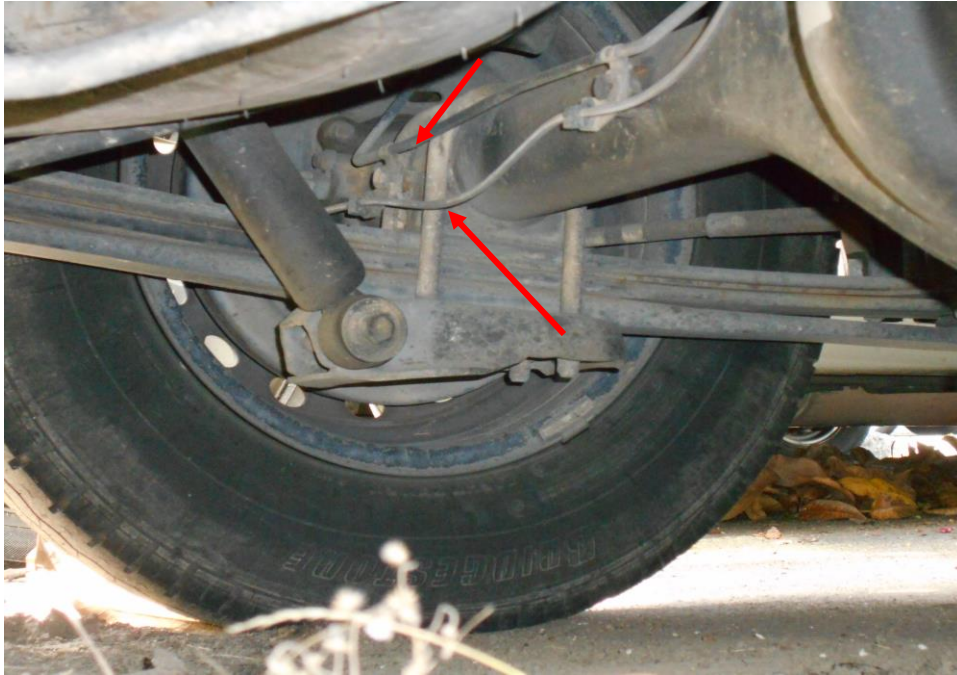
Photo 17 shows the various undercarriage components at the rear left wheel of the Motor Bus, in particular the brake hose (arrowed). We did not observe any leakage of brake fluid at the time of our inspection of the Motor Bus.

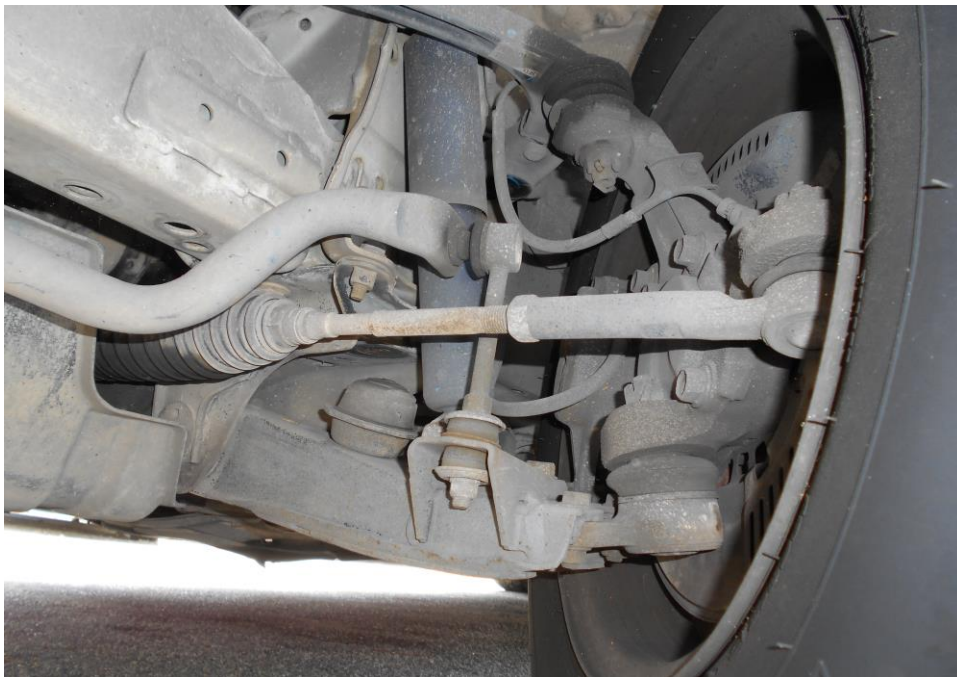
Photo 18 shows the brake hose at the front left wheel of the Motor Bus. We did not observe any leakage of brake fluid. Our visual inspection of the various mechanical components of the Motor Bus's braking system revealed all to be intact and without visible damage, indicating that the braking system was likely to be in serviceable condition at the material time of accident.

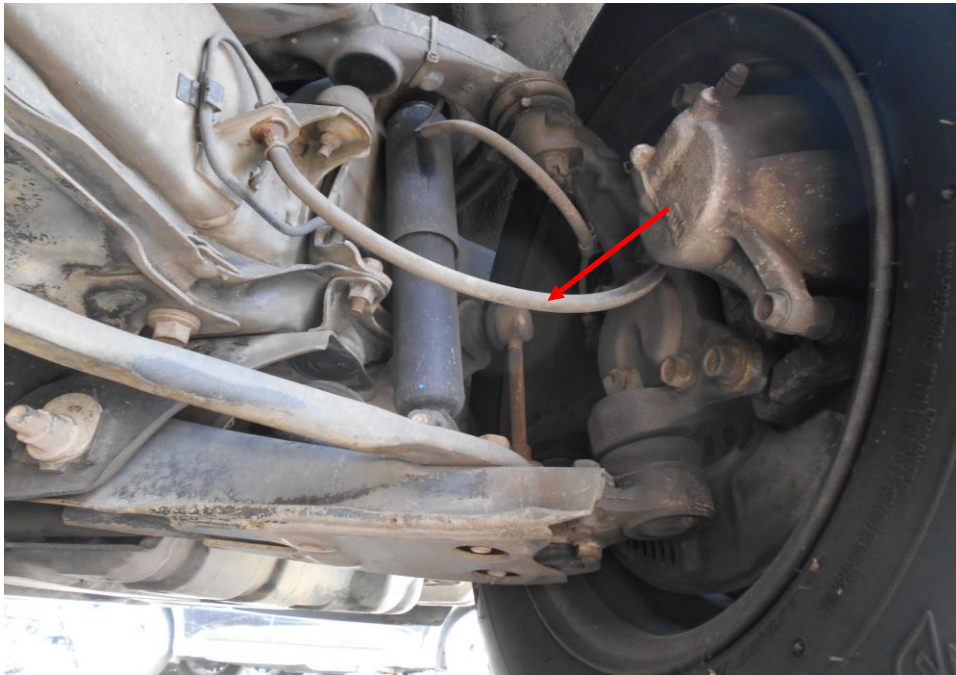
Photo 19 shows the brake hose (arrowed) at the front right wheel of the Motor Bus. We did not observed any leakage of brake fluid at the time of our inspection of the Motor Bus. Our visual inspection of the various mechanical components of the Motor Van's braking system, including its brake calliper, revealed all to be intact and without visible damage.

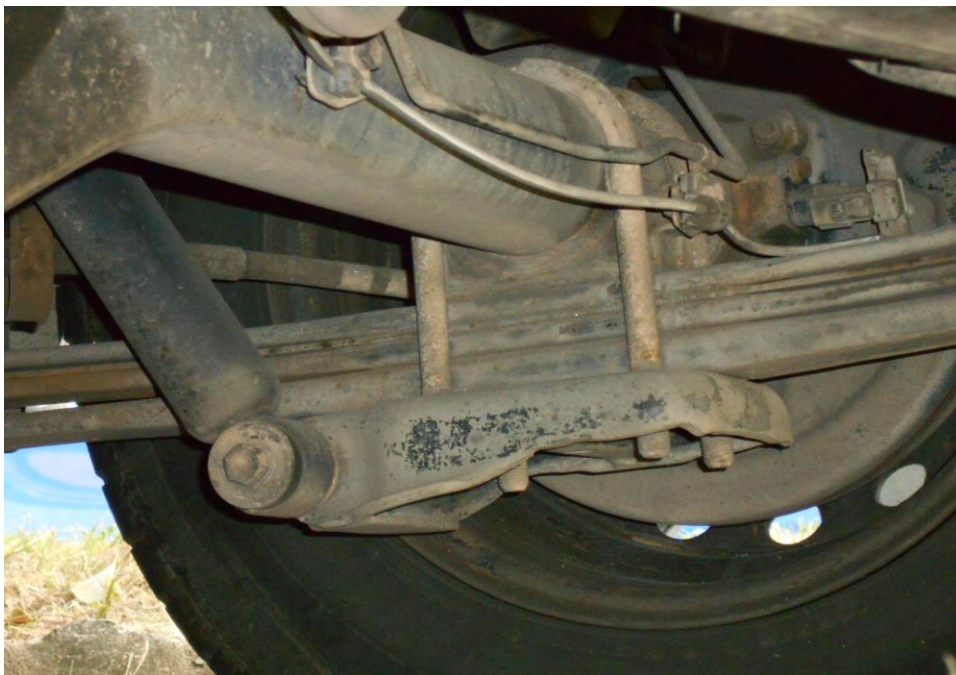
Photo 20 shows the various undercarriage components at the rear right wheel of the Motor Bus. The various steering components were all found to be intact, suggesting that the steering system of the Motor Bus was likely to be in serviceable condition at the material time of accident. There was also no sign of fluid stain(s) observed on the various undercarriage components at the 4 wheels of the Motor Van.

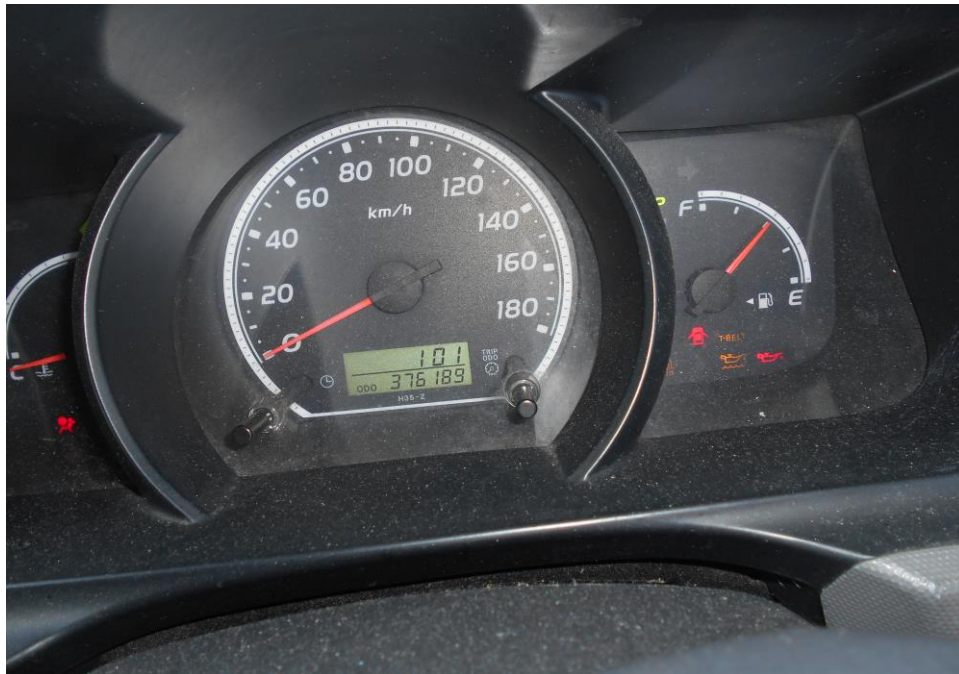
Photo 21 shows the warning lights for the various electronic operating systems of the Motor Bus appearing on its instrument panel during the self-test when the engine was cranked.

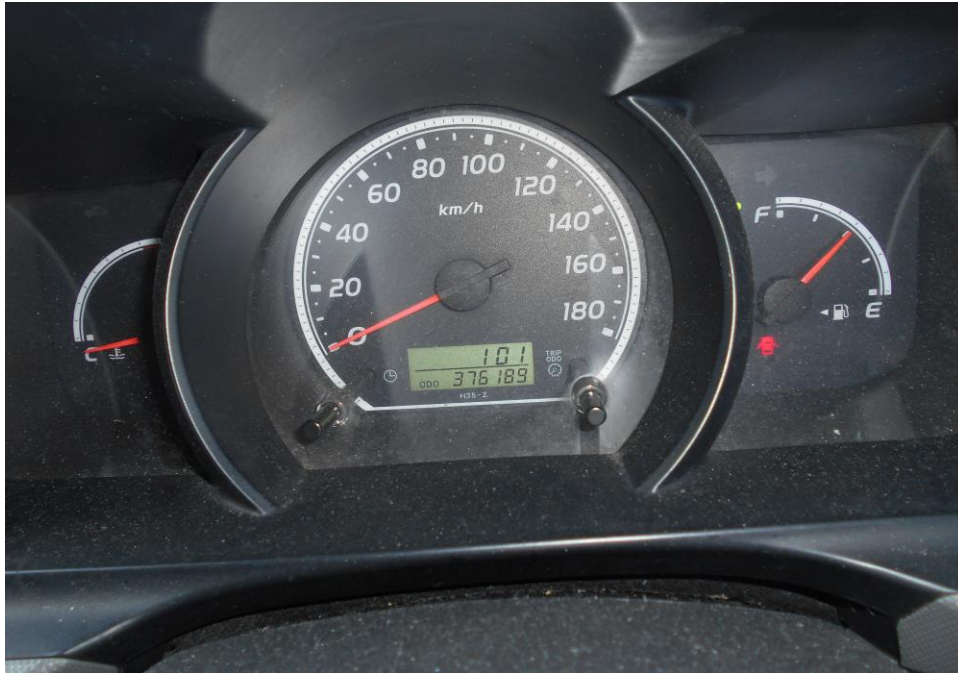
Photo 22 shows no warning lights illuminated on the instrument panel of the Motor Bus after the engine was cranked. This would suggest that there was no abnormality to the various electronic operating systems of the Motor Car.

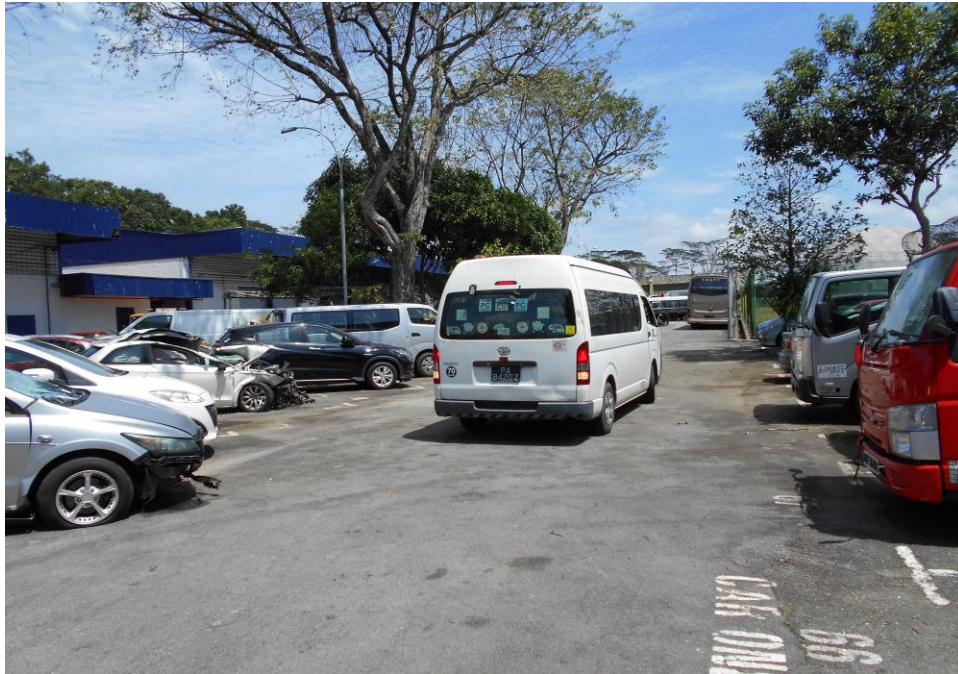
Photo 23 shows a short operational test of the Motor Bus, the test was conducted by driving the Motor Bus forward, stopping, before reversing and coming to a stop again.
