Your Ref: TP/IP/55045/2018  
Our Ref : CI/TPD18019581/Z

08<sup>th</sup> November 2018

**General Investigation Team D**  
Traffic Police Department  
Singapore Police Force  
10 Ubi Avenue 3  
Singapore 408865

### **MECHANICAL INSPECTION REPORT OF MOTOR CAR SLR 4083Y**

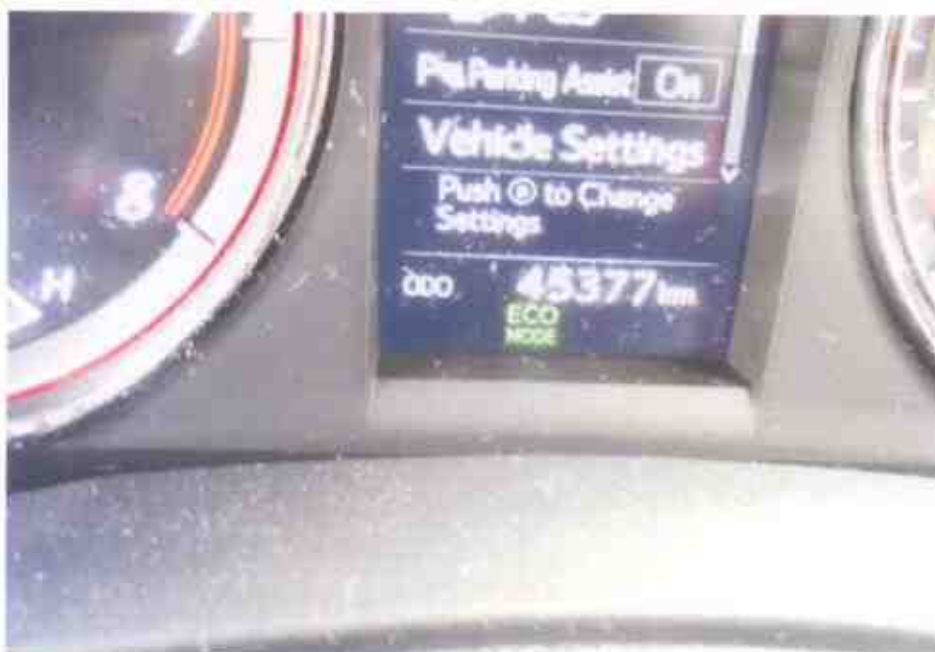
Photo 1 shows the mileage of the Motor Car was 45377 km.

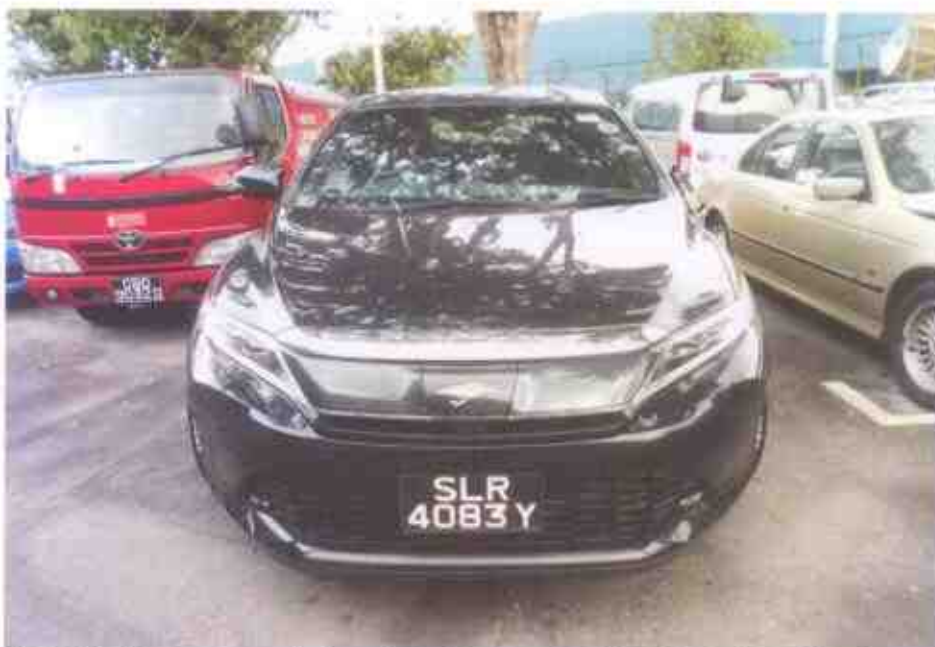
Photo 2 shows a general view of the front body of the Motor Car at the time of our inspection. The Motor Car was observed to be in good condition unaffected by the accident's collision.

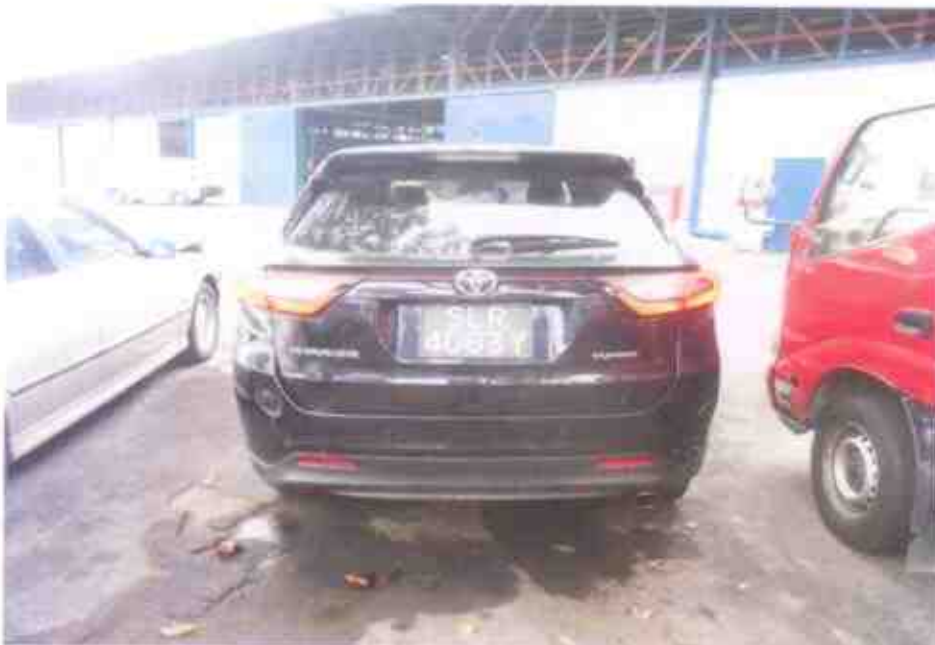
**Photo 3** shows a general view of the rear body of the Motor Car at the time of our inspection. The Motor Car was observed to be in good condition unaffected by the accident's collision.

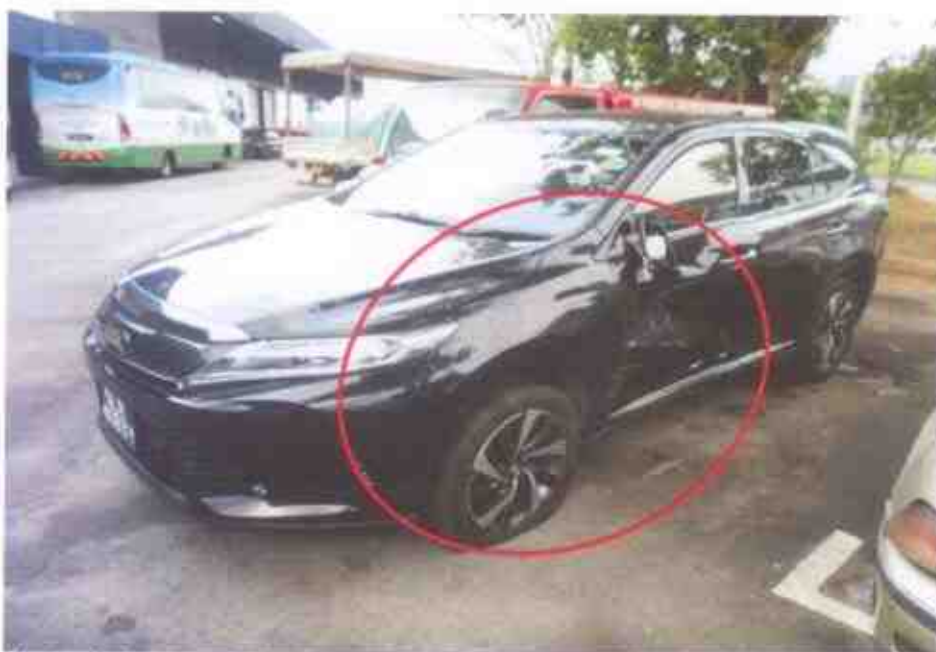
**Photo 4** shows a semi close up view of the front left portion of the Motor Car at the time of our inspection. The Motor Car had sustained relatively minor impact at the front left of the Motor Car including the tyre that was observed to be deflated as a result of the accident.

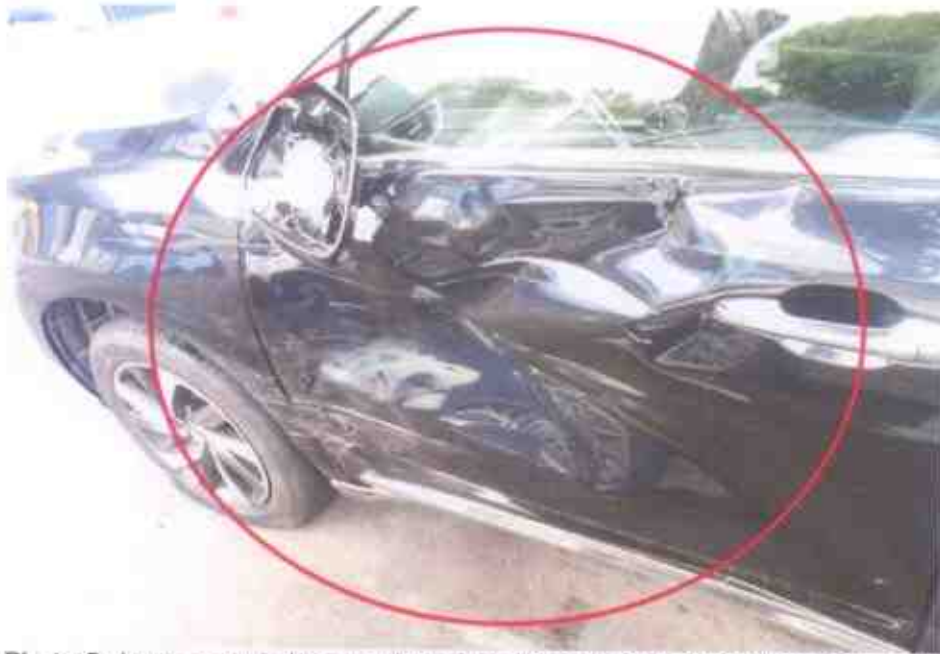
**Photo 5** shows a semi-close up view of the left front door of the Motor Car at the time of our inspection. It was observed to have sustained with damages consistent to the accident's case fact.

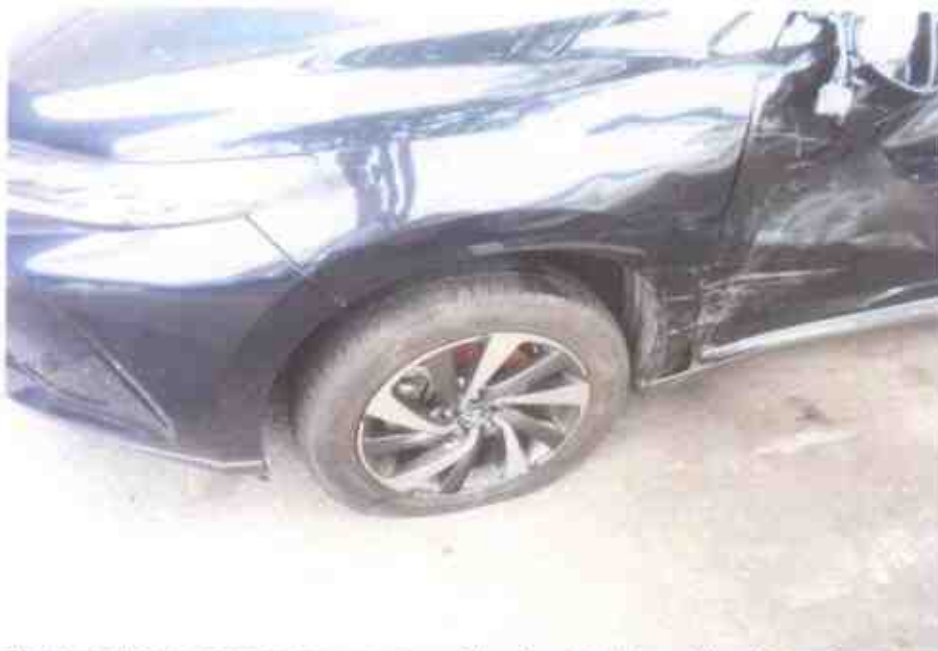
**Photo 6** shows a semi-close up view of the front left tyre of the Motor Car at the time of our inspection. It was observed to be deflated as a result of the accident.

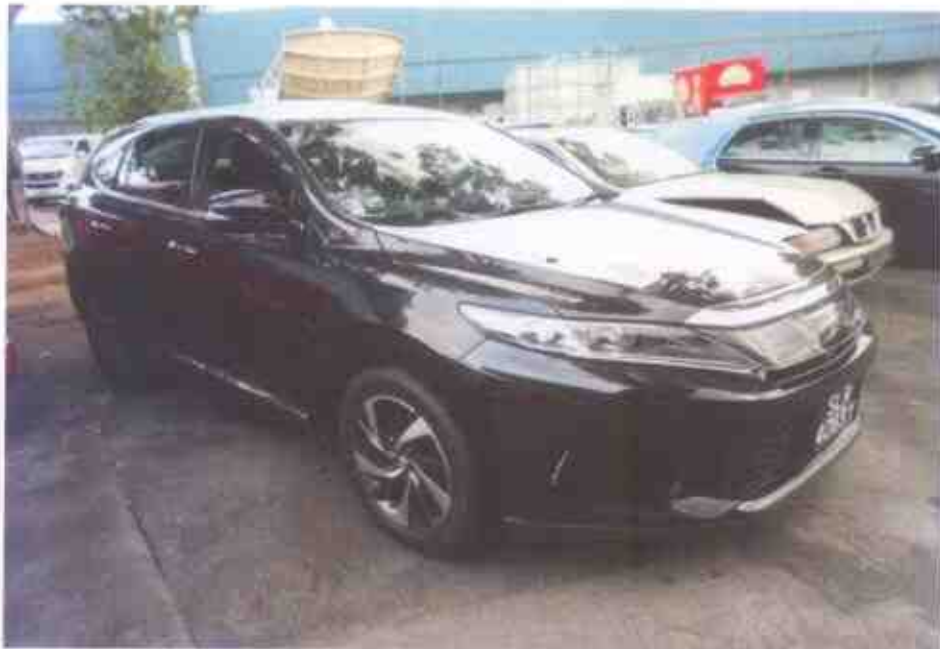
**Photo 7** shows a general view of the front right of the Motor Car. It was observed to be in good condition & unaffected by the accident's collision.

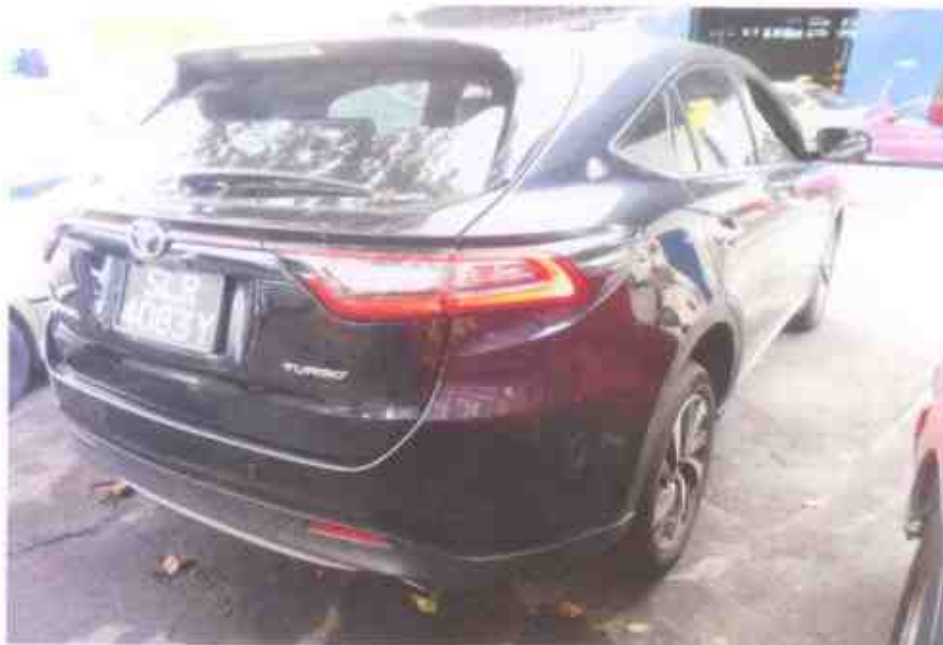
**Photo 8** shows a general view of the rear right of the Motor Car. It was observed to be in good condition & unaffected by the accident's collision.

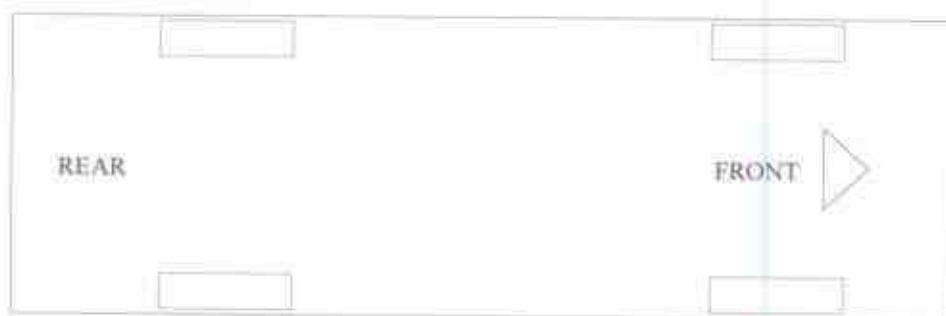
Bridgestone Ecopia H/L 422  
235/55R18 (7mm)

Bridgestone Dueler H/T 687  
235/55R18 (6mm)(Deflated-  
Outer sidewall torn)

Bridgestone Dueler H/T 687  
235/55R18 (6mm)

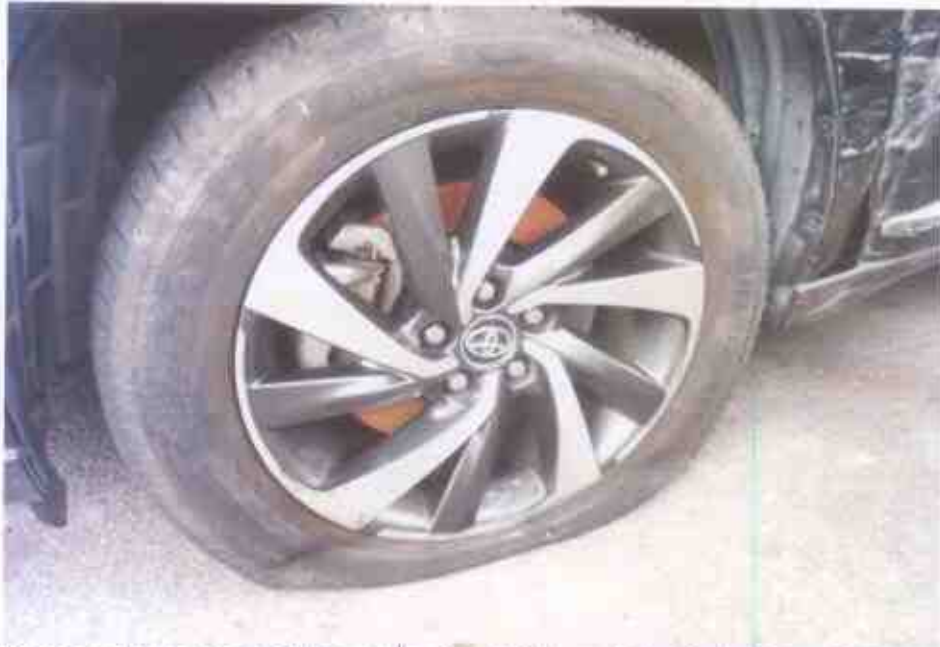
7. The condition for the Motor Car's front left tyre was found to be damaged as a result of the accident's impact collision. Further examination reveals that it was deflated & also sustained torn mark at the outer sidewall likely due to the accident. However, the tread pattern was visually clear across the tyre.
8. As for the Motor Car's 3 tyres (front right, rear left & right tyres), they were observed to be in serviceable condition. We did not find any tear, cut or burst mark(s) on the outer and the inner sidewalls as well as across the tread of the 3 tyres. Visually, the tread patterns were clear. The tyres were also observed to be sufficiently inflated for vehicular operation.
9. All tyre brand, tyre size and remaining tread depth of the 4 tyres were recorded as follows:-

**Photo 9** shows the condition of the front left tyre of the Motor Car, which was observed to be deflated as a result of the accident. Torn mark was found at the outer sidewall. The remaining tread depth of approximately 6mm.

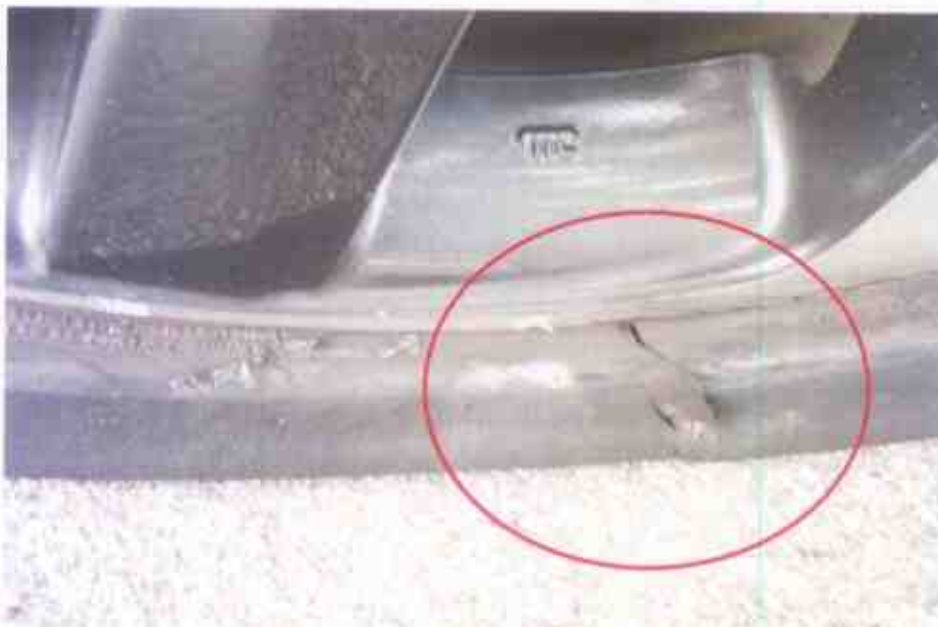
**Photo 10** shows the condition of the front left tyre of the Motor Car, which was observed to be deflated as a result of the accident. Torn mark was found at the outer sidewall. The remaining tread depth of approximately 6mm.

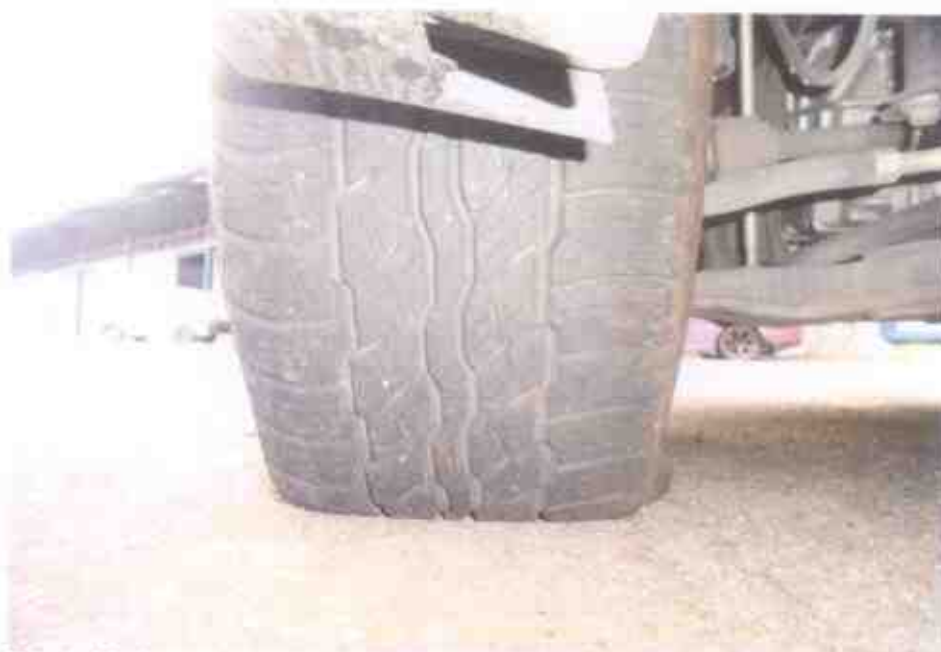
**Photo 11** shows the condition of the front left tyre of the Motor Car, which was observed to be deflated as a result of the accident. The remaining tread depth however found to be at approximately 6mm.

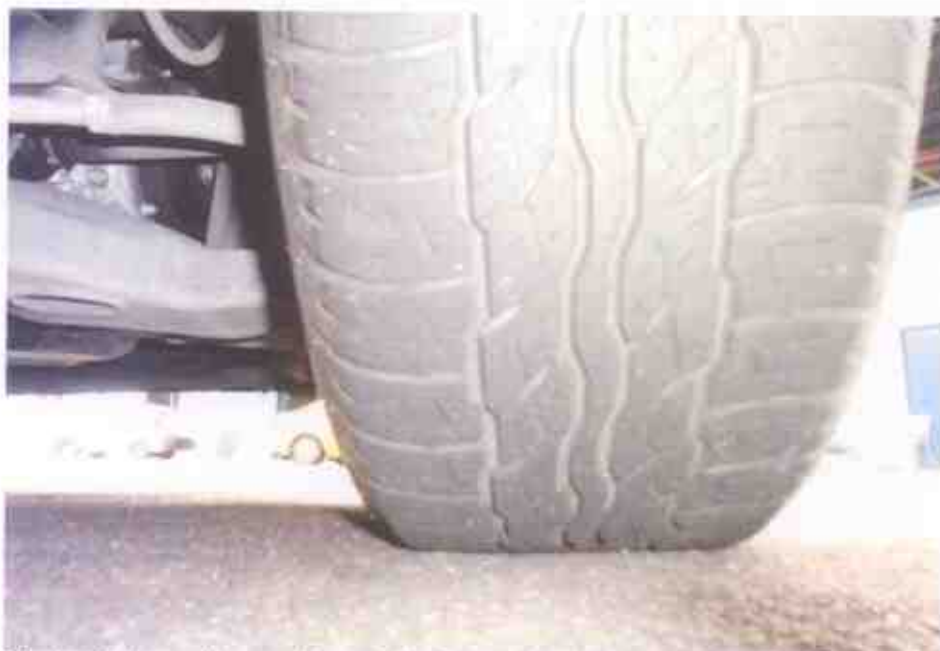
**Photo 12** shows the condition of the front right tyre of the Motor Car, which was observed to be in serviceable condition with remaining tread depth of approximately 6mm. The tyre, which was wrapped around alloy wheel rim, was also observed to be sufficiently inflated for vehicular operation.

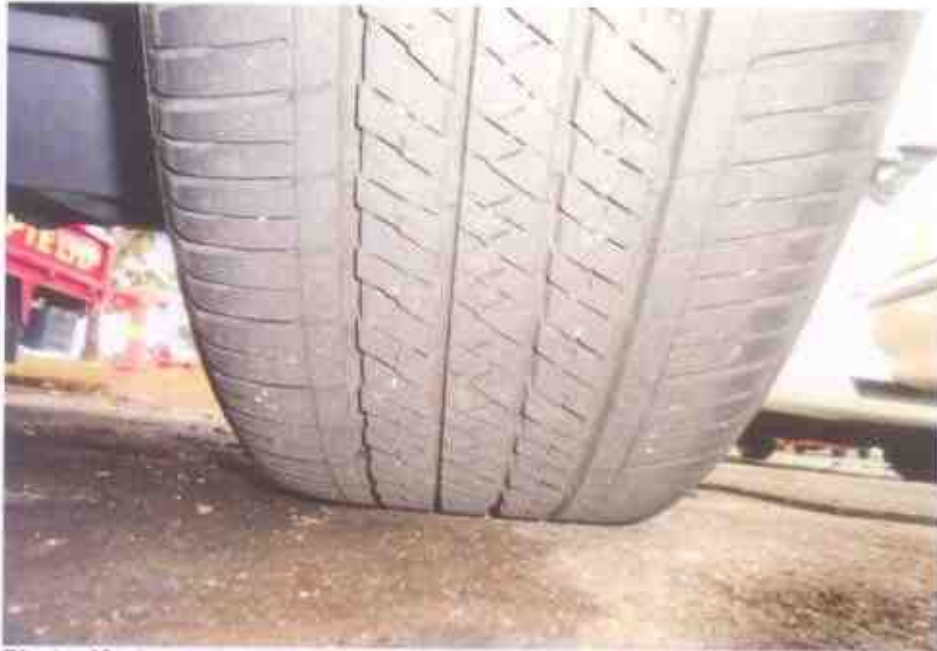
**Photo 13** shows the condition of the rear left tyre of the Motor Car, which was observed to be in serviceable condition with remaining tread depth of approximately 7mm. The tyre, which was wrapped around alloy wheel rim, was also observed to be sufficiently inflated for vehicular operation.

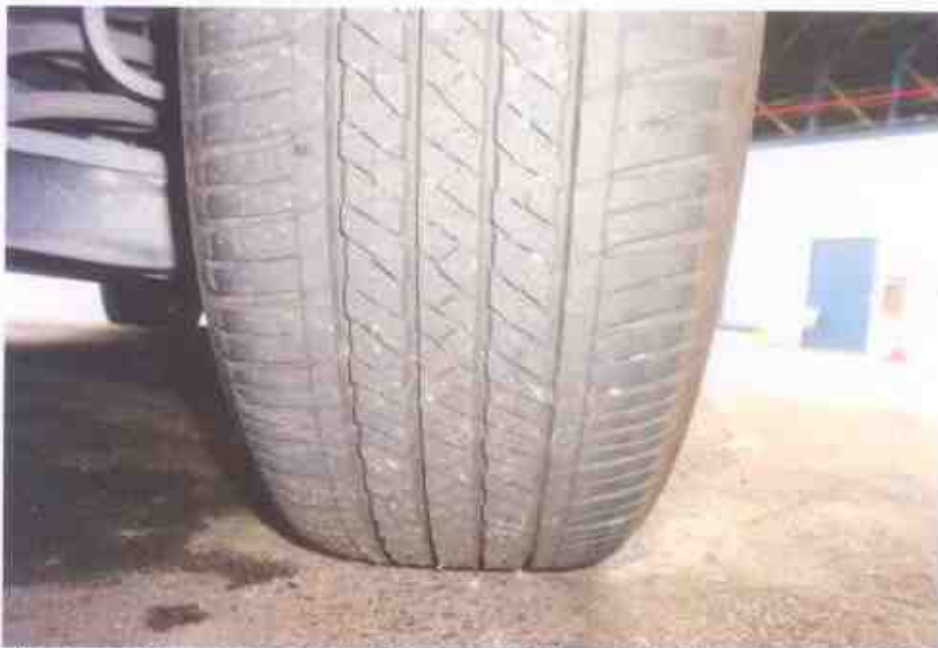
**Photo 14** shows the condition of the rear right tyre of the Motor Car, which was observed to be in serviceable condition with remaining tread depth of approximately 7mm. There was also no tear, cut or burst mark(s) on the outer and the inner sidewalls as well as across the tread of the 4 tyres.

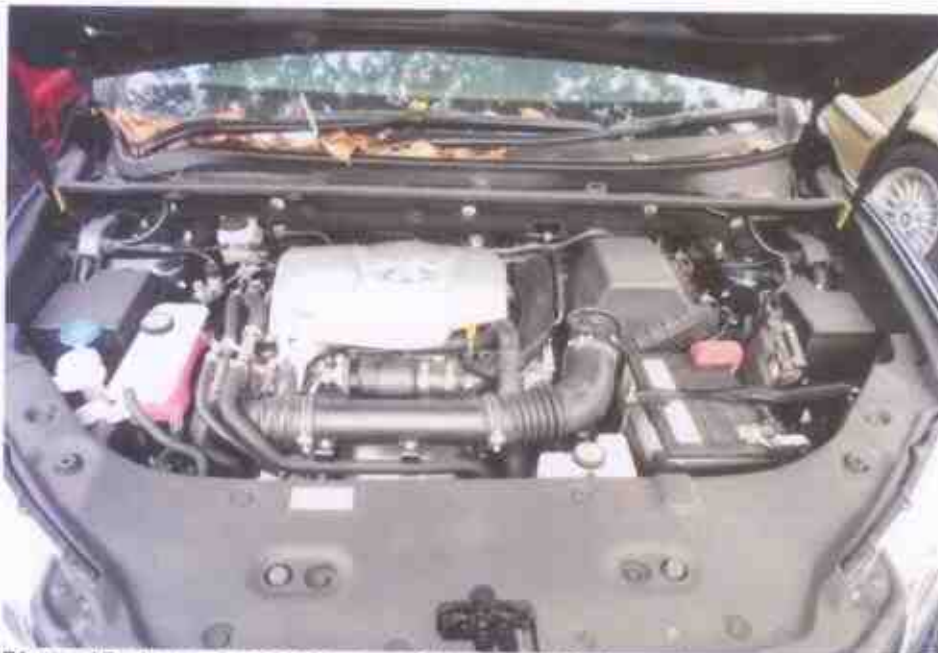
Photo 15 shows a general view of the Motor Car's engine compartment. The various parts and components inside the engine compartment were unaffected by the accident. There was also no sign(s) or indication(s) of fluid leakage and/or fluid stain within the engine compartment.

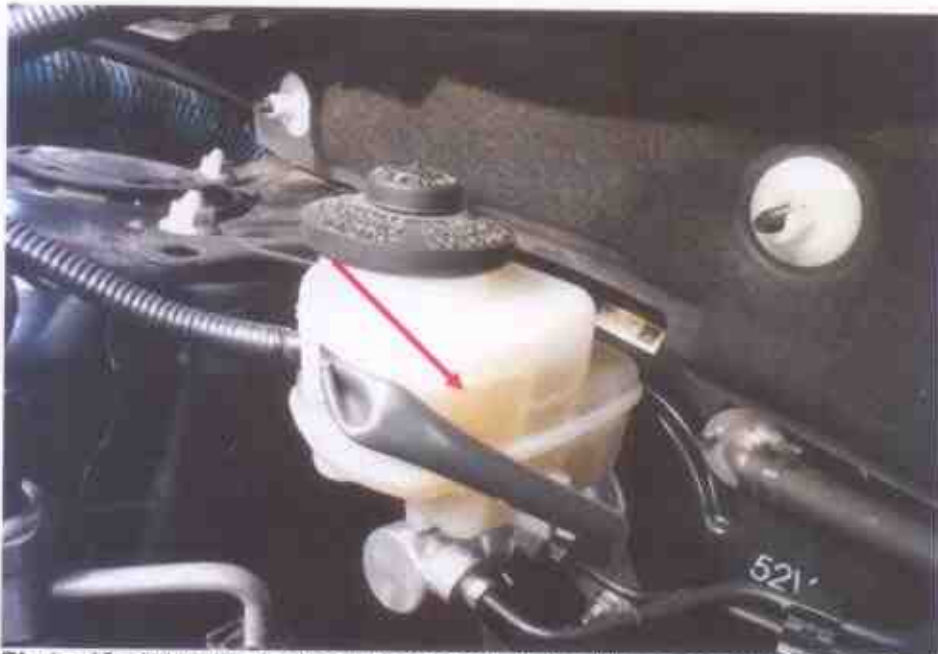
**Photo 16** shows the brake fluid reservoir of the Motor Car at the time of our inspection. The brake fluid was observed to be of sufficient level (arrowed) and without any visible contamination.

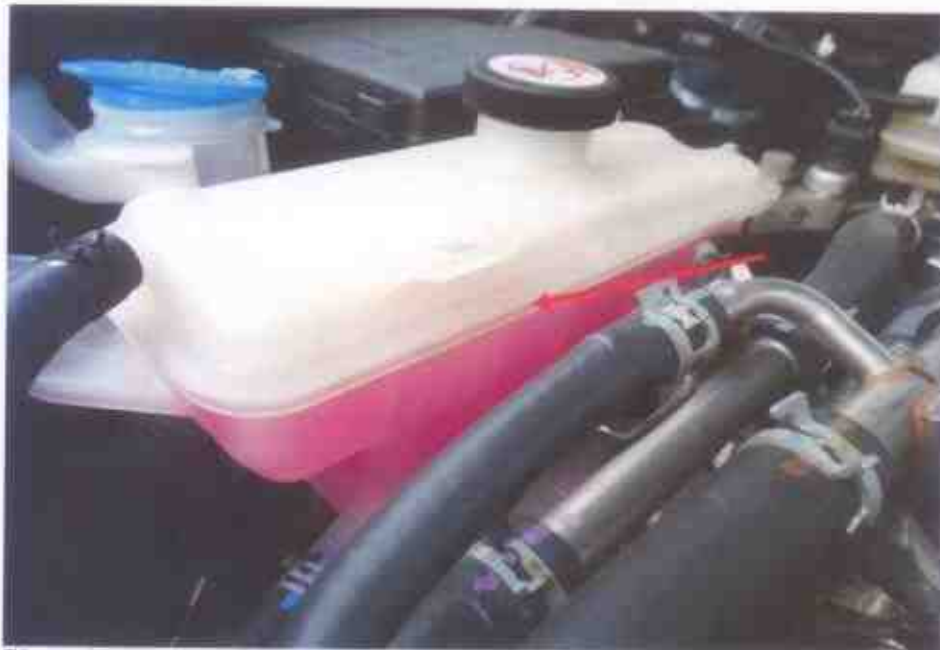
**Photo 17** shows the coolant fluid in the radiator tank of the Motor Car at the time of our inspection. The coolant fluid was observed to be of sufficient level and without any visible contamination.

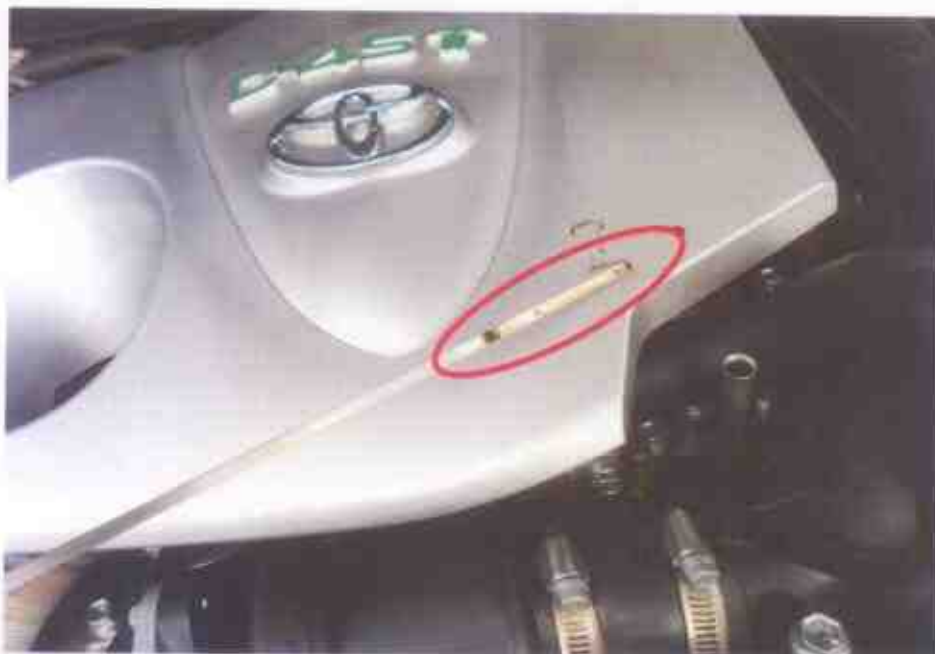
Photo 18 shows the engine oil dip stick of the Motor Car at the time of our inspection. The engine oil was observed to be of sufficient level and without any visible contamination.

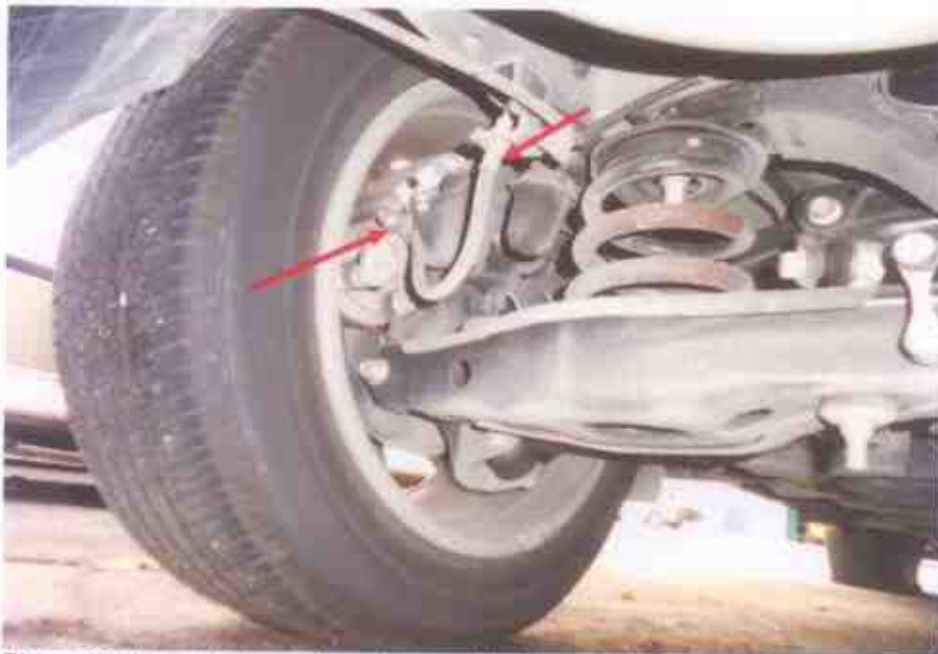
Photo 19 shows the brake hose (arrowed) at the rear left wheel of the Motor Car. We did not observe any leakage of brake fluid at the time of our inspection of the Motor Car. Our visual inspection of the various mechanical components of the Motor Car's braking system revealed all to be intact and without visible damages.

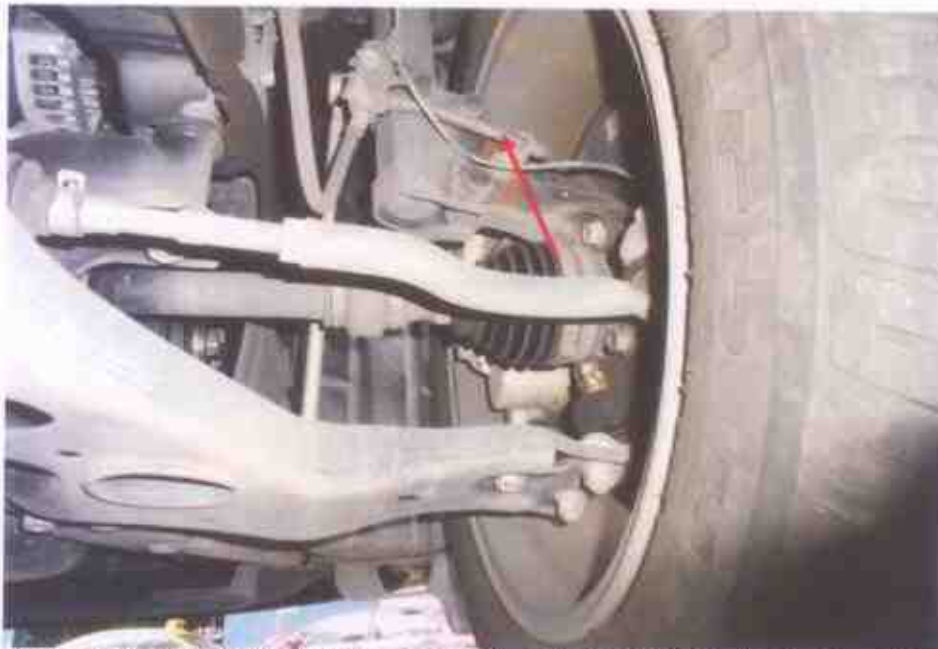
Photo 20 shows the brake hose (arrowed) at the front right wheel of the Motor Car. We did not observe any leakage of brake fluid at the time of our inspection of the Motor Car. Our visual inspection of the various mechanical components of the Motor Car's braking system, including its brake calliper, revealed all to be intact and without visible damage

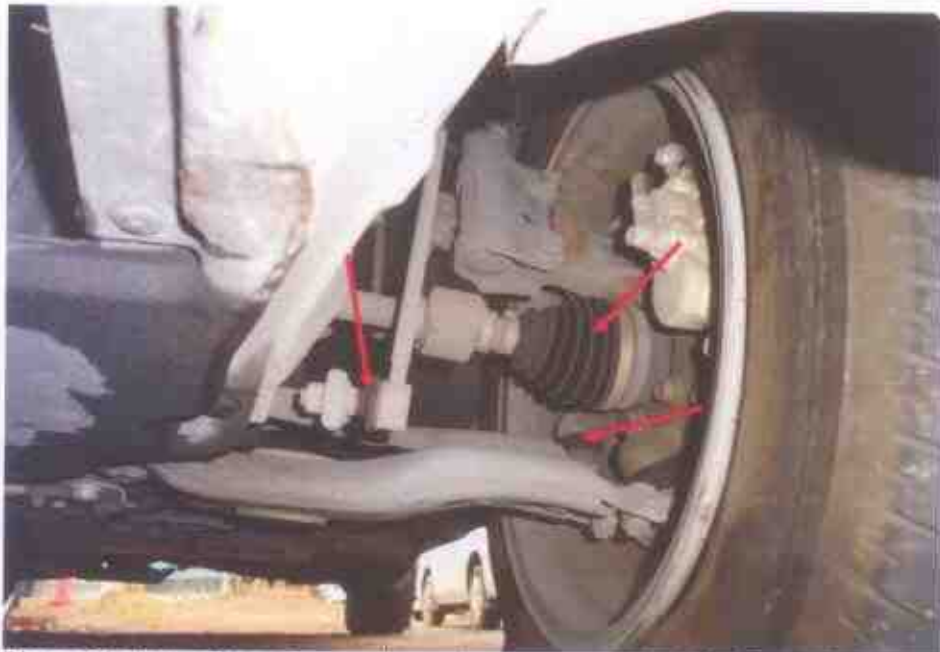
Photo 21 shows the various undercarriage components at the front left wheel of the Motor Car, in particular the steering tie rod (arrowed). The various steering components were all found to be intact, suggesting that the steering system of the Motor Car was likely to be in serviceable condition.

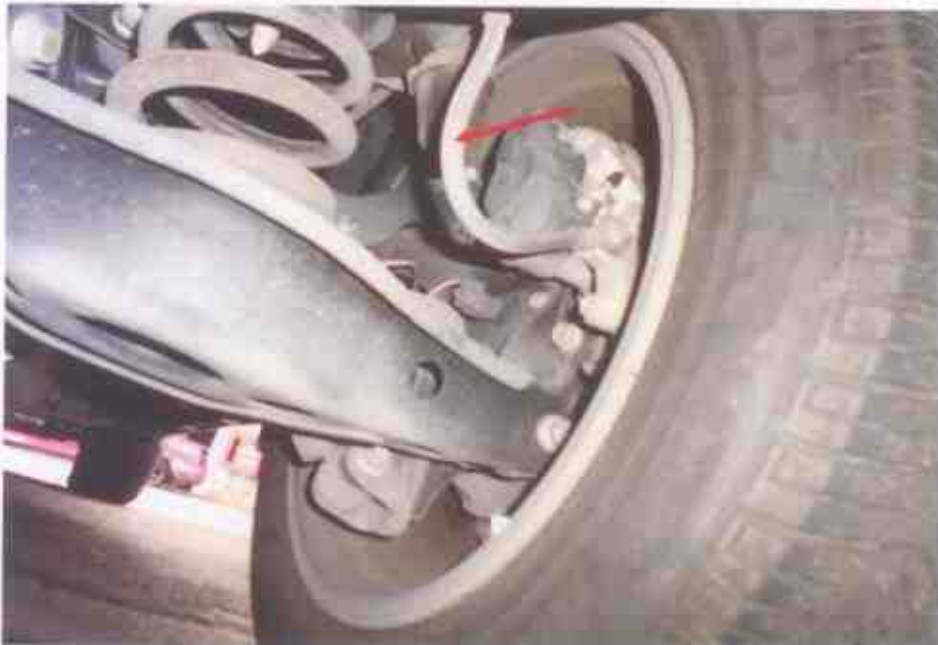
Photo 22 shows the various undercarriage components at the rear right wheel of the Motor Car. We did not observe any leakage of brake fluid at the time of our inspection of the Motor Car. Our visual inspection of the various mechanical components of the Motor Car's braking system revealed all to be intact and without visible damage, indicating that the braking system was likely to be in serviceable condition at the material time of accident.

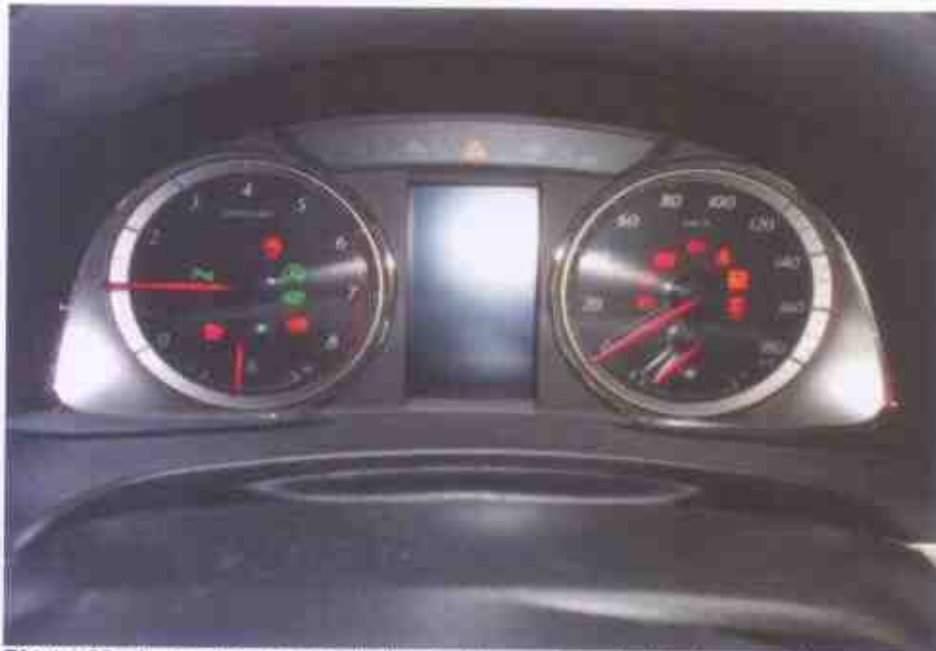
**Photo 23** shows the warning lights for the various electronic operating systems of the Motor Car appearing on its instrument panel during the self-test when the engine is cranked, in particular the ABS light and SRS light.

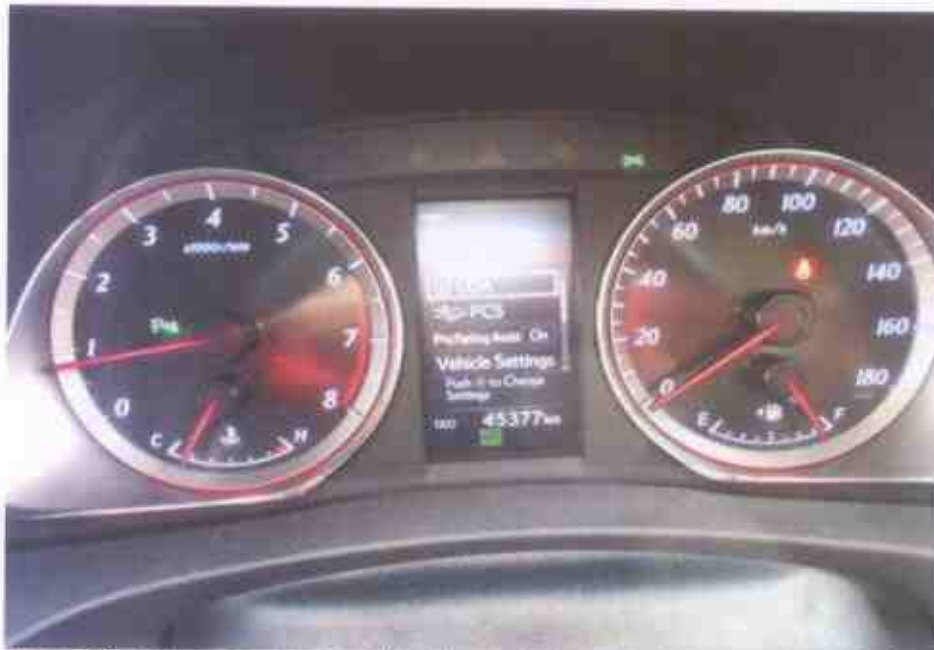
Photo 24 shows: no warning lights illuminated on the instrument panel of the Motor Car after the engine was cranked. This would suggest that there was no abnormality to the various electronic operating systems of the Motor Car, like the ABS and SRS.

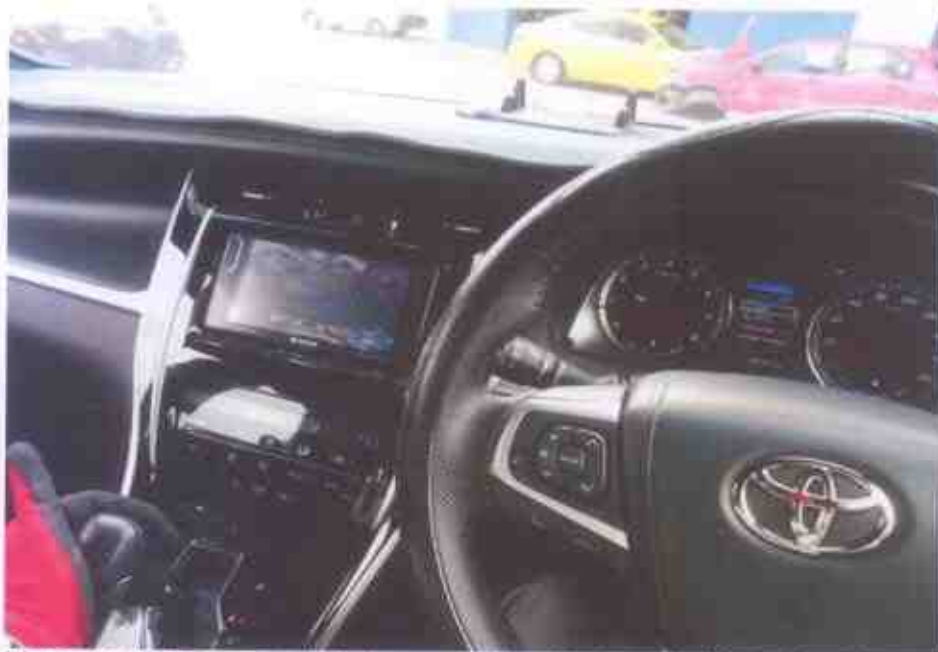
**Photo 25** shows we conducted an operational test on the Motor Car. Reverse mode were engaged at time of our test. There was no abnormality observed at time of testing.

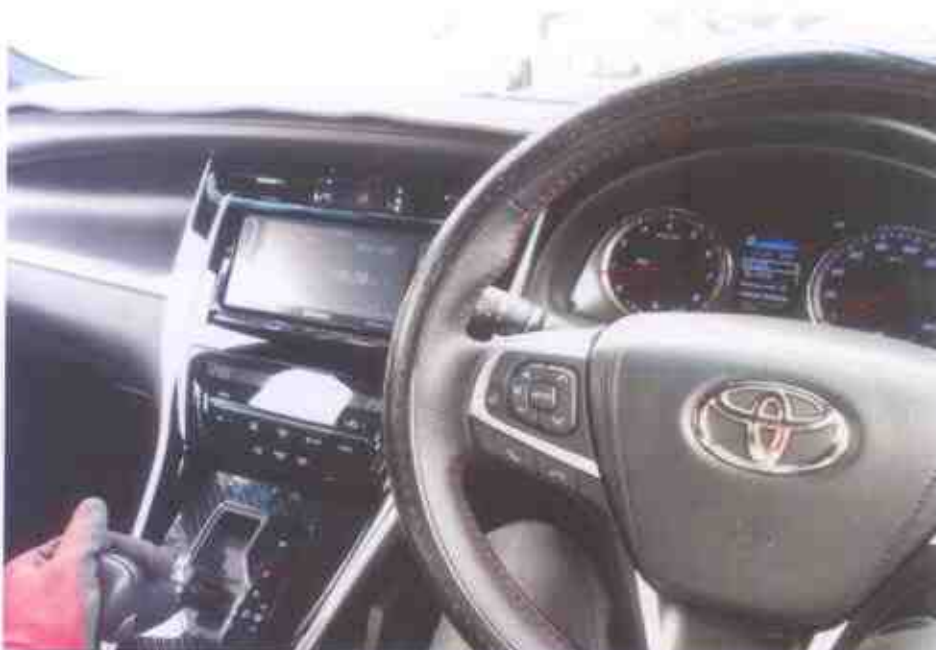
**Photo 26** shows we conducted an operational test on the Motor Car. Drive mode were engaged at time of our test. There was no abnormality observed at time of testing.

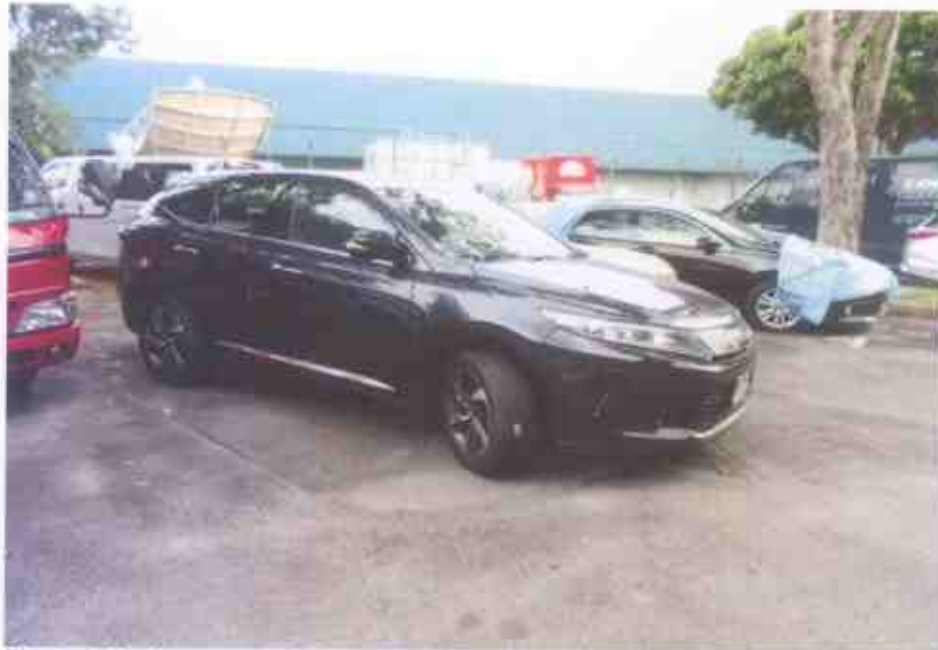
Photo 27 shows we conducted an operational test on the Motor Car. The steering wheel was tested by steering it to the fullest left & right without any abnormalities observed.
