Preliminary Advice

Insured Vehicle No	: SLM66A	Accident Date	: 24/10/2018
TP Vehicle No	: SHA1277L	Assignment Date	: 29/10/2018
Make	: HYUNDAI I40	Est. Duration of Repair	: 9.00
Date of Inspection	: 29/10/2018		
Inspection At	: SOON HOCK MOTOR PTE LTD (HQ) BLK 10 ANG MO KIO INDUSTRIAL PARK 2A, #01-05/06 AMK AUTOPOINT SINGAPORE 568047

VEHICLE DAMAGE INSPECTION REPORT

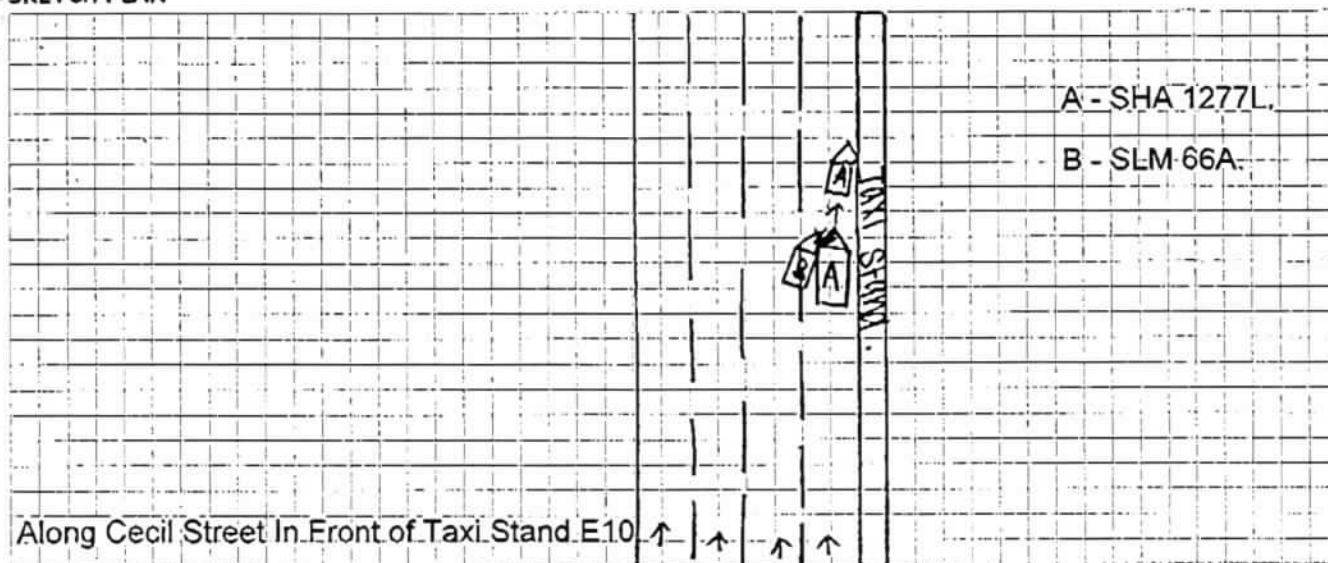
SKETCH PLAN

I was stationary at the Taxi Stand E10 to pick up a passenger. Suddenly I felt an impact on my left as veh (B) (SLM 66A) hit my taxi (A) front left portion. Due to the impact, my taxi (A) hit the pillar on my right and therefore my taxi (A) also sustain damages on front right portion.
