Auto
Consultants
Pte Ltd

**Incident On 29 April 2016 At About 1645hrs Along Pasir
Ris Drive 1 Towards Pasir Ris Drive 12, Involving A
Motorcycle FBK 7736H**

**Requested By
Roy & Partners
101 Cecil Street #11-09
Tong Eng Building
Singapore 069533**

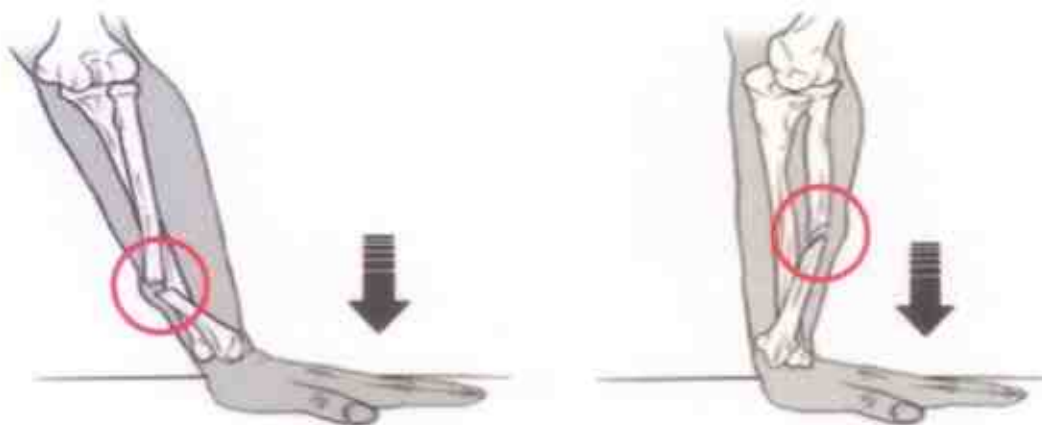
- d) fracture of the bones at the left and right jaw area;
 - e) cut at the left lower lip; and
 - f) abrasion on both thighs.
17. Given the fractures to various bones/limbs, it can reasonably be determined that the bodily injuries sustained by Madam Aini was of an impact type injury. Notably, the fracture of the 2 main bones at the left and right forearm was referred to as Galleazi fracture in the various medical reports. Such fracture involves a partial or complete break of one of the main bones (radial shaft) at the forearm, between the wrist and middle portion of the forearm. Fall on an outstretched hand is typically the cause of such fracture. See illustration below.

18. Since both the left and right forearm of Madam Aini was fractured (Galleazi fracture), and considering the typical cause of such fracture, it can be established that Madam Aini had used both her hands to break a fall hence sustaining the Galleazi fracture. Correspondingly, Madam Aini's 3 left fingers were also fractured/dislocated during this break fall.
19. The fracture of the bones at the left and right jaw area, cut at the left lower lip were indications that the lower part of Madam Aini's face had forcefully impacted onto the road surface. This is consistent to the pattern of the grazed/scratched marks that were seen on Madam Aini's helmet visor, where the helmet had grazed against the road surface, forming the marks on the helmet visor. See photo 1 below.

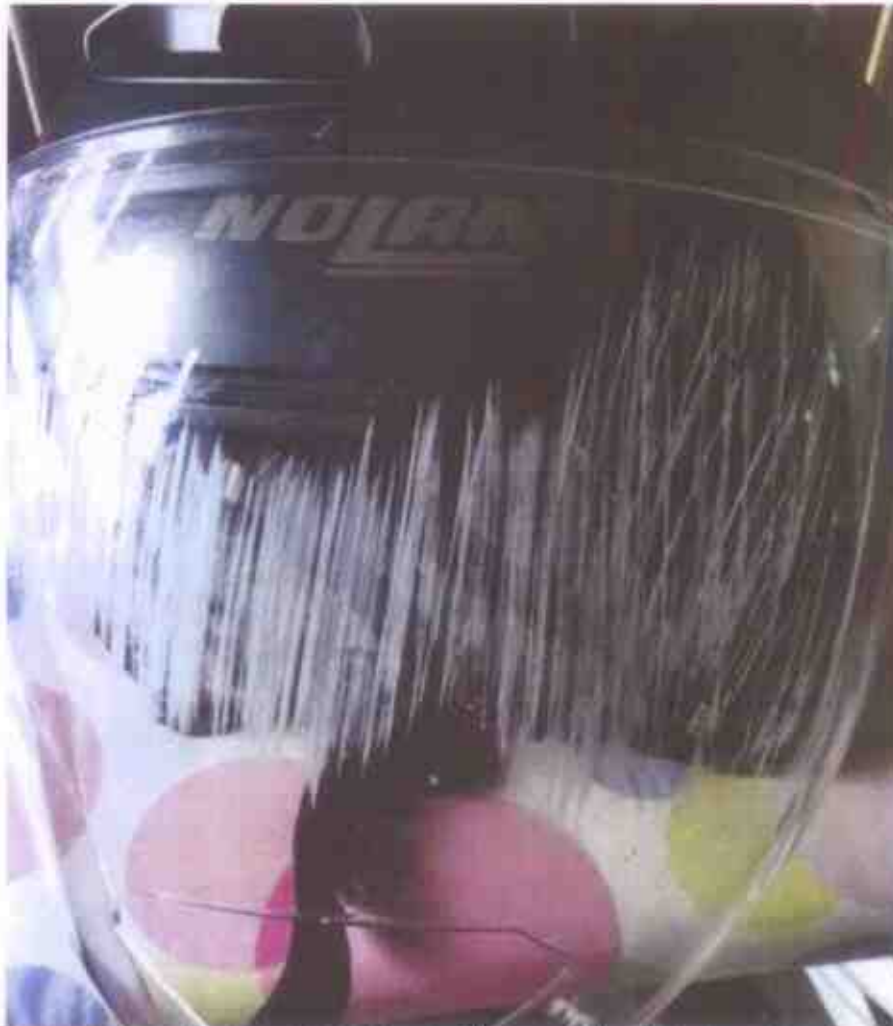
Photo 1 shows Madam Aini's helmet. The grazed/scratched marks seen on Madam Aini's helmet visor are consistent to marks that are formed by the helmet grazing against the road surface.

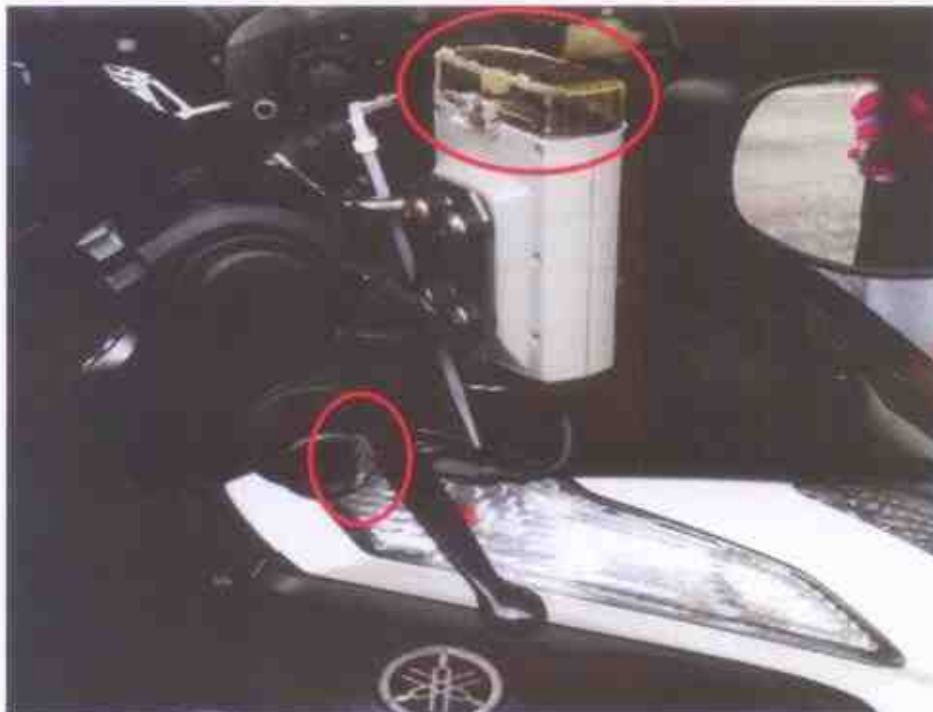
Photo 2 shows marks of grazing nature that was observed on the right side of the Motorcycle, in particular to the right side handle bar and IU cover (circled).

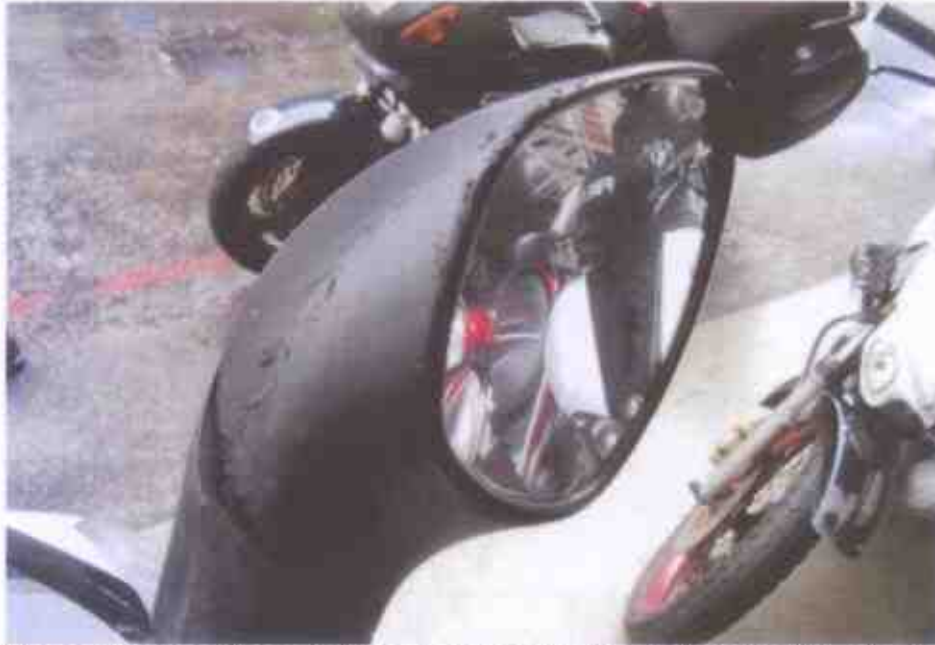
Photo 3 shows marks of grazing nature that was observed on the right side wing mirror of the Motorcycle. The grazing marks are a result of the Motorcycle falling and sliding along the road surface.

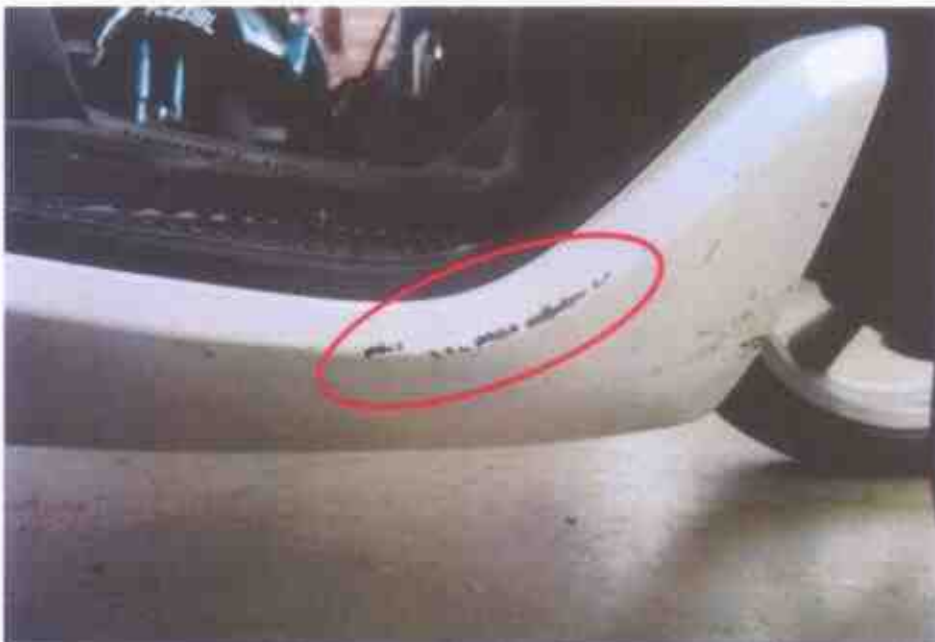
Photo 4 shows marks of grazing nature (circled) that was observed on the right side lower cover of the Motorcycle. Again, these grazing marks were a result of the Motorcycle falling and sliding along the road surface.

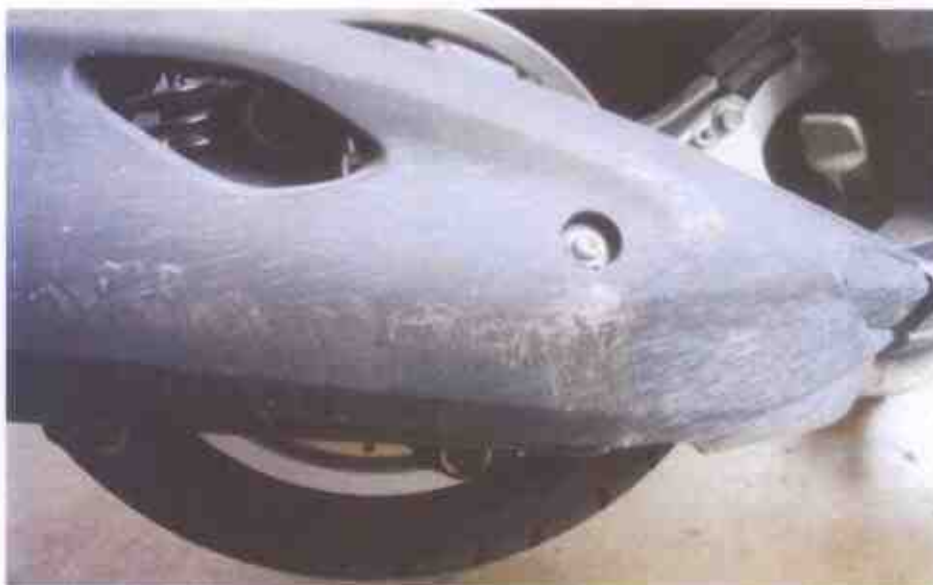
Photo 5 shows marks of grazing nature that was observed on the exhaust guard, which was on the right of the Motorcycle. Such grazing nature marks are commonly associated to a motorcycle falling and thereafter sliding along the ground.

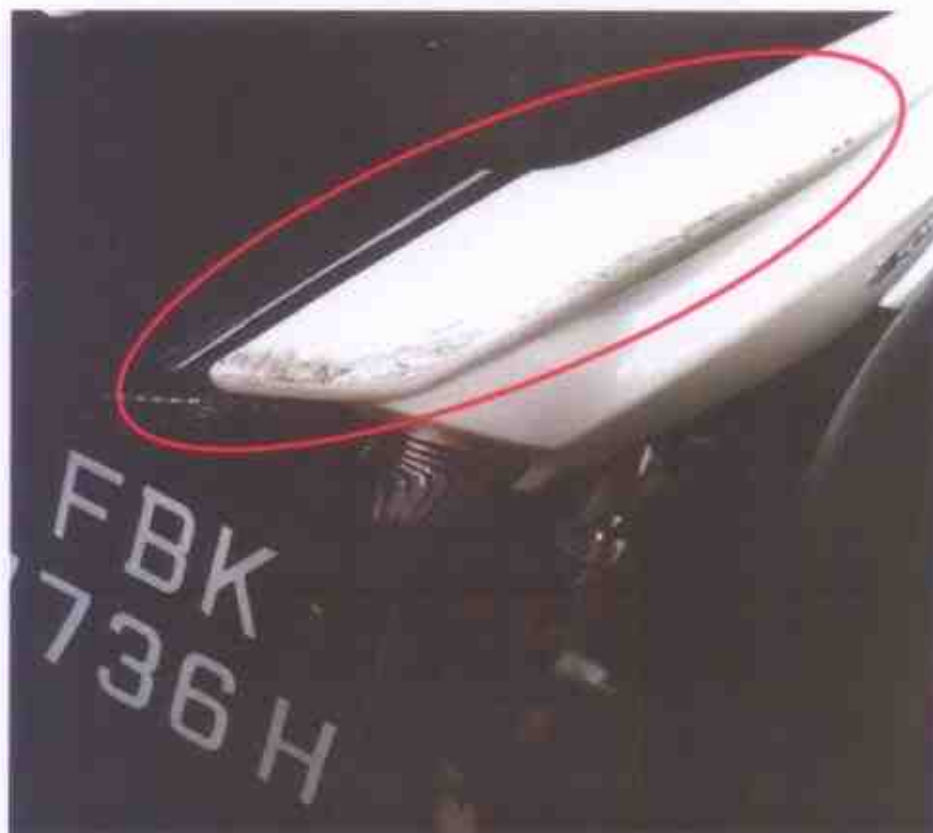
Photo 6 shows marks of grazing nature that was observed on the right side rear cover of the Motorcycle. From the damage pattern seen on the Motorcycle, it can be established that the Motorcycle had fell on its right side and thereafter slid along the road surface at the material time.

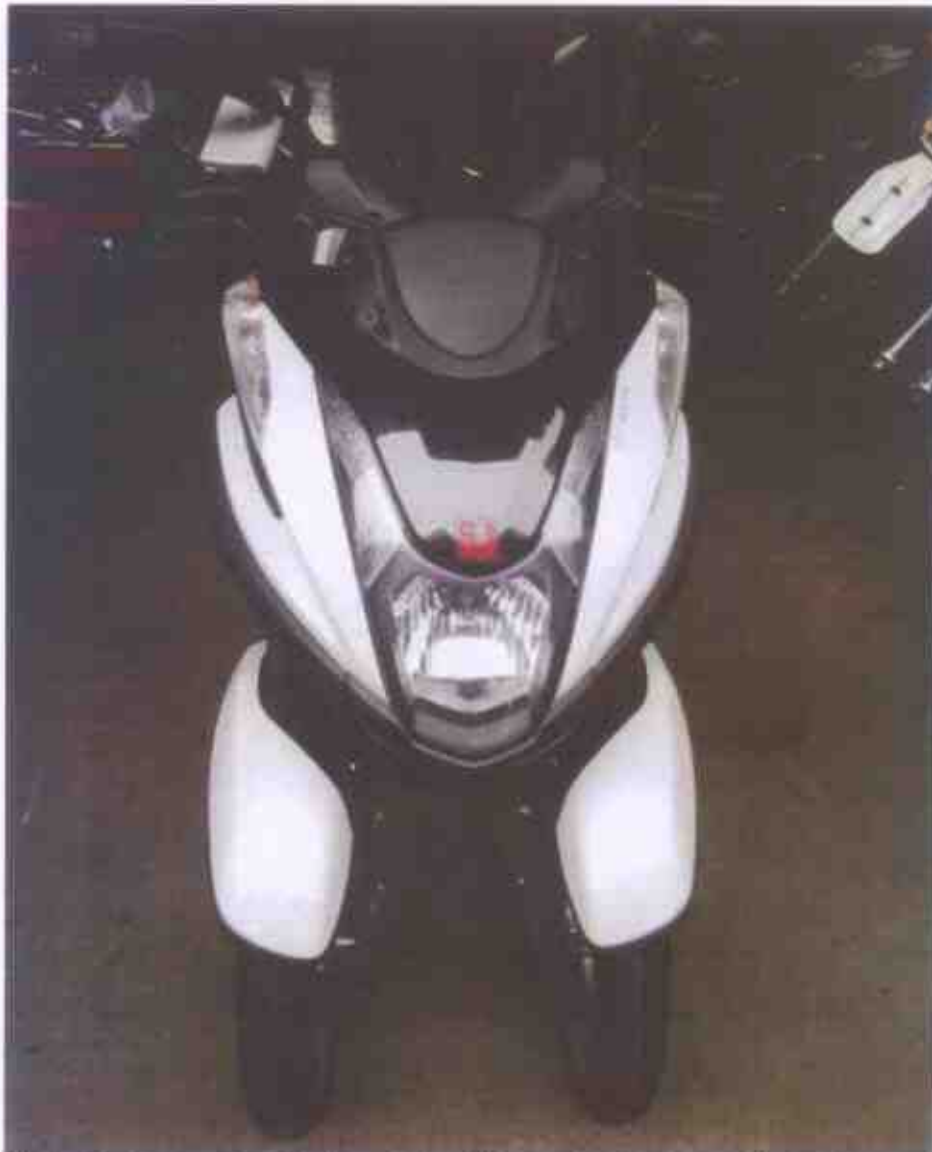
Photo 7 shows a frontal view of the Motorcycle, which is a tri-wheel type of motorcycle. Such type of motorcycle is generally more stable in terms of road handling as compared to a 2-wheel motorcycle. This is another factor that does not seem to suggest that it was possible for the Motorcycle to self-skid at the material time, especially when travelling along a straight stretch of roadway.

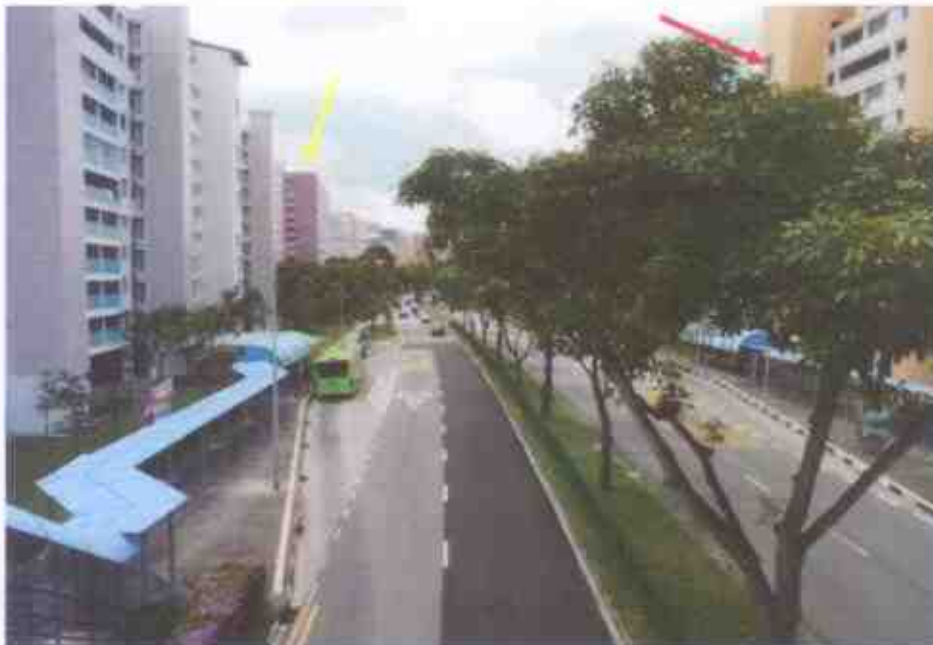
Photo 8 shows a general view of the stretch of roadway of Pasir Ris Drive 1 towards Pasir Ris Drive 12, between Block 547 (yellow arrow) and Block 425 (red arrow). The stretch of road was observed to be relatively straight.

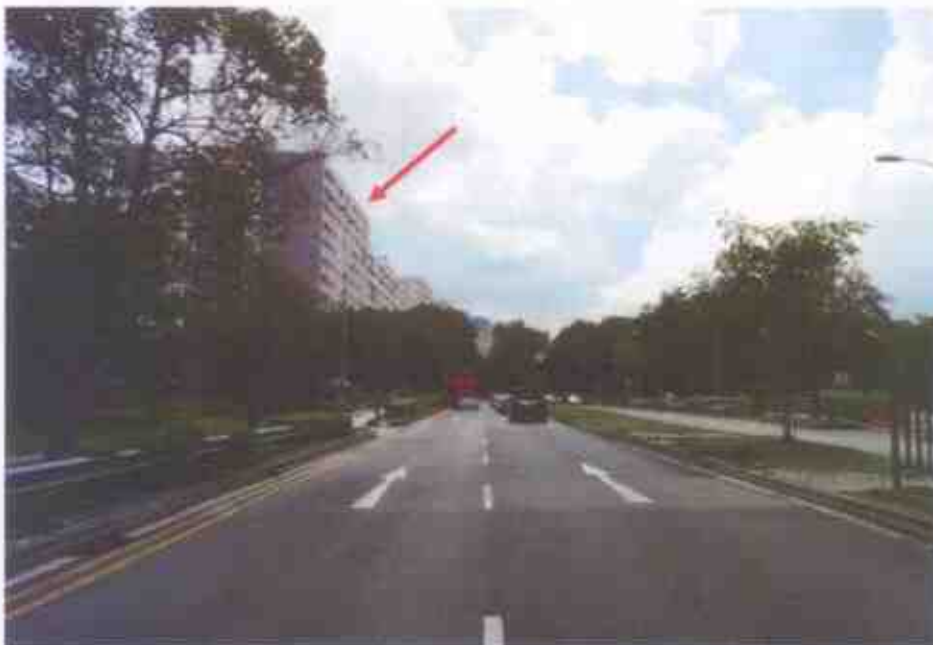
Photo 9 shows a general view of the stretch of roadway of Pasir Ris Drive 1 towards Pasir Ris Drive 12, nearer to Block 547 (arrowed). The stretch of road was observed to be relatively straight. There appears to be no reasonable reason(s) for the Motorcycle, whilst travelling along this stretch of roadway, to self-skid unlike along a bend or a corner, where a motorcycle may possibly skid if understeered or oversteered.

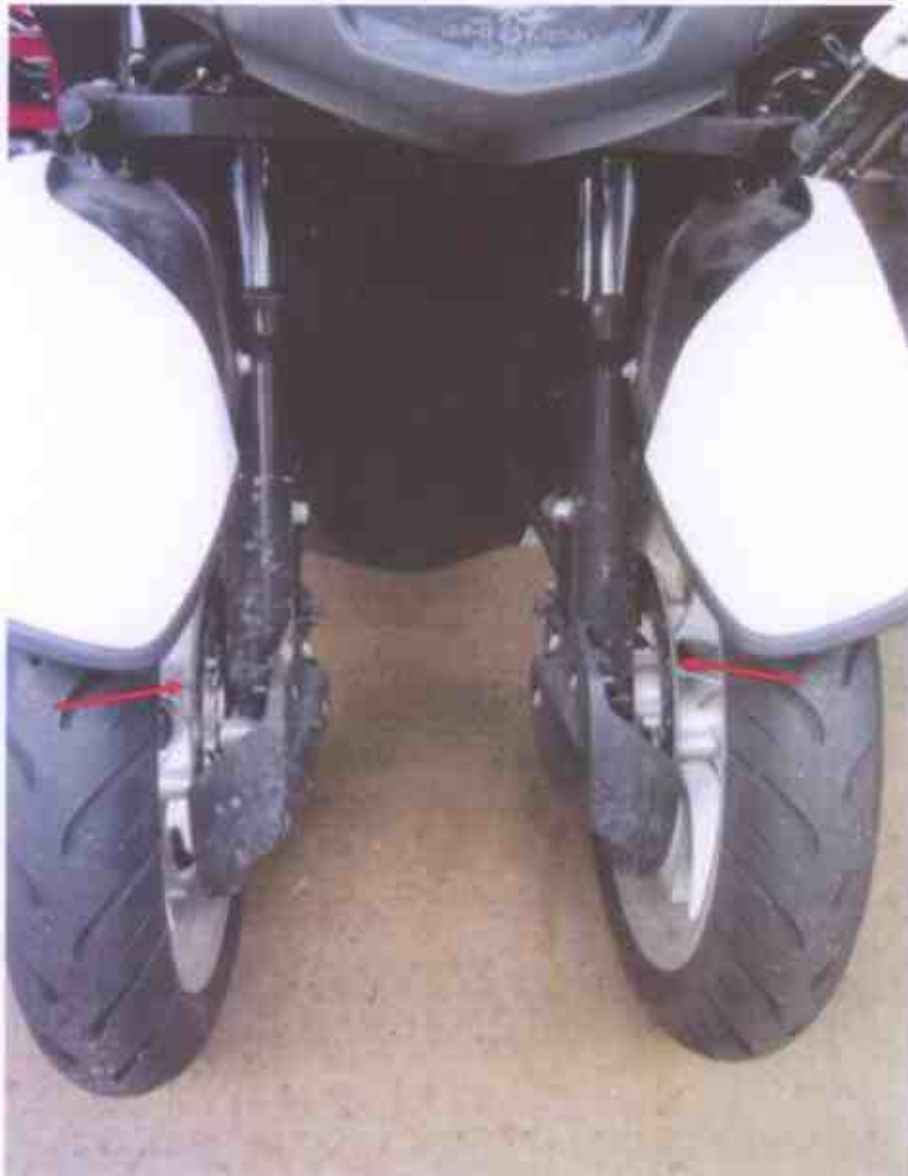
34. To put things into perspective, in a 100% braking efficiency, each wheel of the Motorcycle would have approximately 33% of braking efficiency. In total, the front of the Motorcycle would have approximately 66% braking efficiency compared to approximately 33% to the rear. The ability to stop the rotation (moving) of the front wheels would therefore be approximately double ie the front wheels would stop much quicker than the rear wheels. When hard braking, this could result in the rear of the Motorcycle lifting upwards as the front wheels slows and stops faster than the rear wheels, ultimately leading to Madam Aini being flung forward.

Photo 10 shows a frontal view of the Motorcycle. The braking system of the Motorcycle was of hydraulic pressure type with brake disc at all the wheels. The front wheels of the Motorcycle will stop rotating faster as compared to the rear wheel given that the frontal wheels are individually fitted with its own brake disc (arrowed).

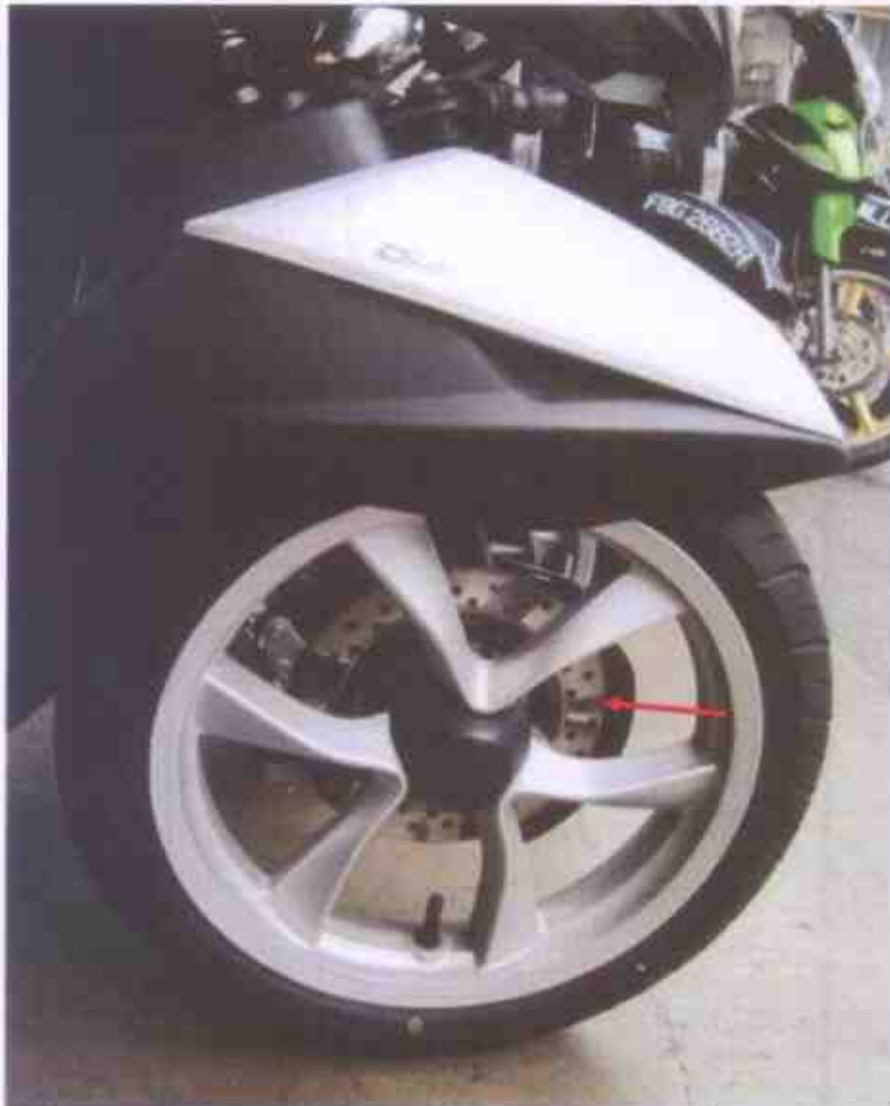
Photo 11 shows the brake disc (arrowed) at the front right wheel of the Motorcycle. The front left wheel and rear wheel of the Motorcycle were similarly fitted with such brake disc as part of the Motorcycle's braking system.
