Auto  
Consultants  
Pte Ltd

26 October 2018

**Incident On 29 April 2016 At About 1645hrs Along Pasir  
Ris Drive 1 Towards Pasir Ris Drive 12, Involving A  
Motorcycle FBK 7736H**

**Requested By  
Roy & Partners  
101 Cecil Street #11-09  
Tong Eng Building  
Singapore 069533**

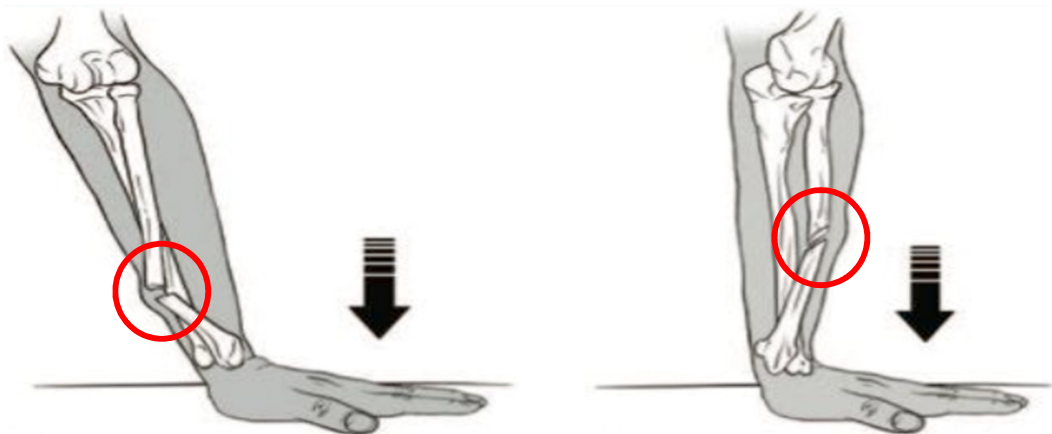
- d) fracture of the bones at the left and right jaw area;
  - e) cut at the left lower lip; and
  - f) abrasion on both thighs.
17. Given the fractures to various bones/limbs, it can reasonably be determined that the bodily injuries sustained by Madam Aini was of an impact type injury. Notably, the fracture of the 2 main bones at the left and right forearm was referred to as Galleazi fracture in the various medical reports. Such fracture involves a partial or complete break of one of the main bones (radial shaft) at the forearm, between the wrist and middle portion of the forearm. Fall on an outstretched hand is typically the cause of such fracture. See illustration below.

18. Since both the left and right forearm of Madam Aini was fractured (Galleazi fracture), and considering the typical cause of such fracture, it can be established that Madam Aini had used both her hands to break a fall hence sustaining the Galleazi fracture. Correspondingly, Madam Aini's 3 left fingers were also fractured/dislocated during this break fall.
19. The fracture of the bones at the left and right jaw area, cut at the left lower lip were indications that the lower part of Madam Aini's face had forcefully impacted onto the road surface. This is consistent to the pattern of the grazed/scratched marks that were seen on Madam Aini's helmet visor, where the helmet had grazed against the road surface, forming the marks on the helmet visor. See photo 1 below.

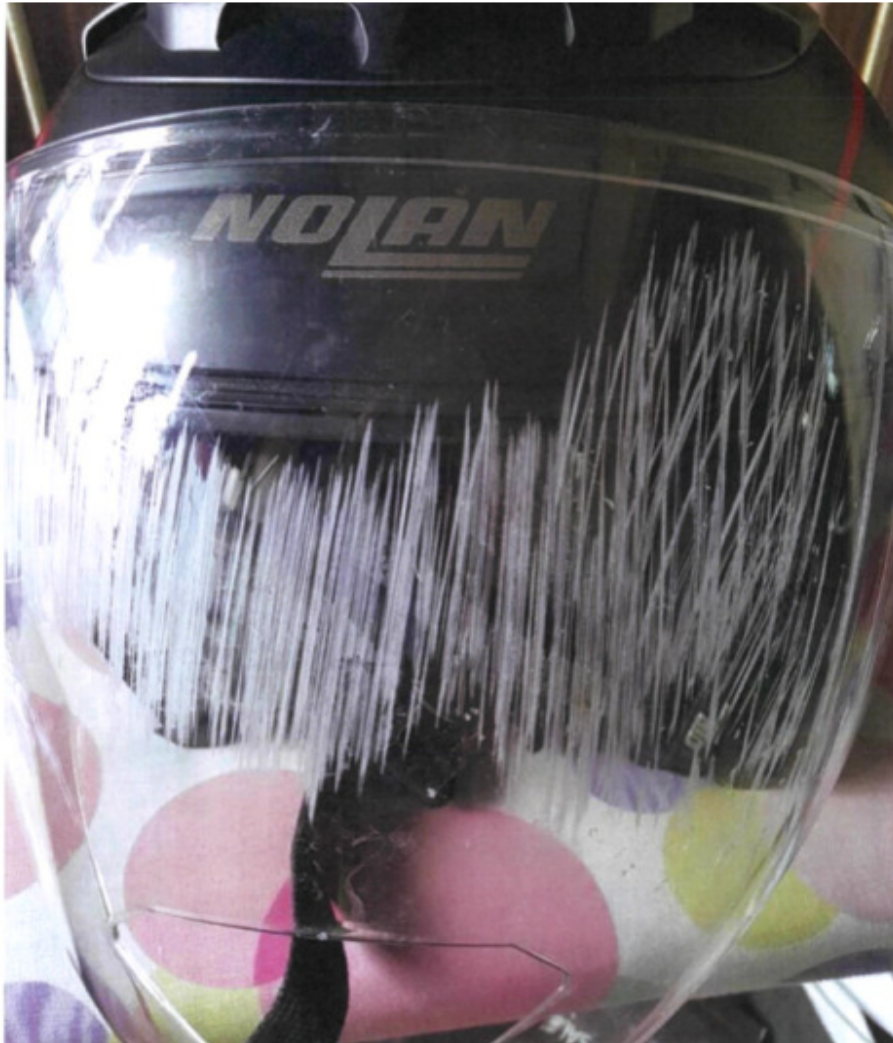
**Photo 1** shows Madam Aini's helmet. The grazed/scratched marks seen on Madam Aini's helmet visor are consistent to marks that are formed by the helmet grazing against the road surface.

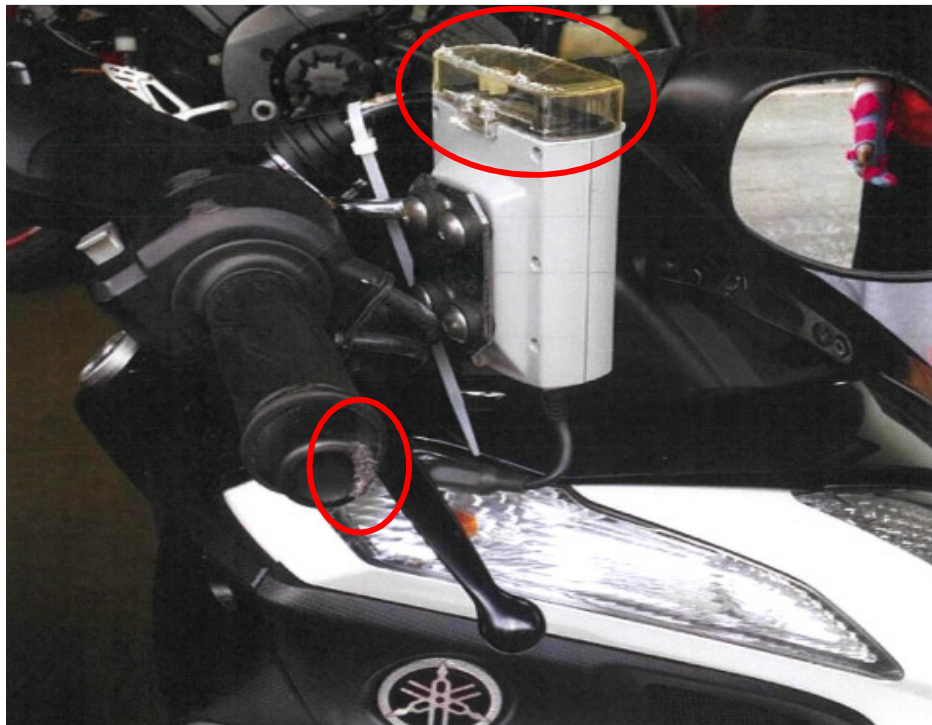
21. My examination of the photographs showing the damage to the Motorcycle revealed damages that were mainly of grazing nature to the right side of the Motorcycle. Such grazing nature marks are commonly associated with a motorcycle falling and thereafter sliding along the ground. Since the grazing nature marks on the Motorcycle were mainly along its right side, it can then be established that the Motorcycle had fell on its right side and slid along the road surface at the material time.
22. I also note what appears to be a lack of impact damage, like bending, crushing, breaking of body parts seen on the Motorcycle, which would seem to indicate that the Motorcycle was not exposed to an impact from, or onto any object and/or motor vehicle. In other words, the physical damage to the Motorcycle seems to indicate that it had fell on its own See photo 2 – 6 below.

**Photo 2** shows marks of grazing nature that was observed on the right side of the Motorcycle, in particular to the right side handle bar and IU cover (circled).

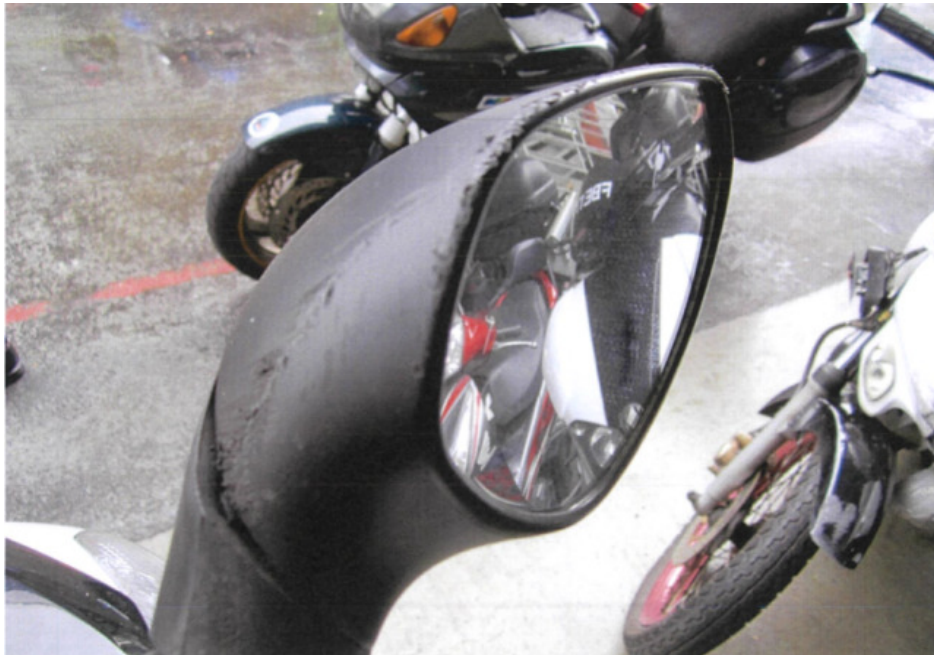
**Photo 3** shows marks of grazing nature that was observed on the right side wing mirror of the Motorcycle. The grazing marks are a result of the Motorcycle falling and sliding along the road surface.

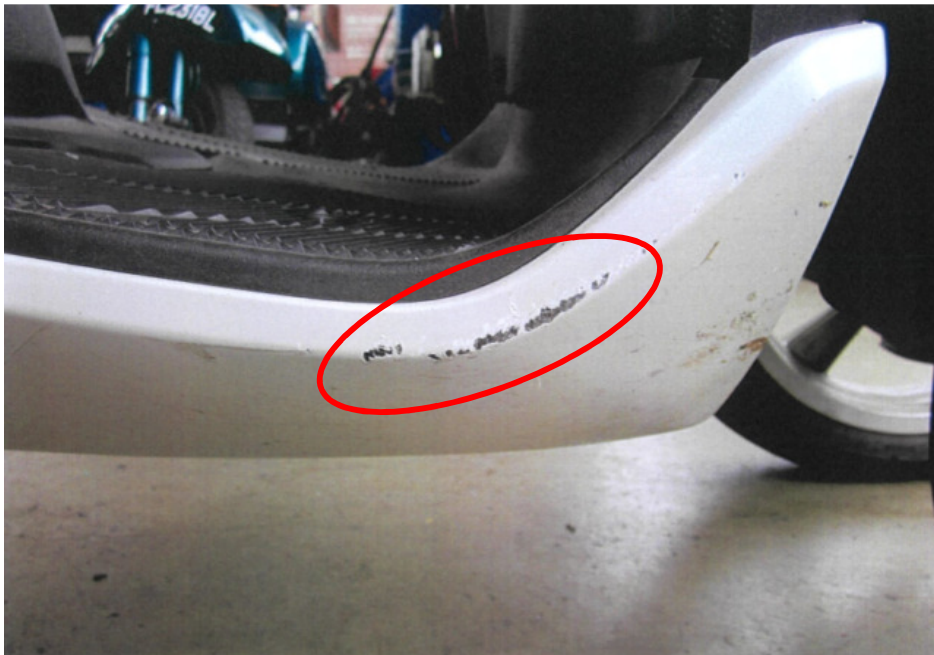
**Photo 4** shows marks of grazing nature (circled) that was observed on the right side lower cover of the Motorcycle. Again, these grazing marks were a result of the Motorcycle falling and sliding along the road surface.

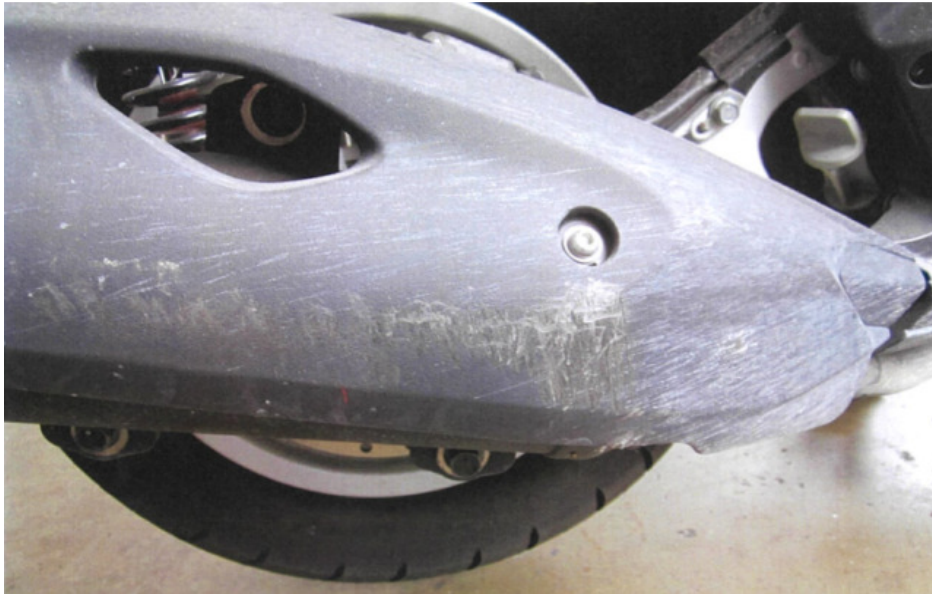
**Photo 5** shows marks of grazing nature that was observed on the exhaust guard, which was on the right of the Motorcycle. Such grazing nature marks are commonly associated to a motorcycle falling and thereafter sliding along the ground.

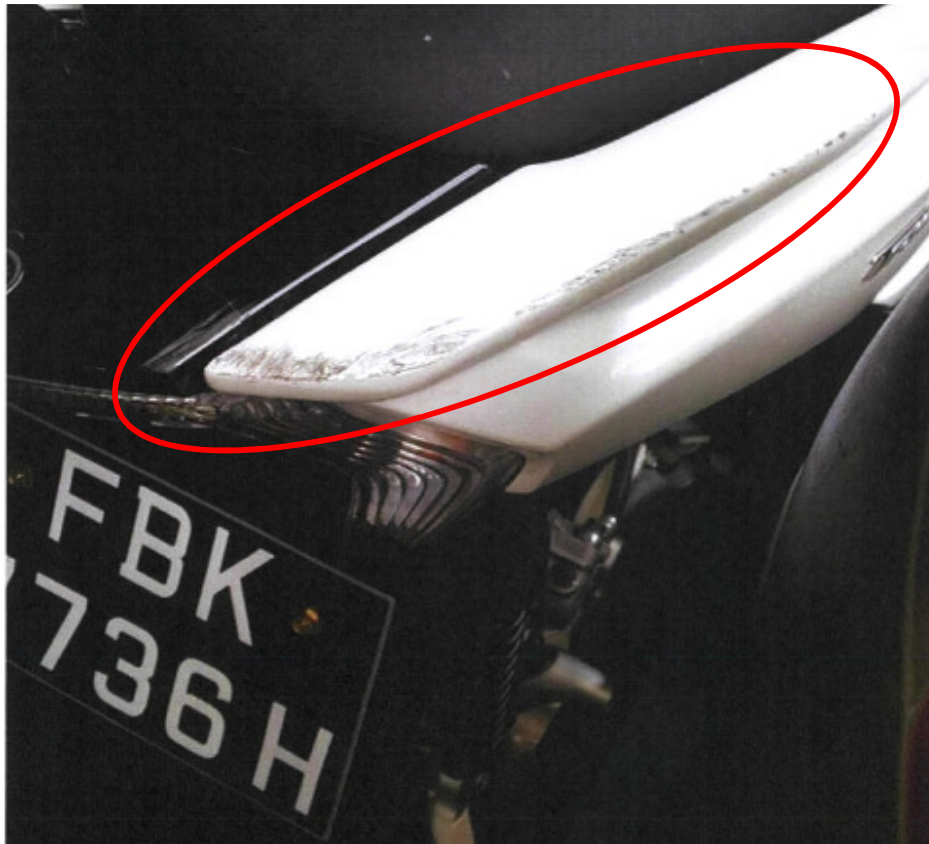
**Photo 6** shows marks of grazing nature that was observed on the right side rear cover of the Motorcycle. From the damage pattern seen on the Motorcycle, it can be established that the Motorcycle had fell on its right side and thereafter slid along the road surface at the material time.

23. In general, the physical damage to the Motorcycle indicates that it had fell on its own without any impact intervention, which may suggest of a self-skid scenario. However, the bodily injuries sustained by Madam Aini, which was discussed earlier, does not appear to correspond to Madam Aini falling with the Motorcycle in a self-skid scenario.

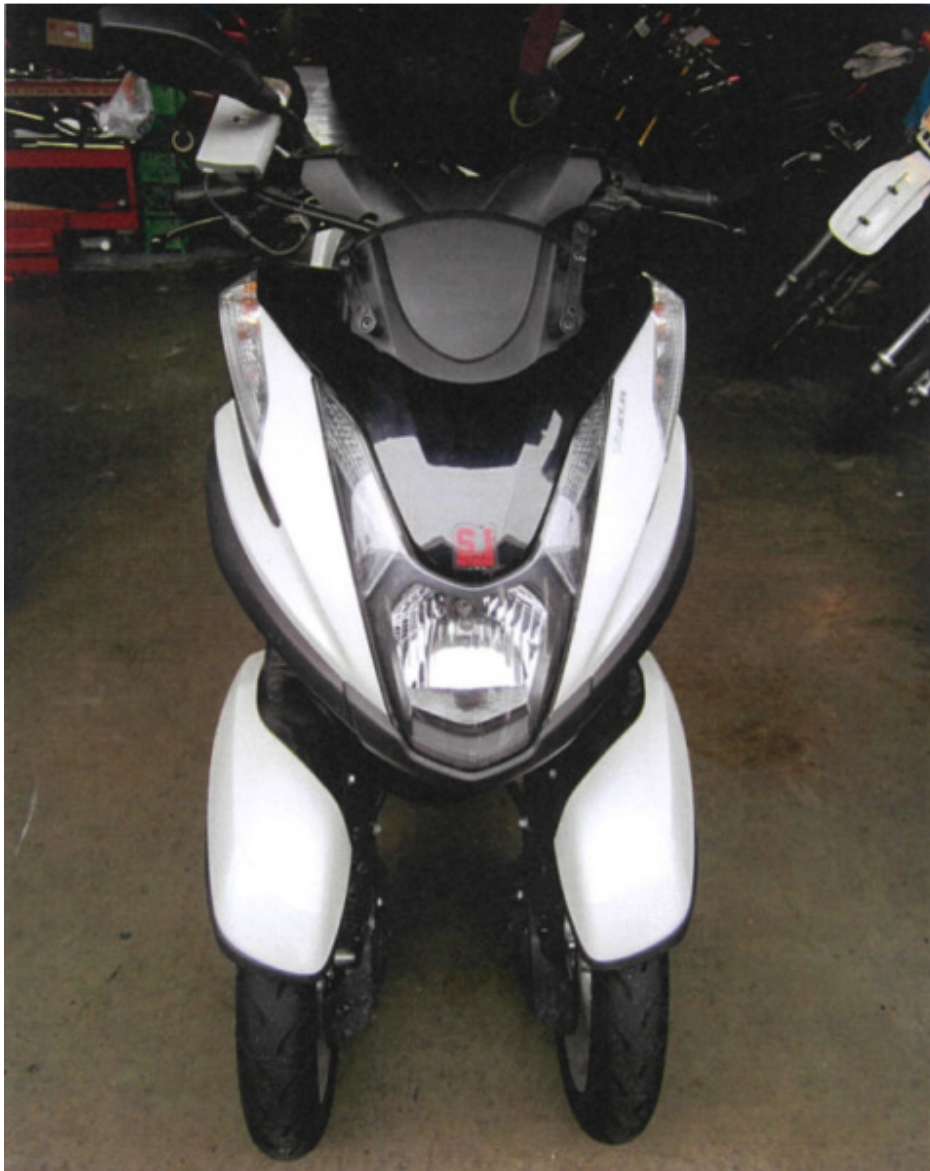
**Photo 7** shows a frontal view of the Motorcycle, which is a tri-wheel type of motorcycle. Such type of motorcycle is generally more stable in terms of road handling as compared to a 2-wheel motorcycle. This is another factor that does not seem to suggest that it was possible for the Motorcycle to self-skid at the material time, especially when travelling along a straight stretch of roadway.

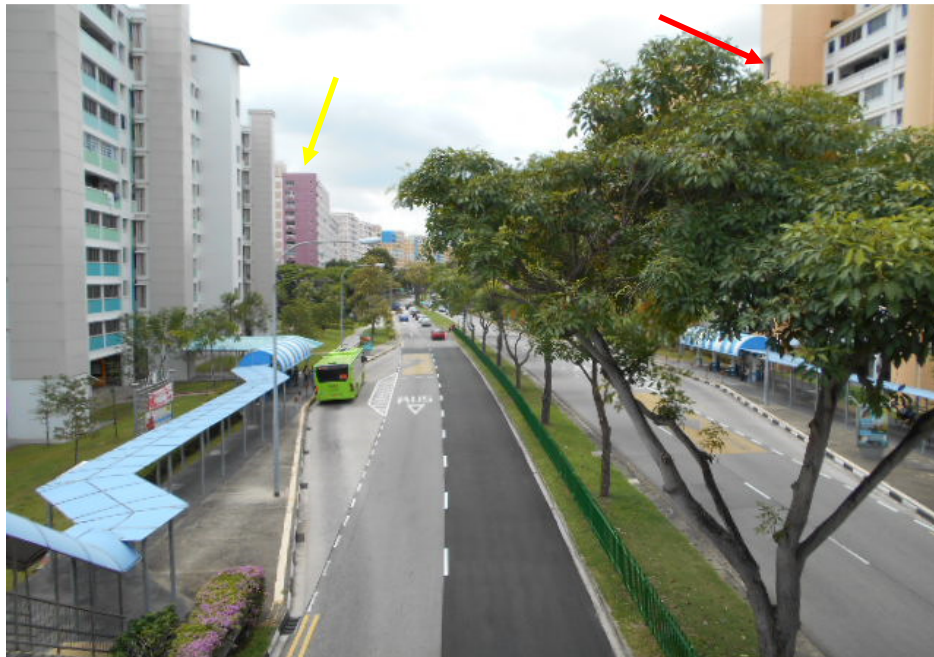
**Photo 8** shows a general view of the stretch of roadway of Pasir Ris Drive 1 towards Pasir Ris Drive 12, between Block 547 (yellow arrow) and Block 425 (red arrow). The stretch of road was observed to be relatively straight.

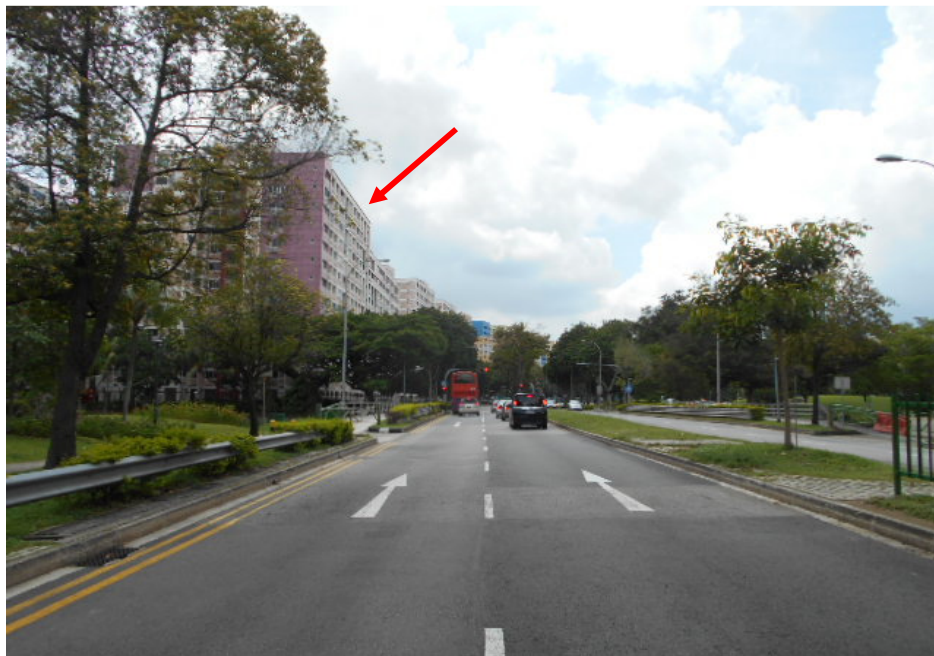
**Photo 9** shows a general view of the stretch of roadway of Pasir Ris Drive 1 towards Pasir Ris Drive 12, nearer to Block 547 (arrowed). The stretch of road was observed to be relatively straight. There appears to be no reasonable reason(s) for the Motorcycle, whilst travelling along this stretch of roadway, to self-skid unlike along a bend or a corner, where a motorcycle may possibly skid if understeered or oversteered.

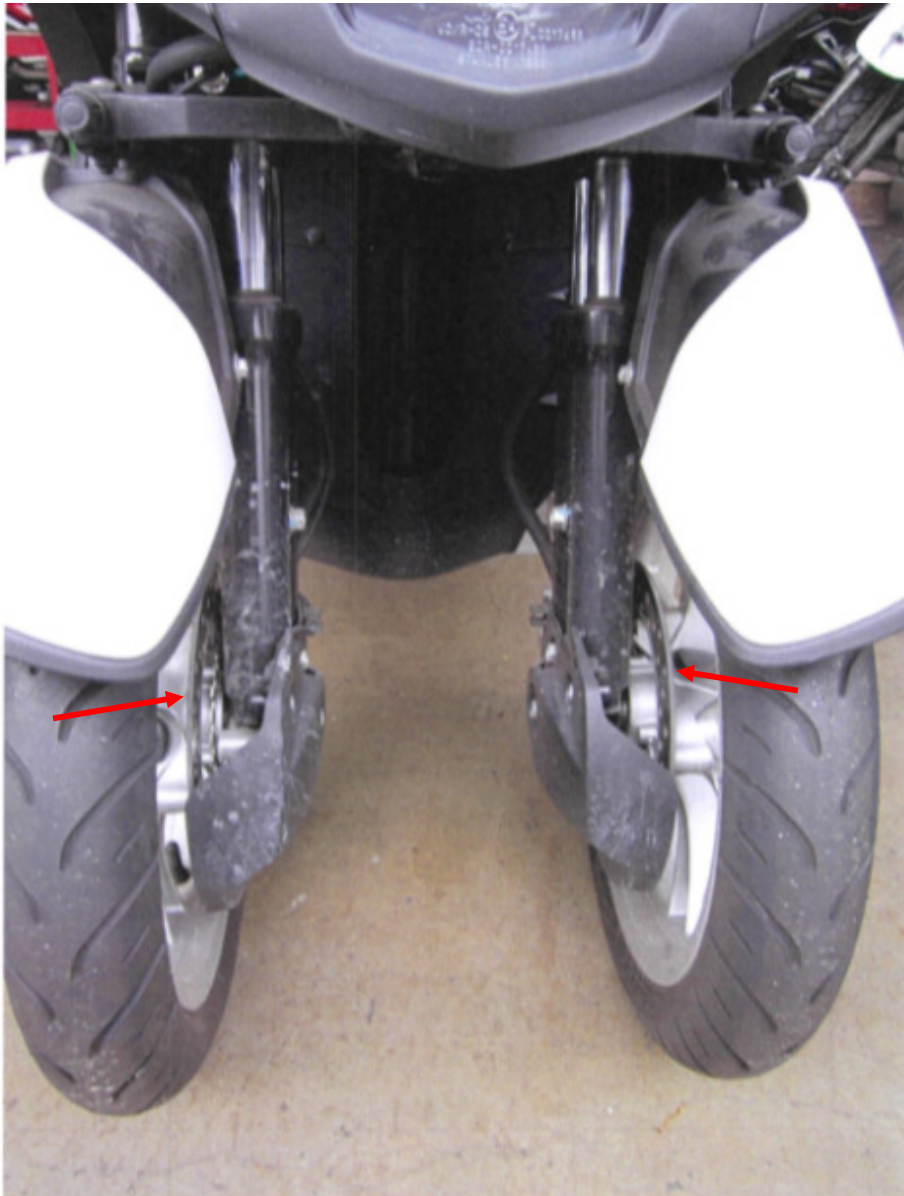
33. On the other hand, if Madam Aini had applied hard braking (emergency brake) in an accident avoidance situation, then it would have been possible for her to be flung forward without any eventual collision. I note that the braking system of the Motorcycle was of hydraulic pressure type with brake disc at all the wheels. The braking efficiency to the front of the Motorcycle was more efficient as compared to the rear given that there were 2 wheels at the front and 1 wheel at the rear.

34. To put things into perspective, in a 100% braking efficiency, each wheel of the Motorcycle would have approximately 33% of braking efficiency. In total, the front of the Motorcycle would have approximately 66% braking efficiency compared to approximately 33% to the rear. The ability to stop the rotation (moving) of the front wheels would therefore be approximately double ie the front wheels would stop much quicker than the rear wheels. When hard braking, this could result in the rear of the Motorcycle lifting upwards as the front wheels slows and stops faster than the rear wheels, ultimately leading to Madam Aini being flung forward.

**Photo 10** shows a frontal view of the Motorcycle. The braking system of the Motorcycle was of hydraulic pressure type with brake disc at all the wheels. The front wheels of the Motorcycle will stop rotating faster as compared to the rear wheel given that the frontal wheels are individually fitted with its own brake disc (arrowed).

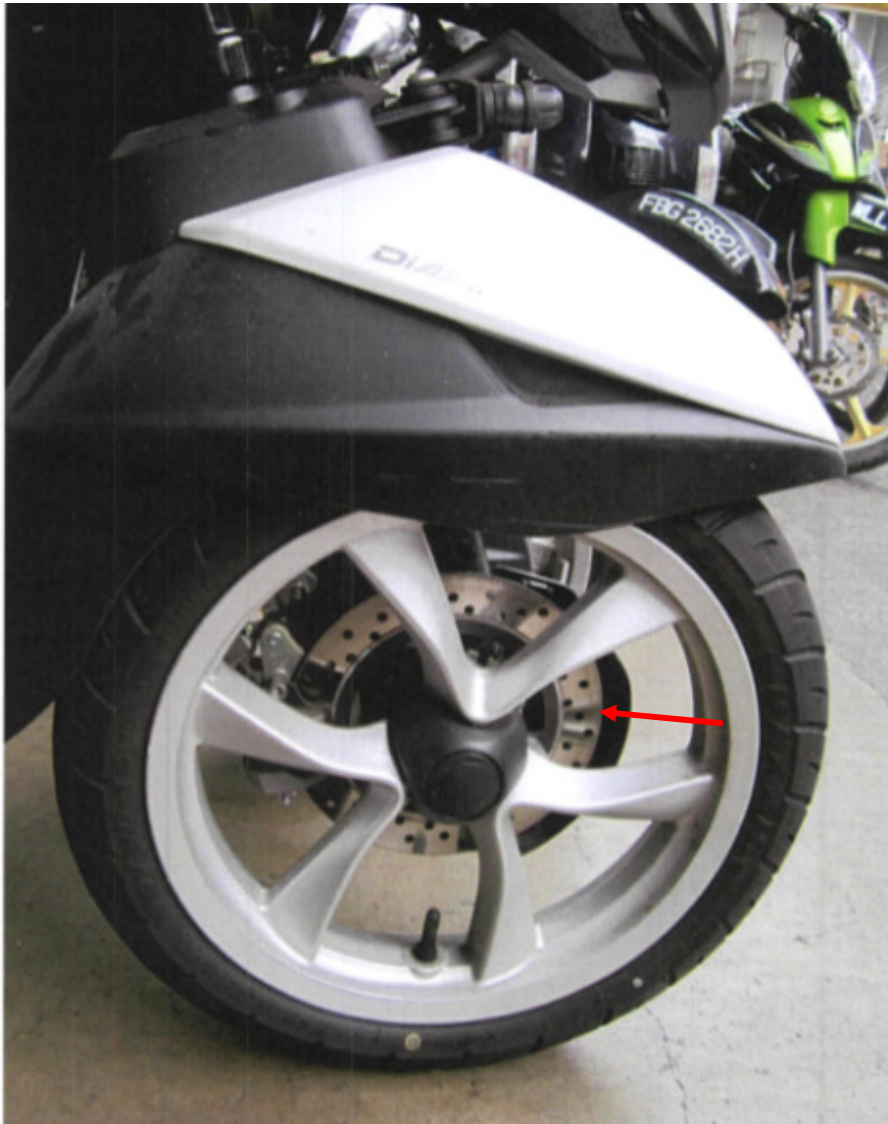
**Photo 11** shows the brake disc (arrowed) at the front right wheel of the Motorcycle. The front left wheel and rear wheel of the Motorcycle were similarly fitted with such brake disc as part of the Motorcycle's braking system.
