Your Ref : 0751639458SG  
Our Ref : CS/AIG18019712/D

**AUTOMOBILE TECHNICAL INVESTIGATION REPORT OF INCIDENT  
INVOLVING SLK 3868T AND SJS 1599P ON 21 OCTOBER 2018**

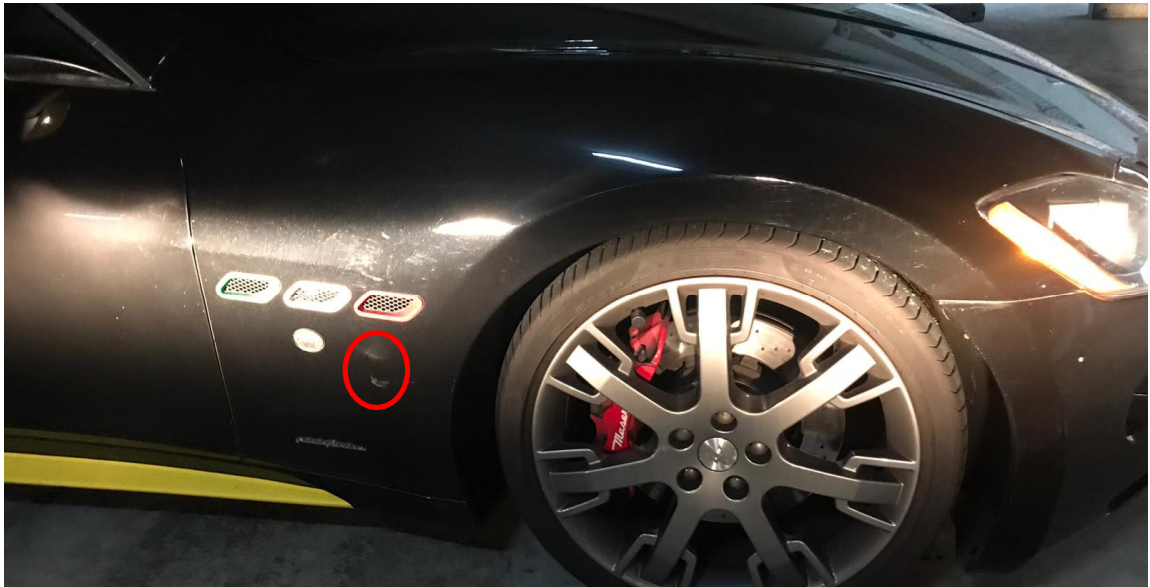
6. The damage to the Third Party Vehicle could not be clearly seen from the 27 coloured photographs of the Third Party Vehicle attached in the Automobile Inspection Report of SK Auto Consultants, and from the 15 coloured photographs taken by LKK Auto Consultants Pte Ltd. My close examination of the 3 coloured photographs showing the Third Party Vehicle at the incident scene had however, revealed what appears to be an "L" shape imprint mark on the lower area of its front right fender, just after the front right wheel. No other damage was seen from the photographs that I had reviewed.

**Photo 1** shows a general view of the front right body of the Third Party Vehicle at the incident scene. From the photographs at the incident scene, I had observed what appears to be an “L” shape imprint mark on the lower area of its front right fender (circled), just after the front right wheel. No other damage was seen from the photographs that I had reviewed.

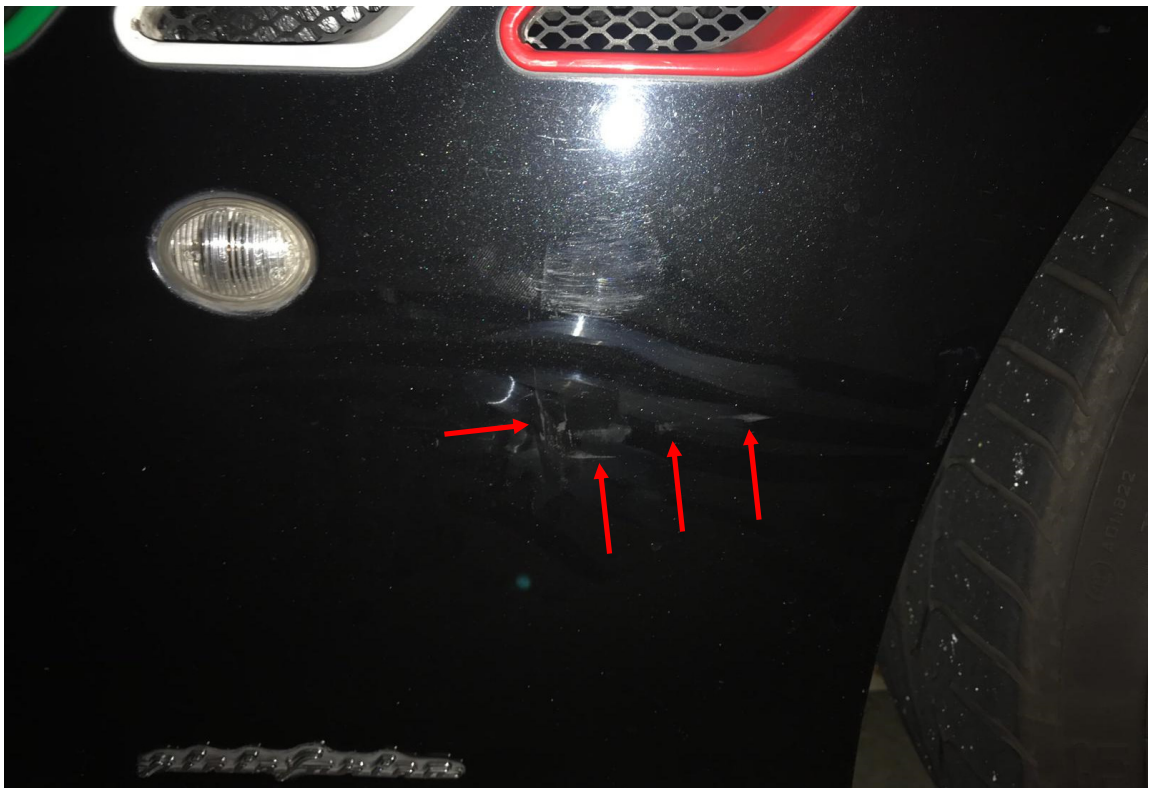
7. In general, the physical damage observed on the Third Party Vehicle suggests that it had sustained an impact directly onto its front right fender. The "L" shape imprint mark was a result of a load/force from a similarly shaped object pressing onto the front right fender, in a right to left direction. This load/force was relatively light. See photo 1 – 3 below.

**Photo 2** shows a closer view of the damaged area where the “L” shape imprint mark (arrowed) was found on the front right fender of the Third Party Vehicle. The imprint mark was a result of a load/force from a similarly shaped object pressing onto the front right fender, in a right to left direction.

- b) comparing this measured height with the front right fender of the Third Party Vehicle, I note that the height above ground level of the bottom horizontal end of the Insured Vehicle's front number plate casing (42cm) was at a similar height above ground level to where the "L" shape imprint mark was found (refer to photograph 2 & 3 above);

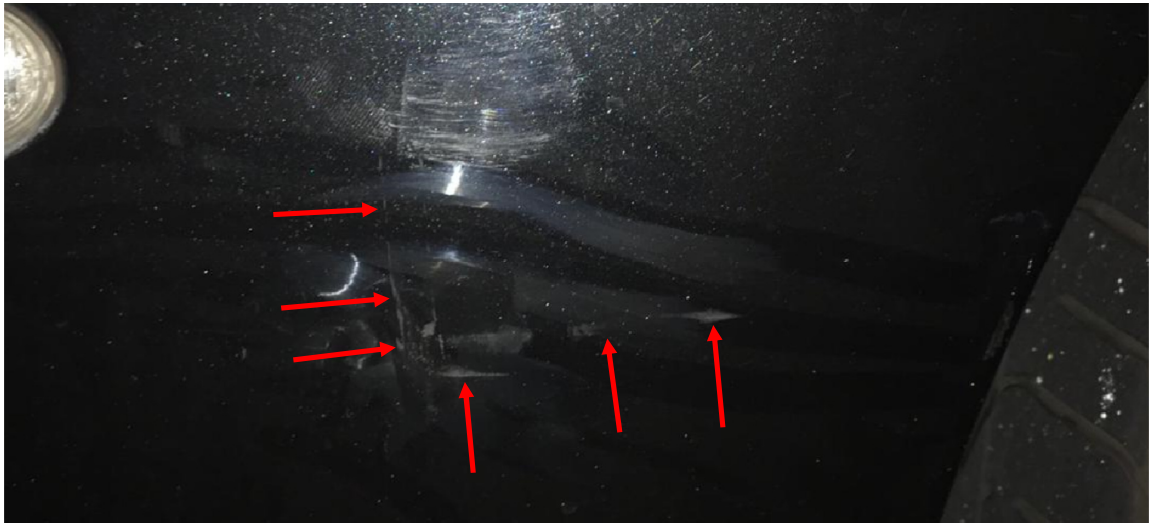
**Photo 3** shows a close-up/zoom in view of the “L” shape imprint mark (arrowed) which was caused by a load/force from a similarly shaped object pressing onto the front right fender of the Third Party Vehicle, in a right to left direction.

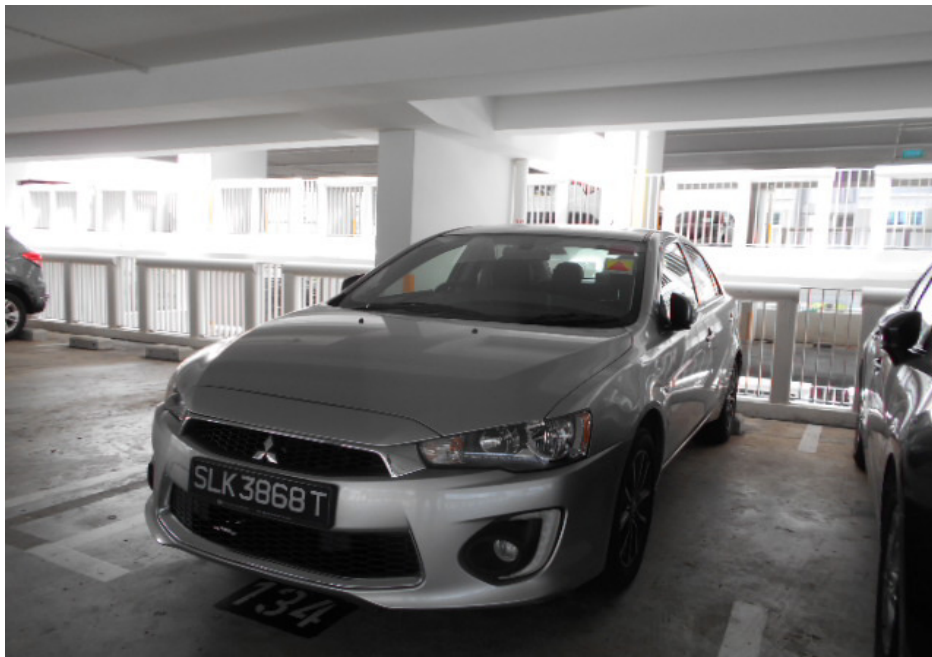
**Photo 4** shows a general view of the front left body of the Insured Vehicle at the time of my inspection. The inspection carried out had primarily focused on the frontal body of the Insured Vehicle, as the incident was reported to be of a head to side nature where the Insured Vehicle was on the right side of the Third Party Vehicle at the material time. The mileage of the Insured Vehicle at the time of my inspection was recorded to be 25,405km.

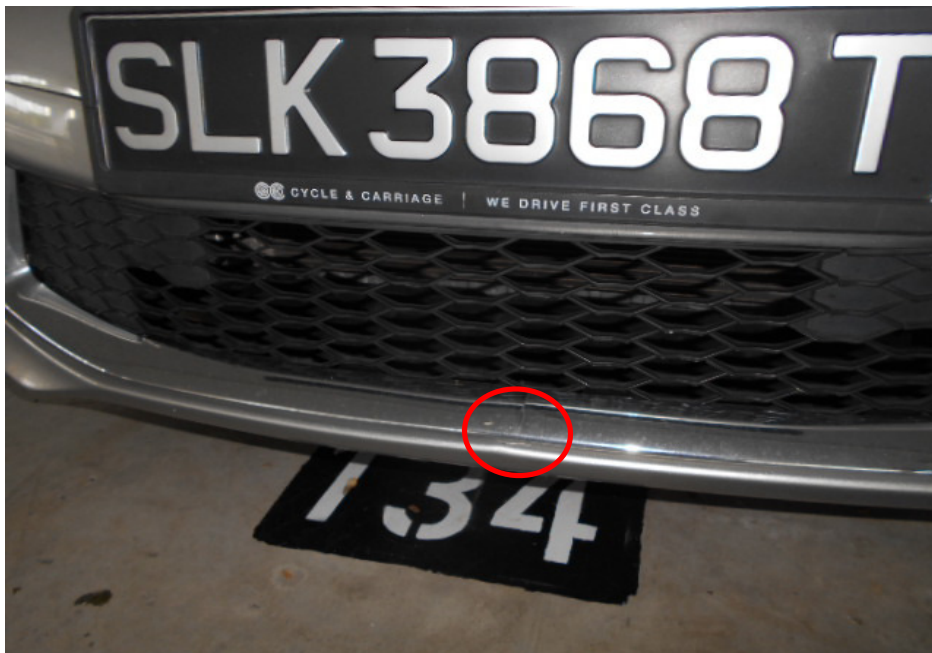
9. The lower area of the Insured Vehicle's front bumper was observed to be distorted. This was at the centre of the front bumper, in front of the front bumper lower grille. The front bumper lower grille chrome moulding was also observed to be cracked at the same distorted area of the front bumper. The front number plate casing and front number plate were also slightly bent at the area adjacent to its bottom left corner. See photo 4 – 7 below

**Photo 5** shows a general view of the lower area of the Insured Vehicle's front centre. The front bumper was observed to be distorted while the front bumper lower grille chrome moulding was observed to be cracked. These damages were at the same area of the Insured Vehicle ie front centre lower area (circled).

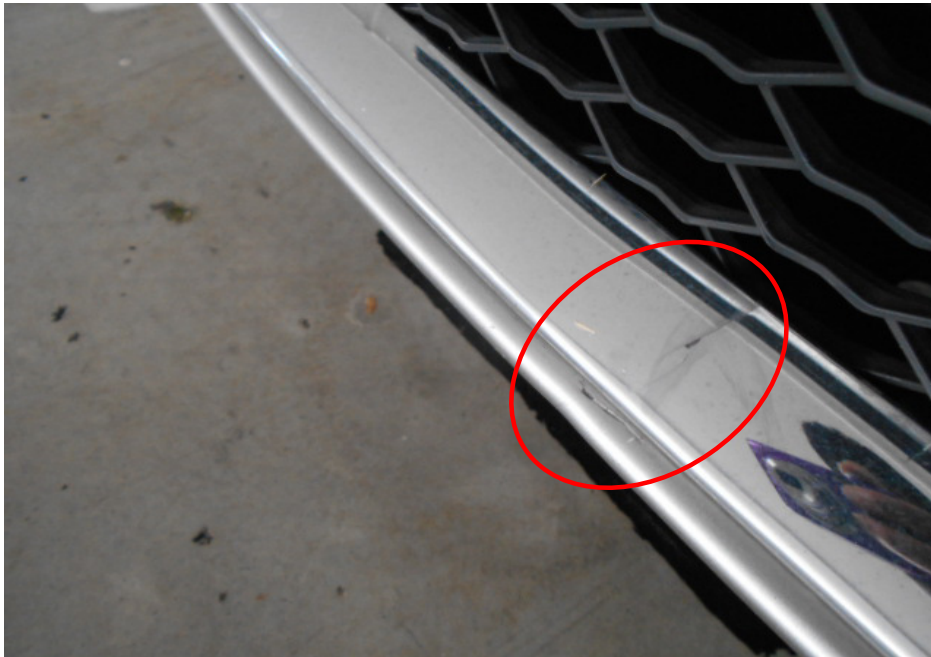
**Photo 6** shows a closer view of the distorted front bumper and cracked front bumper lower grille chrome moulding (circled). These damages were at the front centre lower area of the Insured Vehicle.

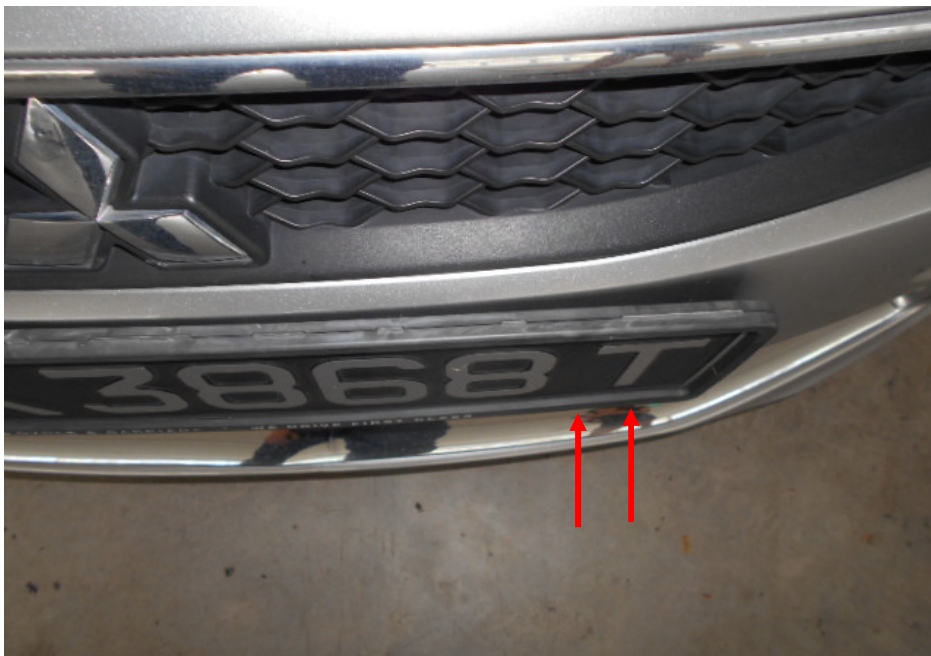
**Photo 7** shows the bent front number plate and front number plate casing (arrowed) of the Insured Vehicle. This was at the left side of the front number plate, adjacent to the bottom left corner.

11. My focus of the Insured Vehicle's front number plate was due to the shape of the "L" imprint mark on the Third Party Vehicle's front right fender corresponding to the shape of the front number plate casing, at the bottom left corner edge where the bottom horizontal end of the front number plate casing joins the vertical end of the front number plate casing.

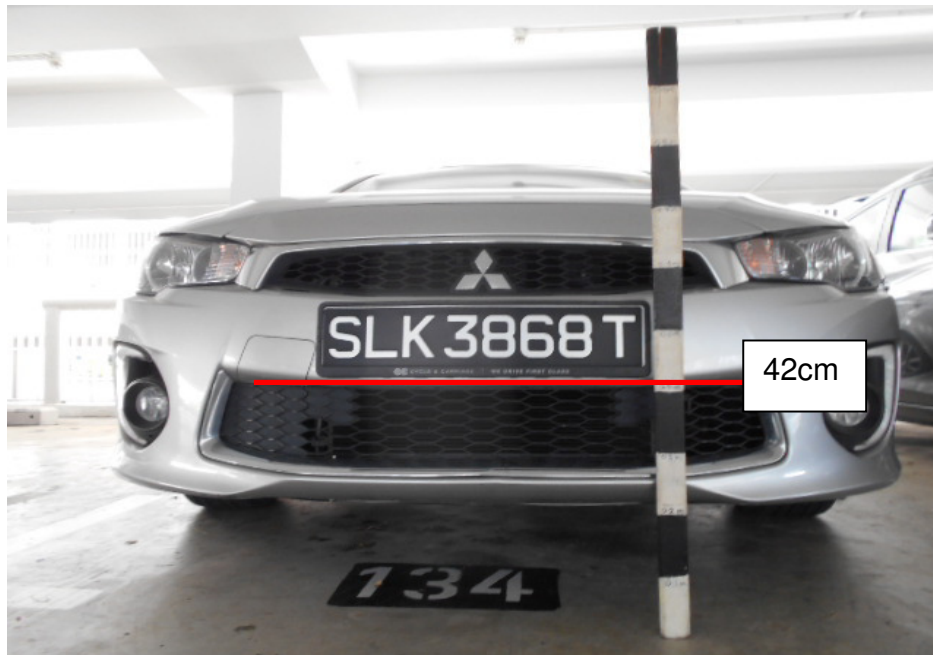
12. I now set out below the findings gathered following the height measurements that was conducted: -
  - a) the height of the bottom horizontal end of the Insured Vehicle's front number plate casing was measured to be approximately 42cm above ground level;

- c) the measurements carried out appear to then indicate that the "L" shape imprint mark found on the front right fender of the Third Party Vehicle was caused by contact from the front number plate casing of the Insured Vehicle. See photo 8 & 9 below.

**Photo 8** shows the height measurement that was conducted on the frontal body of the Insured Vehicle. The bottom horizontal end of the Insured Vehicle's front number plate casing was measured to be approximately 42cm above ground level.

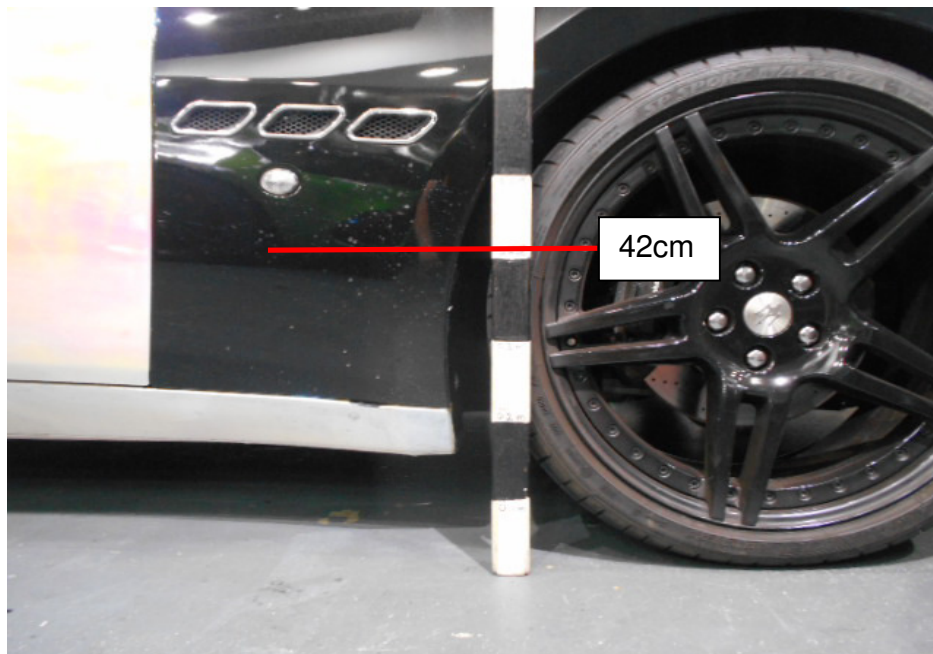
**Photo 9** shows the height measurement that was conducted on the front right fender of a similar make and model vehicle as the Third Party Vehicle. The height of the bottom horizontal end of the Insured Vehicle's front number plate casing (42cm) was at a similar height above ground level on the Third Party Vehicle where the "L" shape imprint mark on its front right fender was found (refer to photograph 2 & 3 above).

13. Having investigated and technically analyzing the material evidence available at the time of writing this report, I am of the opinion that there was contact between the frontal body of the Insured Vehicle and the front right body of the Third Party Vehicle at the material time of incident. The contact was between the front number plate of the Insured Vehicle and the front right fender of the Third Party Vehicle.
14. I am also of the opinion that the impact force from the contact was relatively light, resulting in a 'L' shape imprint mark to be formed on the front right fender of the Third Party Vehicle.
