Your Ref: C10002188
Our Ref :CS/AGI18019736/D

16 November 2018

**DAMAGE CONSISTENCY REPORT OF INSURED VEHICLE SKS 6234Y
INVOLVED IN A FLOOD INCIDENT ON 28 OCTOBER 2018**

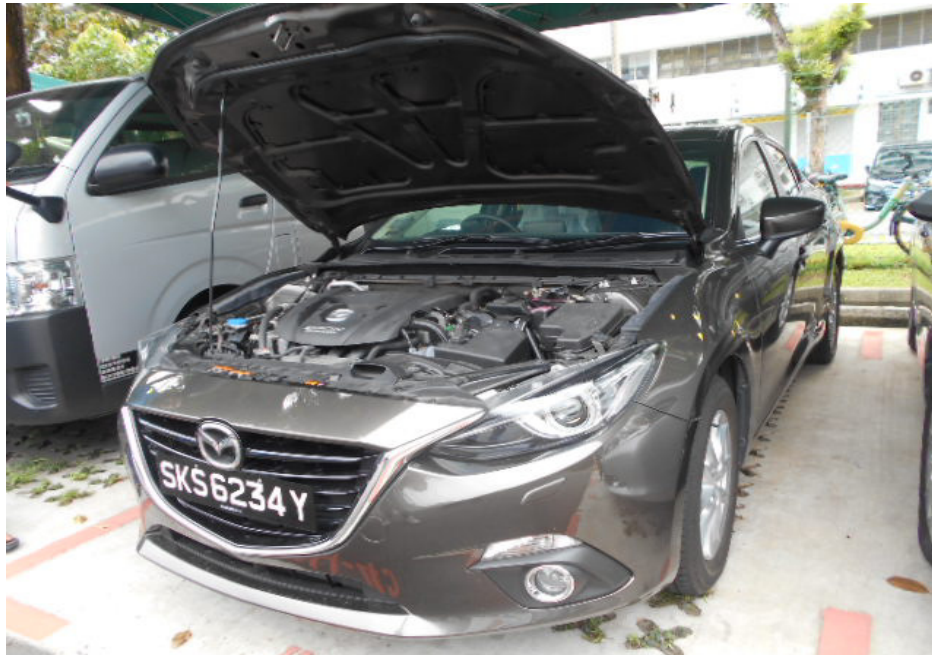
Photo 1 shows a general view of the front left body of the Insured Vehicle. Generally, the Insured Vehicle was found to be in good condition at the time of my inspection.

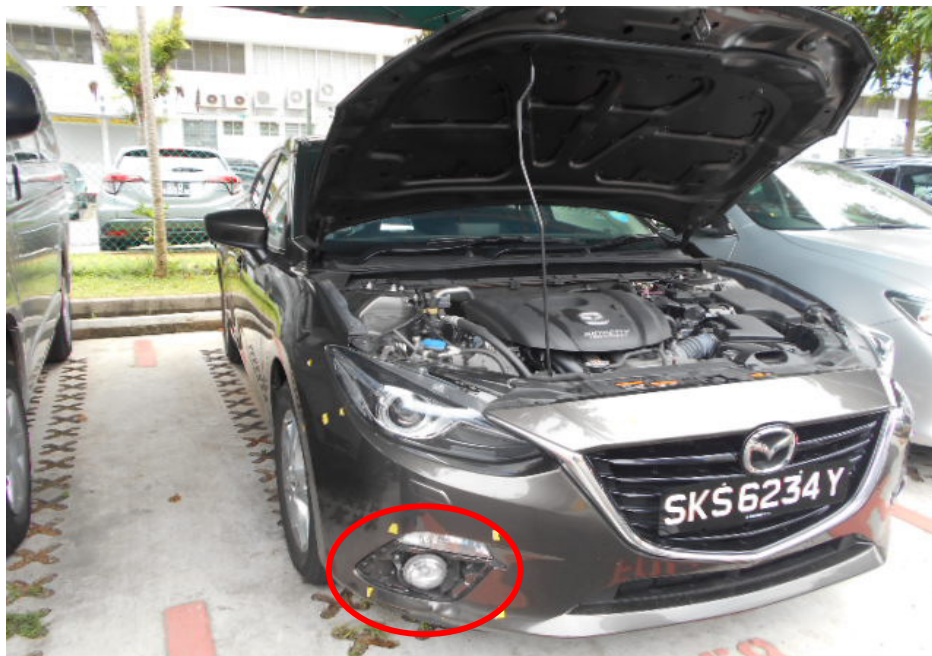
3. The Insured Vehicle was observed to be of good general condition at the time of my inspection. Its right front fog lamp garnish was observed to be dislodged. Its front bumper, at the area directly below the right front fog lamp, was also observed to be deformed/dented.

Photo 2 shows a general view of the front right body of the Insured Vehicle. Its right front fog lamp garnish was observed to be dislodged. Its front bumper, at the area directly below the right front fog lamp, was also observed to be deformed/dented (circled).

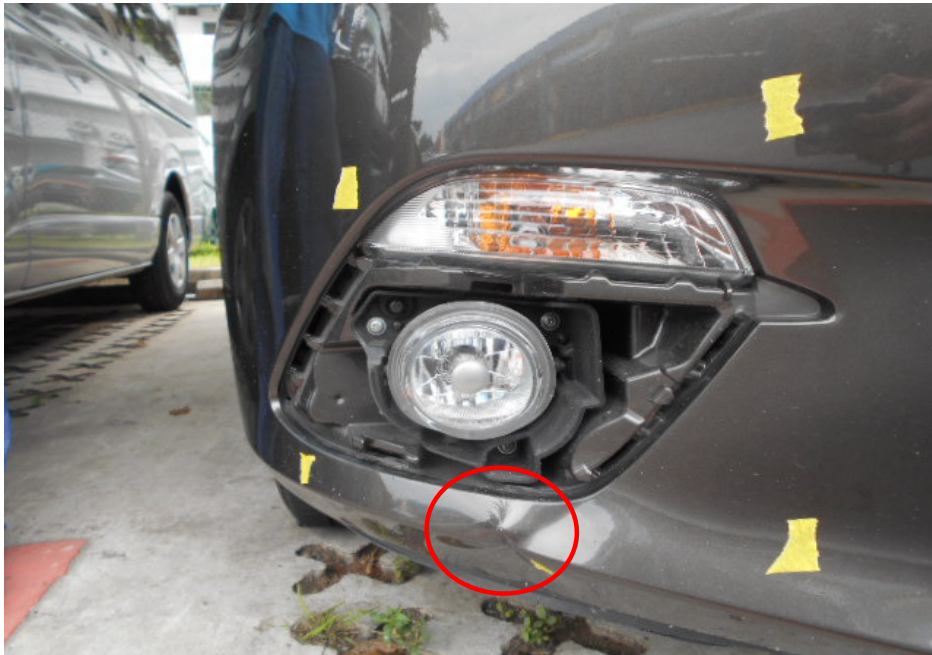
Photo 3 shows a closer view of the dislodged right front fog lamp garnish and deformed/dented (circled) front bumper, at the area directly below the right front fog lamp.

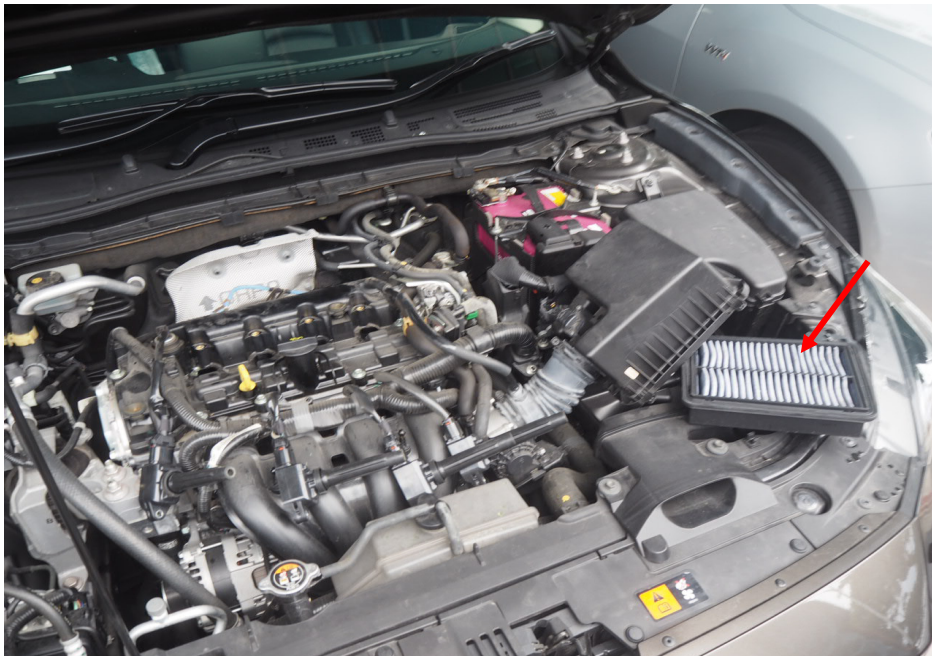
Photo 4 shows a general view of the Insured Vehicle's engine compartment. The air filter (arrowed) was checked for sign(s) or indication(s) of involvement in a flood incident.

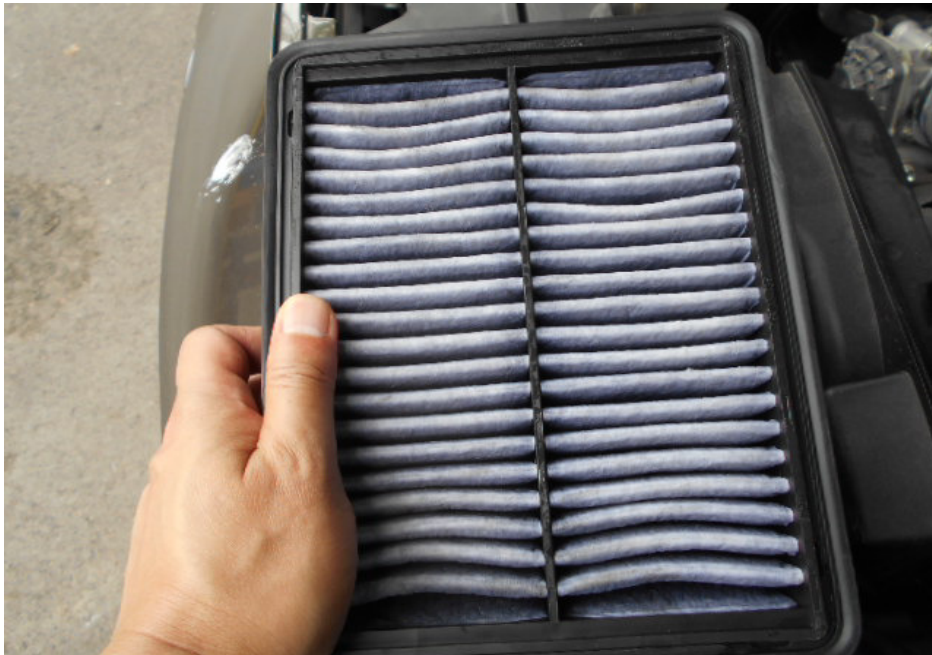
4. Upon checking for sign(s) or indication(s) of involvement in a flood incident, the top cover of the Insured Vehicle's air filter housing was removed. At which point, I found the air filter to be damp. The spark plugs were also subsequently removed and were similarly found to be damp. The physical condition of the air filter and spark plugs seen on the Insured Vehicle can be relied on to establish that the Insured Vehicle was indeed involved in a flood incident.

Photo 5 shows a closer view of the air filter of the Insured Vehicle. The air filter was found to be damp, which was one of the signs observed at the time of my inspection that indicate the Insured Vehicle was indeed involved in a flood incident.

12. The damp air filter and damp spark plugs further indicate that water had entered the engine of the Insured Vehicle. From the recorded statement of the owner/driver, the Insured Vehicle had stalled as it was being driven through the flood. The reason for the stall was likely due to the spark plug, which was no longer able to create a spark (ignition) for the combustion process because it was wet.

13. Water was able to reach the spark plugs through the air intake system of the Insured Vehicle, evident from the damp air filter. During engine operation, air is "sucked" into the engine, travelling through the air filter, to form a mixture with the fuel for combustion. At the material time of incident, water and air was sucked into the engine, wetting the air filter as it passes through into the intake manifold of the engine.

17. The physical evidence found on the Insured Vehicle at the time of my inspection on 30 October 2018 indicates that water had entered the engine. For such type of damage, the mechanical components inside the engine like the connecting rod, crank shaft, piston etc are recommended to be replaced in order to prevent these components from sudden failure (breaking) during engine operation.

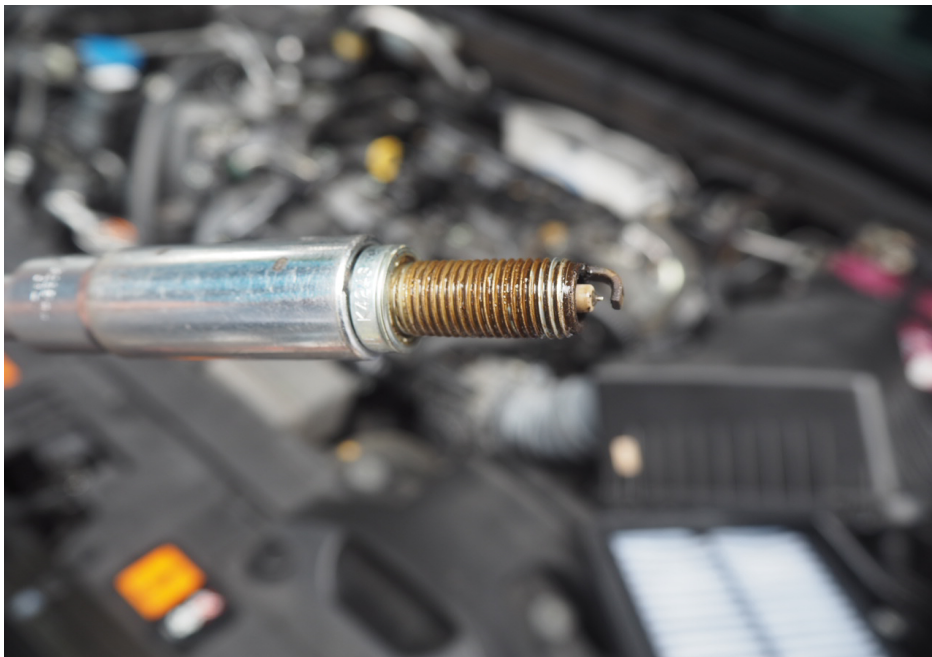
Photo 6 shows a close view of the Insured Vehicle's spark plugs. The spark plugs were seen covered with water, indicating that the Insured Vehicle was involved in a flood incident.

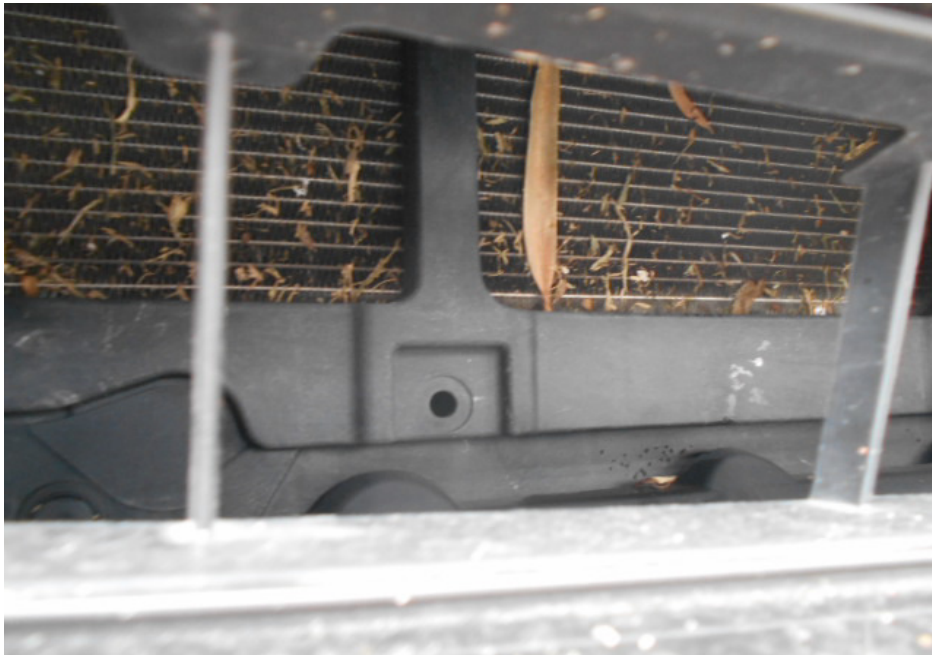
Photo 7 shows the dried leaves that were all trapped on the fins of the air condenser of the Insured Vehicle. The condition of the air condenser corresponds to the Insured Vehicle being involved in a flood incident.

15. Considering that dried leaves were found trapped on the lower part of the air condenser (at the lower part of the front grille height), it is likely that water had entered the engine of the Insured Vehicle from the opening that is located at the lower part of the front bumper, since the height of this opening was approximately around the same height. Refer to photograph 7 above.

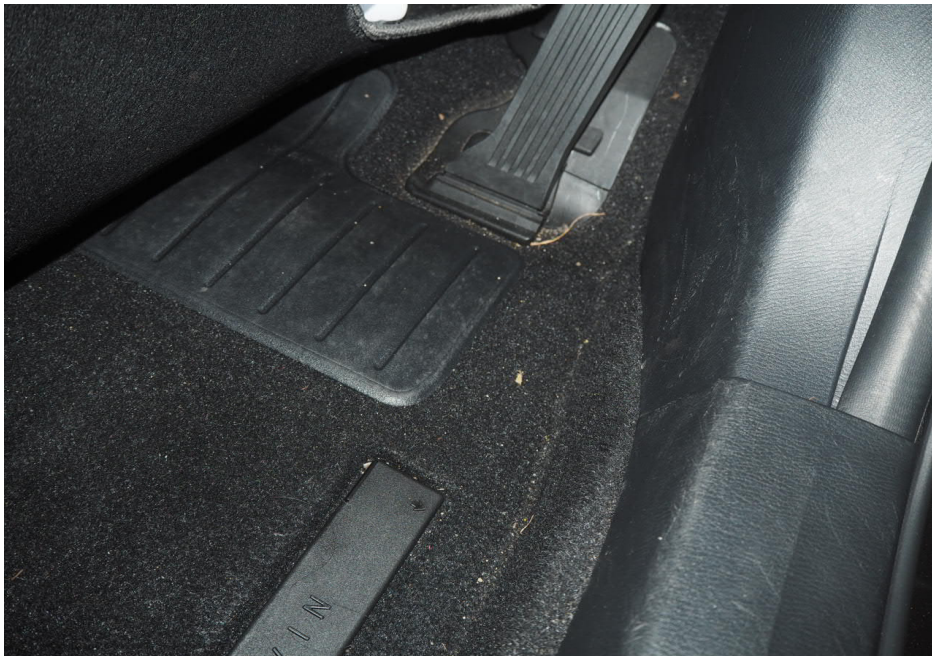
Photo 8 shows the upholstery at the driver's side of the Insured Vehicle. The upholstery was damp at the time of my inspection. This was another observation gathered from my inspection of the Insured Vehicle that corresponds to its involvement in a flood incident.

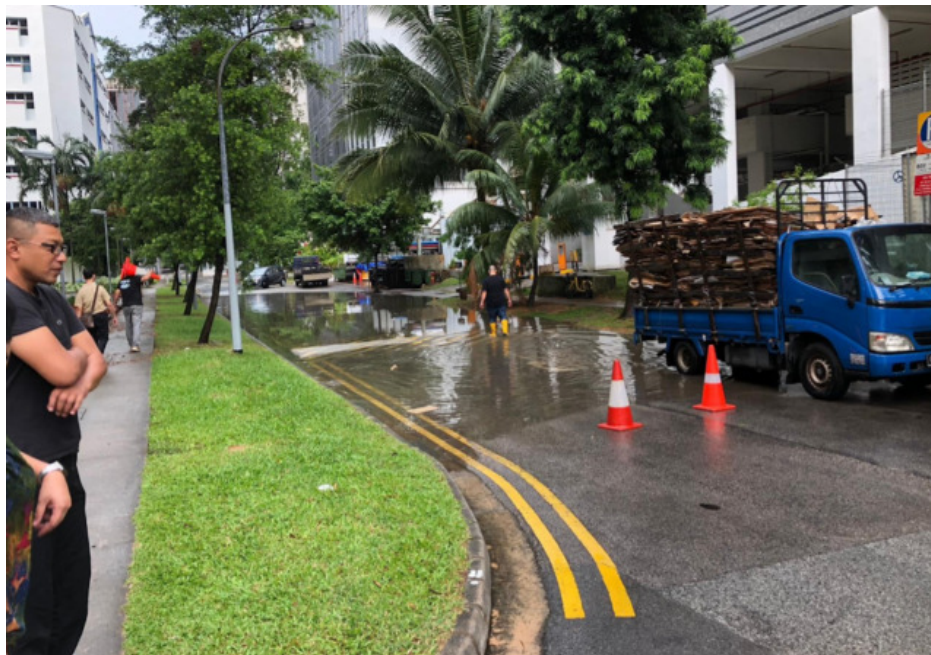
8. The Scene Investigation Report dated 01 November 2018 by M/s A-PAC Investigation Solutions Pte Ltd had contained a photograph that was taken at the incident location after the rain had stopped. From this photograph, it can be seen that the entire width of the roadway was covered with raised level of water (flooded). The water had covered about 30m of the stretch of road. See photo 9 below.

Photo 9 shows the photograph of the incident location that was contained in the Scene Investigation Report dated 01 November 2018 by M/s A-PAC Investigation Solutions Pte Ltd

9. It was also observed from the photograph that the top surface of a road hump was still visible and not covered with water. This was subsequently used by M/s A-PAC Investigation Solutions Pte Ltd to measure the height of the raised level of water, which is a reasonable method of measurement ie by using a fixed object/road feature as reference. From the measurement, it was established that the raised water was approximately 9cm above road surface.

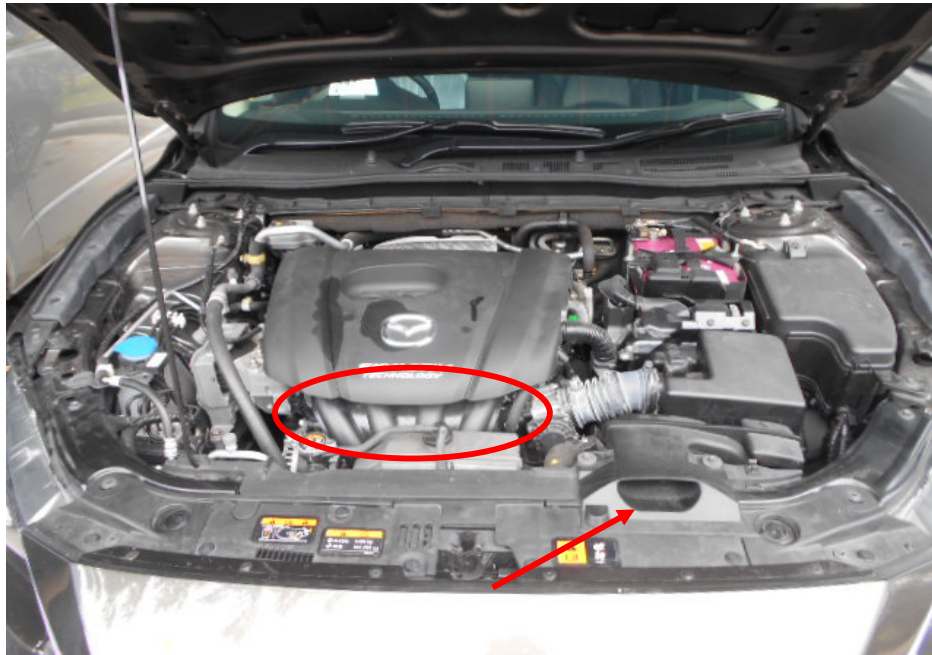
Photo 10 shows the air intake opening (arrowed) of the Insured Vehicle that is located at the front bonnet height. Air for engine combustion enters the intake manifold (circled) from this opening, which is one of 2 openings for such purpose.

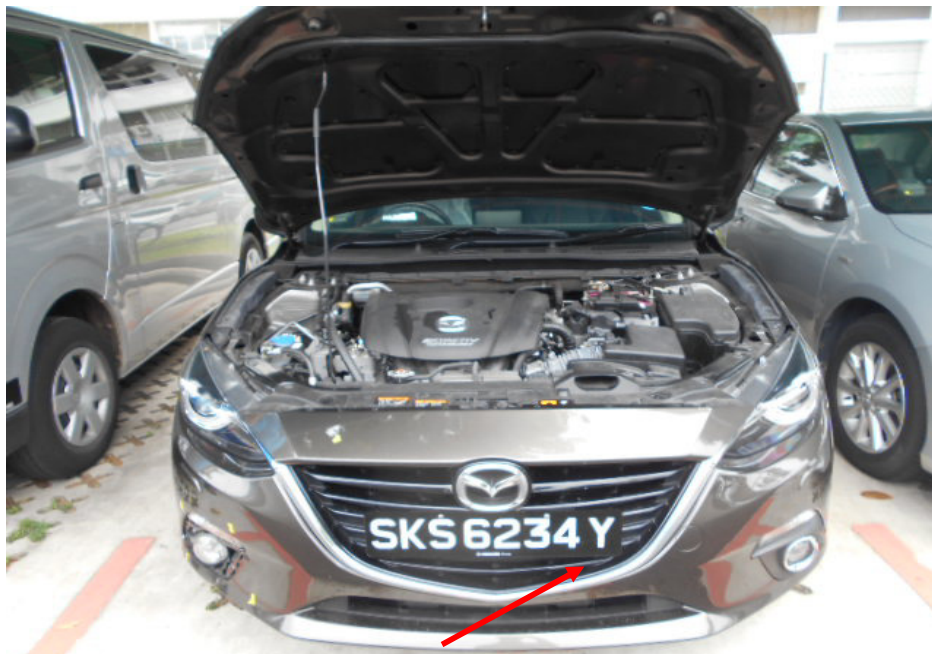
Photo 11 shows the approximate location where the other air intake opening of the Insured Vehicle is located. This was at the lower part of the front bumper (approximately arrowed), behind the radiator fan. Air for engine combustion enters the intake manifold from this opening, which is one of 2 openings for such purpose. Water had likely entered the engine of the Insured Vehicle from this opening given its relatively low height above ground level.
