Your Ref: Mercedes Benz C200
(chassis number WDD2052422F577627)
Our Ref : CI/TP18019747/D

30 October 2018

**INSPECTION REPORT OF AN UNREGISTERD MERCEDES BENZ C200
MOTOR CAR WITH CHASSIS NUMBER WDD2052422F577627**

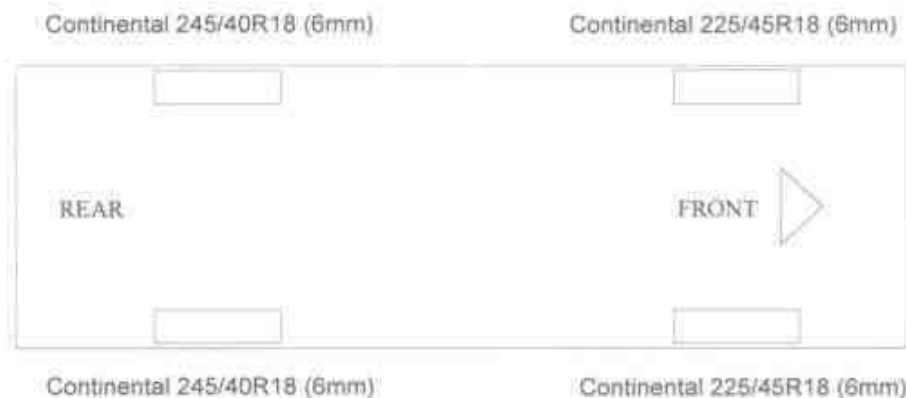
6. It was fitted with 18inch sport wheel rims that were wrapped with tyres that were observed to be of serviceable condition. The tyres were also sufficiently inflated for vehicular operation. The tyre brand, tyre size and approximate remaining tread depth of the 4 tyres of the Motor Car were recorded as follows: -

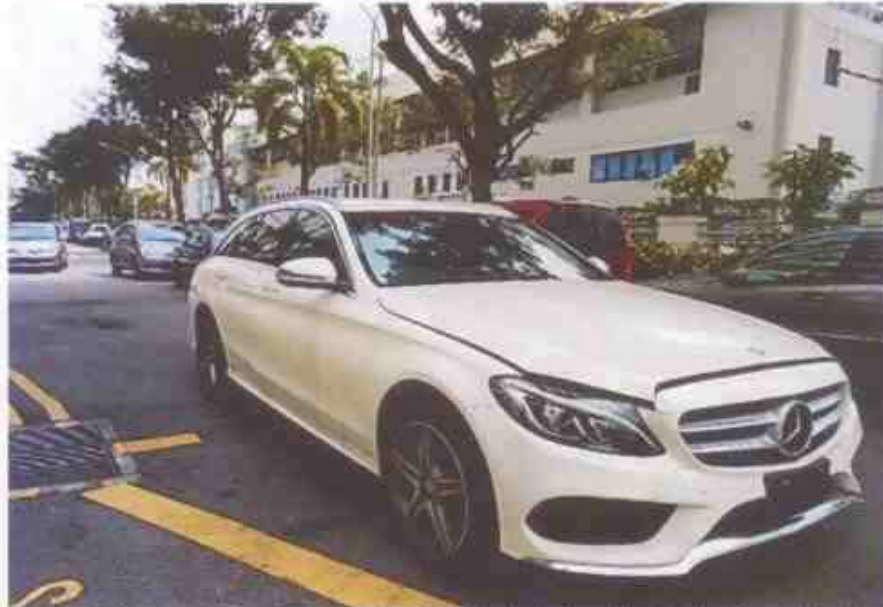
Photo 1 shows a general view of the front right body of the Motor Car at the time of my inspection. The Motor Car was observed to be in relatively good general condition with no loose exterior fittings observed.

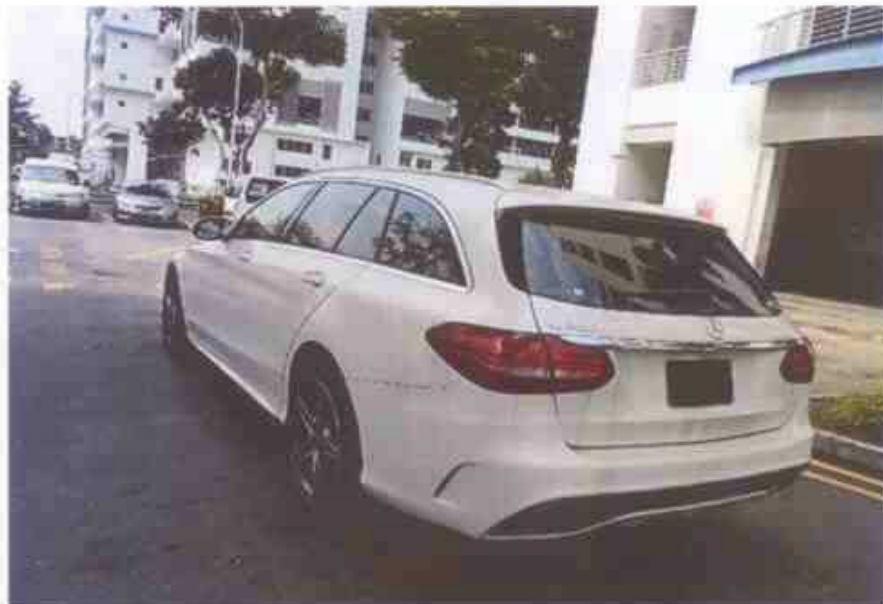
Photo 2 shows a general view of the rear left body of the Motor Car at the time of my inspection. The Motor Car was observed to be in relatively good general condition with no loose exterior fittings observed.

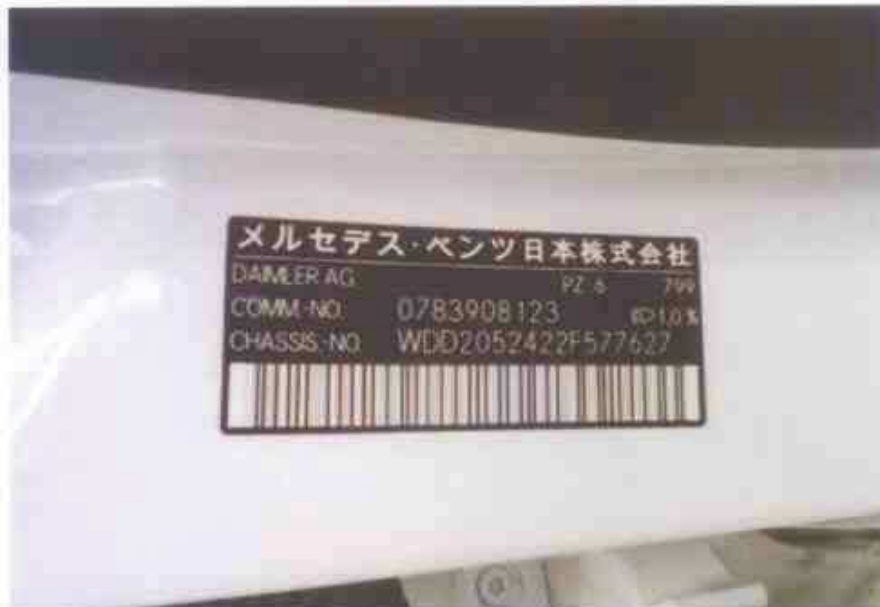
Photo 3 shows the chassis number of the Motor Car. The chassis number recorded was WDD2052422F577627.

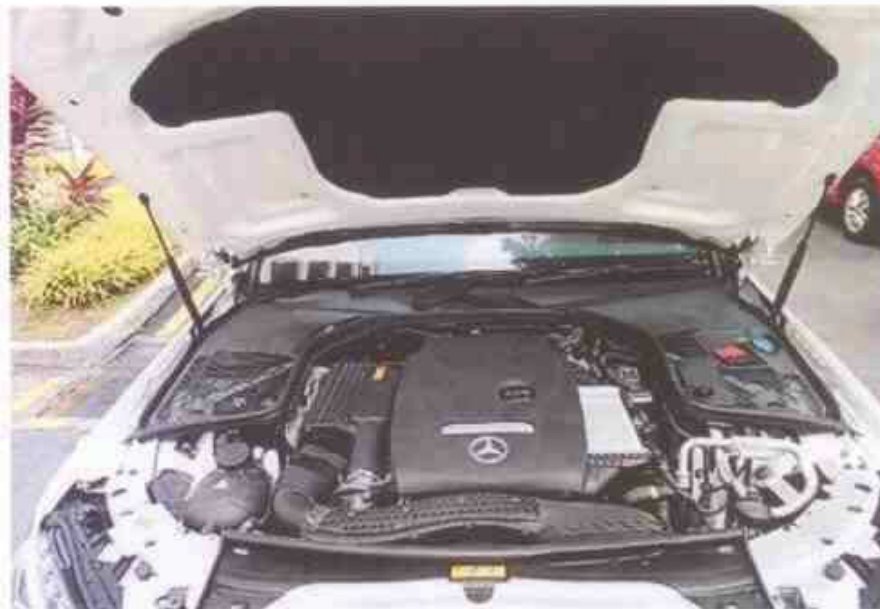
12. My examination of the engine compartment of the Motor Car revealed that the various parts and components inside the engine compartment were all intact and properly fitted. The engine oil, brake fluid and engine coolant were all found to be of sufficient level for operating purposes. Visually, there was also no contamination found to these fluids.
13. My checks on the underside of the Motor Car revealed no sign(s) or indication(s) of fluid leakage and/or fluid stain(s). The engine block and automatic transmission assembly were both secured properly. They were not mounted onto the chassis body or any integral body part of the Motor Car. All undercarriage components of the Motor Car were also observed to be intact and secured in an appropriate manner.

Photo 4 shows a general view of the engine compartment of the Motor Car at the time of my inspection. The various parts and components inside the engine compartment were all observed to be intact and properly fitted. There was also no sign(s) or indication(s) of fluid leak and/or fluid stain found inside the engine compartment. The engine oil, brake fluid and engine coolant were all found to be of sufficient level for operating purposes. Visually, there was also no contamination found to these fluids.

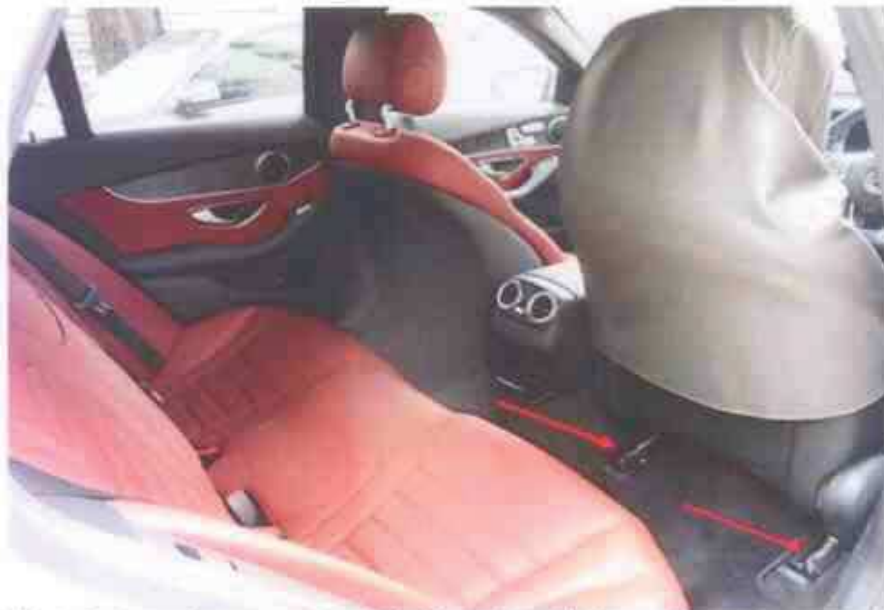
10. The seats of the Motor Car were found to be secured to the floor board of the Motor Car via seat rails bolted onto the floor board. Retractable seat belt reels and pre-tensioners were fitted on all seats of the Motor Car. The seat belt reels were able to be fastened securely to the respective pre-tensioner that is fixed to the side of all the seats.

Photo 5 shows the rear seats of the Motor Car. All the seats were secured via seat rails (arrowed) to the floor board. The seats were also fitted with a retractable seat belt reel and pre-tensioner. The seat belts were tested and able to be fastened to the pretensioners that were fitted on the side of each individual seat.

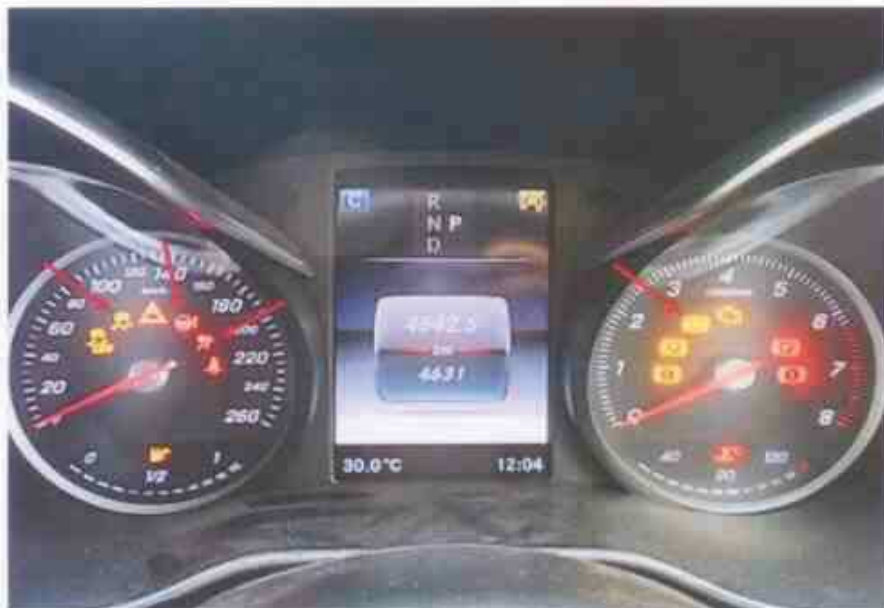
Photo 6 shows the warning lights for the various electronic safety features appearing on the instrument panel of the Motor Car during its self-test when the engine is cranked, in particular the ABS, SRS, PSA and TCS lights (arrowed).

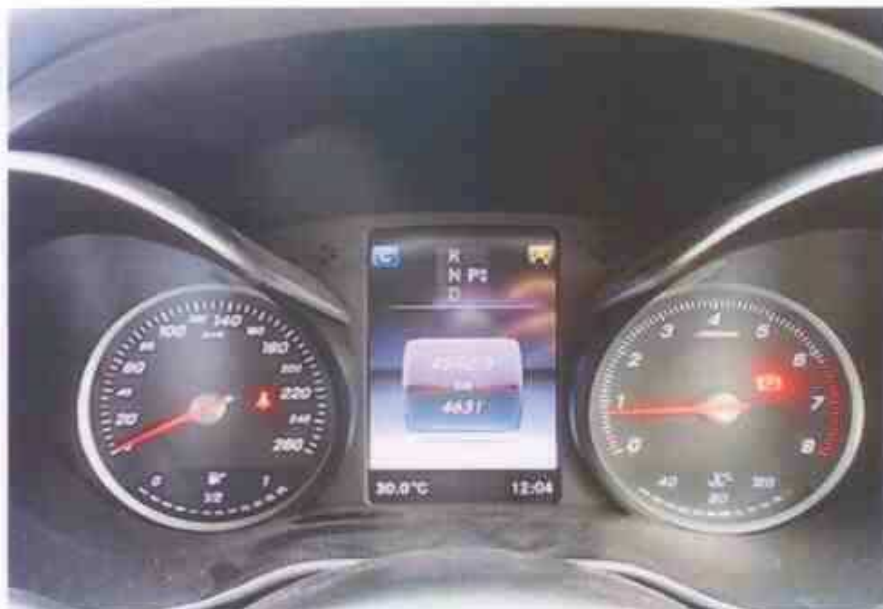
11. The Motor Car's automatic self-test of the functionality of its various electronic safety features like the Anti-Brake Lock System (ABS), Supplemental Restraint System (SRS), Power Steering Assist (PSA) and Traction Control System (TCS) during cranking of the engine had indicated that these electronic systems were in working condition. This was determined from the respective warning lights disappearing from the instrument panel after the self-test.

Photo 7 shows the respective warning lights no longer illuminated, indicating that there is no fault detected to the ABS, SRS, PSA and TCS systems of the Motor Car during the self-test. These electronic systems were hence in working condition at the time of my inspection.

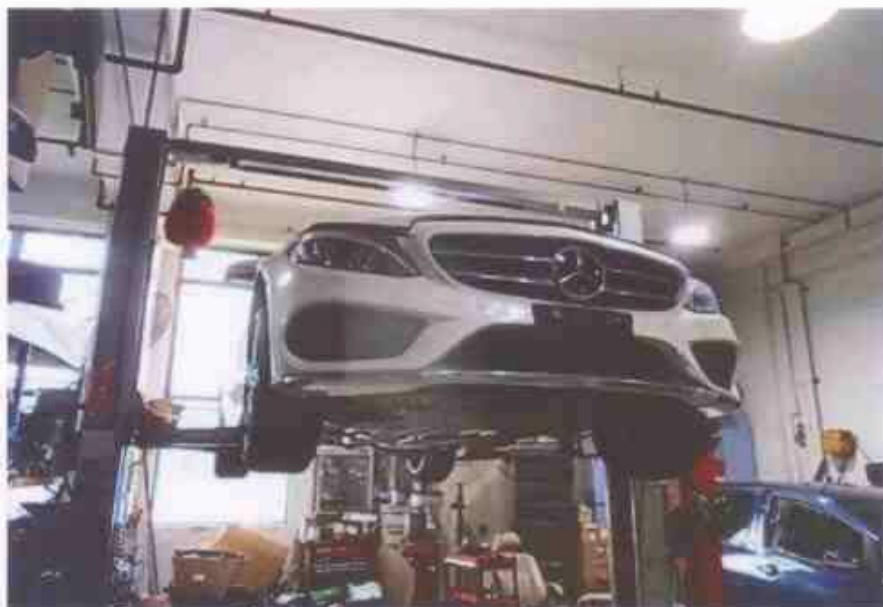
Photo 8 shows the Motor Car hoisted up for checks on its undercarriage. There was no sign(s) or indication(s) of fluid leakage and/or fluid stain(s). The undercarriage components of the Motor Car were also all observed to be intact and secured in an appropriate manner.

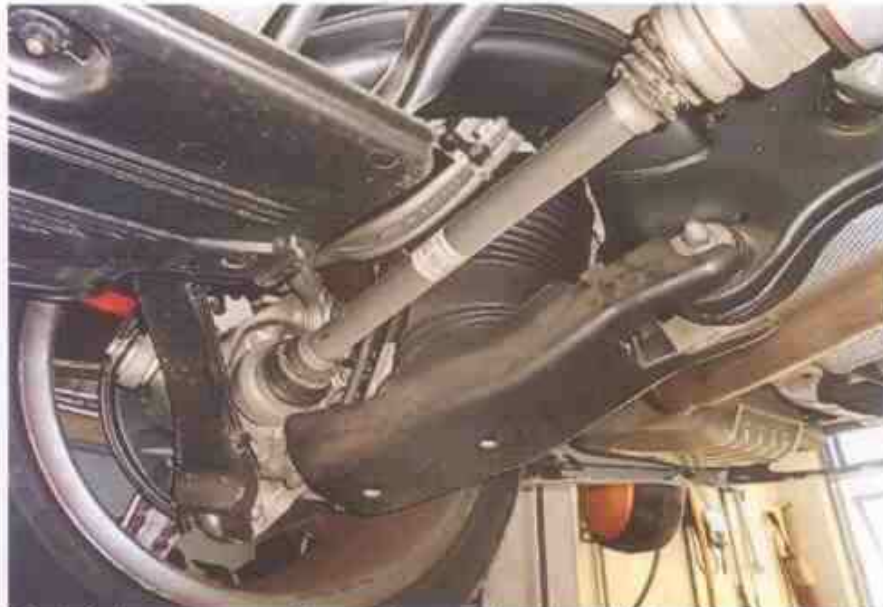
Photo 9 shows a general view of the control arms and linkages at the rear right wheel of the Motor Car. I did not observe any fluid leak and/or fluid stain on the underside of the Motor Car. All of the Motor Car's undercarriage components were observed to be intact and secured in an appropriate manner.

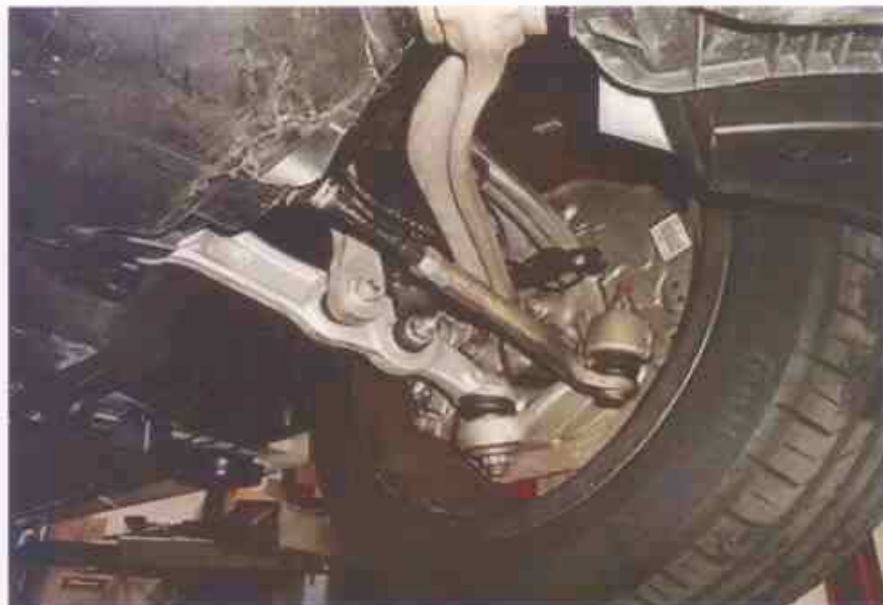
Photo 10 shows the various undercarriage components at the front left wheel of the Motor Car. The mechanical components, control arms and linkages were all found to be intact and secured in an appropriate manner.

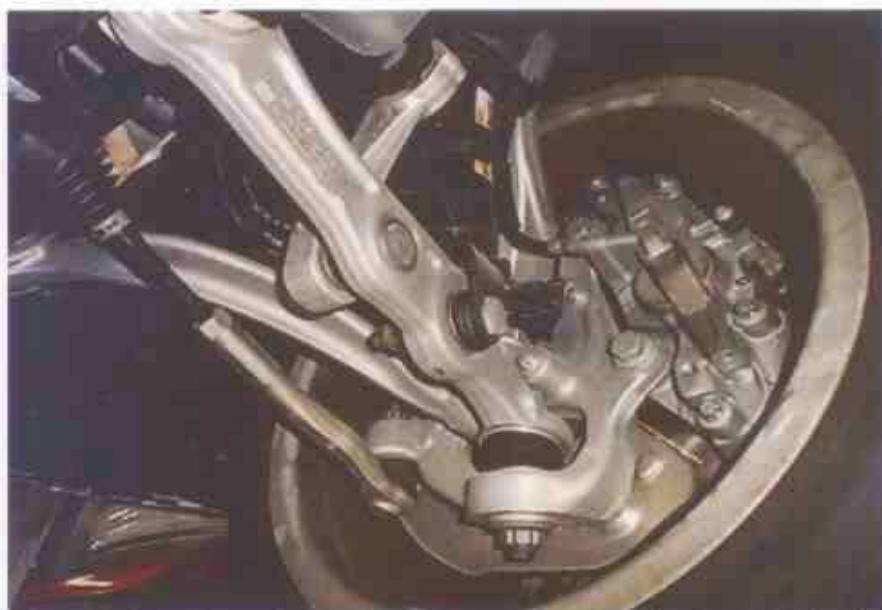
Photo 11 shows the various undercarriage components at the front right wheel of the Motor Car. The mechanical components, control arms and linkages were all found to be intact and secured in an appropriate manner.

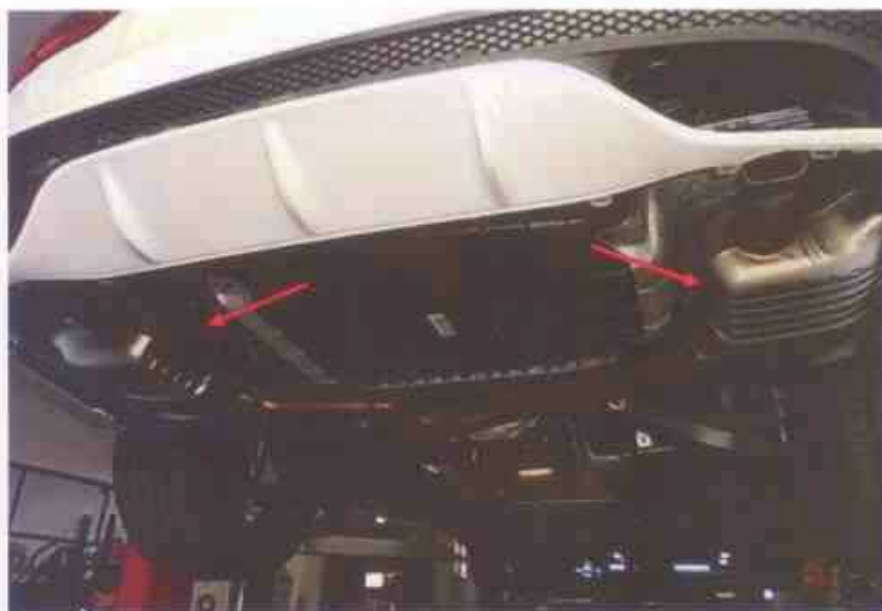
Photo 12 shows the Motor Car's rear exhaust mufflers (arrowed). My examination of the Motor Car's exhaust system revealed no sign(s) or indication(s) of any cut or weld marks along its exhaust pipes and on its rear mufflers.

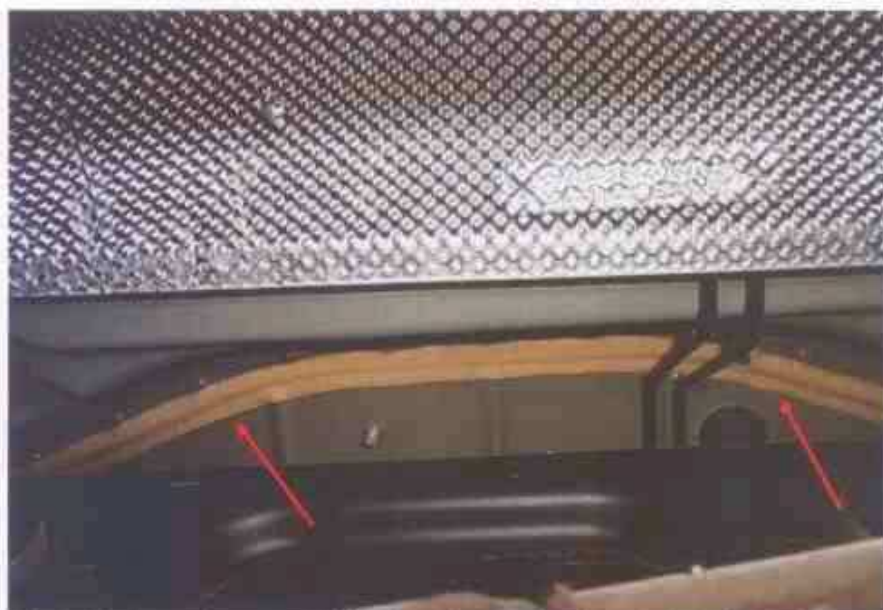
9. Visually, I did not find any weld marks, other than the original spot weld marks, on the chassis body of the Motor Car. The original factory sealant at the joints along the chassis body was also untouched, again indicating that no replacement of the chassis body was carried out; and that the chassis body was originally fitted.

Photo 13 shows the structural body at the rear floorboard of the Motor Car. The original factory sealant (arrowed) at the joints along the chassis body was untouched, indicating no work was done on the chassis body of the Motor Car and that the chassis body was originally fitted.

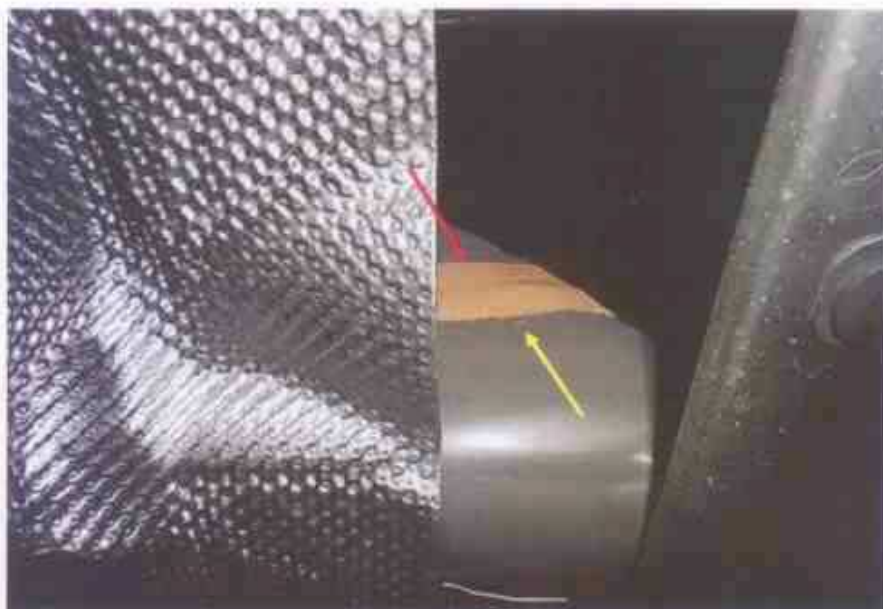
Photo 14 shows the structural body at the centre left of the Motor Car. Visually, I did not find any weld marks other than original spot weld marks (yellow arrow) on the chassis of the Motor Car. The original factory sealant (red arrow) at the joints along the chassis body was untouched, indicating no work was done on the chassis body of the Motor Car and that the chassis body was originally fitted.

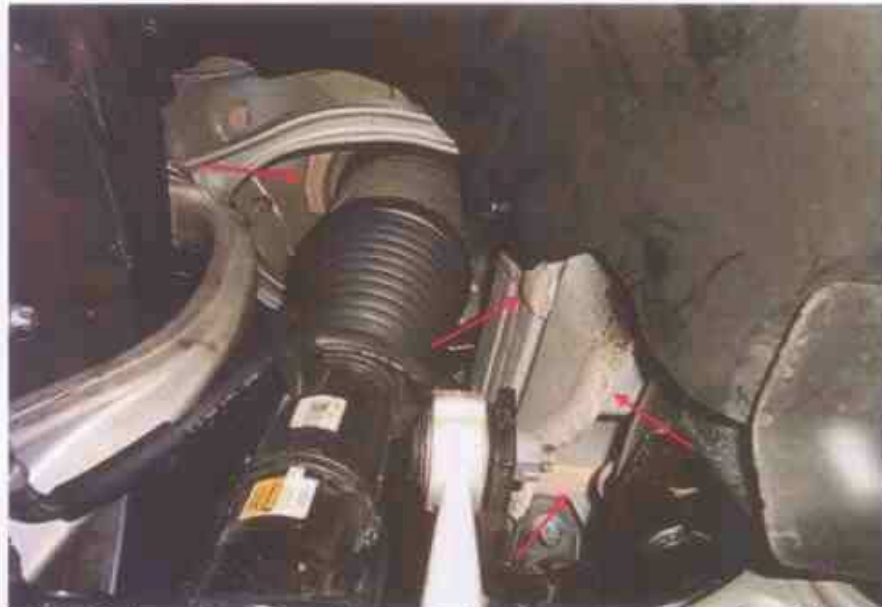
Photo 15 shows the structural body and wheel house panel at the front left of the Motor Car. The original factory sealant (arrowed) at the joints along the chassis body was untouched, indicating no work was done on the chassis body of the Motor Car and that the chassis body was originally fitted.

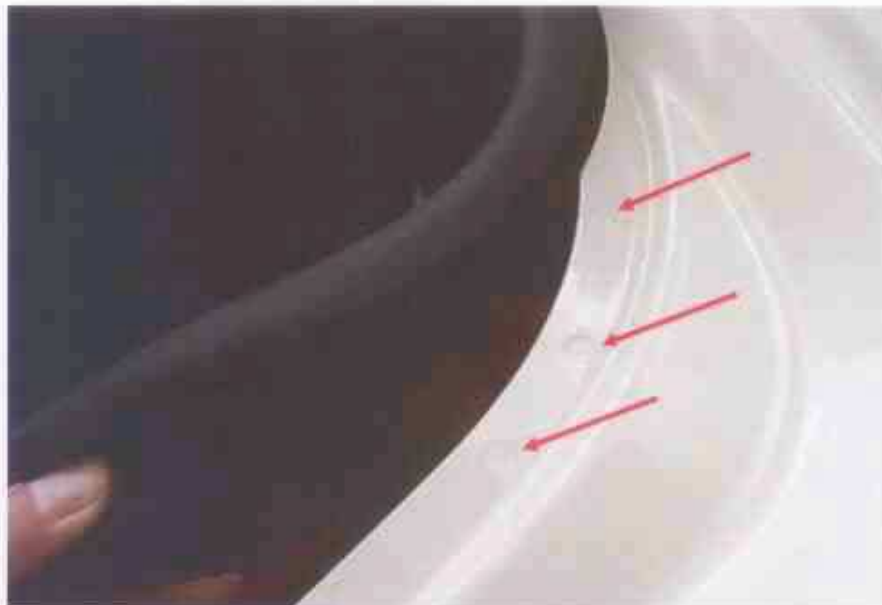
Photo 16 shows the left rear body panel of the Motor Car. I did not find any weld marks other than original spot weld marks (arrowed) on the body panels of the Motor Car, indicating that there was no re-welding works carried out; and that the body panels of the Motor Car were originally fitted.

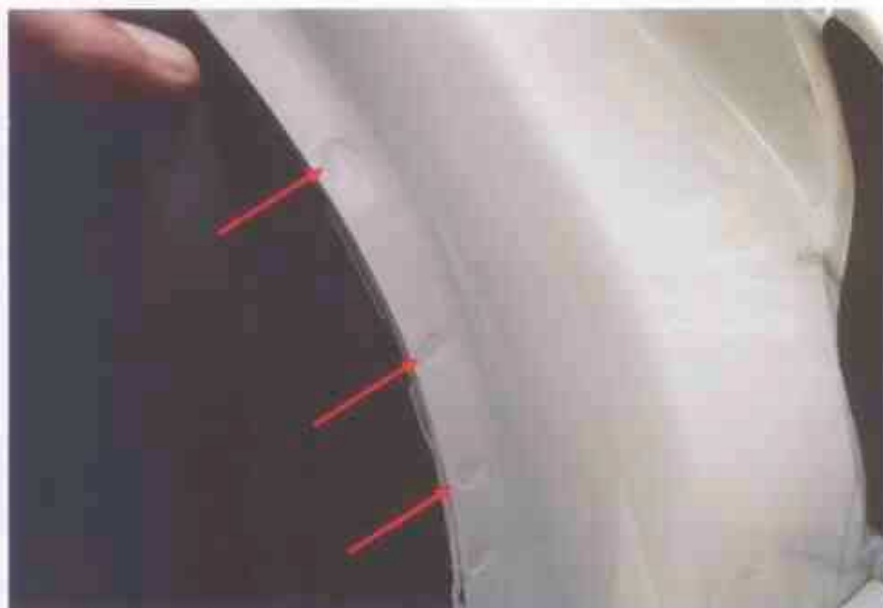
Photo 17 shows the right "A" pillar of the Motor Car. I did not find any weld marks other than original spot weld marks (arrowed) on the body panels of the Motor Car, indicating that there was no re-welding works carried out; and that the body panels of the Motor Car were originally fitted.
