Your Ref: BMW 523i
(chassis number WBA5A32020D793034)
Our Ref : CI/TP18019750/D

INSPECTION REPORT OF AN UNREGISTERD BMW 523i MOTOR CAR WITH CHASSIS NUMBER WBA5A32020D793034

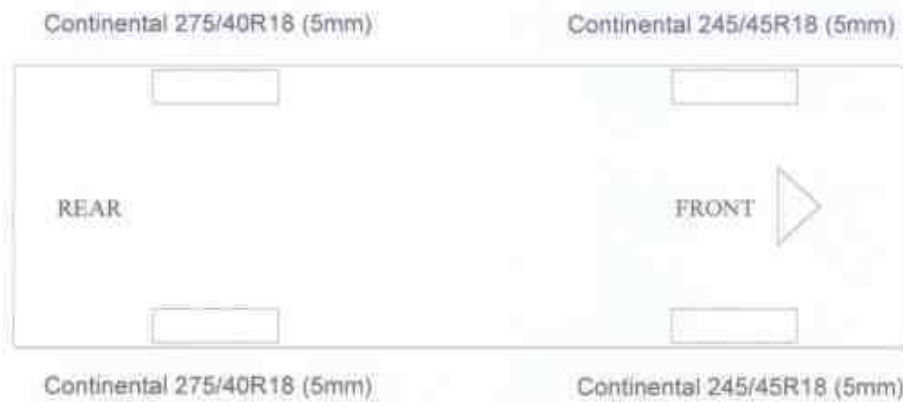
6. It was fitted with 18inch sport wheel rims that were wrapped with tyres that were observed to be of serviceable condition. The tyres were also sufficiently inflated for vehicular operation. The tyre brand, tyre size and approximate remaining tread depth of the 4 tyres of the Motor Car were recorded as follows: -

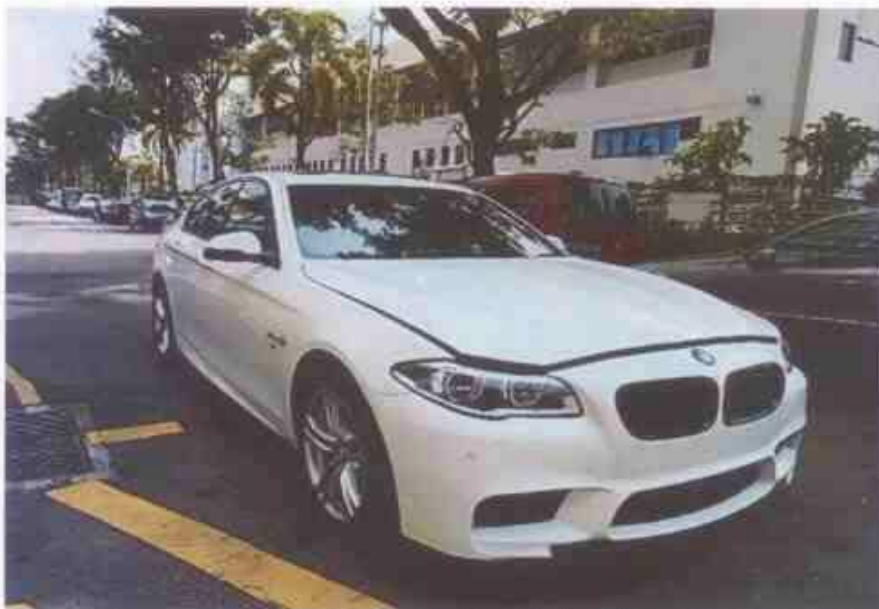
Photo 1 shows a general view of the front right body of the Motor Car at the time of my inspection. The Motor Car was observed to be in relatively good general condition with no loose exterior fittings observed.

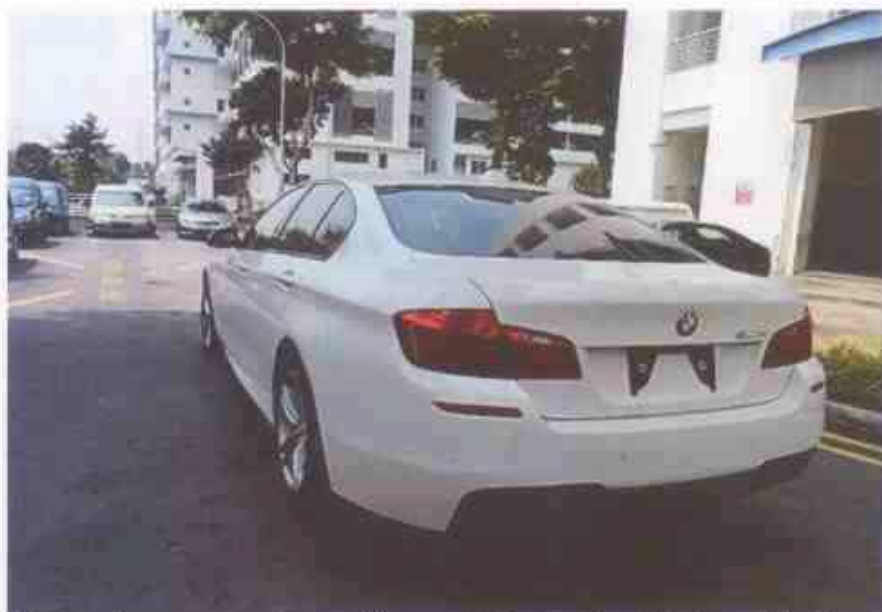
Photo 2 shows a general view of the rear left body of the Motor Car at the time of my inspection. The Motor Car was observed to be in relatively good general condition with no loose exterior fittings observed.

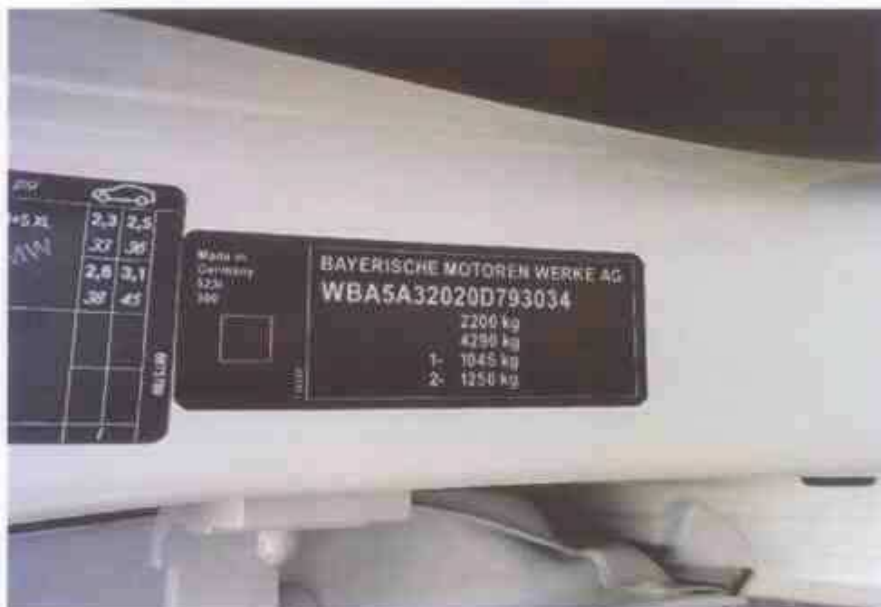
Photo 3 shows the chassis number of the Motor Car. The chassis number recorded was WBA5A32020D793034.

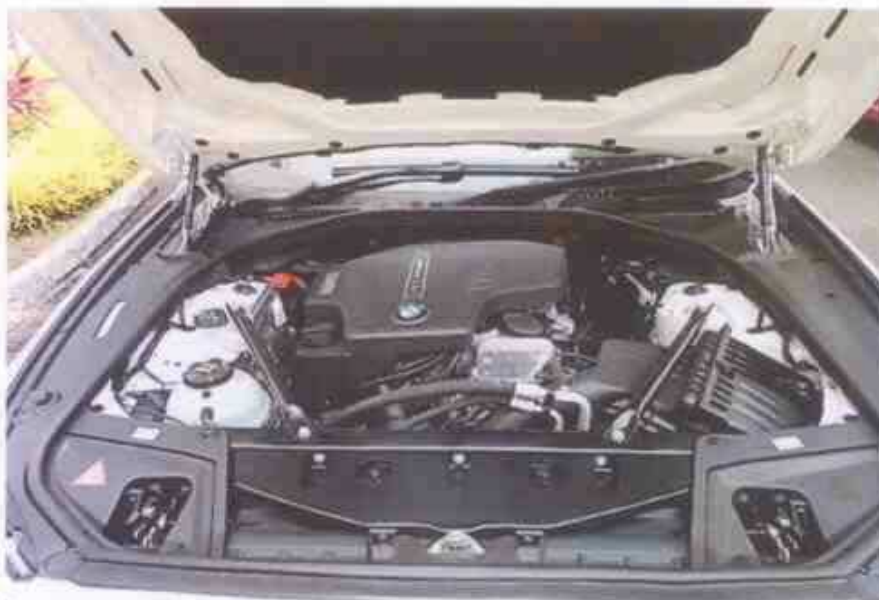
12. My examination of the engine compartment of the Motor Car revealed that the various parts and components inside the engine compartment were all intact and properly fitted. The engine oil, transmission fluid, brake fluid and engine coolant were all found to be of sufficient level for operating purposes. Visually, there was also no contamination found to these fluids.
13. My checks on the underside of the Motor Car revealed no sign(s) or indication(s) of fluid leakage and/or fluid stain(s). The engine block and automatic transmission assembly were both secured properly. They were not mounted onto the chassis body or any integral body part of the Motor Car. All undercarriage components of the Motor Car were also observed to be intact and secured in an appropriate manner.

Photo 4 shows a general view of the engine compartment of the Motor Car at the time of my inspection. The various parts and components inside the engine compartment were all observed to be intact and properly fitted. There was also no sign(s) or indication(s) of fluid leak and/or fluid stain found inside the engine compartment.

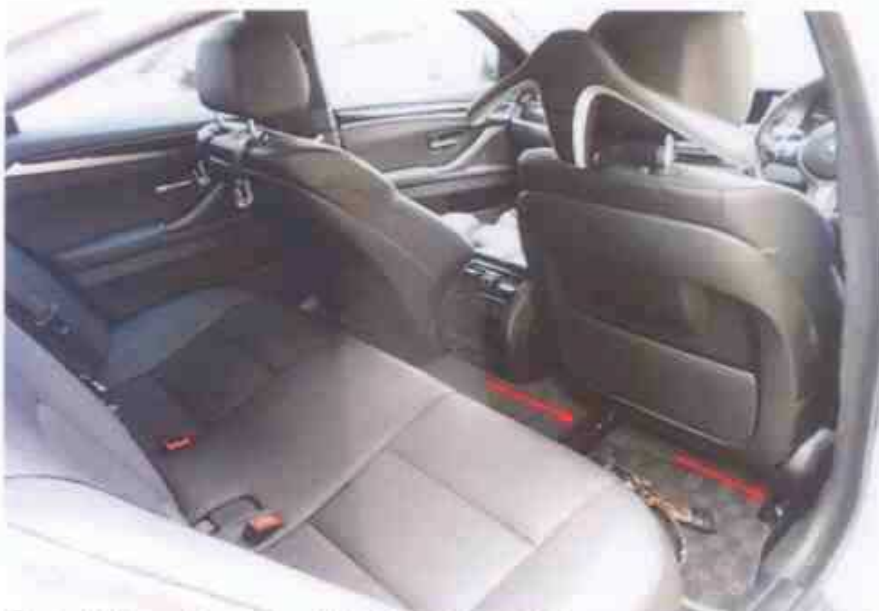
10. The seats of the Motor Car were found to be secured to the floor board of the Motor Car via seat rails bolted onto the floor board. Retractable seat belt reels and pre-tensioners were fitted on all seats of the Motor Car. The seat belt reels were able to be fastened securely to the respective pre-tensioner that is fixed to the side of all the seats.

Photo 5 shows the seats of the Motor Car, which were secured via seat rails (arrowed) to the floor board. All the seats of the Motor Car were fitted with a retractable seat belt reel and pre-tensioner. The seat belts were also able to be fastened to the pretension that were fitted on the side of each individual seat.

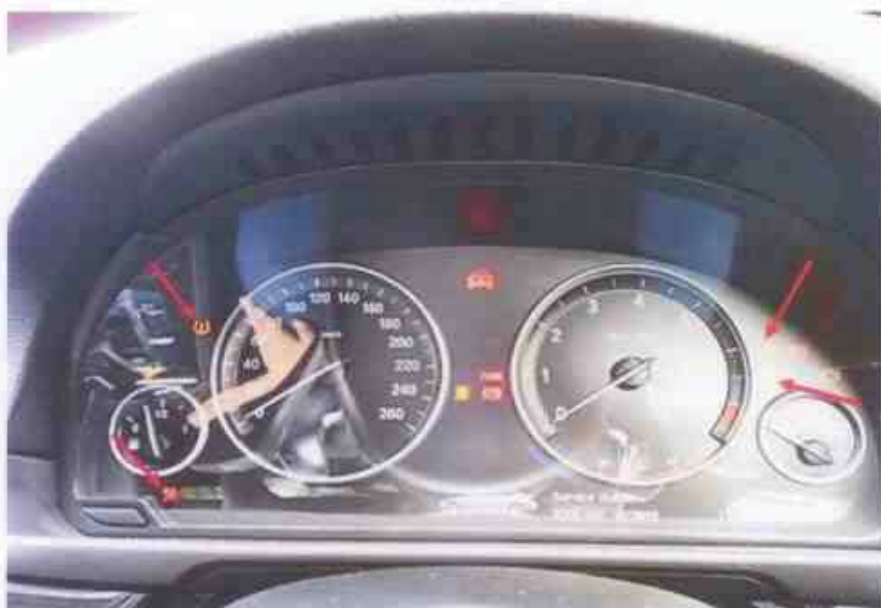
Photo 6 shows the warning lights for the various electronic safety features appearing on the instrument panel of the Motor Car during its self-test when the engine is cranked, in particular the ABS, SRS, TPM and DSC lights (arrowed).

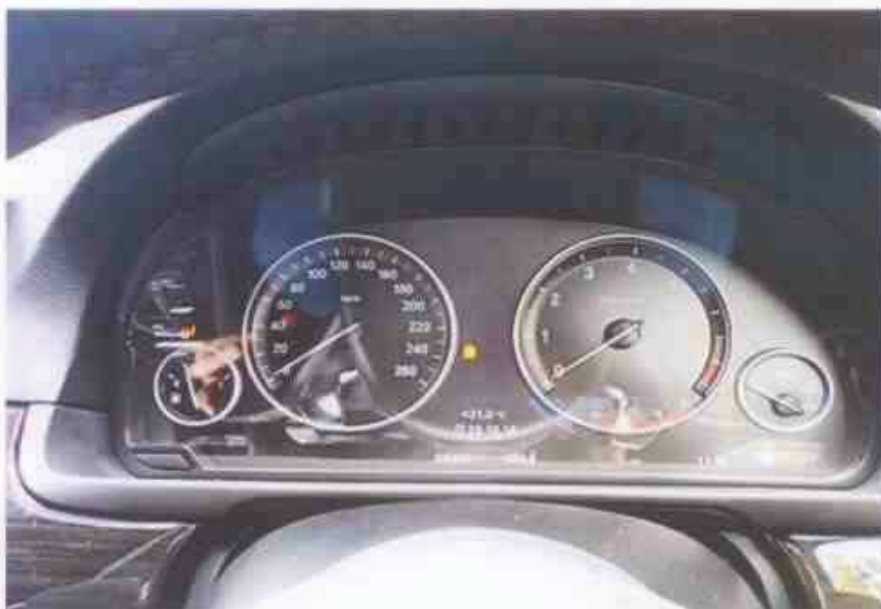
11. The Motor Car's automatic self-test of the functionality of its various electronic safety features like the Anti-Brake Lock System (ABS), Supplemental Restraint System (SRS), Tyre Pressure Monitor (TPM) and Dynamic Stability Control (DSC) during cranking of the engine had indicated that these electronic systems were in working condition. This was determined from the respective warning lights disappearing from the instrument panel after the self-test.

Photo 7 shows the respective warning lights no longer illuminated, indicating that there is no fault detected to the ABS, SRS, TPM and DSC systems of the Motor Car during the self-test. These electronic systems were hence in working condition at the time of my inspection.

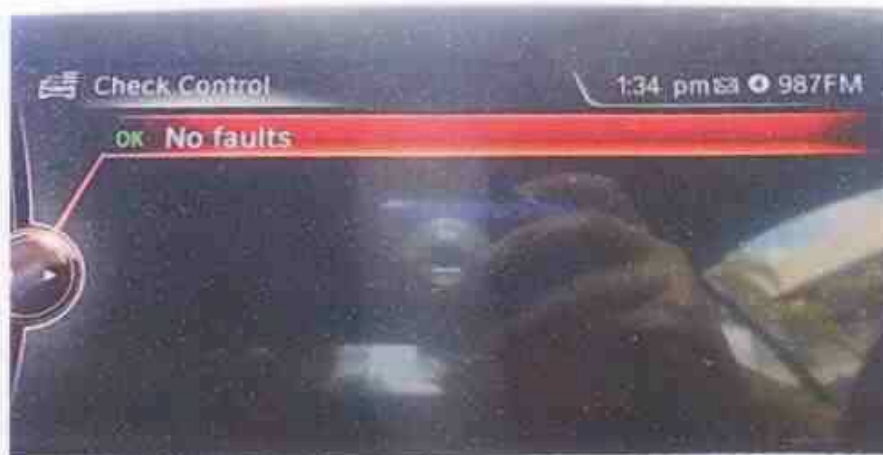
19. An on-board self-diagnostic check on the various controls and systems of the Motor Car was initiated during my inspection, and at the end of the check, there was no fault(s) found.

Photo 8 shows no fault(s) was detected to the various controls and systems of the Motor Car after my initiation of the Motor Car's on-board self-diagnostic check.

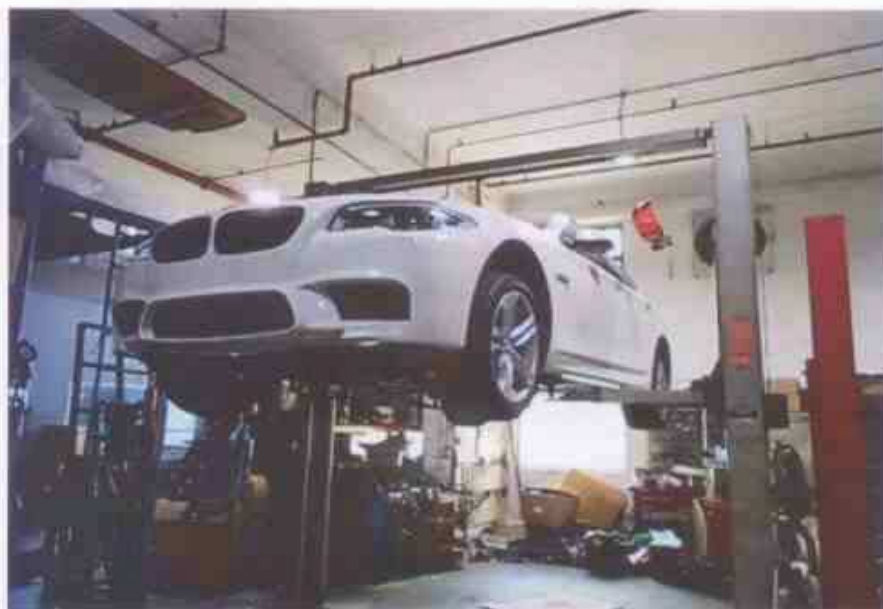
Photo 9 shows the Motor Car hoisted up for checks on its undercarriage. There was no sign(s) or indication(s) of fluid leakage and/or fluid stain(s). The undercarriage components of the Motor Car were also all observed to be intact and secured in an appropriate manner.

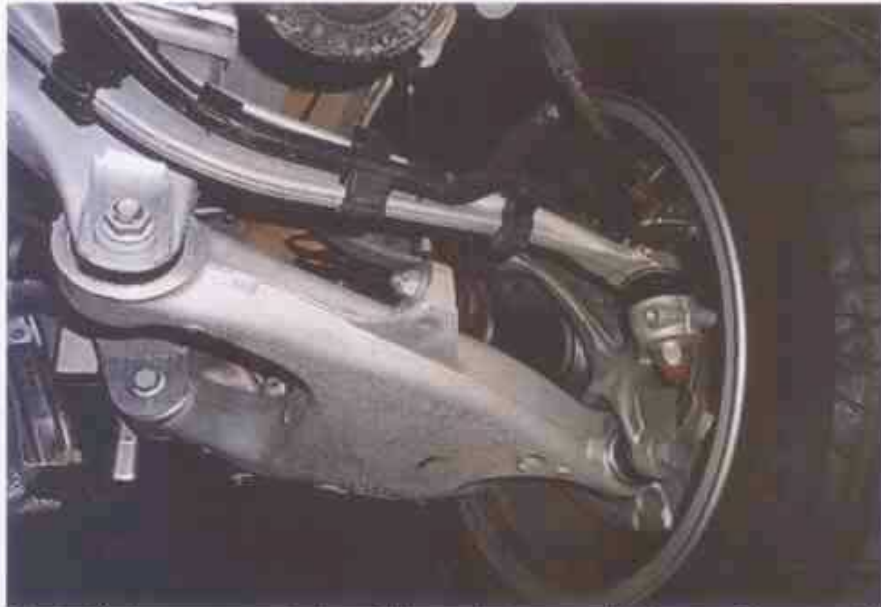
Photo 10 shows a general view of the control arms and linkages at the rear right wheel of the Motor Car. I did not observe any fluid leak and/or fluid stain on the underside of the Motor Car. All of the Motor Car's undercarriage components were observed to be intact and secured in an appropriate manner.

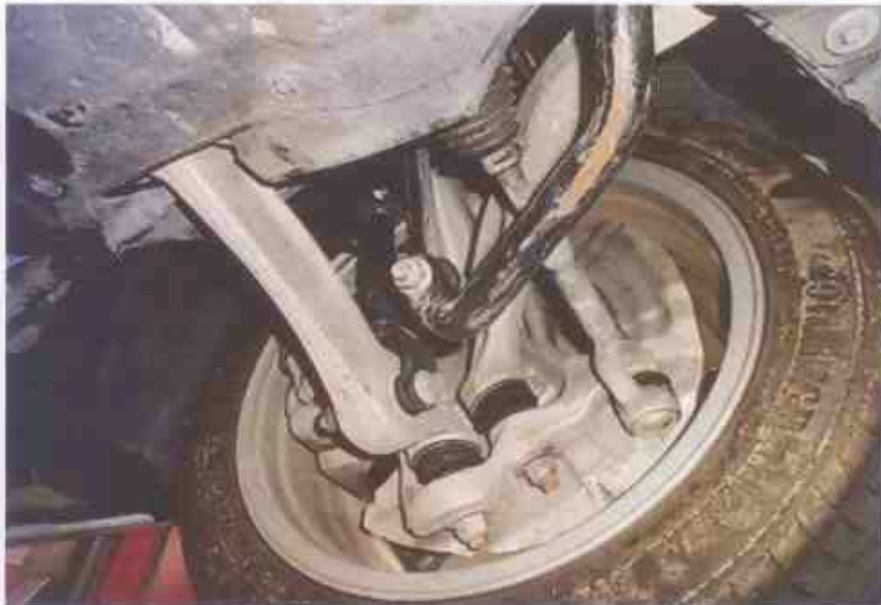
Photo 11 shows the various undercarriage components at the front left wheel of the Motor Car. The mechanical components, control arms and linkages were all found to be intact and secured in an appropriate manner.

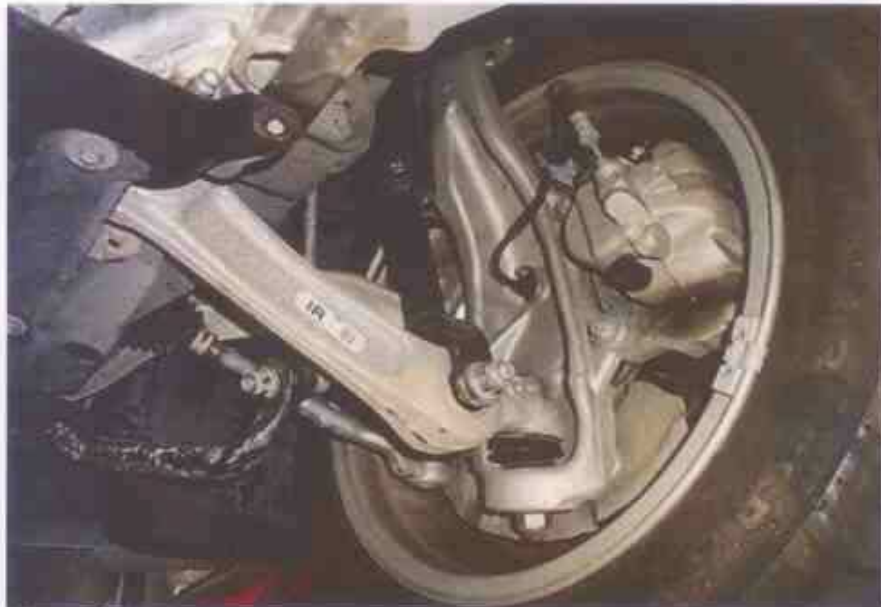
Photo 12 shows the various undercarriage components at the front right wheel of the Motor Car. The mechanical components, control arms and linkages were all found to be intact and secured in an appropriate manner.

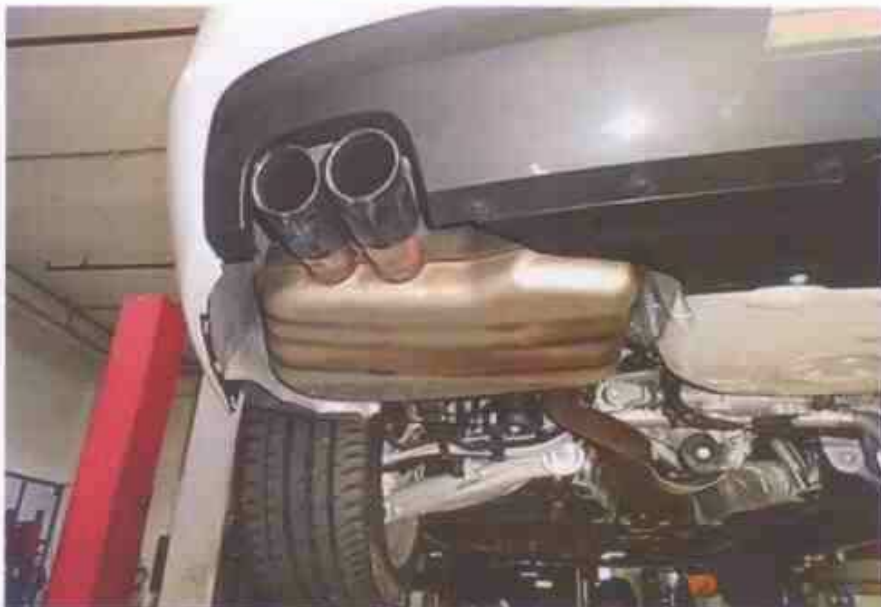
Photo 13 shows the Motor Car's rear exhaust muffler. My examination of the Motor Car's exhaust system revealed no sign(s) or indication(s) of any cut or weld marks along its exhaust pipes and on its rear mufflers.

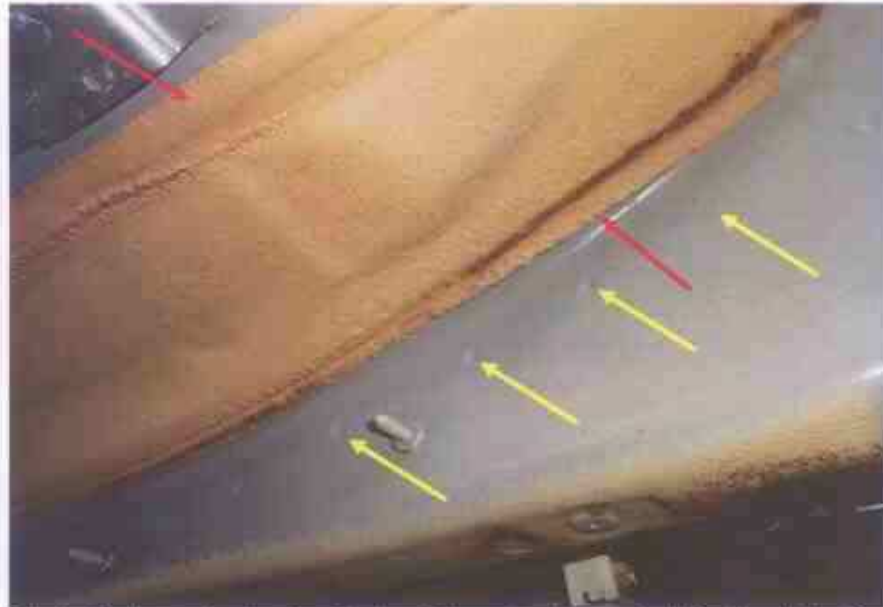
9. Visually, I did not find any weld marks, other than the original spot weld marks, on the chassis body of the Motor Car. The original factory sealant at the joints along the chassis body was also untouched, again indicating that no replacement of the chassis body was carried out; and that the chassis body was originally fitted.

Photo 14 shows the structural body at the underside centre left of the Motor Car. Visually, I did not find any weld marks other than original spot weld marks (yellow arrow) on the chassis body of the Motor Car. The original factory sealant (red arrow) at the joints along the chassis body was also untouched, indicating no work was done on the chassis body of the Motor Car and that the chassis body was originally fitted.

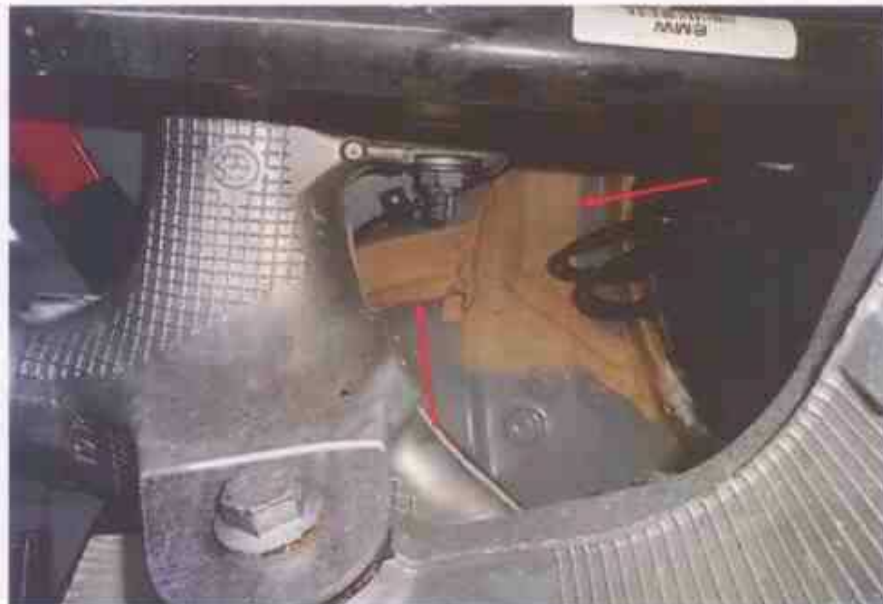
Photo 15 shows the structural body at the underside rear right of the Motor Car. Visually, The original factory sealant (arrowed) at the joints along the chassis body was untouched, indicating no work was done on the chassis body of the Motor Car and that the chassis body was originally fitted.

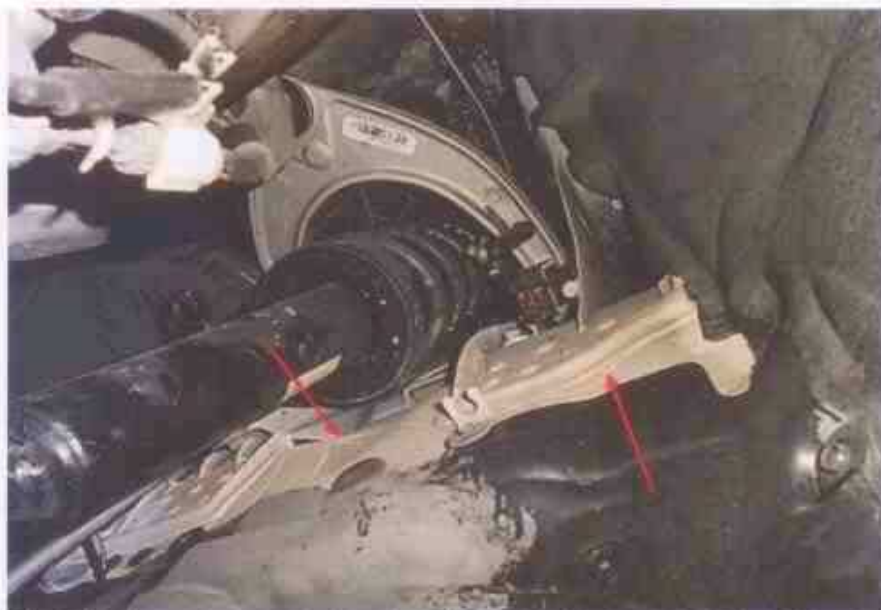
Photo 16 shows the structural body at the underside front left of the Motor Car. The original factory sealant (arrowed) at the joints along the chassis body was untouched, indicating no work was done on the chassis body of the Motor Car and that the chassis body was originally fitted

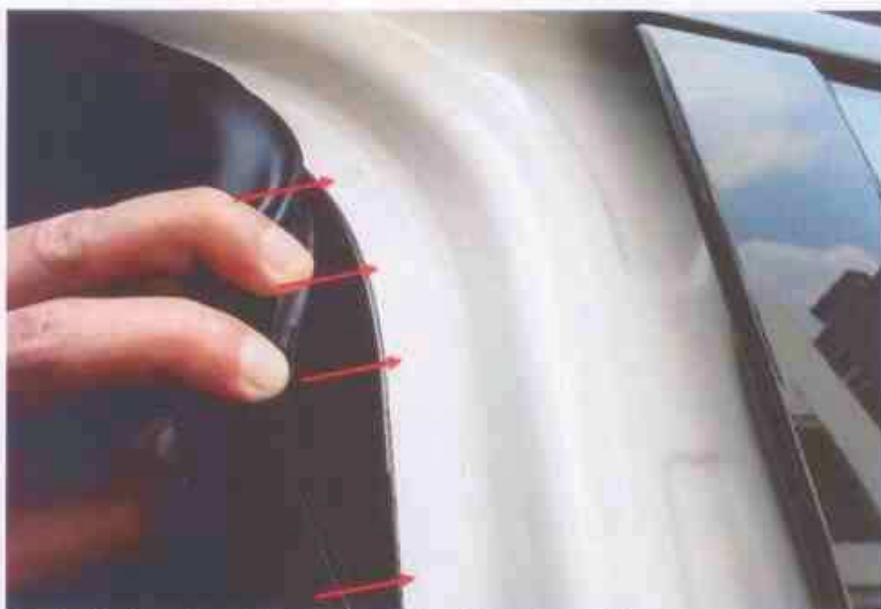
Photo 17 shows the right "B" pillar of the Motor Car. I did not find any weld marks other than original spot weld marks (arrowed) on the body panels of the Motor Car, indicating that there was no re-welding works carried out; and that the body panels of the Motor Car were originally fitted

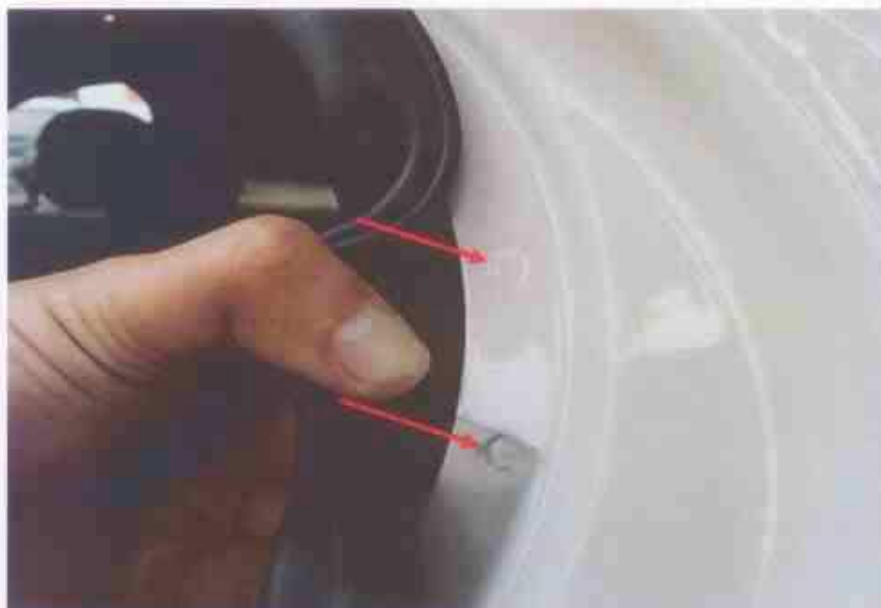
Photo 18 shows the rear left "C" pillar of the Motor Car. I did not find any weld marks other than original spot weld marks (arrowed) on the body panels of the Motor Car, indicating that there was no re-welding works carried out; and that the body panels of the Motor Car were originally fitted.
