Your Ref : D18/7418/SG/FIRE
Our Ref : CI/FCI18019909/N

19 October 2018

**TECHNICAL INVESTIGATION REPORT OF FIRE INCIDENT INVOLVING THE
INSURED VEHICLE SHD 8841X ON 10 OCTOBER 2018**

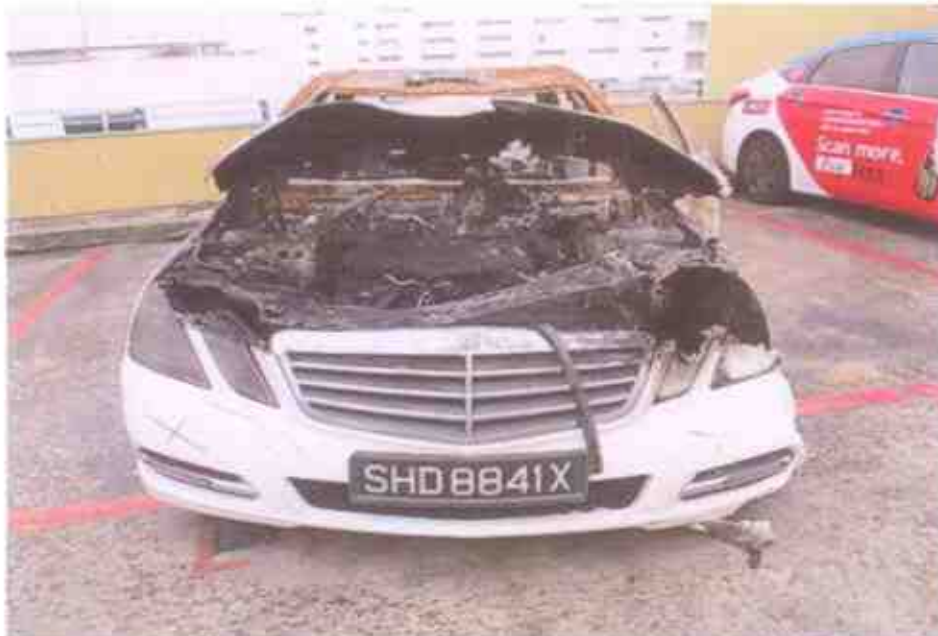
Photo 1 shows the general view of the front portion of the Insured Vehicle at the time of our inspection. The Insured Vehicle was observed to have sustained extensive fire damage all around. Its engine compartment and interior compartment were completely burnt. Rust had accumulated all over the rear and centre portion of the Insured Vehicle as a result of exposure to environmental condition for a period of time.

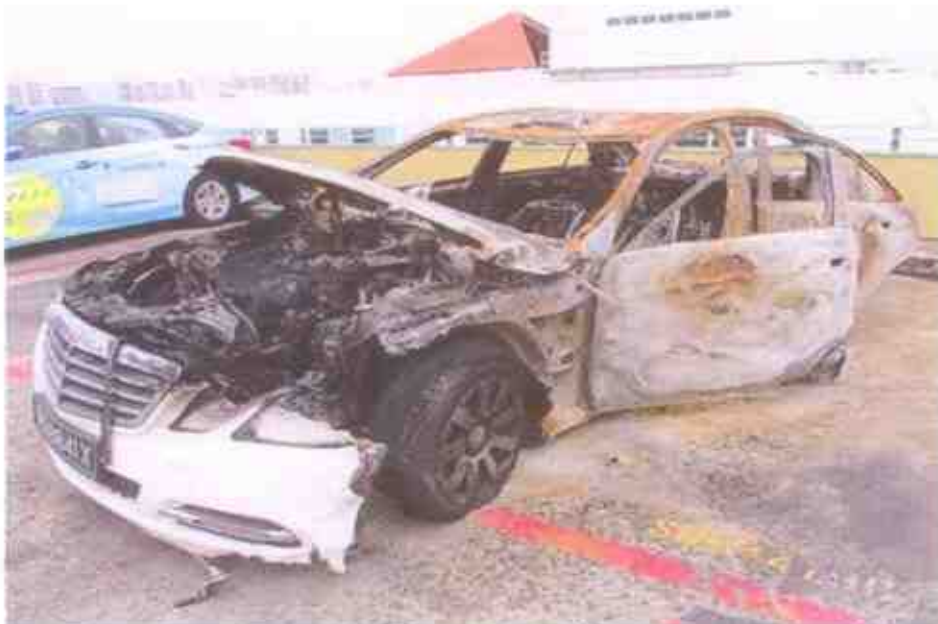
Photo 2 shows the general view of the left body of the Insured Vehicle at the time of our inspection. The Insured Vehicle was observed to have sustained extensive fire damage all around. Rust had accumulated all over the rear and centre portion of the Insured Vehicle as a result of exposure to environmental condition for a period of time.

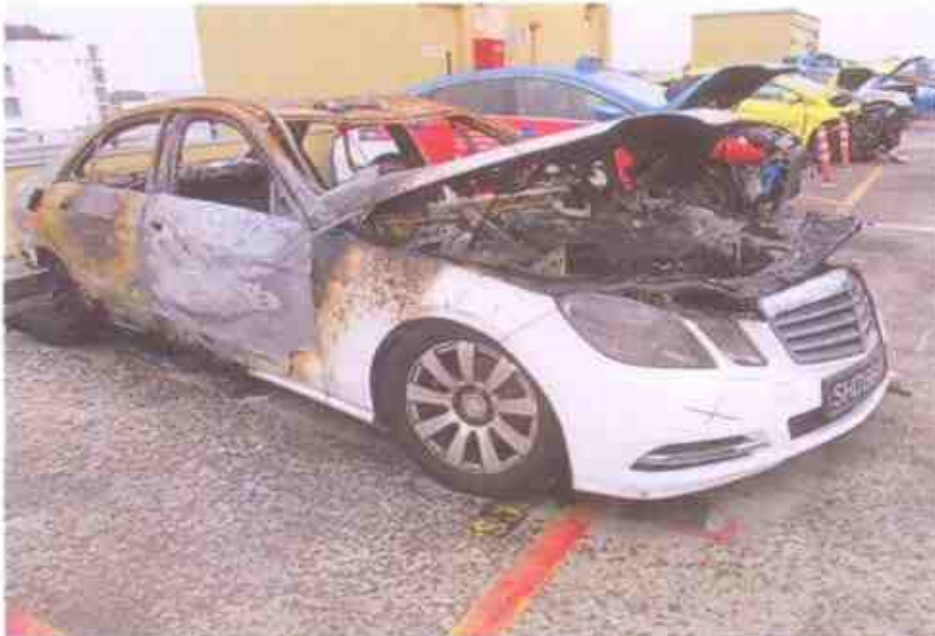
Photo 3 shows the general view of the right body of the Insured Vehicle at the time of our inspection. The Insured Vehicle was observed to have sustained extensive fire damage all around. Rust had accumulated all over the rear and centre portion of the Insured Vehicle as a result of exposure to environmental condition for a period of time.

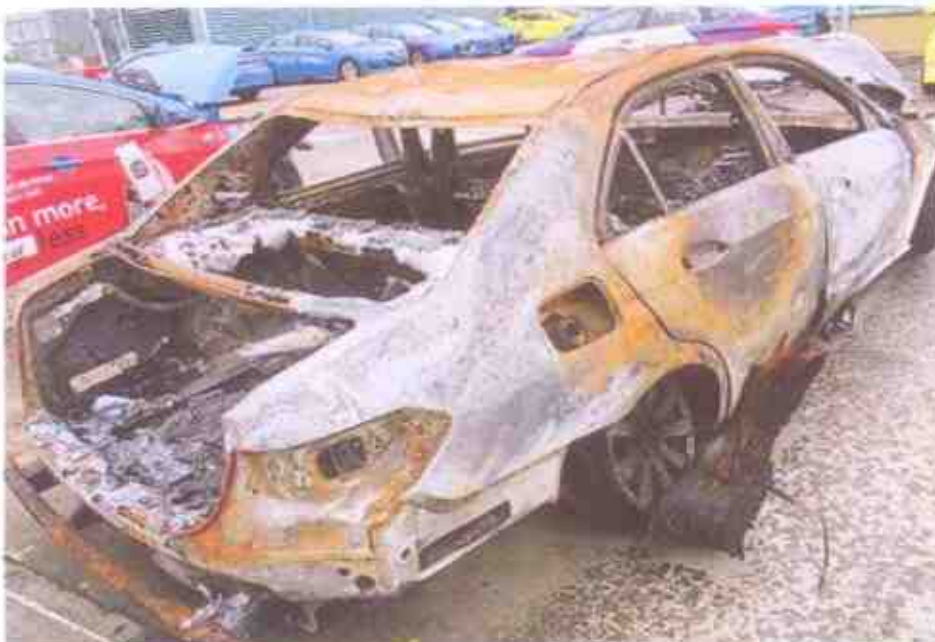
Photo 4 shows the general view of the rear right body of the Insured Vehicle at the time of our inspection. The Insured Vehicle was observed to have sustained extensive fire damage all around. Rust had accumulated all over the rear and centre portion of the Insured Vehicle as a result of exposure to environmental condition for a period of time.

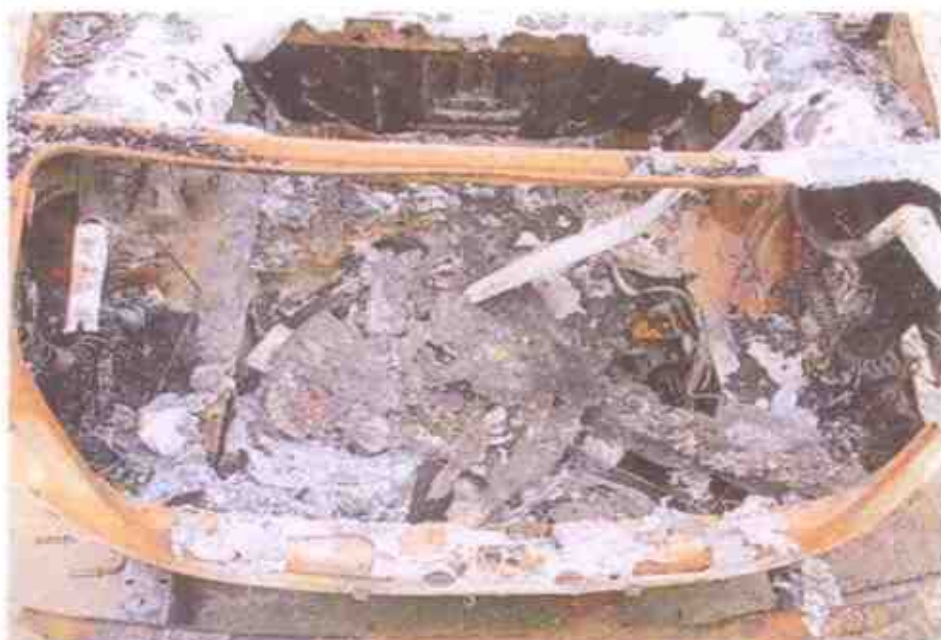
Photo 5 shows the general view of the rear boot compartment of the Insured Vehicle at the time of our inspection. The rear boot compartment sustained extensive fire damage. Rust had accumulated all over the rear portion of the Insured Vehicle as a result of exposure to environmental condition for a period of time.

6. Based on the circumstances for this particular case, the fire appears to have originated within the rear boot compartment of the Insured Vehicle, somewhere around the rear right portion of the rear boot compartment. This can also be determined from the nature of fire damage which was observed to be most extensive at the rear portion of the Insured Vehicle.

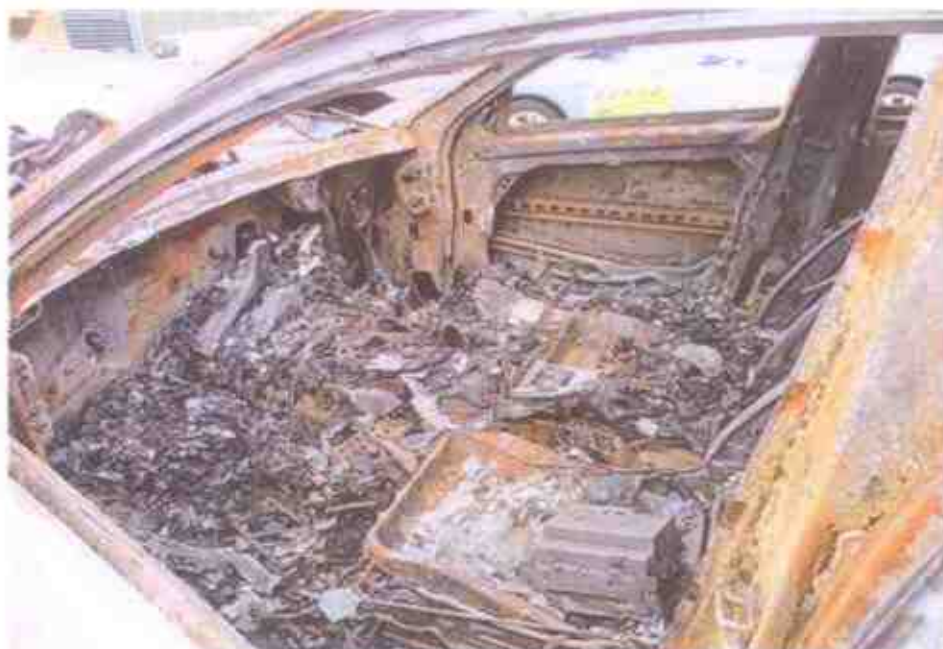
Photo 6 shows the general view of the interior compartment of the Insured Vehicle at the time of our inspection. Its interior compartment was completely burnt as a result of the fire.

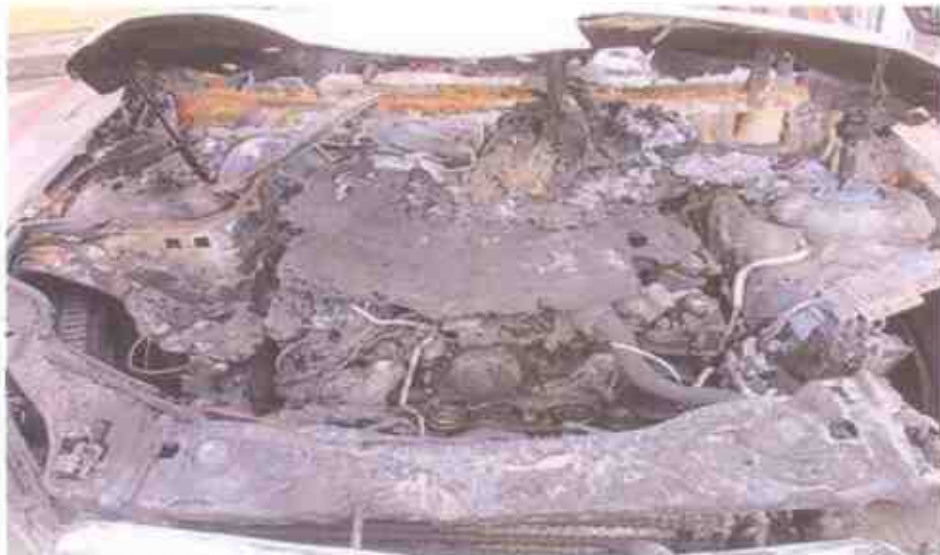
Photo 7 shows the engine compartment of the Insured Vehicle at the time of our inspection. The entire engine compartment of the Insured Vehicle was observed to be severely burnt. Most of the parts inside the engine compartment were found to be burnt and/or melted as a result of the fire.

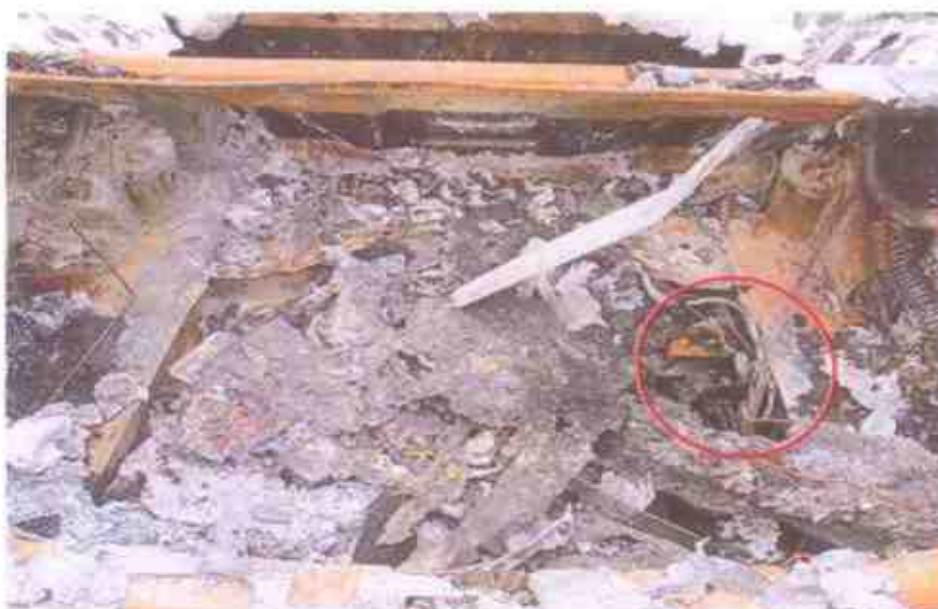
7. Upon closer examination of the rear right portion of the rear boot compartment, which was where the fire to the Insured Vehicle had likely started, we had found greenish residue on several burnt stretches of original factory fitted wirings around the rear right portion of the rear boot compartment, leading from the battery. The presence of such greenish residue indicates internal heating of copper wires, a sign of an electrical short circuit occurring. The greenish residue is normally left behind from oxidation as a result of chemical reaction involving the copper wires. This physical evidence would then appear to suggest that the cause of fire to the Insured Vehicle could have possibly been due to electrical in nature. See photos 8 - 11 below.

Photo 8 shows the original factory fitted wirings around the rear right portion of the rear boot compartment, which is in the immediate vicinity where the fire to the Insured Vehicle had likely started. We had found greenish residue on several burnt stretches of these wirings leading from the battery (circled). The presence of such greenish residue indicates internal heating of copper wires, a sign of an electrical short circuit occurring. The greenish residue is normally left behind from oxidation as a result of chemical reaction involving the copper wires.

25. The possibility of the fire being due to electrical in nature would then seem more likely given that engine overheating, external and internal factors would seem unlikely. The fire being due to electrical nature is also supported by the condition of the wirings that were found in the rear boot compartment of the Insured Vehicle, which was earlier discussed in paragraph 7 above.

27. Having investigated and technically analysed the damages of burnt nature to the Insured Vehicle, we are of the view that the cause of fire to the Insured Vehicle was of electrical in nature. For this particular case, the fire had originated along the original factory fitted wirings somewhere around the rear right portion of the rear boot compartment, leading to the battery.

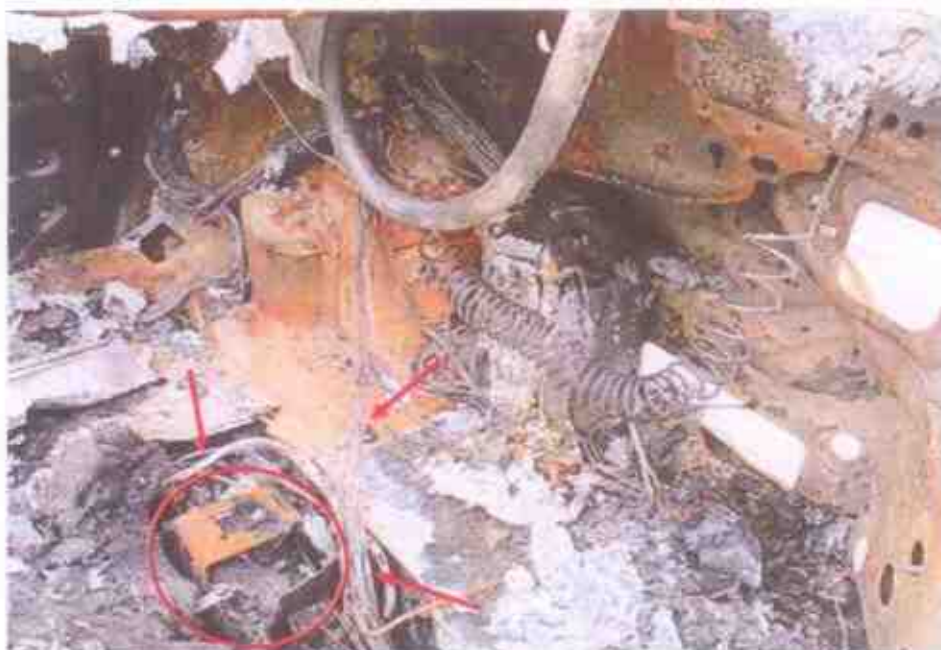
Photo 9 shows a closer view of the greenish residue found on some of the burnt stretches of original factory fitted wirings (arrowed) leading from the battery (circled). The presence of such greenish residue suggests occurrence of an electrical short circuit.

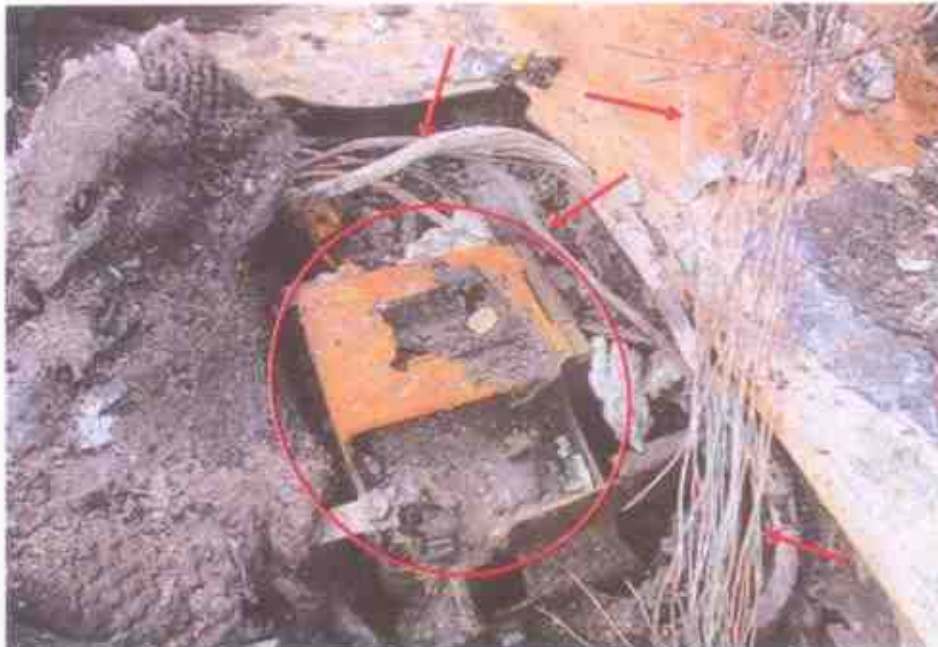
Photo 10 shows a close up view of the greenish residue found on some of the burnt stretches of original factory fitted wirings (arrowed) leading from the battery (circled). The presence of such greenish residue suggests occurrence of an electrical short circuit.

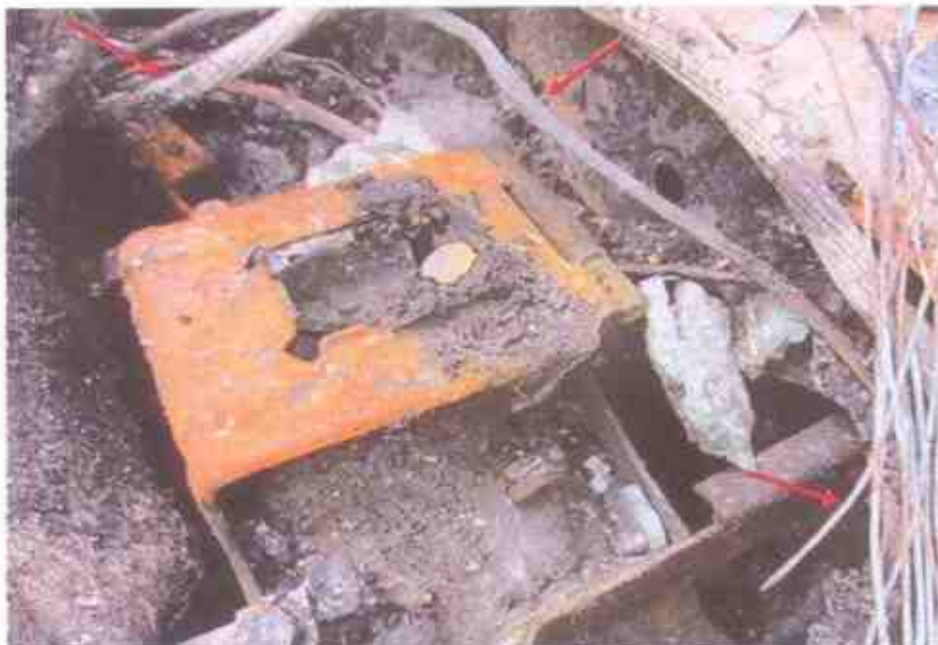
Photo 11 shows a close up view of the greenish residue found on some of the burnt stretches of original factory fitted wirings (arrowed) leading from the battery. The presence of such greenish residue suggests occurrence of an electrical short circuit.

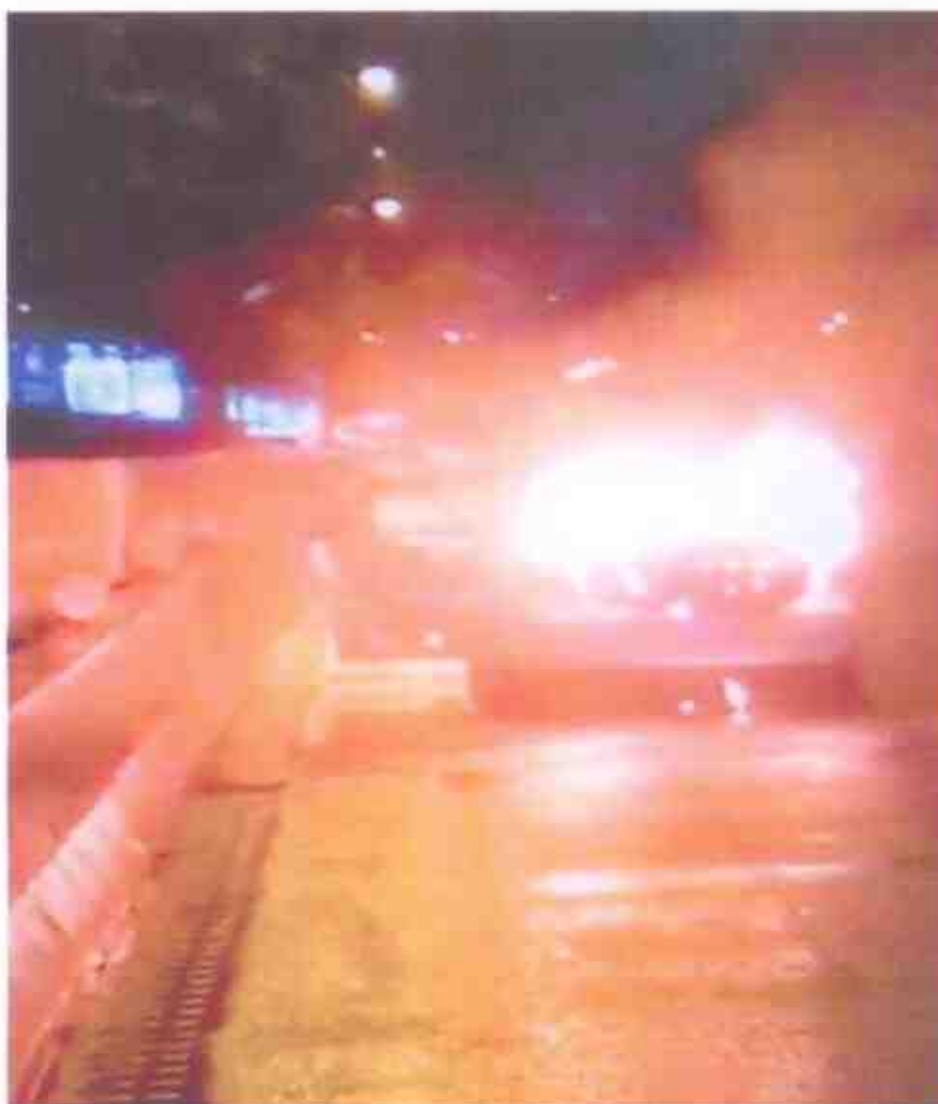
Photo 12 shows the Insured Vehicle at the road shoulder of the SLE when the fire occurred.

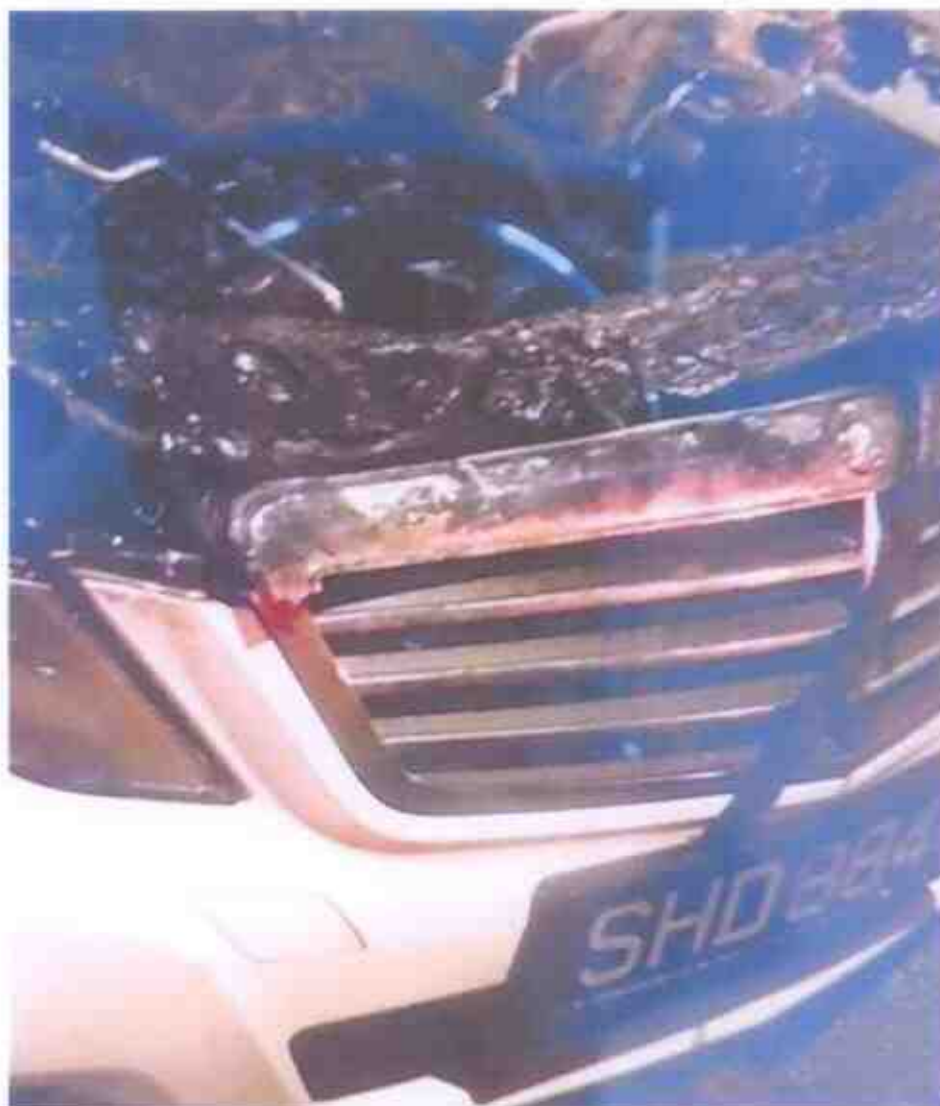
Photo 13 shows the front portion of the Insured Vehicle after the fire was extinguished. In general, the damages sustained to the front portion had corresponded to the events that were related to us by Mr Ho, which is the fire had not started from the front bonnet.

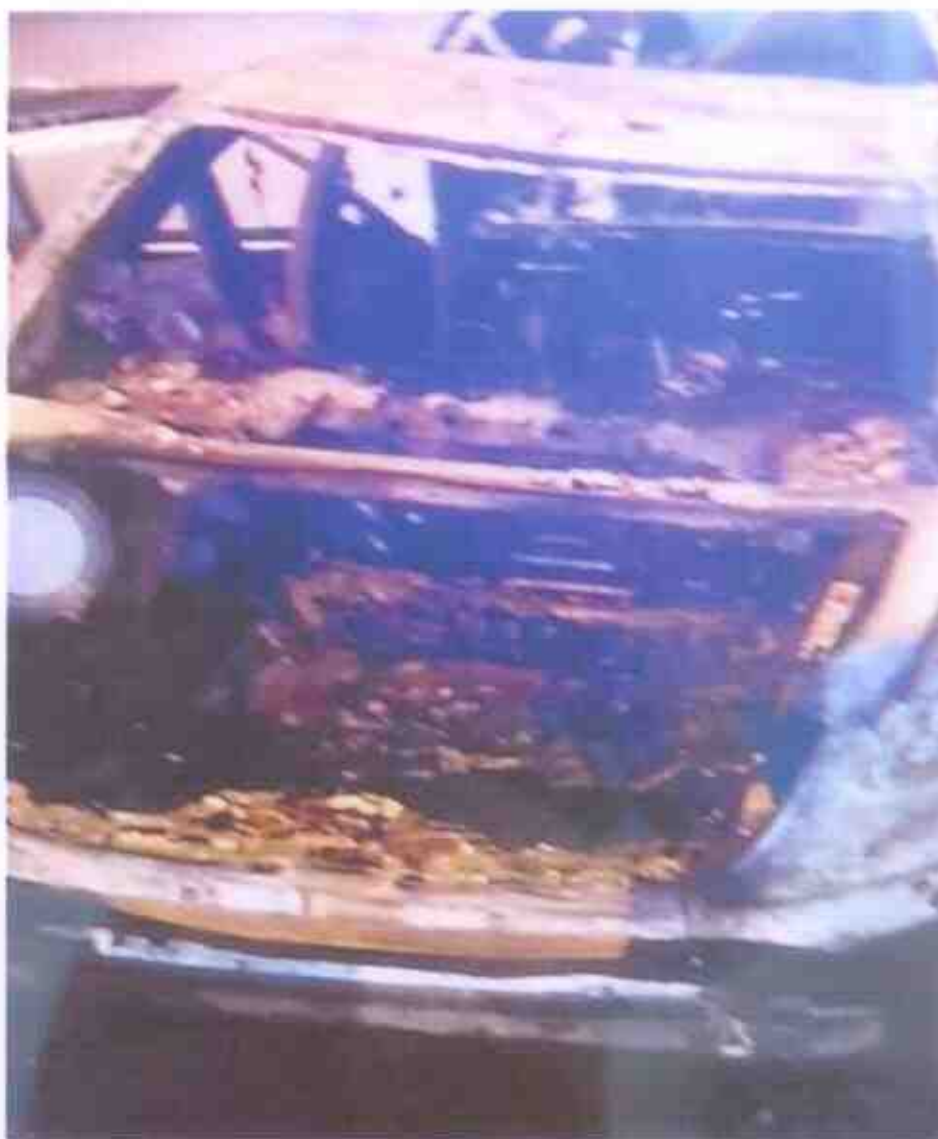
Photo 14 shows the rear portion of the Insured Vehicle after the fire was extinguished. In general, the extensive damages sustained to the rear portion had corresponded to the events that were related to us by Mr Ho, which is the fire started from the rear boot compartment.

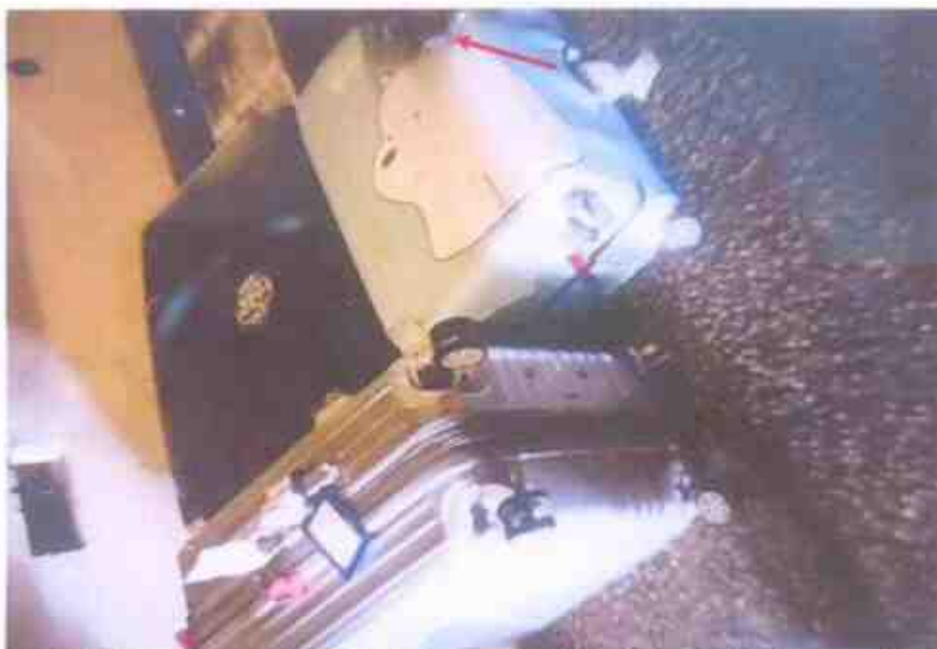
Photo 15 shows the luggage that was removed from the rear boot compartment of the Insured Vehicle by Mr Ho soon after the fire broke out. Only 1 of the luggage sustained visible fire damage (arrowed).

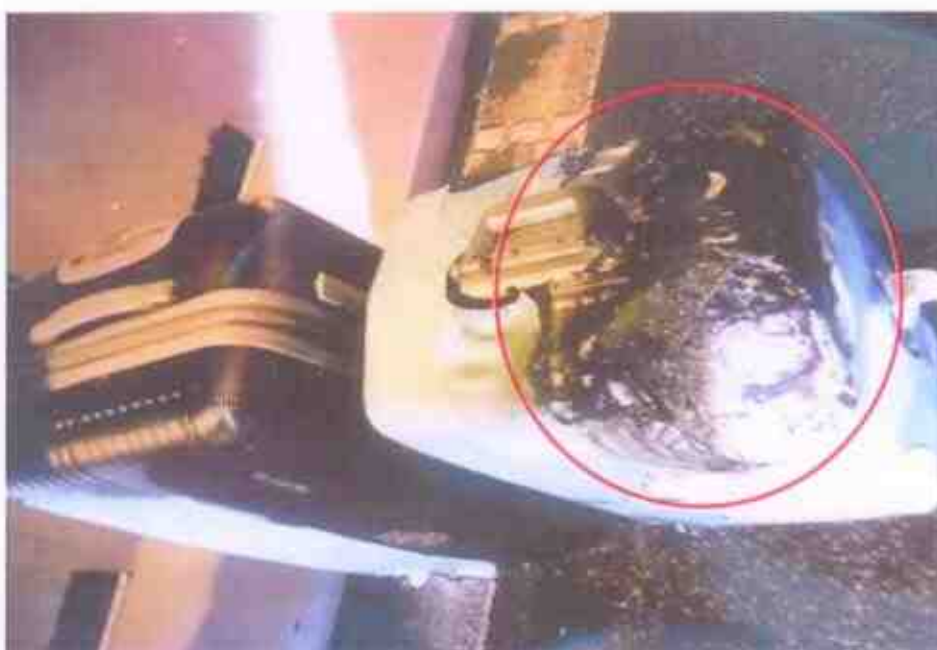
Photo 16 shows 2 of the luggage that was removed from the rear boot compartment of the Insured Vehicle soon after the fire broke out. Only 1 of the luggage sustained visible fire damage (circled). In general, this photograph had corresponded to the events that were related to us by Mr Ho, which is the burnt luggage was placed nearest to the immediate vicinity where the fire had occurred.

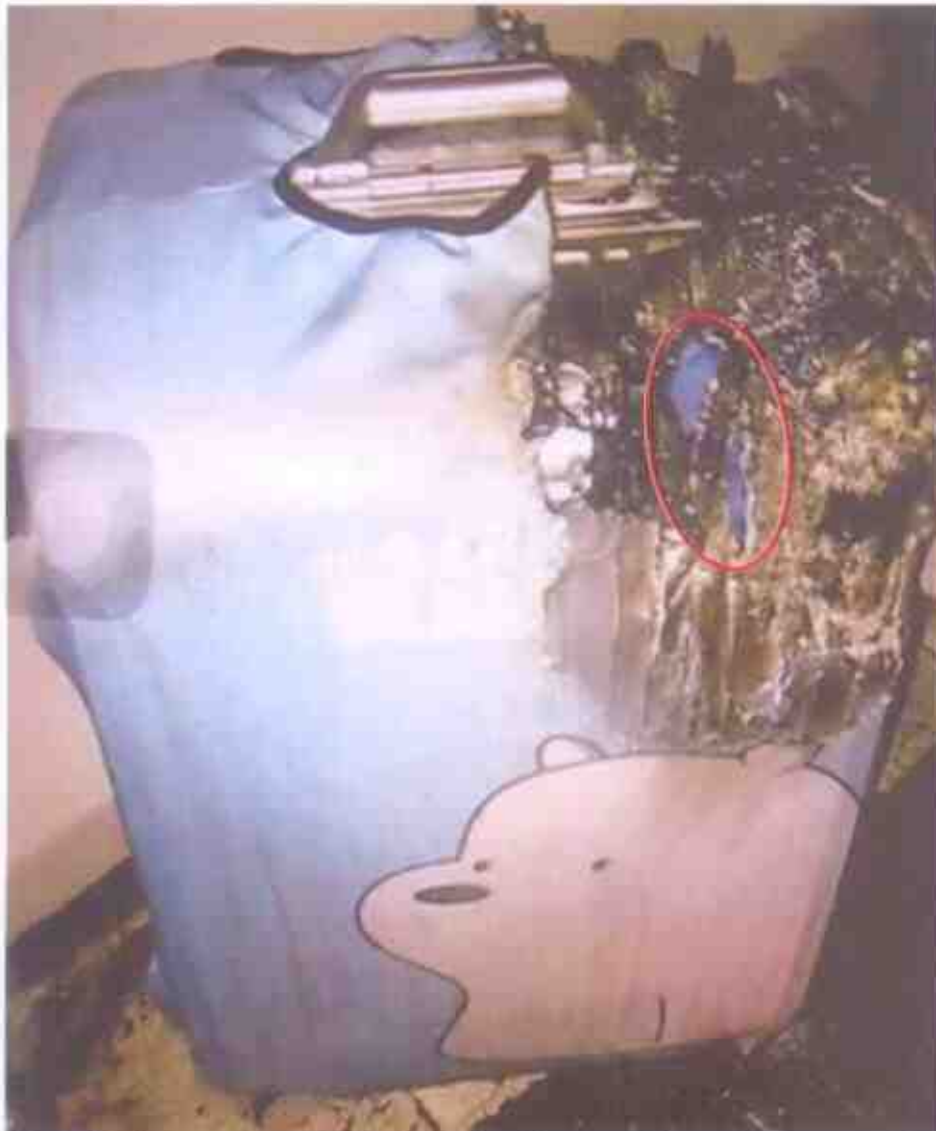
Photo 17 shows a close up view of the burnt luggage. Upon closer examination, we observed that the contents of the luggage were unaffected by the fire (circled). In general, the damages sustained to the exterior portion of the luggage had corresponded to the events that were related to us by Mr Ho, which is the fire had started from the rear boot compartment of the Insured Vehicle and not from the luggage.

24. The possibility of the fire being due to internal factors (passengers' luggage amongst others) would also seem unlikely as the damages of burnt nature sustained by the passenger's luggage were mainly on the exterior body. The contents of the luggage were relatively unaffected by the fire.
