Ref : CS/SPF18020194/Gtbe2

**1. Policy Particulars :- OWN DAMAGE**

| Insured Veh. | | Veh. Inspected | TP 1077B |

| Make & Model | YAMAHA XJ900P | c.c | 892 |

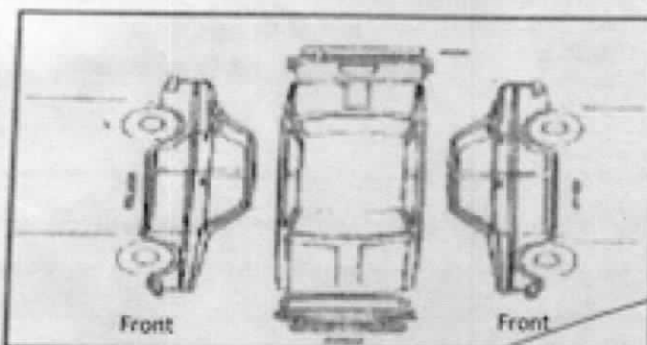
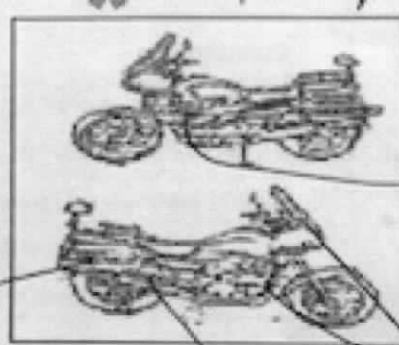
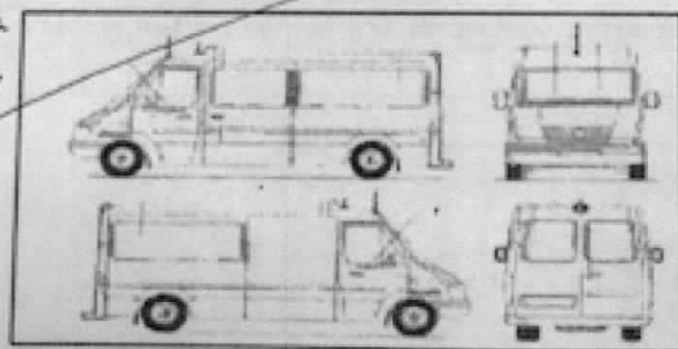
- 1) front right lower scratches 2) front right crashbar bent and scratches  
 3) rear right crashbar bent and scratches 4) right rear corner scratches  
 5) left front siren minor scratches 6) To check wheel alignment
- Pls mark affected area with X after repair

Siren  
 minor  
 scratches

Right front  
 crashbar  
 bent  
 and  
 scratches

Right  
 rear  
 crashbar  
 bent and  
 scratches

Right  
 front  
 corner  
 scratches

Left  
 front  
 scratches
