REF: CS3 / MS(17022610 / B #6-11

**Subject:** [New Assignment] Insured - Samwoh Corporation Pte Ltd - Accident involving shovel loader and third party vehicle XD501R on 18/11/2017 - MSIG : 537722PLY

## ADJUSTMENT ON REPAIR COST FOR VEHICLE NO. XD 501R

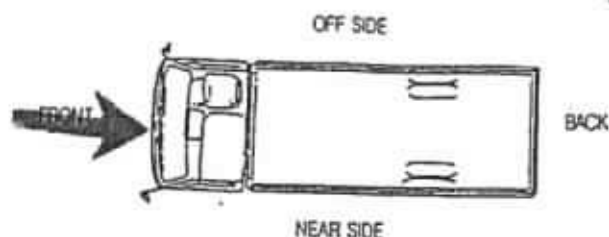
Direction of Impact (→)

Damages sustained were consistent with the subject vehicle being involved in a collision with another vehicle and the impact was delivered onto the frontal portion of the vehicle.

Damages sustained were the front body panel & its inner reinforcement- dented/buckled/warped over an extensive area, front corner panel o/s & n/s- buckled, front bumper assembly, front door pillar o/s & n/s- buckled, o/s & n/s front door & their inner reinforcement- bent, front sill panel o/s & n/s- buckled etc. -----
