Your Ref : 565906
Our Ref : CS3/MSG18013911/N

10 October 2018

**AUTOMOBILE TECHNICAL INVESTIGATION REPORT OF ACCIDENT
INVOLVING SCE 3638D AND SJT 7818M ON 27 JULY 2018**

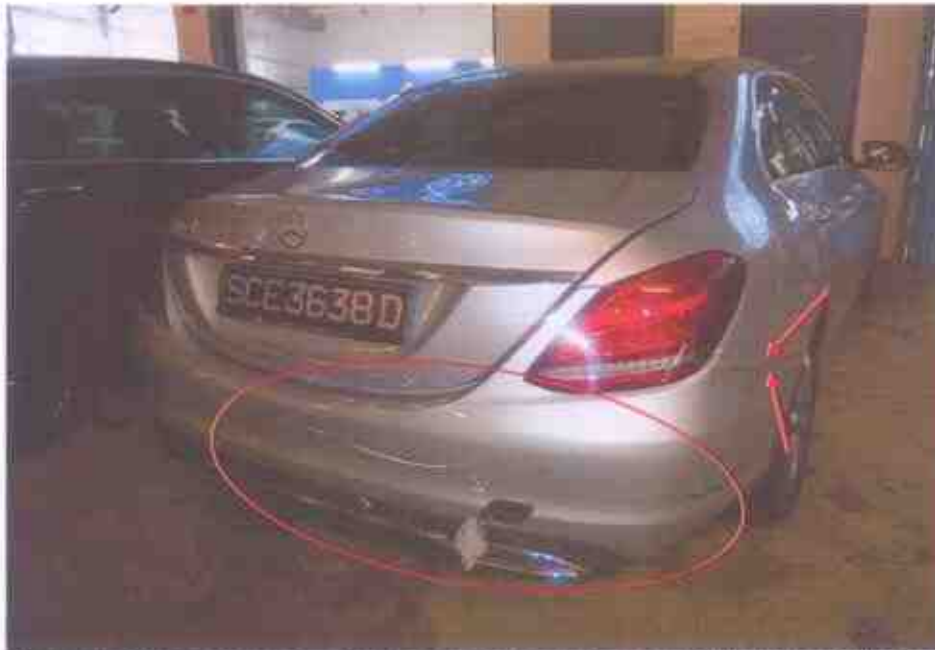
Photo 1 shows a right view of the rear portion of the C180 at the time of the Pre-Repair Survey conducted by LKK Auto Consultants Pte. Ltd. taken 5 days after the accident. The damages were concentrated on the right portion of the rear bumper (circled). There was a slight misalignment at the right corner edges of the rear bumper (arrowed).

- 21. The impact of the contact may have caused the paint cracks on the rear bumper of the C180. The impact of the contact may have also caused the dislodgment of the right reverse sensor as well as the tow hook cover of the C180.

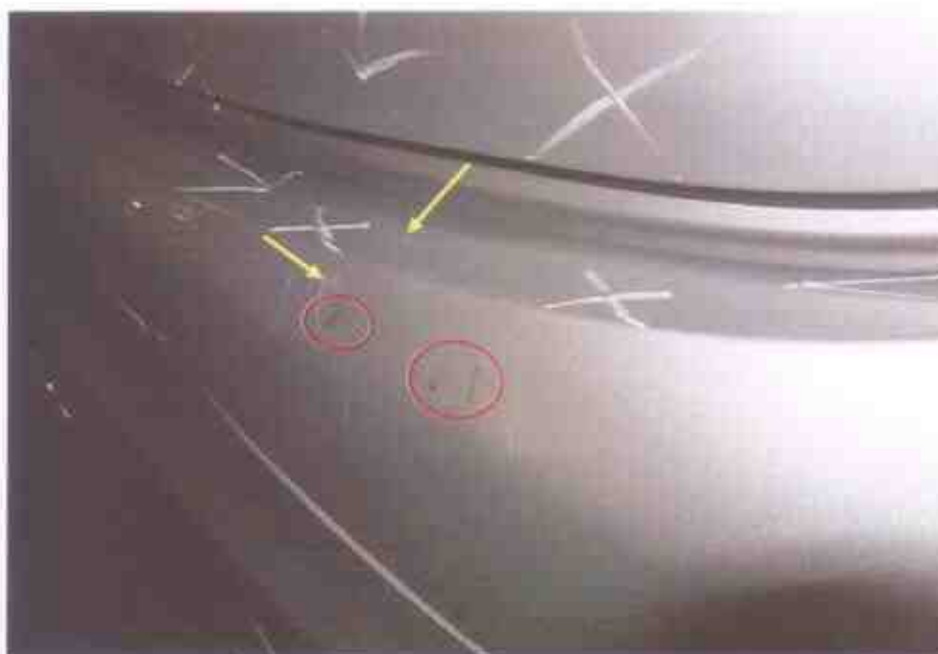
Photo 2 shows the paint cracks (arrowed) as well as the vertical black marks on the right portion of the rear bumper (circled).

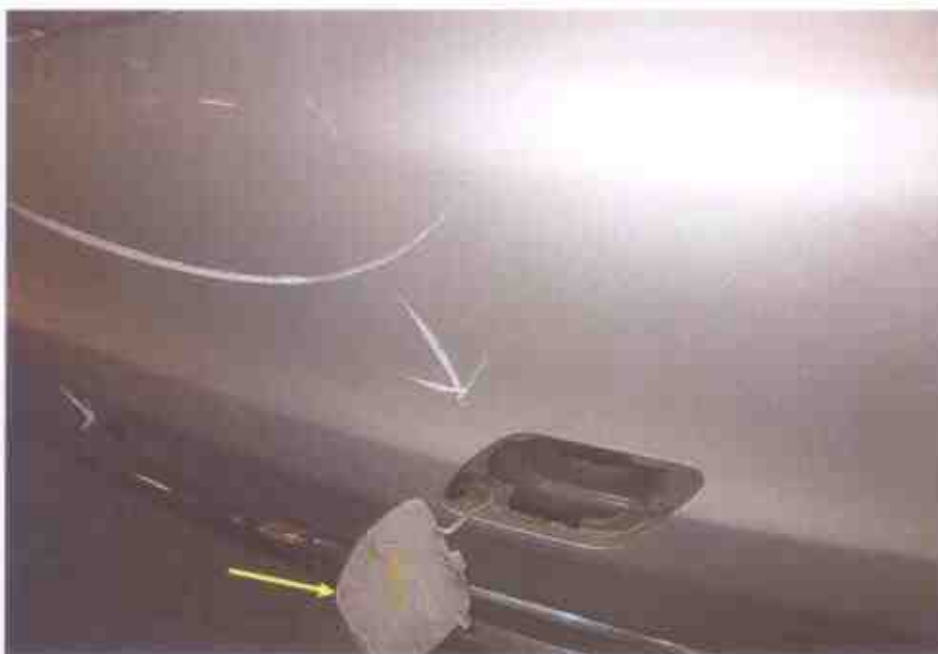
Photo 3 shows a close up view of the dislodged tow hook cover (arrowed).

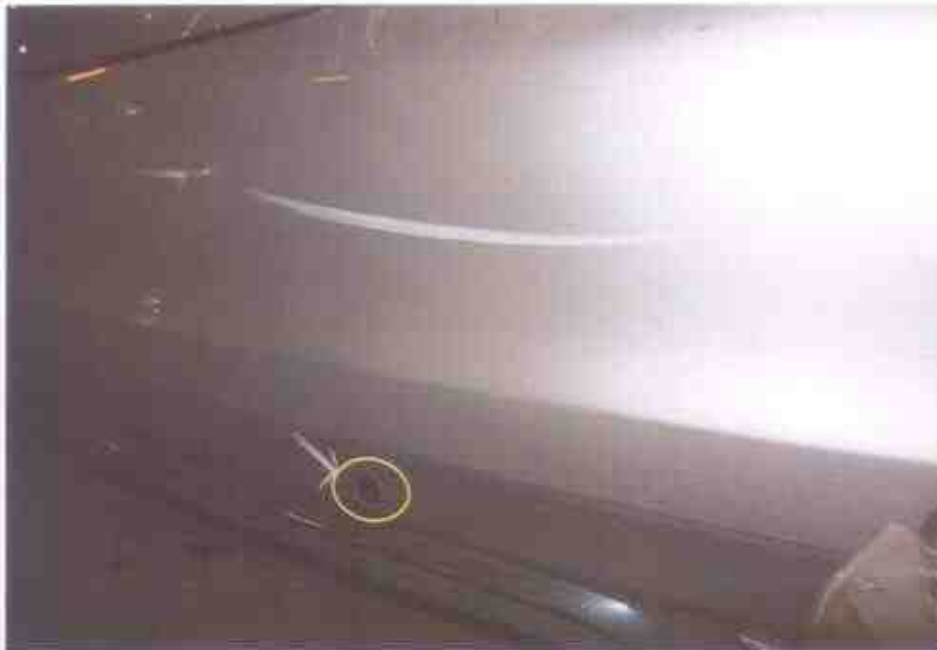
Photo 4 shows a closer view of the dislodged right reverse sensor (circled).

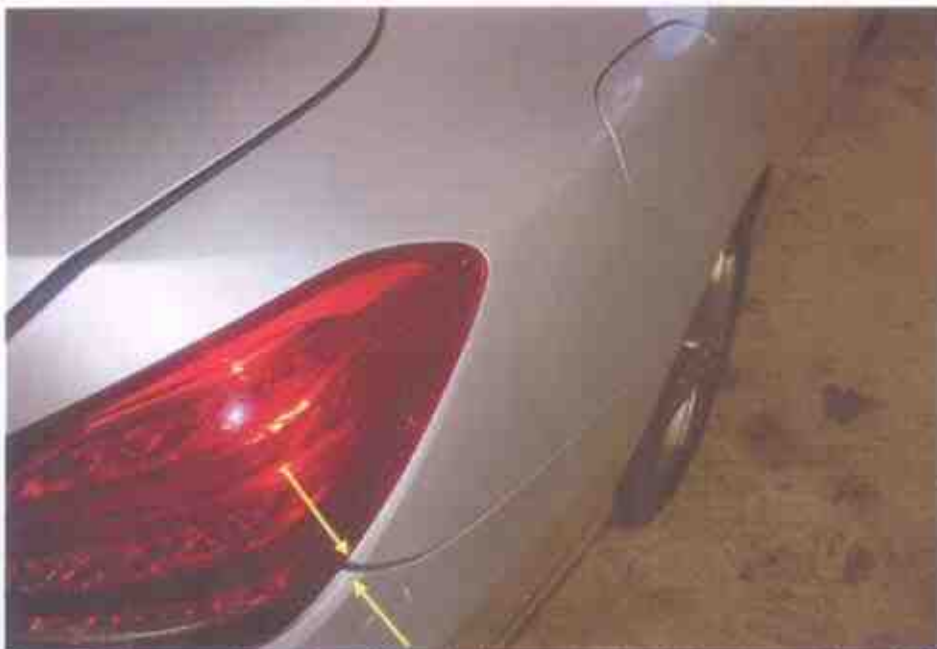
Photo 5 shows a closer view of the misalignment at the right corner edges of the rear bumper (arrowed).

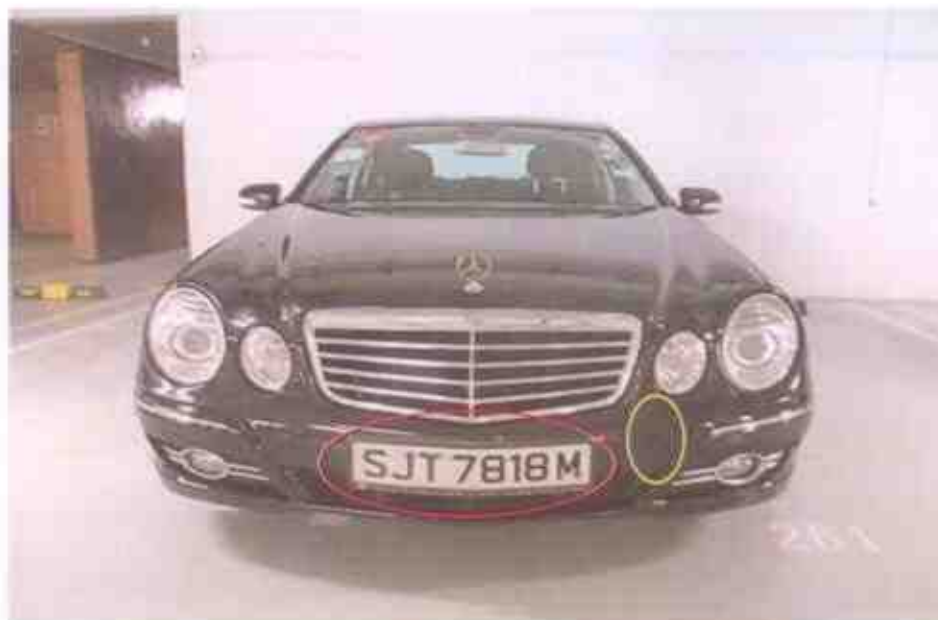
Photo 6 shows the general view of the front portion of the E200 at the time of our physical inspection. We note that there was a slight distortion on the top and left portion of the E200's front number plate frame, indicating that it had sustained an impact directly onto its front number plate (red circle). We also noticed a faint vertical indentation at the left portion of the front bumper (yellow circle).

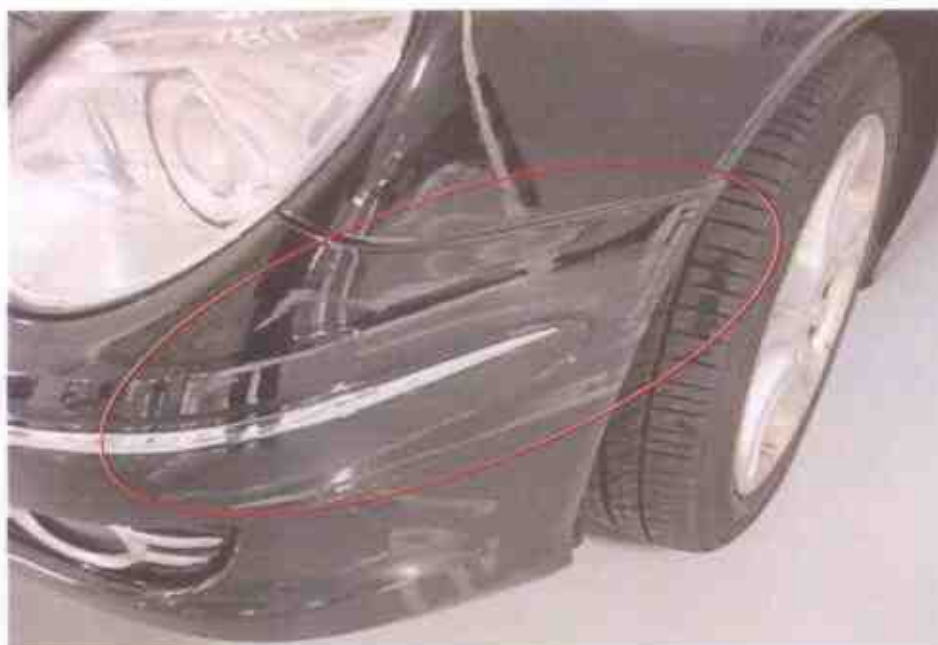
Photo 7 shows a closer view of the left front portion of the E200 at the time of our physical inspection. We observed that the E200 had sustained numerous damages on its front left portion as a result of past accidents (circled) as mentioned by Mr Loh who was present during the physical inspection.

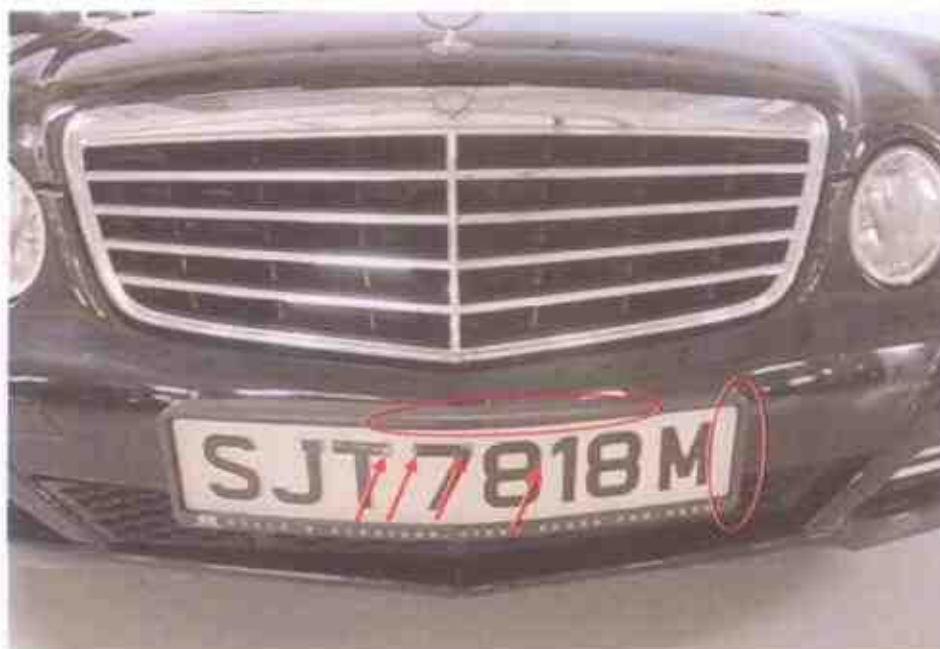
Photo 8 shows the distortion on the top and left portion of the E200's front number plate frame (circled), indicating that it had sustained an impact directly onto its front number plate. Upon closer examination, we observed whitish marks on the top alpha-numeric letterings of the front number plate (arrowed).

15. It would appear that the most significant damage to the E200 that could possibly have been a result of contact with the rear portion of the C180 was the front number plate of the E200. This is also taking into consideration that the rear bumper is the most protruded body part at the rear portion of the C180 where in the event of any contact, it will be the first body part that will come into contact with the front number plate of the E200. The reason for which is the slight horizontal crack on the damaged tow hook cover of the C180 was caused by an object pressing onto the rear portion of the C180. If one was to consider the distortion on the top portion of the E200's front number plate frame, it would then appear that the slight horizontal crack was caused by the front number plate of the E200.

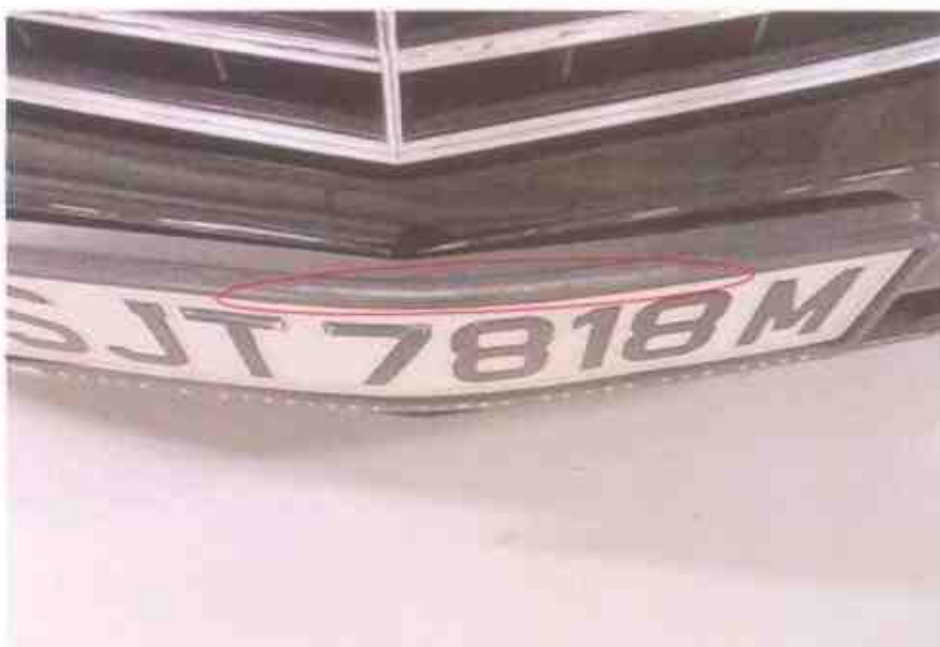
Photo 9 shows a closer view of the distortion on the top portion of the E200's front number plate frame (circled).

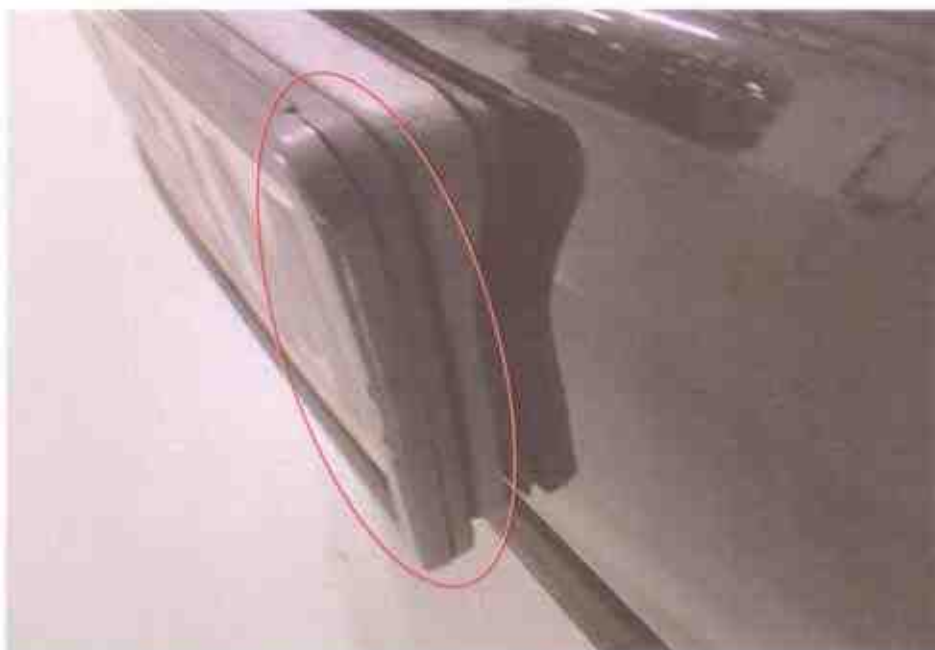
Photo 10 shows a closer view of the distortion on the left portion of the E200's front number plate frame (circled).

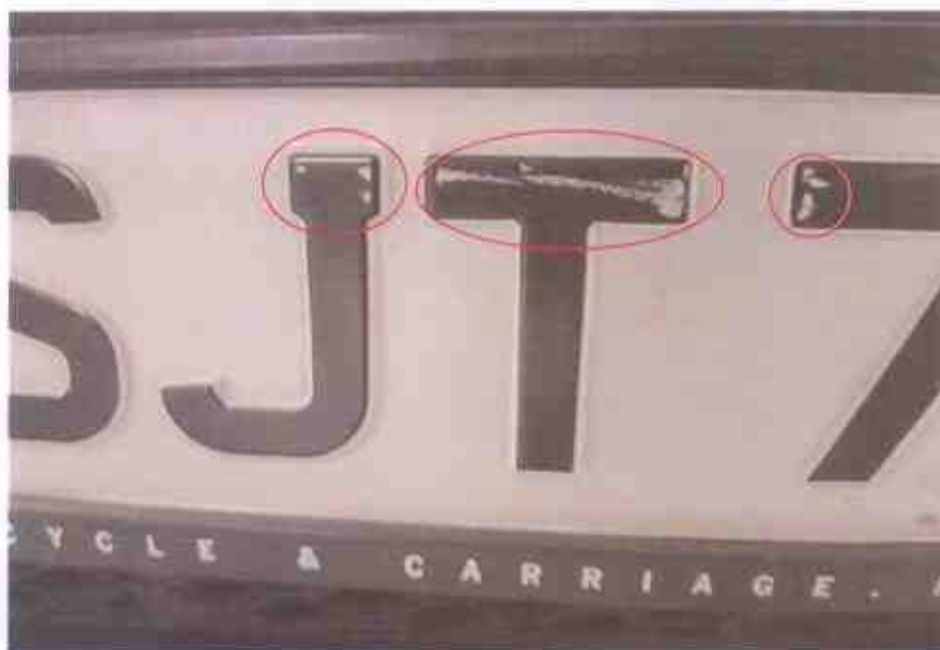
Photo 11 shows a close up view of the whitish marks on some of the top alphanumeric letterings of the front number plate (circled).

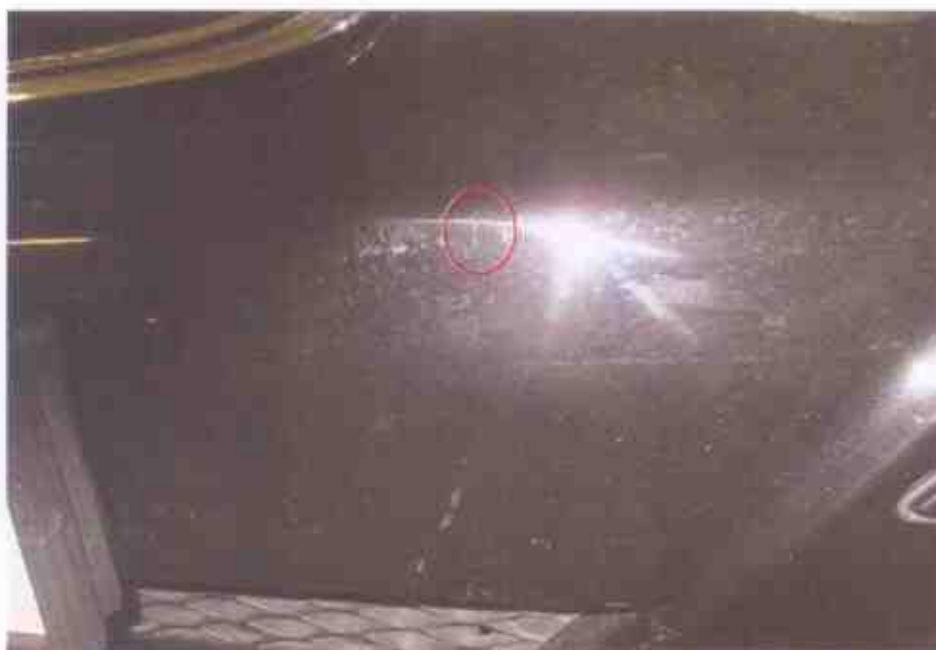
Photo 12 shows the faint vertical indentation at the left portion of the front bumper (circled).

16. Furthermore, if one was to consider the slight vertical indentation on the left portion of the E200's front bumper, it would then appear that the slight vertical indentation was caused by the C180's tow hook cover. See photos 16 & 17 below.

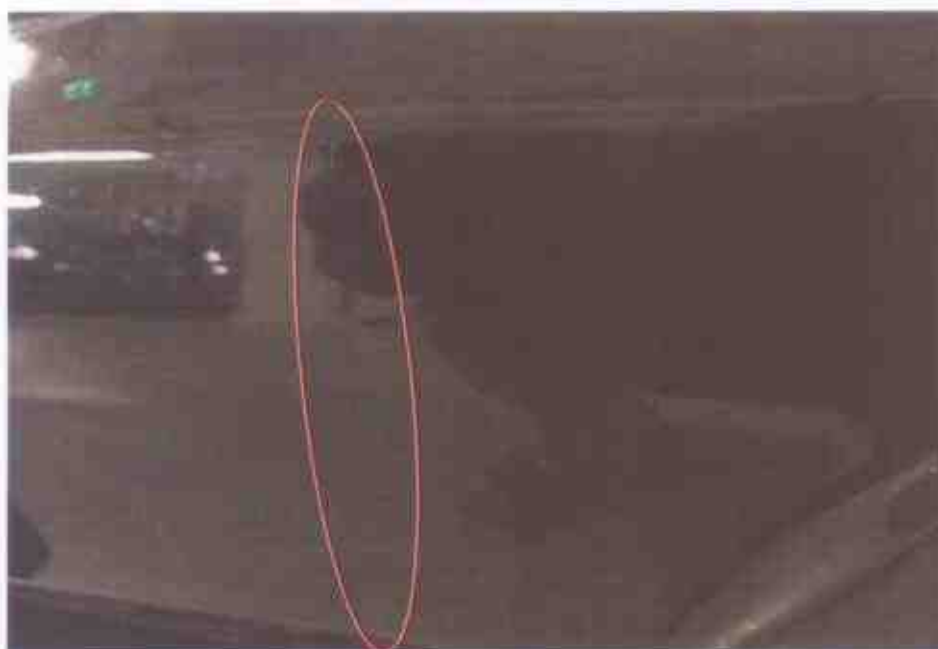
Photo 13 shows a close up view of the faint vertical indentation at the left portion of the front bumper (circled).

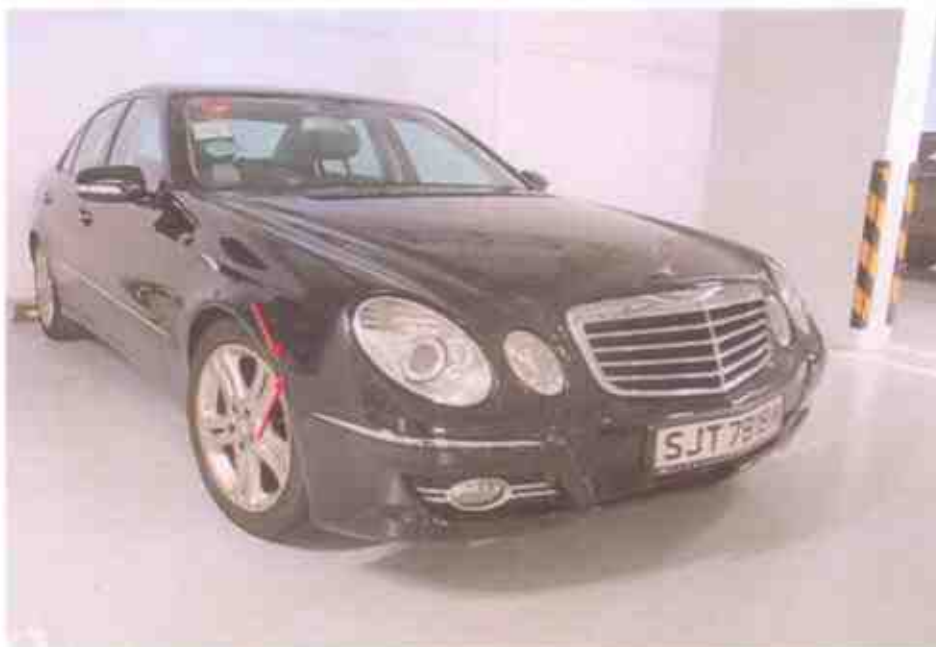
Photo 14 shows a closer view of the right corner edge of the front bumper of the E200. We observed that there was no misalignment at the corner edges (arrowed).

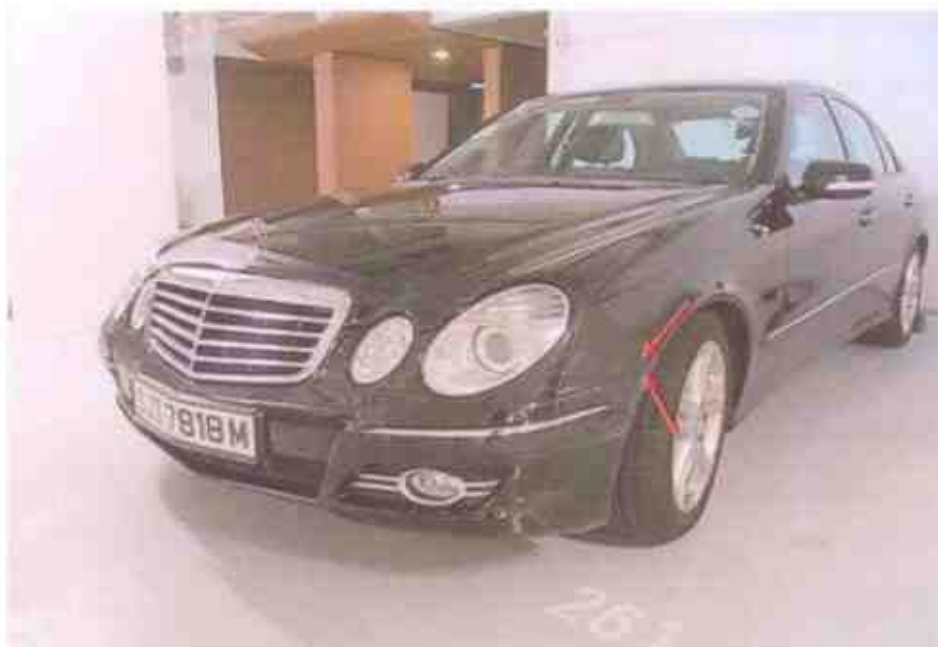
Photo 15 shows a closer view of the left corner edge of the front bumper of the E200. We observed that there was no misalignment at the corner edges (arrowed).

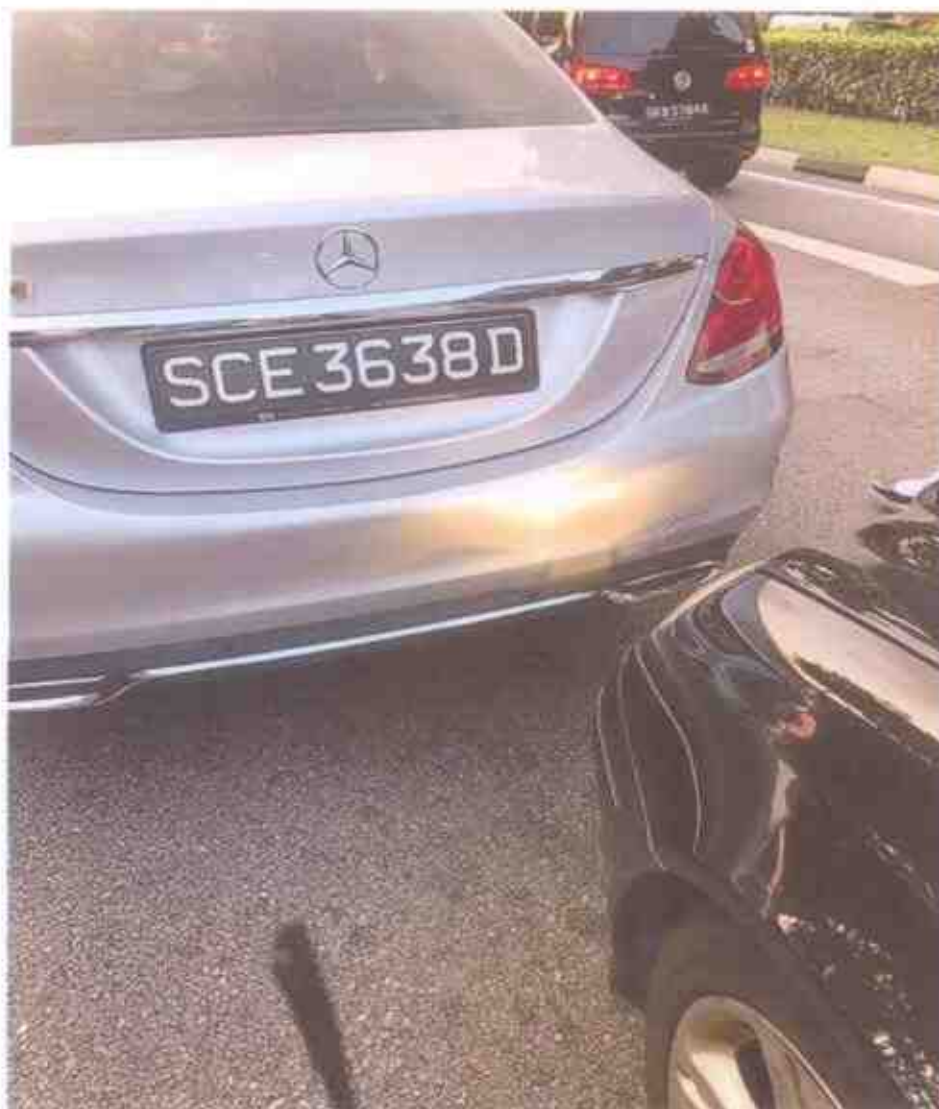
14. For this case, we were able to obtain from Mr Loh several post- accident photographs. It shows the final position of the Involved Motor Cars at the accident scene. The front left portion of the E200 was observed to be directly behind the rear right portion of the C180. Upon closer examination of these photographs, we observed a slight horizontal crack on the damaged tow hook cover of the C180.

Photo 16 shows a rear view of the position of the Involved Motor Cars after the accident. The front left portion of the E200 was observed to be directly behind the rear right portion of the C180.

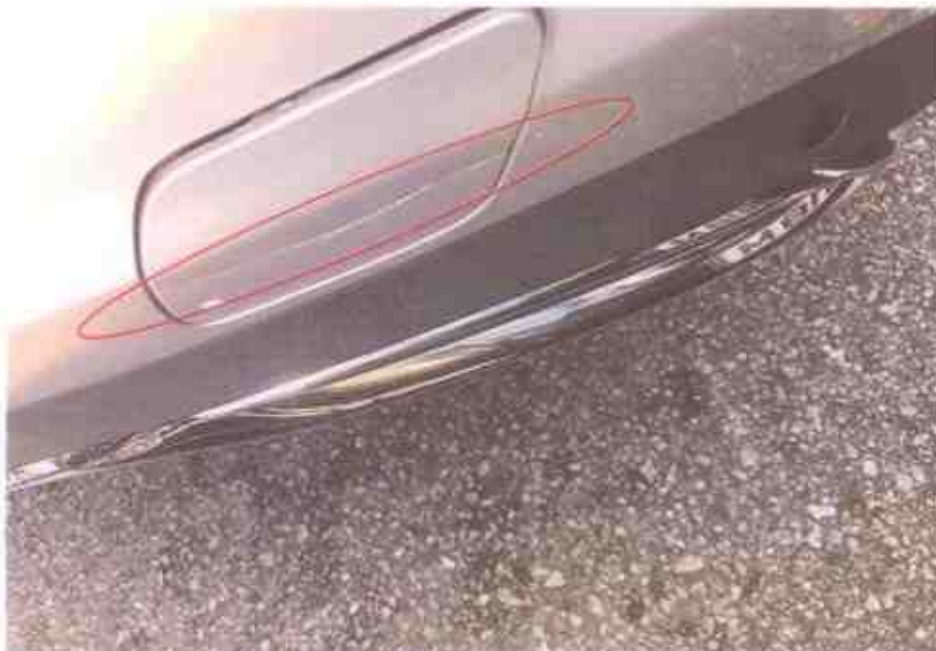
Photo 17 shows a close up view of the damaged tow hook cover of the C180 post- accident. We observed a horizontal indentation on the tow hook cover (circled)

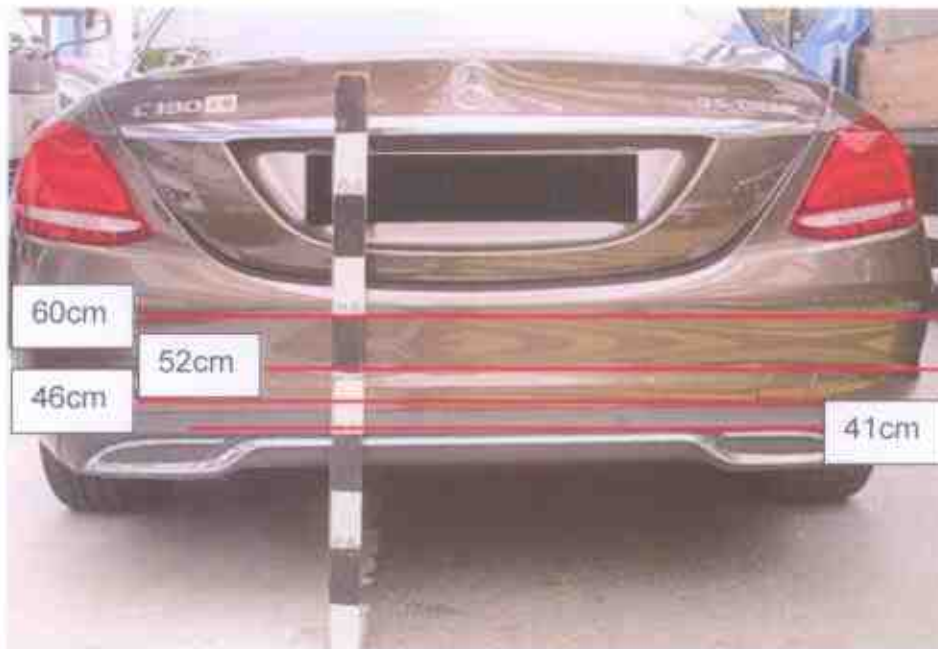
Photo 18 shows the height measurement being conducted on the rear portion of the C180 (using a similar make and model). The height above ground level of the C180's dislodged right reverse sensor was measured to be approximately 41cm. The height range above ground level of the C180's dislodged tow hook cover was measured to be between 46cm to 52cm. The height above ground level of the top portion of the C180's rear bumper at the area where the black marks and paint cracks were found was measured to be approximately 60cm.

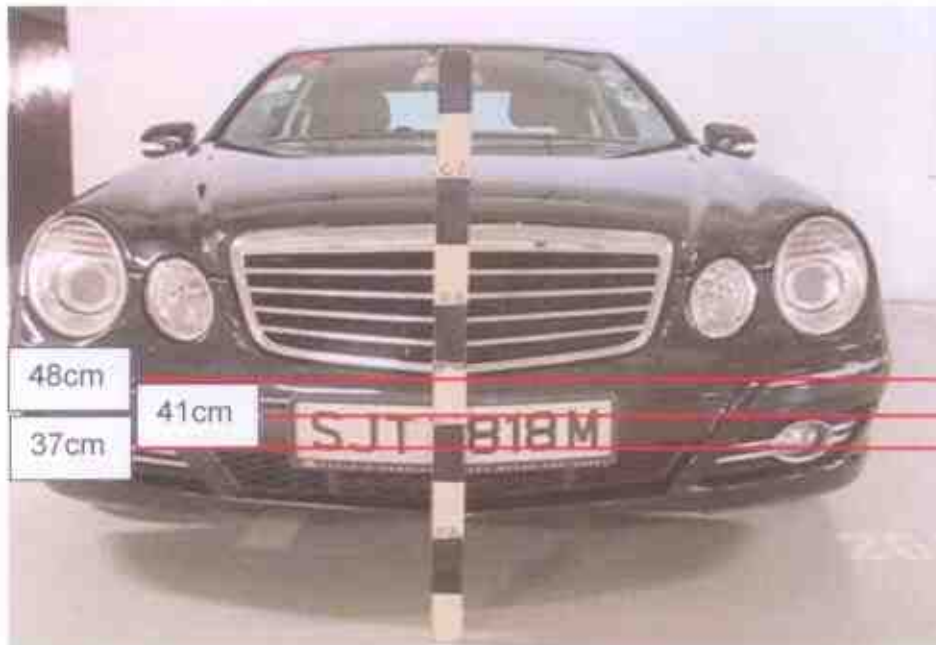
Photo 19 shows the height measurement being conducted on the front portion of the E200. The height range above ground level of the vertical indentation found on the left portion of the E200's front bumper was measured to be approximately between 37cm to 48cm. The bodypart at 41cm above ground level was the top portion of the alpha- numeric letterings of the front number plate where the whitish marks were found.
