Our ref: CS/FCI18020627/Dvd3

**INITIAL INSPECTION REPORT OF VEHICLE NO. SHA 3687Z**

## ADJUSTMENT ON REPAIR COST FOR VEHICLE NO. SHA 3687Z

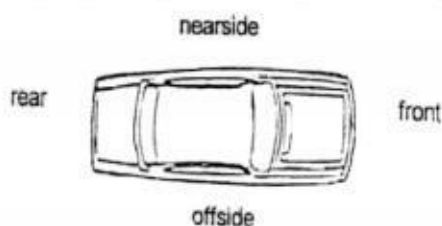
The vehicle sustained damages at the n/s front portion, n/s rear portion and n/s body.

Comments/Present Status:  
Damages Consistent
