Photographs of the Accident Vehicle

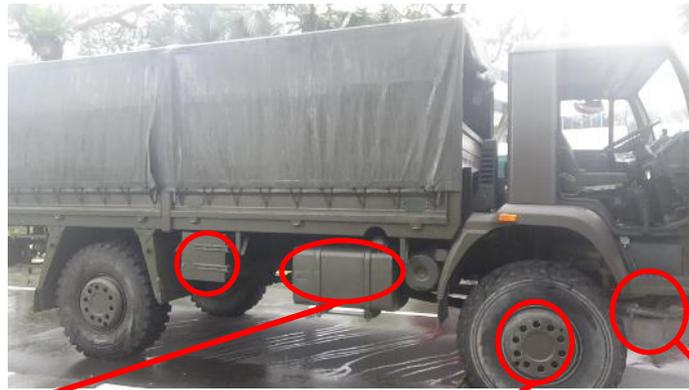
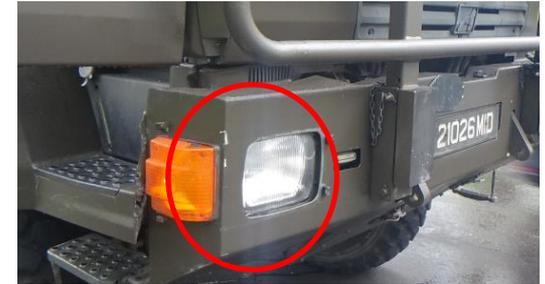
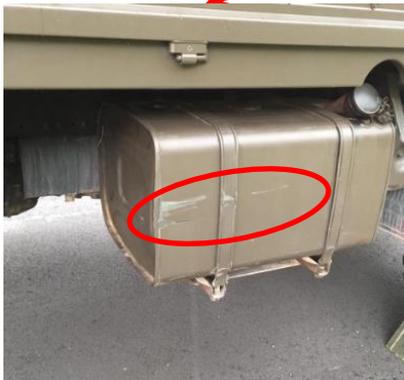
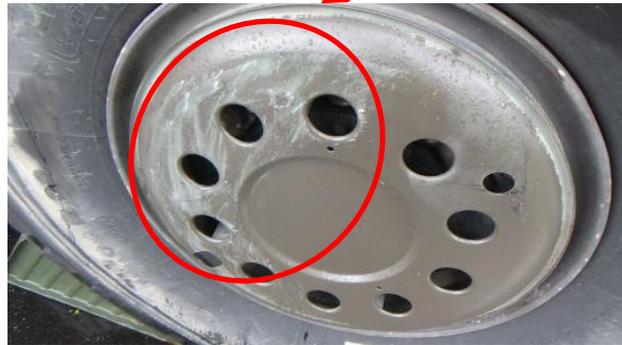
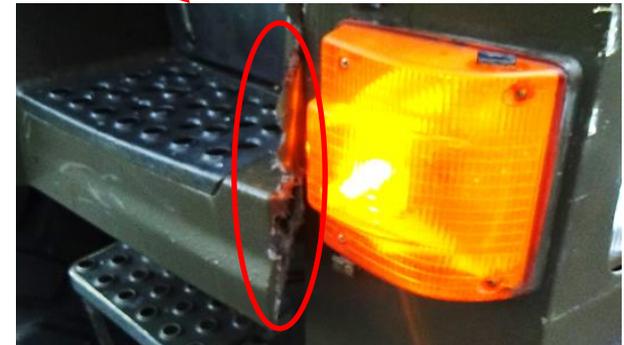
MID 21026 suffered graze marks on right front tyre rim, fuel tank and BII compartment box. Right headlight guard and driver step pedal were broken.

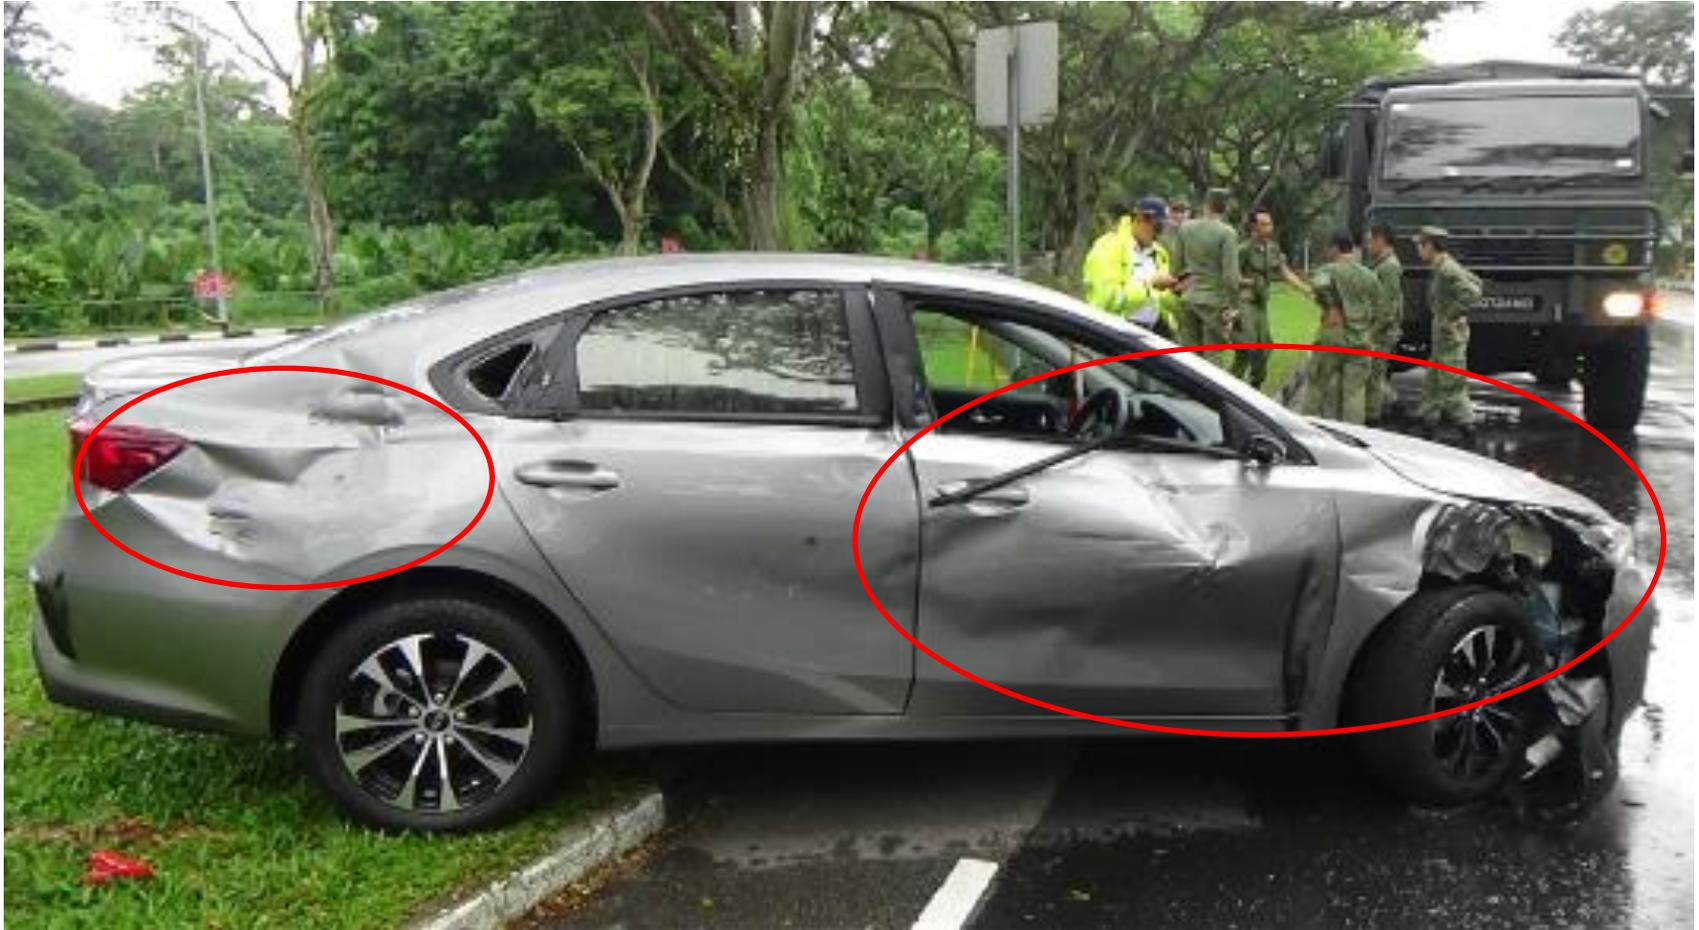
Photograph of Impact Point

The front, right body above the wheel of civilian saloon car (SMD 6048Z) was torn and crumpled inwards. There were scratches and dents along the right body of civilian saloon car (SMD 6048Z). The window of the driver seat was shattered.
