VEHICLE DAMAGE INSPECTION REPORT

Our Ref: 739/TP/2018

Reg No:	SMD3629S	Make &	Toyota
Reg date:	24/7/2009	Model	Vios E Auto
Colour:	Silver	Engine No:	1NZX946960
Type:	Motor Car	Chassis No:	MR053HY9305123919
Type of Claims:	Third Party	Odometer No:	143898km
		Engine Cap:	1497cc

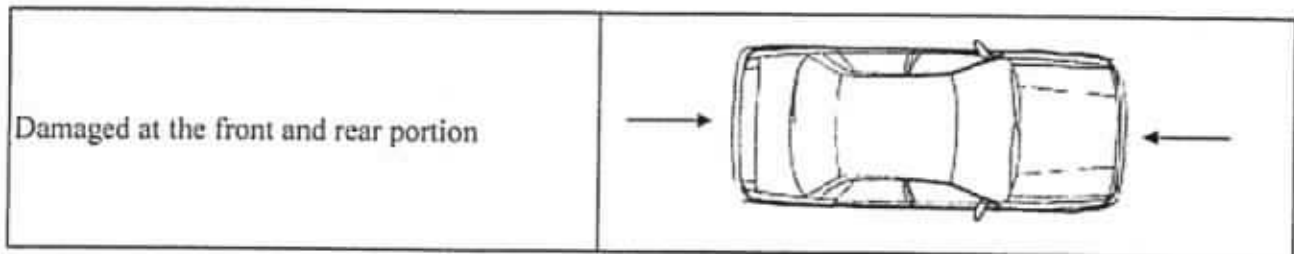
POINT OF IMPACT

GENERAL DESCRIPTION OF DAMAGES

Our visual inspection of the vehicle revealed that the damages noted are at the front and rear portion.

We have inspected the actual damages found on the vehicle and recommend the replacement of parts and repairs accordingly. The estimated repair cost is \$13,569.78. The repairer has agreed to undertake the repairs at our adjusted lump sum amount of \$9,700.00.
