## CVR Accident Photos

# LKK Auto Consultants Pte Ltd

## 1. Policy Particulars :- THIRD PARTY CLAIM

Registration No. QX 1282T

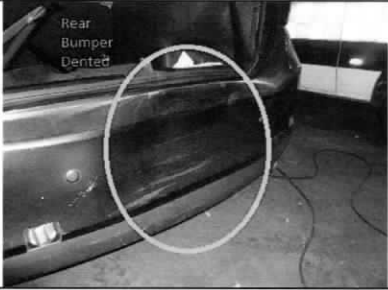
Rear Bumper Dented (Pic 1)	Rear Bumper Dented (Pic 2)

1.1	REAR BUMPER	1	DEFORMED	\$605.00	\$605.00	
1.2	REAR BUMPER REINFORCEMENT	1	BENT	\$296.45	\$296.45	
1.3	REAR END PANEL	1	DENTED	\$459.80	\$459.80	
1.4	REAR END PANEL GARNISH	1	DEFORMED	\$133.10	\$133.10

1. Remove Rear Bumper (Pic 1-4)
2. Remove Reverse Sensor to facilitate repair works
3. Remove Rear Bumper Reinforcement (Pic 6)
4. Remove Rear End Panel (Pic 7)

9. Remove RHS Boot Lid Cover Tail Lamp (Pic 15)
10. Replace Rear Bumper (Pic 1-4)
11. Re-Install back Reverse Sensor onto new Rear Bumper
12. Replace Rear LH Bumper Tow Eye Cover (Pic 5)

21. Wiring for LHS & RHS Boot Lid Cover Tail Lamp (Pic 14-15)
22. Align Boot Lid Cover
23. Putty & Spray Paint for Rear Complete Bumper (Pic 1-4)
24. Putty & Spray Paint for Boot Lid Cover (Pic 9-12)

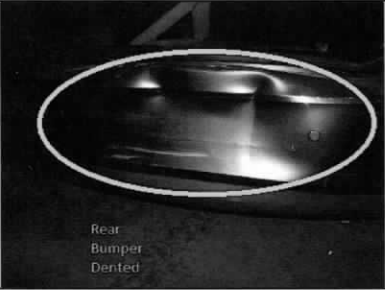
<p>Rear Bumper Dented</p>

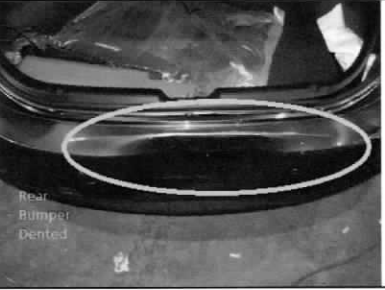
<p>Rear Bumper Dented</p>
Rear LH Bumper Tow Eye Cover Missing (Pic 5)	Rear Bumper Reinforcement Missing (Pic 6)

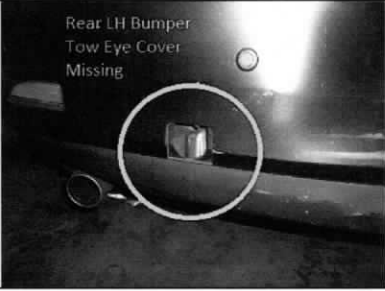
<p>Rear LH Bumper Tow Eye Cover Missing</p>

1.5	BOOT LID COVER	1	DEFORMED	\$665.50	\$665.50	
1.6	BOOT LID COVER HINGES (LEFT & RIGHT)	2	SERVICEABLE	\$350.90	\$0.00	
1.7	REAR LH BUMPER TOW EYE COVER	1	MISSING	\$42.35	\$42.35

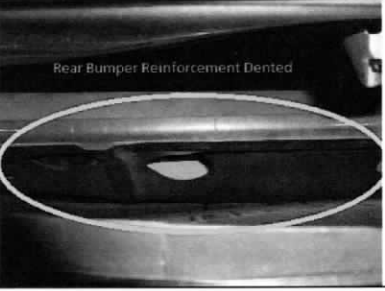
<p>Rear Bumper Reinforcement Dented</p>
Rear End Panel Dented (Pic 7)	Rear Bumper Reinforcement Dented (Pic 8)

13. Replace Rear Bumper Reinforcement (Pic 6)
14. Replace Rear End Panel (Pic 7)
15. Replace Rear End Panel Garnish (Pic 8)
16. Replace Boot Lid Cover (Pic 9-12)

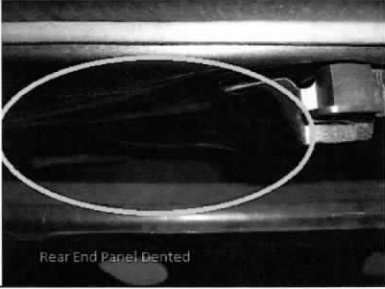
<p>Rear End Panel Dented</p>

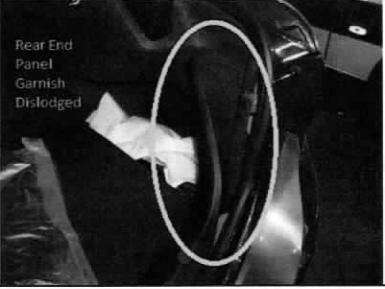
<p>Rear End Panel Garnish Dislodged</p>
Rear End Panel Dented (Pic 9)	Rear End Panel Garnish Dislodged (Pic 10)

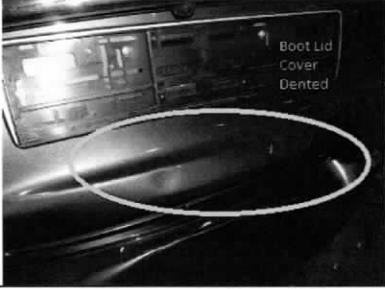
<p>Boot Lid Cover Dented</p>

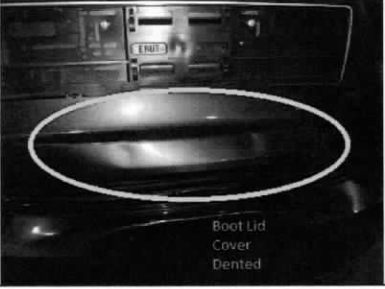
<p>Boot Lid Cover Dented</p>
Boot Lid Cover Dented (Pic 11)	Boot Lid Cover Dented (Pic 12)

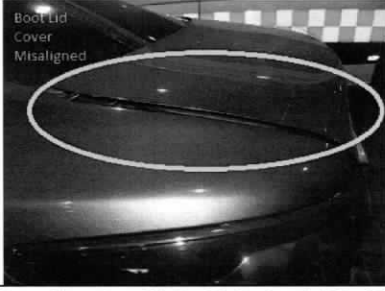
<p>Boot Lid Cover Misaligned</p>

17. Replace Both Side Boot Lid Cover Hinges (Pic 11-12)
18. Replace Rear Number Plate (Pic 13)
19. Replace LHS Boot Lid Cover Tail Lamp (Pic 14)
20. Replace RHS Boot Lid Cover Tail Lamp (Pic 15)

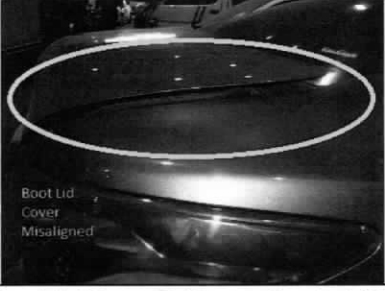
<p>Boot Lid Cover Misaligned</p>
Rear Number Plate Dislodged (Pic 13)	LHS Boot Lid Cover Tail Lamp Cracked (Pic 14)
