Your Ref: TP/IP/42521/2018
Our Ref: CI/TPD18021189/Z

Fatal Accident Investigation Team
Traffic Police Department
Singapore Police Force
10 Ubi Avenue 3
Singapore 408865

MECHANICAL INSPECTION REPORT OF MOTORCYCLE FBL 1211P

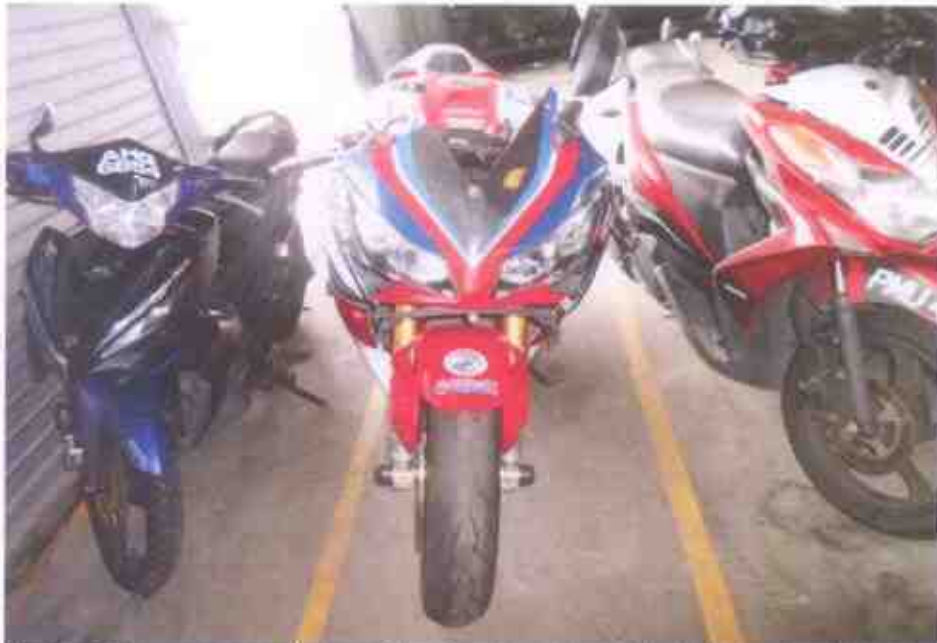
Photo 1 shows a general view of the frontal portion of the Motorcycle at the time of our inspection. The Motorcycle was observed to be have sustained with damages due to the accident collision.

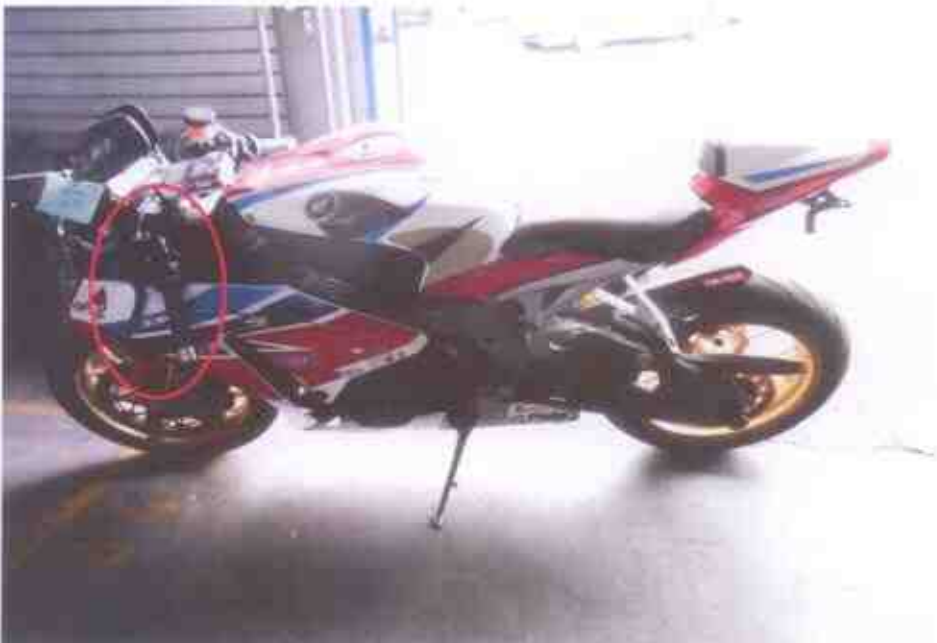
Photo 2 shows a general view of the front left body of the Motorcycle at the time of our inspection. The Motorcycle was observed to be sustained with damages due to the accident collision. Amongst the body parts damaged was its left handle bar, which was observed to be dislodged from the original structure.

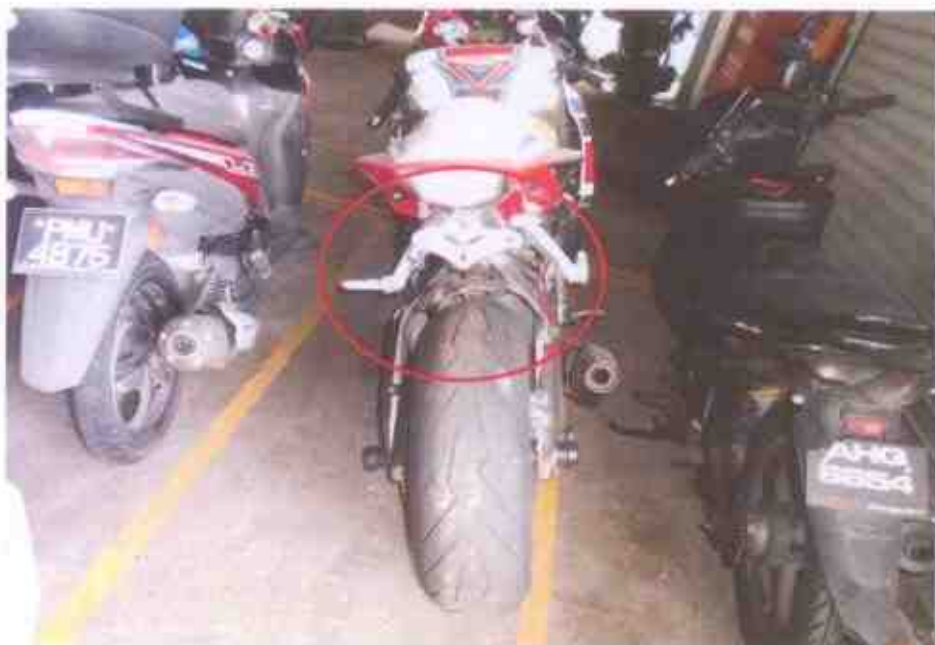
Photo 3 shows a general view of the rear body of the Motorcycle at the time of our inspection. The Motorcycle was observed to sustain with damages which affects the rear mudguard, rear licence plate & rear left signal lamp due to the accident.

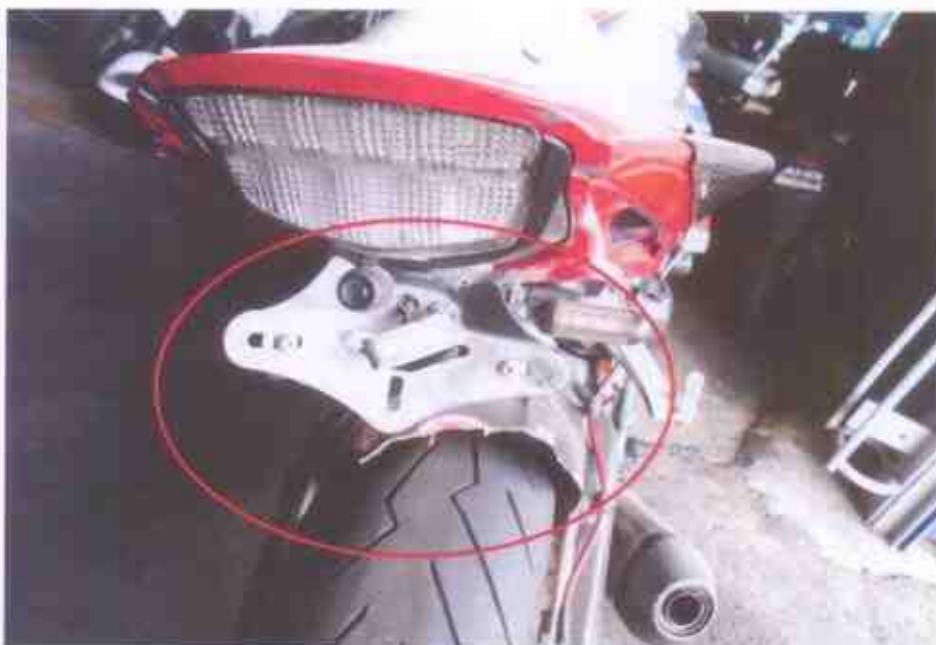
Photo 4 shows a close-up view of the rear portion of the Motorcycle at the time of our inspection. The Motorcycle was observed to sustain with damages which affects the rear mudguard, rear licence plate & rear left signal lamp due to the accident.

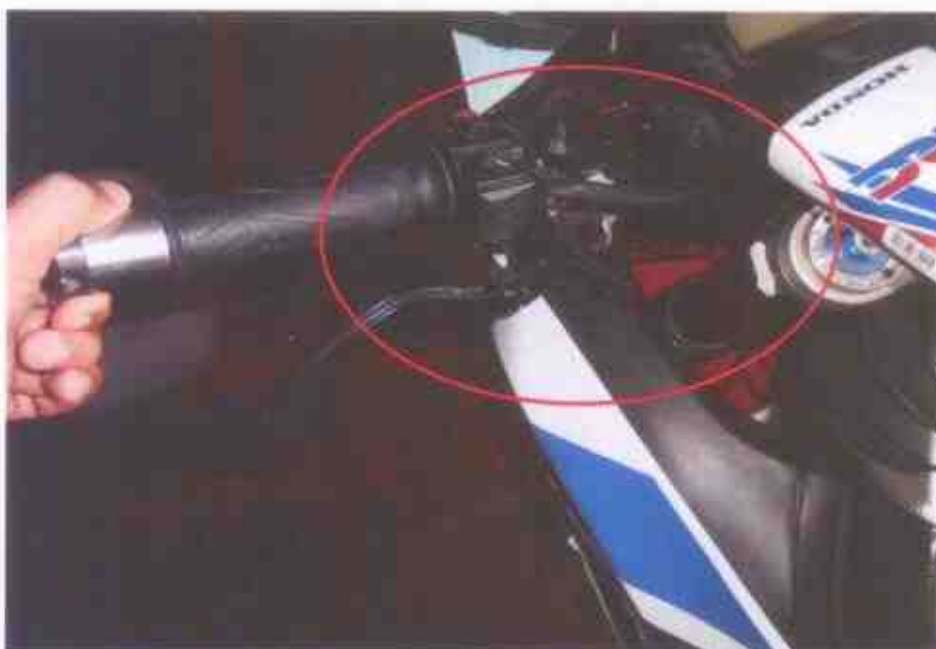
Photo 5 shows a semi close-up view of the frontal portion of the Motorcycle at the time of our inspection. The Motorcycle was observed to be sustained with dislodged left hand side handle bar due to the accident collision.

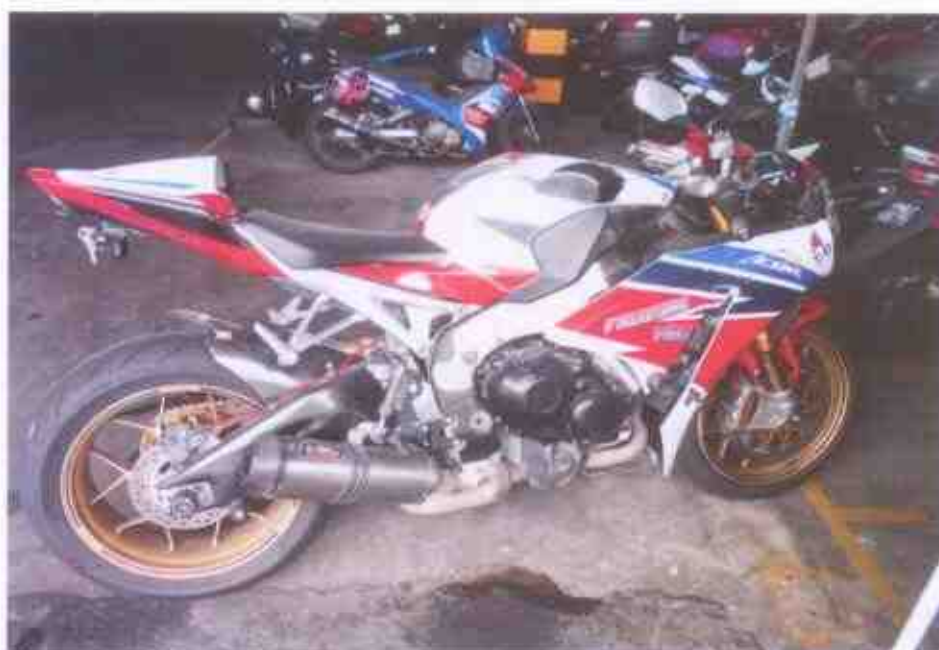
Photo 6 shows a general view of the front right portion of the Motorcycle at the time of our inspection. The Motorcycle was observed to be sustained with damages due to the accident collision.

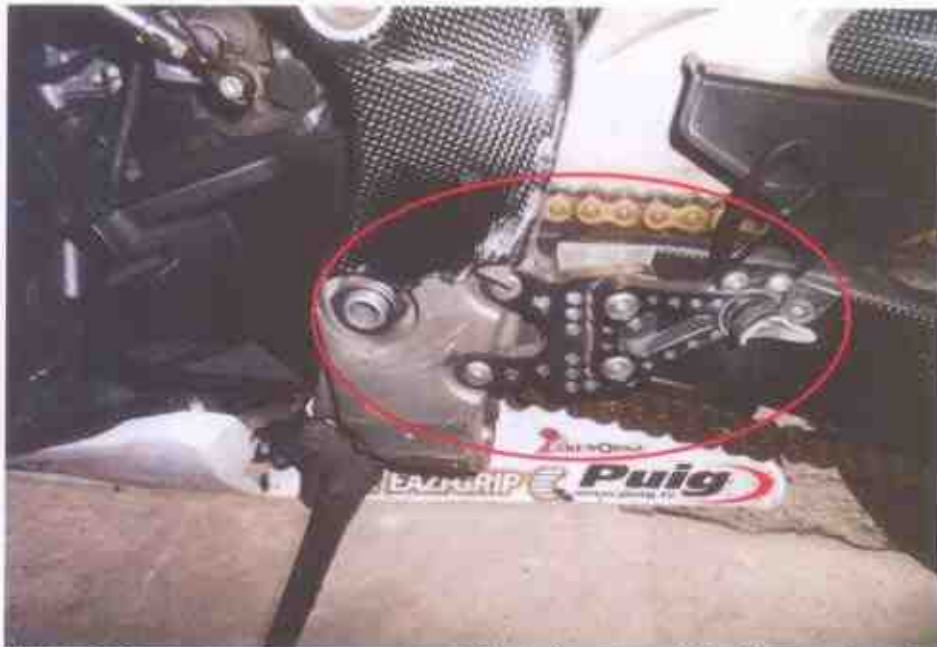
Photo 7 shows a semi close-up view of the left portion of the Motorcycle at the time of our inspection. The Motorcycle was observed to have sustained with dislodged left side foot rest & gear shift pedal due to the accident collision.

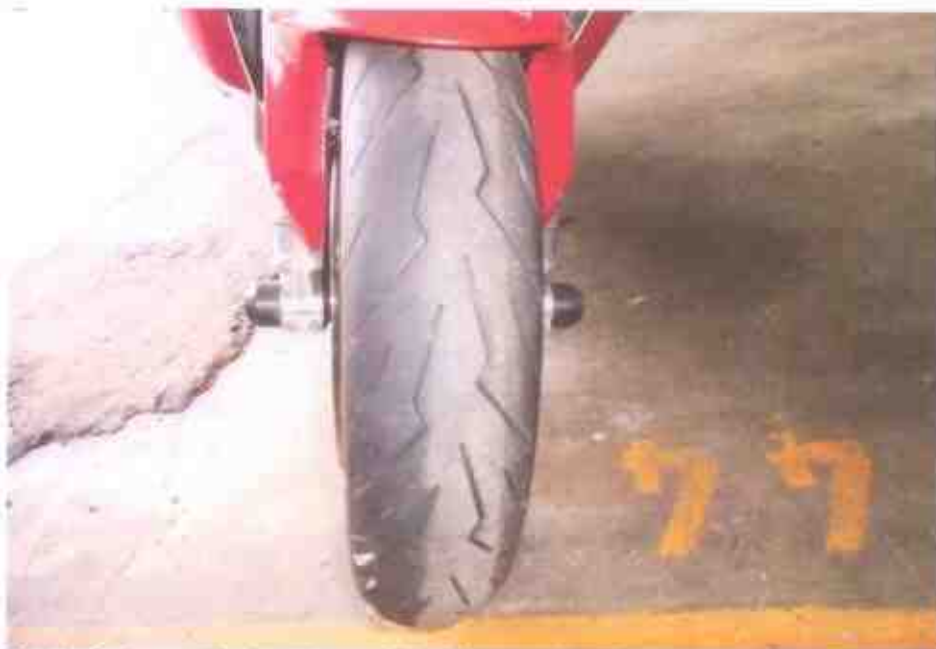
Photo 8 shows the front tyre of the Motorcycle. The pattern of the tread was clearly visible with remaining tread depth of about 2mm. There was no tear, burst mark(s) and/or punctured hole(s) on the sidewalls as well as across the tread of the rear tyre unaffected by the accident's impact collision.

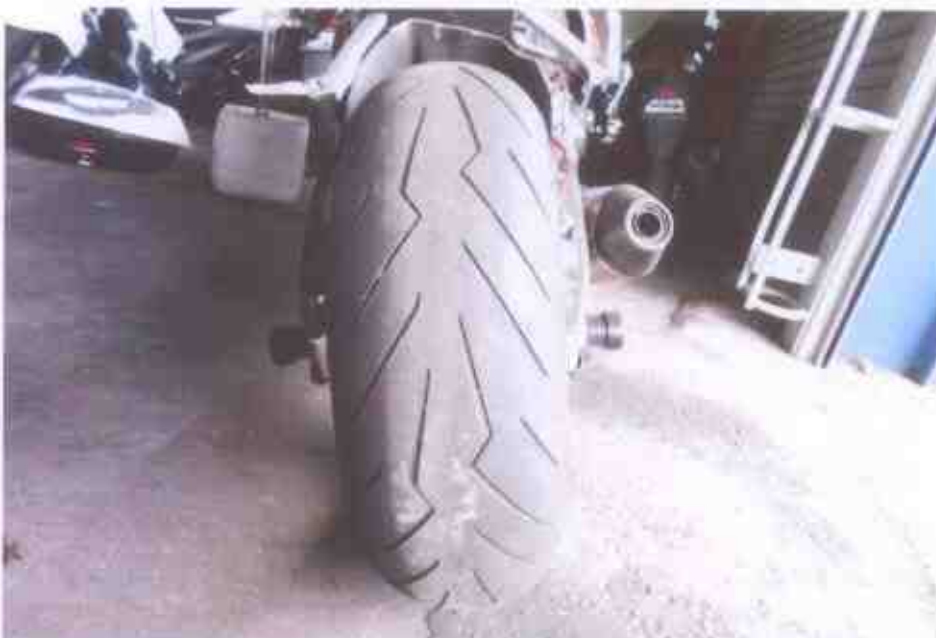
Photo 9 shows the rear tyre of the Motorcycle. The pattern of the tread was clearly visible with remaining tread depth of about 3mm. There was no tear, burst mark(s) and/or punctured hole(s) on the sidewalls as well as across the tread of the rear tyre unaffected by the accident's impact collision.

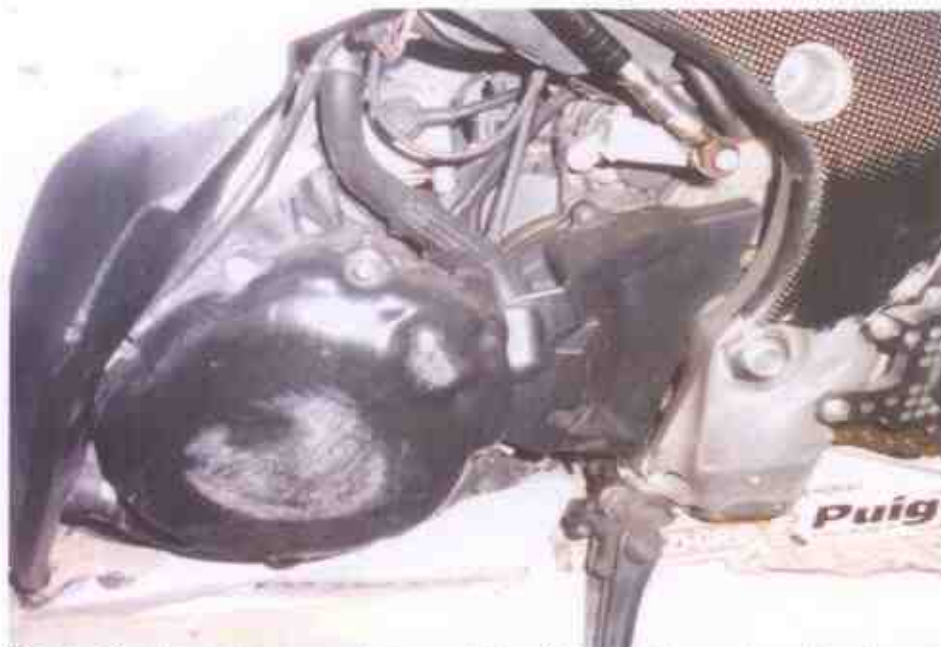
Photo 10 shows the general view of the Motorcycle's engine. No signs or indication of any engine leakage at time of our inspection.

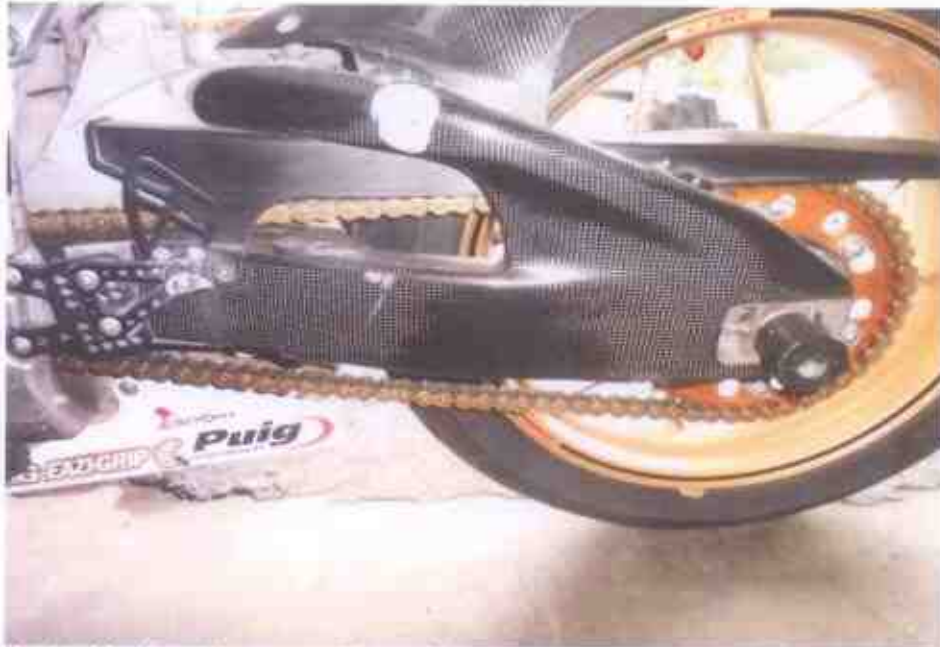
Photo 11 shows the general view of the gear train of the Motorcycle, which was observed to be intact with no misalignment. It was also adequately lubricated for operating purposes.

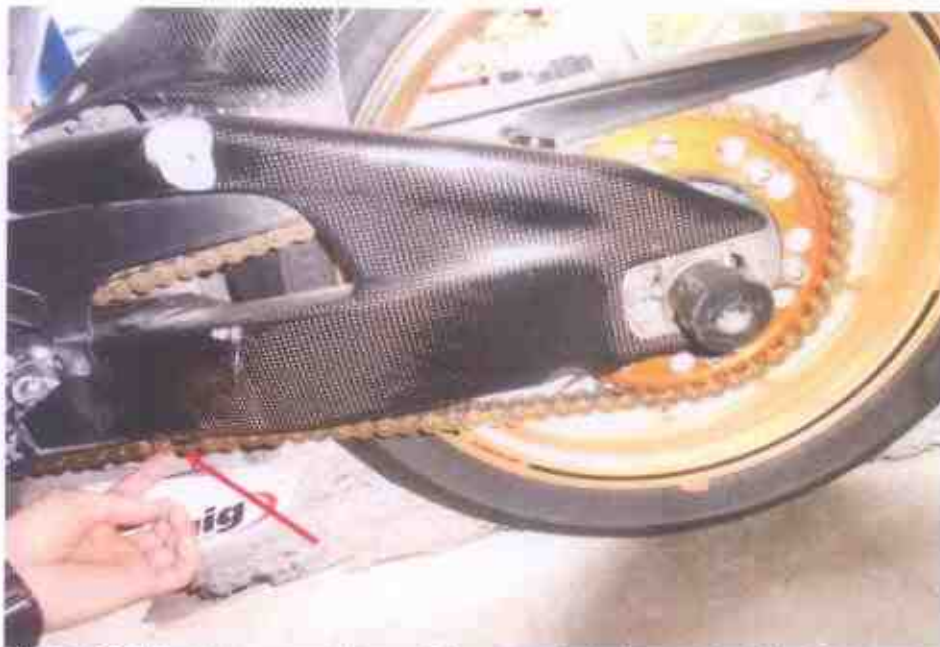
Photo 12 shows the general view of the gear train (arrowed) of the Motorcycle, which was observed to be intact with no misalignment. It was also adequately lubricated for operating purposes. Free play tension was also observed & found adequately acceptable.

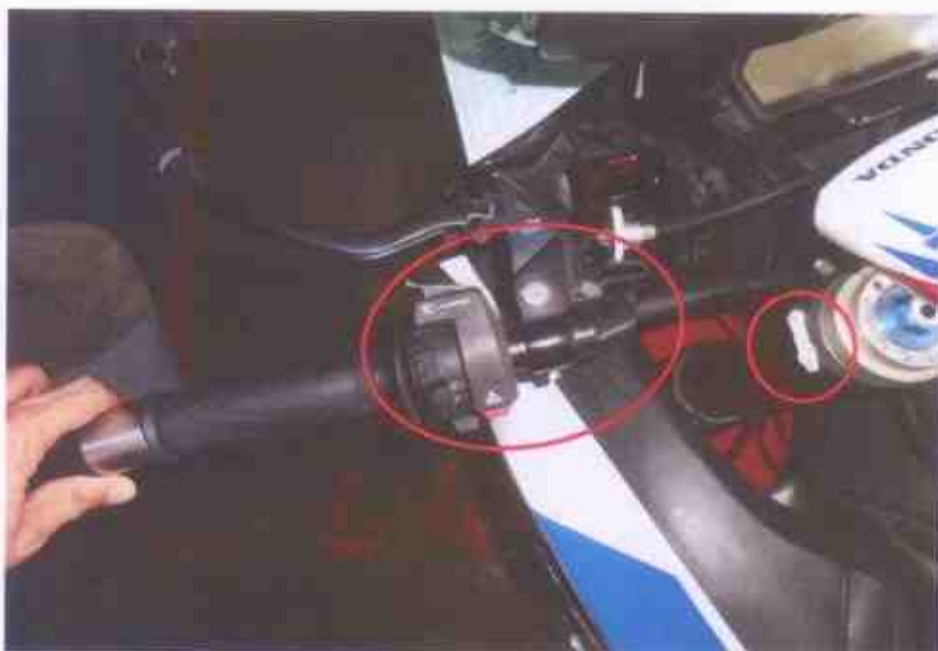
11. For this case, we were not able to conduct any test(s) on the steering system of the Motorcycle due to the damage on its steering system. The left handle bar was found to be dislodged from the original installation as a result of the accident, hence causing the whole steering system to be in a state of immobility.

Photo 13 shows the front left side handle bar was observed to be dislodged as a result of the accident. Hence, we are not able to conduct any tests on the steering system of the Motorcycle.

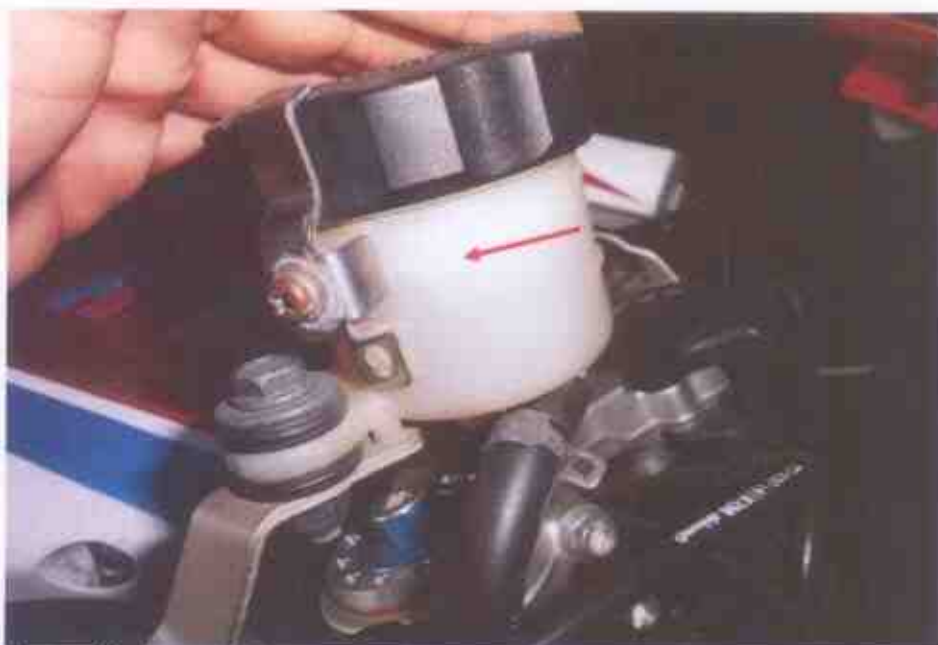
Photo 14 shows the front brake fluid reservoir had indicated that the brake fluid was of sufficient level for operational purposes, and without contamination.

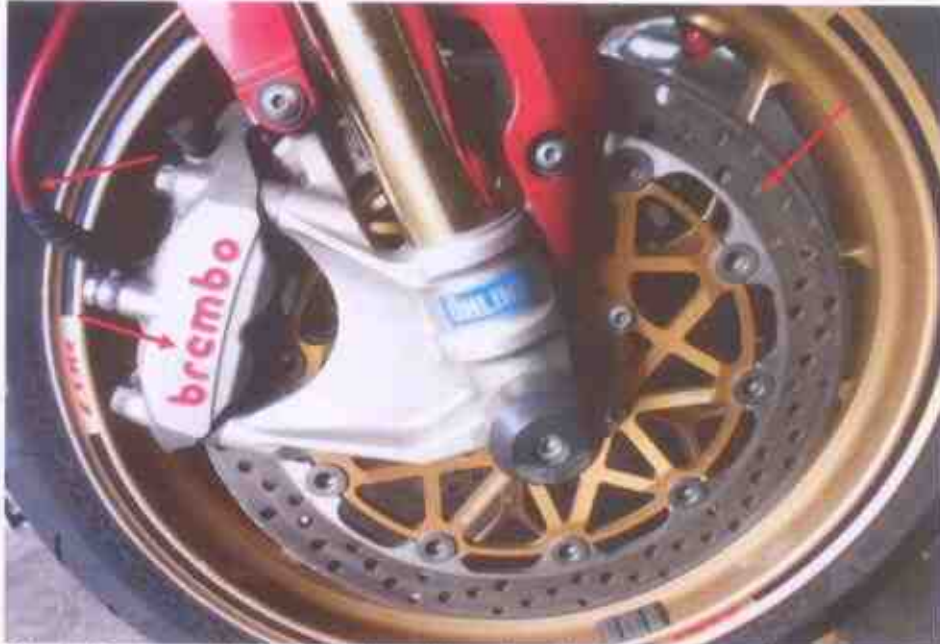
Photo 15 shows the front brake caliper, front brake disc, front brake pad and front brake hose of the Motorcycle, which are all part of the components in the front brake system of the Motorcycle. Our observation found that the front braking components were unaffected by the accident.

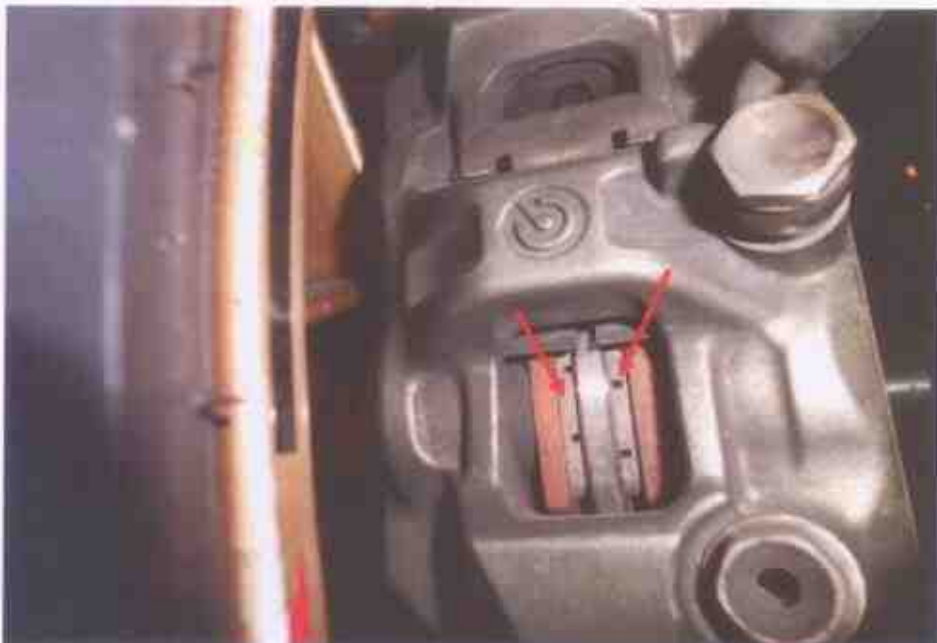
Photo 16 shows the front brake pad of the Motorcycle (arrowed), which are part of the components in the front brake system of the Motorcycle reveal to be adequately sufficient for operational purposes.

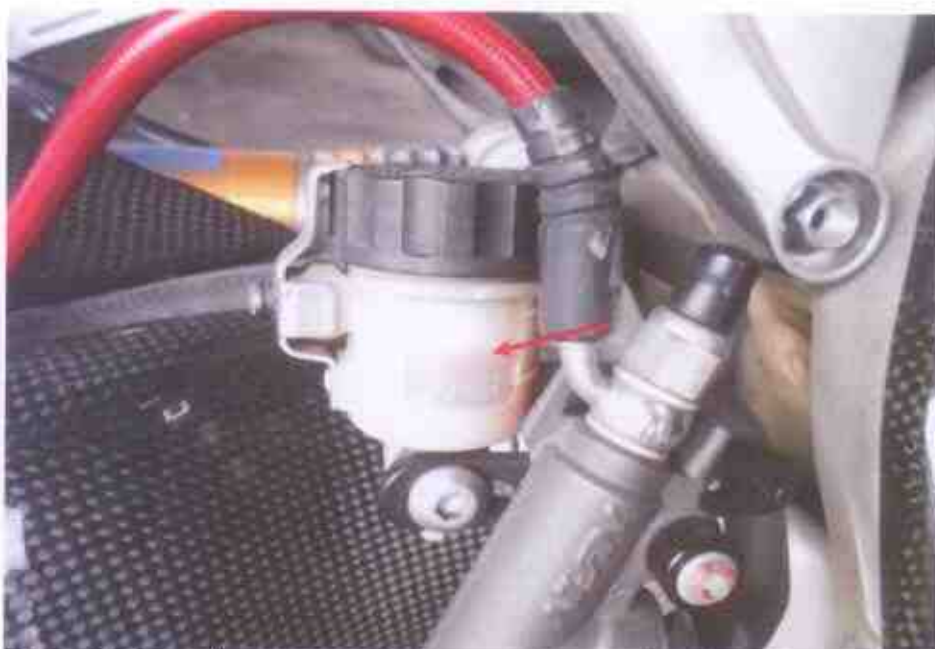
Photo 17 shows the rear brake fluid reservoir had indicated that the brake fluid was of sufficient level for operational purposes, and without contamination.

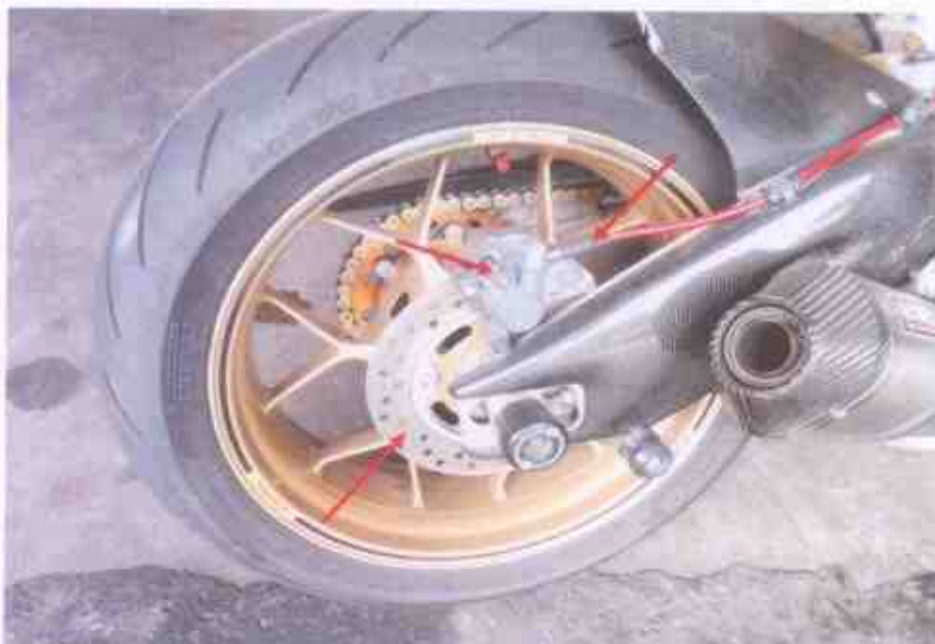
Photo 18 shows the rear brake calliper, rear brake disc and rear brake hose of the Motorcycle, which are all part of the components in the rear brake system of the Motorcycle. Our observation found that the rear braking components were unaffected by the accident.

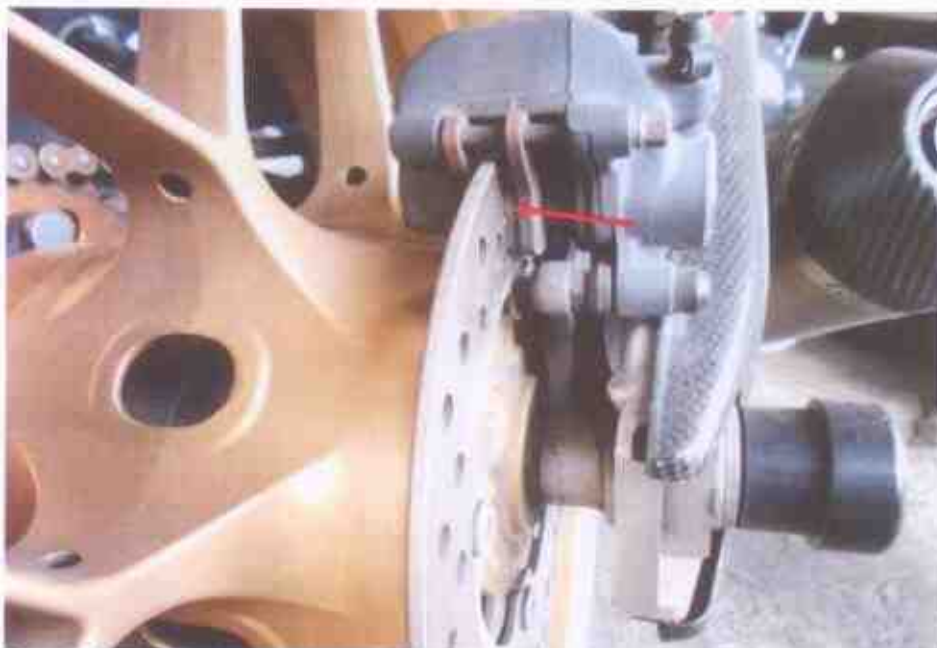
Photo 19 shows the rear brake pad of the Motorcycle (arrowed), which are part of the components in the rear brake system of the Motorcycle reveal to be adequately sufficient for operational purposes.
