## VEHICLE DAMAGE INSPECTION REPORT

Our Ref: 750/TP/2018

1. Policy Particulars :- THIRD PARTY CLAIM (RESURVEY INSPECTION)			
Insured Veh.	SGG 1389C	Veh. Inspected	SJU 8171H
Policy No.	PNPV2017-00003447-01	Coverage (\$)	0.00
Claim No.	1201800012743	Excess (\$)	0.00
Assign From	CLARA LI	Assign Date	22/11/2018

### ADJUSTMENT ON REPAIR COST FOR VEHICLE NO. SJU 8171H

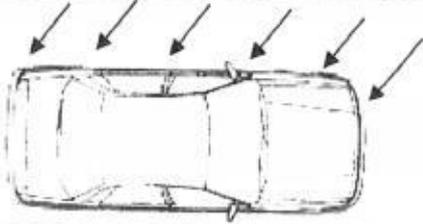
## POINT OF IMPACT

Damaged at the front, left hand front and left hand rear portion

Our visual inspection of the vehicle revealed that the damages noted are at the front, left hand front and left hand rear portion.
