Your Ref : S8M0148A  
Our Ref : CS/ASM18021294/Z

30<sup>th</sup> November 2018

**TECHNICAL INVESTIGATION REPORT OF FIRE INCIDENT INVOLVING THE INSURED VEHICLE SJZ 2191M ON 22<sup>nd</sup> November 2018**

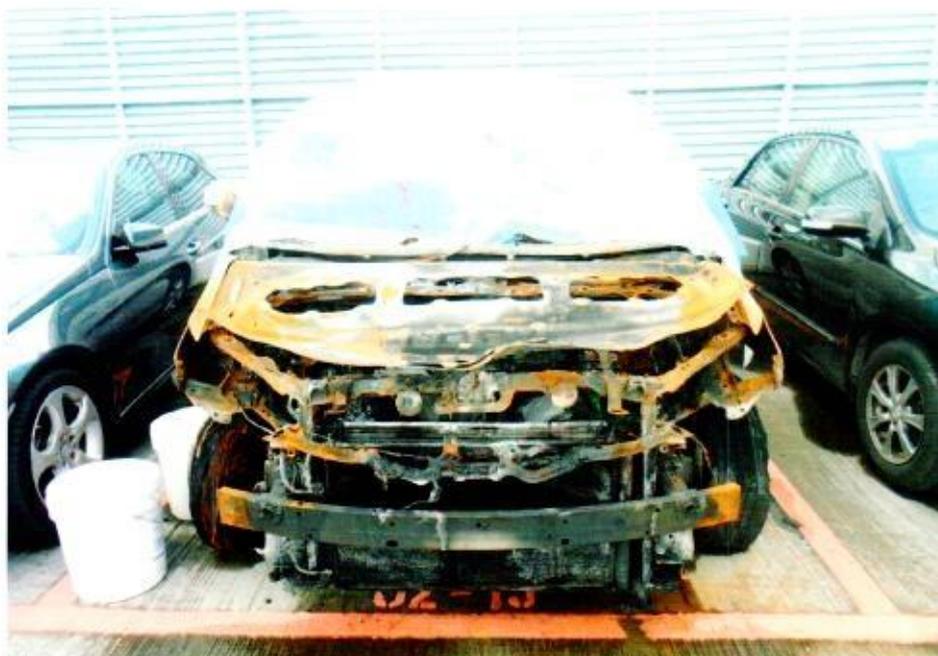
**Photo 1** shows the general view of the front right portion of the Insured Vehicle at the time of our inspection. The fire damage to the Insured Vehicle was confined to its front and interior portion. Its front bumper, front bonnet, front grille and front right headlamp and interior parts were amongst the body parts that were found to have been affected as a result of the fire.

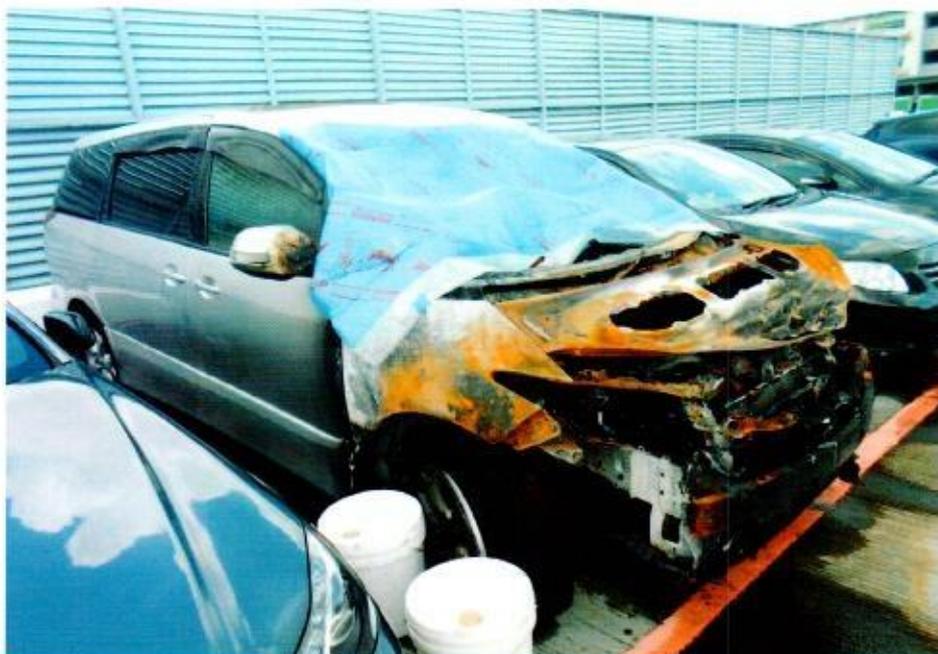
**Photo 2** shows the general view of the front right portion of the Insured Vehicle at the time of our inspection. The fire damage to the Insured Vehicle was confined to its front portion. Its front bumper, front bonnet and front left headlamp were amongst the body parts that were found to have been affected as a result of the fire.

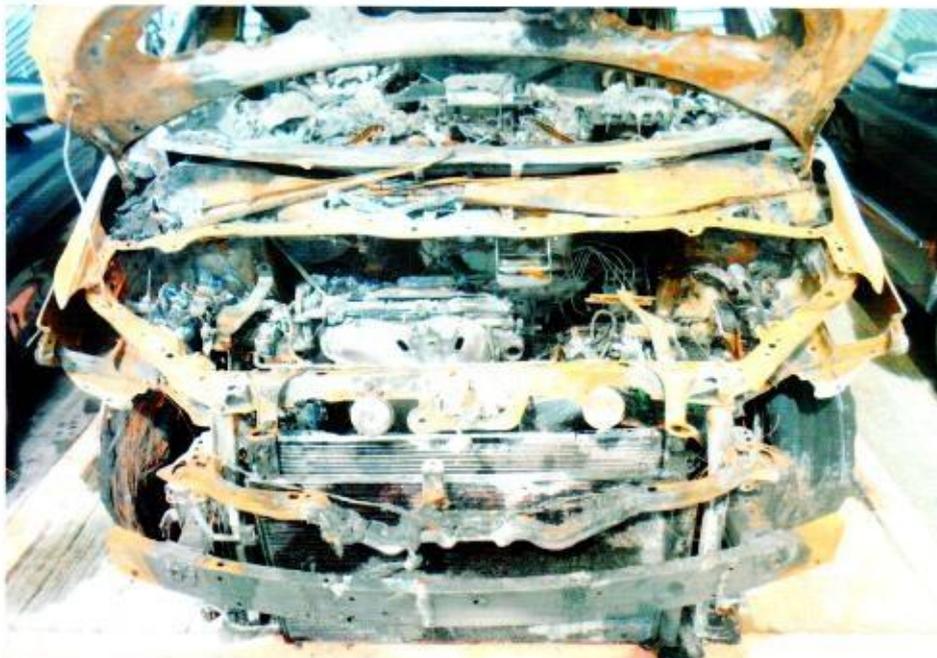
**Photo 3** shows the engine compartment of the Insured Vehicle at the time of our inspection. The entire engine compartment of the Insured Vehicle was observed to be severely burnt. Most of the parts inside the engine compartment were found to be burnt and/or melted as a result of the fire.

8. For this particular case, the fire appears to have originated within the engine compartment of the Insured Vehicle, This can be determined from the burn pattern and the high heat intensity burn marks (whitish burn marks) found on the front bonnet and front left side fender of the Insured Vehicle.
9. These whitish burn marks are a result of exposure to prolong heat intensity. Rust would normally start to develop around these areas soon after a fire as prolonged exposure to high heat intensity usually causes steel/metal material body parts to be exposed to natural environmental condition. See photo 7 below.

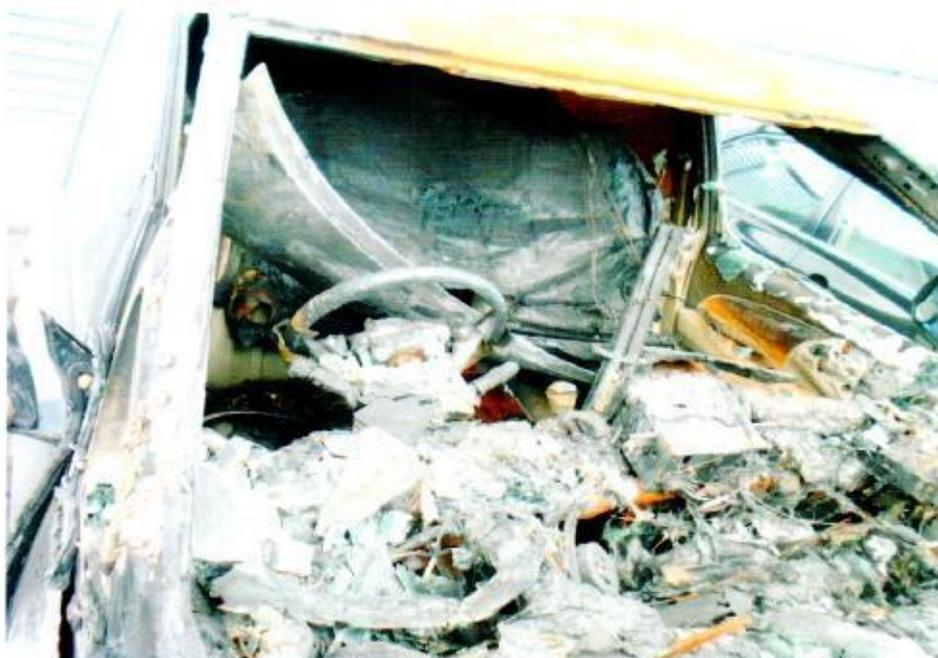
**Photo 4** shows the windshield of the Insured Vehicle, which was observed to be missing amongst the parts that were found to have been damaged as a result of the fire.

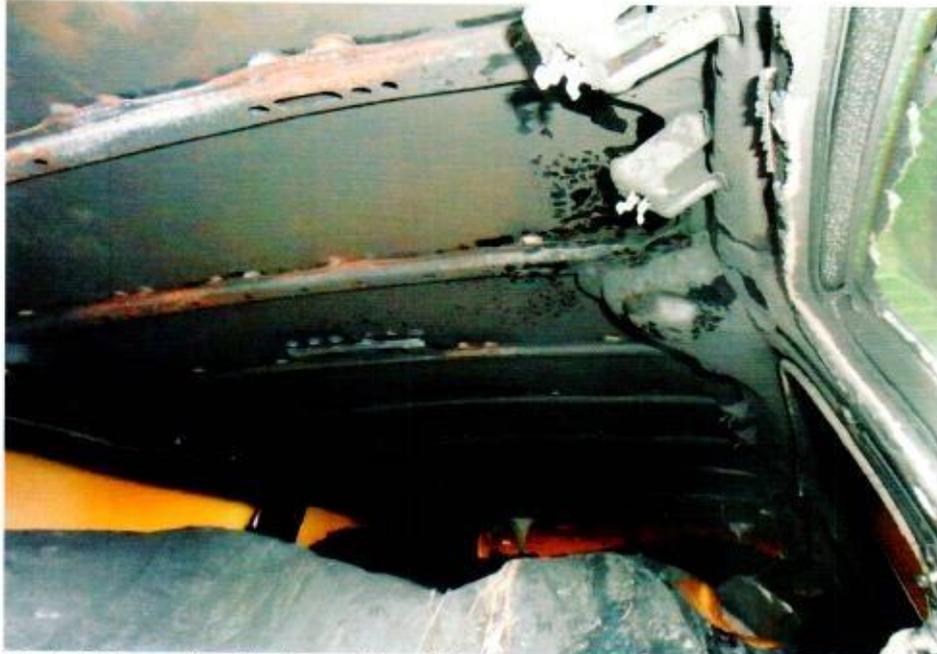
**Photo 5** shows the interior roof top of the Insured Vehicle, which was observed to be burnt. It was amongst the parts that were found to have been damaged as a result of the fire.

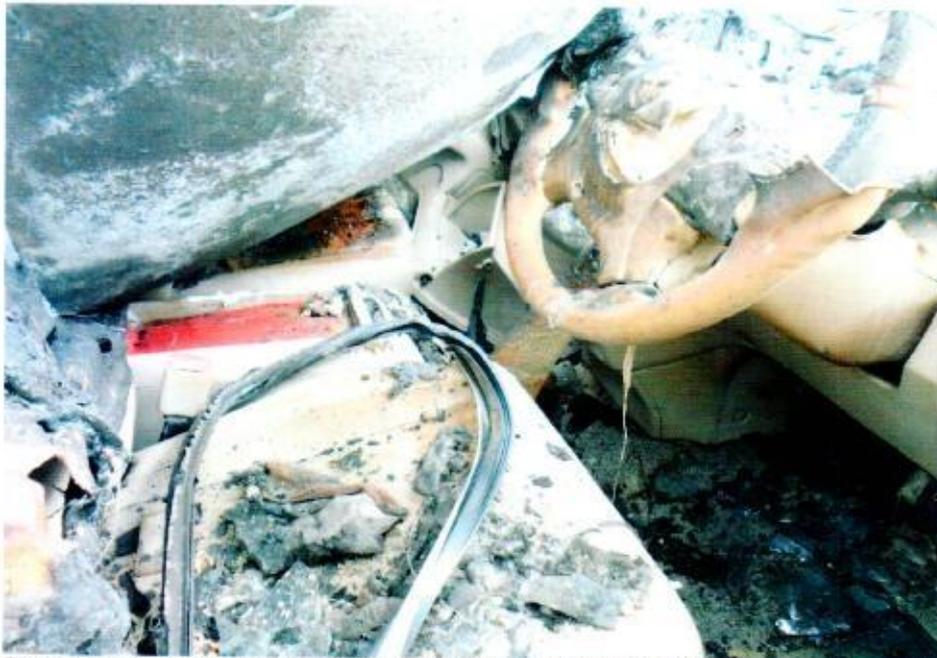
**Photo 6** shows the interior cabin of the Insured Vehicle, which was observed to be burnt. It was amongst the parts that were found to have been damaged as a result of the fire.

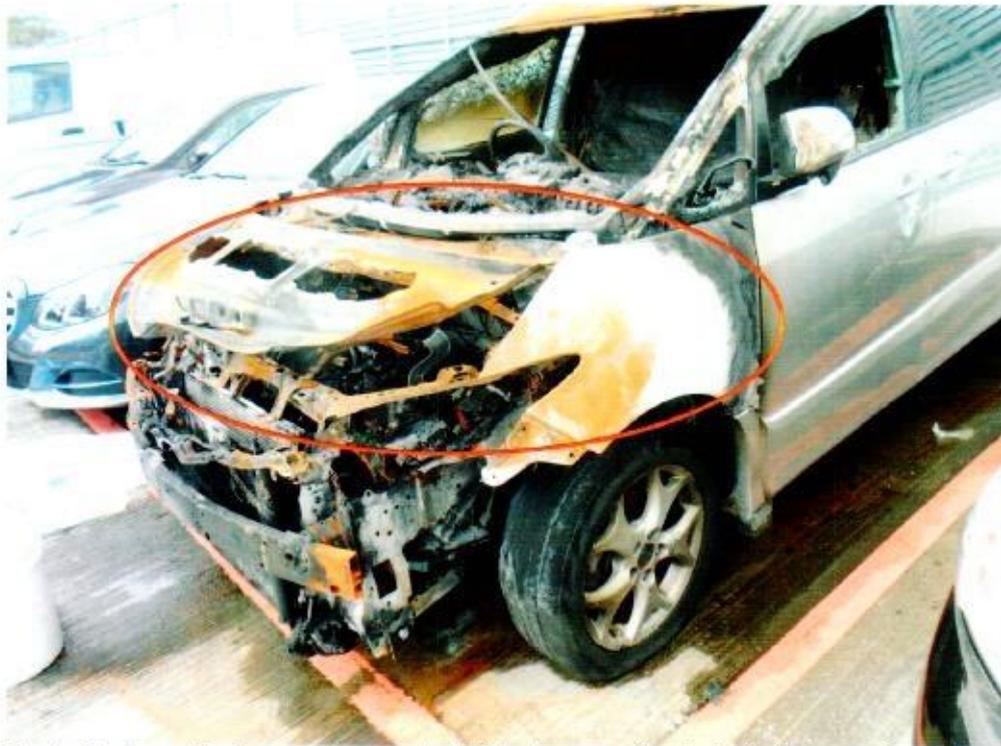
**Photo 7** shows the burn pattern and whitish burn marks (circled) that were found on the top side of the front bonnet of the Insured Vehicle. Such whitish burn marks are a result of exposure to prolong heat intensity, which may indicate where the fire had started. Rust would also begin to develop on these areas soon after the fire.

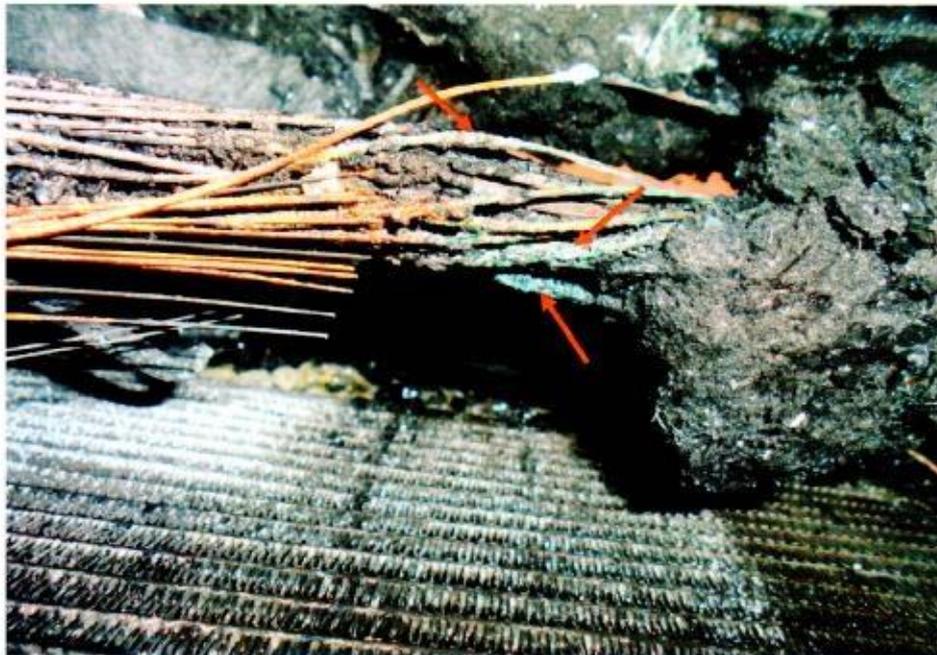
10. Upon closer examination of the area around the front left of the engine compartment, which was in the immediate vicinity of where the fire to the Insured Vehicle had likely started, we had found several stretches of wiring burnt internally to its bare copper state. These wirings were observed to be greenish in colour believe to be the focal point of the ignition of fire. The wirings of the Insured Vehicle and are likely to be the original engine wire harness. Such condition normally indicate internal heating of copper wires which is a sign of an electrical short circuit occurring. This would then appear to suggest that the cause of fire to the Insured Vehicle could have possibly been due to electrical in nature. See photo 8 - 9 below.

**Photo 8** shows the close-up view of the wirings around the front of the engine compartment, which was in the immediate vicinity where the fire to the Insured Vehicle had likely started. These wirings were observed to be greenish in colour believe to be the focal point of the ignition of fire. The wirings (red arrow) were found to have been burnt internally, suggesting occurrence of an electrical short circuit. The wirings also appear to be an original engine wire harness of the insured vehicle.

26. Having investigated and technically analysed the damages of burnt nature to the Insured Vehicle, we are of the view that the cause of fire to the Insured Vehicle was of electrical in nature. For this particular case, the fire had originated along the wiring inside the engine compartment, somewhere around the front of the engine compartment. The wiring was an original factory fitted on the Insured Vehicle.
27. We did not find any evidence which had suggested that the cause of fire to the Insured Vehicle was due to poor maintenance and/or recurring electrical problem.
28. There were no modification(s) or additional electronic and/or electrical component(s) fitted on the Insured Vehicle at the time of our inspection of the Insured Vehicle.

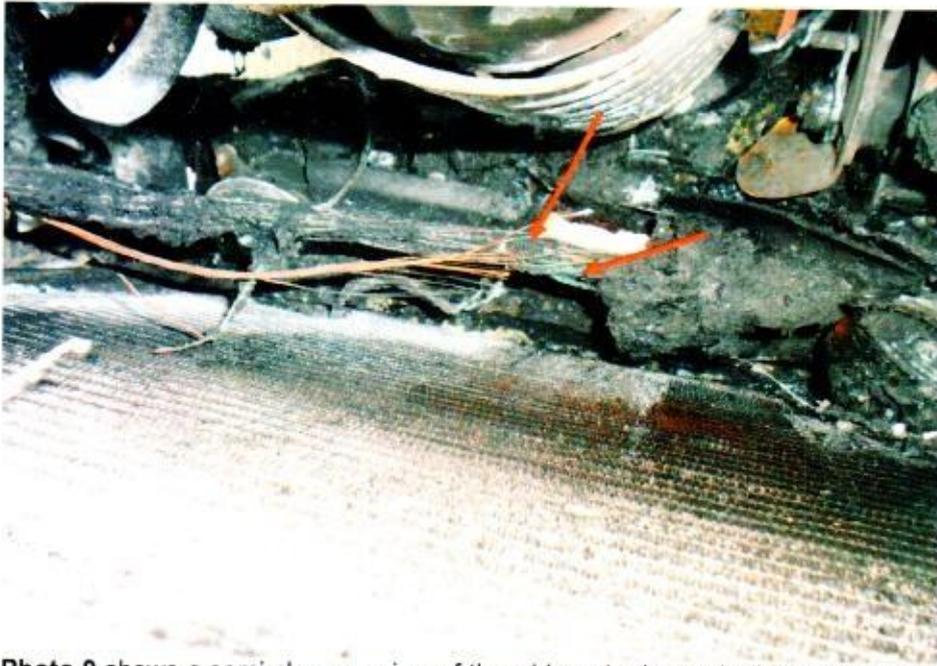
**Photo 9** shows a semi-close up view of the wirings (red arrow) which were found to have been burnt internally, suggesting occurrence of an electrical short circuit.

24. The possibility of the fire being due to electrical in nature would then seem more likely given that engine overheating and external factor would both seem unlikely. The fire being due to electrical nature is also supported by the condition of the wirings of the Insured Vehicle, which was earlier discussed in paragraph 10 above.

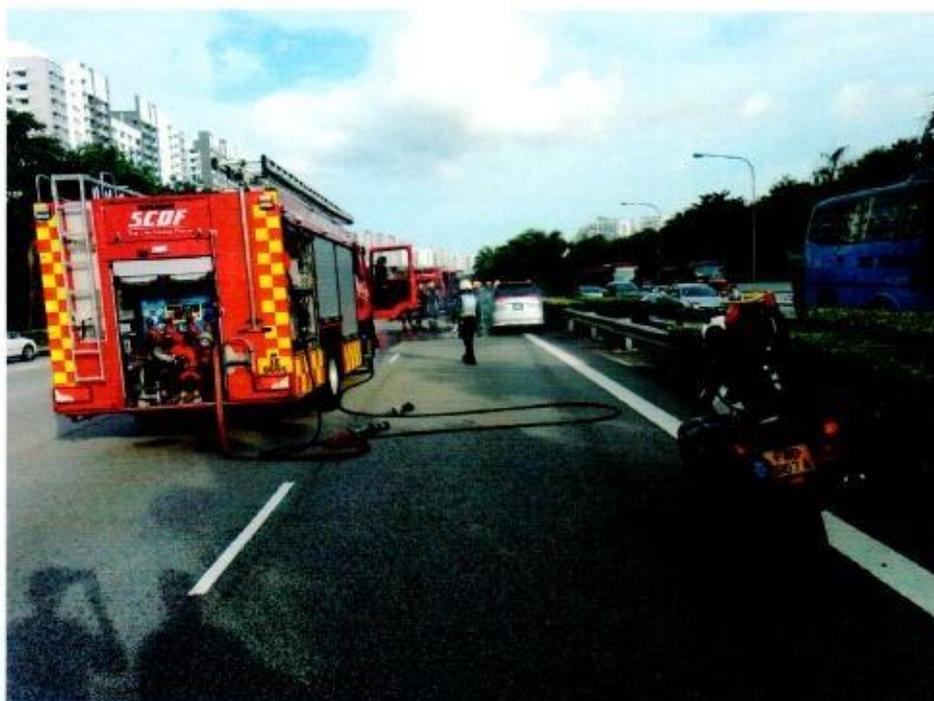
**Photo 11** shows the Insured Vehicle at the incident scene. SCDF fire fighters were seen trying to extinguish the fire from the Insured Vehicle.

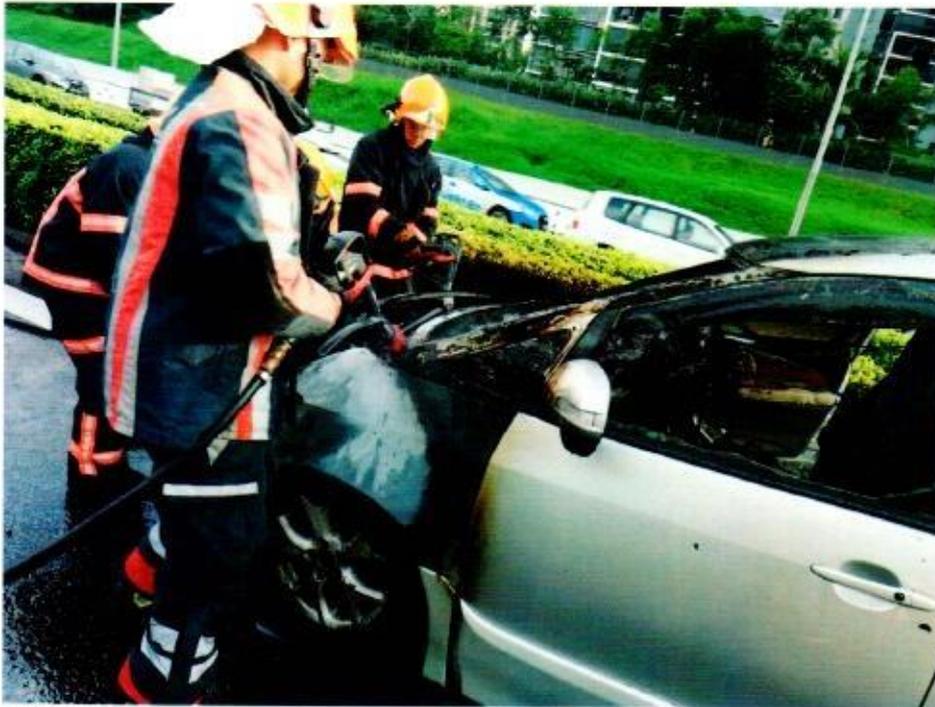
Photo 12 shows the Insured Vehicle at the incident scene. SCDF fire fighters were seen trying to extinguish the fire from the Insured Vehicle.
