Your Ref: Z18VC05000872
Our Ref : CS/LPC18021332/Z

03rd December 2018

**TECHNICAL INVESTIGATION REPORT OF FIRE INCIDENT INVOLVING THE
INSURED VEHICLE YN 9976E ON 24th November 2018**

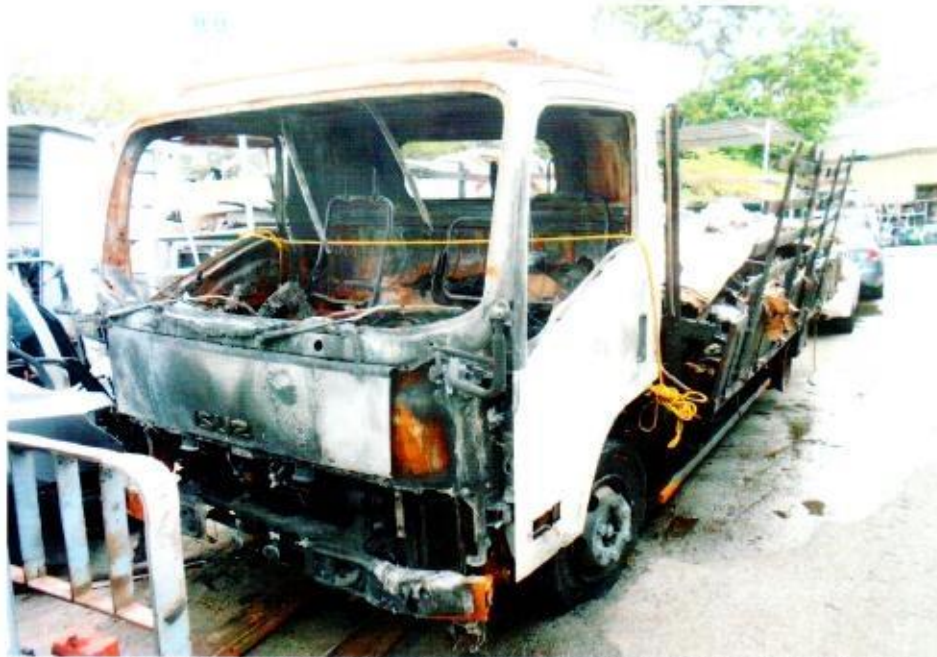
Photo 1 shows the general view of the front left portion of the Insured Vehicle at the time of our inspection. The Insured Vehicle was observed to have sustained extensive fire damage all around. Its engine compartment and interior compartment were completely burnt. Rust had accumulated all over the Insured Vehicle as a result of exposure to environmental condition for a period of time.

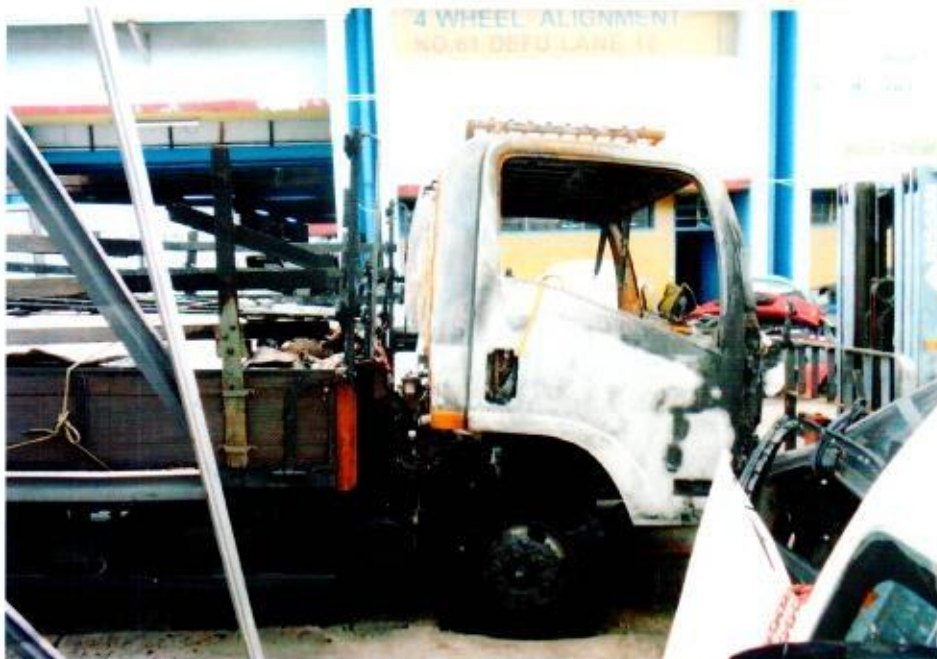
Photo 2 shows the general view of the right front portion of the Insured Vehicle at the time of our inspection. The Insured Vehicle was observed to have sustained extensive fire damage all around. Rust had accumulated all over the Insured Vehicle as a result of exposure to environmental condition for a period of time.

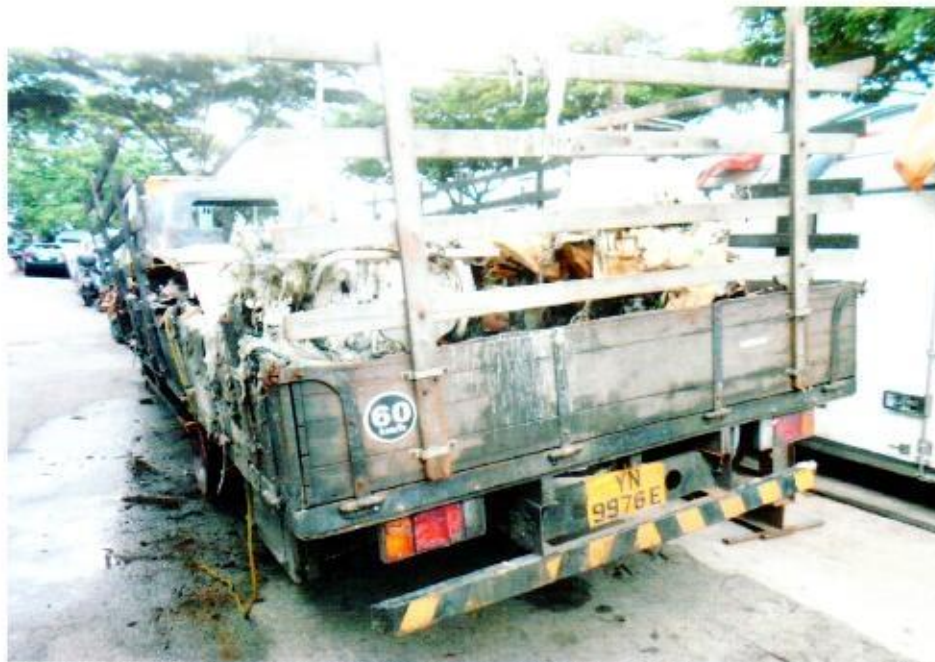
Photo 3 shows the general view of the rear body of the Insured Vehicle at the time of our inspection. The Insured Vehicle was observed to have sustained extensive fire damage at the rear storage compartment. Carton boxes, plastics, steel materials were found to be burnt which were located at the rear compartment affected by the fire.

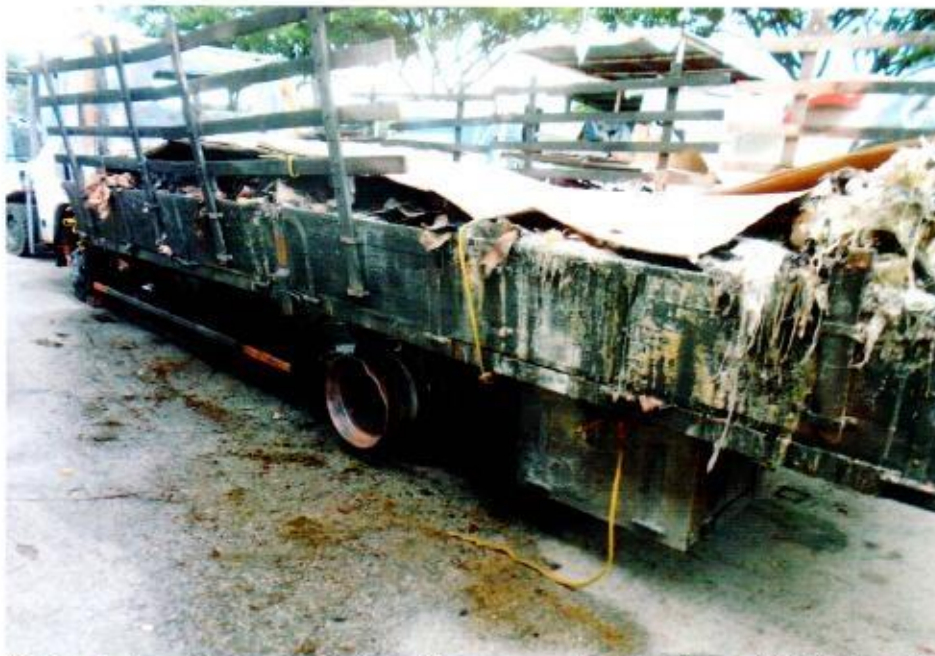
Photo 4 shows the general view of the rear body of the Insured Vehicle at the time of our inspection. The Insured Vehicle was observed to have sustained extensive fire damage at the rear storage compartment. Carton boxes, plastics, steel materials were found to be burnt which were located at the rear compartment affected by the fire.

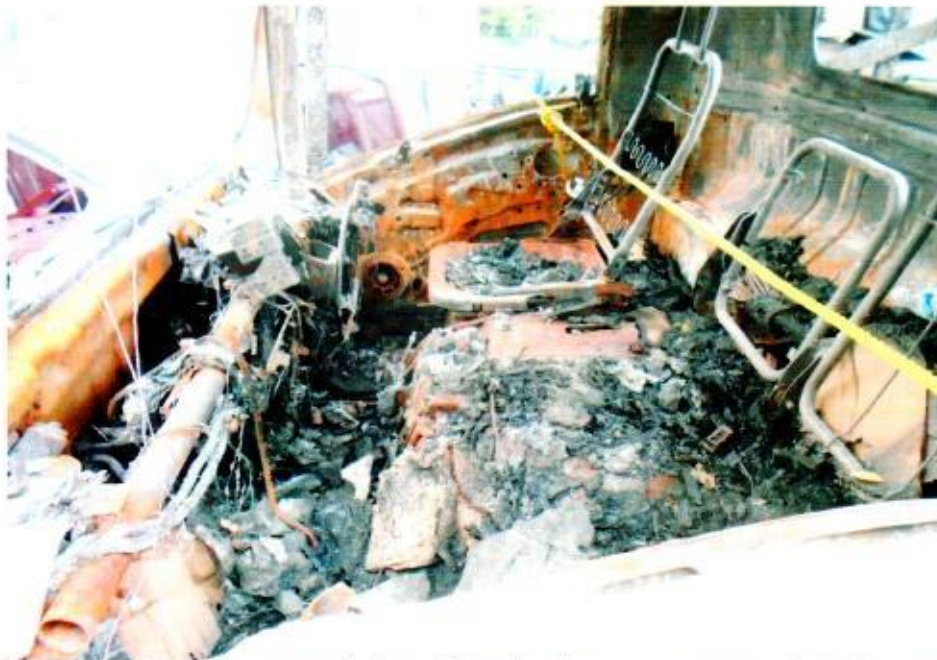
Photo 5 shows the general view of the interior compartment of the Insured Vehicle at the time of our inspection. Its interior compartment was completely burnt as a result of the fire.

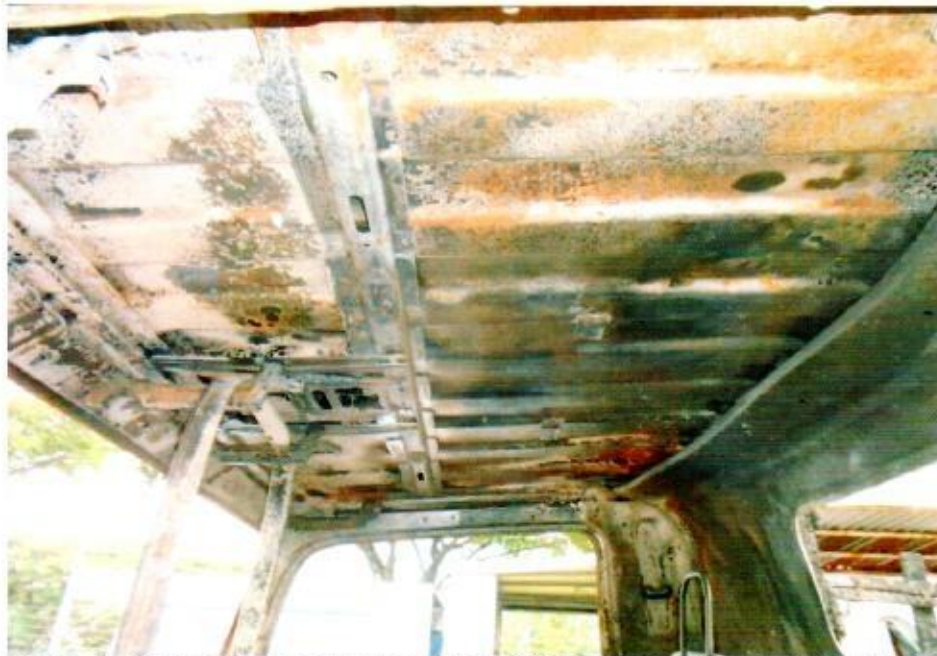
Photo 6 shows the general view of the interior compartment of the Insured Vehicle at the time of our inspection. Its interior compartment was completely burnt as a result of the fire.

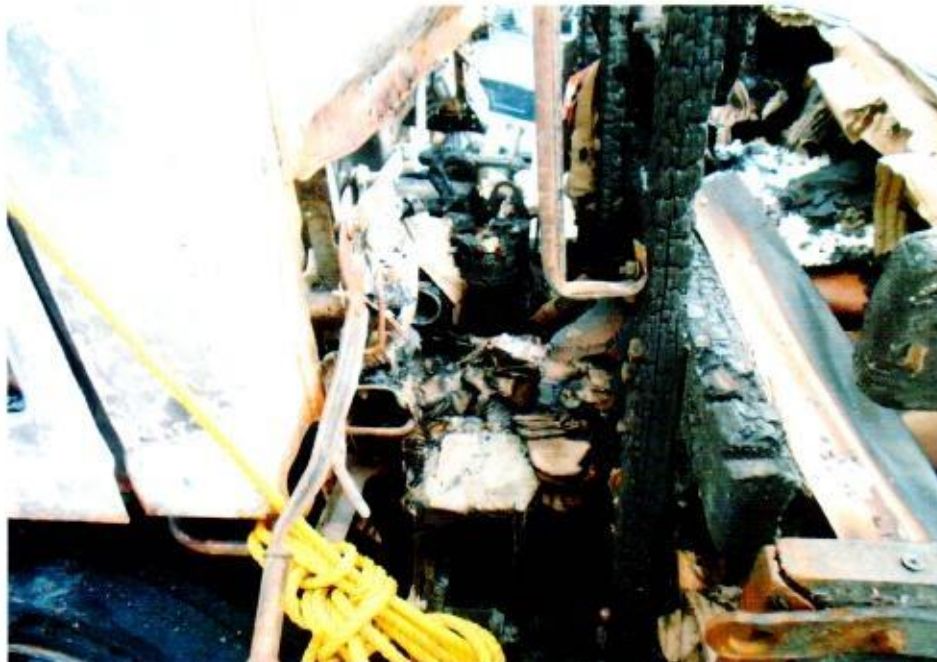
Photo 7 shows part of the engine compartment of the Insured Vehicle at the time of our inspection. The entire engine compartment of the Insured Vehicle was observed to be severely burnt. Most of the parts inside the engine compartment were found to be burnt and/or melted as a result of the fire.

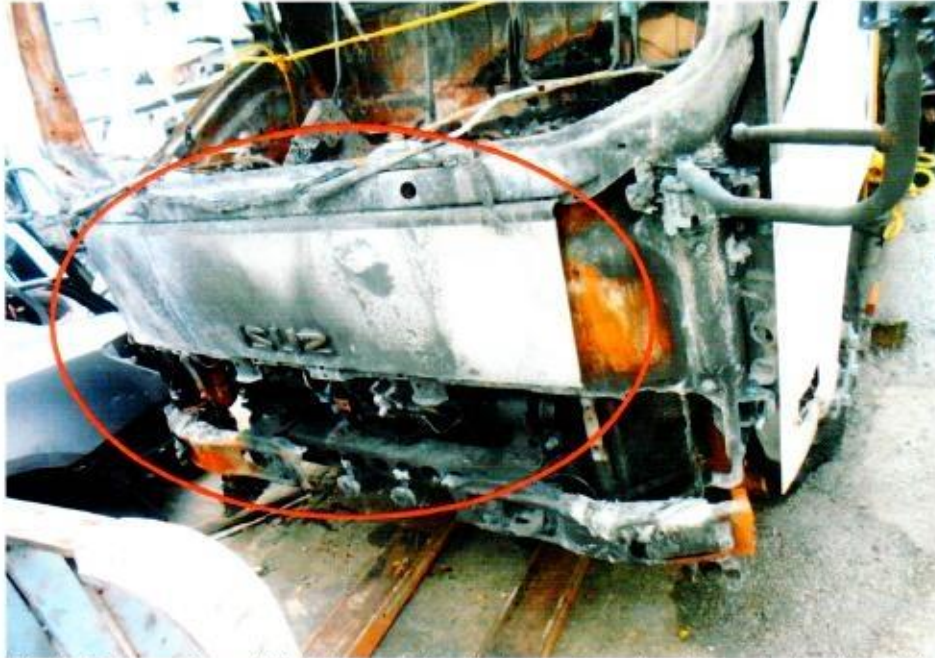
7. For this particular case, the fire appears to have originated within the engine compartment of the Insured Vehicle. This can be determined from the burn pattern and the high heat intensity burn marks (whitish burn marks) found as well as the rust that had developed on the exterior side of the Insured Vehicle.
8. The whitish burn marks are a result of exposure to prolonged heat intensity. Rust would normally start to develop around these areas soon after a fire as prolonged exposure to high heat intensity usually causes steel/metal material body parts to be exposed to natural environmental condition. The rust that had developed on the exterior side of the Insured Vehicle is an indication that the engine compartment had sustained exposure to prolonged high heat intensity. See photo 8 below.

Photo 8 shows the whitish burn marks that were found on the exterior side of the Insured Vehicle (circled). Such whitish burn marks are a result of exposure to prolonged heat intensity. Rust would also begin to develop on these areas soon after the fire. The development of rust is an indication that the area was exposed to prolonged exposure to high heat intensity, which had caused the steel/metal material of the passenger side engine access panel to be exposed to natural environmental condition.

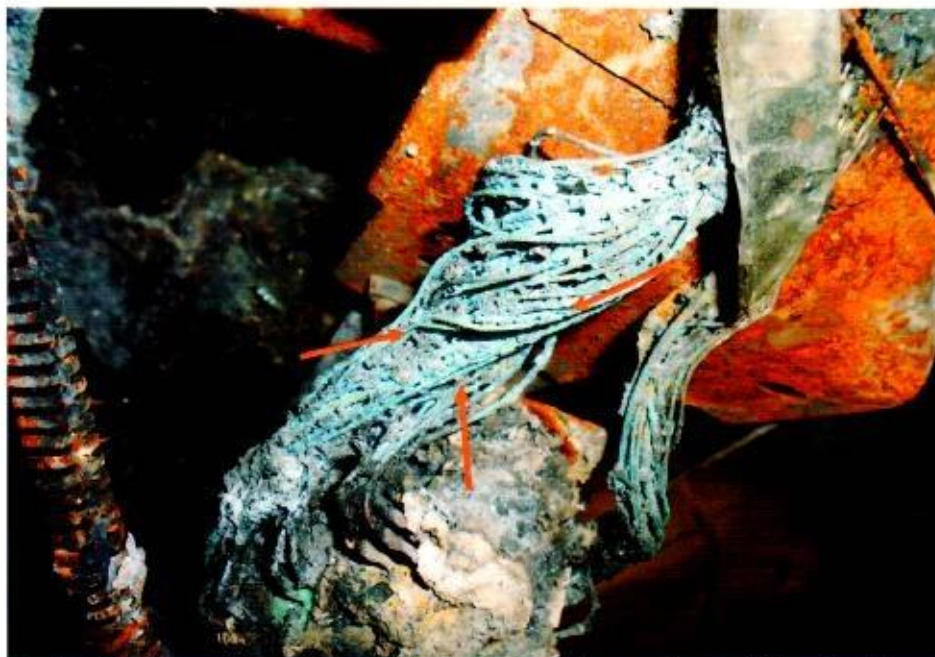
9. Upon closer examination of the engine compartment, which was where the fire to the Insured Vehicle had likely started, we had found several stretches of wiring with green residue. These wirings were original factory fitted wirings that were around the centre portion of the engine compartment. We also found greenish residue on several stretches of wirings leading from the battery of the Insured Vehicle. The presence of greenish residue indicates internal heating of copper wires, a sign of an electrical short circuit occurring. The greenish residue is normally left behind from oxidation as a result of chemical reaction involving the copper wires. These physical evidences would appear to suggest that the cause of fire to the Insured Vehicle could have possibly been due to electrical in nature. See photos 9 - 13 below.

Photo 9 shows the wirings around the centre portion of the dashboard compartment which is near to the vicinity where the fire to the Insured Vehicle had likely started. We observed greenish residue on the wirings at the centre portion of the dashboard compartment (arrowed).

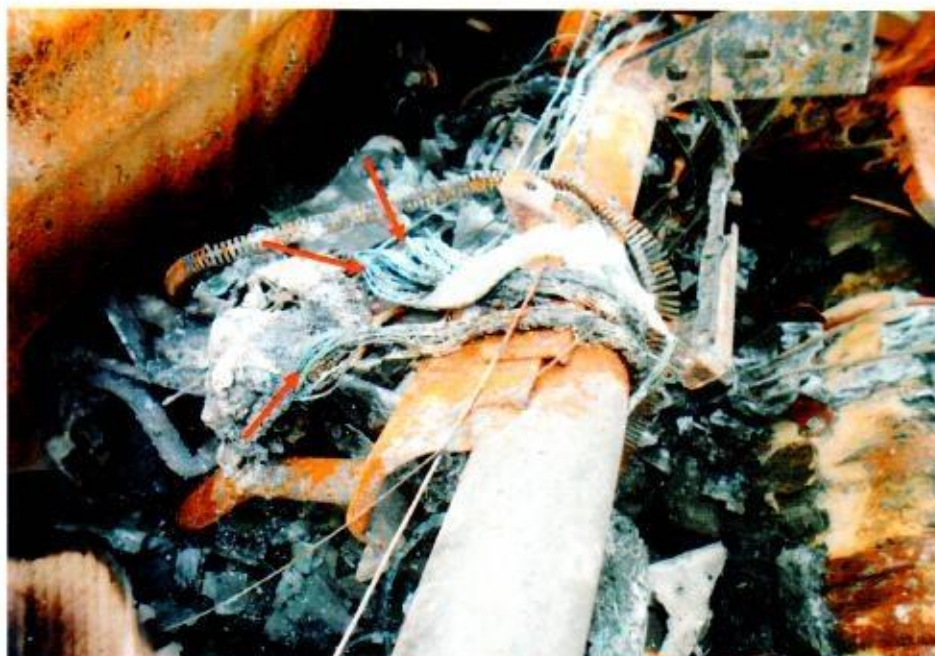
Photo 10 shows a closer view of the greenish residue found on the wirings at the centre portion of the dashboard compartment (arrowed). This seems to suggest the occurrence of an electrical short circuit.

22. The possibility of the fire being due to electrical in nature is also possible. The fire being due to electrical in nature is also supported by the condition of the wirings that were found in the engine compartment of the Insured Vehicle, which was earlier discussed in paragraph 9 above. However, given that Mr Lee had first seen fire at the rear compartment where the carton boxes are located, the cause of fire is more likely due to external factor.

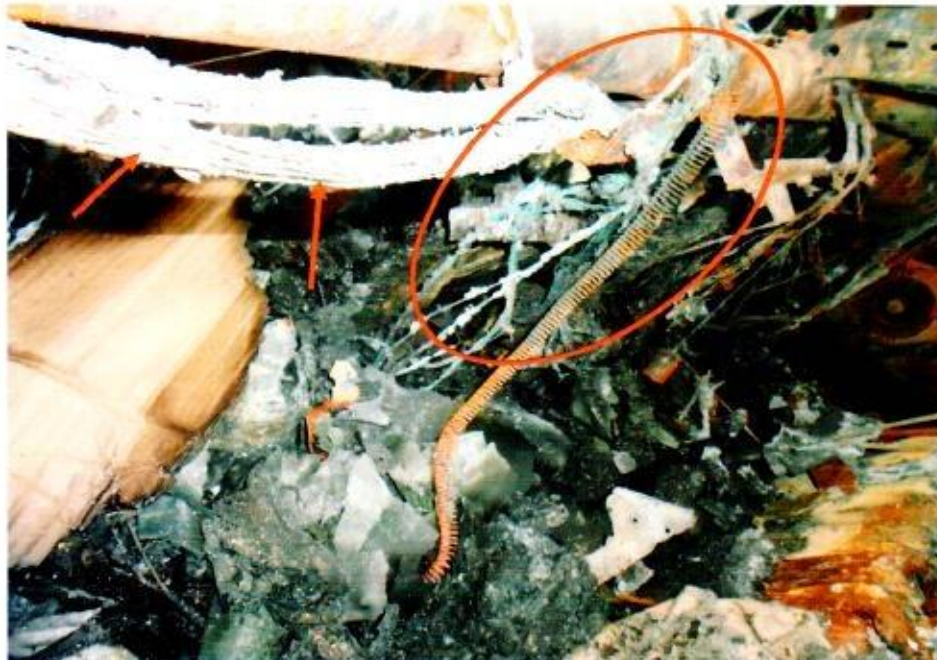
Photo 11 shows the original stretch wirings located at the centre portion of the dashboard (circled) of the Insured Vehicle. We observed greenish residue on these wirings (arrowed).

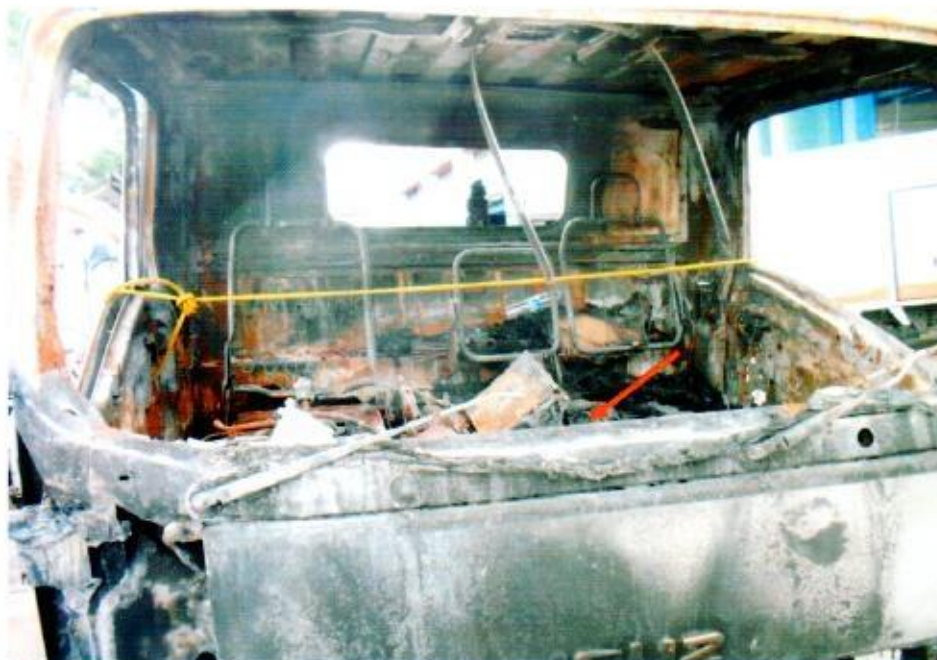
Photo 12 shows a general view of the front dashboard where the possible shot circuit wirings of the Insured Vehicle (arrowed).

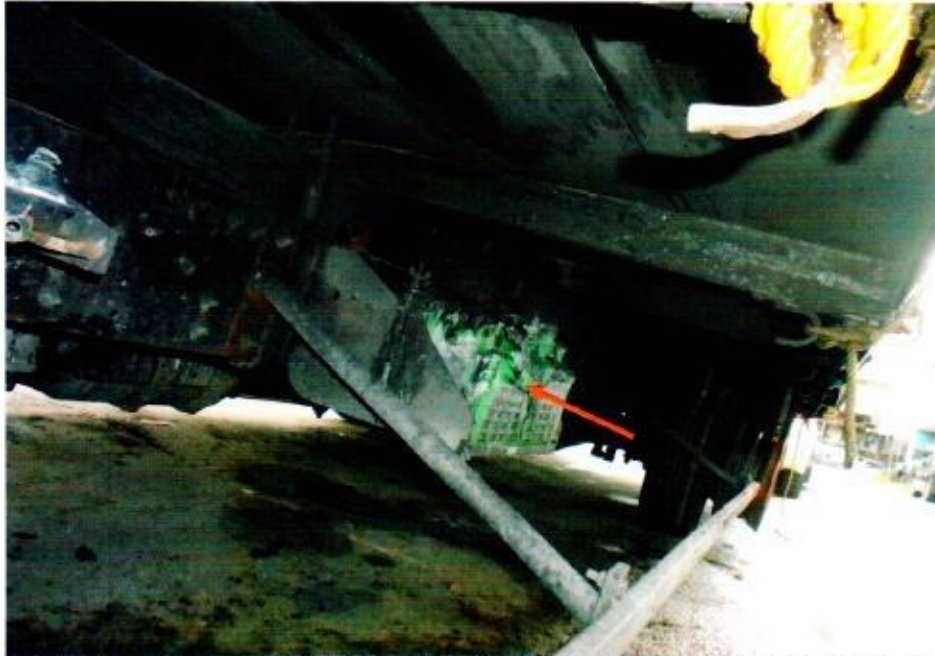
Photo 13 shows a general view of the melted battery of the Insured Vehicle due to the fire incident.

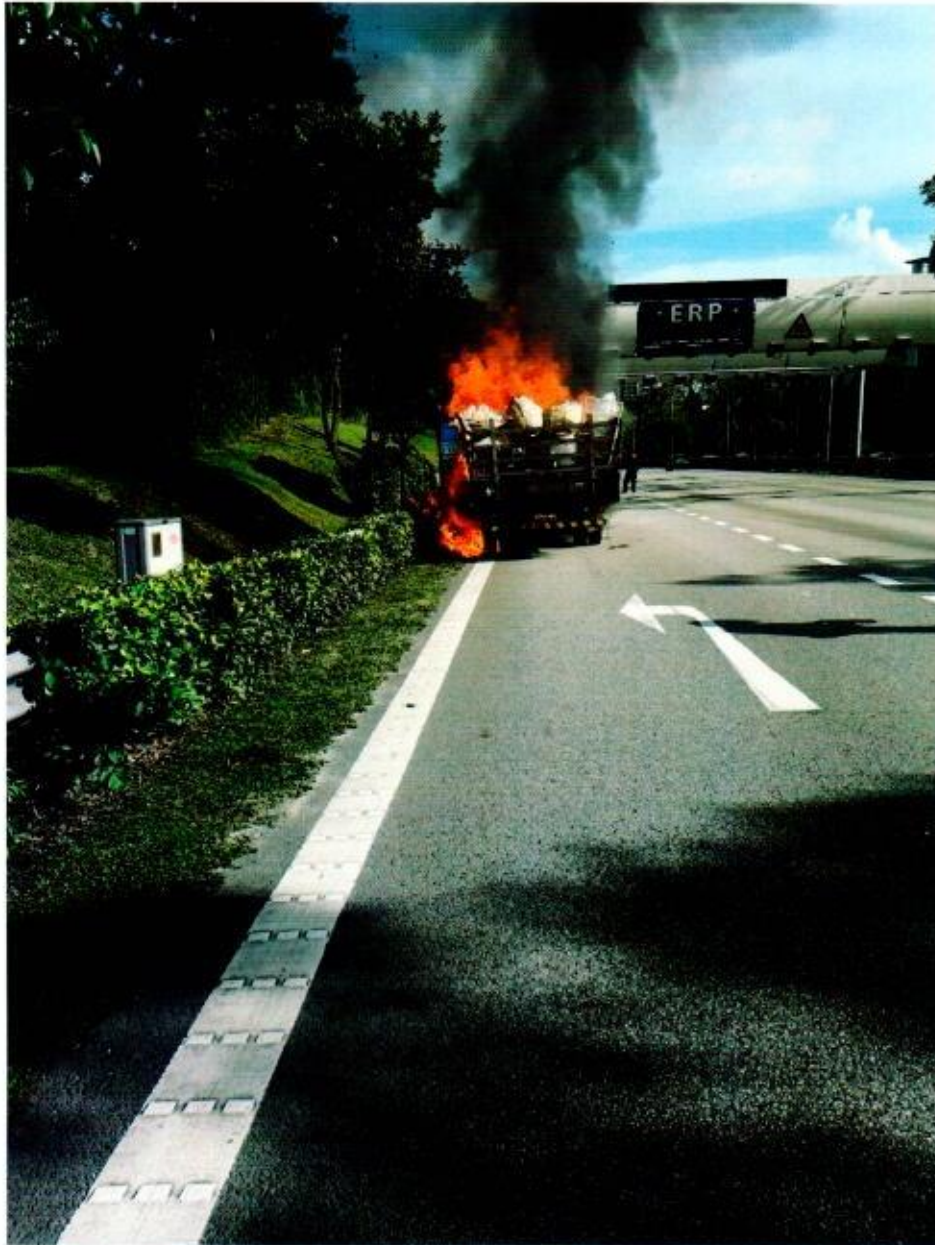
Photo 14 shows the Insured Vehicle engulfed in flames before the arrival of the SCDF.

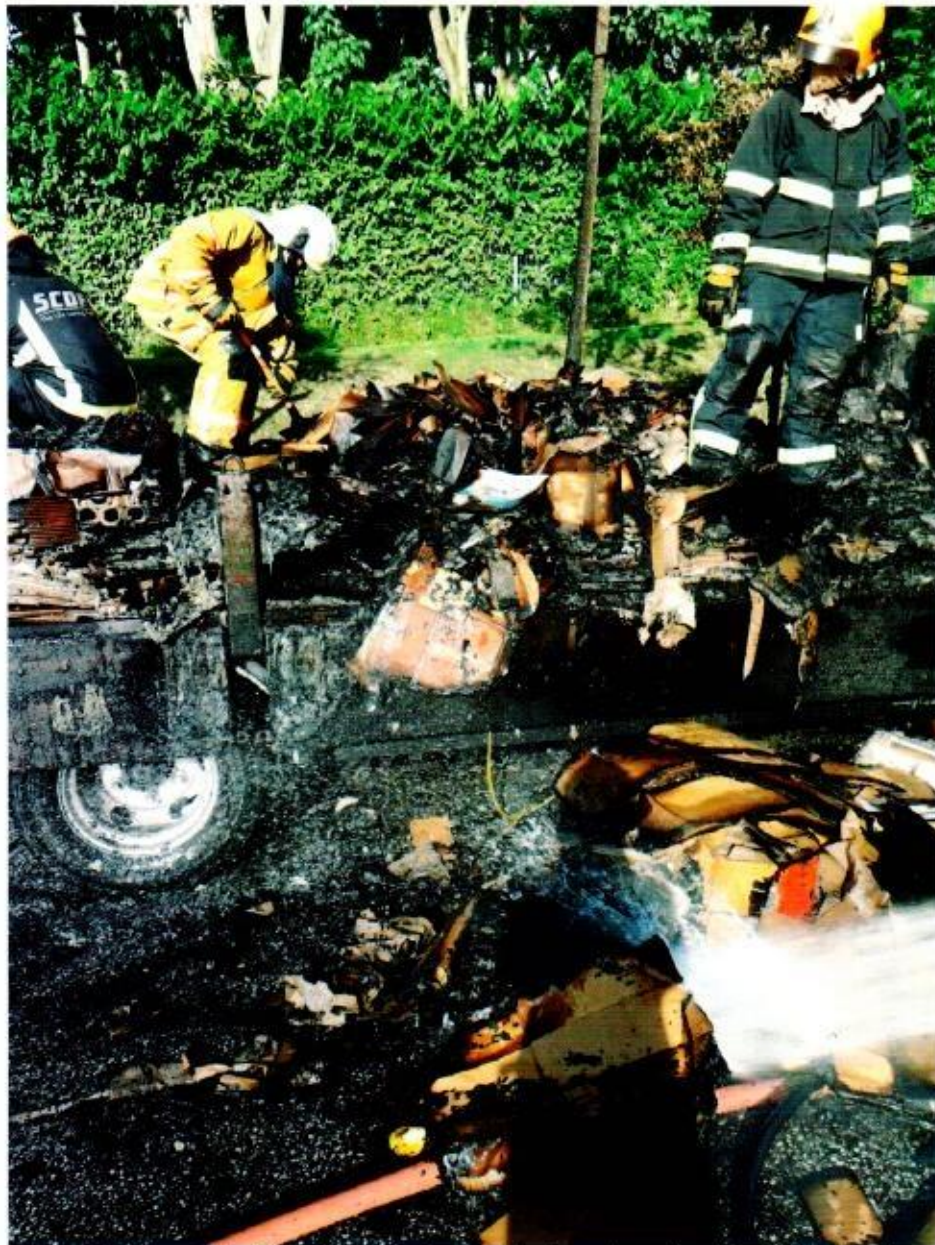
Photo 15 shows the SCDF conducting preliminary investigations after the fire to the Insured Vehicle was extinguished.
