**PRELIMINARY ADVICE OF VEHICLE NO.**

**SHA 3924P**

**ADJUSTMENT ON REPAIR COST FOR VEHICLE NO. SHA 3924P**

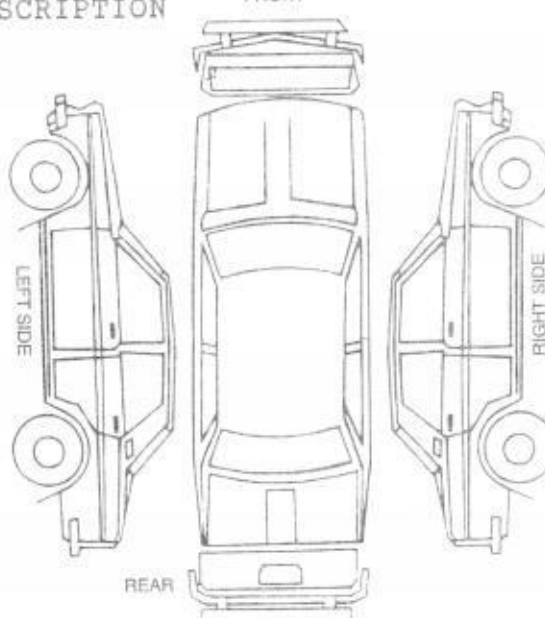
FRONT

The vehicle sustained damages at the  
N/S Front Portion
